REPLICATION OF THE SCULPTURE AT ST. PAUL'S CHAPEL
Application to the NYC Landmarks Preservation Commission

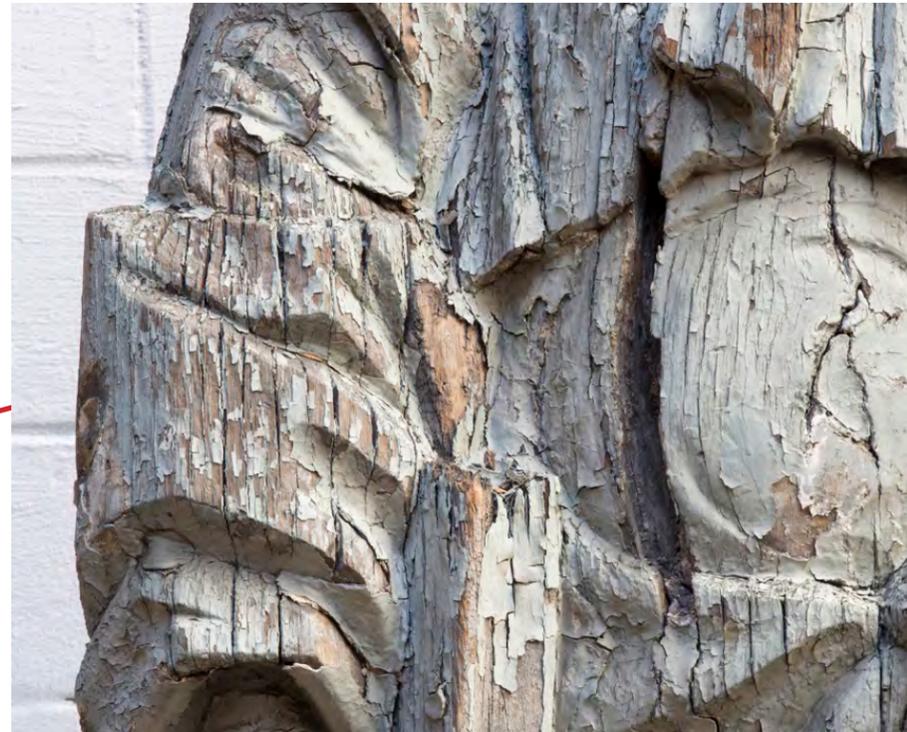
A. Detail of extensive splits in wood and loss of coatings.

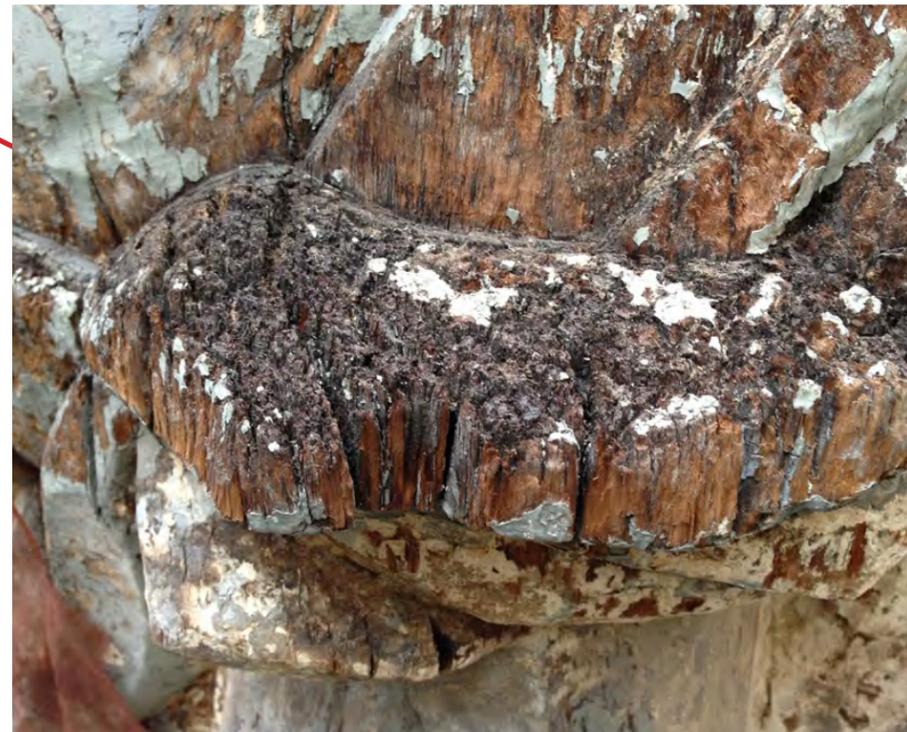
B. Detail of extensive deterioration of the wood.

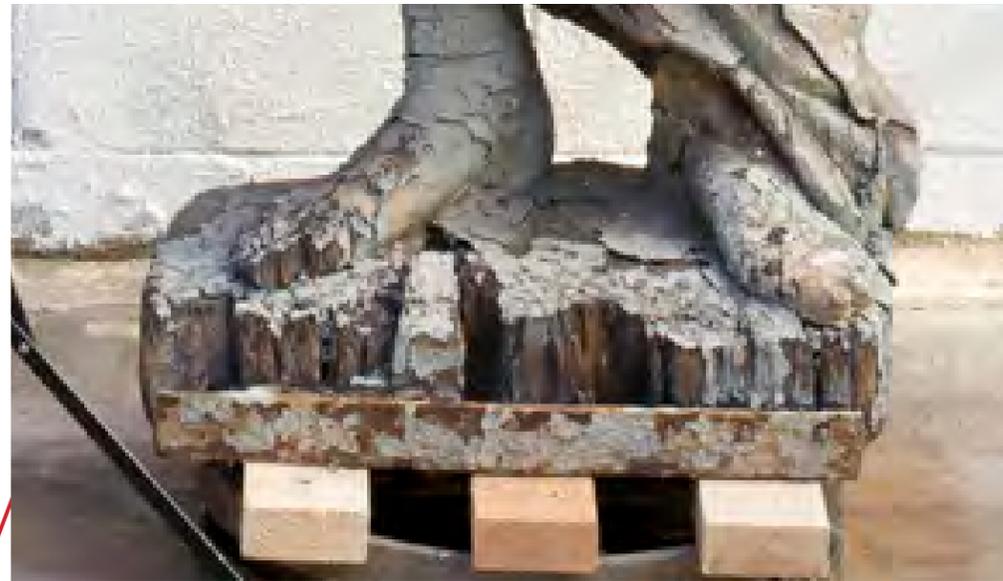
A. Base of sculpture before removal of unsalvageable deteriorated wood.

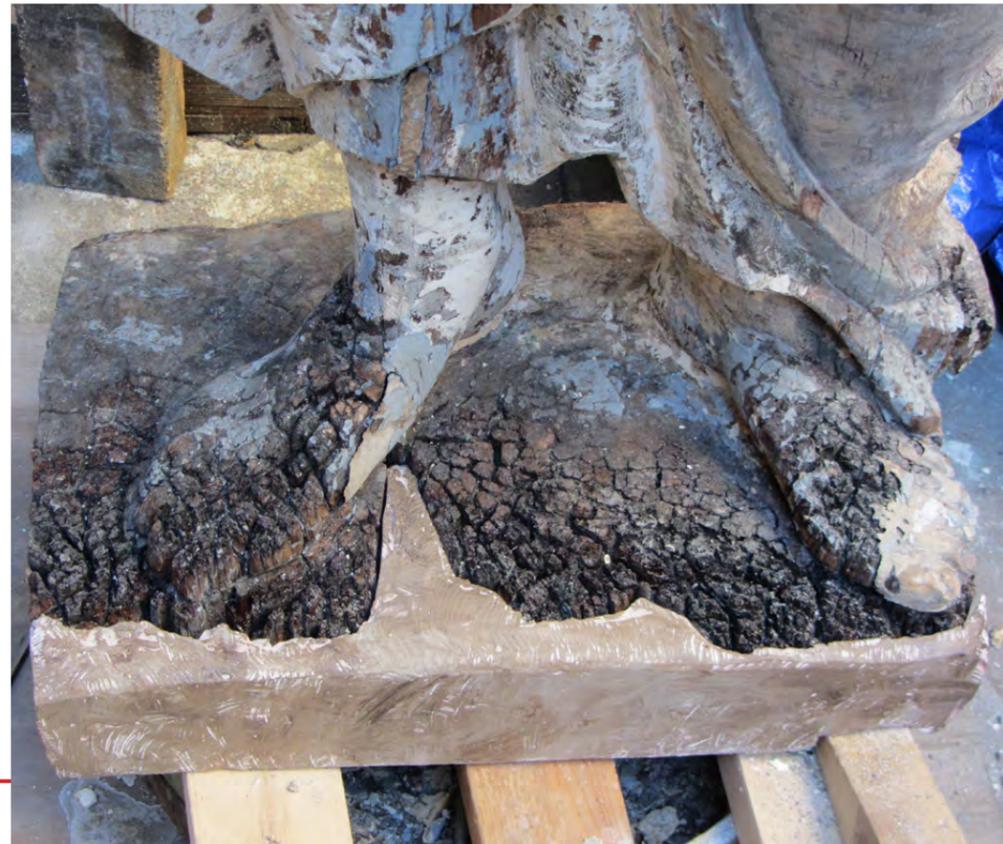
B. Base of sculpture following removal of all unsalvageable deteriorated wood. Grey material is a resin that has been cast to infill the largest loss.

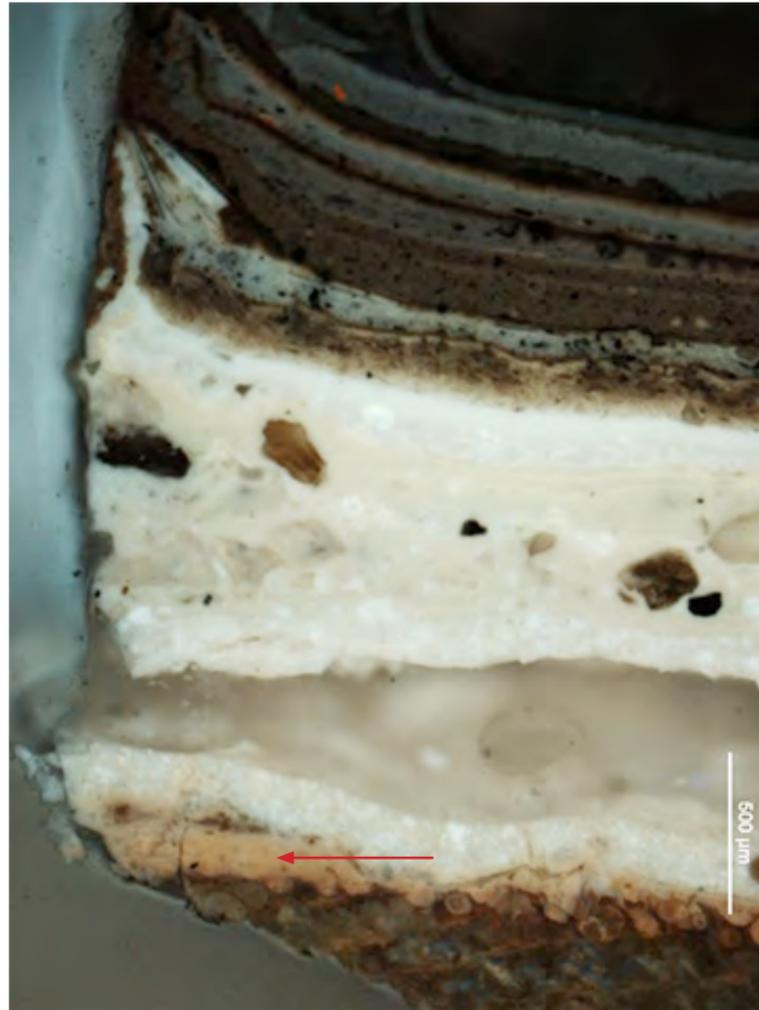
8. The bracketed layers are the c. 1930 “liquid marble.” It was applied not to make the sculpture look like stone, but to provide a hard, dense barrier to protect the wood and a smooth surface for painting. The remnants of pre-1930 coatings are identified by the red arrow.

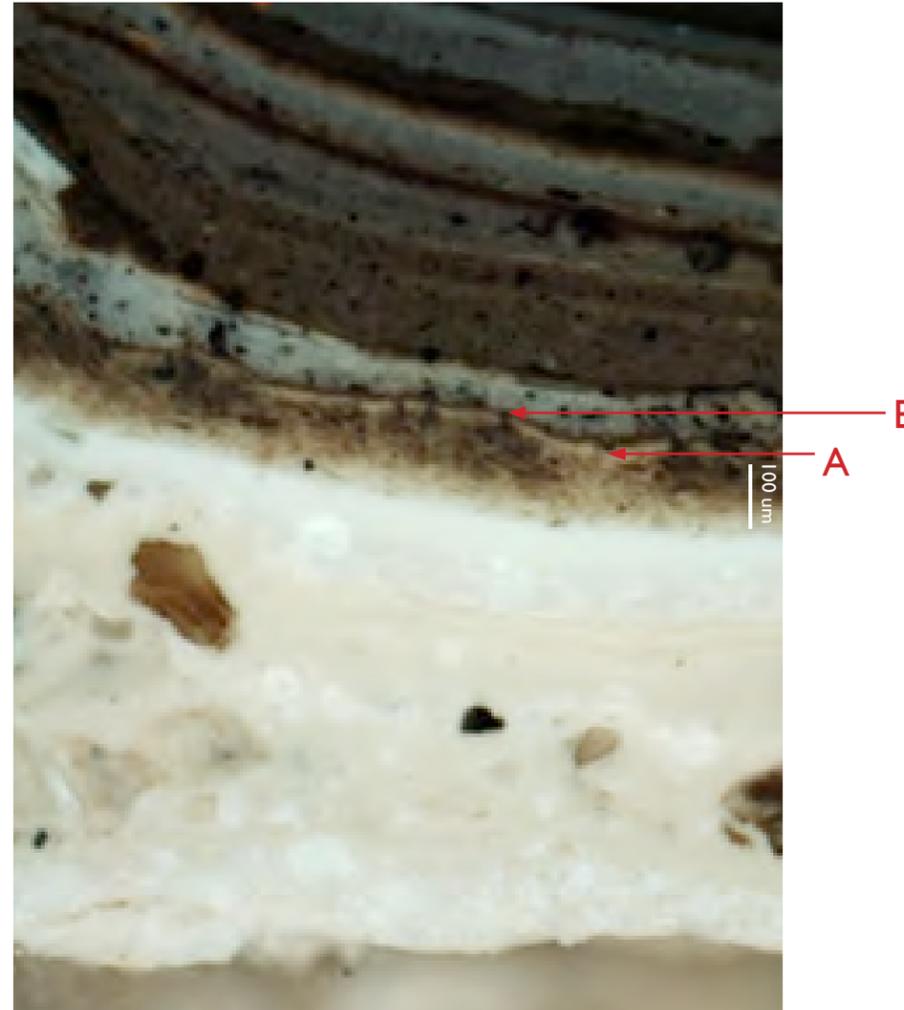
9. Red arrow A indicates the layer believed to be the primer applied on top of the “liquid marble” and red arrow B is believed to be the 1930s finish paint, which in the archival literature is noted to be a ‘natural color.’

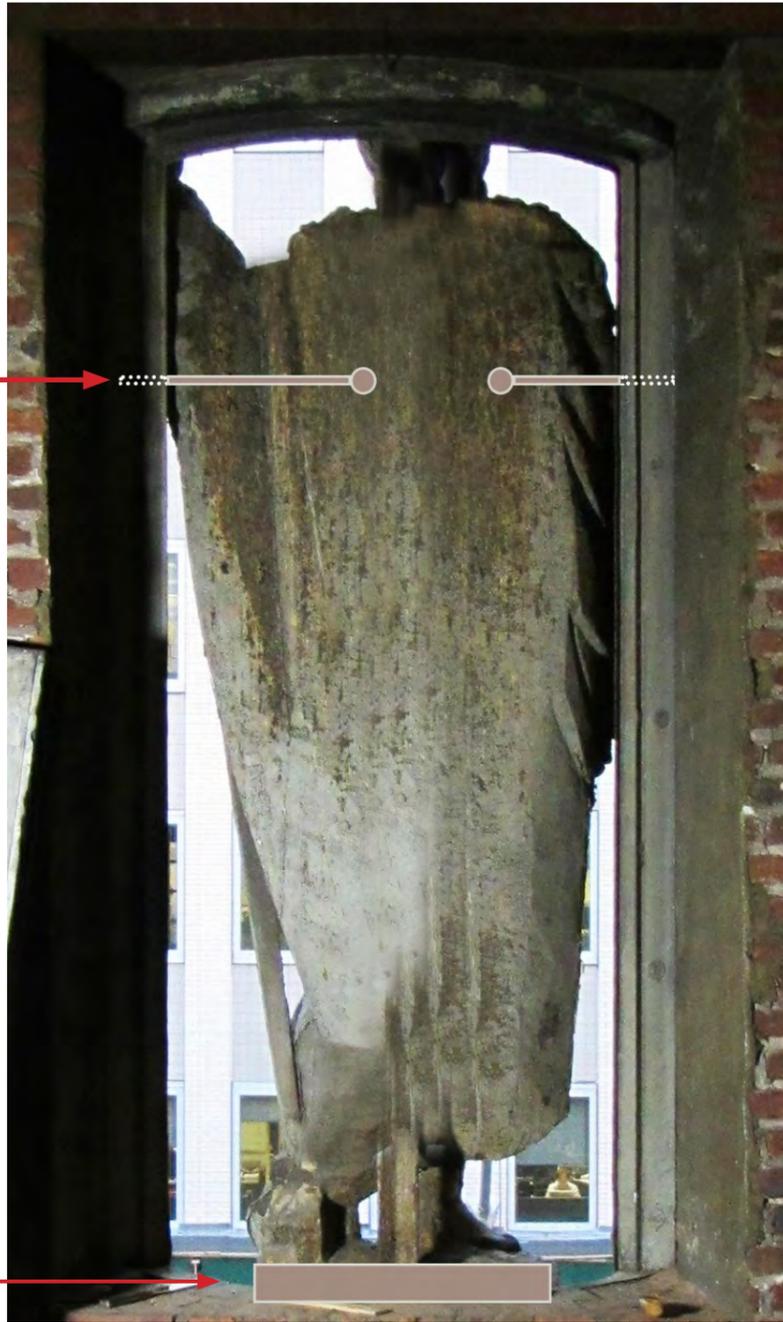
18. Back elevation as viewed from attic (niche doors are removed). Image shows historic sculpture for reference only.

Replica secured with stainless steel rods bolted to internal armature and anchored into masonry at jambs of niche and with stainless steel angle at rear of base anchored to internal armature of replica and bolted to base of niche.

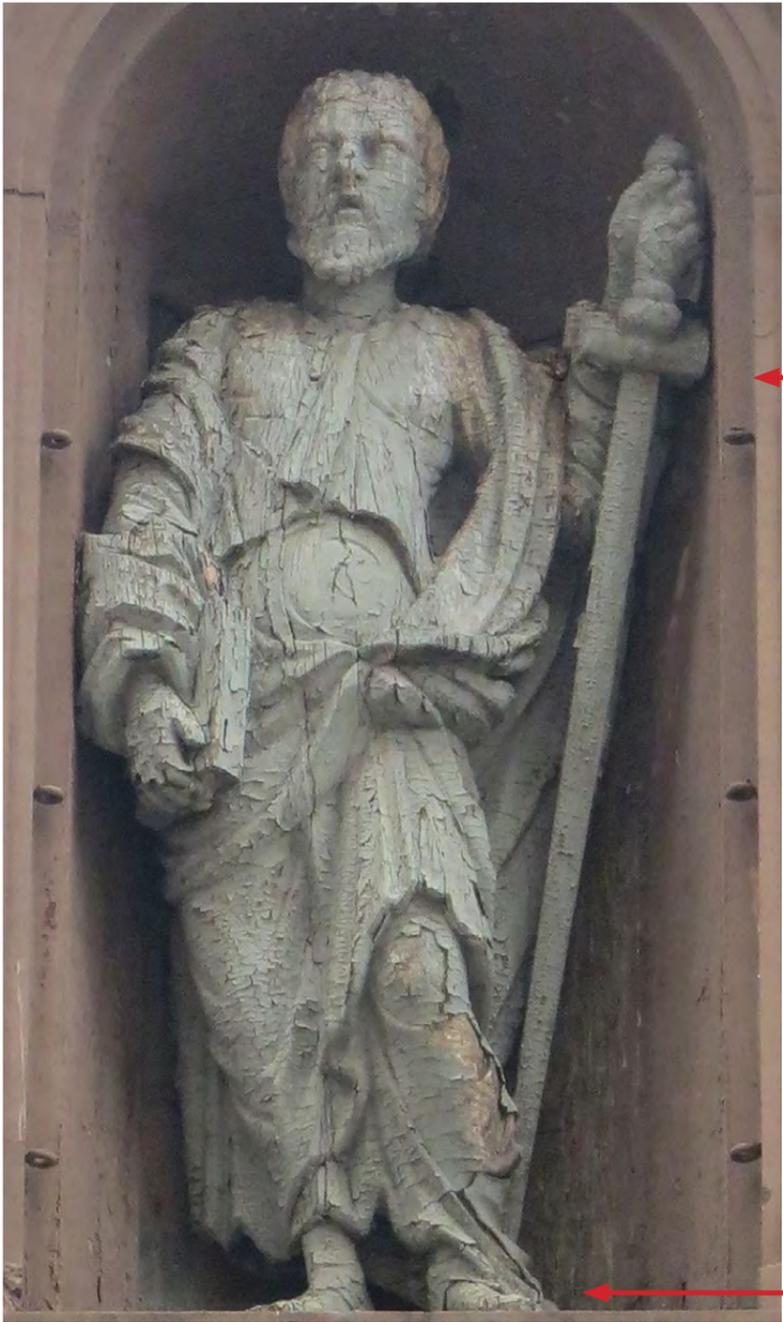
Anchorage (at back of sculpture) located at widest point to minimize visibility.

Base anchorage not visible from front.

19. Front elevation showing location of proposed anchorage for replica. Image shows historic sculpture for reference only.

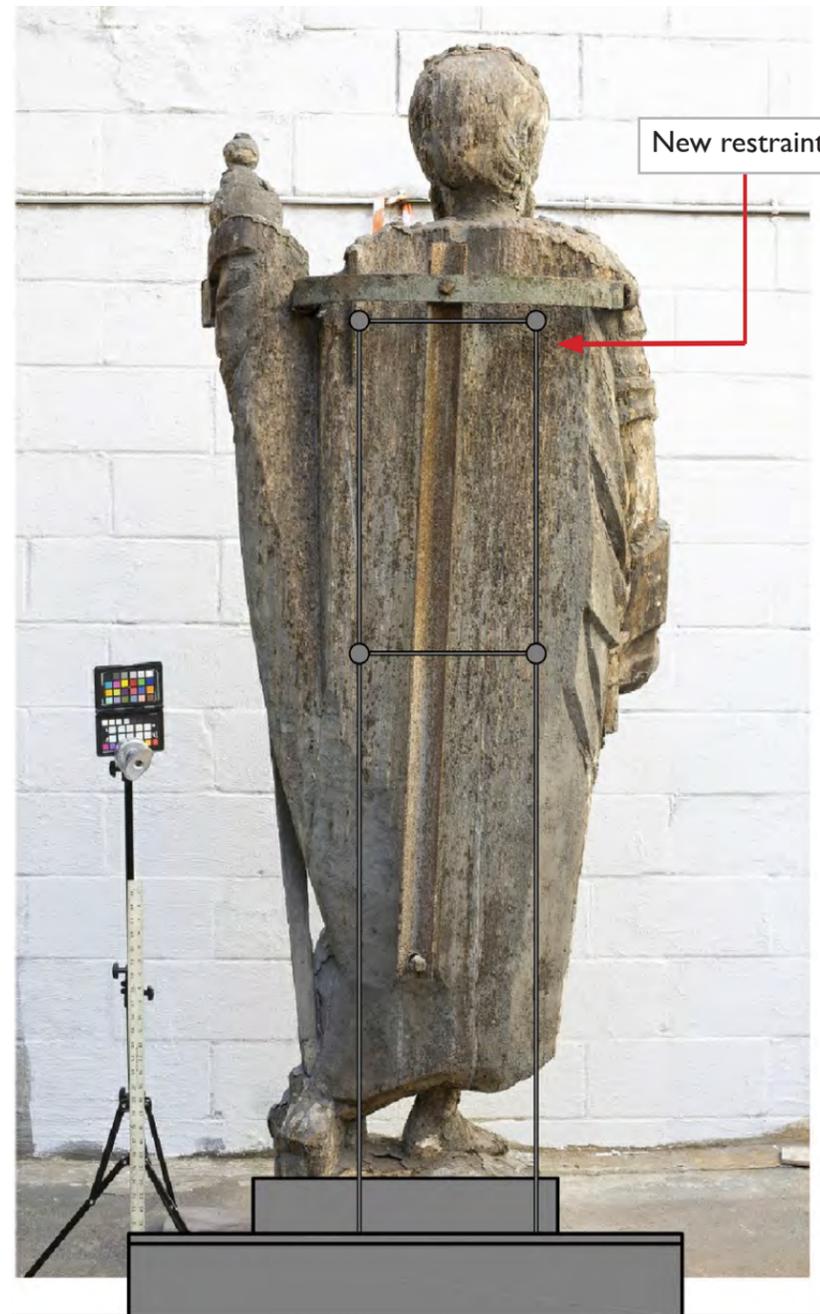
22. Back elevation of historic sculpture showing proposed protective base and plinth for indoor exhibition. The sculpture will be restrained with two slender stainless steel rods anchored at four points to the sculpture and to the new metal base. Restraint is a necessary precaution in case someone touches the sculpture and because New York City is in an earthquake zone.
