FACADE UPDATE

PROJECT:
10 JAY STREET

DATE:
JUNE 14, 2016

10 JAY - CURRENT CONDITIONS

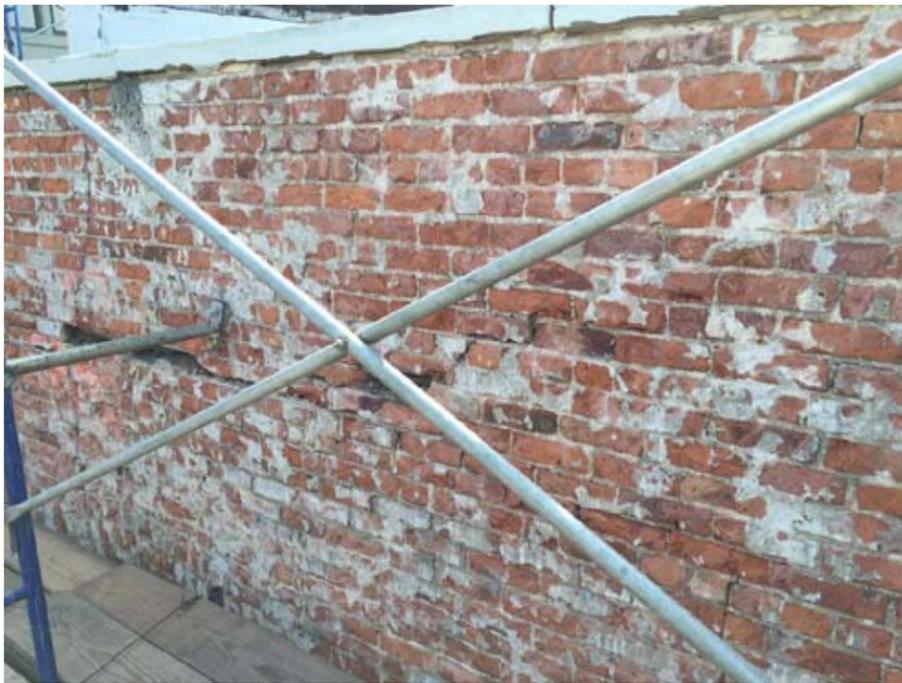
Photo #2

East Elevation:

Conditions at the parapet of the: east elevation. Note brick is severely deteriorated, has lost its fire skin and there are large cracks and gaps in the brickwork.

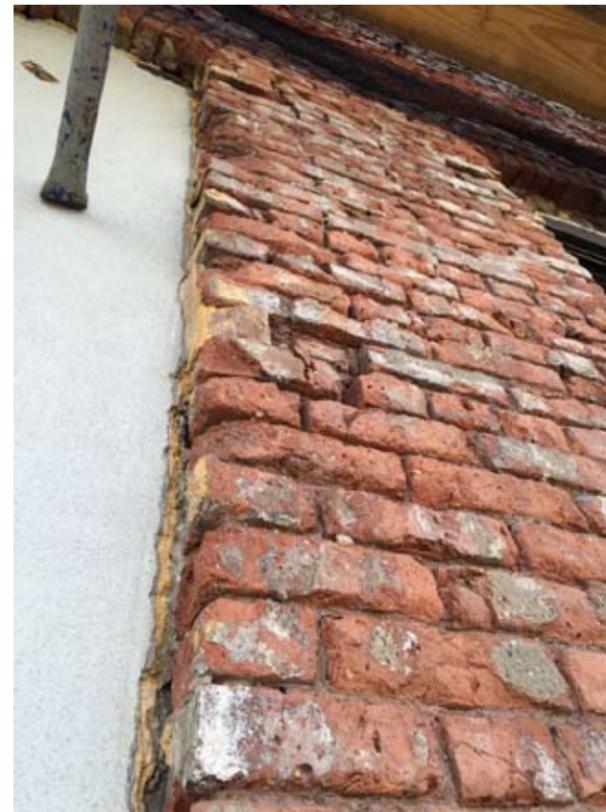
Photo #3

East Elevation:
Deteriorated brickwork, spalling, open joints and lost fire skin at infilled window.

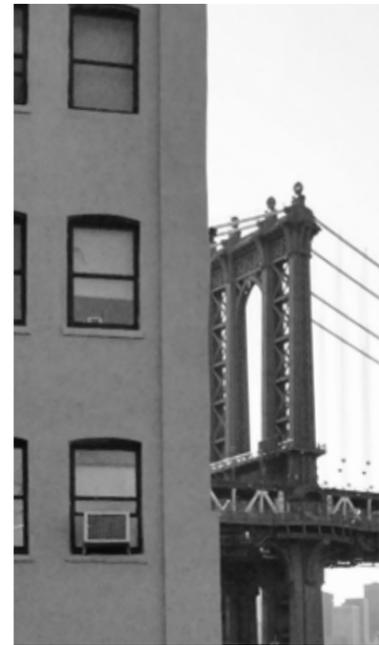
Photo #5

East Elevation:

Cracking at southeast corner.

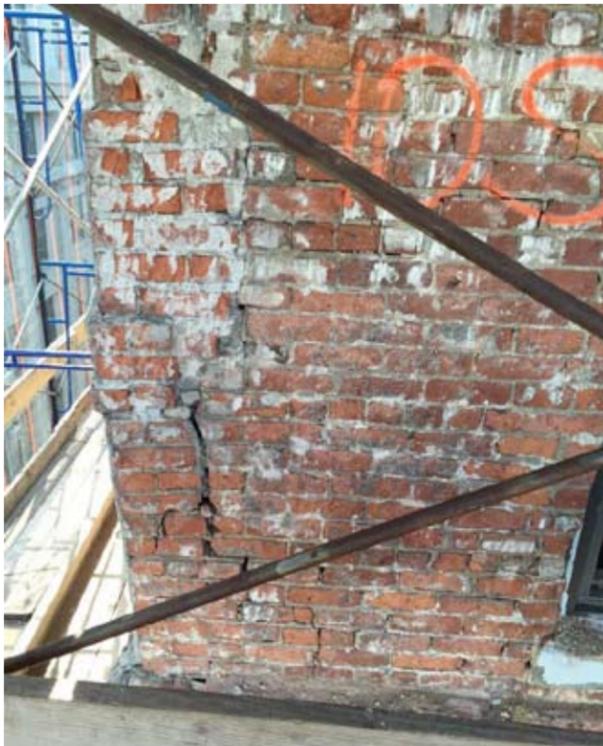
Photo #4

East Elevation:

Severe cracking at 10th floor southeast corner.

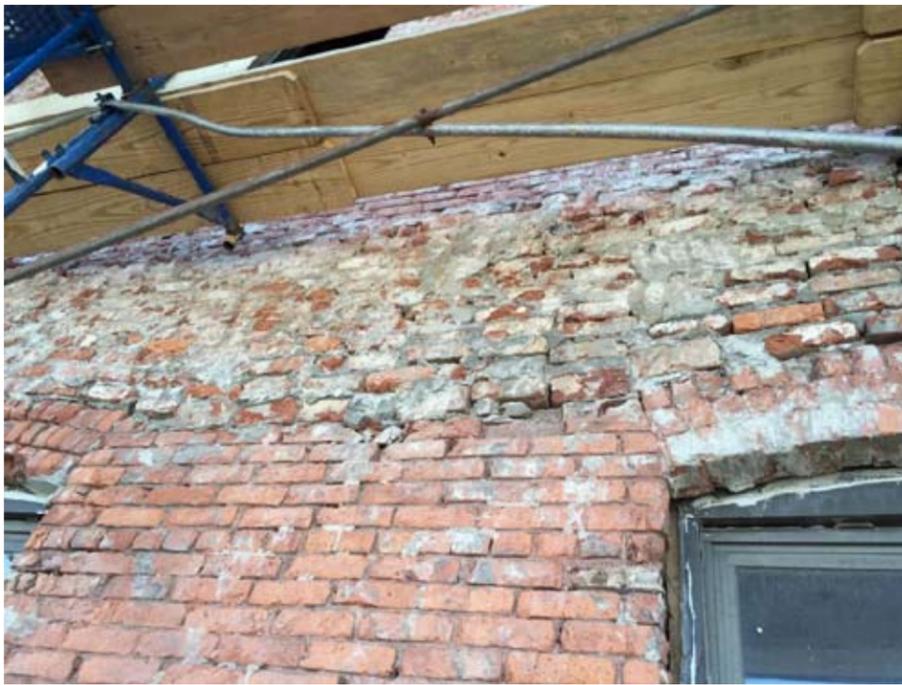
Photo #6

East Elevation:

Area of previously collapsed stringcourse masonry at the 9th floor. Area was filled in with salvaged brick prior to stuccoing over. Note that the masonry is now bulging heavily.

There has been extensive and severe movement of the cornices at the fifth floor and ninth floor levels. Probes into the cornices have revealed that the brick masonry is sagging away from the building. Horizontal displacement was apparent in many areas, with horizontal displacements of up to four inches readily apparent. Displacement of the stone water table on the cornices was readily apparent in many areas.

The deterioration of the cornices appears to be associated with several deficiencies including water infiltration particularly from the back of the water tables, movement caused by freeze-thaw cycling, overstress of the mortar, lack of masonry ties, and general breakdown of the mortar.

The cornices are severely deteriorated and are at risk of immediate collapse. Immediate measures need to be implemented to support or remove the cornices. Long term repairs require the removal of the cornices and replacement / reconstruction of the cornices.

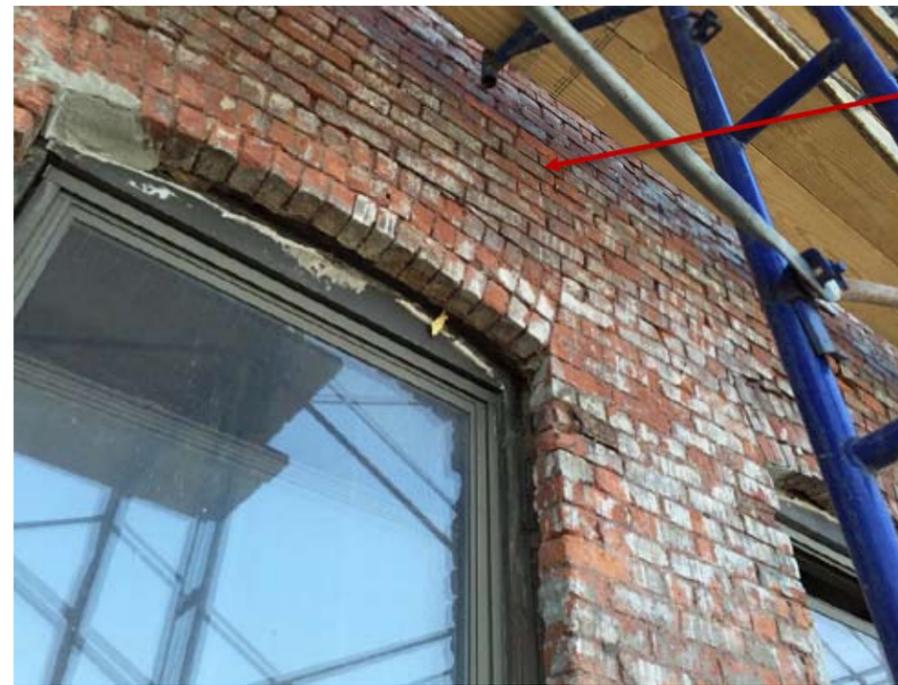
Photo #7

Extreme bulging at spandrel area indicating deteriorated spandrel steel behind brickwork.

Probes of the east wall have revealed significant corrosion of the spandrel beams at all areas probed. The full extent of the deterioration will not be known until the facade is removed. Addressing the deterioration of the spandrel beams will likely impact the terra cotta bay immediately adjacent to the spandrel beams.

Repair of the corroded spandrel beams will require the removal of the masonry façade above the affected areas in order to gain access to the spandrel beams. Repairs will consist of reinforcing or replacing the deteriorated members.

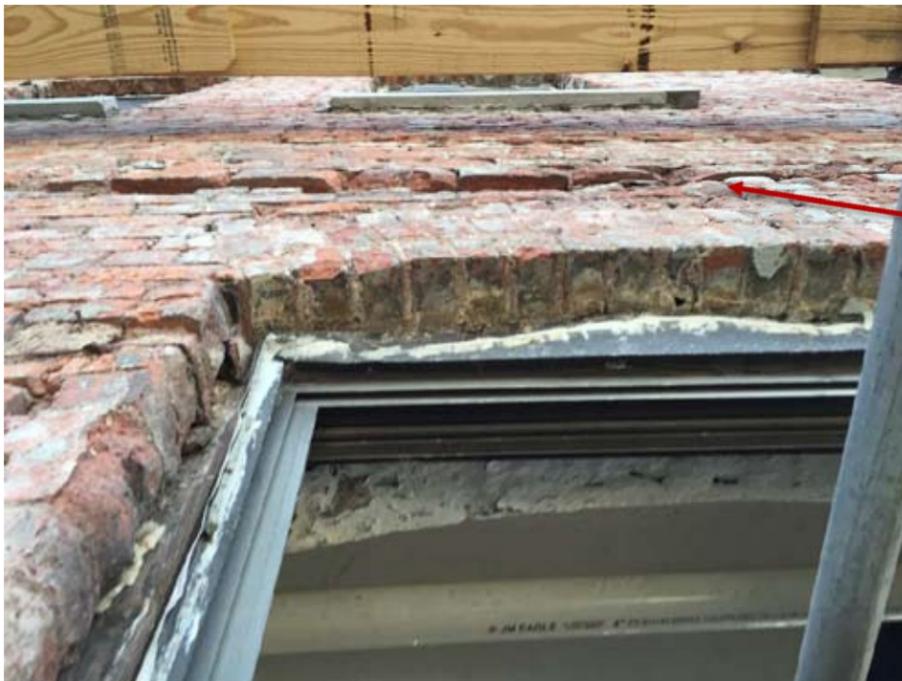
Photo #8

East Elevation:

Displaced brick at spandrel.

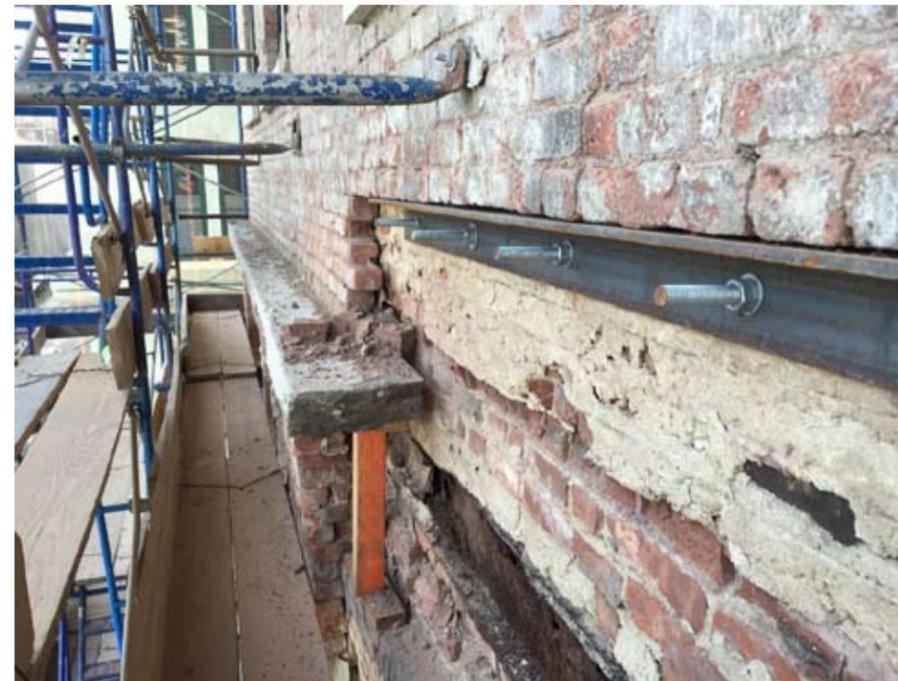
Photo #9

East Elevation:

Collapse at 5th floor stringcourse. New steel is temporary shoring of masonry above spandrel beam.

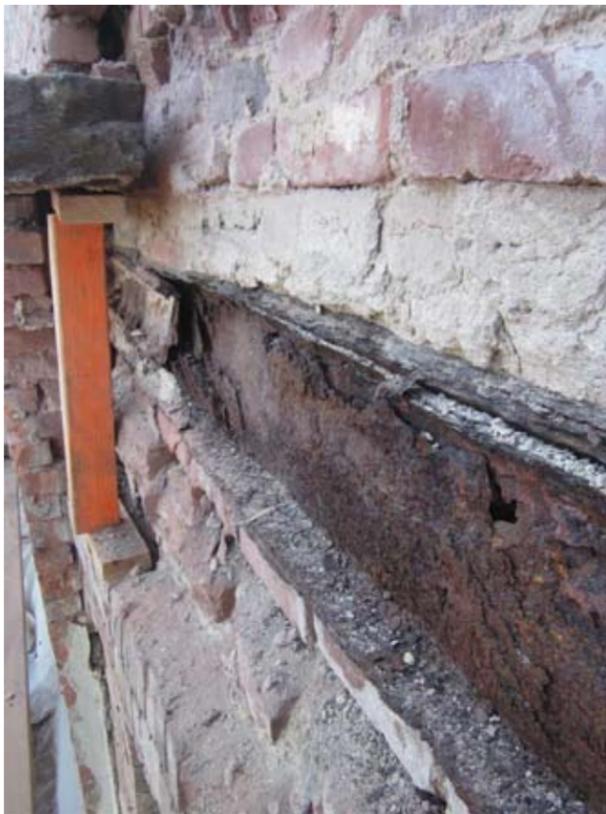
Photo #10

East Elevation:

Severely corroded steel at collapsed stringcourse.

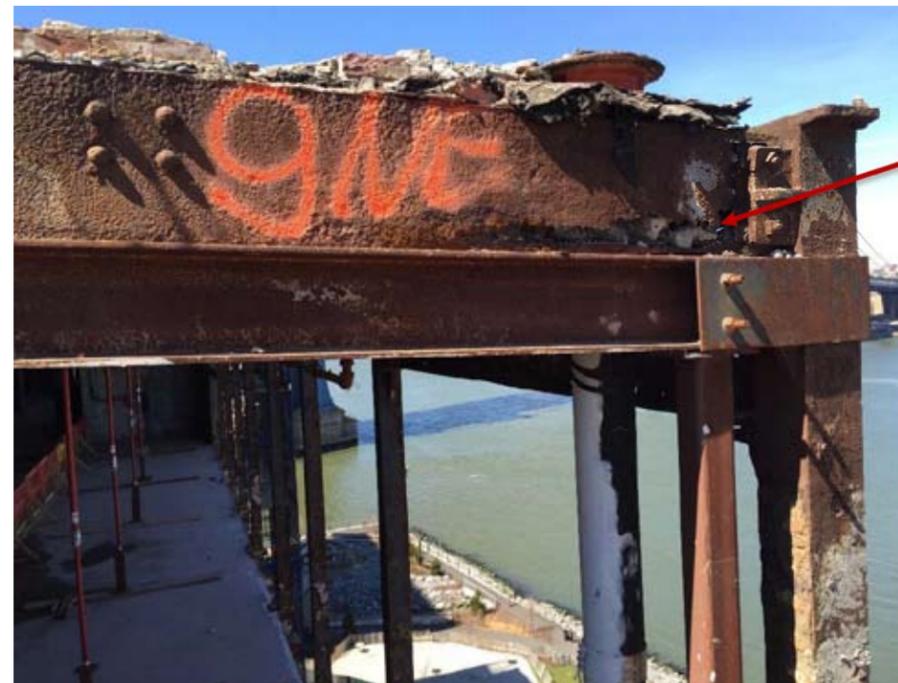
Photo #11

East Elevation:

Missing steel at beam web due to extreme corrosion.

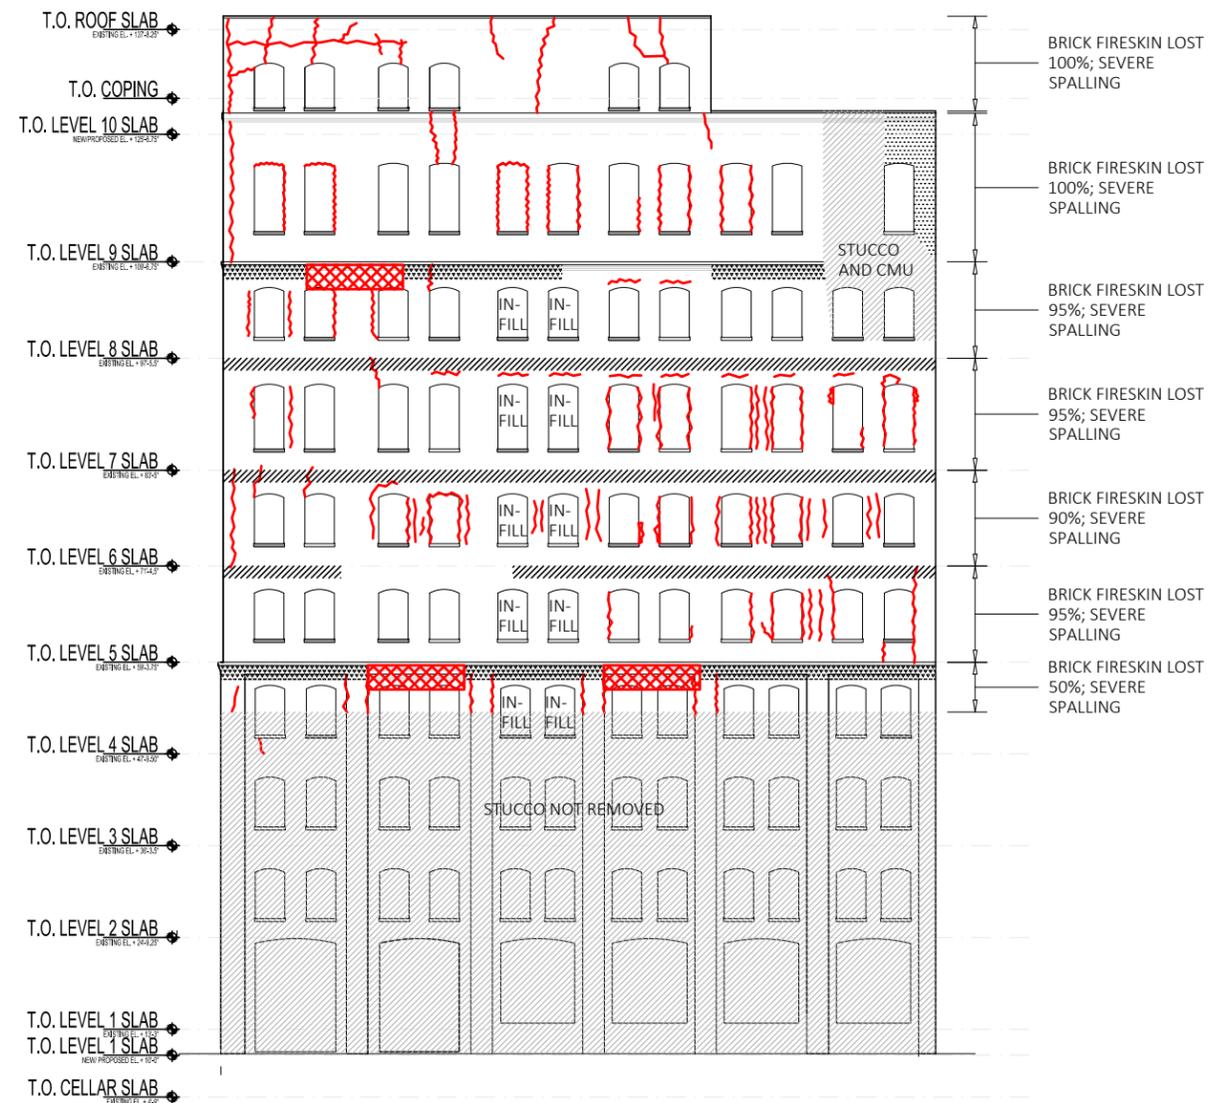
RESTORATION CONDITIONS PHOTOS / ELEVATION

The brick masonry of the east wall is severely deteriorated. Among the specific conditions are bulges at spandrel beams, displaced masonry at cornices, missing mortar, dead mortar, cracks at columns, cracks at spring points of masonry arches. The deterioration of the brick masonry appears to be associated with several deficiencies including moisture infiltration through the porous masonry, movement caused by freeze-thaw cycling, corrosion of structural framing behind the masonry, overstress of the brick masonry, lack of masonry ties, and general breakdown of the mortar.

The cornices are severely deteriorated and are at risk of immediate collapse. Immediate measures need to be implemented to support or remove the cornices.

Removal of the existing masonry construction of the east wall is recommended. Since the existing masonry wall functions as a shear wall to stabilize the building, the structural frame of the building will require new bracing to be designed and installed to maintain structural integrity of the building.

Project scope has been expanded to expose all the structural framing of the east wall. Project plans will be developed to repair or replace deteriorated structural framing based on the specific conditions encountered.
