1 EXISTING CROSBY STREET - LOOKING EAST

SEVERE CRACKING AND MOVEMENT; HAZARDOUS CONDITION AT BRICK MASONRY AND LINTEL

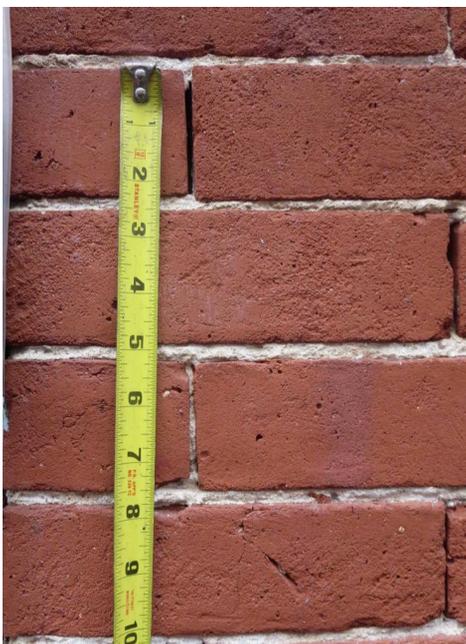
2 EXISTING COATING REMOVAL AT BRICK

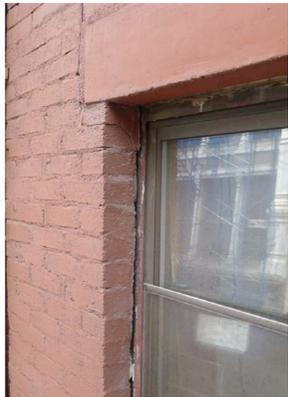
DELAMINATION: FACE BRICK HAS SEPARATED FROM INNER WYTHES THROUGHOUT FACADE

NON-HISTORIC STONE SILL BACK PITCHED TO INTERIOR (NOTE ACCUMULATION OF SPOILS FROM ACTIVE CRACKING)

NON-ORIGINAL LINTEL (TYP): STONE LINTEL REMOVED AND STEEL BEAM ADDED WHEN WINDOW CONFIGURATION ALTERED (SEE NOTE AT TOP).

DISPLACEMENT: WALL IS OUT OF PLANE (TYP)

SPALLING AT STONE SILLS (TYP)

NON-HISTORIC MATERIAL: RECONSTRUCTED BRICK DOES NOT MATCH ORIGINAL

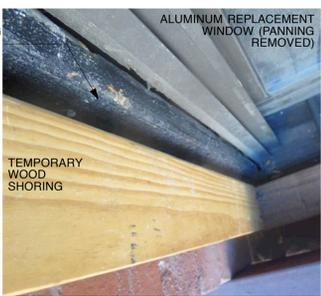
EXISTING BRICK MOLD VIEW AT JAMB
WOOD BRICK MOLDING PRESENT AT TOP FLOOR ONLY. THESE WINDOW OPENINGS ARE NON-HISTORIC AND THE WINDOWS HAVE BEEN REPLACED. BRICK MOLDING MISSING AT OTHER OPENINGS.

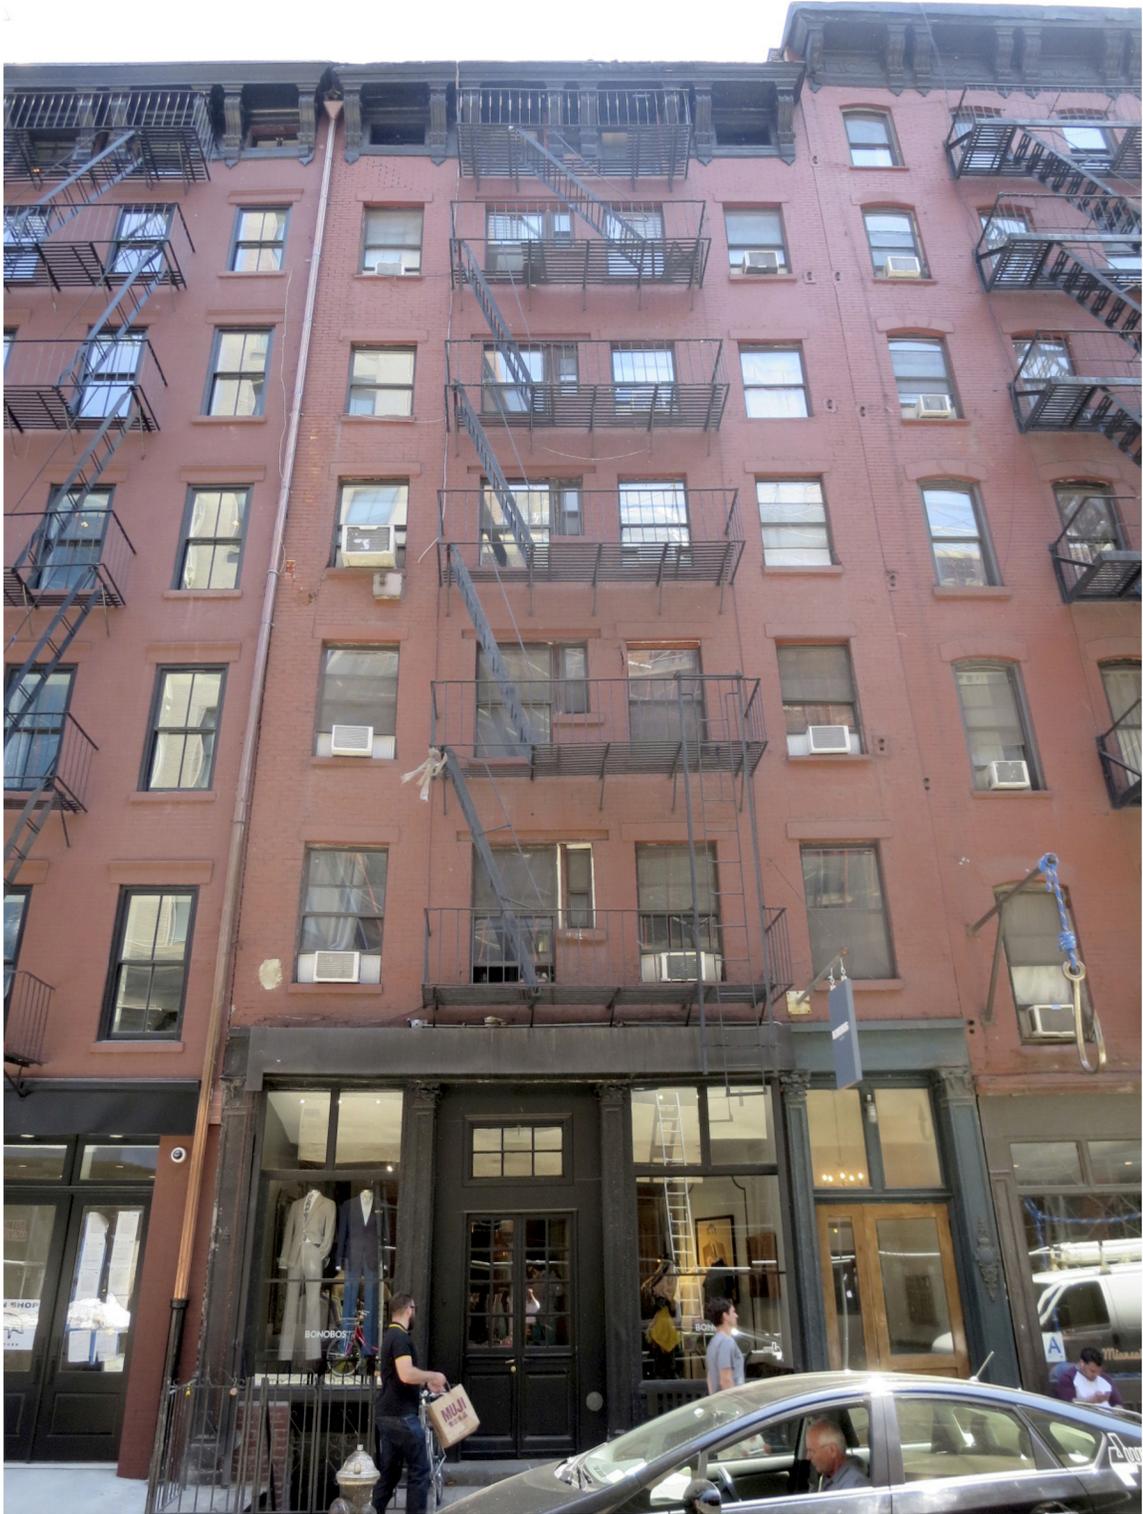
Figure 2: West facade, looking east, June 2014 before shoring was installed. (TAFAs photo.)

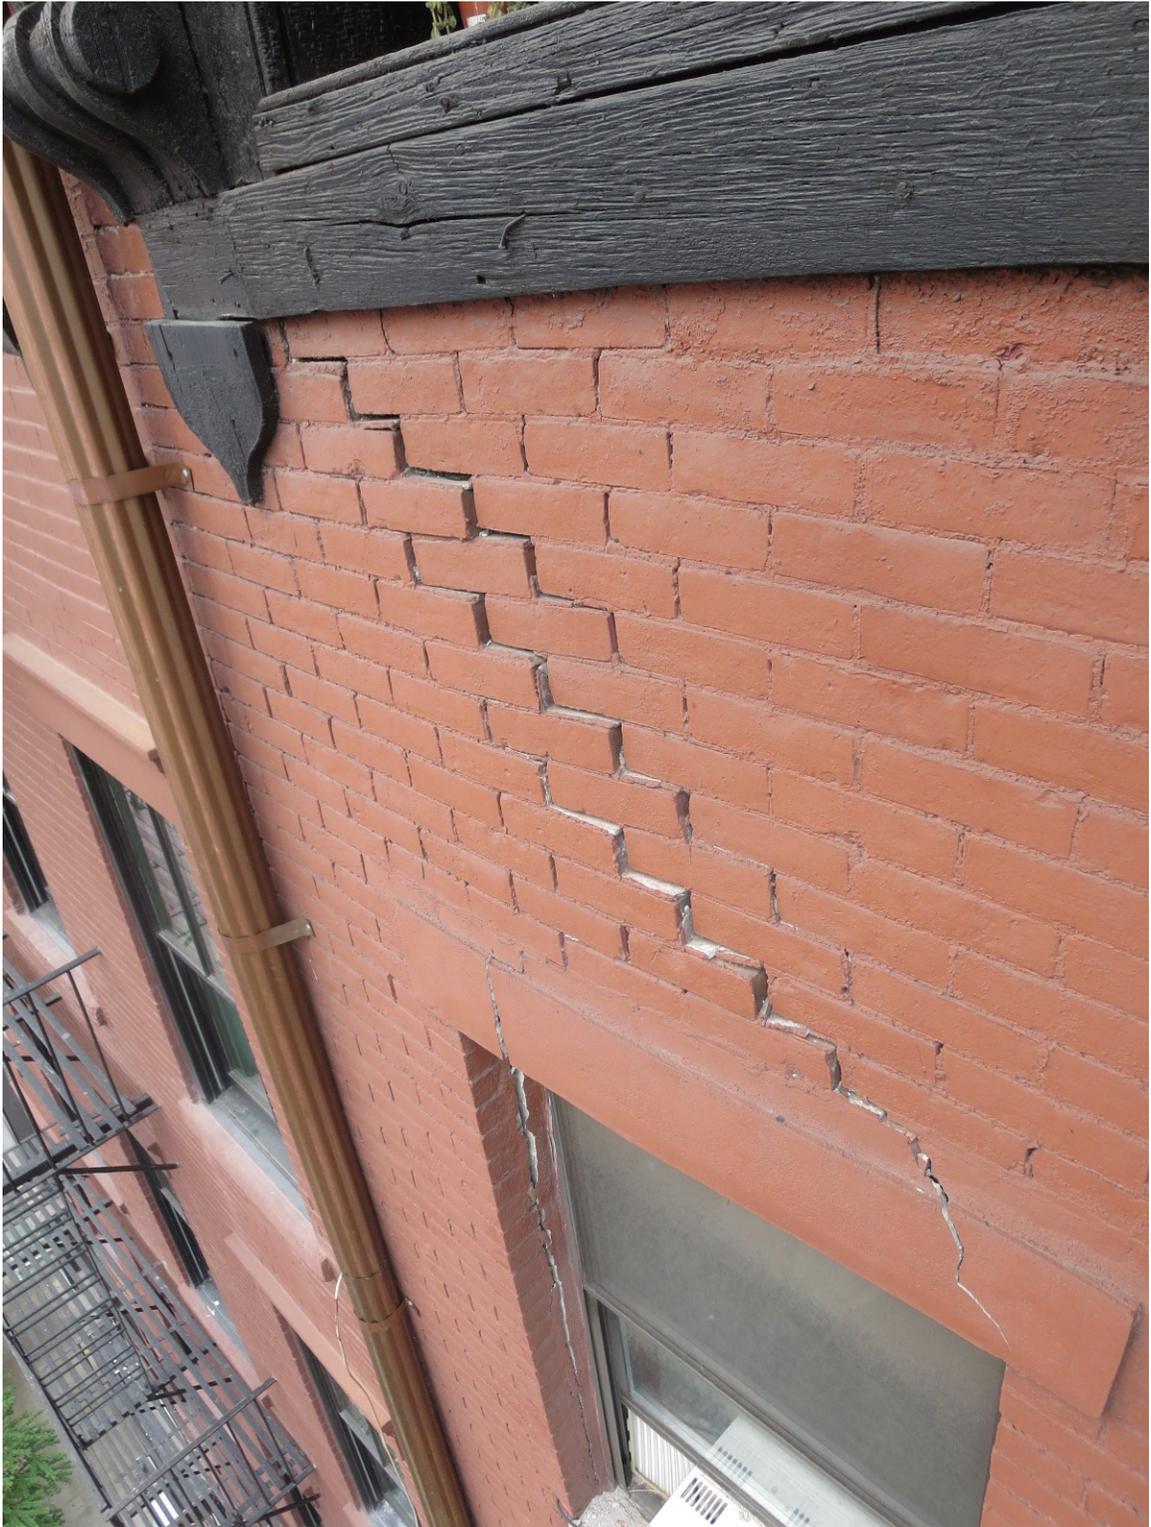
Figure 3: 6th floor lintel (below), cracked at both ends, crack in pier below left end of lintel bearing, cracked and displaced spandrel panel. June 2014, before shoring was installed. (TAFa photo.)

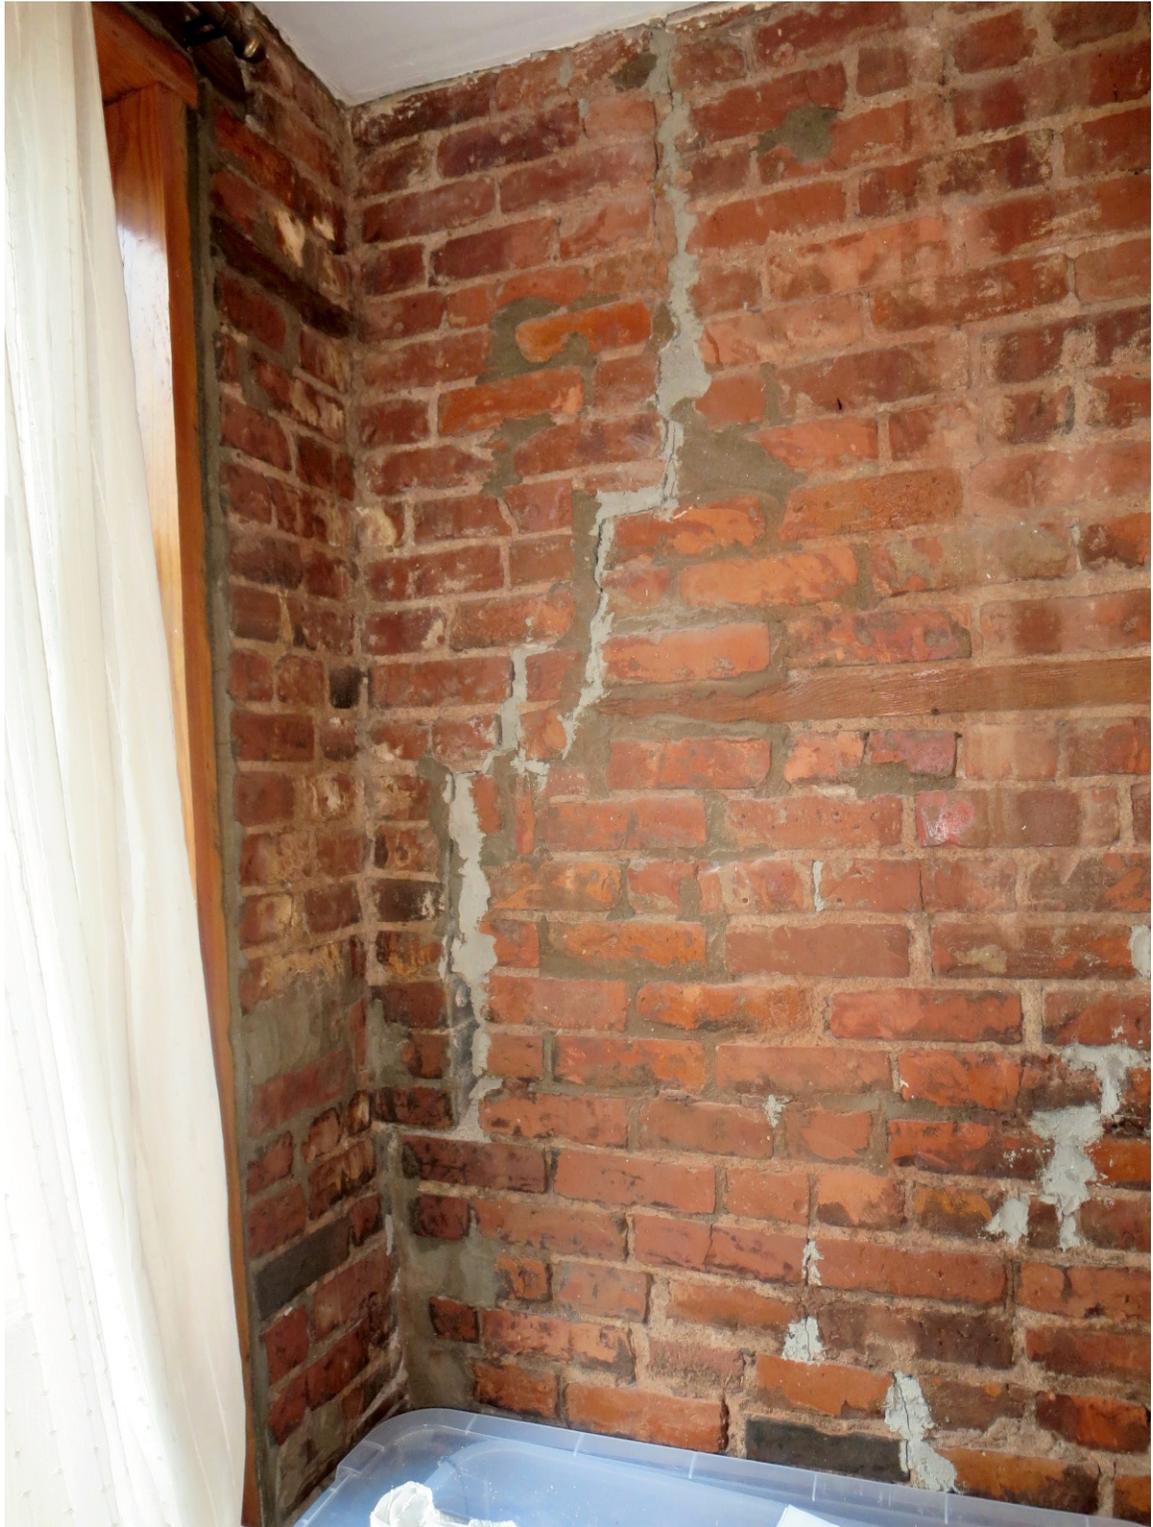
Figure 4: Interior of NW corner at 6th floor. Note repeated repairs and overall outward movement of west wall (to the left). June 2104 before shoring was installed. (TAFAs photo.)

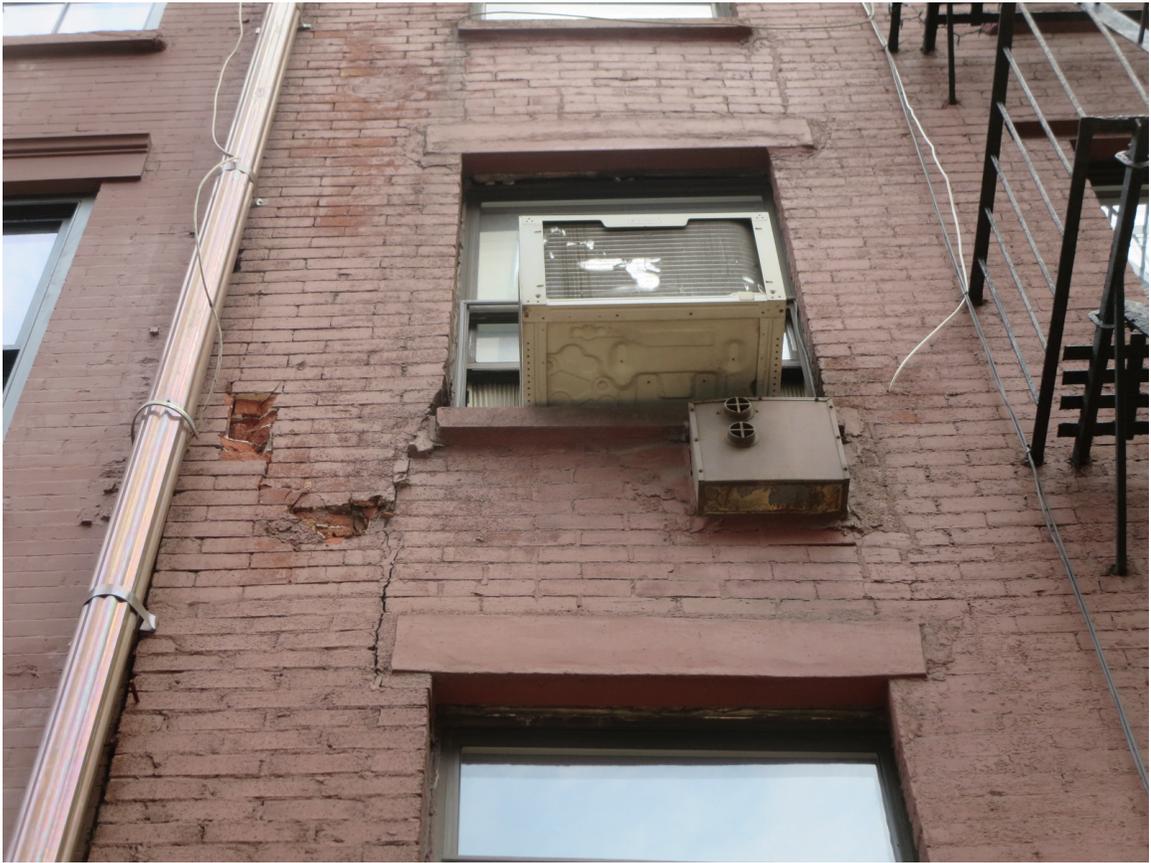
Figure 5: Crack and displacement at north end of west facade. June 2014, before shoring was installed. (TAFA photo.)

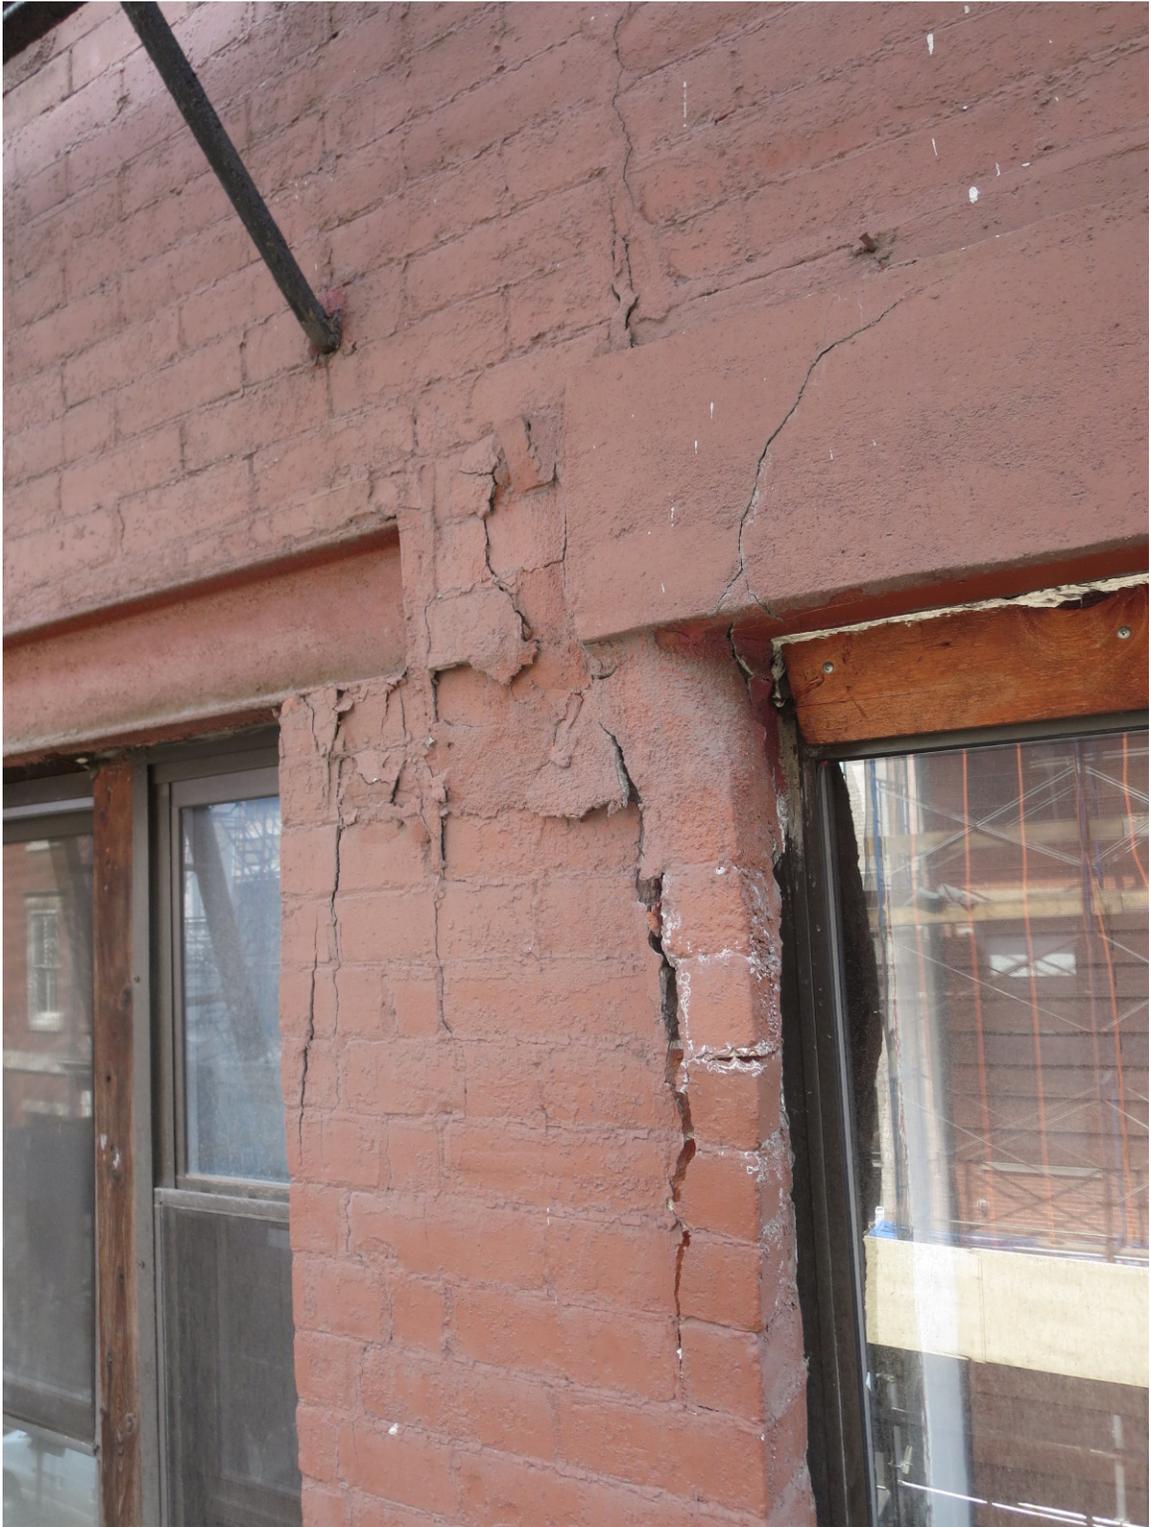
Figure 6: Buckled lintel bearing at right, "ordinary" lintel bearing end crack at left. June 2014 before shoring was installed. (TAFA photo.)
