2.5. HISTORIC AND ARCHAEOLOGICAL RESOURCES

2.5.1. Existing Conditions

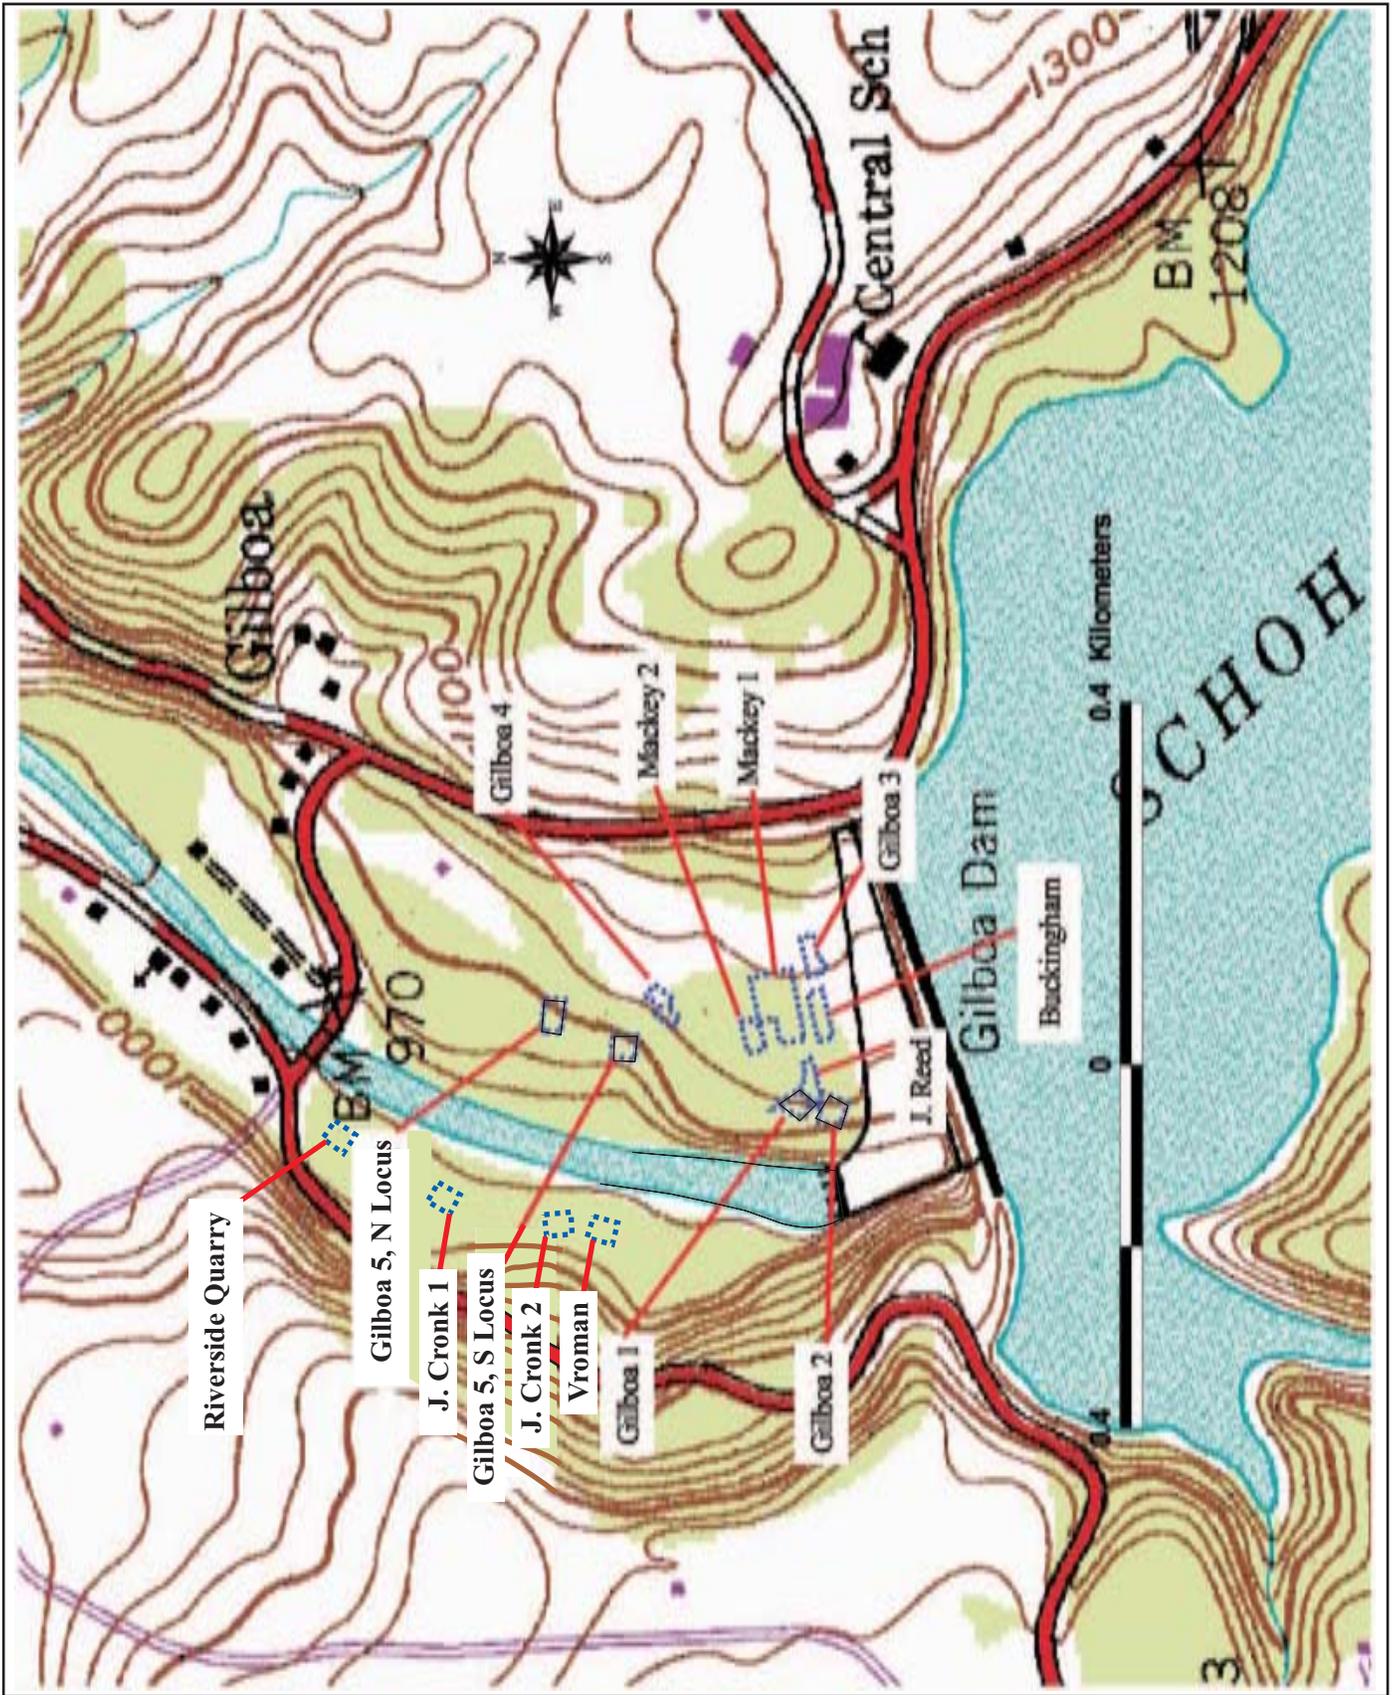
**Location of Identified Gilboa Dam
Examined Sites**

Gilboa 1 – Eligible for the National Register; foundation remains present. Data recovery recommended or avoidance of impacts.

Gilboa 2 – Not eligible for the National Register. No data recovery recommended, low research potential. No impact avoidance necessary.

J. Reed – Eligible for the National Register; foundation remains present. Data recovery recommended or avoidance of impacts.

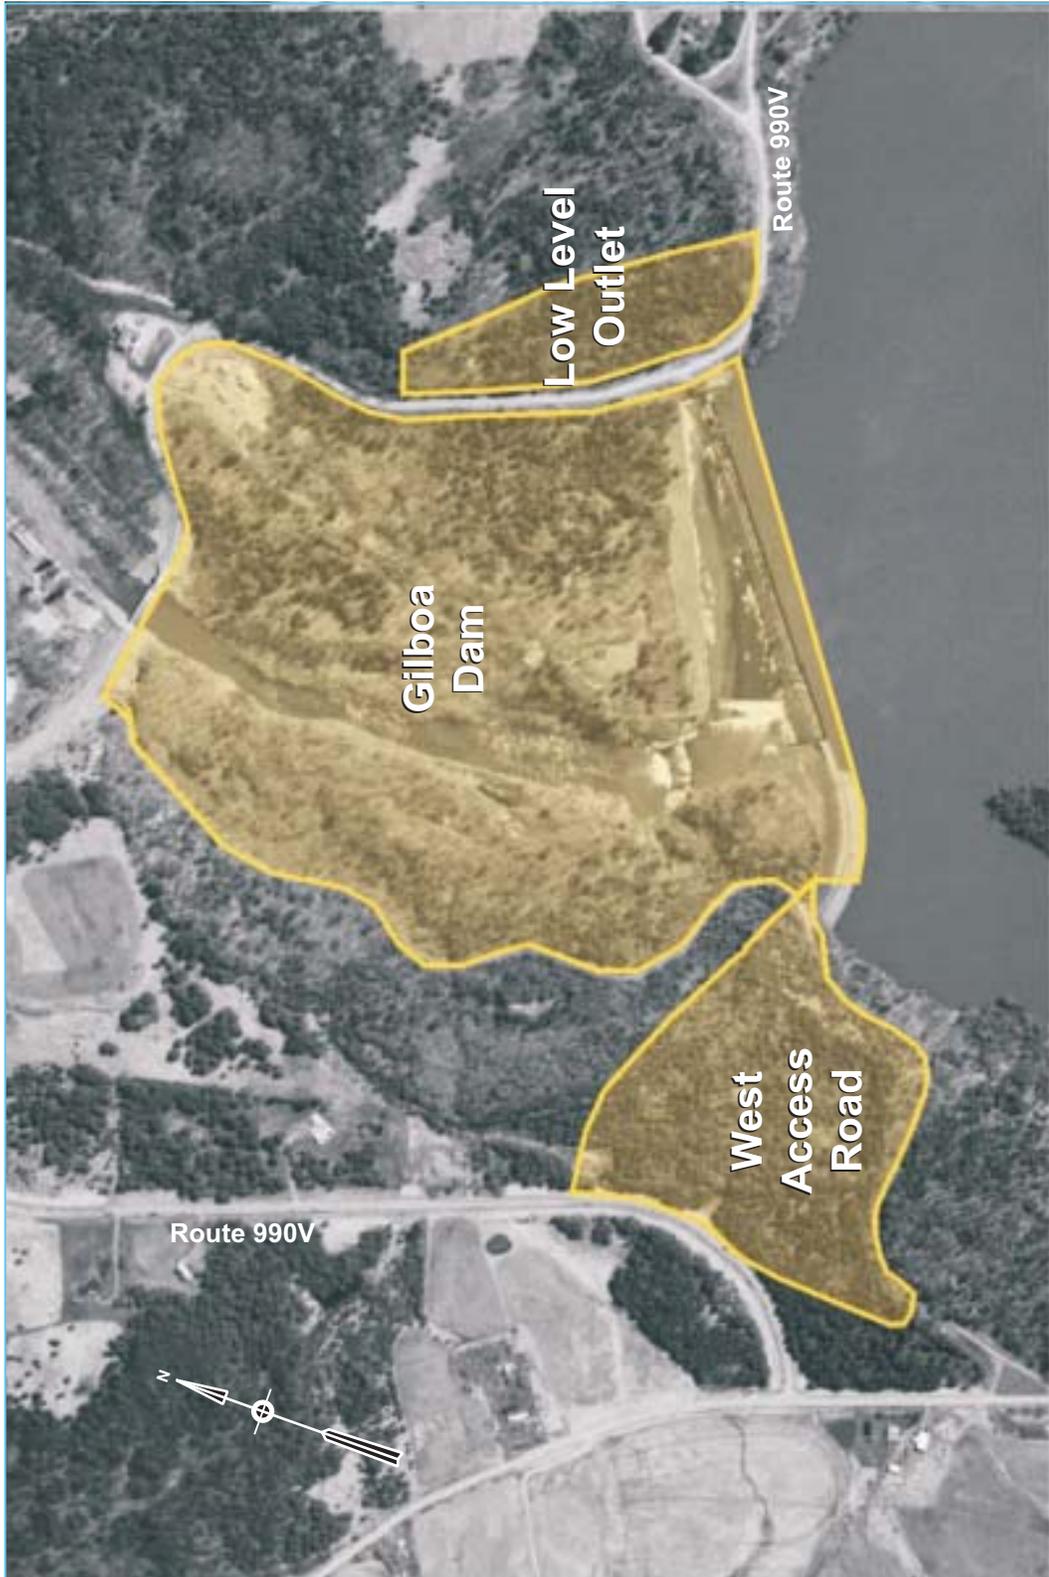
Figure 2.6-1

Gilboa Dam Natural Resource Study Areas

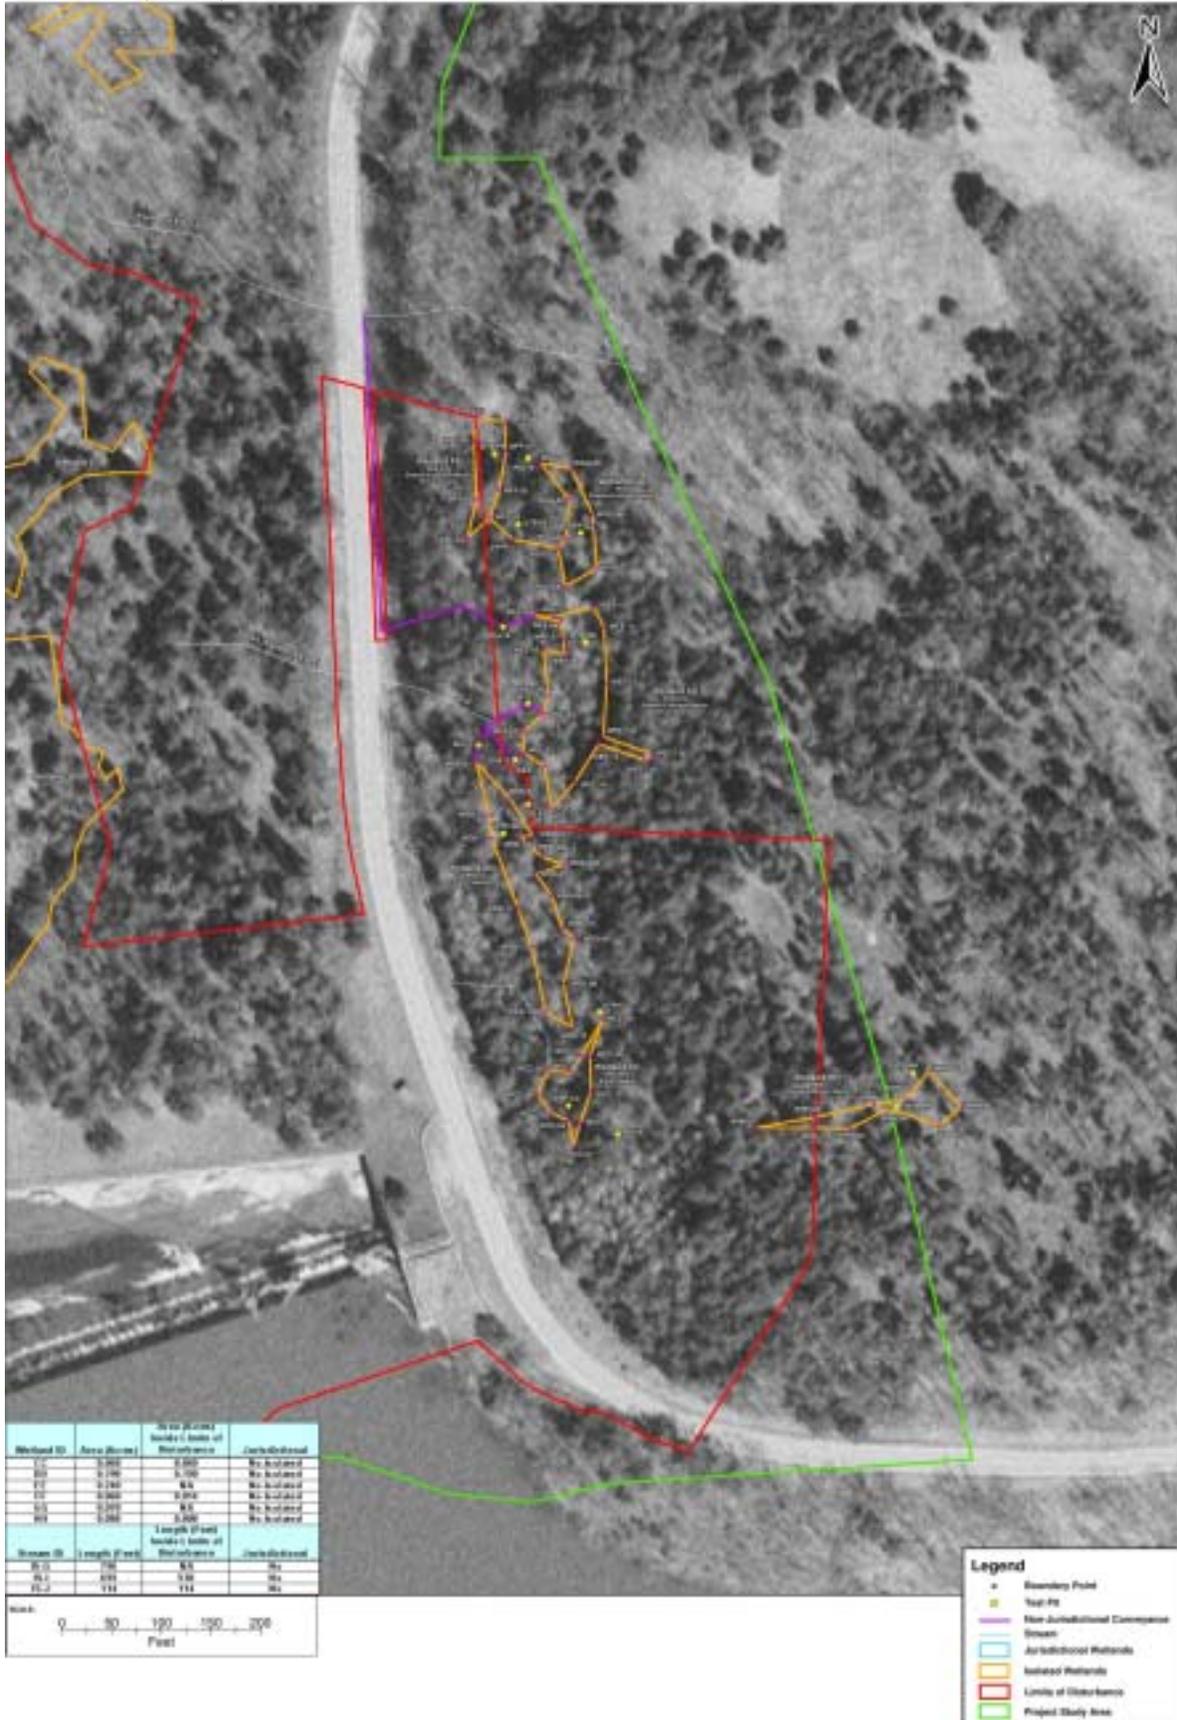
Figure 2.6-4

Wetlands and Waterways in the Low Level Outlet Study Area

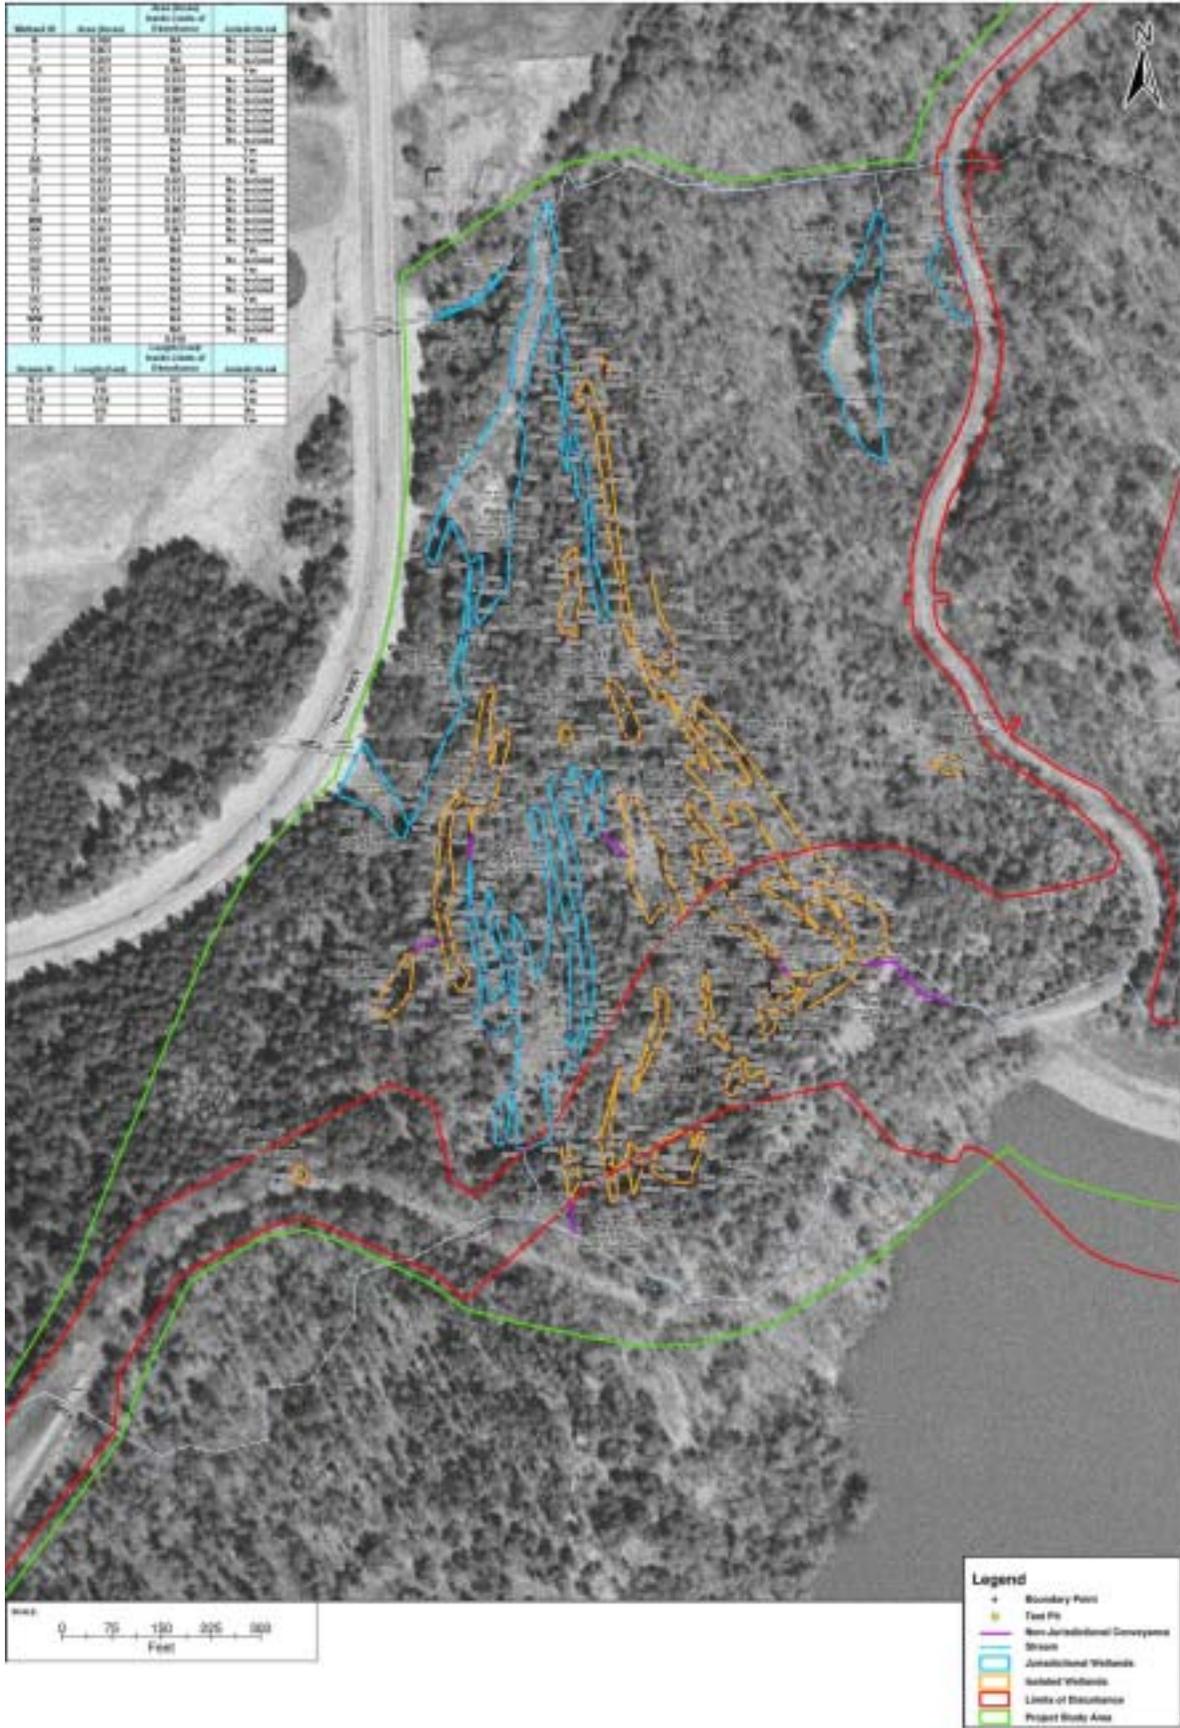
Figure 2.6-5

Wetlands and Waterways in the West Access Road Study Area

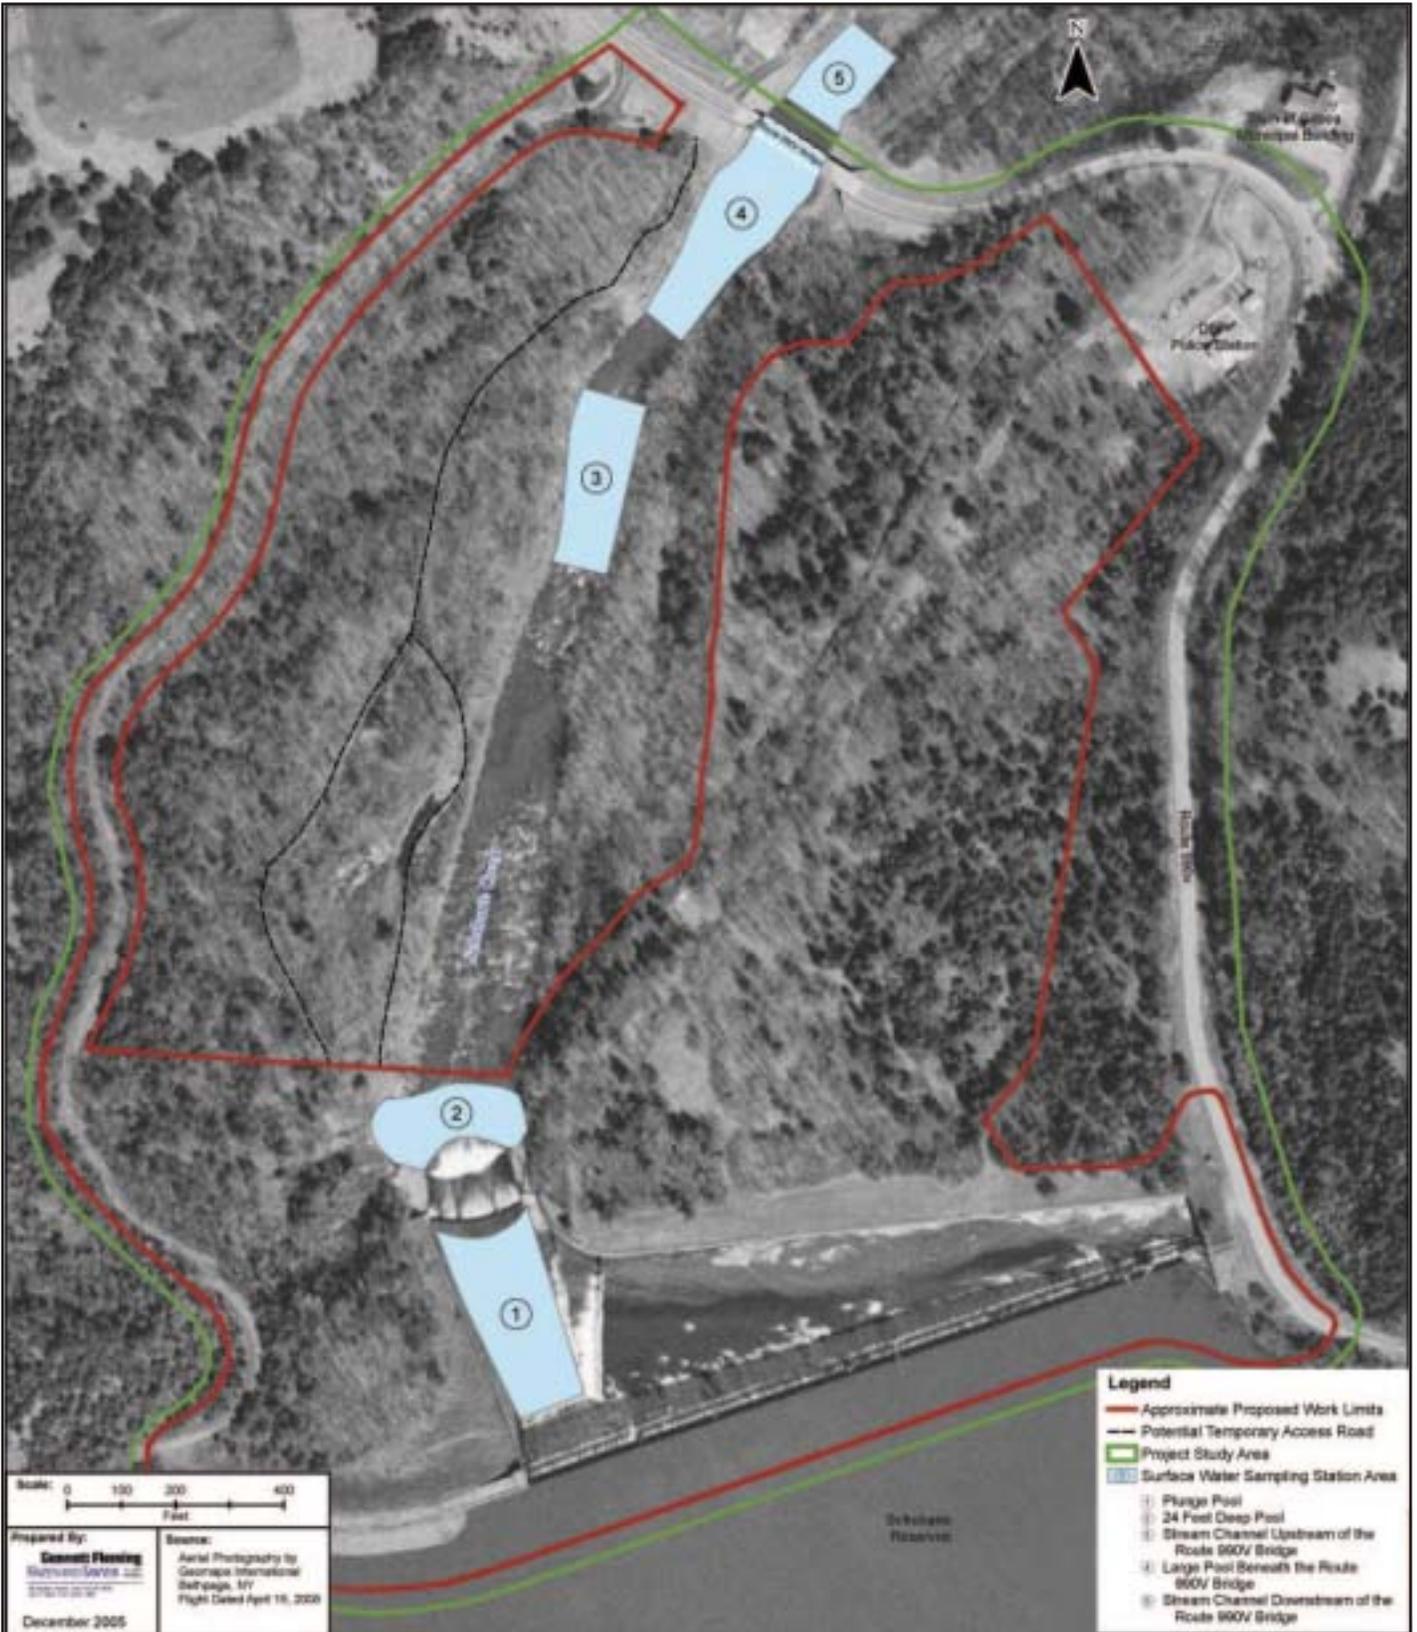
Figure 2.6-6

Surface Water Quality Sampling Stations

Five water quality sampling stations were established: the Plunge Pool immediately downstream of the Dam, a 24-foot deep pool downstream of the Plunge Pool, the stream channel upstream of the NYS Route 990V Bridge, a large pool beneath the NYS Route 990V Bridge, and the stream channel downstream of the NYS Route 990V Bridge (Figure 2.6-6). The survey was conducted during a period of low streamflow. Please see Methodology section for further explanation on sampling location descriptions.

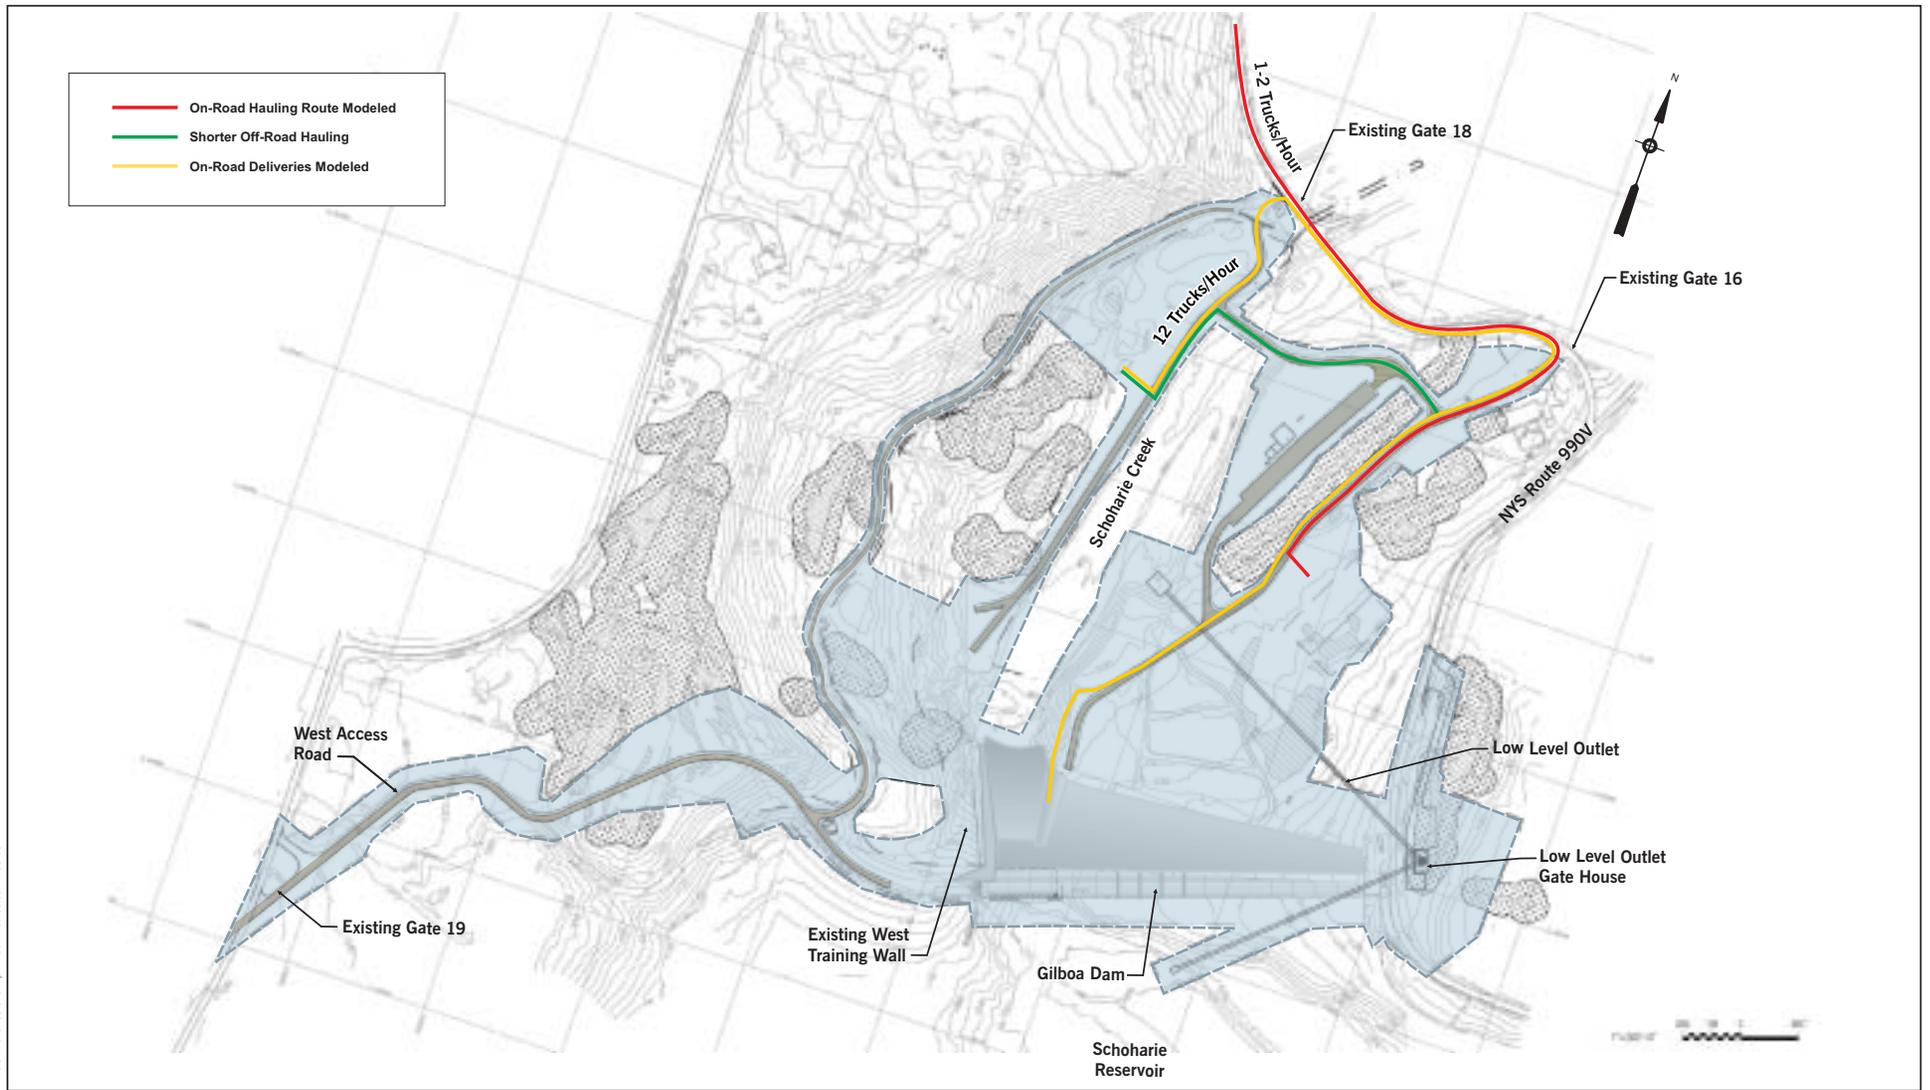
Designated Reconstruction Activities for Seven Areas

Area	Reasonable Worst Case Scenario (Phase Three)
1	Demolition & concrete placement
2	Truck traffic
3	Material staging
4	Material staging
5	Concrete production
6	Demolition & concrete placement
7	Demolition & reconstruction

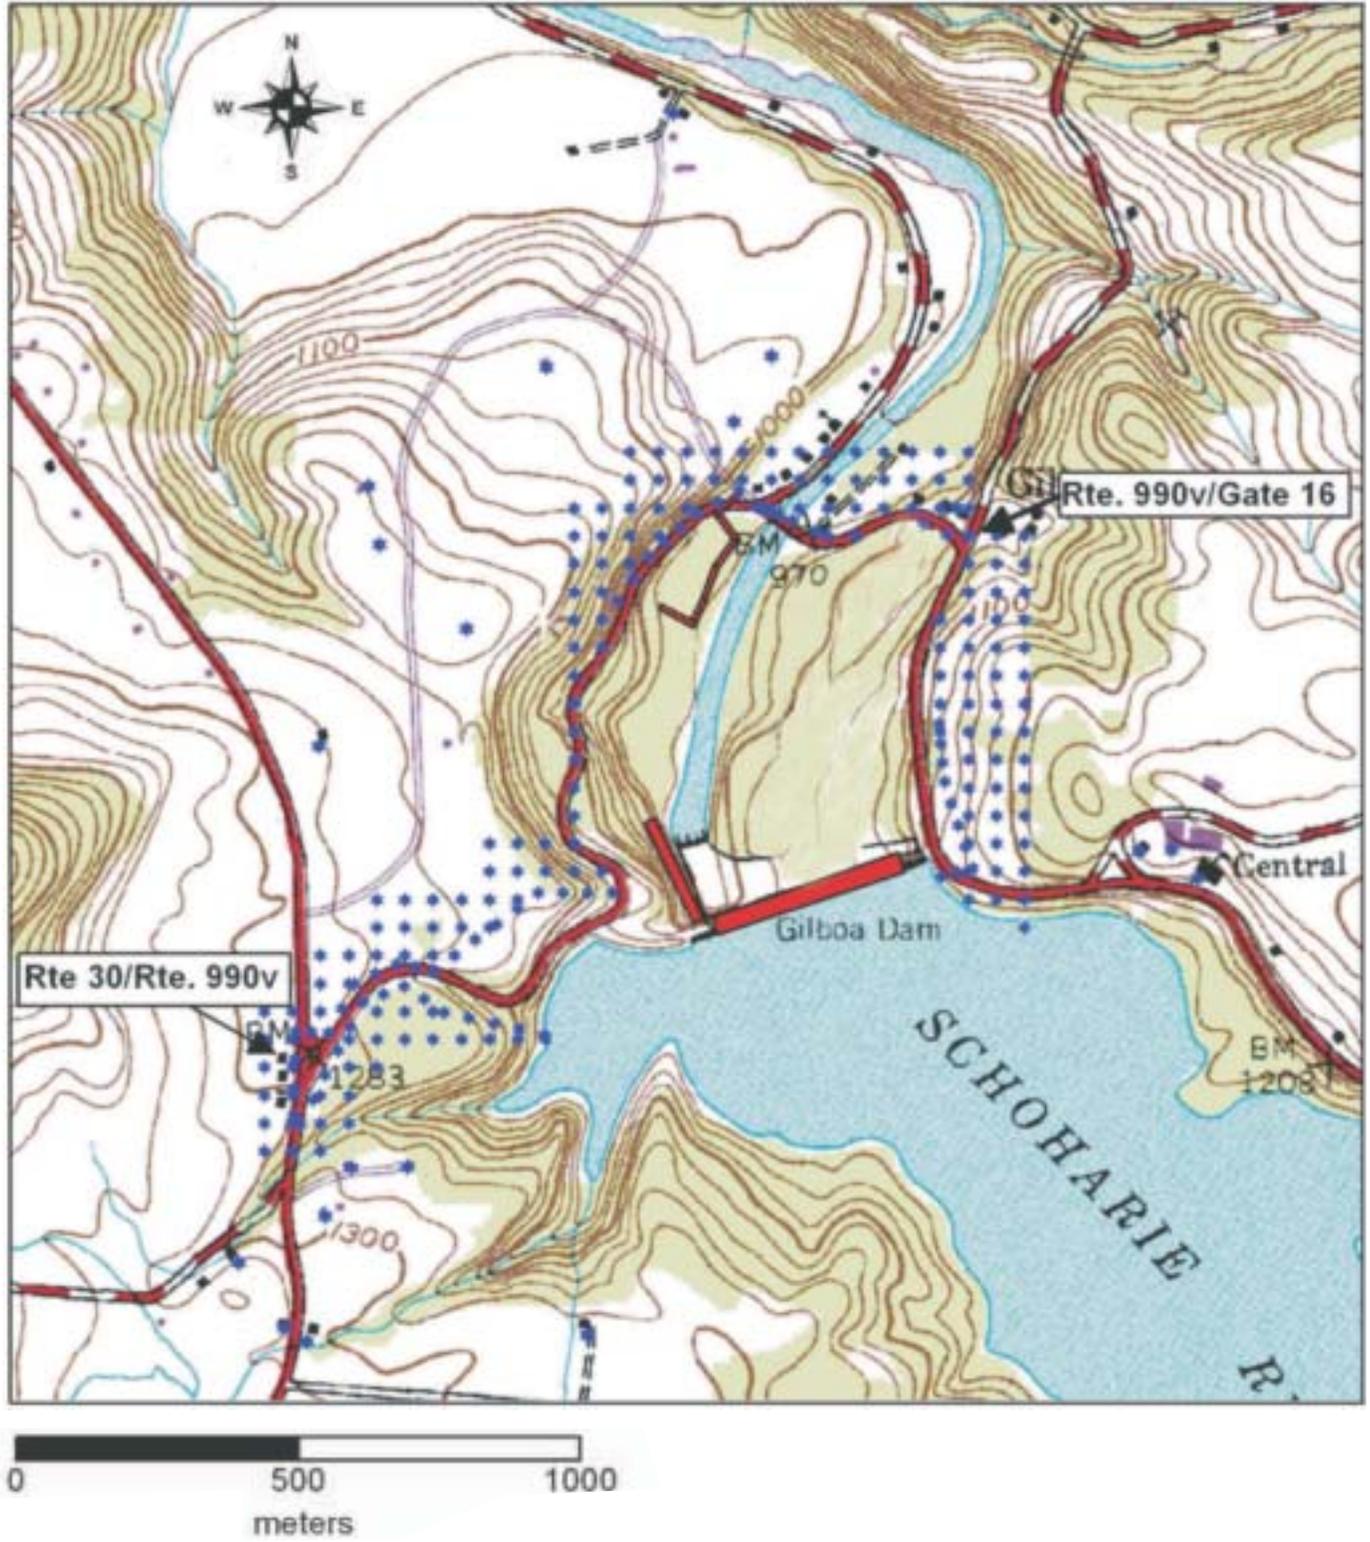
Figure 2.8-3

Location of Project Receptors
