NYC Green Infrastructure Plan: 2011 Preliminary Pilot Monitoring Results

UPDATE SUPPLEMENT

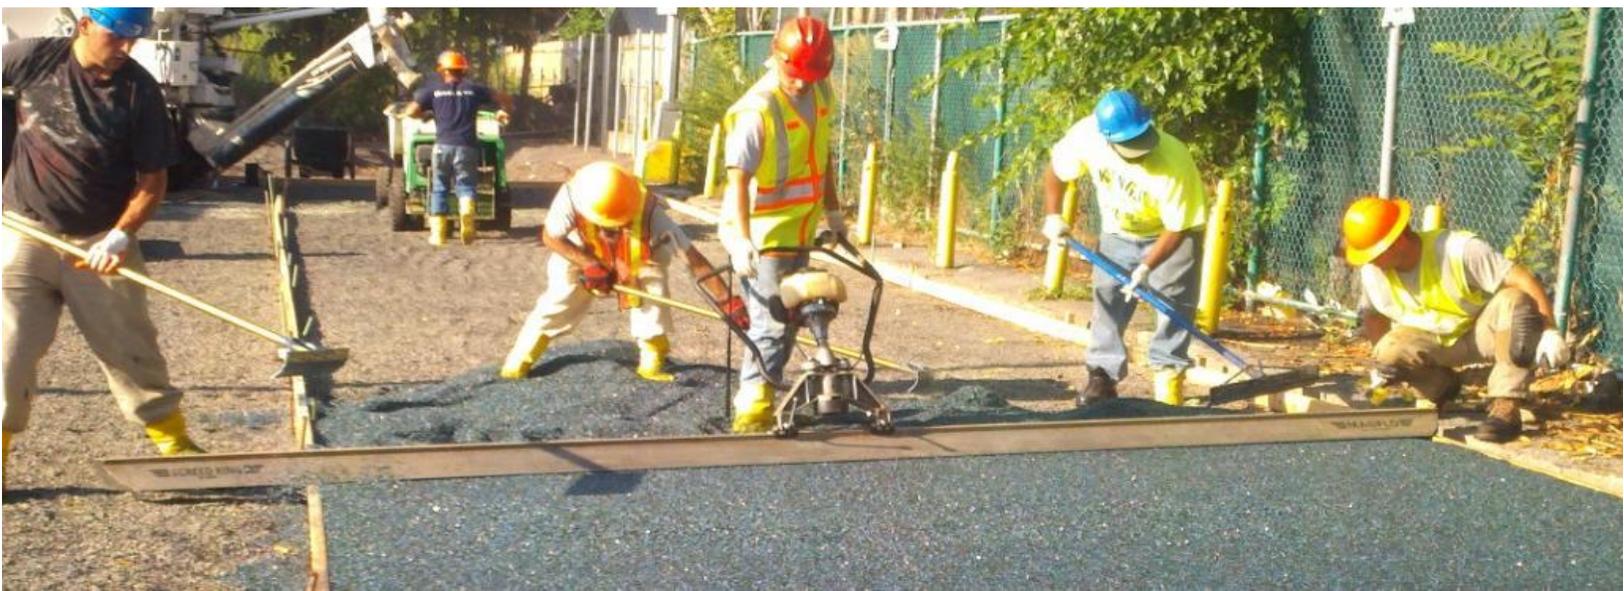
In the parking lot at Far Rockaway, standard asphalt, porous asphalt, and FilterPave™ (shown here) pilots installed in 2011 are currently being monitored to compare stormwater runoff reduction performance.

A comparative hydrograph of measured outflow from an example storm event for each of the pavement sections illustrates no outflow at underdrains from the porous asphalt and FilterPave™ sections while considerable outflow is observed from the standard pavement (Chart 10).

The porous asphalt and FilterPave™ sections have shown apparent 100% volume retention for all monitored storms (Chart 11). This suggests that the subsurface storage volume and underlying soil infiltration rates are able to capture all precipitation without discharging to the combined sewer. Monitoring of the standard asphalt also shows volume retention through surface ponding; further quality control of the accuracy of this data and potential sources of observed storage is being conducted.

Durability of each pavement pilot has been visually monitored. Surface wear, chipping, and rutting of the FilterPave™ surface have been observed and are under further investigation. No noticeable signs of wear have been observed in the porous asphalt section.

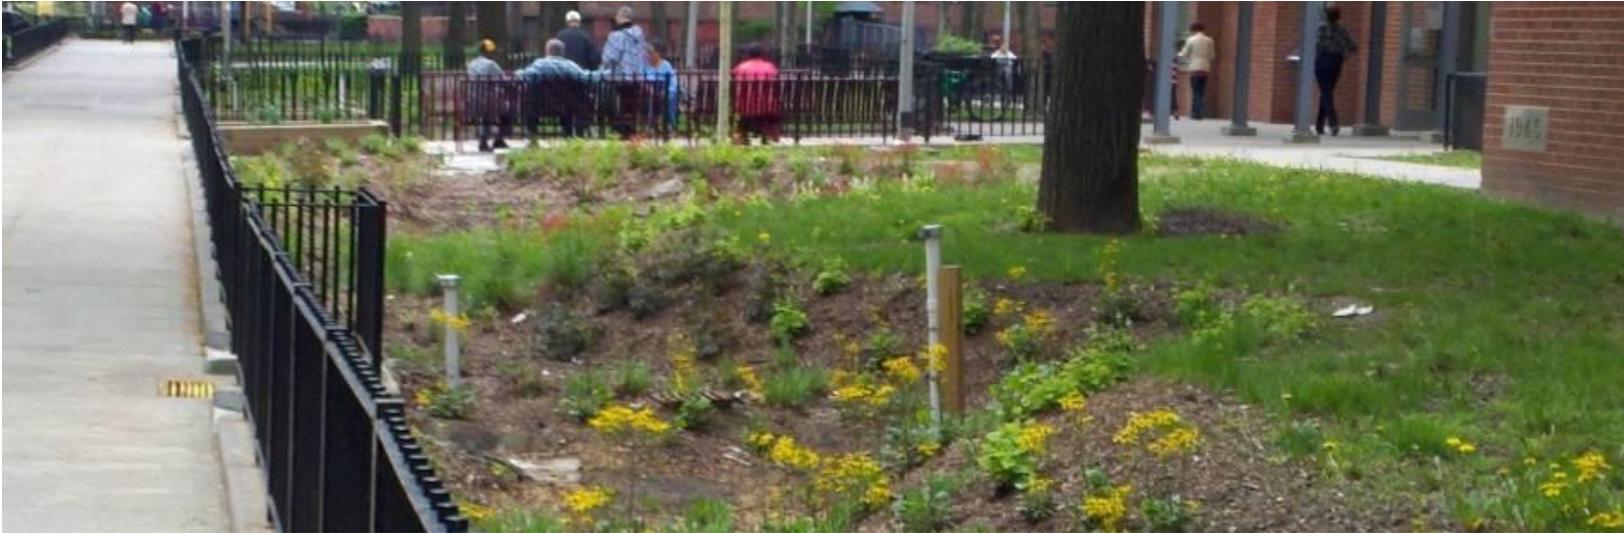
Surface stage gauges installed in bioretention facilities at the Bronx River Houses Community Center are used to measure the capacity of the facilities to pond water.

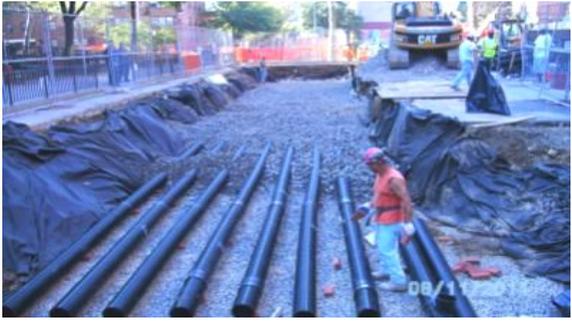
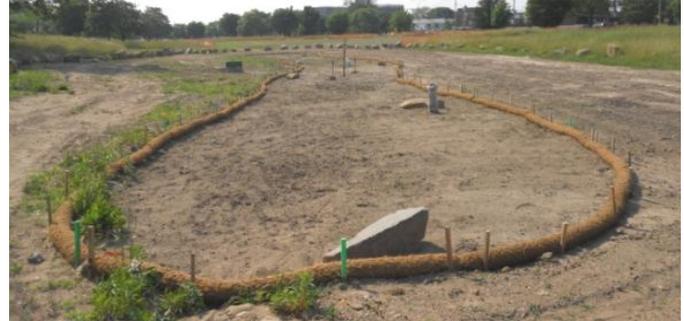
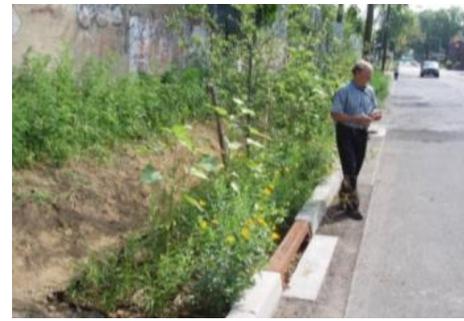
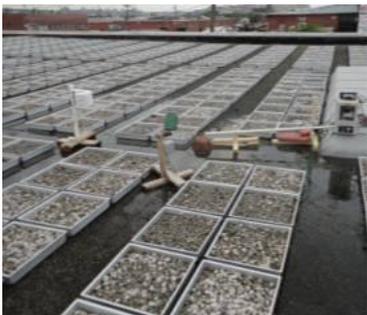
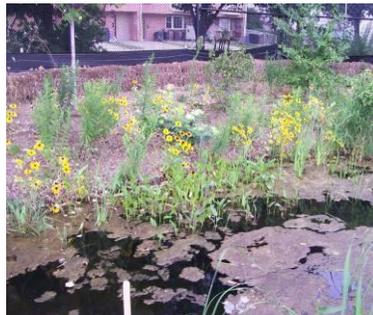
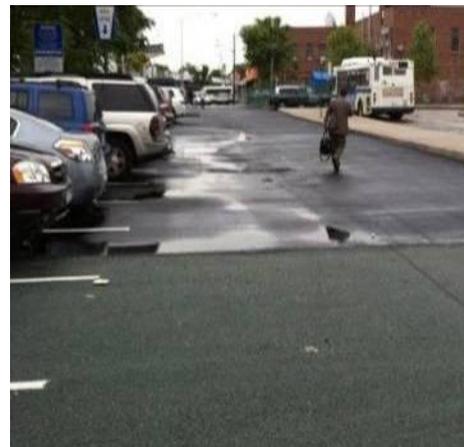
Bronx River Houses perforated pipe system

North & South Conduit bioretention

99th Ave. street-side infiltration swale

Metropolitan Avenue blue roof trays

Spring Creek wet meadow

Far Rockaway porous pavement

Figure 1. The location of green infrastructure pilots that are currently being monitored in priority CSO watersheds across the City.

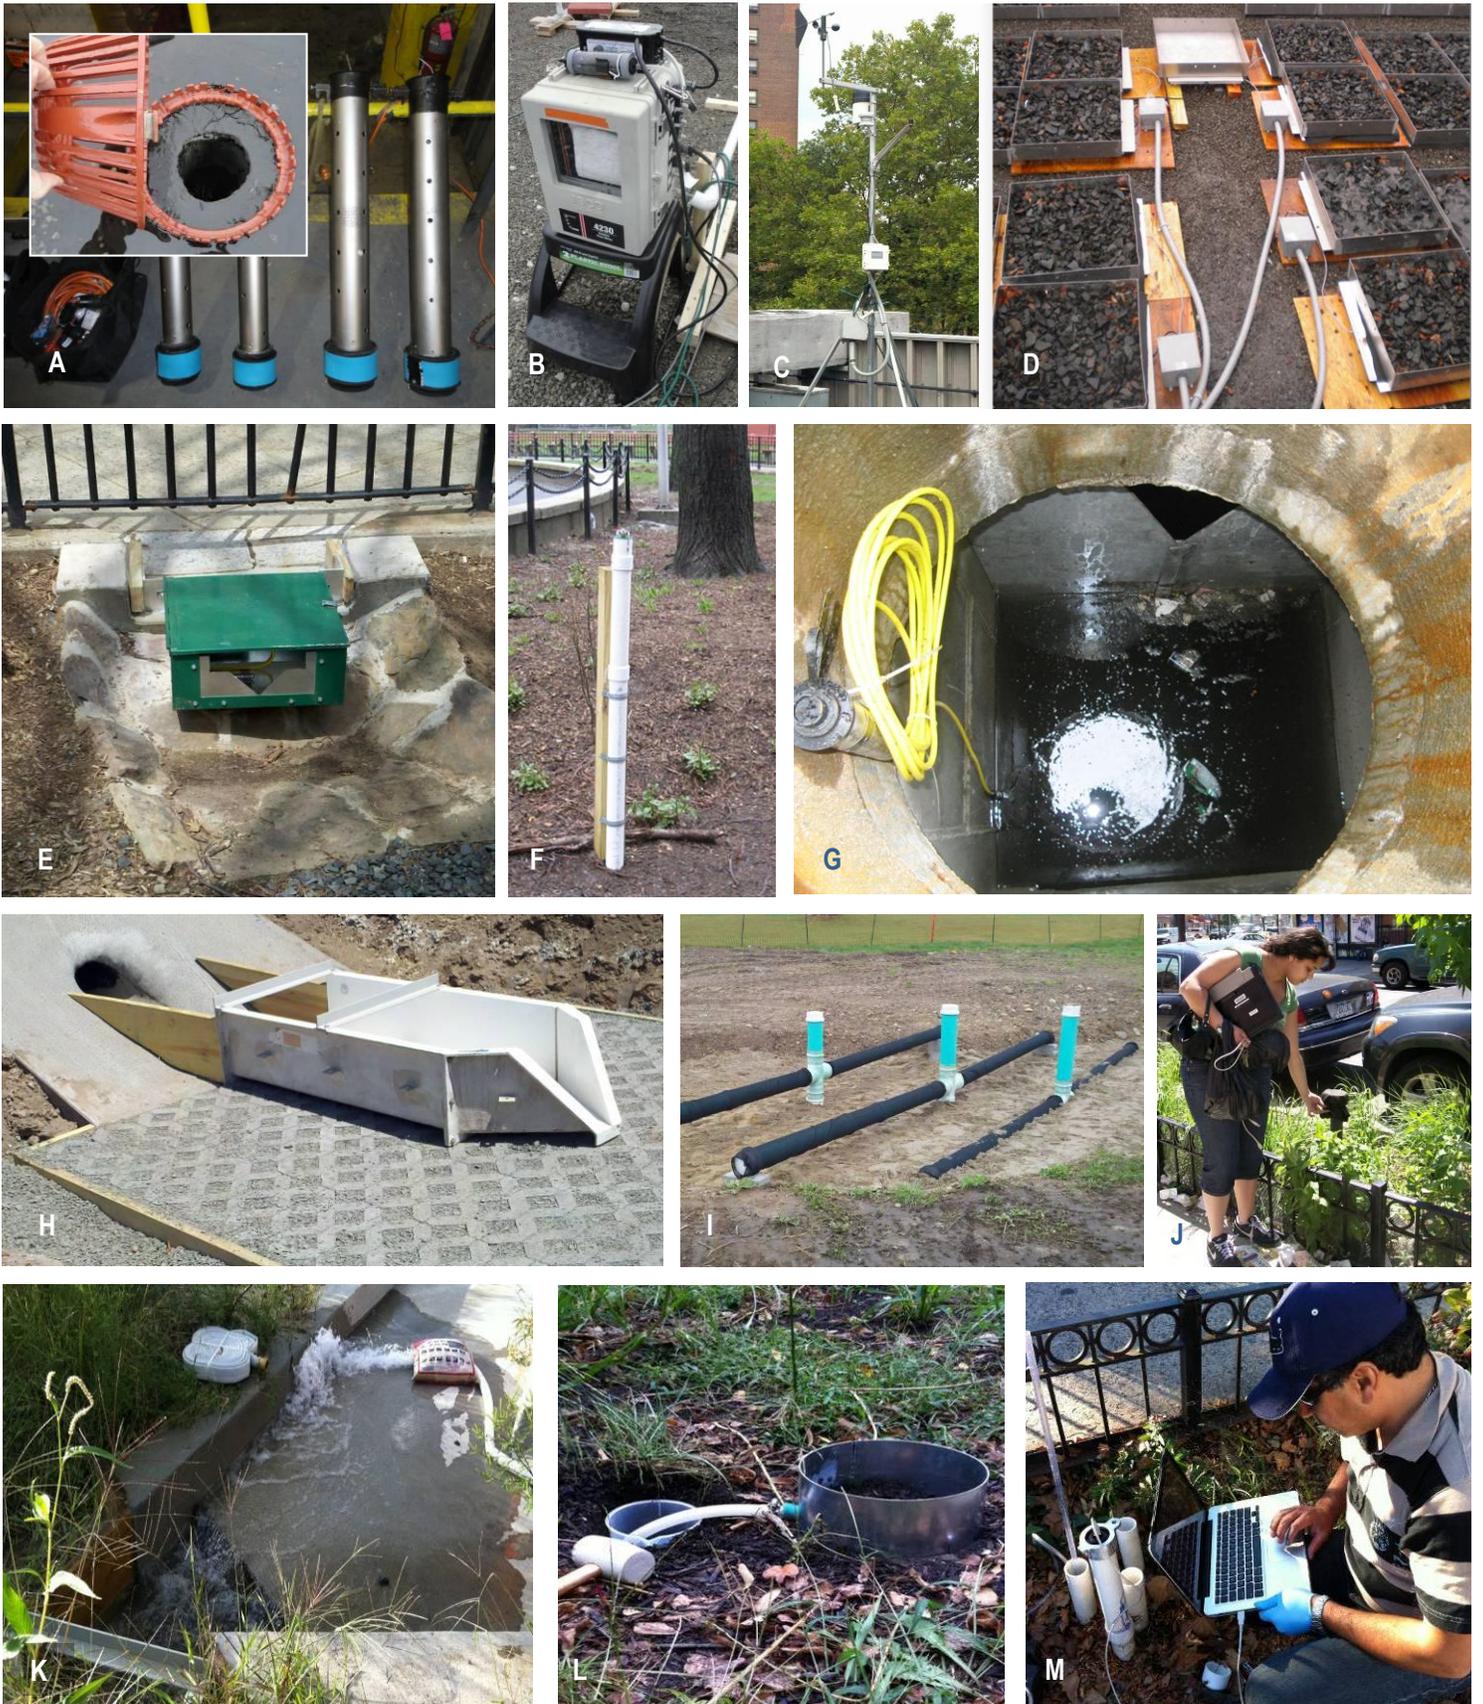
Figure 2. A diversity of equipment and sampling techniques were used at each site including: (A) Roof drain inserts, (B) ISCO 4230 Bubbler Flow Meter; (C) weather station; (D) Arlyn Series 320D-CR Scales and Data Logger; (E) V-notch weir and pressure transducer; (F) stage gauge; (G) water level logger and weir plate; (H) H-flume; (I) water quality sampling wells; (J) street side monitoring well; (K) hydrant testing for curb loss estimates and equipment calibration; (L) infiltration tests; and (M) piezometers.

Quantitative monitoring was conducted primarily through remote monitoring equipment, such as pressure transducer water level loggers in conjunction with weirs or flumes to measure flows (Figure 2). This equipment monitored aspects of source control performance at a regular interval, typically 5 minutes. Site visits were conducted regularly to download and maintain this equipment, as well as assess qualitative monitoring aspects. Monitoring equipment setups at each site were designed in an attempt to evaluate the major functional elements of each source control. Rain gauges and/or weather stations were installed at some pilot locations to collect more locally-accurate weather data. On-site testing and calibration efforts included infiltration tests and metered discharges (through hydrant testing) to calibrate flow monitoring equipment and assess the validity of assumptions used in pilot performance analysis.

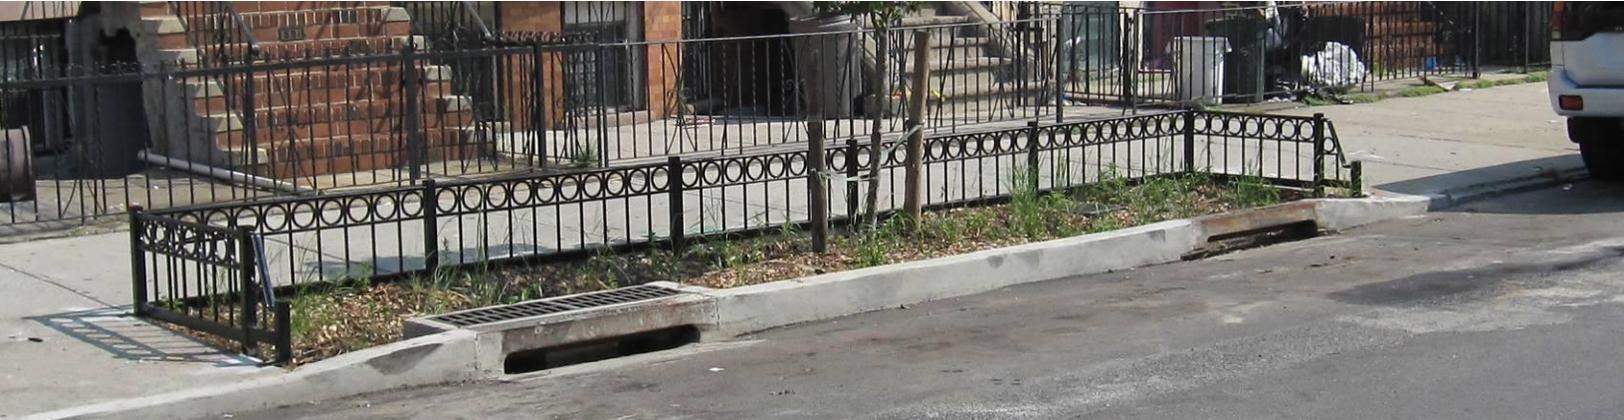
Enhanced tree pits, like the one installed here at Ridgewood Avenue, are street-side source controls that capture, treat, and infiltrate stormwater at existing curb inlets.

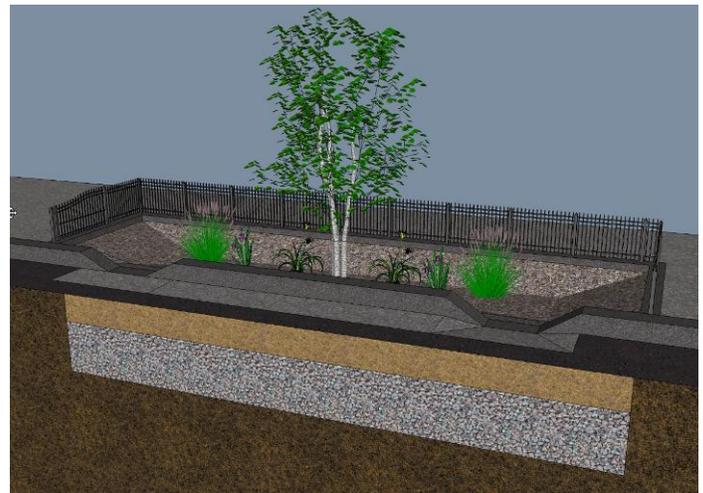
Example design of a street-side infiltration swale.

There are two designs for source control pilots installed in the right-of-way: enhanced tree pits (ETP) and street-side infiltration swales (SSIS). Constructed within the sidewalk areas adjacent to the roadway, both designs are similar. ETPs are 20 feet long, with an engineered soil layer underlain by gravel, recycled glass, or storage chambers. SSISs are 40 feet long, and only have an engineered soil substrate. Water is diverted from the gutter into the source controls through newly-constructed inlets, modified inlets, or curb cuts. Water ponds in the system and is taken up by plants, filters through media, infiltrates, or overflows back into the drainage system. Monitoring devices used include pressure transducers, piezometers, soil moisture sensors, and rain gauges.

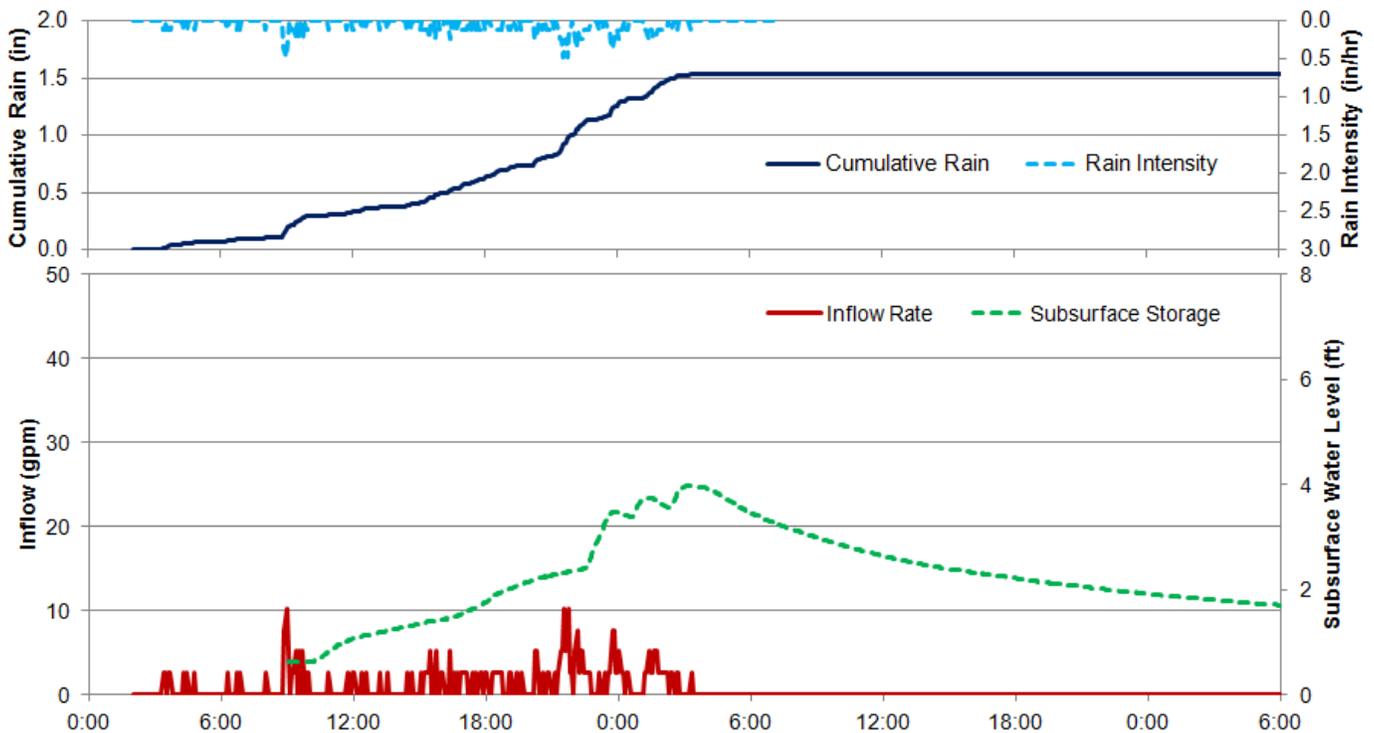
Chart 1. Hydrograph showing enhanced tree pit performance during 1.5-inch storm at Blake Ave on Dec 7, 2011.

An example hydrograph shows inflow rates and subsurface storage for a 1.5-inch storm event (Chart 1). Volume retention performance of four ETP and three SSIS pilots show a high level of volume retention for most small storm events except for the installations at Eastern Pkwy and Howard Ave. (Chart 2).

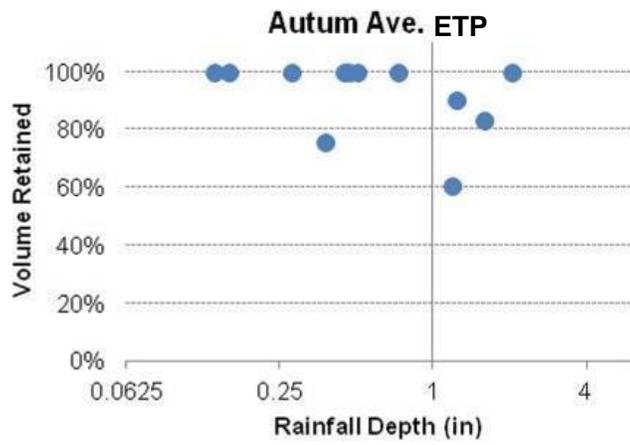
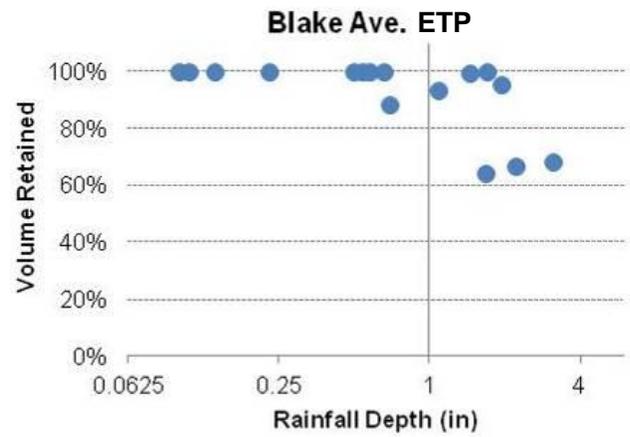
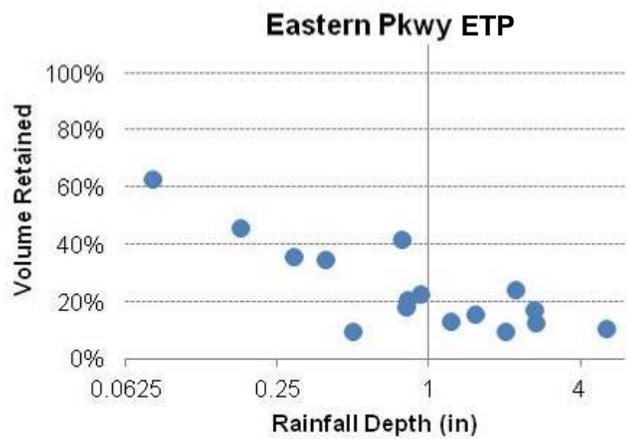
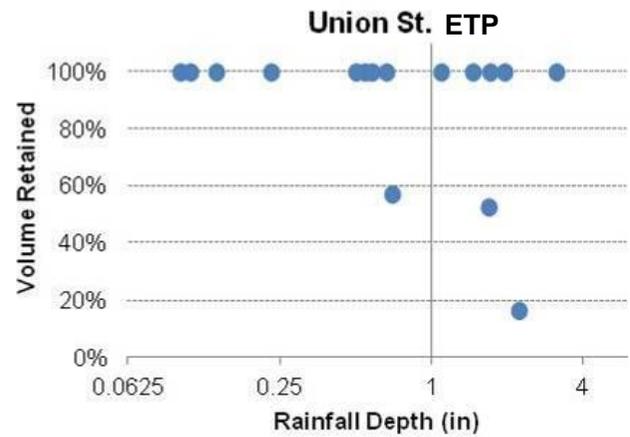
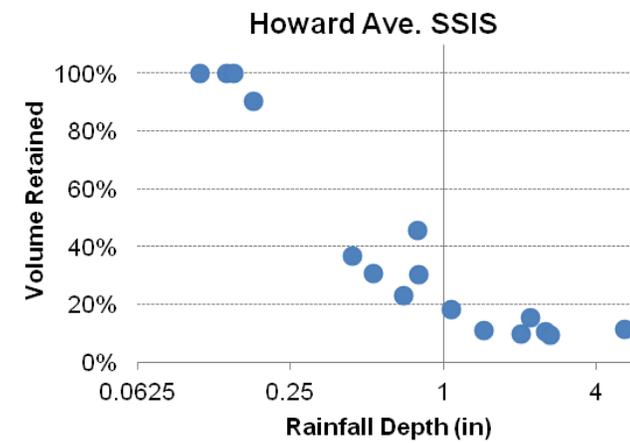
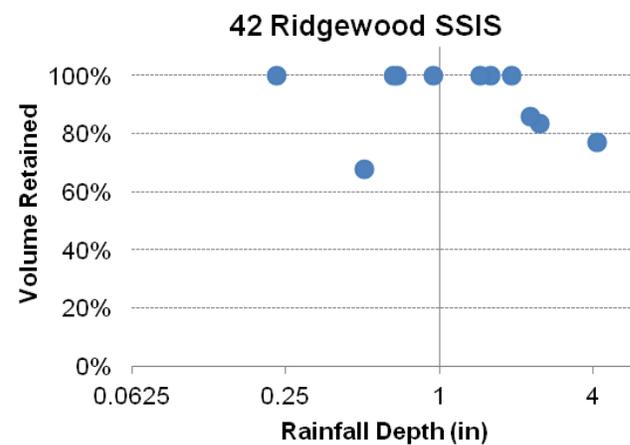
Chart 2. Comparison of enhanced tree pit and street-side infiltration swale performance across all sites monitored in 2011 (each dot represents a single storm event; however, overlap may occur for storms with similar depths).

- Early 2011 results (not shown here) were not as good as those provided due to frequently observed inlet clogging. This issue was resolved by installing open curb cuts;
- Relatively low Eastern Pkwy ETP performance is likely due to the very large watershed area compared to source control area; and

- Relatively poor capture at the Howard Ave. SSIS site is likely due to the steep, short slope and may be a function of the catch basin design. The installation of small check dams just before the catch basin may improve overall capture rates.

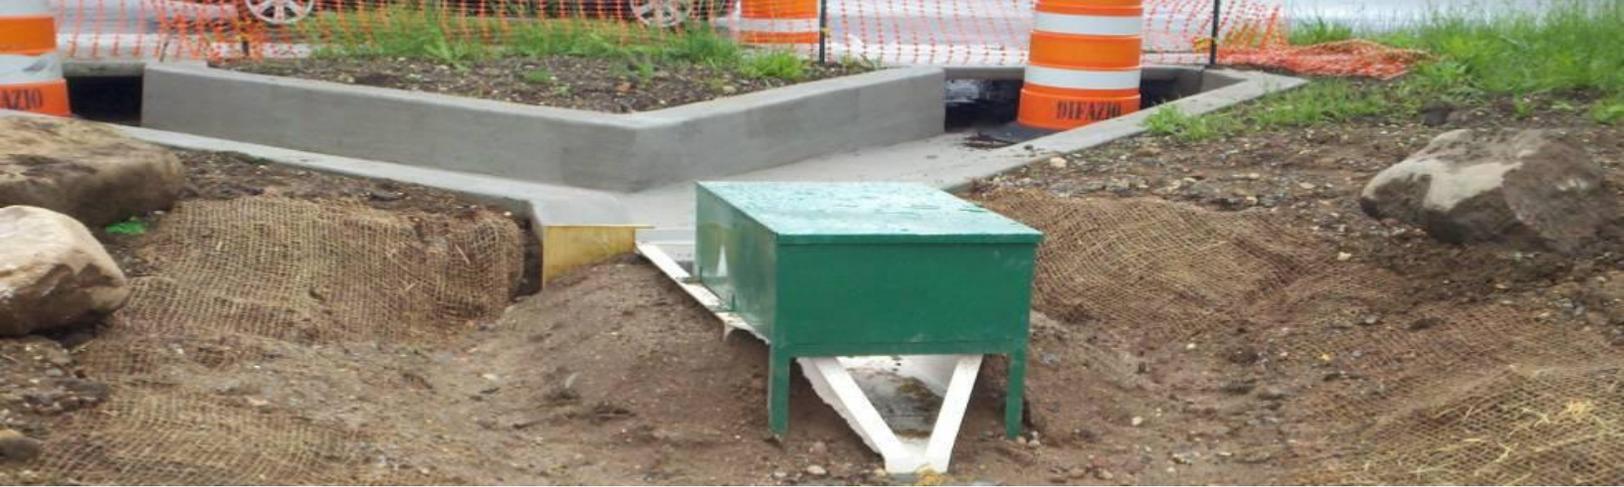
The bioretention facility at North and South Conduit Avenues receives stormwater runoff from curb inlets and curb cuts on surrounding roadways. To measure the amount of flow entering the pilot, temporary H-flumes were installed at inlet locations.

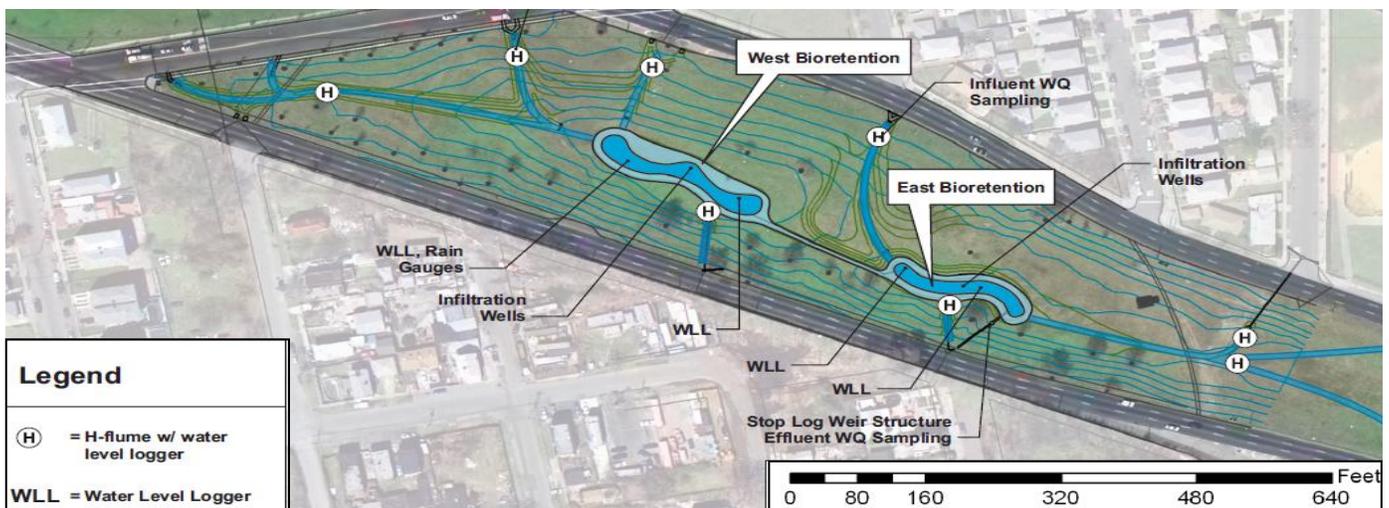
Map showing monitoring locations at the North and South Conduit pilot.

This pilot includes a pair of connected, vegetated bioretention areas located within the median of the North and South Conduit Avenues. Modifications to the road drainage system (i.e., curb cuts, inlet modifications, and catch basin modifications) were required to direct runoff into the facilities via pipes or vegetated swales. Inflow is measured using H-flumes at each of the inlet channels. The bioretention areas are connected via a surface overflow channel and a subsurface underdrain. A grated outlet structure serves as a surface overflow for the entire system. Combined underdrain and surface overflow leaving the system in a single pipe is measured with a pressure transducer, water level logger, and weir plate.

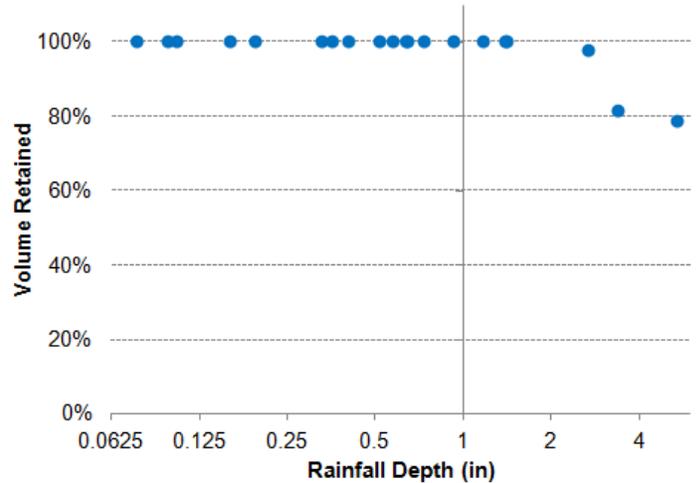
Chart 4. Bioretention performance across all storms monitored (each dot represents a single storm event; however, overlap may occur for storms with similar depths).

An example hydrograph comparison of inflow and outflow rates and surface storage is shown in Chart 3 for a 1.1-inch storm event. A significant amount of storage occurred on the surface of this facility during this event, and no outflows were observed following this event. Preliminary data indicate that for storm events less than two inches, the bioretention facility is providing 100% volume retention (Chart 4).

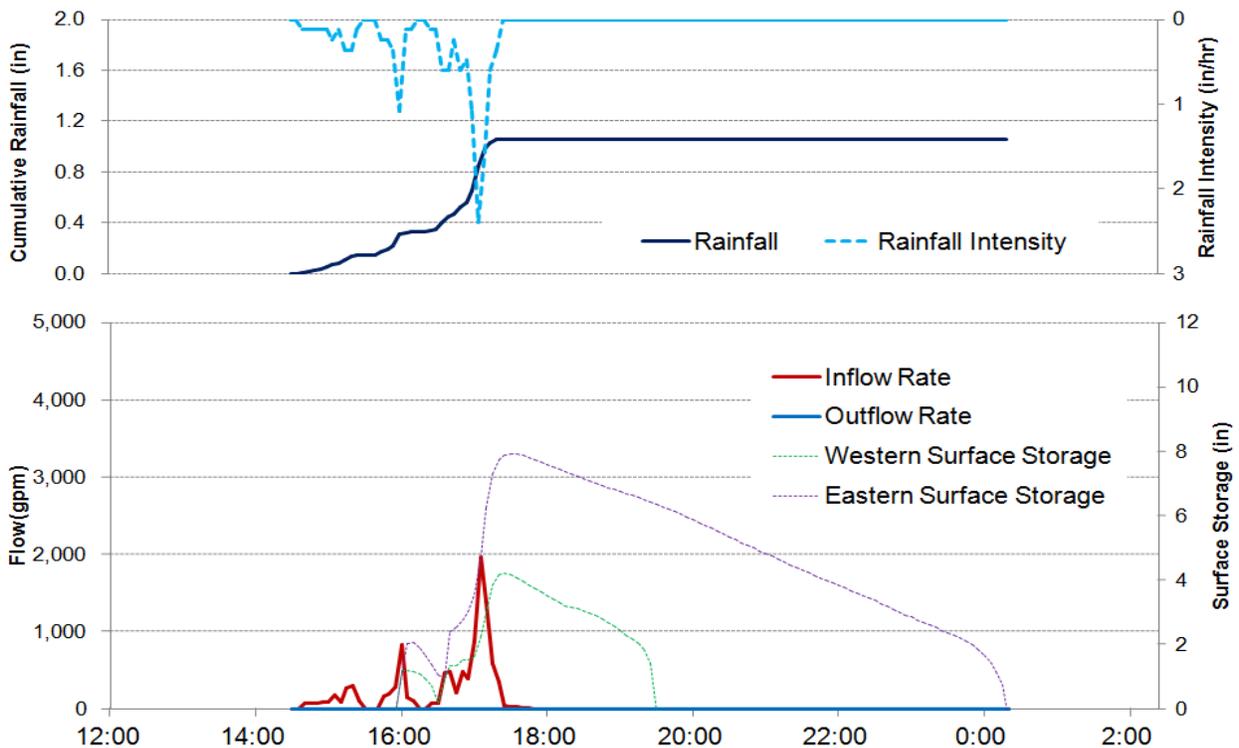
Chart 3. Hydrograph showing bioretention performance during 1.1– inch storm at North & South Conduit on Aug 9, 2011.

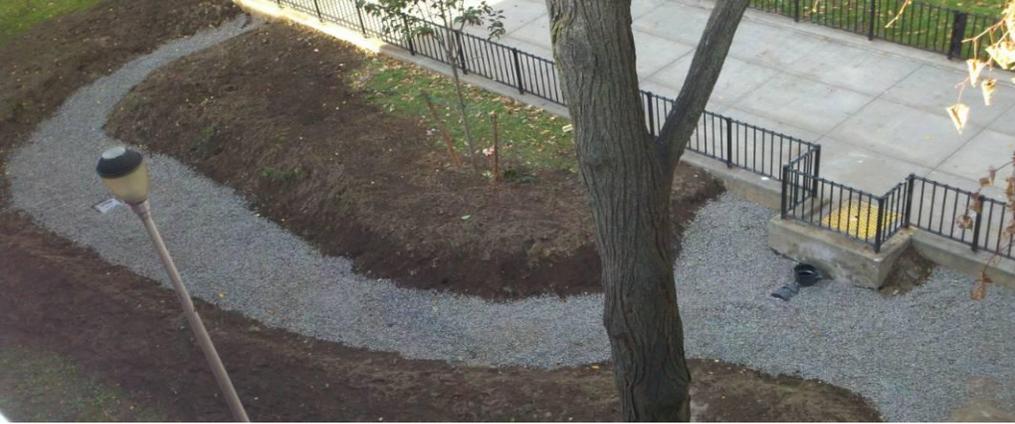
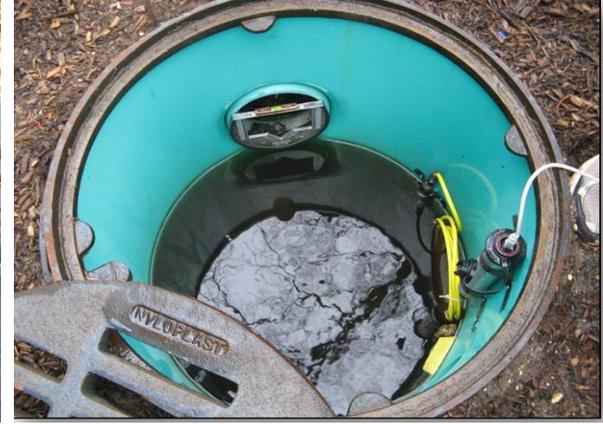
A view from the Bronx River Houses Community Center roof overlooks the installation of the gravel subsurface layer below one of the five bioretention facilities. The discharge from underdrains within the gravel is monitored in catch basins using water level loggers and weir plates.

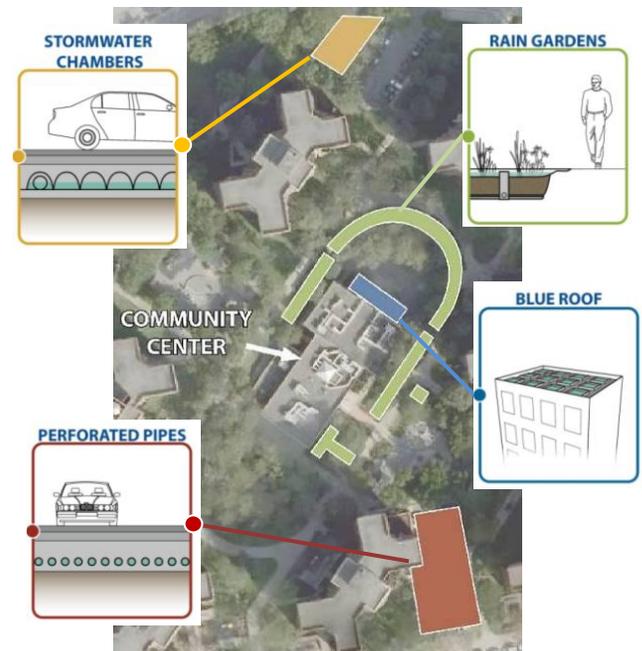
Green infrastructure installations at the Bronx River Houses.

This site contains five bioretention facilities (referred to on-site as rain gardens) installed within the existing landscaping around the Community Center; a blue roof tray system installed at the Community Center; as well as two subsurface systems—stormwater chambers and perforated pipes—installed beneath the north and south parking lots, respectively. Monitoring analyses for this report include data from only the bioretention and stormwater chamber pilots.

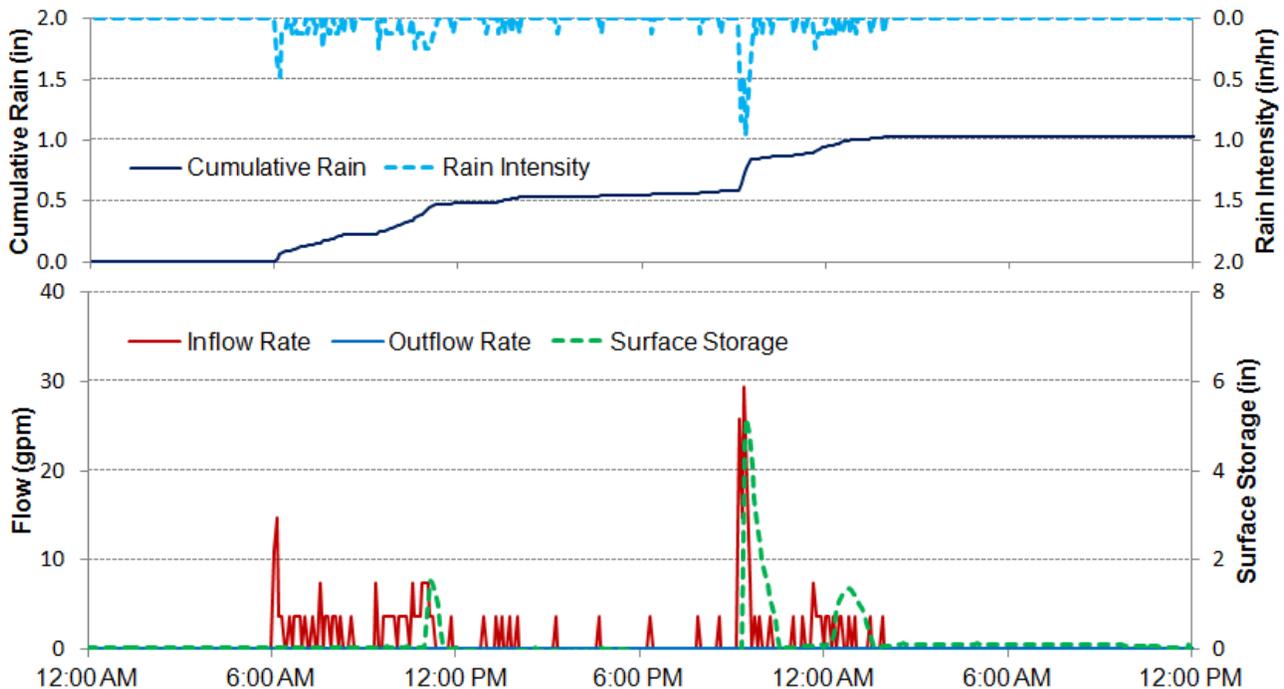
Chart 5. Example hydrograph showing performance of Bioretention #3 at the Bronx River Houses during a 1-inch storm event on Oct 19, 2011.

Hydrograph comparisons of inflow and outflow rates indicate little to no outflow from bioretention facilities during small storm events (Chart 5). Occasional outflow was observed during deep or intense rainfall events.

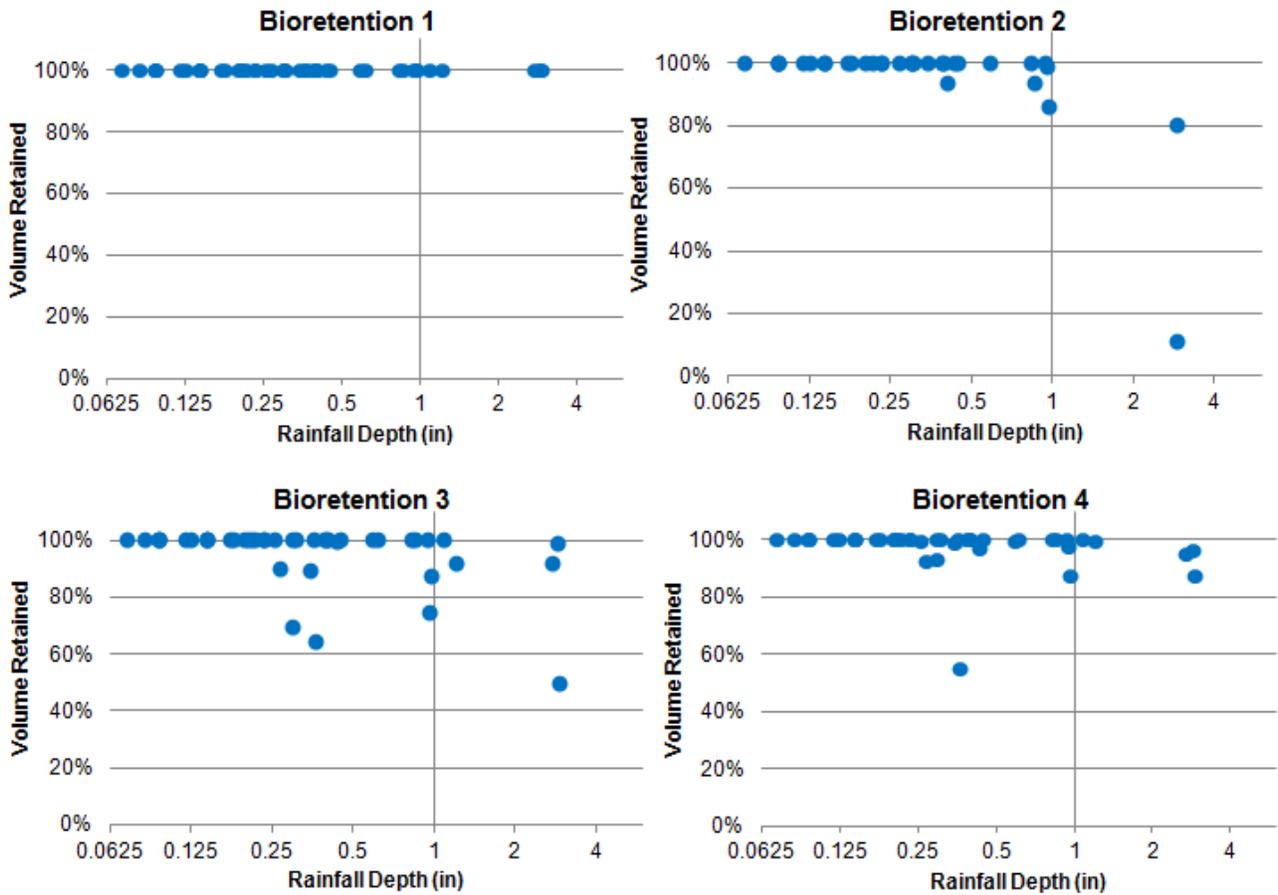
Chart 6. Retention performance at four of five bioretention installations at the Bronx River Houses for all storms monitored (each dot represents a single storm event; however, overlap may occur for storms with similar depths).

All of the bioretention facilities, while variable in performance, have shown 80-100% volume reduction for most storms less than 1 inch (Chart 6). This indicates a relatively high percentage of soil retention with subsequent evapotranspiration and/or infiltration. Surface storage in each bioretention allows for slow seepage.

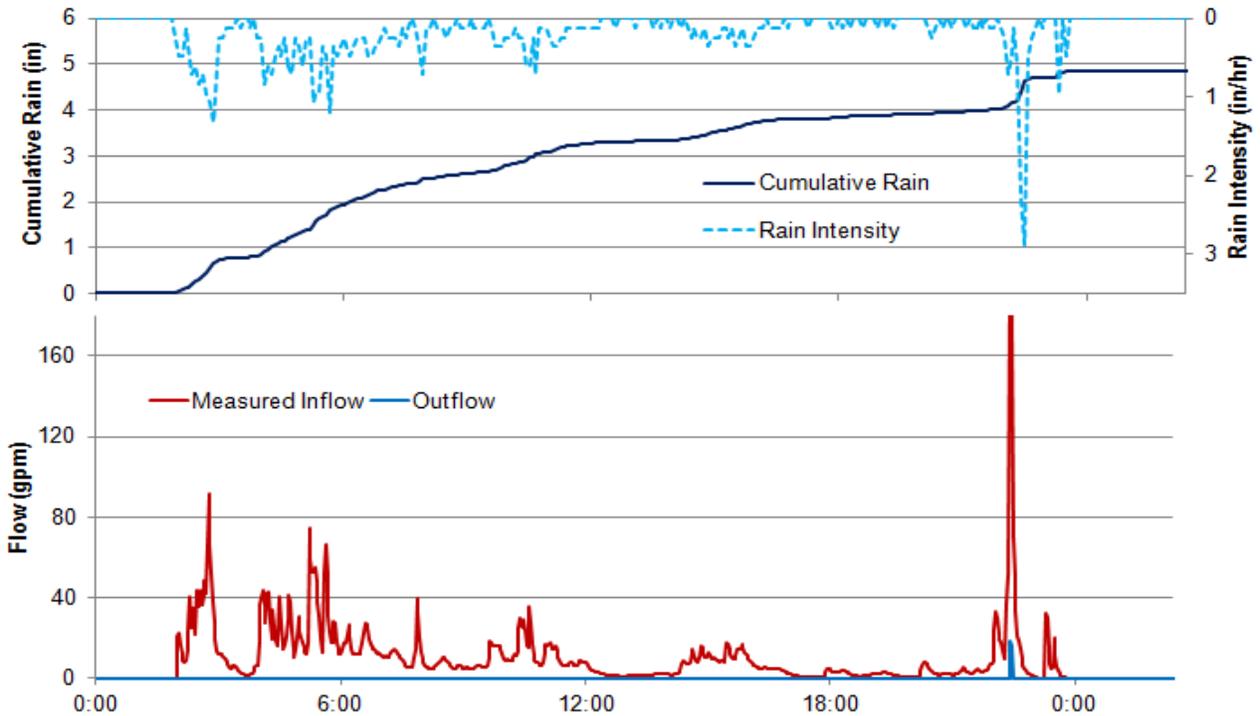
Chart 7. Example hydrograph showing performance of subsurface stormwater chambers at the Bronx River Houses during a 4.8-inch storm on Aug 15, 2011.

The subsurface stormwater chambers show little to no outflow during large events, as shown in Chart 7, for a 4.8-inch storm.

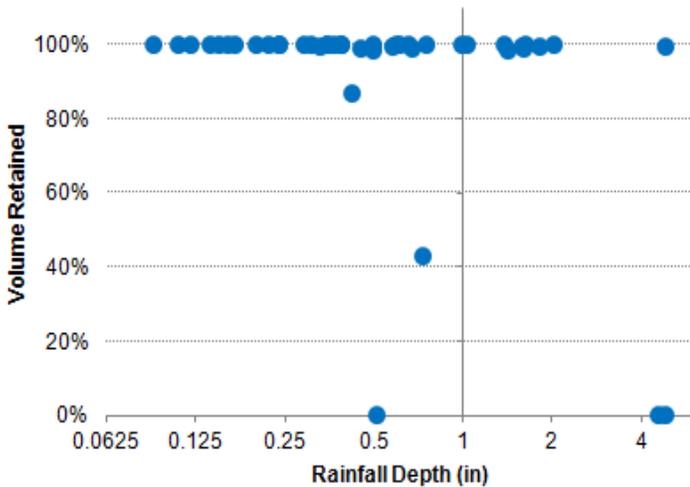
Chart 8. Subsurface stormwater chamber retention performance for all storms monitored (each dot represents a single storm event; however overlap may occur for storms with similar depths).

For most events less than 1-inch, the stormwater chambers have shown 100% volume reduction (Chart 8). For events larger than 1 inch, some outflows are observed; although peak outflows are reduced compared to rate of inflow or rate of runoff without controls (Chart 9).

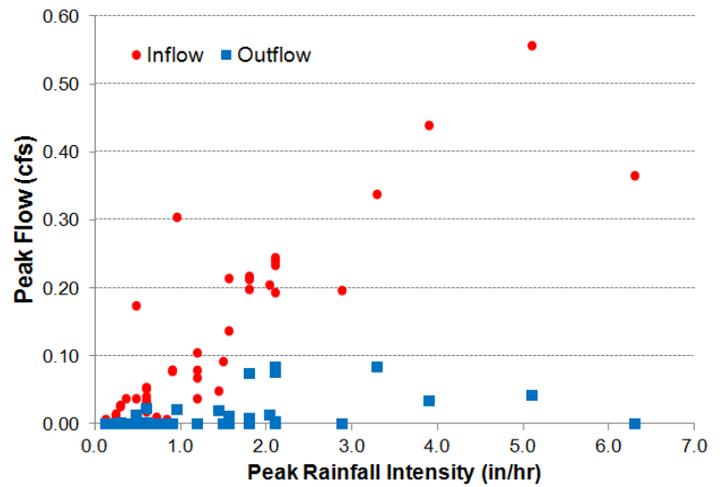
Chart 9. Storage chamber peak control performance for all storms monitored (each point represents a single storm event; however overlap may occur for storms with similar depths).

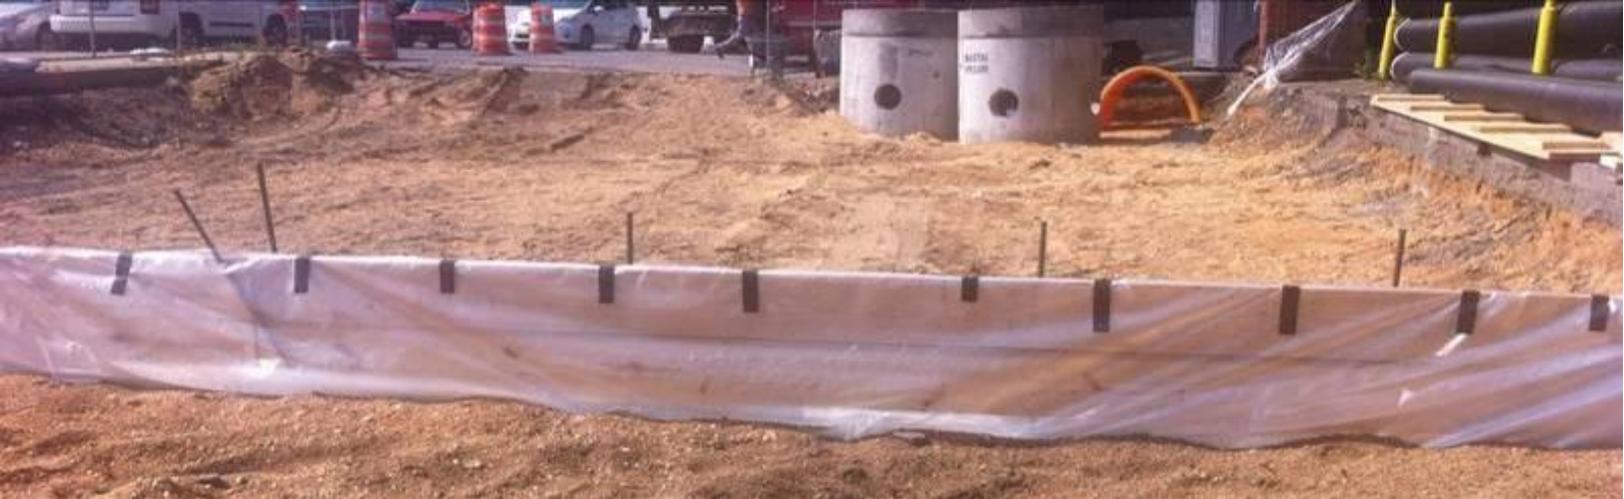
Designed specifically for monitoring, vertical barriers were installed between adjacent installations of pavement at the Far Rockaway pilot in order to isolate subsurface flows. Asphalt berms were used on the surface to separate runoff between each of the pavement areas.

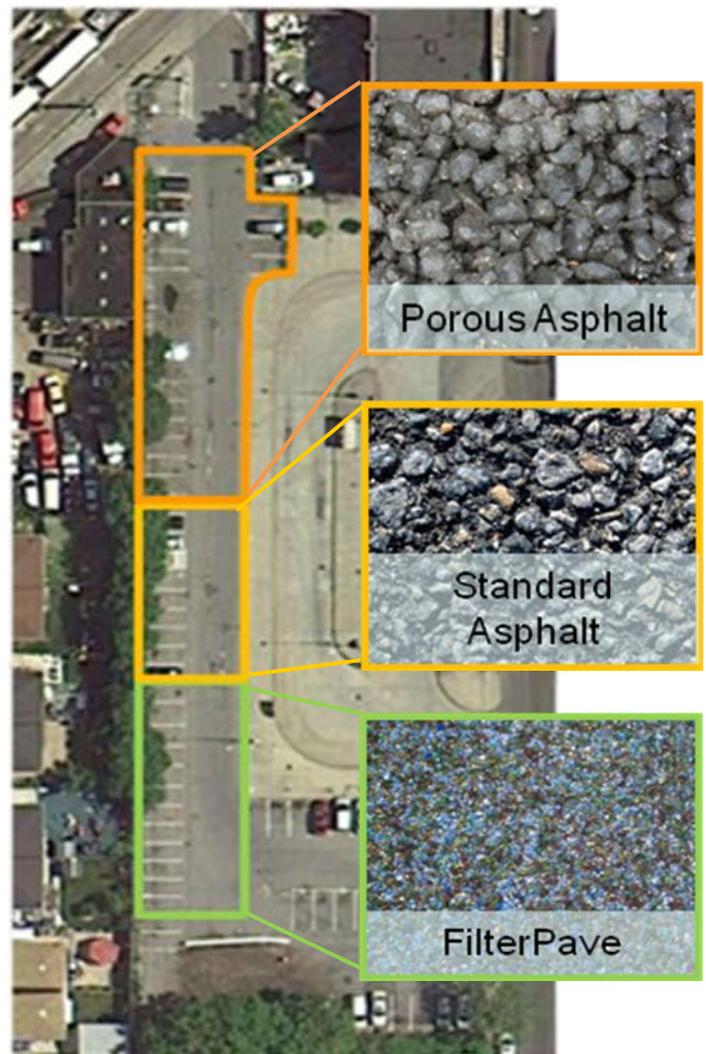
Arrangement of pavement types in the Far Rockaway parking lot.

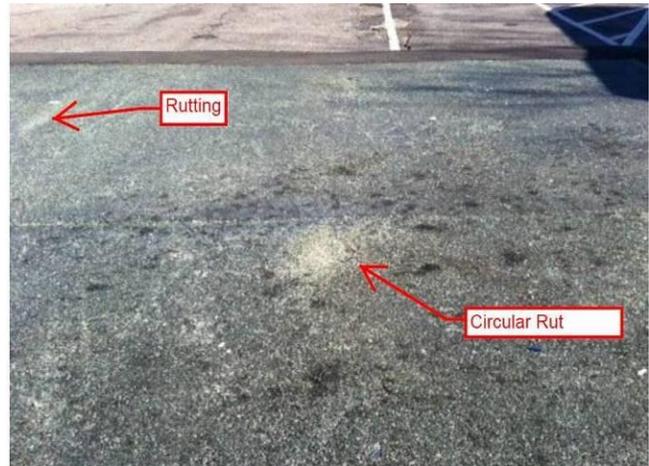
Closer inspection of the FilterPave™ surface during the monitoring period has revealed rutting and surface wear.

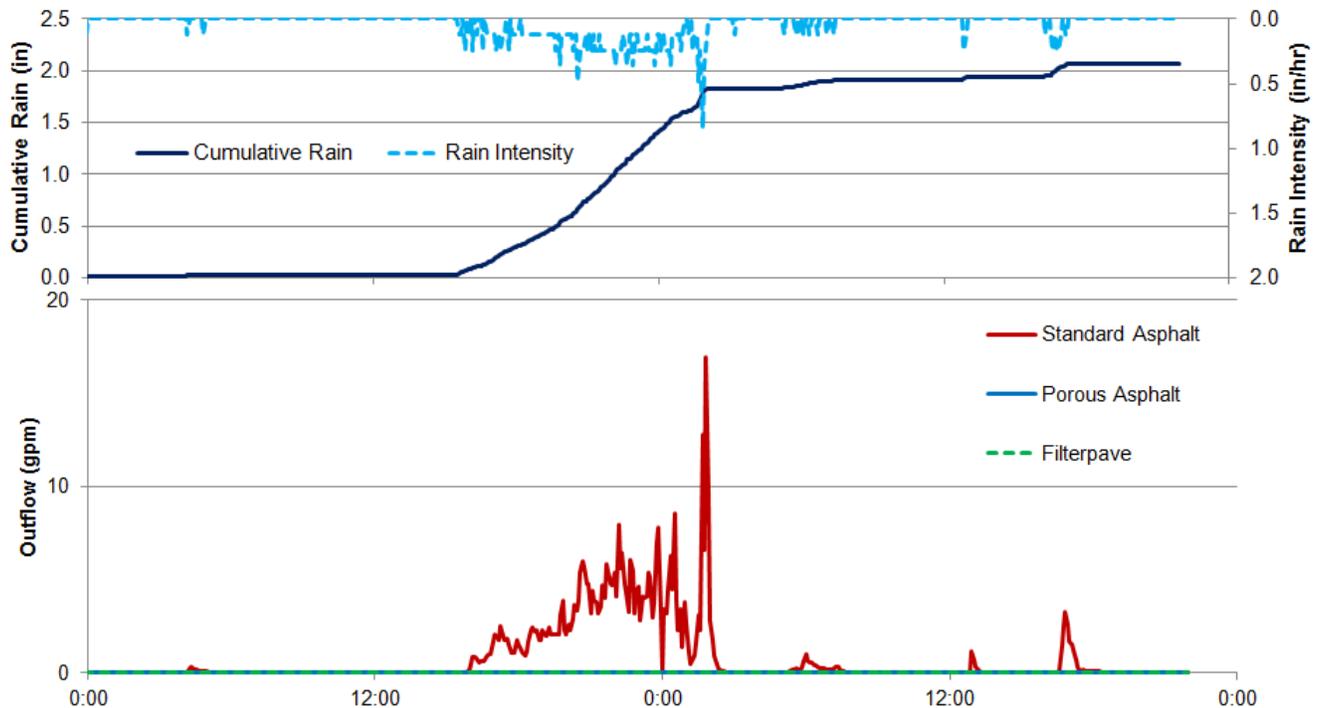
Chart 10. Example hydrograph comparing storm outflow by pavement type during a 2.1-inch storm at Far Rockaway on Nov 22, 2011.
