NYC Green Infrastructure Plan: 2011 Preliminary Pilot Monitoring Results

UPDATE SUPPLEMENT

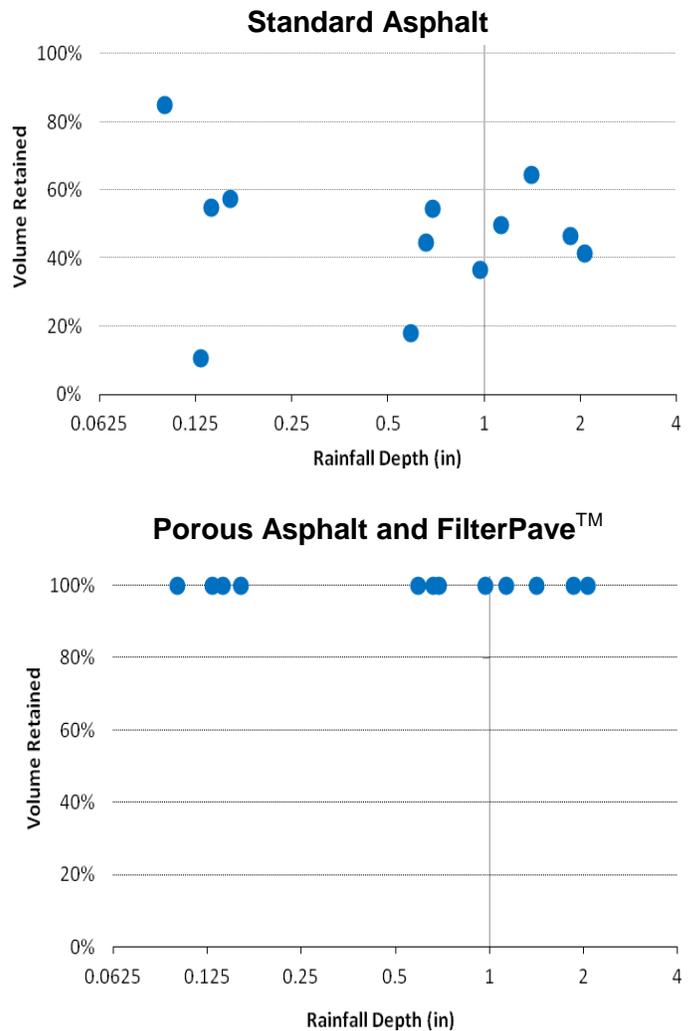
Chart 11. Runoff retention performance for specified pavement types (each dot represents a single storm event; however, overlap may occur for storms with similar depths).

The porous asphalt and FilterPave™ sections have shown apparent 100% volume retention for all monitored storms (Chart 11). This suggests that the subsurface storage volume and underlying soil infiltration rates are able to capture all precipitation without discharging to the combined sewer. Monitoring of the standard asphalt also shows volume retention through surface ponding; further quality control of the accuracy of this data and potential sources of observed storage is being conducted.

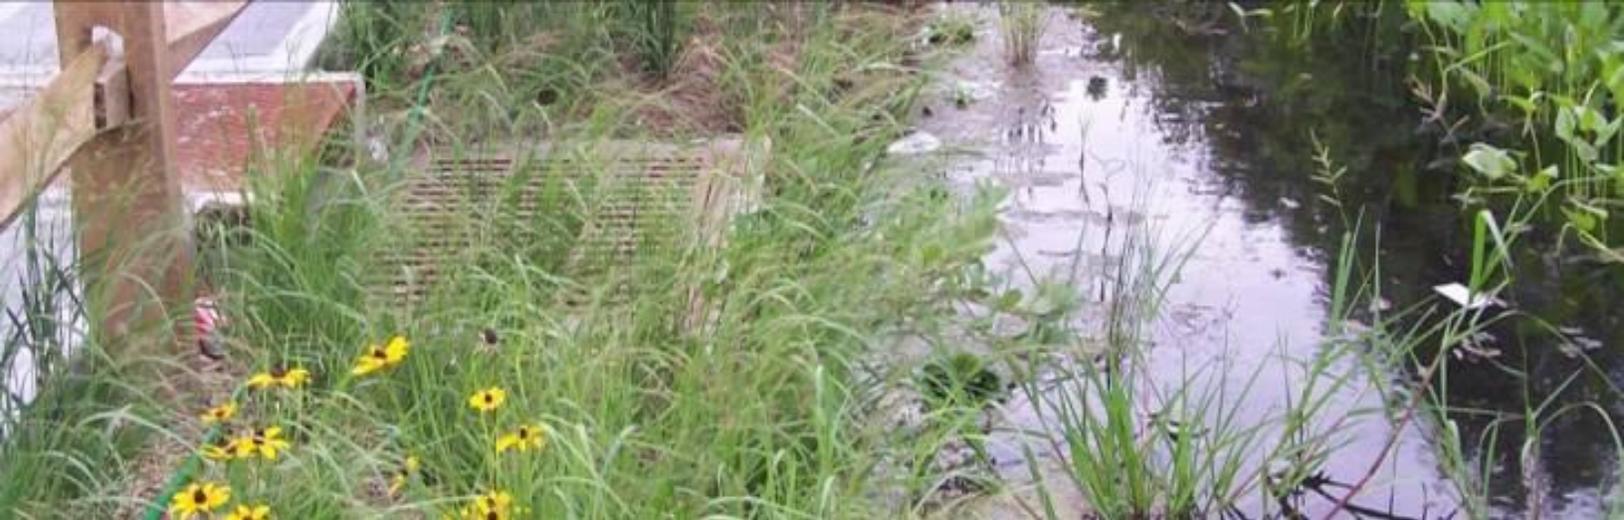
Vegetation in the wet meadow pilot at the Spring Creek MTA Bus Terminal was specifically selected for tolerance to saturated conditions.

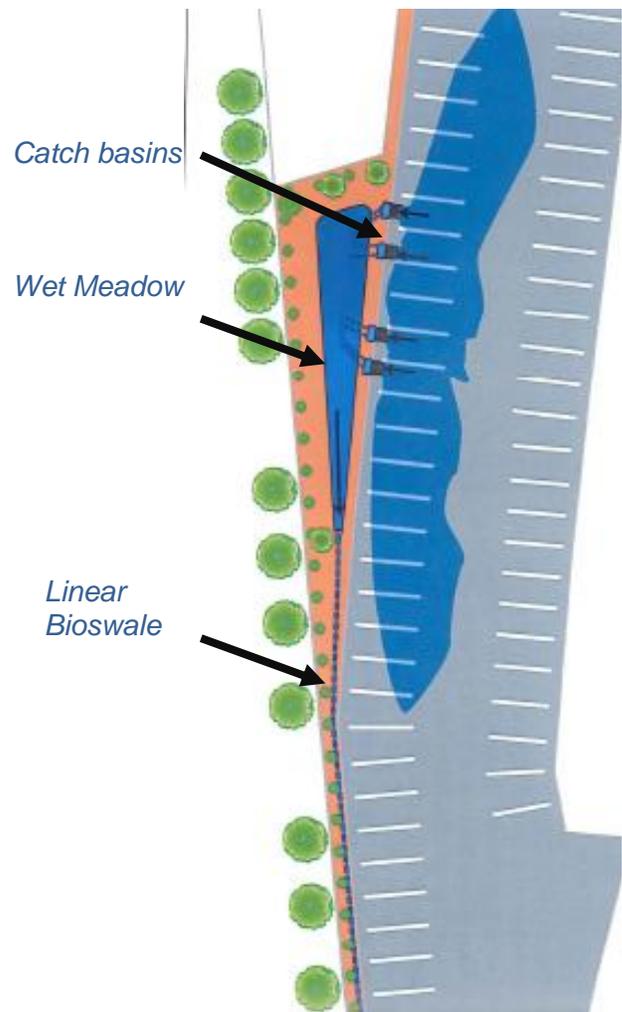
Stormwater runoff from the MTA parking lot is diverted to the wet meadow via perimeter catch basins. Excess water in the wet meadow overflows into an infiltrating bioswale.

At the Spring Creek Metropolitan Transit Authority (MTA) bus terminal, a stormwater wetland (wet meadow), was constructed to manage runoff from the parking lot, which is conveyed to the source control through catch basins. A solar-powered groundwater pump maintains a permanent 1-foot deep pool to support indigenous wetland plants. Overflow from the wetland is directed into a linear bioswale designed to promote infiltration into the soil (e.g., sand and recycled glass subsurface layers).

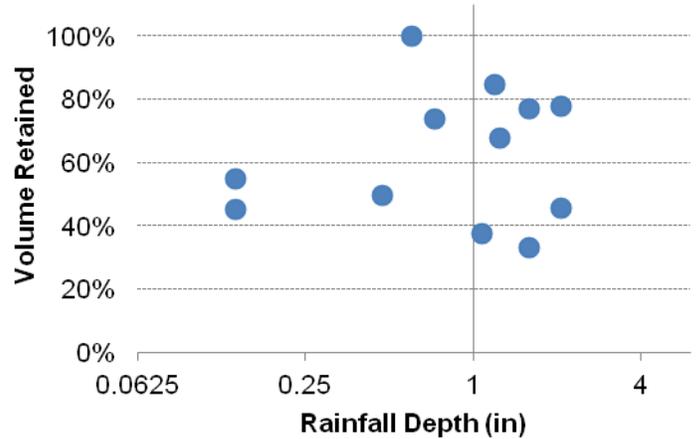
Chart 13. Volume retention performance at the MTA wet meadow pilot (each dot represents a single storm event; however, overlap may occur for storms with similar depths).

- The occasional, relatively low volume retention percentage at this site is likely due to parking lot topography, which directs runoff into existing dry wells. Additional effort is anticipated in 2012 to better define the drainage area to the practice and to address issues with the monitoring equipment. For example, the installation of check dams may reduce flows to the dry wells and siltation of overflow channels.

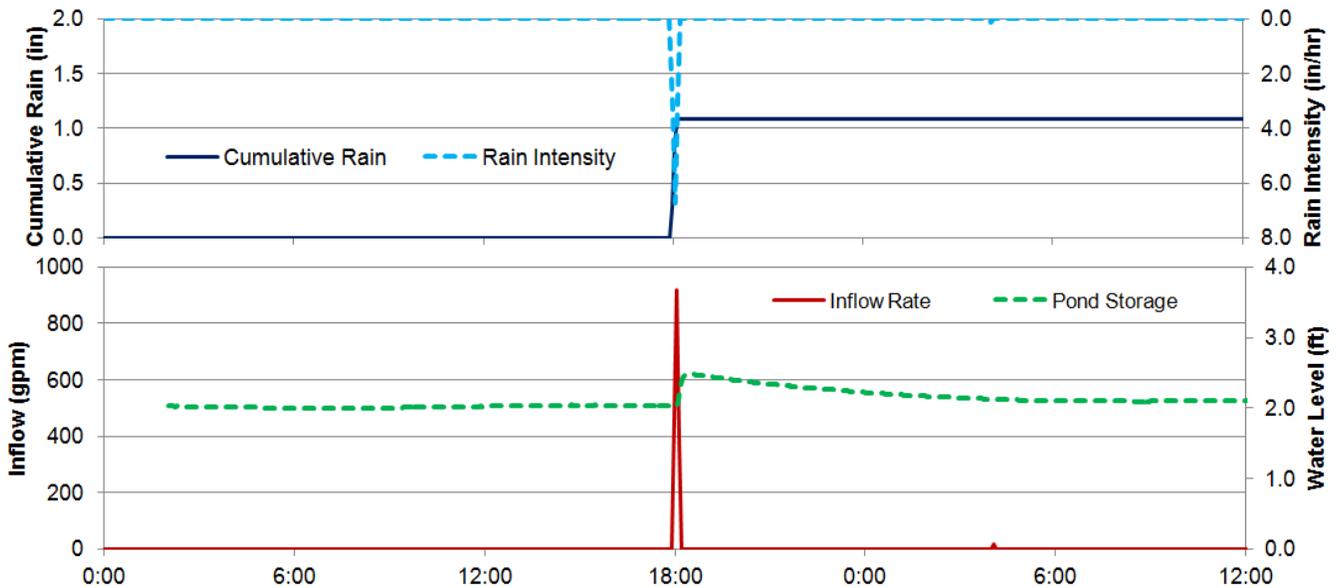
Chart 12. Example hydrograph showing wet meadow storage during a 1.1- inch storm on Aug 18, 2011.

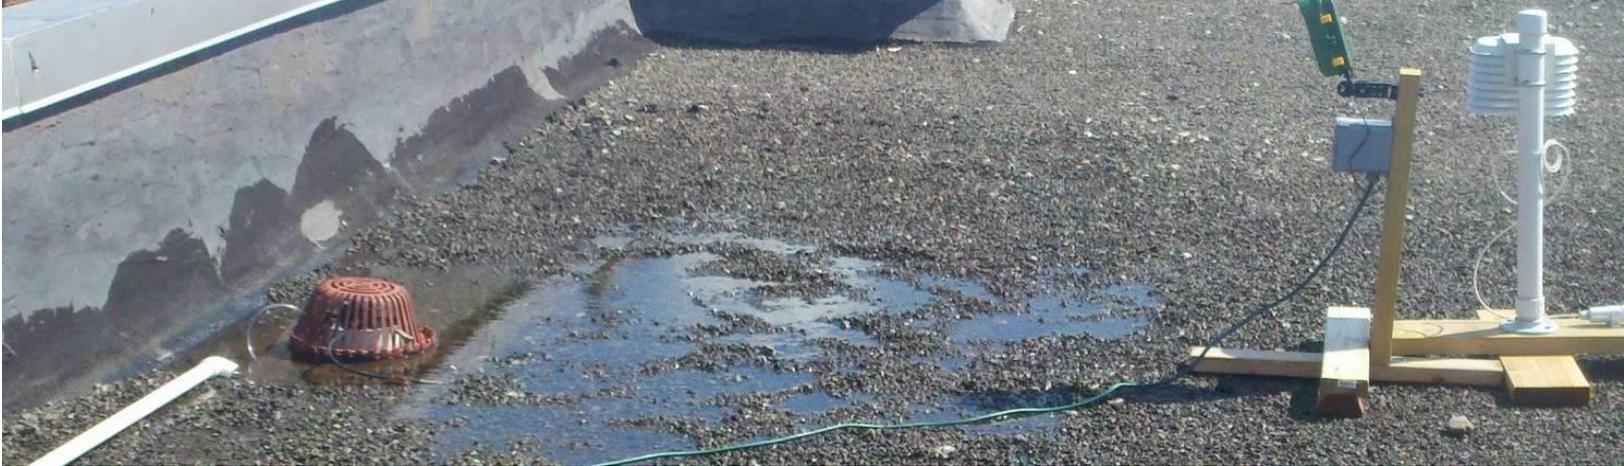
At the Metropolitan Avenue pilot, three variations on blue roof designs are being monitored: modified outlet, check dams, and tray systems. Specially designed inserts were installed inside existing drain pipes in order to measure outflow.

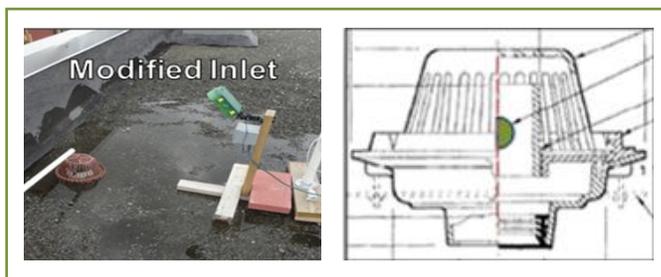
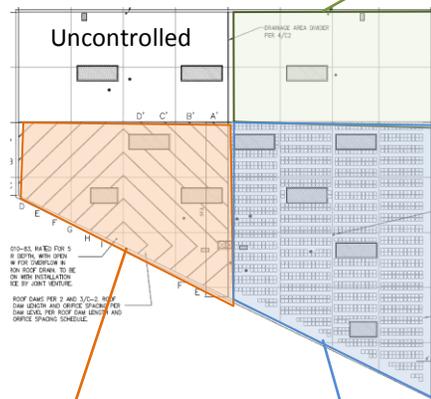
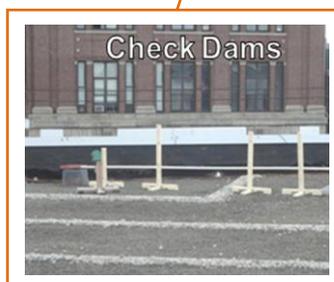
The roof was divided into three pilot areas and a comparable uncontrolled reference area.

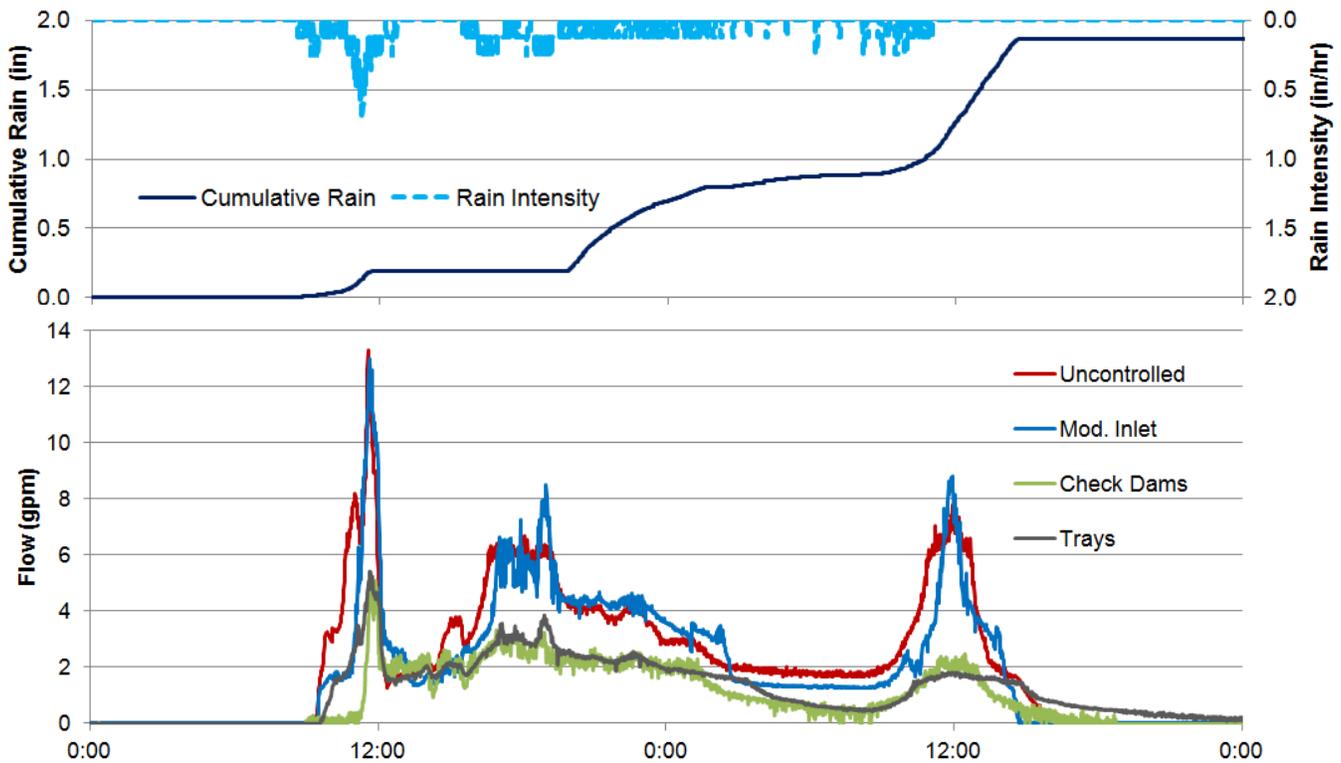
Chart 14. Example hydrographs from a 1.9-inch storm comparing three blue roof pilots against an uncontrolled area on Oct 29, 2011.

An example hydrograph comparison of outflow rates for a 1.9-inch storm between the uncontrolled and three pilot sites show some detention of rainfall using check dams and trays (Chart 14). Retention performance charts show scattered results with trays providing 50% volume reduction for most storms while check dams and modified inlets are similar to uncontrolled conditions (Chart 15). Chart 16 shows the performance of the pilot to reduce peak flows across a range of rainfall intensities; trays and check dams appear to perform the best for low intensity storms. Median drawdown durations were as follows: 1.2 hrs (uncontrolled); 2.7 hrs (modified inlet); 5.8 hrs (check dams); and 7.8 hrs (trays).

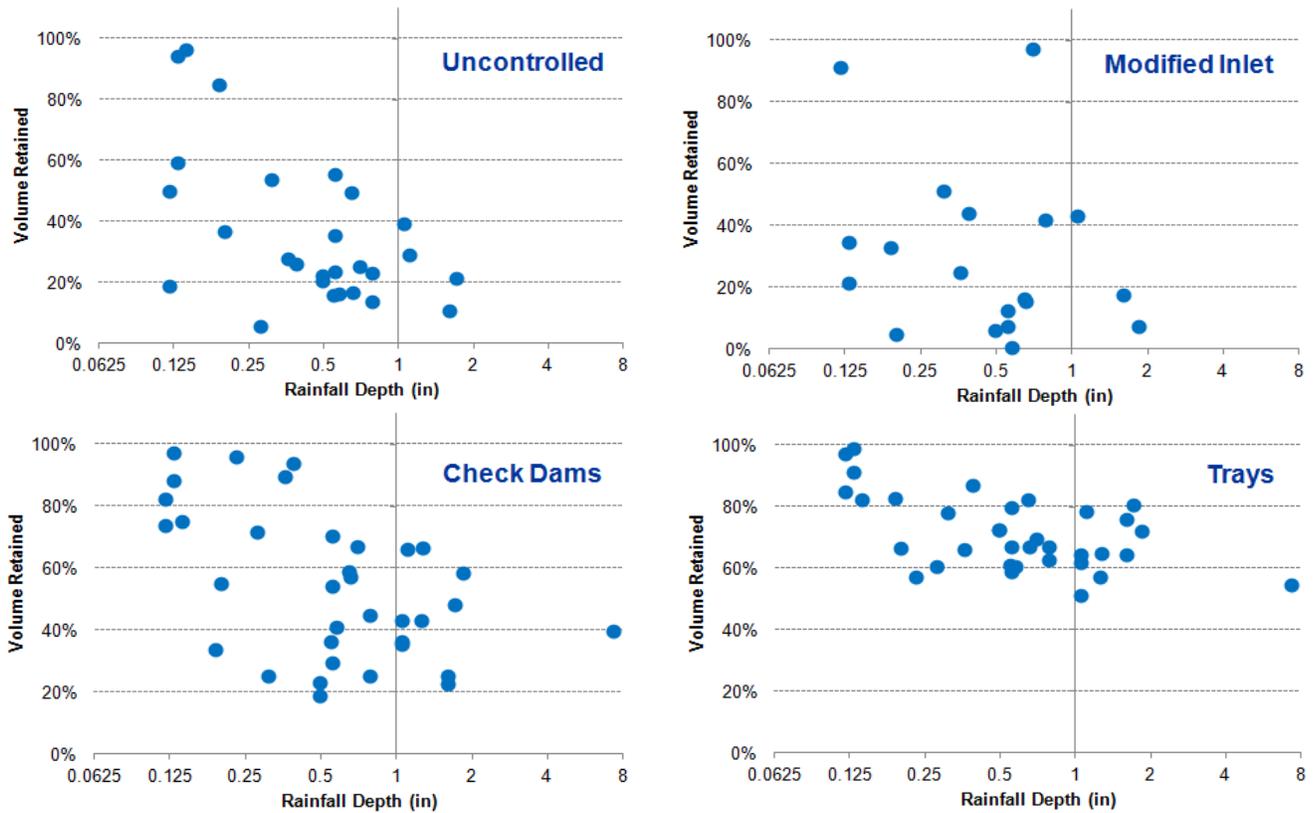
Chart 15. Volume retention performance of rooftop pilots (each dot represents a single storm event).

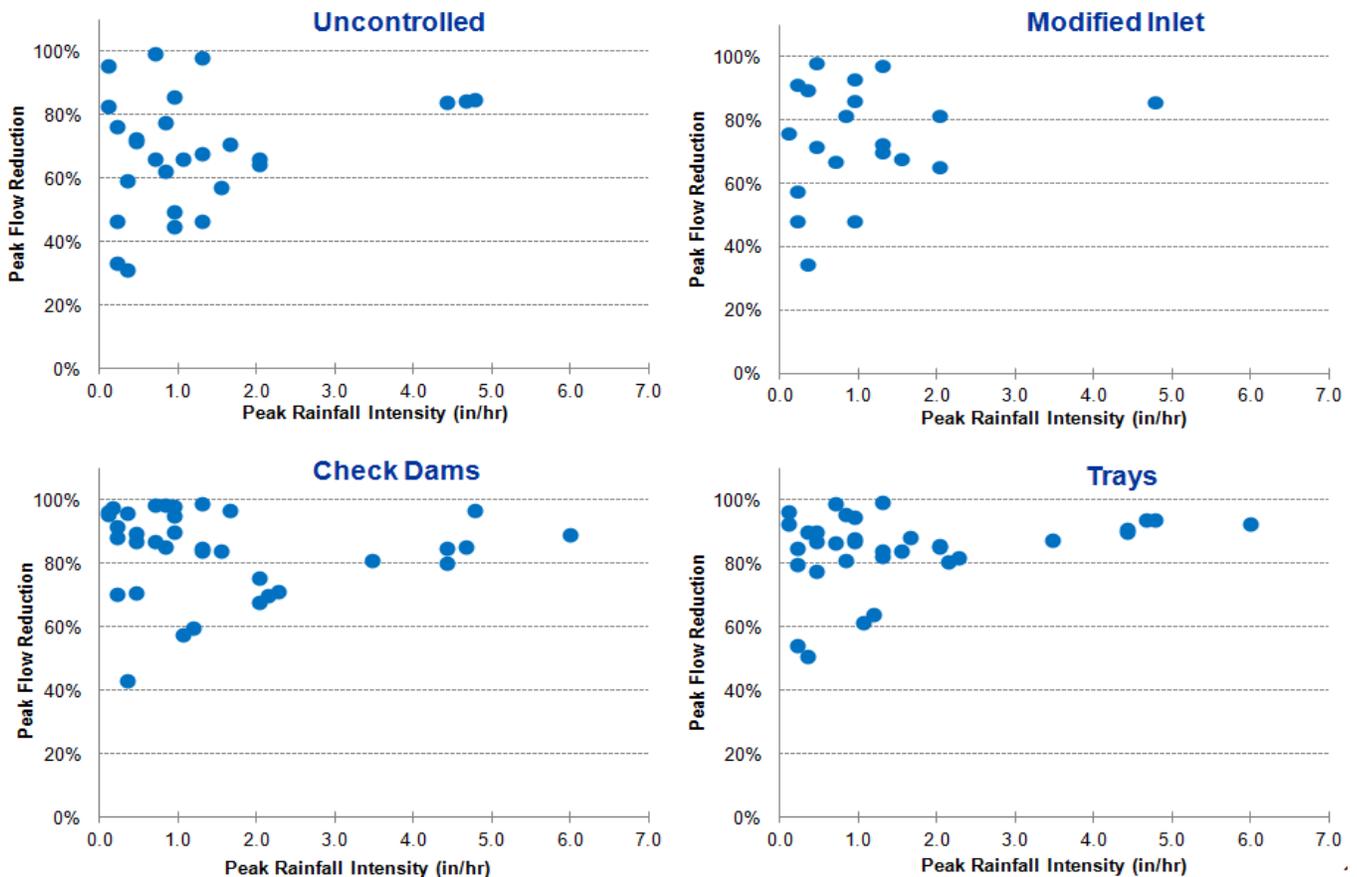
Chart 16. Peak flow reduction performance of rooftop pilots (each dot represents a single storm event).

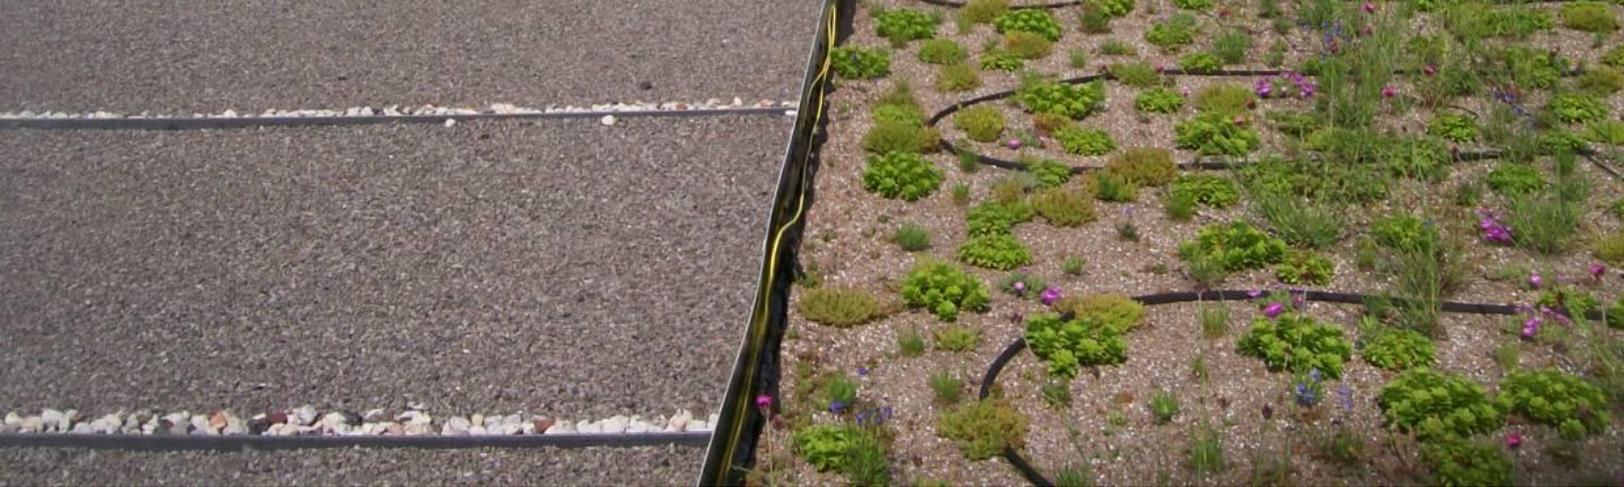
At PS 118, two rooftop source controls—a green roof and blue roof—were installed and are currently being monitored.

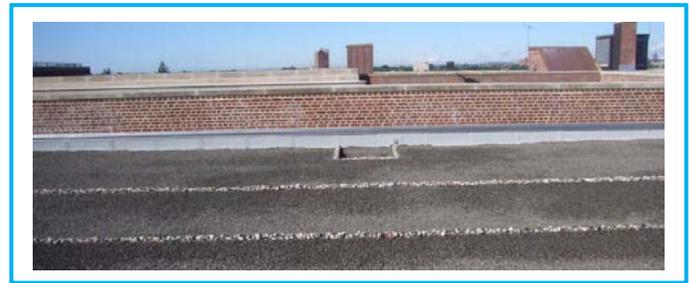
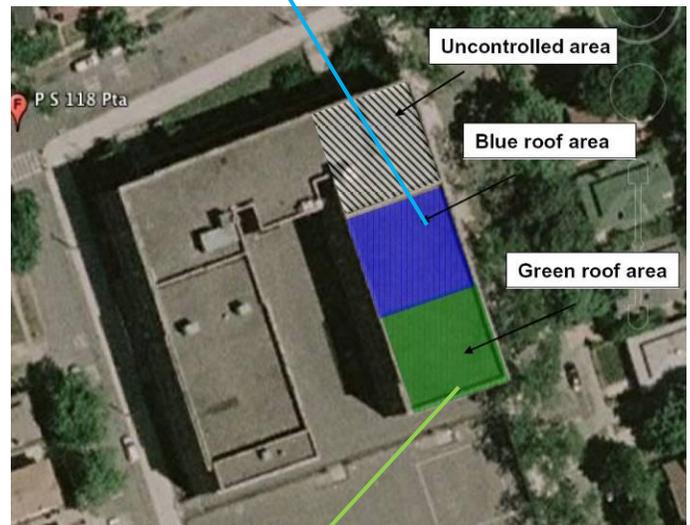
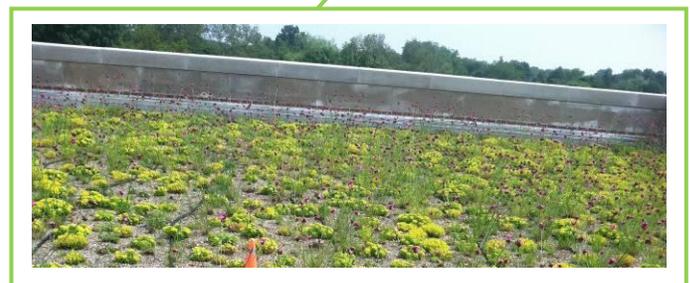
Arrangement of the blue roof, green roof, and uncontrolled areas at the PS 118 pilot site.

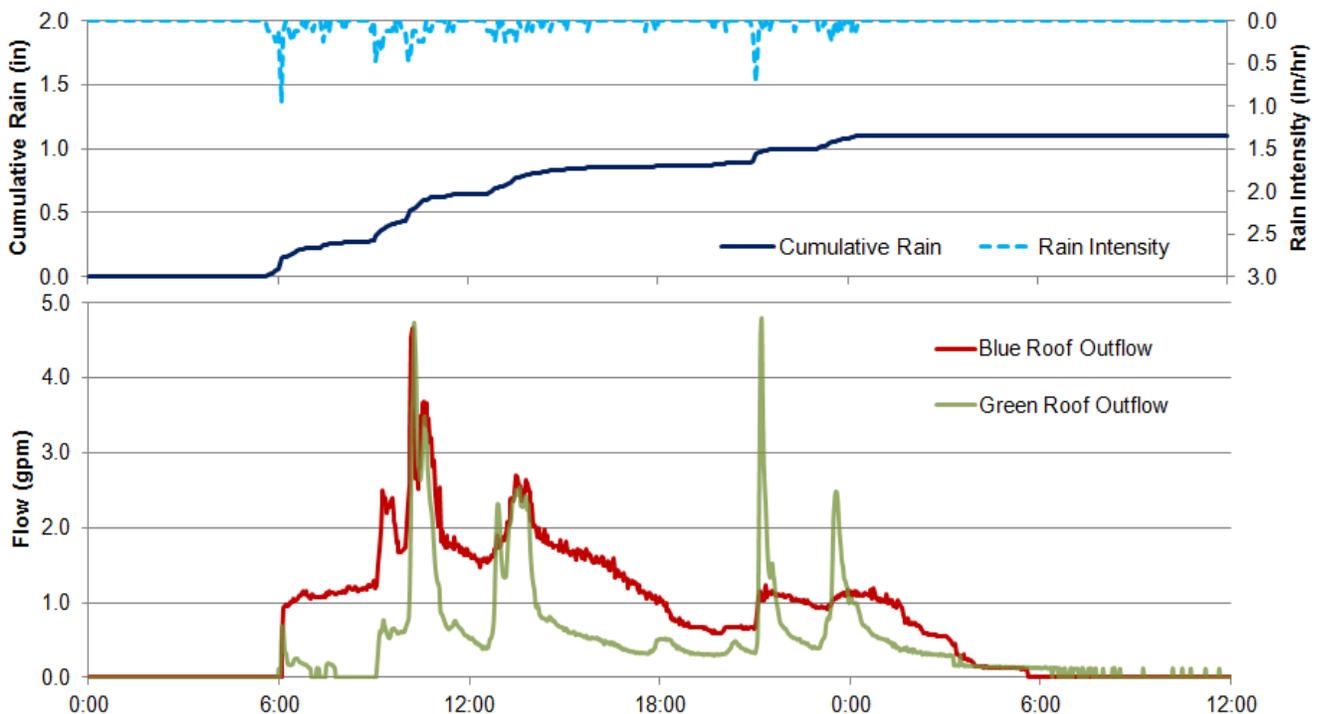
Chart 17. Example hydrograph comparing outflow from rooftop pilots at PS 118 during a 1.1-inch storm on Oct 19, 2011.

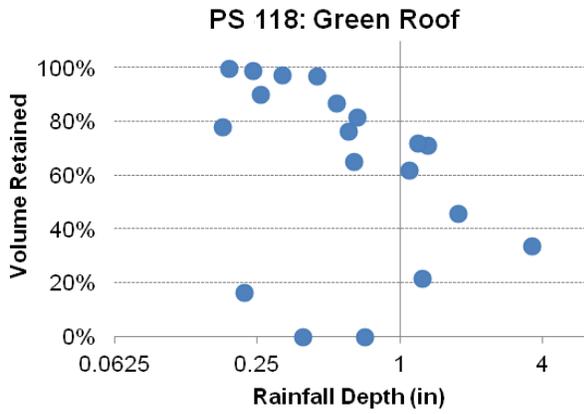
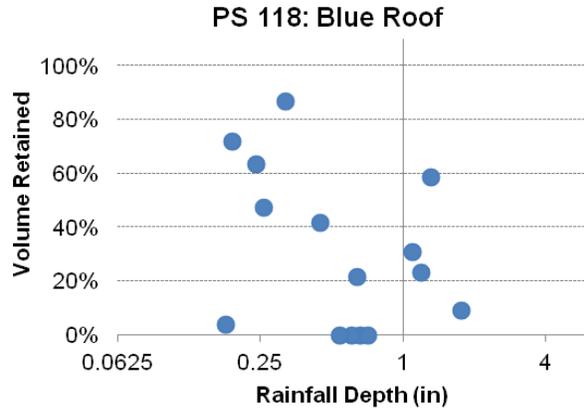
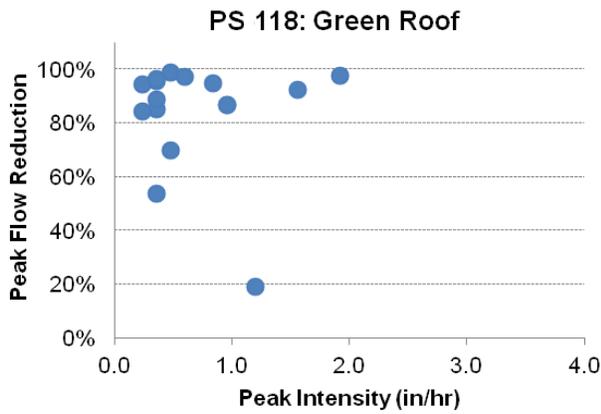
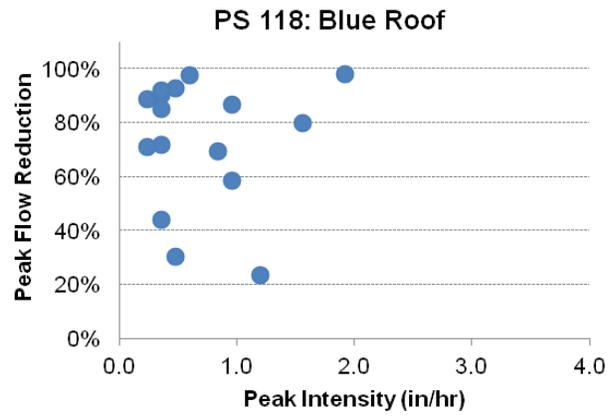
Chart 18. Volume retention (left) and peak flow reduction (right) performance of PS 118 blue and green roofs (each dot represents a single storm; however, overlap may occur for storms with similar depths).

- Both source control types provided significant peak runoff reduction, for low intensity storms;
- Preliminary observations indicate that the green roof may provide slightly better runoff control benefits than the blue roof.
- For larger storms, both systems can also offer significant rate reduction and modest volume reduction.

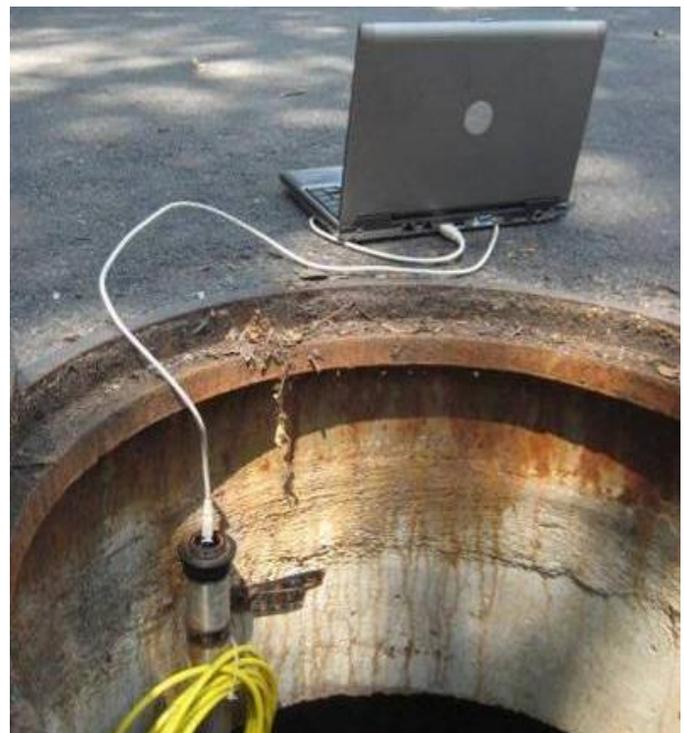
Water level logger used to measure outflow in a monitoring manhole for subsurface system.
