**New York City Department of Transportation
Office of School Safety Engineering**

School Safety Engineering Project

FINAL REPORT: St. Ann, Bronx

**Prepared by
The RBA Group and URBITRAN Associates Inc.**

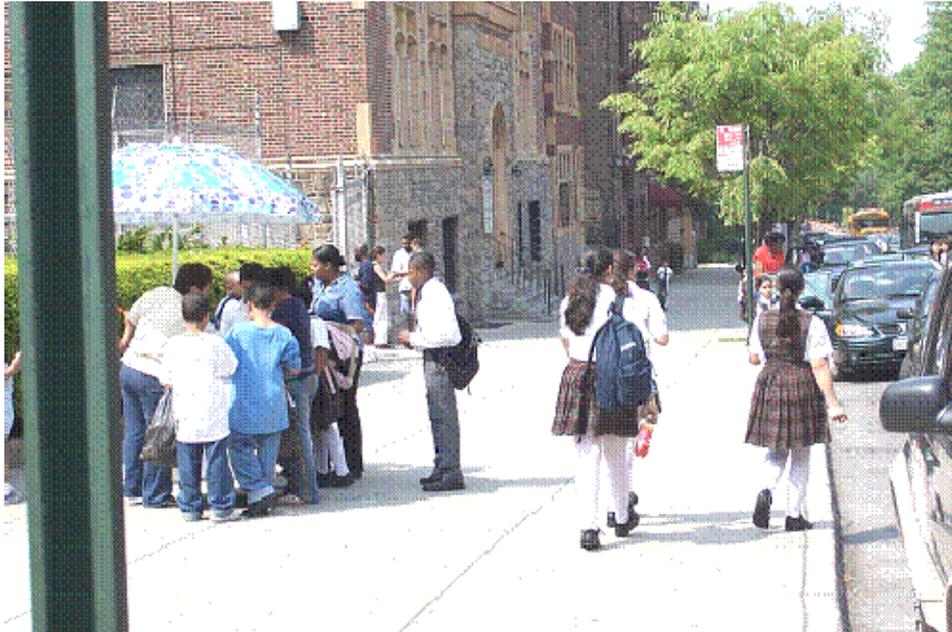
There were very few additional student pedestrian traffic generators observed in the vicinity of the school. However, several sidewalk vendors were observed near the intersection of Bainbridge Avenue and East Gun Hill Road (see Figures 2 and 3). There is also a pizzeria located on the north side of Gun Hill Road between Bainbridge Avenue and Wayne Avenue.

Figure 2: Sidewalk vendor shown on west side of Bainbridge Avenue, near St. Ann School

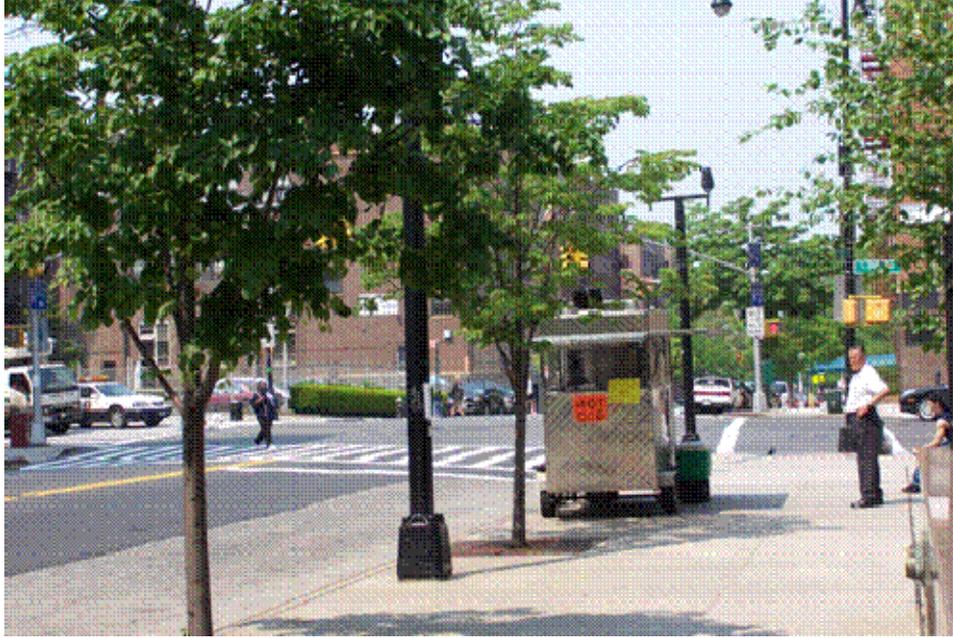
Figure 3: Sidewalk vendor shown on east side of Bainbridge Avenue, south of East Gun Hill Road

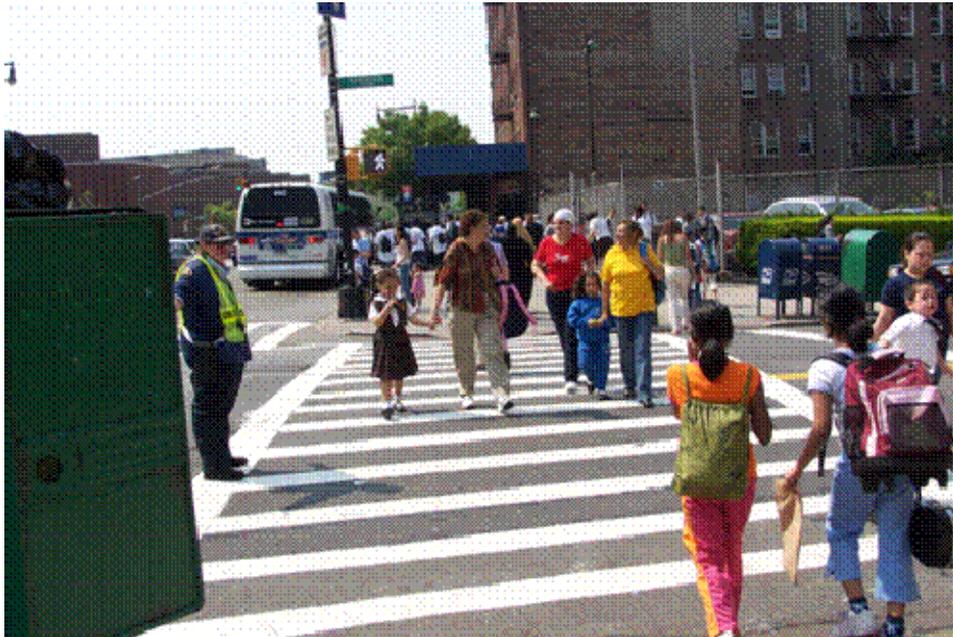
School officials indicated that a school crossing guard is assigned to the intersection of Bainbridge Avenue and East Gun Hill Road (see Figure 4). The crossing guard location is shown in Exhibit 3 at the end of this section.

Figure 4: Looking west at the intersection of Bainbridge Avenue and East Gun Hill Road (note crossing guard)

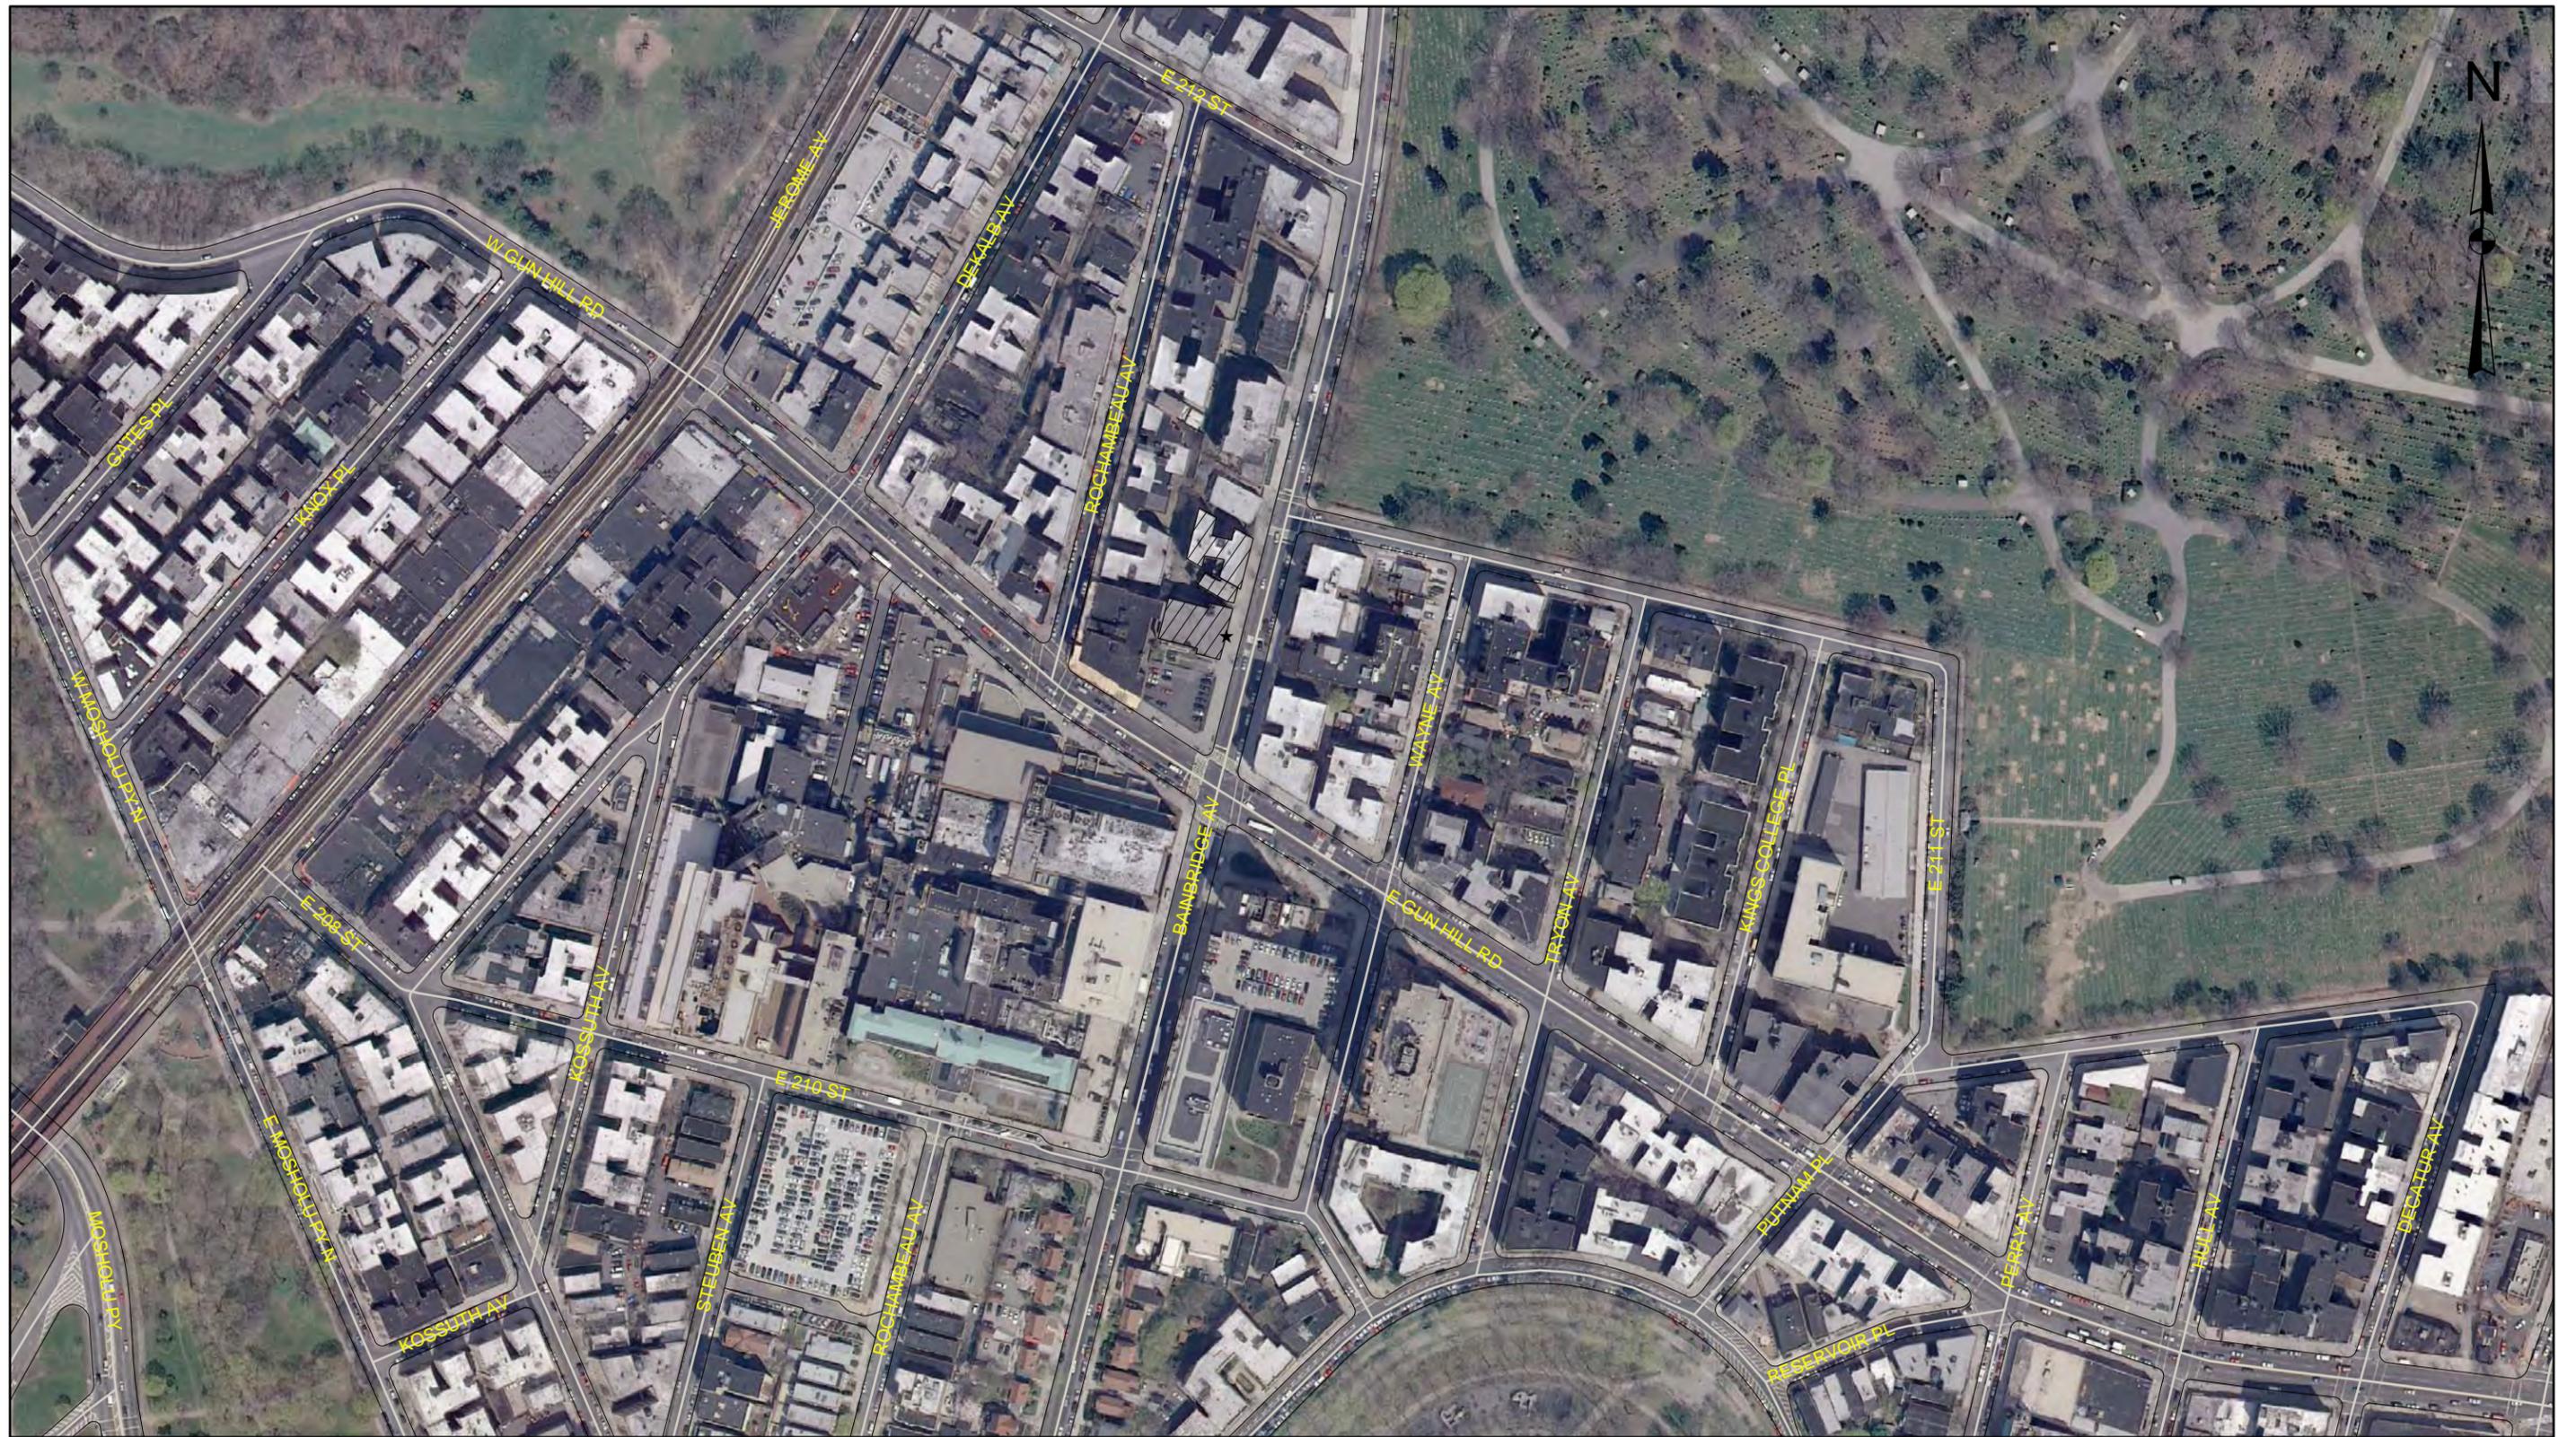
EXHIBIT 1
ST. ANN ES BRONX
AERIAL PHOTOGRAPH

Exhibit 1 shows an aerial view of the neighborhood surrounding St. Ann School, which generally consists of high-density residential uses. St. Ann School is situated west of Bainbridge Avenue and north of Gun Hill Road. The school is also bounded by Rochambeau Avenue to the west, and is located west of the T-type intersection of Bainbridge Avenue and East 211th Street. Woodlawn Cemetery occupies the northeast corner of the Bainbridge Avenue and East 211th Street intersection, and extends northward along the east side of Bainbridge Avenue, and then along the east side of Jerome Avenue up to East 233rd Street. Montefiore Medical Center is located on the south side of East Gun Hill Road, with the hospital itself on the southwest corner of East Gun Hill Road and Bainbridge Avenue. The emergency entrance is just south of East Gun Hill Road on Bainbridge Avenue.

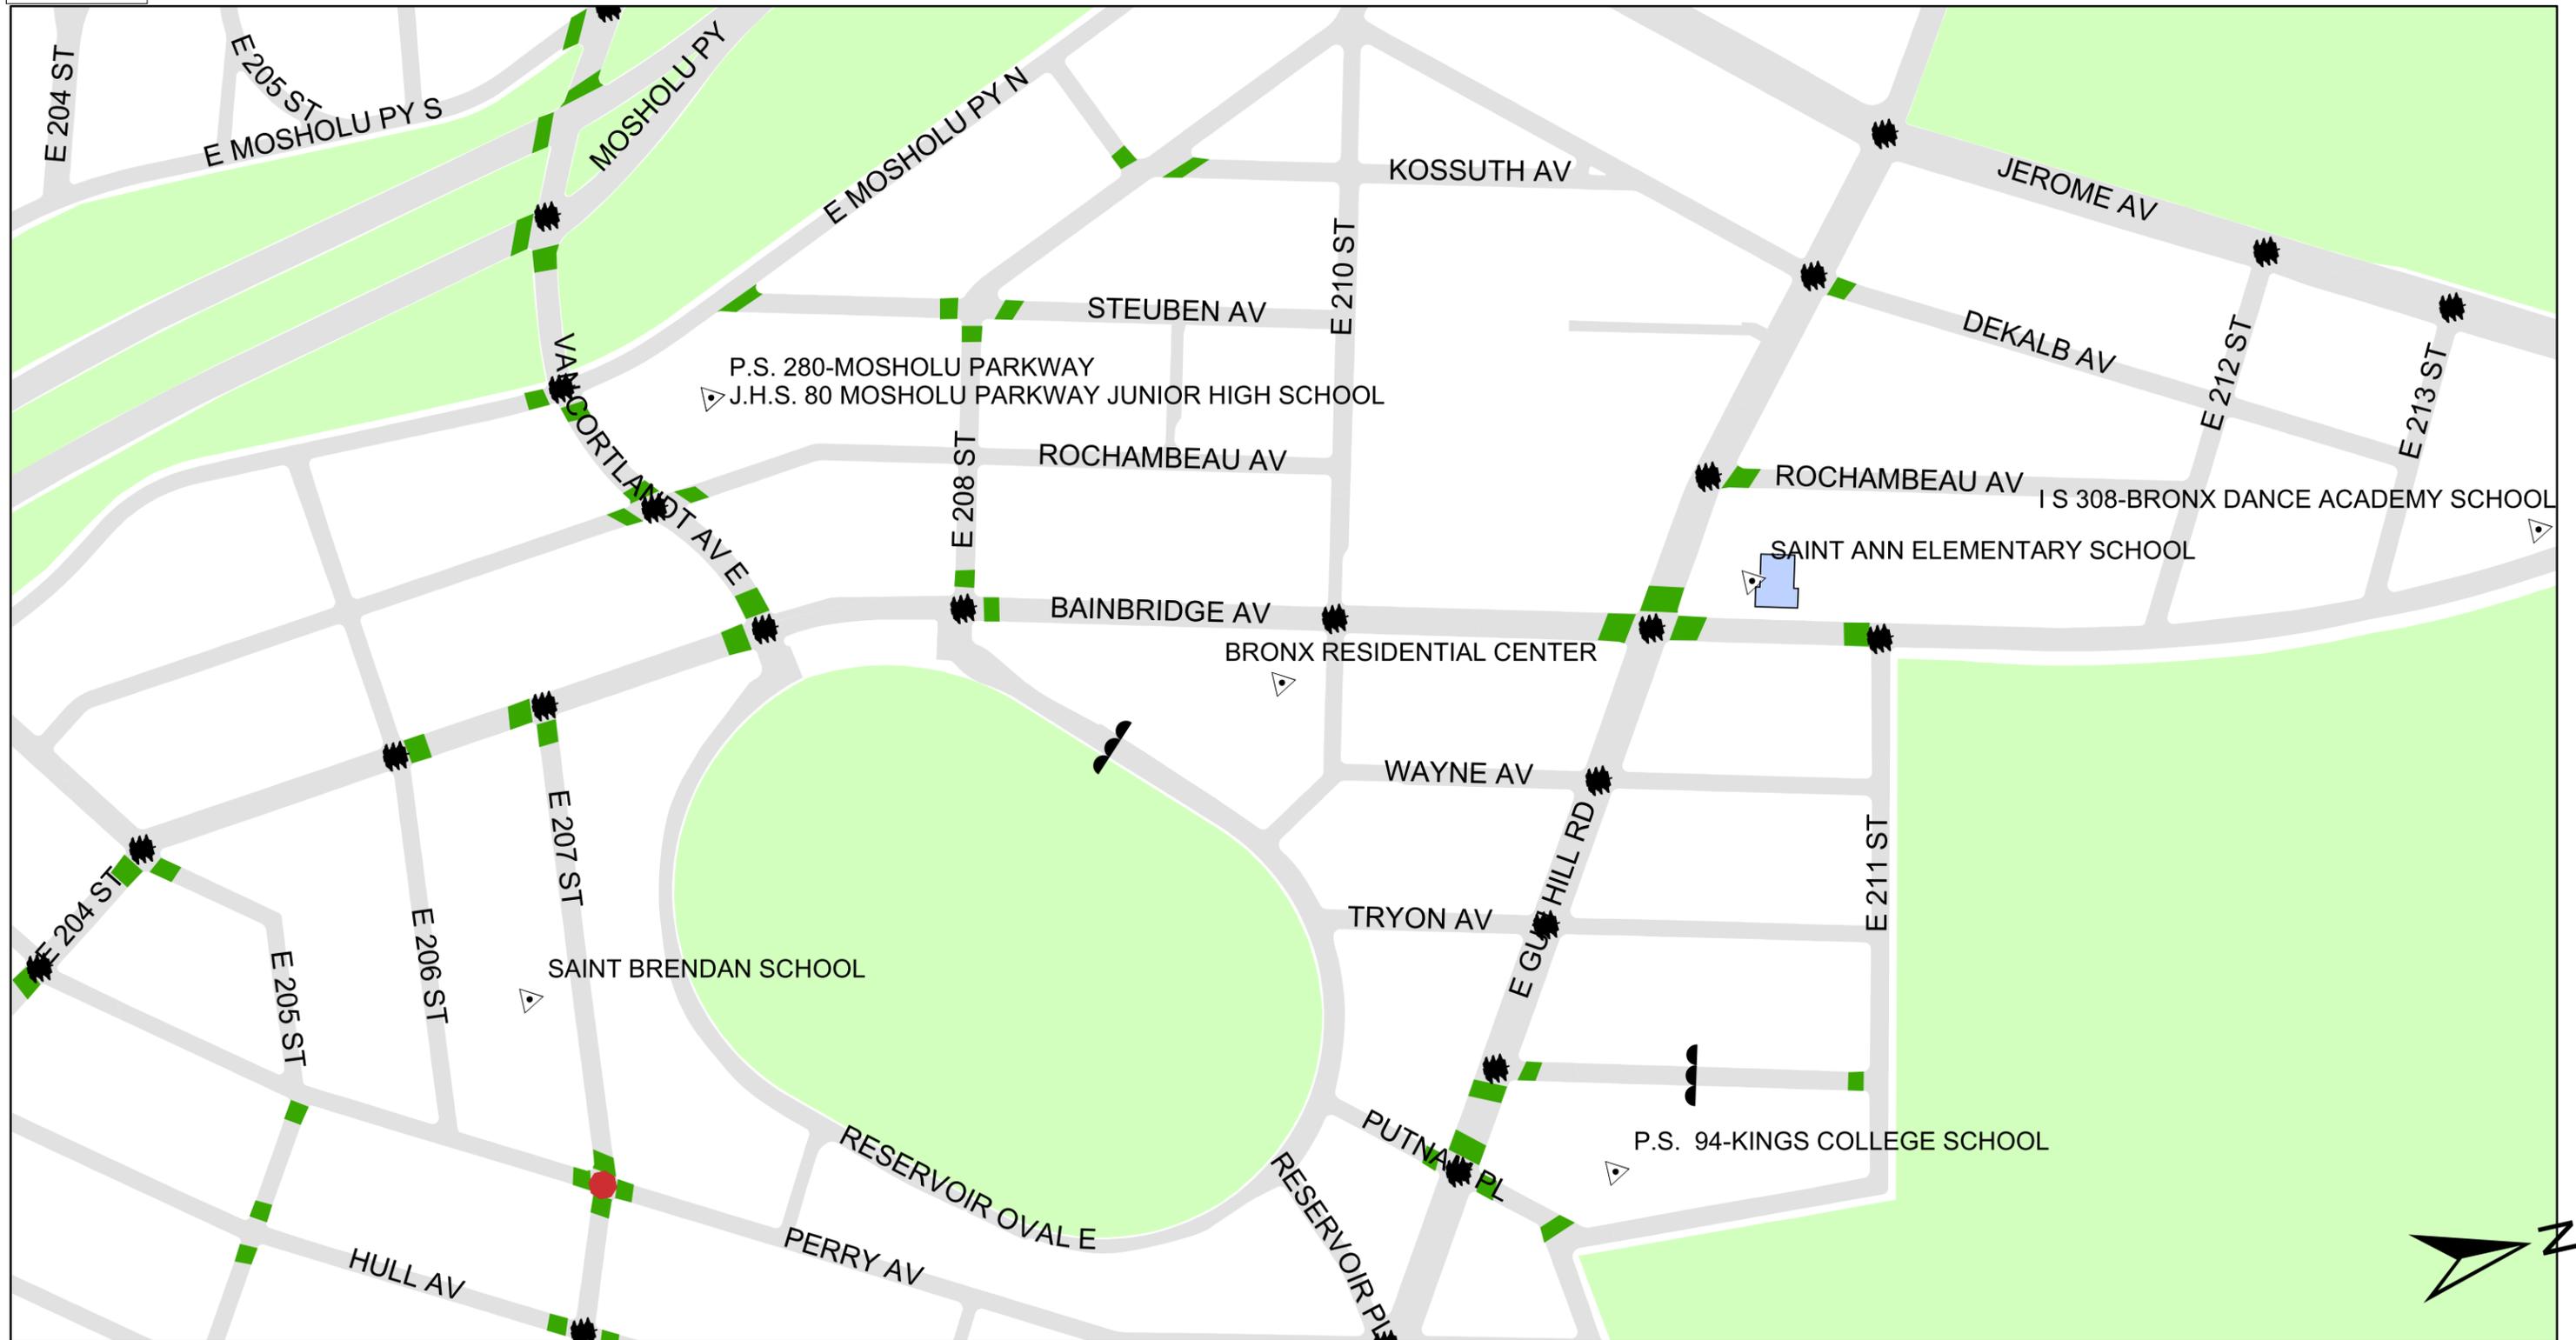
EXHIBIT 2

The School Traffic Safety Map was established to help provide the maximum degree of safety for children going to and from school - by indicating the location of speed reducers, school crosswalks and some traffic control devices. (While virtually all intersections in NYC benefit from traffic control devices - such as stop signs, traffic signals, yield signs, and all way stop signs - this map shows only traffic signals and all way stop signs.) The school crosswalks that are shown are ladder striped and make the crosswalk more visible to drivers and help make the intersection safer. These crosswalks are where school children are recommended to cross.

Exhibit 2 shows the existing school signals and pavement markings around P.S. 70. It should be noted that a citywide signage program is currently underway to upgrade school signage to current Federal Manual on Uniform Traffic Control Devices (MUTCD) standards of fluorescent yellow-green signs accompanied by downward pointing arrows. (Signs scheduled to be installed under this program are shown as “existing” in Exhibit 6.)

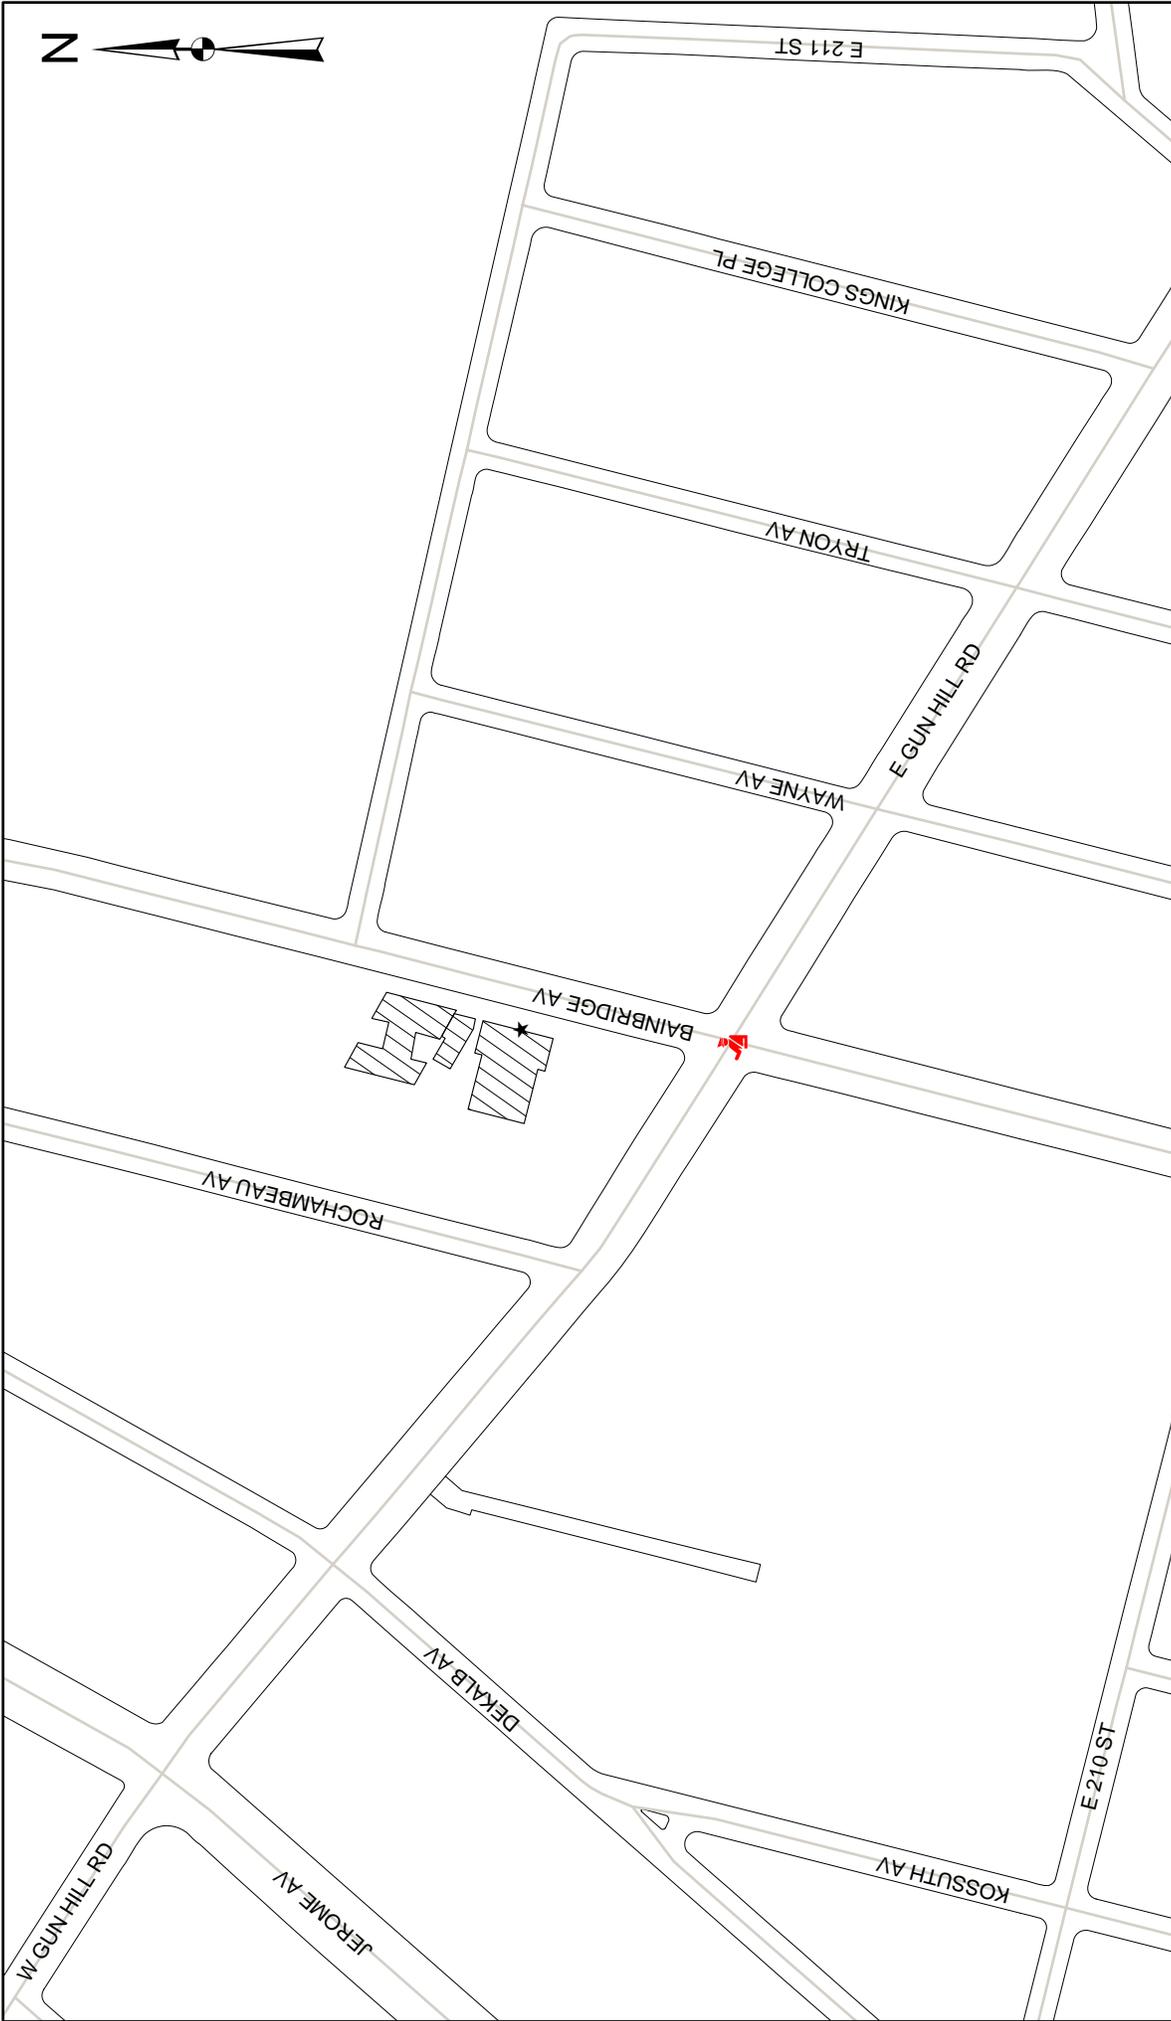
EXHIBIT 3

CROSSING GUARDS LOCATION

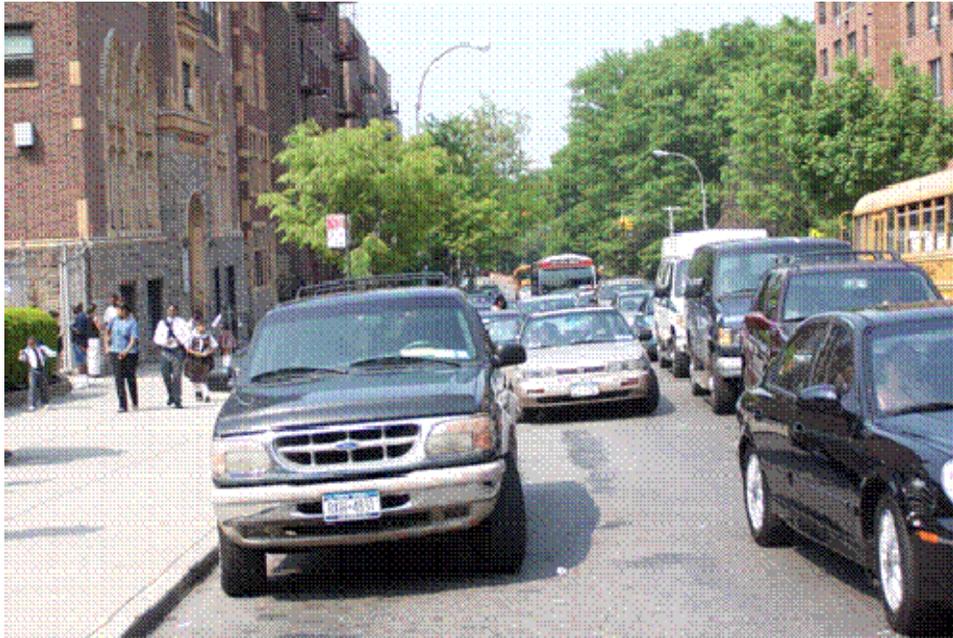
Double parking was observed in front of the school on Bainbridge Avenue during afternoon dismissal (see Figures 5 and 6). The morning arrival period is also reported as congested, especially during inclement weather.

Figure 5: Double parking along Bainbridge Avenue, in front of St. Ann School, following afternoon dismissal

Extend the existing “NO STANDING 7AM – 7PM MONDAY THROUGH FRIDAY” parking regulation to include an area 30 feet in front of the main entrance to the school. (This is a typical requirement for all NYC schools in order to provide for emergency access to and from the school.)

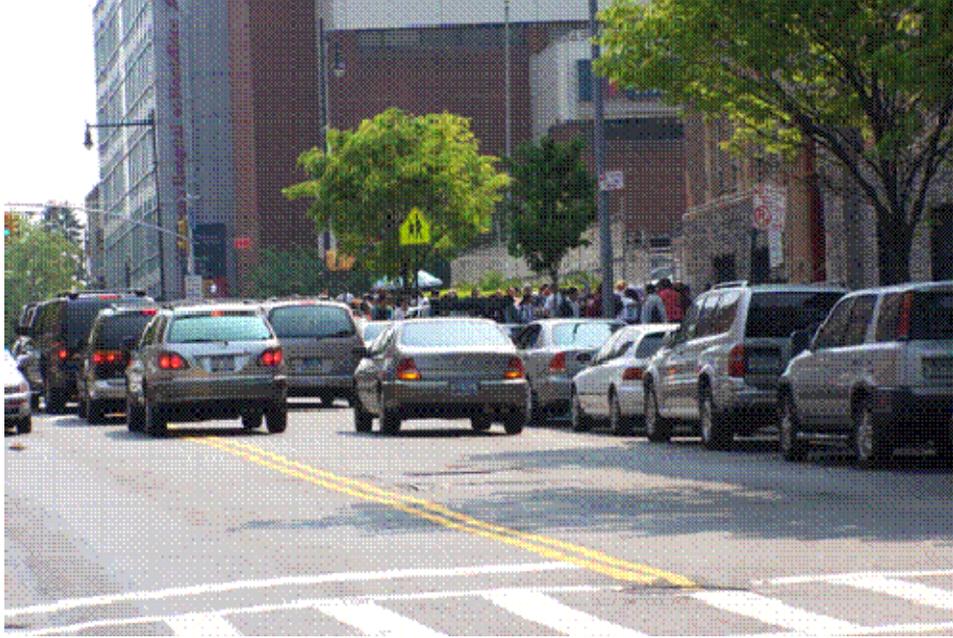
Figure 6: Mid-block congestion in front of St. Ann School following afternoon dismissal

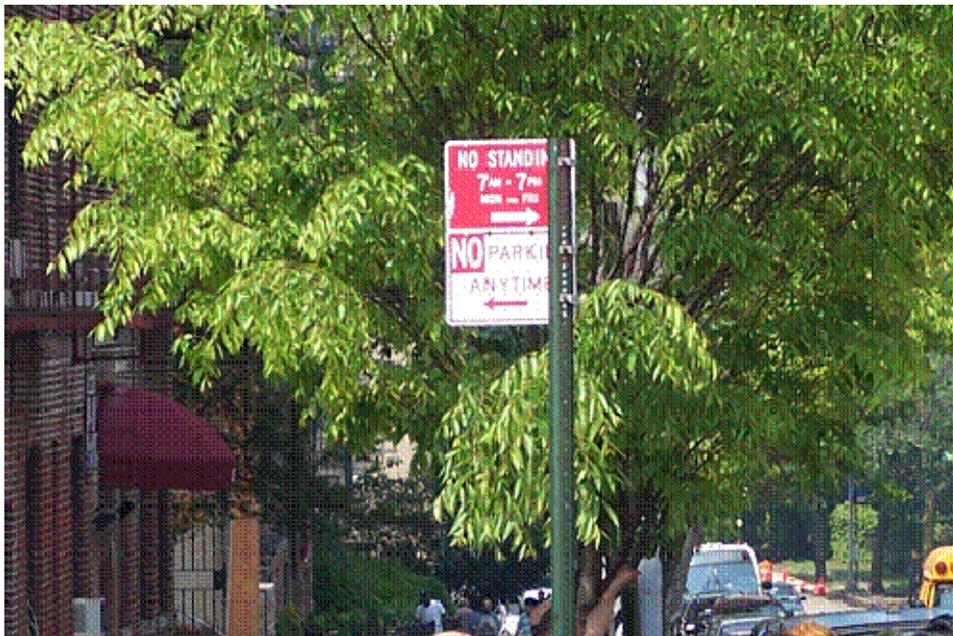
Figure 7: Parking regulation sign in front of St. Ann School

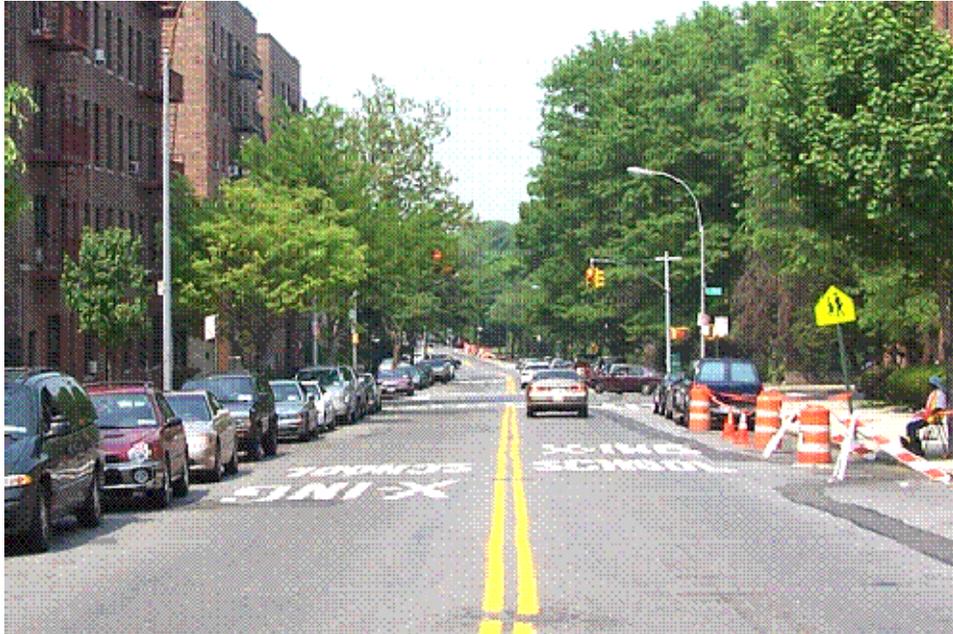
Figure 8: Typical advance school crossing pavement markings and signing

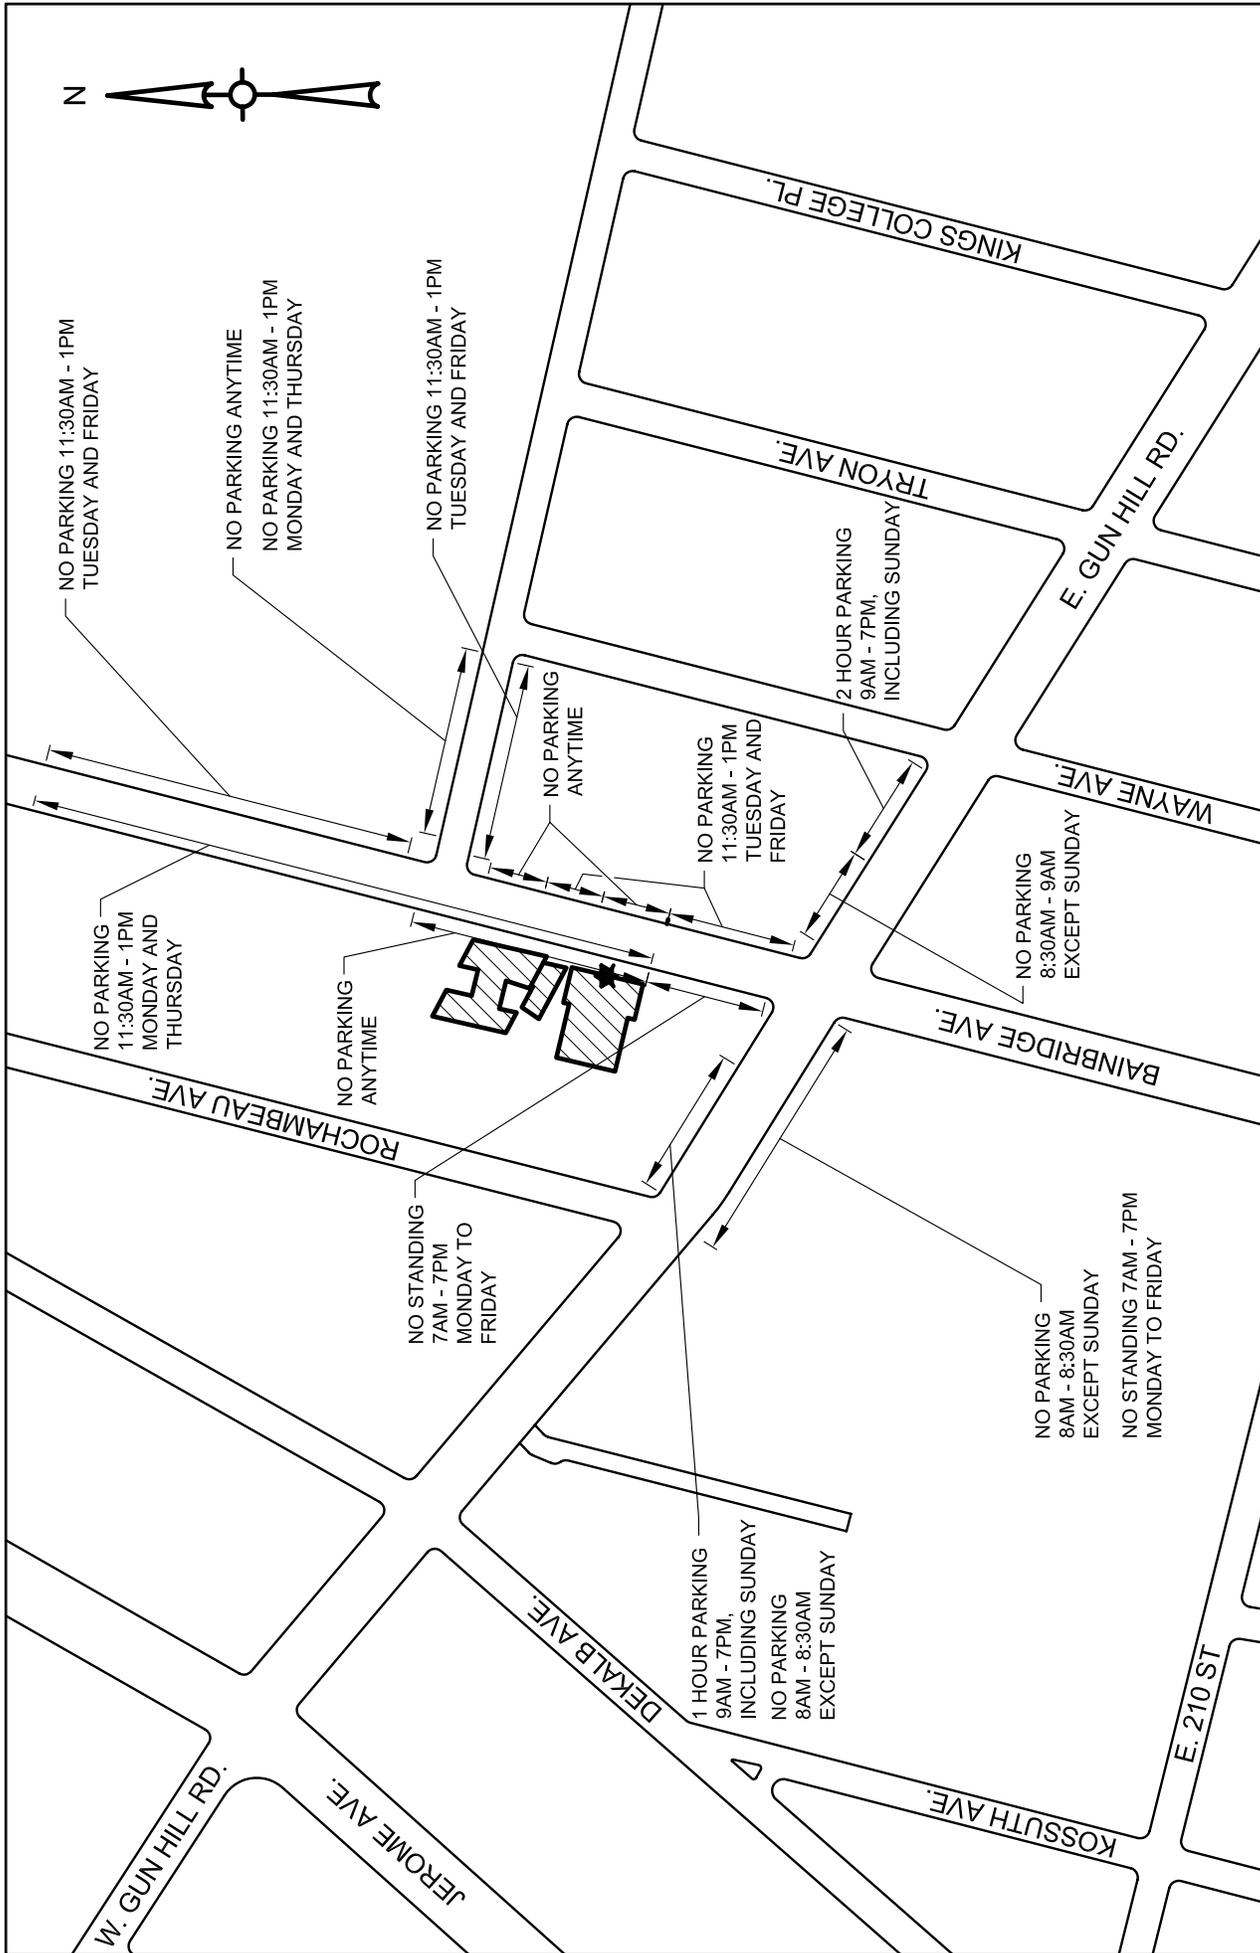
EXHIBIT 4

Parking regulations around the school block are shown in Exhibit 4. Typical parking regulation signs are shown in Figure 7.

EXISTING PARKING REGULATIONS

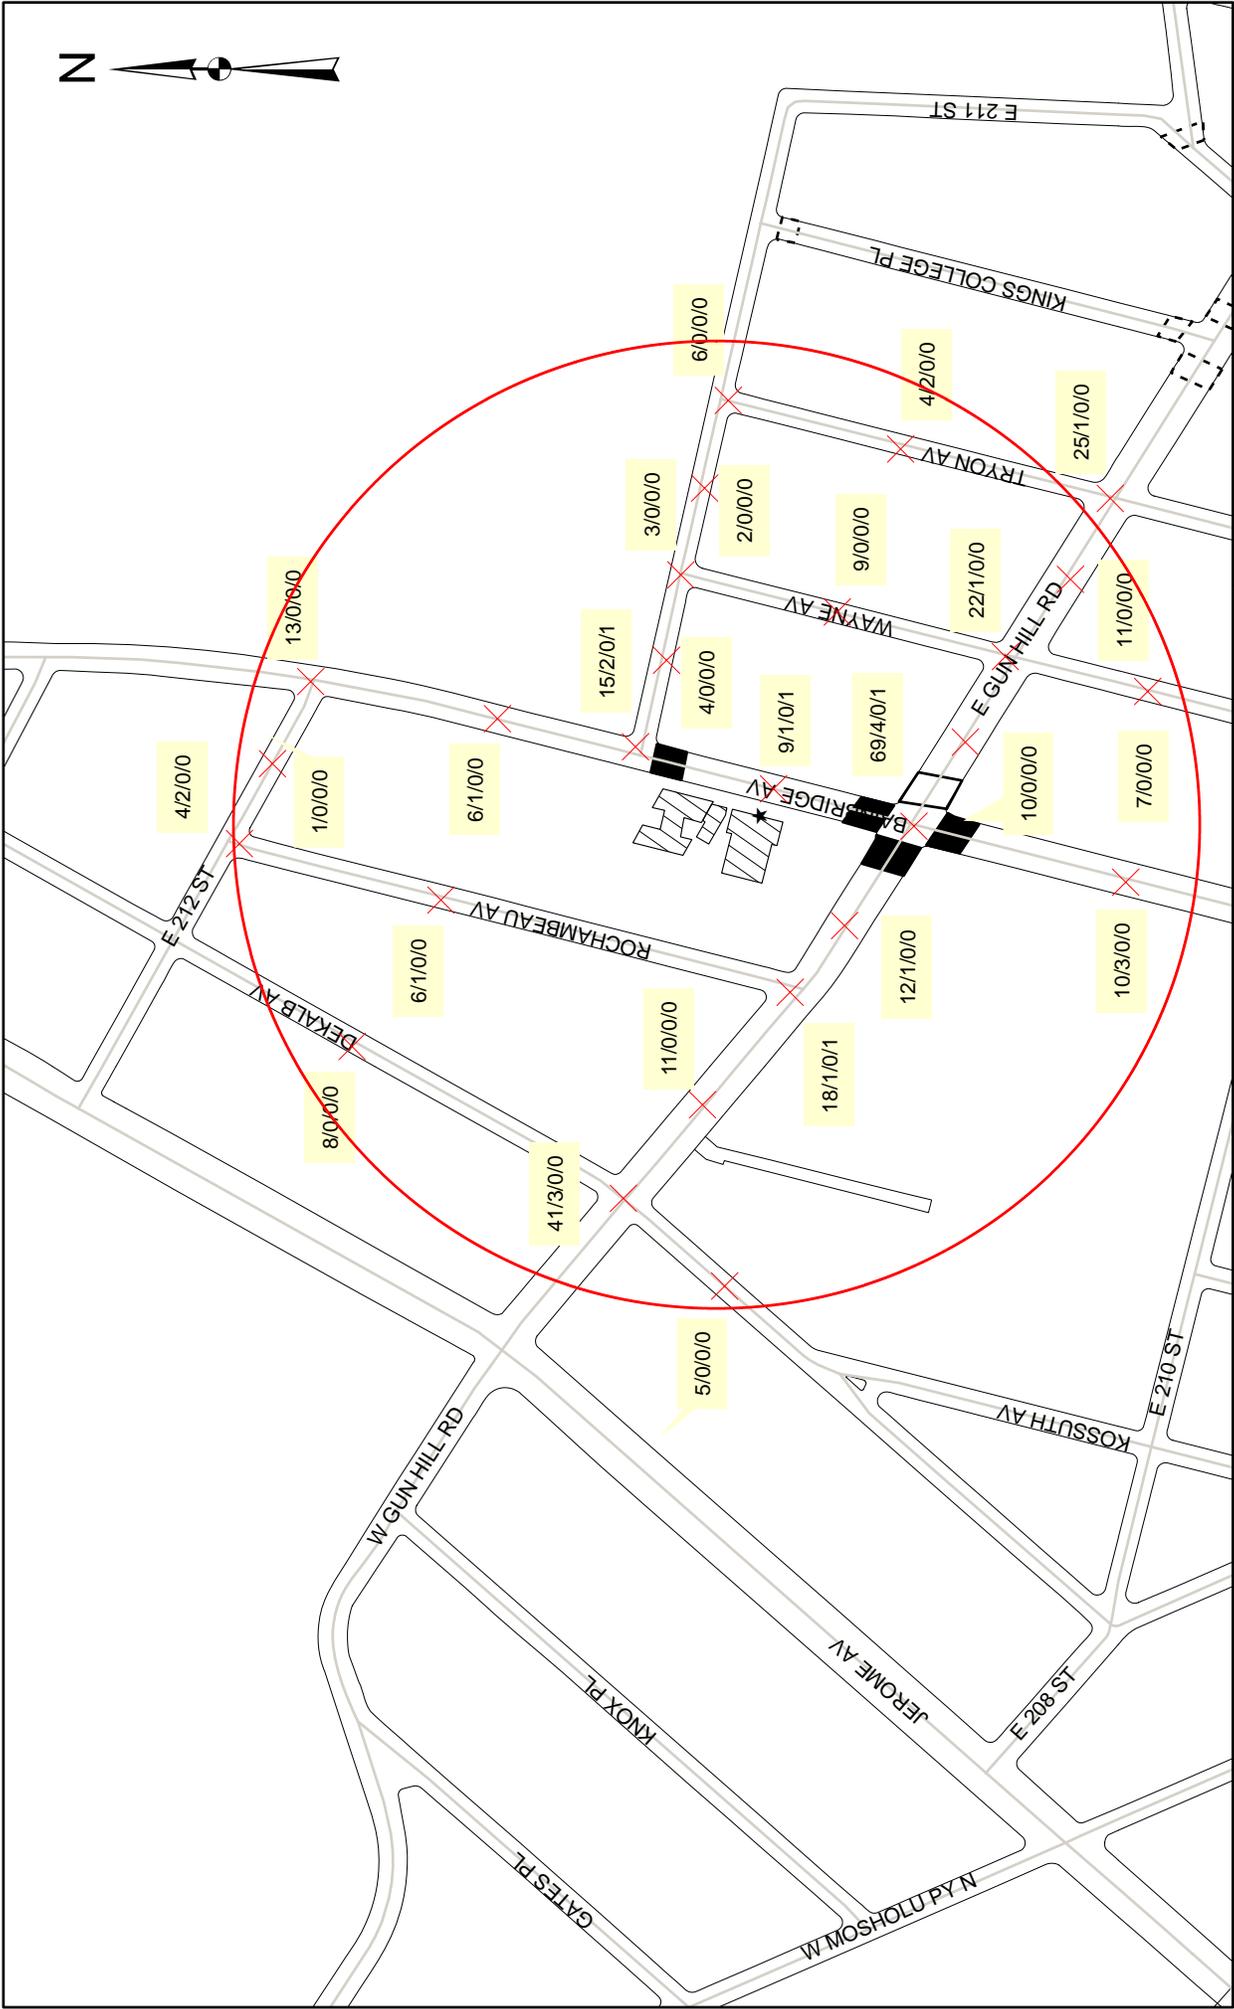
EXHIBIT 5

Exhibit 5 and Table 2 show a summary of accidents, as obtained from the New York State Department of Motor Vehicles (DMV), in the vicinity of St. Ann School for the three-year period from January 1, 1998 through December 31, 2000. The DMV data provides some detail relating to the circumstances and cause of the accident. Table 3 is a summary of more recent accident data obtained from the NYC Police Department (NYPD). Though current through 2004, the NYPD data does not provide the same level of detail as the DMV data.

ACCIDENT SUMMARY (1998-2000)

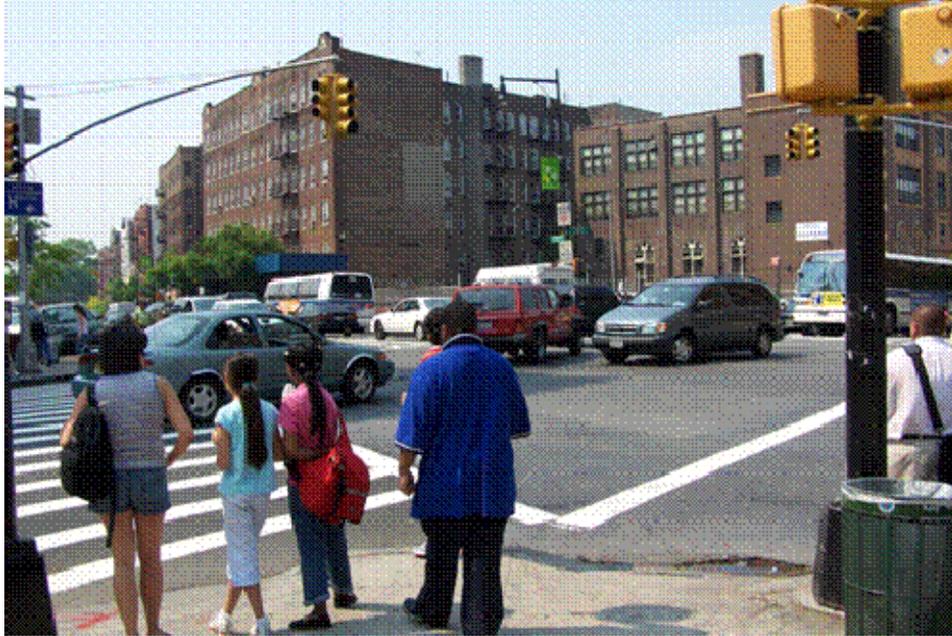
This is a signalized intersection with school crosswalks located across the west leg of East Gun Hill Road, and the north and south legs of Bainbridge Avenue. East Gun Hill Road is a two-way street with two traffic lanes and a parking lane on each side of the roadway. Bainbridge Avenue is two-way street with one traffic lane and a parking lane on each side of the roadway (see Figure 9).

This intersection was the site of 69 accidents between 1998 and 2000, including four pedestrian accidents, one of which was school-related (Table 2). In the school-related accident, a 14-year-old pedestrian sustained a “possible injury” on January 4, 2000 at 2:00 pm. The pedestrian’s actions were reported as “crossing against the signal.” At the time of the accident, the lighting condition was reported as daylight, and the road was wet

Figure 9: Looking northwest across intersection of Gun Hill Road and Bainbridge Avenue

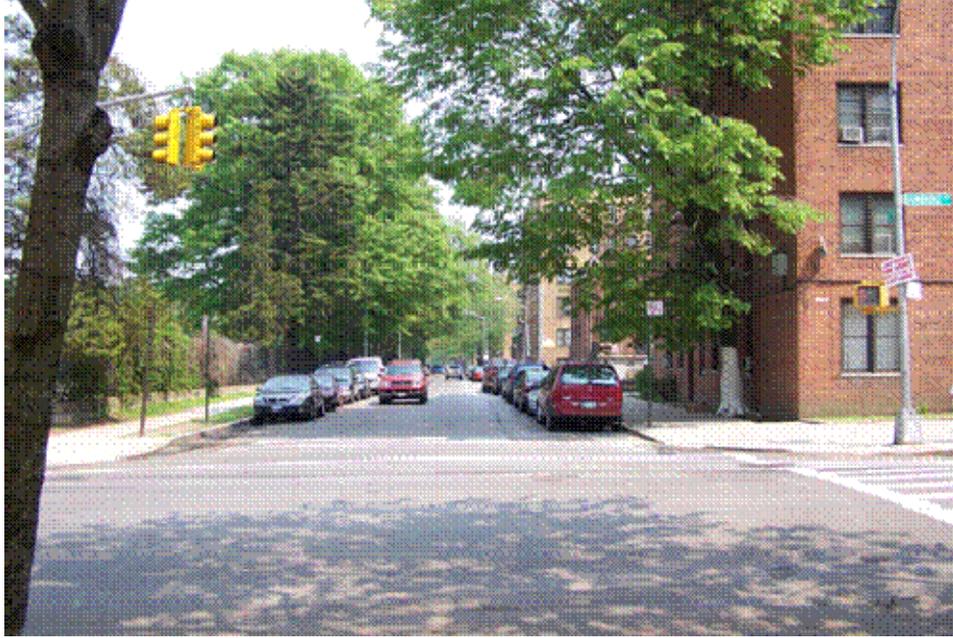
This is a signalized intersection, with a school crosswalk located across the south leg of Bainbridge Avenue, and pedestrian crosswalks located across the north leg of Bainbridge Avenue and the east leg of East 211th Street. Bainbridge Avenue is a two-way street with one traffic lane and a parking lane on each side of the roadway. East 211th Street is a two-way street, with one traffic lane and parking on each side of the roadway (see Figure 10).

This intersection was the site of 15 accidents between 1998 and 2000, including two pedestrian accidents, one of which was school-related (Table 2). In the school-related accident, a six-year-old pedestrian sustained a “non-incapacitating injury” on January 6, 1998 at 8:00 am. The pedestrian’s actions were reported as “emerging from behind a parked vehicle.” At the time of the accident, the lighting condition was reported as daylight, the road was wet, and the weather condition was reported as fog. There were no pedestrian fatalities during this time period.

Figure 10: Looking east on East 211th Street across Bainbridge Avenue

Overall, pedestrian ramps in the vicinity of the school appear to be standard. However, one exception is at the T-intersection of Bainbridge Avenue and East 211th Street. The ramps on either side of the north leg of this intersection are missing. In addition, the ramp on the west side of Bainbridge Avenue for the school crosswalk located across the south leg of the intersection is also missing.

At the Bainbridge Avenue and East 211th Street intersection, the pedestrian ramp on the west side of Bainbridge Avenue for the school crosswalk across the south leg is missing. Both ramps for the pedestrian crosswalk located across the north leg of this intersection are also missing.

- A pedestrian ramp should be installed on the west side of Bainbridge Avenue for the school crosswalk located across the south leg of the intersection.
- Pedestrian ramps should be installed on both sides of Bainbridge Avenue for the pedestrian crosswalk located across the north leg of the intersection.
- *Install curb extensions at the following intersections*
 - At the northwest and southwest corners of the East Gun Hill Road and Bainbridge Avenue intersection.

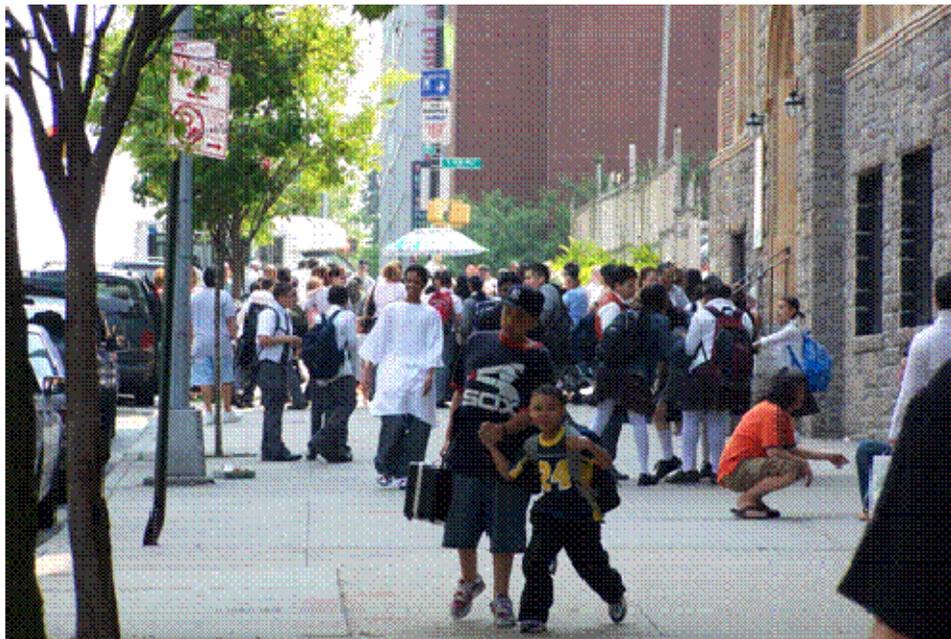
The roadways and sidewalks in the vicinity of St. Ann School are generally 15 to 20 feet wide and in fair condition (see Figure 11).

Figure 11: Looking south along sidewalk on east side of Bainbridge Avenue in front of St. Ann School
