**New York City Department of Transportation
Office of School Safety Engineering**

School Safety Engineering Project

FINAL REPORT: St. Ann, Bronx

**Prepared by
The RBA Group and URBITRAN Associates Inc.**

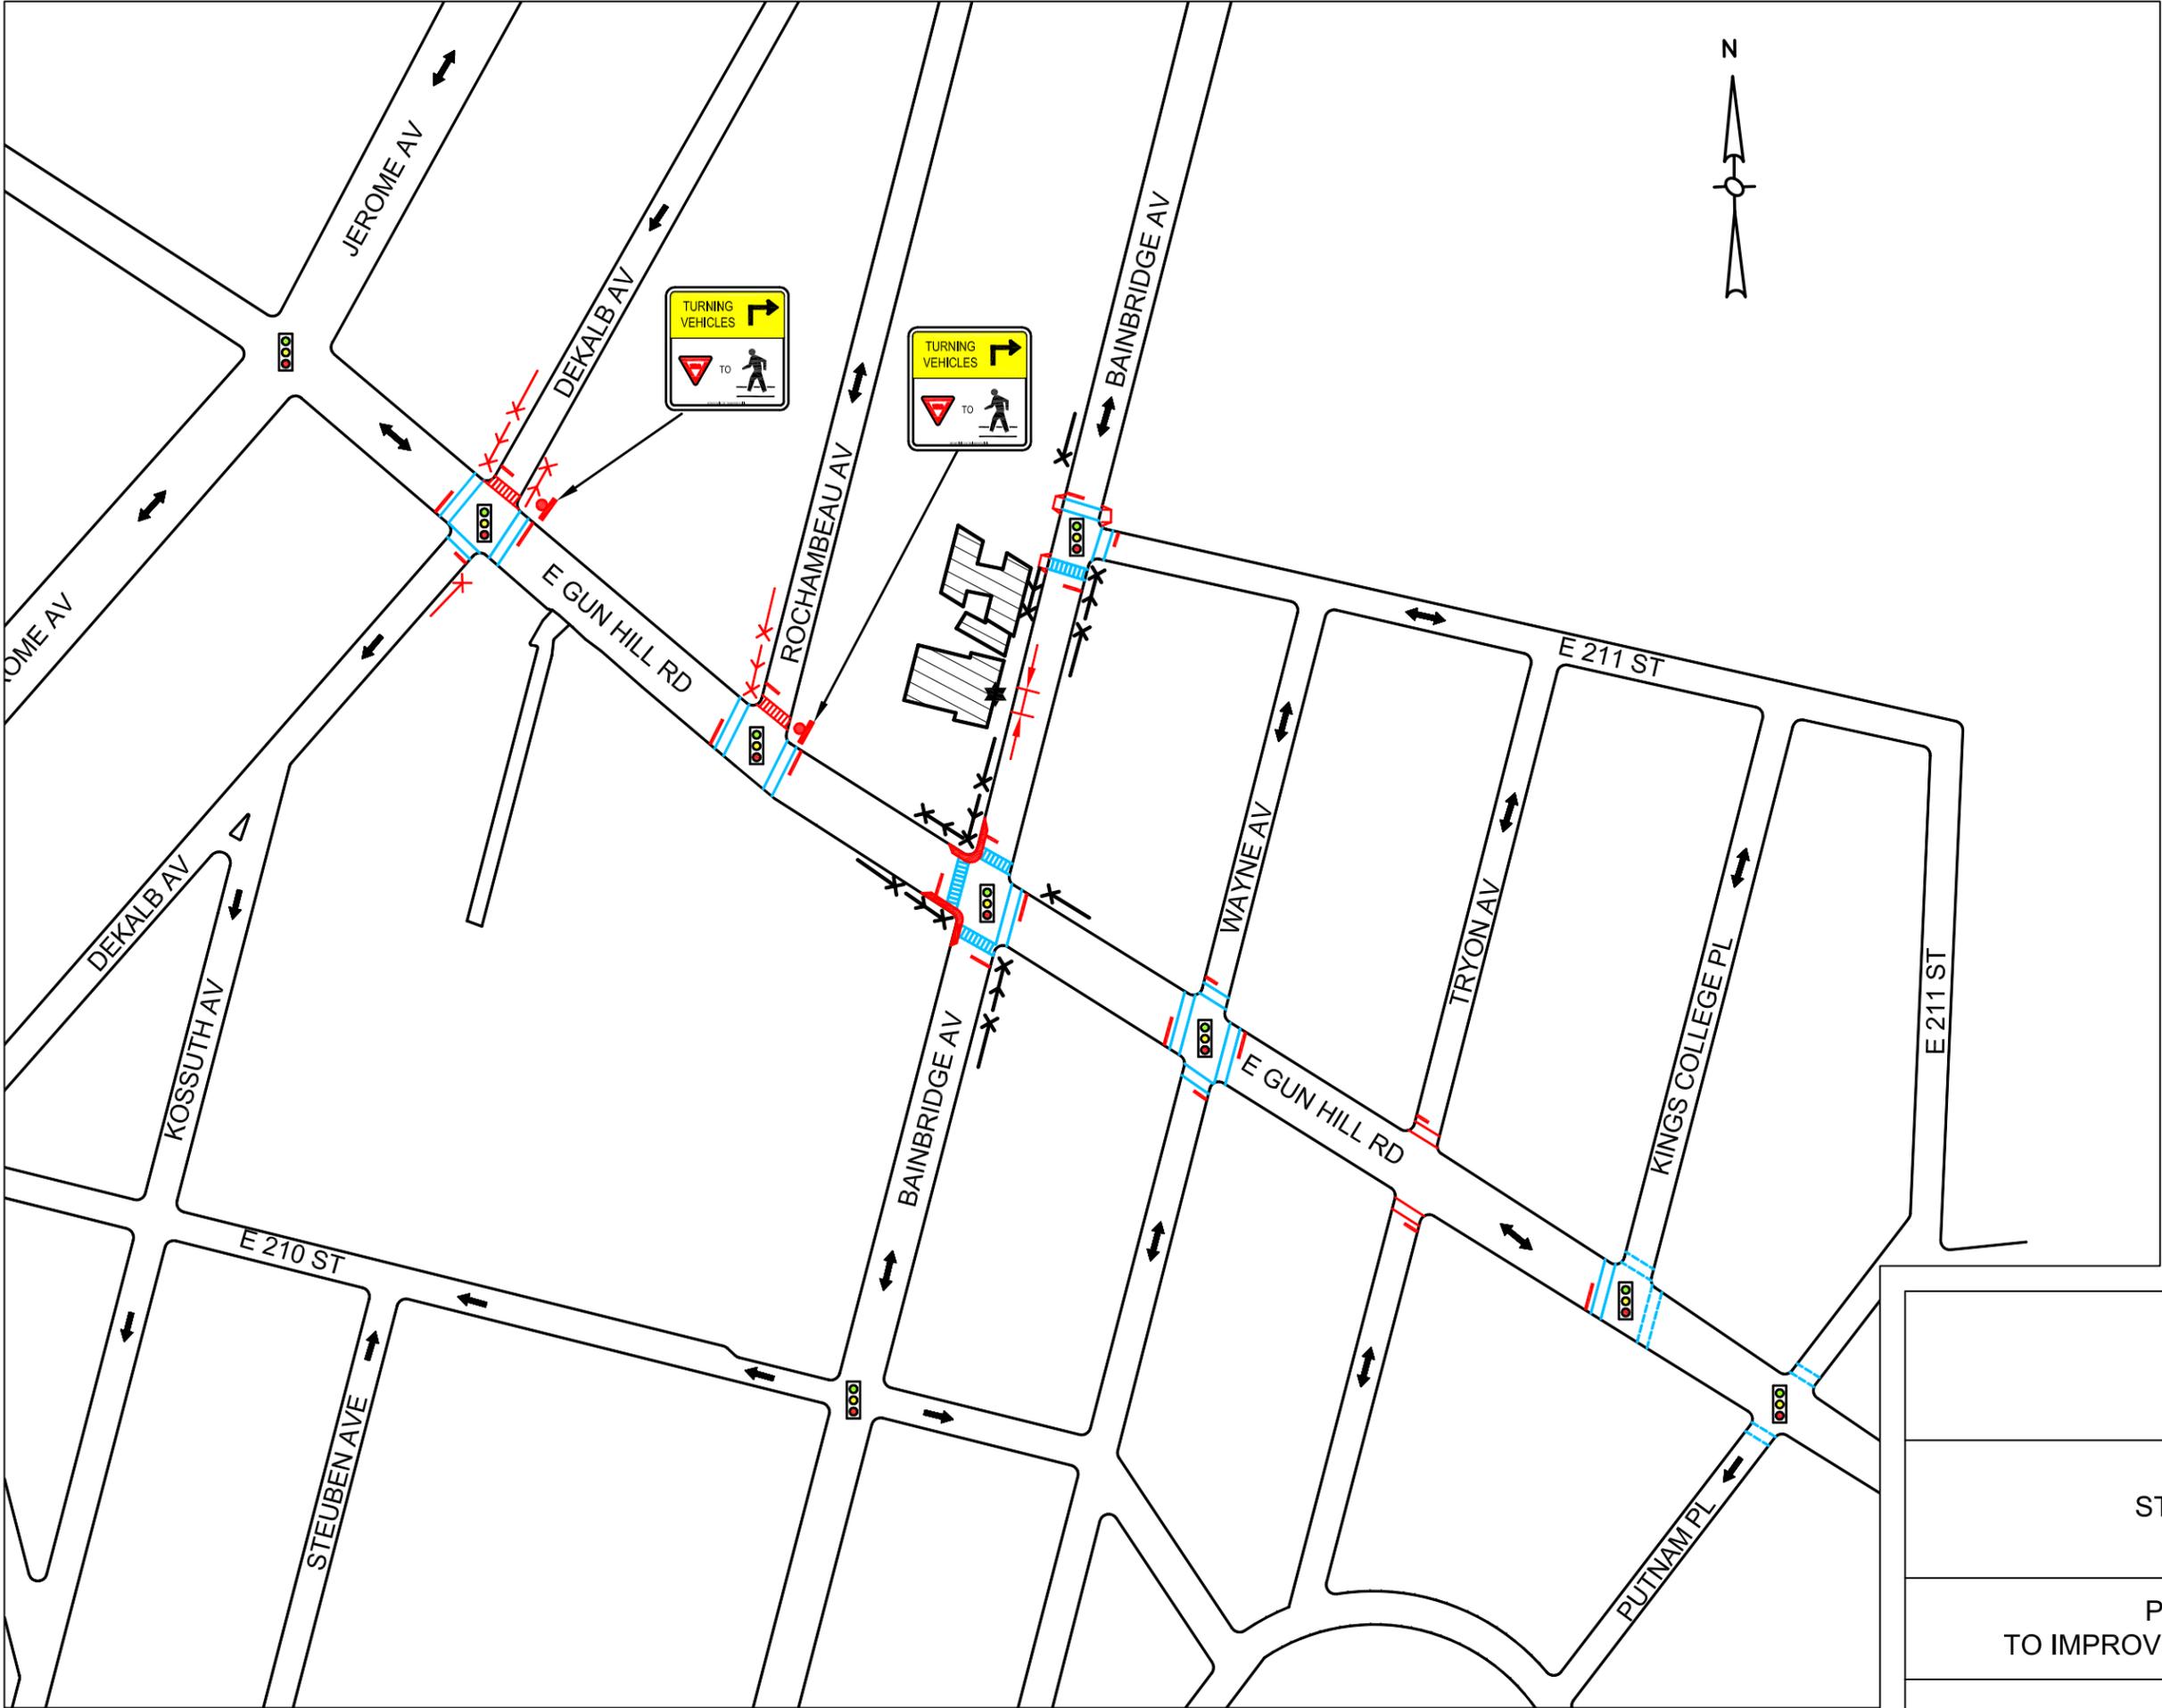
EXHIBIT 6

PROPOSED MEASURES
TO IMPROVE SCHOOL PEDESTRIAN SAFETY

This section describes the proposed measures to improve student pedestrian safety around St. Ann School. The proposed recommendations are divided into short-term and long-term measures. Short-term measures are those that potentially can be performed in-house. Long-term measures involve capital improvements. Each of the short- and long-term measures recommended for St. Ann School is discussed as follows, and is shown in more detail in Exhibit 6 at the end of this section.

Curb extensions (neckdowns) should be installed at the corners shown in Exhibit 6. The purpose of a curb extension is to provide additional refuge space for pedestrians, to shorten the crossing distance for pedestrians, and to reduce the speed of vehicles approaching and turning on school crosswalks. A curb extension will not eliminate or reduce the width of any travel lanes. Curb extensions are not proposed where they would hinder the ability of a vehicle to turn.
