School Safety Engineering Project

FINAL REPORT: I.S 145 (Joseph Pulitzer School), Queens

**Prepared by
The RBA Group and URBITRAN Associates Inc.**

March 22, 2006

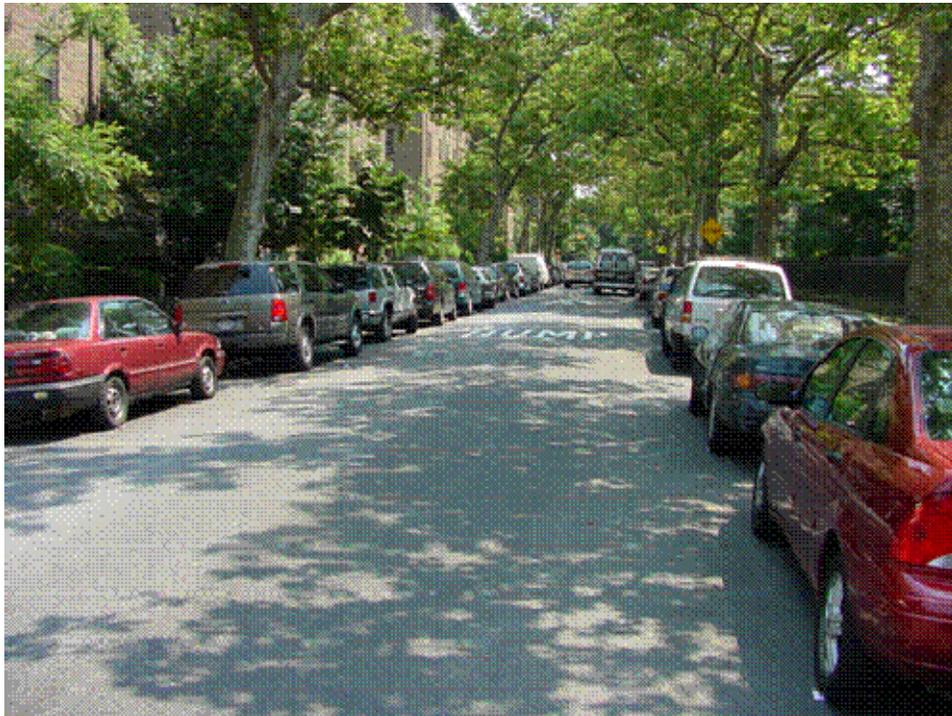
Figure 1: Looking south on 80th Street (school building is to the right)

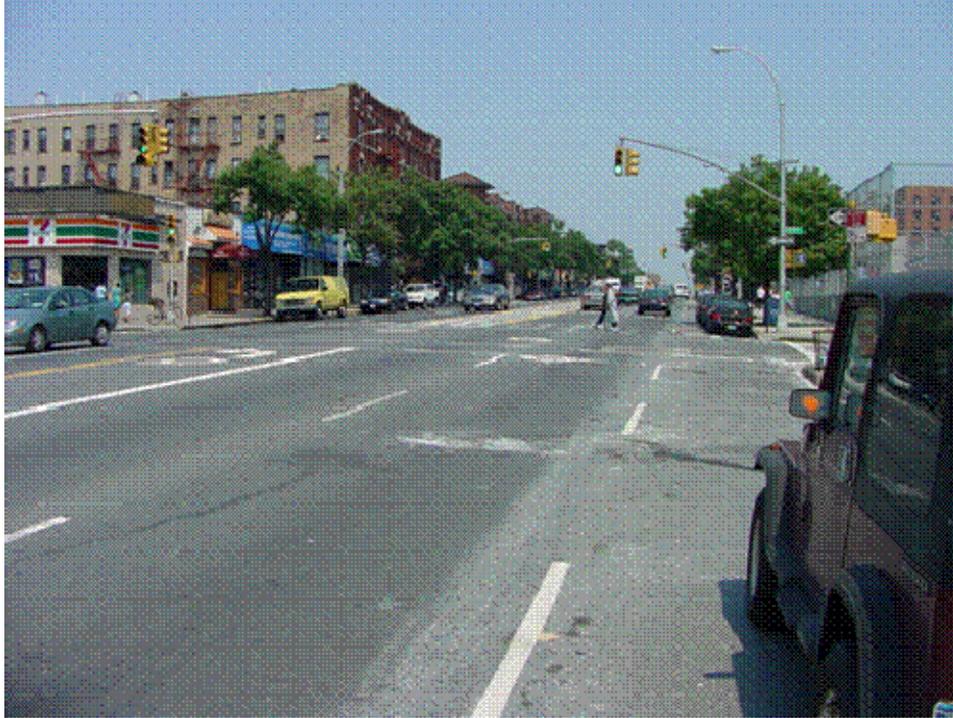
There is a 7-Eleven store on the north side of Northern Boulevard across the street from the school. Additionally, there are many commercial enterprises along Northern Boulevard, including restaurants and delis that are an attraction for I.S. 145 students.

Figure 3: The 7-Eleven store on the north side of Northern Boulevard is an attraction for I.S. 145 student pedestrians

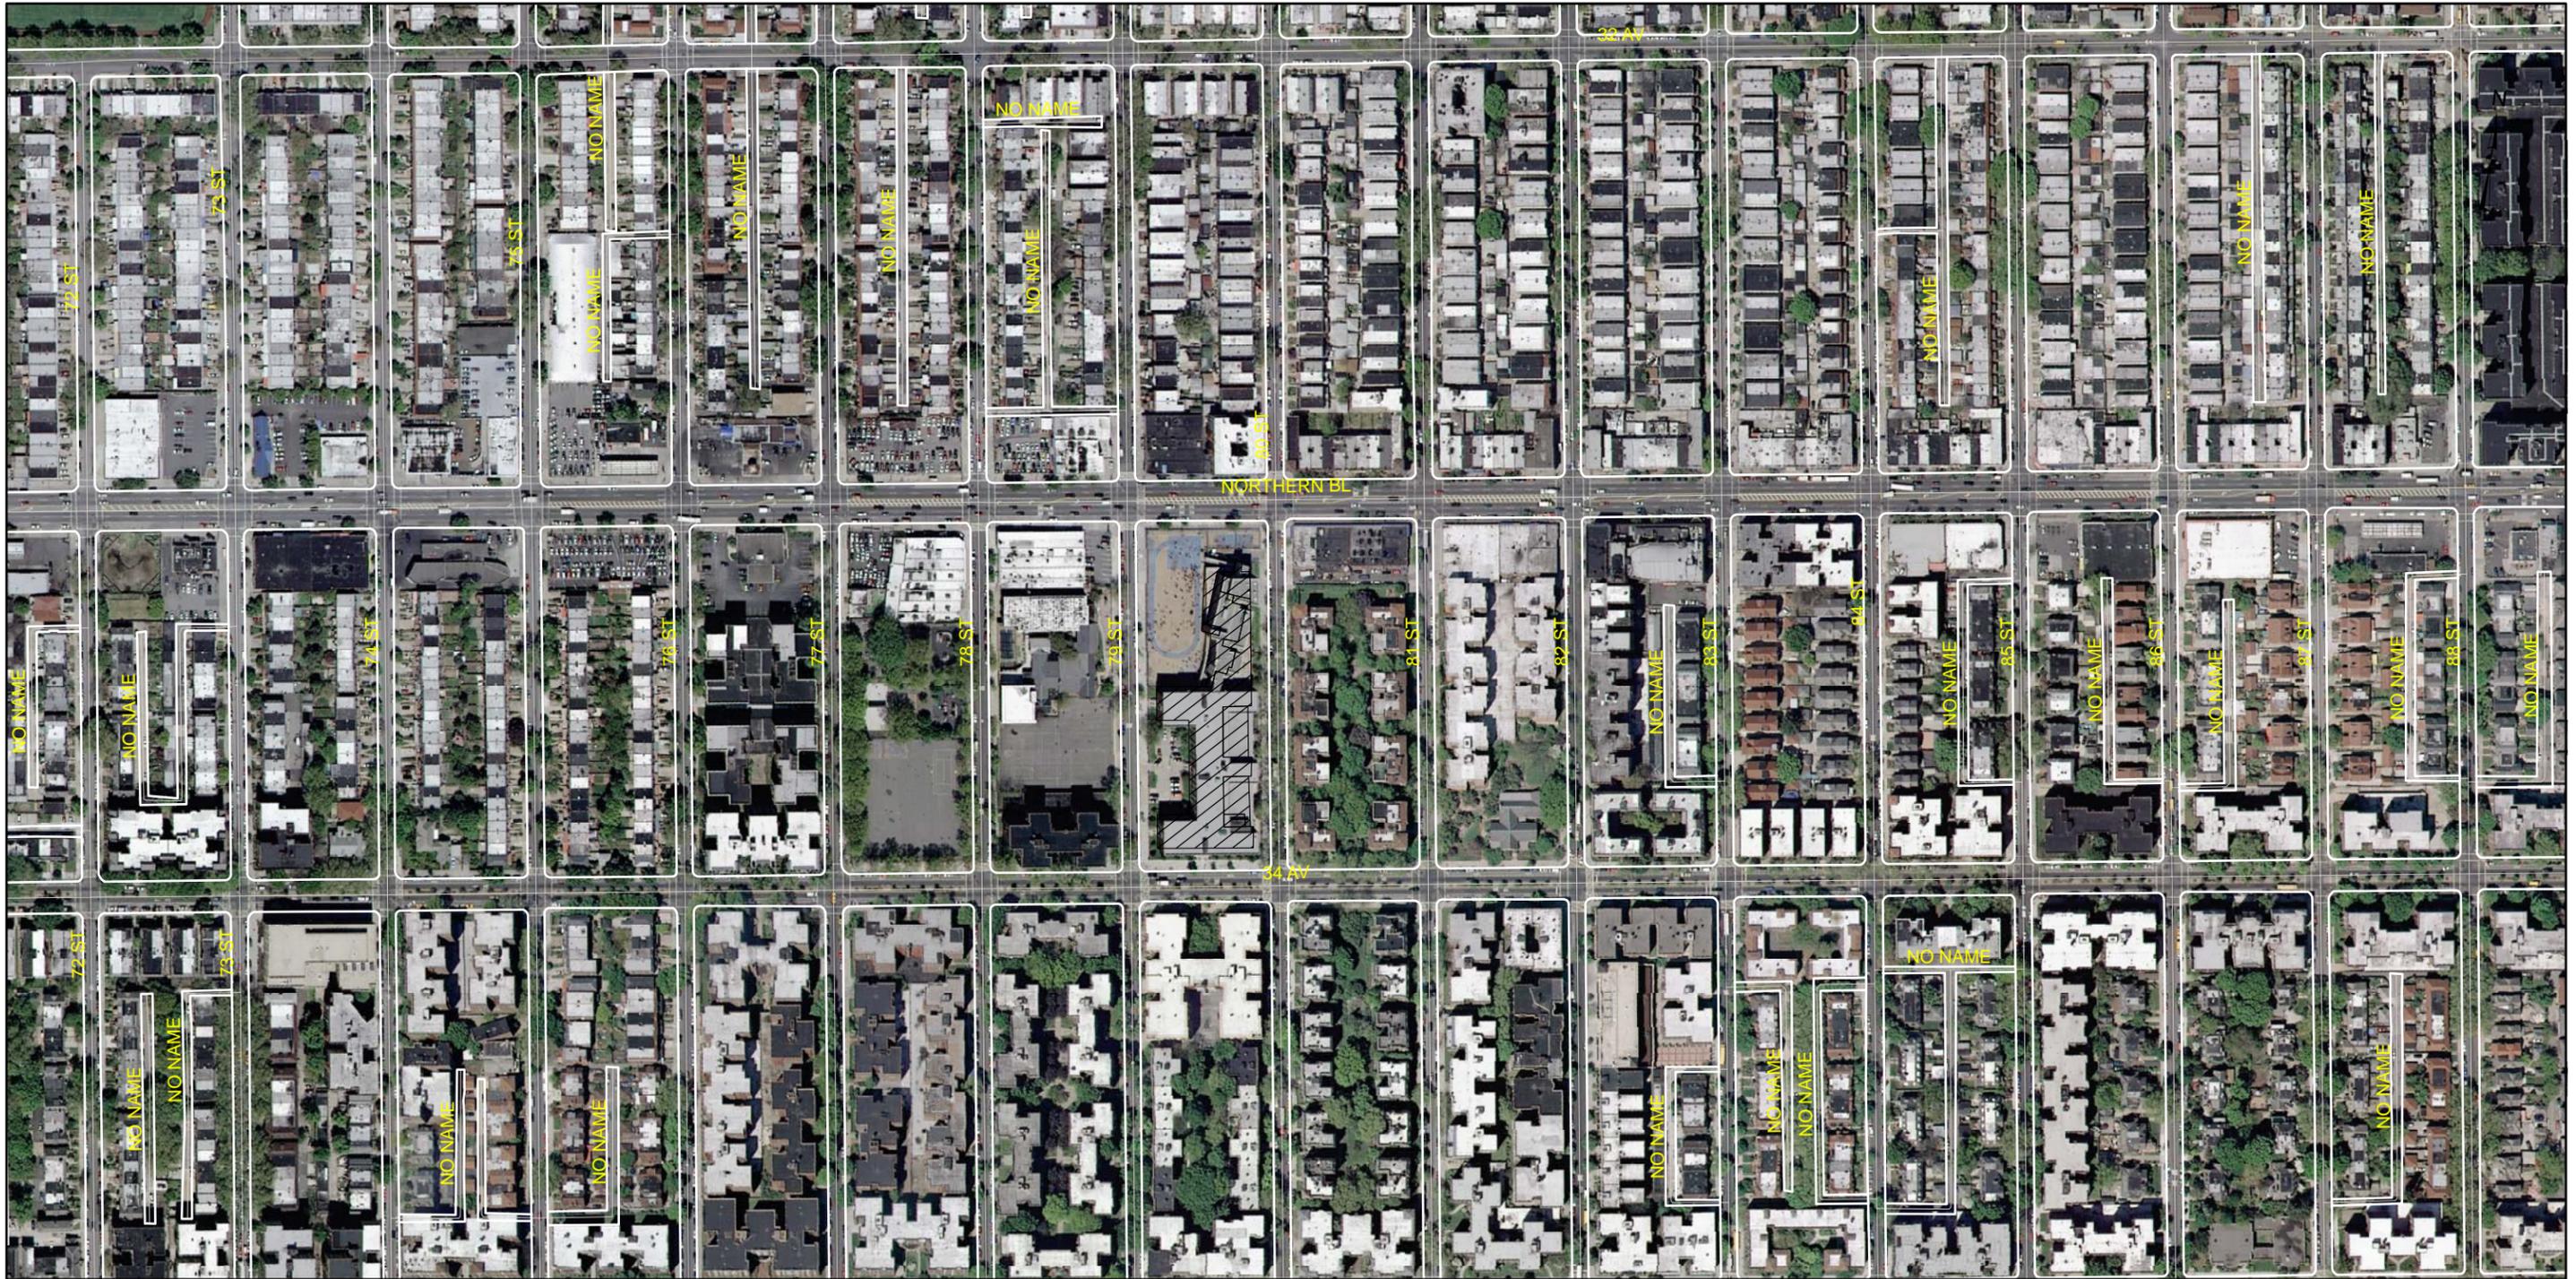
EXHIBIT 1

Exhibit 1, at the end of this section, shows an aerial view of the neighborhood surrounding the school. I.S. 145 is bounded by Northern Boulevard to the north, 34th Avenue to the south, 79th Street to the west, and 80th Street to the east. The area surrounding the school is generally residential in nature, with high-density apartment buildings. Northern Boulevard has significant commercial activities and carries considerable traffic volumes. Vendors selling food are located at dismissal times in various areas surrounding the school.

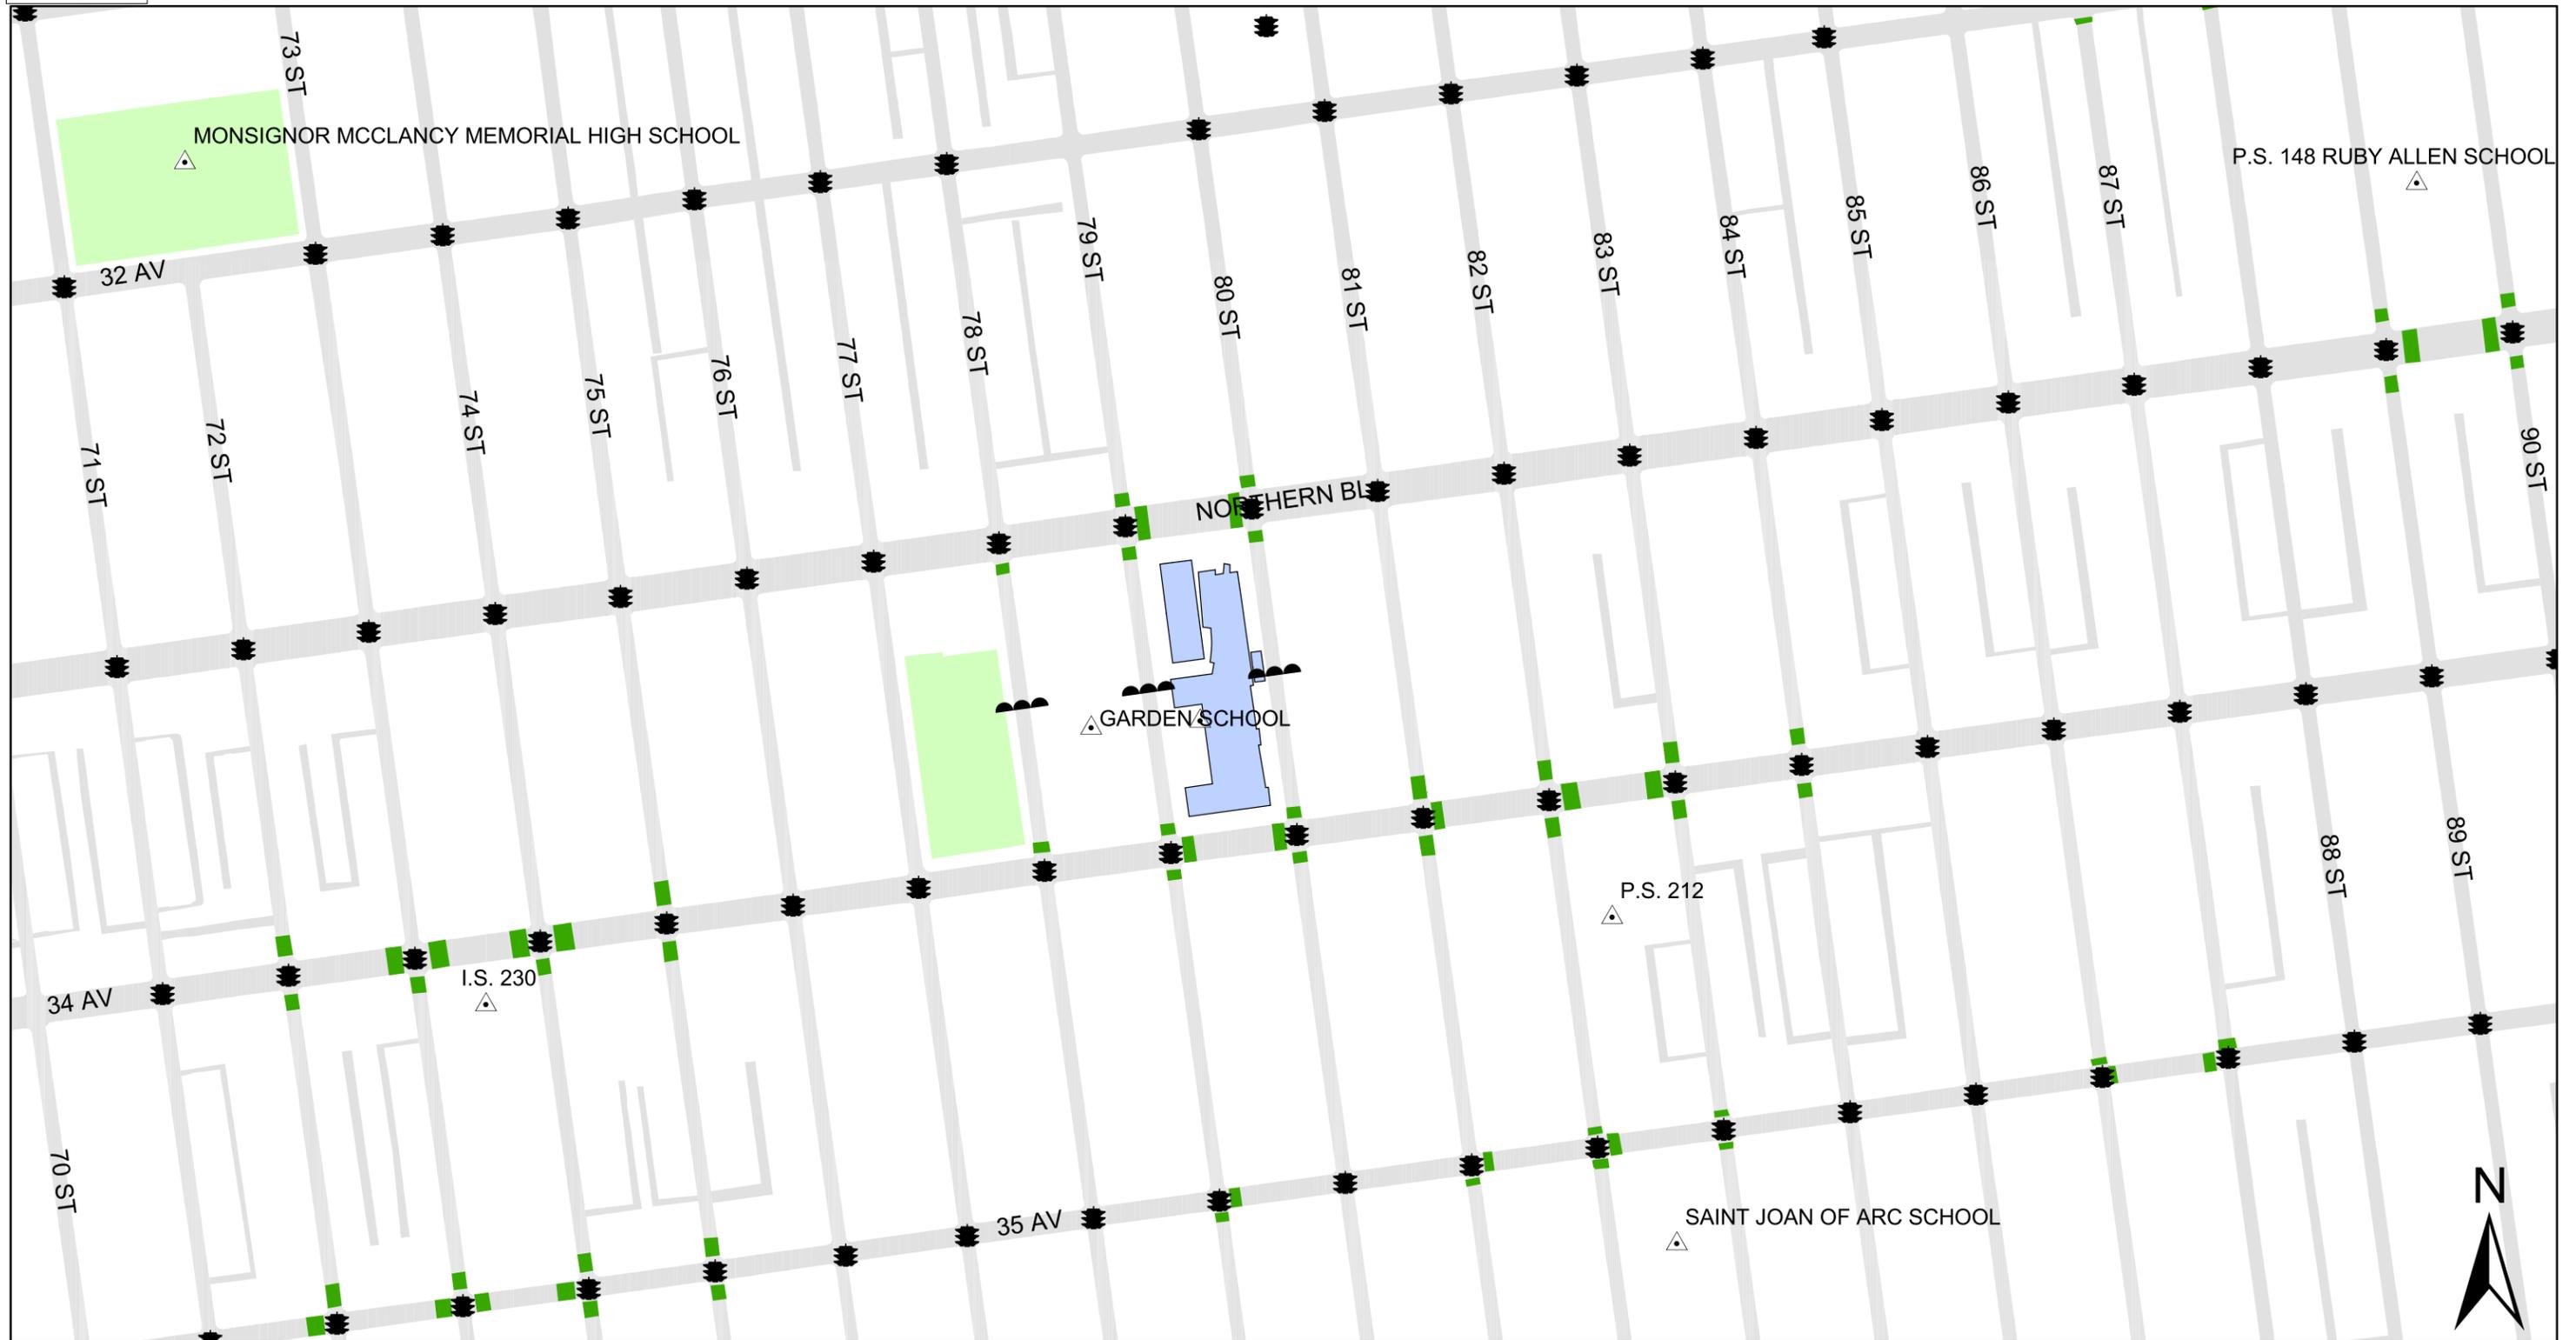
EXHIBIT 3

The School Traffic Safety Map was established to help provide the maximum degree of safety for children going to and from school - by indicating the location of speed reducers, school crosswalks and some traffic control devices. (While virtually all intersections in NYC benefit from traffic control devices - such as stop signs, traffic signals, yield signs, and all way stop signs - this map shows only traffic signals and all way stop signs.) The school crosswalks that are shown are ladder striped and make the crosswalk more visible to drivers and help make the intersection safer. These crosswalks are where school children are recommended to cross.

Exhibit 3, at the end of Section 2, shows the existing signals, and school signs and pavement markings assigned to I.S. 145. It should be noted that a citywide signage program is currently underway to upgrade school signage to the current edition of the Federal Manual of Uniform Traffic Control Devices (MUTCD) standards of fluorescent yellow-green accompanied by downward pointing arrows. Signs scheduled to be installed under this program are shown as “existing” in Exhibit 8.

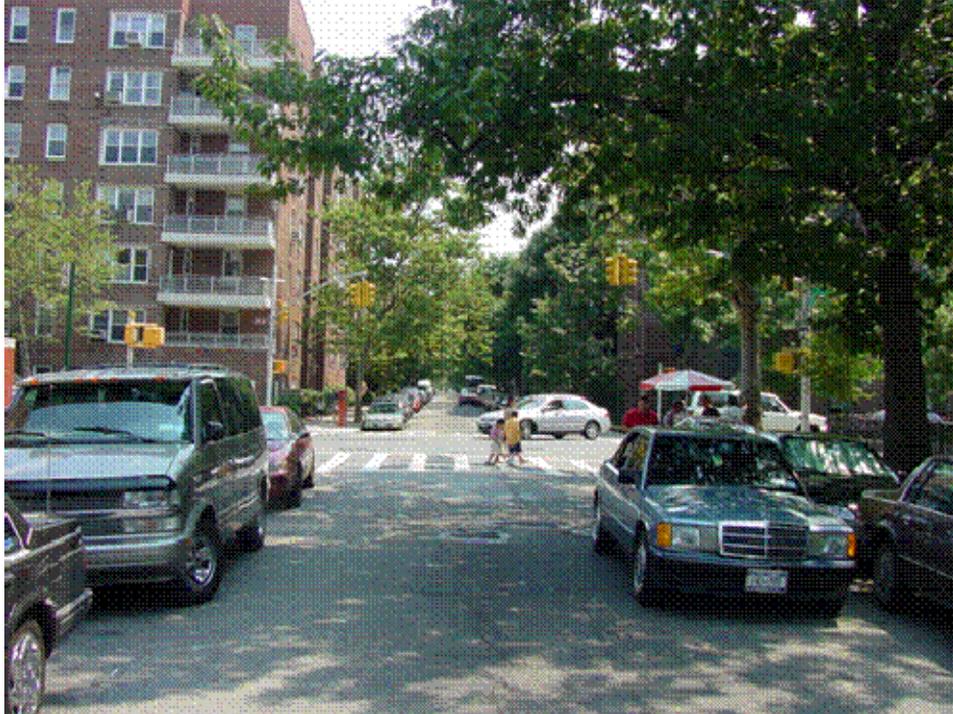
This is a signalized intersection with school crosswalks located across the north and south legs of 79th Street and the east leg of 34th Avenue, with a standard pedestrian crosswalk located across the west leg of 34th Avenue. Thirty-Fourth Avenue is a two-way street with one travel lane, a bicycle lane, and a parking lane on each side of the roadway, with a landscaped median along the center of the roadway separating eastbound and westbound traffic. Seventy-Ninth Street is a one-way northbound street with one travel lane and parking on both sides of the roadway. Higher volumes of traffic are experienced on 34th Avenue.

There were twelve (12) accidents reported at this intersection between 1998 and 2000: none of these accidents was a pedestrian accident (Table 2). The NYPD accident data (Table 3) also shows twelve (12) accidents between 2001 and 2004. There were no pedestrian accidents or fatalities reported during the same four-year period.

Figure 4: Looking south on 79th Street at 34th Avenue intersection

- Westbound and northbound approaches of 34th Avenue and 79th Street intersection
- Eastbound and southbound approaches of 34th Avenue and 80th Street intersection
- Westbound and northbound approaches of Northern Boulevard and 79th Street intersection
- Eastbound and southbound approaches of Northern Boulevard and 80th Street intersection
- Westbound and northbound approaches of 35th Avenue and 79th Street intersection

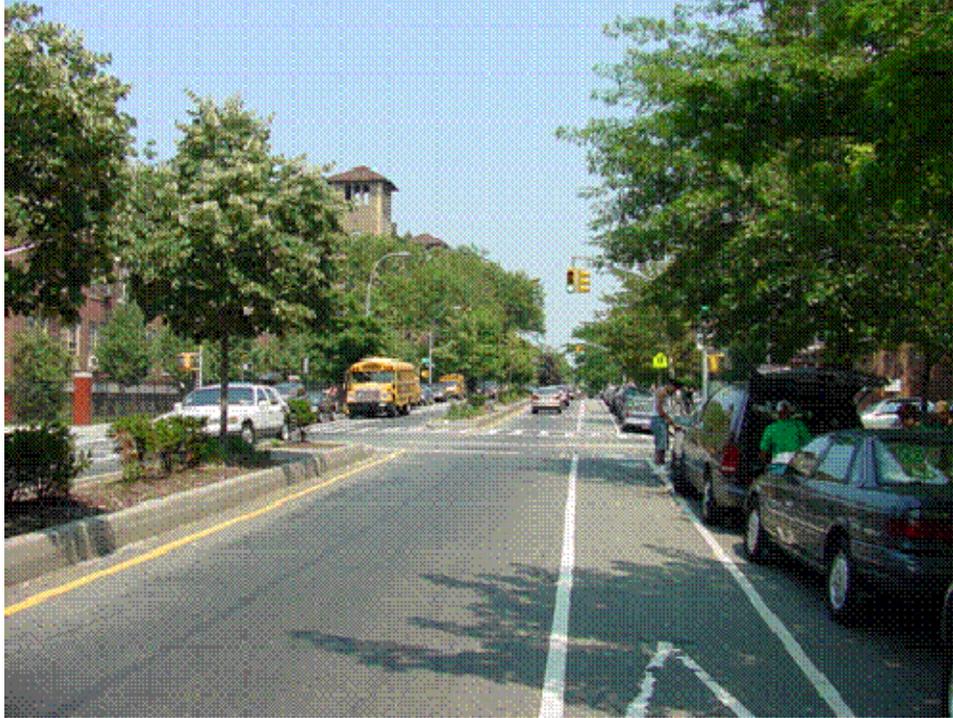
Figure 5: Looking east on 34th Avenue at 79th Street intersection

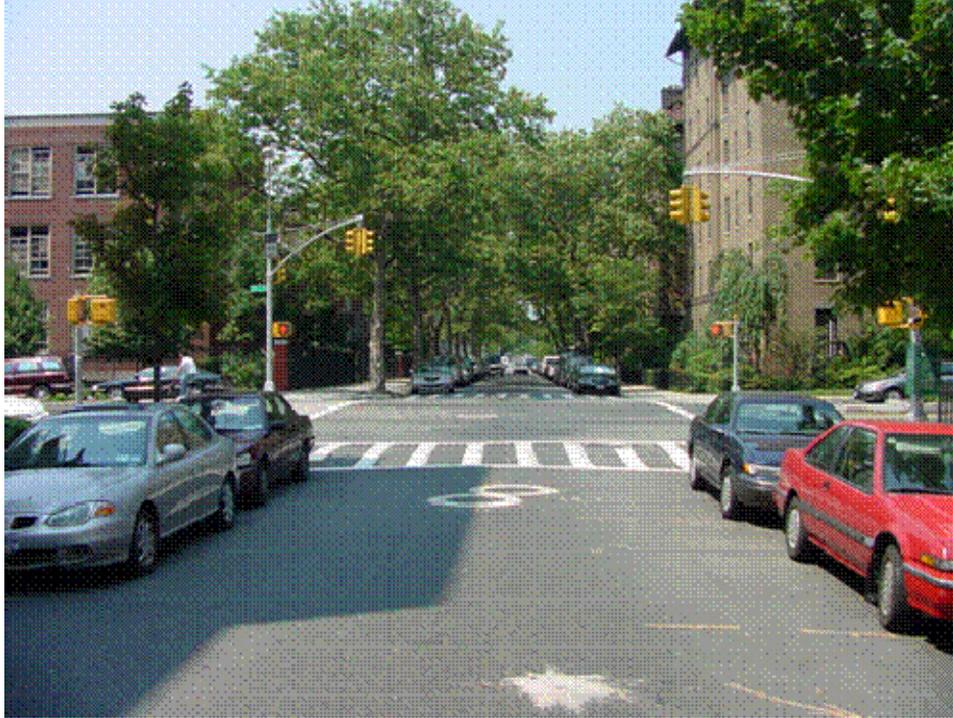
This is a signalized intersection with school crosswalks located across the north and south legs of 80th Street and the west leg of 34th Avenue, with a pedestrian crosswalk located across the east leg of 34th Avenue. Thirty-Fourth Avenue is a two-way street with one travel lane, a bicycle lane, and a parking lane on each side of the roadway, with a landscaped median along the center of the roadway separating eastbound and westbound traffic. Eightieth Street is a one-way southbound street with one travel lane and parking on both sides of the roadway. Higher volumes of traffic are experienced on 34th Avenue.

This intersection has been the site of thirteen (13) accidents reported at this intersection between 1998 and 2000: none of these accidents was a pedestrian accident (Table 2). The NYPD accident data (Table 3) shows twenty (20) accidents reported at this intersection between 2001 and 2004: none of these accidents was a pedestrian accident.

Figure 6: Looking north on 80th Street at 34th Avenue intersection, school is on far left

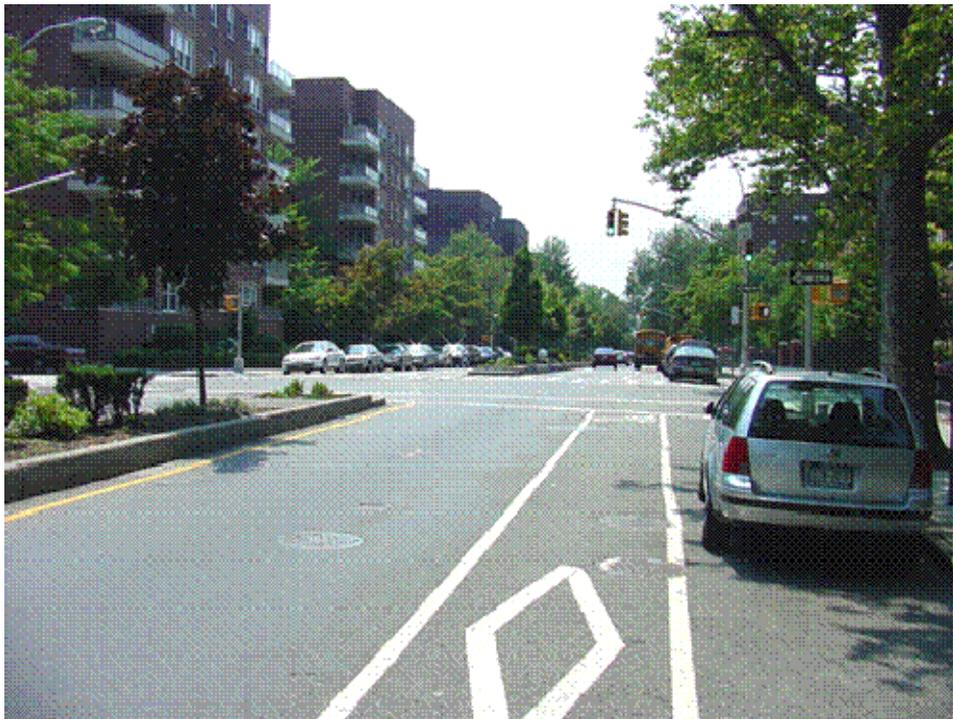
Figure 7: Looking west on 34th Avenue at 80th Street intersection

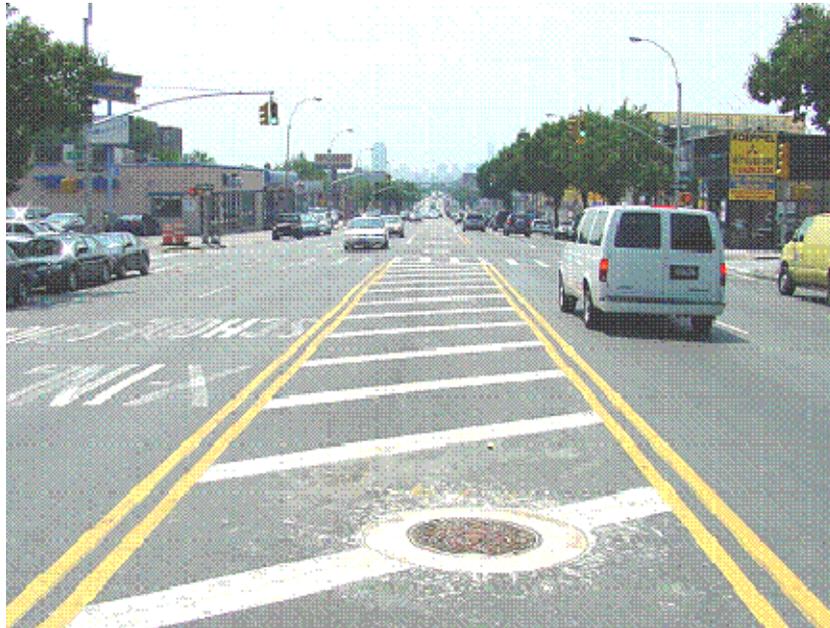
This is a signalized intersection with school crosswalks located across the north and south legs of 79th Street and the east leg of Northern Boulevard. A standard pedestrian crosswalk is located across the west leg of Northern Boulevard. Northern Boulevard is a two-way street with two travel lanes and a parking lane on each side of the roadway, with an approximately ten-foot wide painted center median separating eastbound and westbound traffic. There is a dedicated left turn lane for eastbound Northern Boulevard traffic. Seventy-Ninth Street is a one-way northbound street with one travel lane and parking on both sides of the roadway. Substantially higher volumes of traffic are experienced on Northern Boulevard.

This intersection has been the site of forty-two (42) accidents between 1998 and 2000; two (2) of these were pedestrian accidents, one (1) of which was school-related. In the school-related accident, a twelve-year old pedestrian sustained a “non-incapacitating injury” on Monday, June 8, 1998 at 4:00 p.m. while “crossing against the signal” at the intersection. The road was dry and the weather was clear. There were no pedestrian fatalities during this period. The NYPD accident data (Table 3) shows fifty-four (54) accidents including one pedestrian accident, which was not school-related or a fatality between 2001 and 2004.

Figure 8: Looking west along Northern Boulevard at 79th Street intersection

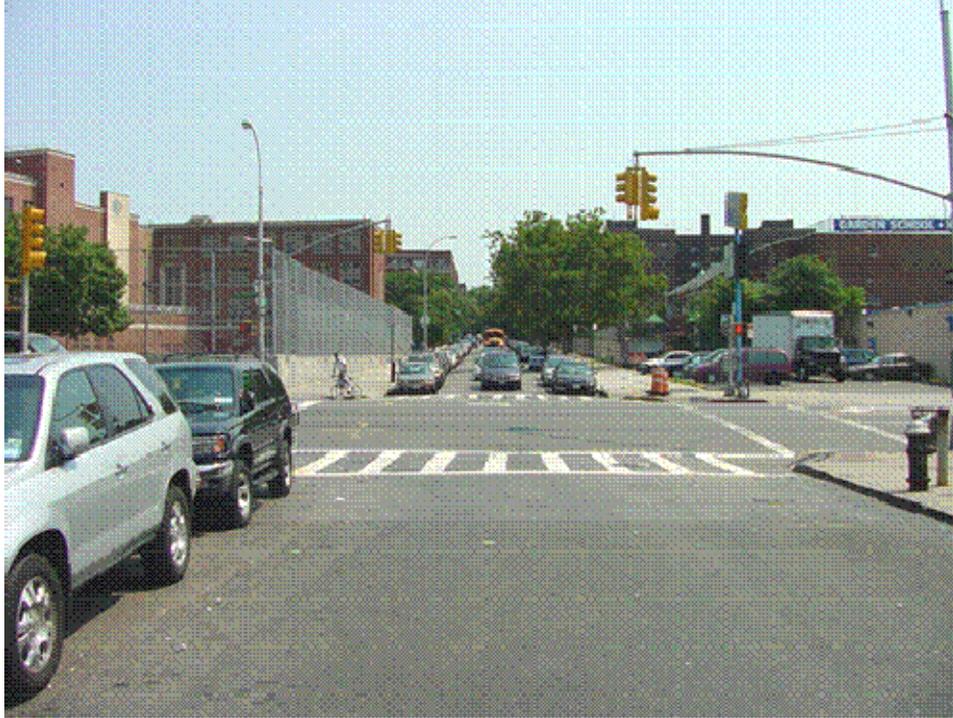
Figure 9: Looking south along 79th Street at Northern Boulevard intersection, school is on far left

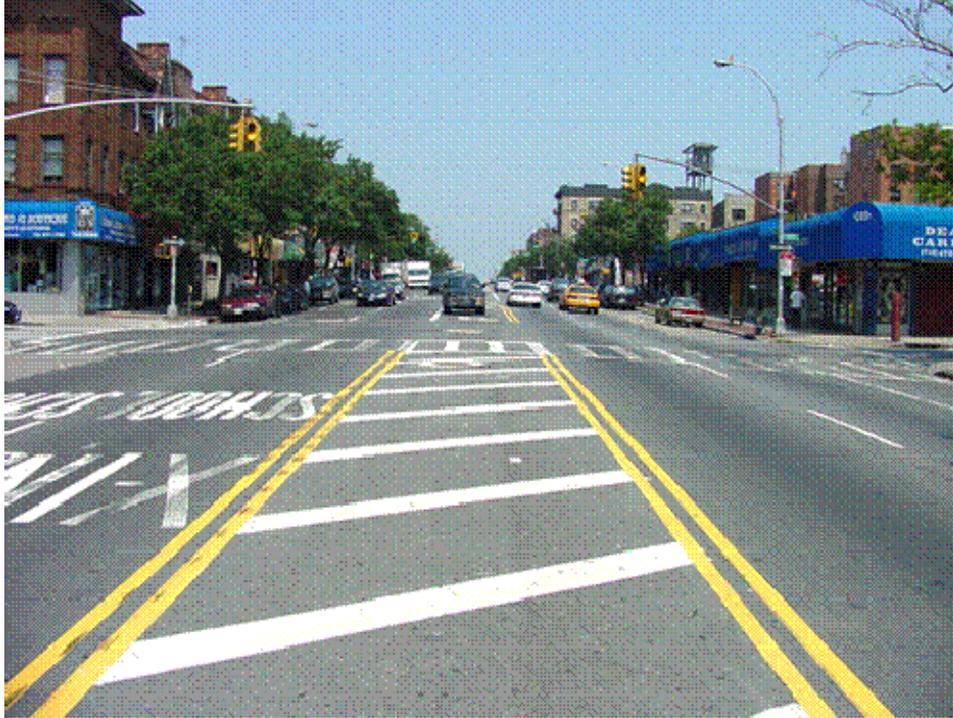
This is a signalized intersection with school crosswalks located across the north and south legs of 80th Street and the west leg of Northern Boulevard. A pedestrian crosswalk is located across the east leg of Northern Boulevard. Northern Boulevard is a two-way street with two travel lanes and a parking lane on each side of the roadway, with an approximately ten-foot wide painted center median separating eastbound and westbound traffic. There is a dedicated left turn lane for westbound Northern Boulevard. 80th Street is a one-way southbound street with one travel lane and parking on both sides of the roadway. Substantially higher volumes of traffic are experienced on Northern Boulevard.

This intersection was the site of thirty-eight (38) accidents between 1998 and 2000; two (2) of these were pedestrian accidents, neither of which were school-related. There were no pedestrian fatalities during this period. The NYPD accident data (Table 3) shows sixty-five (65) accidents including one (1) pedestrian accident between 2001 and 2004. There were no pedestrian fatalities or school-related accidents during the same four-year period.

Figure 10: Looking east along Northern Boulevard at 80th Street intersection

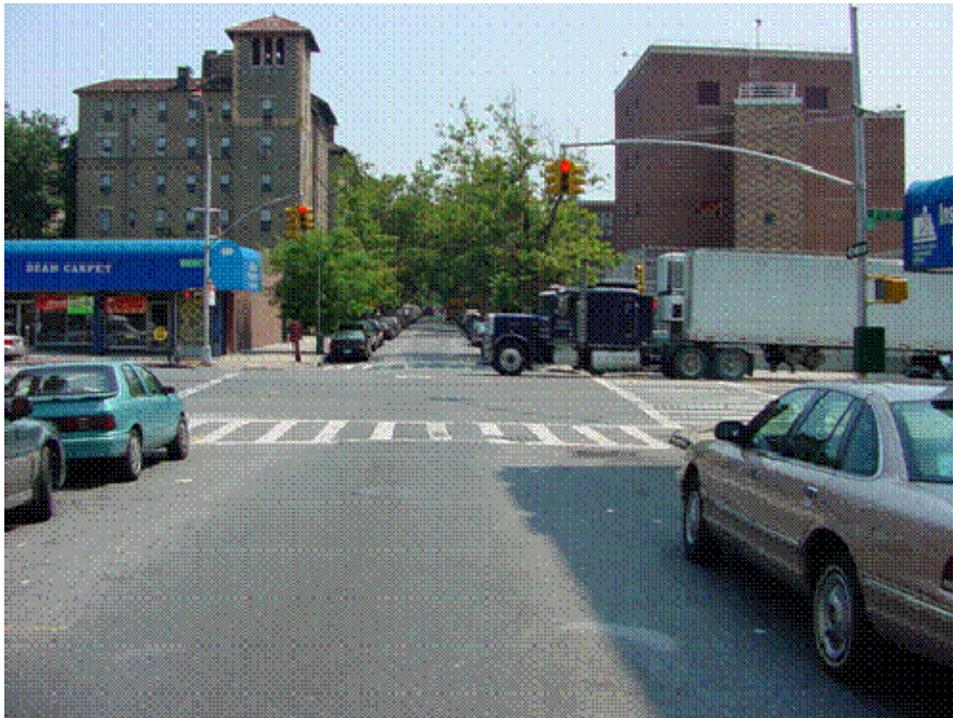
Figure 11: Looking south along 80th Street at Northern Boulevard intersection, school is on the far right

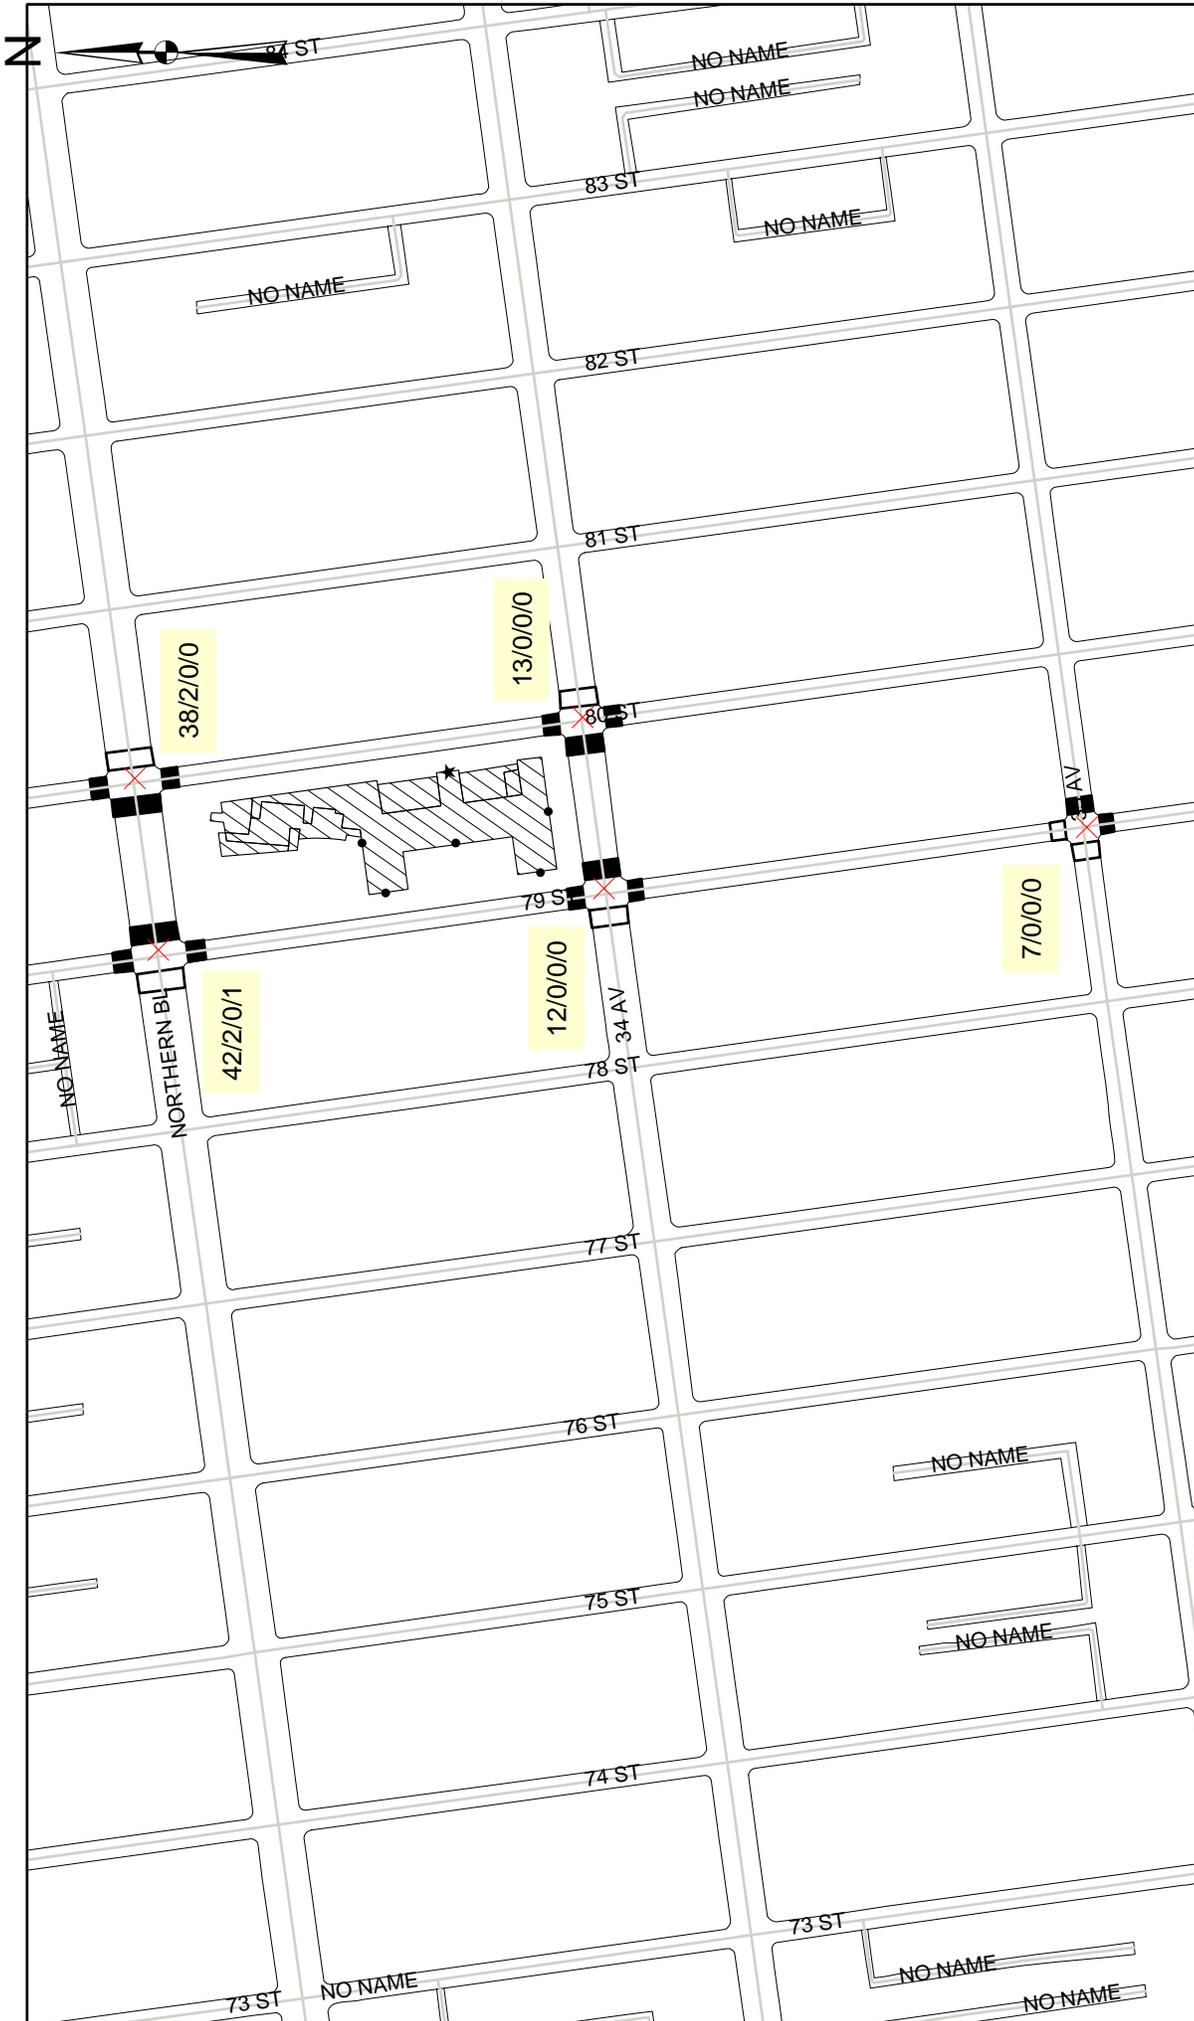
EXHIBIT 5
I.S. 145 QUEENS
J. PULITZER INTERMEDIATE SCHOOL
ACCIDENT SUMMARY (1998-2000)

Exhibit 5, at end of this section, and Table 2 show a summary of accidents, as obtained from the New York State Department of Motor Vehicles (NYS DMV) in the vicinity of I.S. 145 for a three-year period from January 1, 1998 to December 1, 2000. The NYS DMV data provides some detail relating to the cause of an accident. Table 3 provides a summary of more recent accident data obtained from the New York City Police Department (NYPD). Though current through 2004, the NYPD data does not provide the same level of detail as the NYS DMV data.

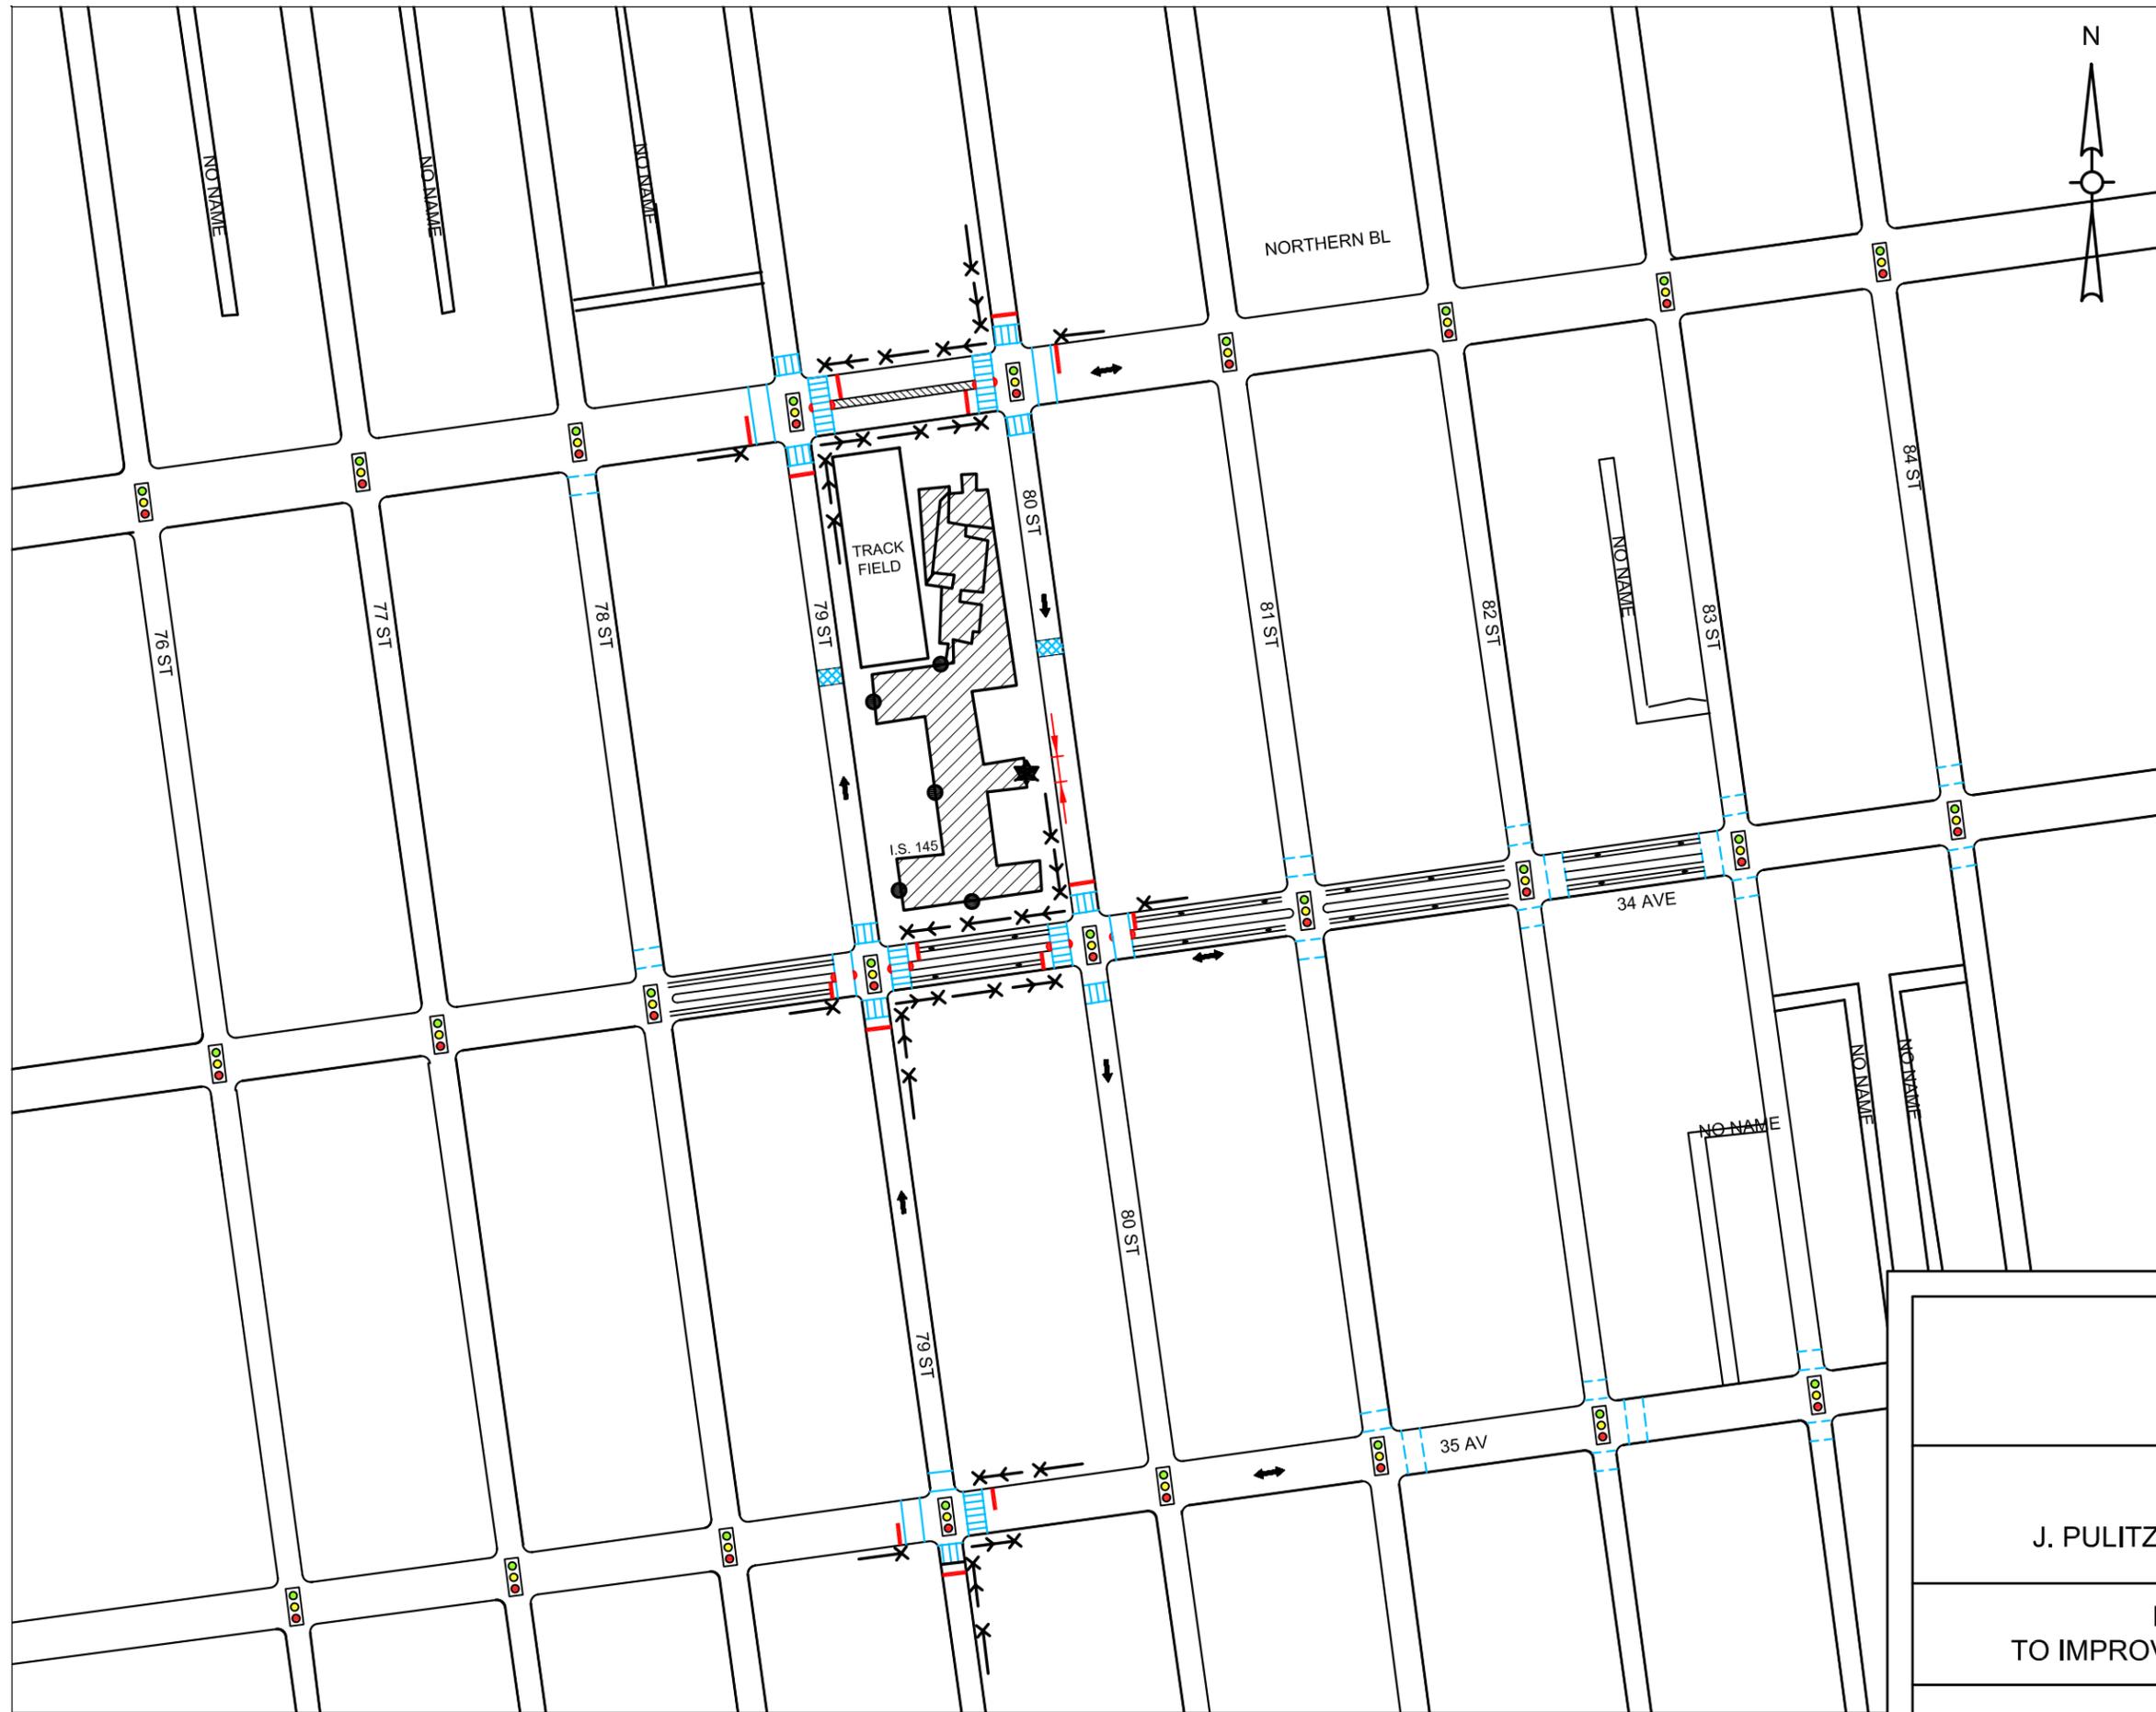
EXHIBIT 6

This section describes the proposed measures to improve school pedestrian safety around I.S. 145. The proposed recommendations are divided into short-term and long-term measures. Short-term measures are those that potentially can be performed in-house. Long-term measures involve capital improvements. Each of the short- and long-term measures recommended for I.S. 145 is discussed as follows, and is shown in more detail in Exhibit 6 at the end of this section.

➤ Consider refuge islands at the following intersections as shown in Exhibit 6:

- Provide a pedestrian refuge island by extending the median through the school crosswalk at the east leg of 34th Avenue/79th Street and at the west leg of 34th Avenue/80th Street, as shown in Exhibit 6.

- Provide a pedestrian raised concrete refuge island at the east leg of Northern Boulevard/79th Street and at the west leg of Northern Boulevard/80th Street, as shown in Exhibit 6.

The refuge islands with extended medians will provide a refuge for pedestrians who do not complete the crossing during the flashing “Don’t Walk” indication. The proposed median should be at least 5-foot wide, should extend beyond the crosswalk, and should have at least 5-feet at grade cut through section. These medians are not proposed where they would hinder the ability of vehicles to turn. Final details pertaining to proposed refuge islands and curb extensions will be developed during Final Design.
