**New York City Department of Transportation  
Office of School Safety Engineering**

**School Safety Engineering Project**

**FINAL REPORT: I.S. 68, Isaac Bildersee School, Brooklyn**

Prepared by  
The RBA Group/Urbitrans Associates

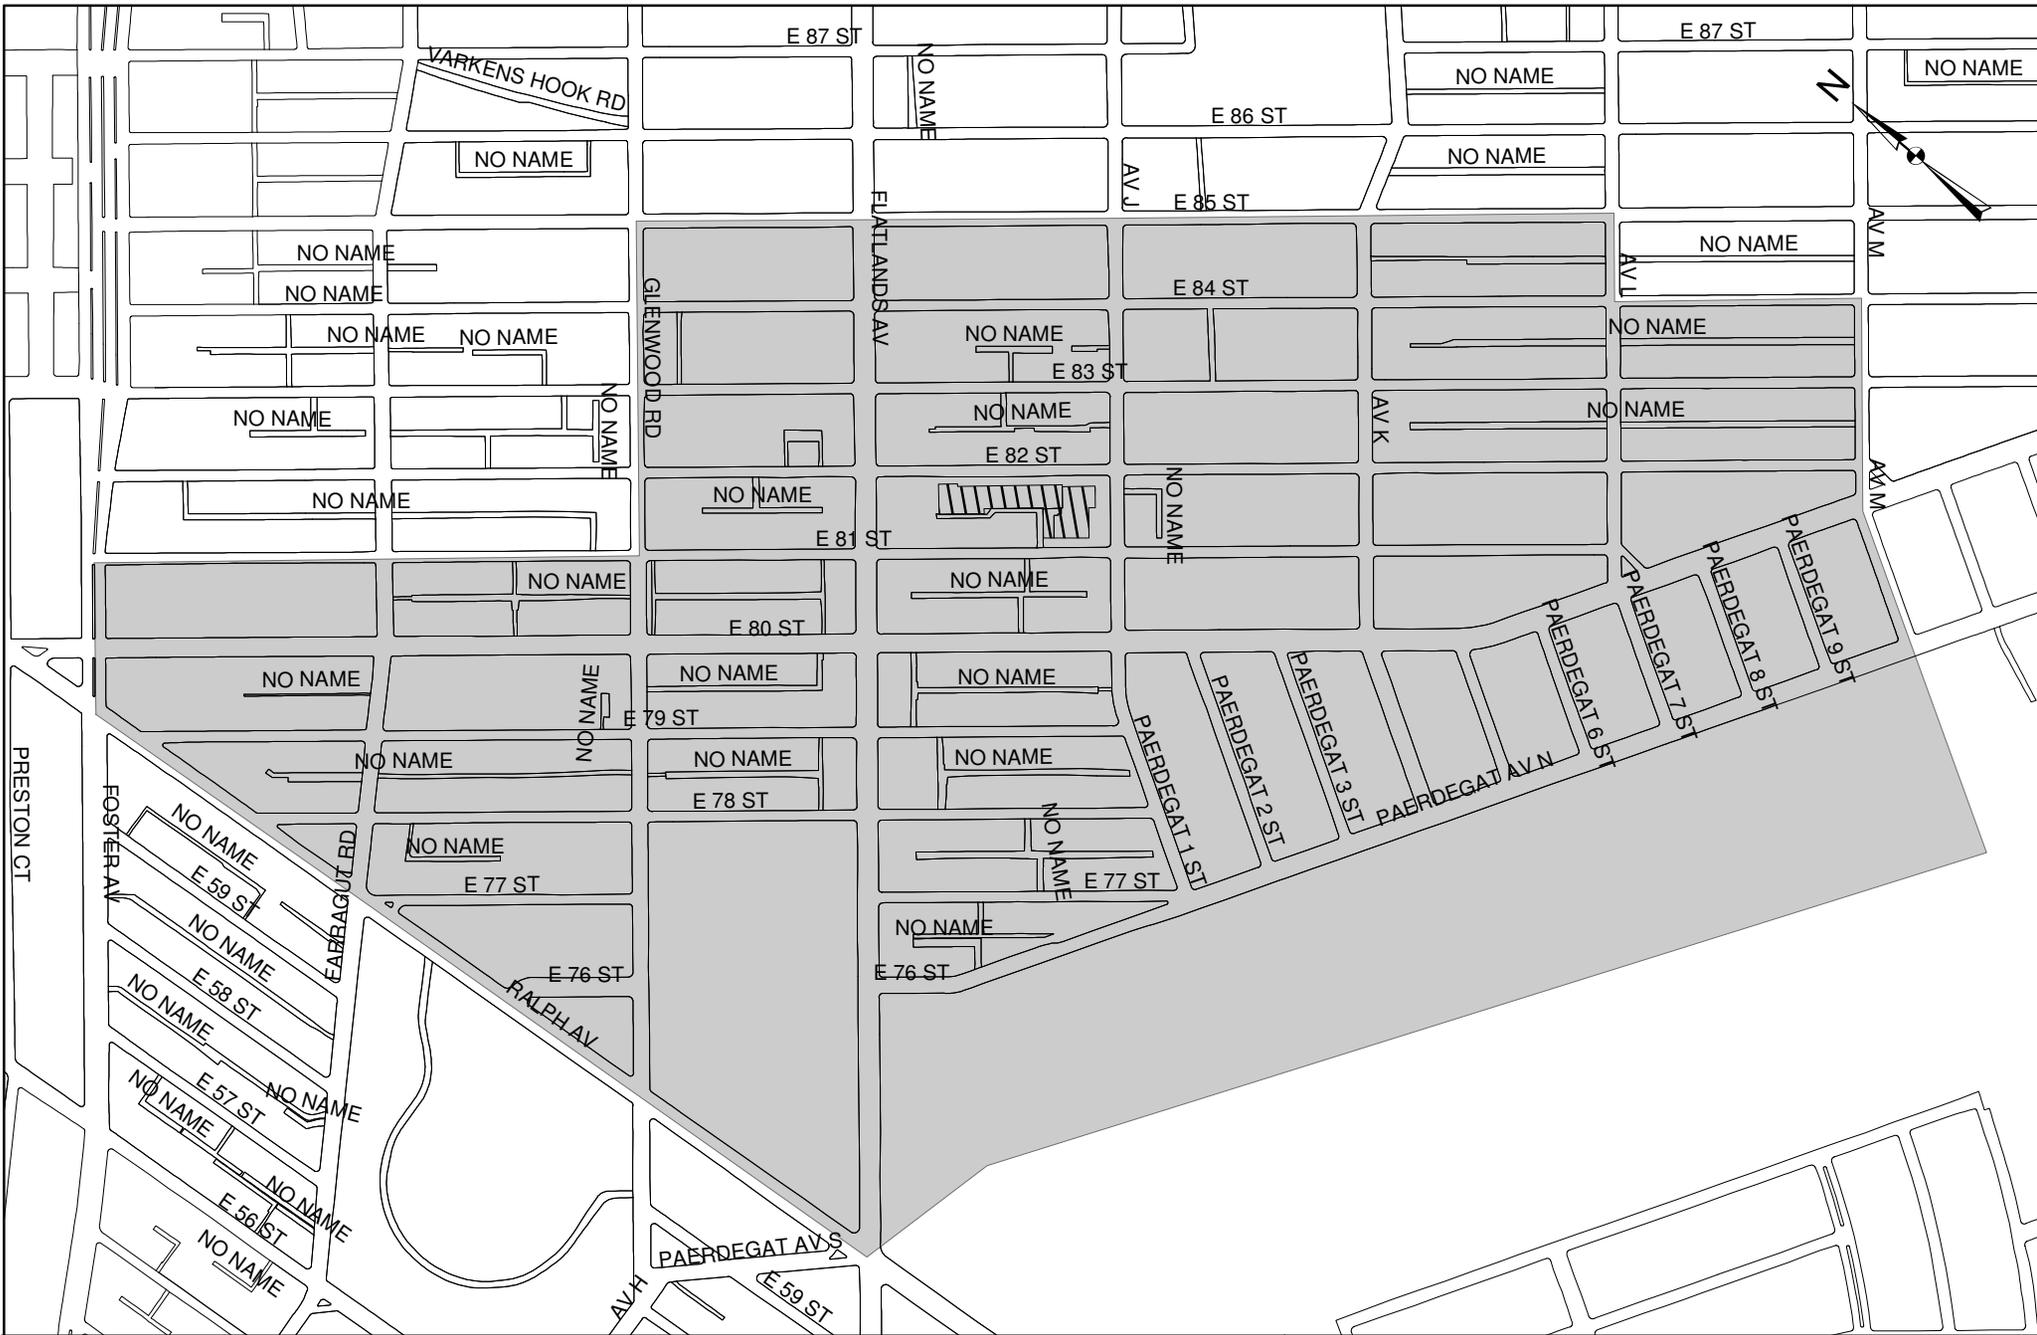
**EXHIBIT 2**  
**I.S. 68, BROOKLYN**  
**CATCHMENT AREA**

Many I.S. 68 students come from two nearby housing complexes: the Bay View Houses located on Seaview Avenue between East 102<sup>nd</sup> Street and East 105<sup>th</sup> Street, and the Breukelen Houses on Flatlands Avenue at East 108<sup>th</sup> Street. These housing complexes are not within the Department of Education established catchment area (See Exhibit 2 for Catchment Area).

It is recommended that a new school crosswalk be installed on the north leg at Flatlands Avenue and East 81<sup>st</sup> Street. The catchment area indicates that students of I.S. 68 come from west of the school; therefore, the proposed school crosswalk will facilitate students walking to school.

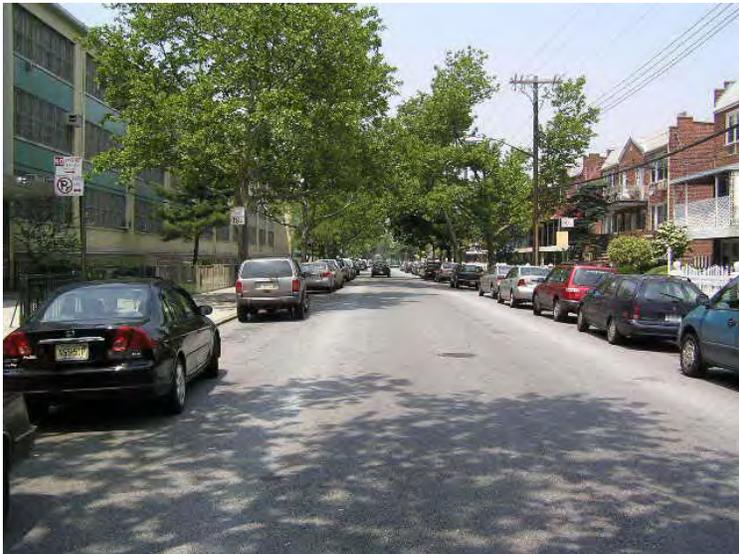
*Figure 1: Looking north on East 82<sup>nd</sup> Street, south of Flatlands Avenue, Brooklyn*

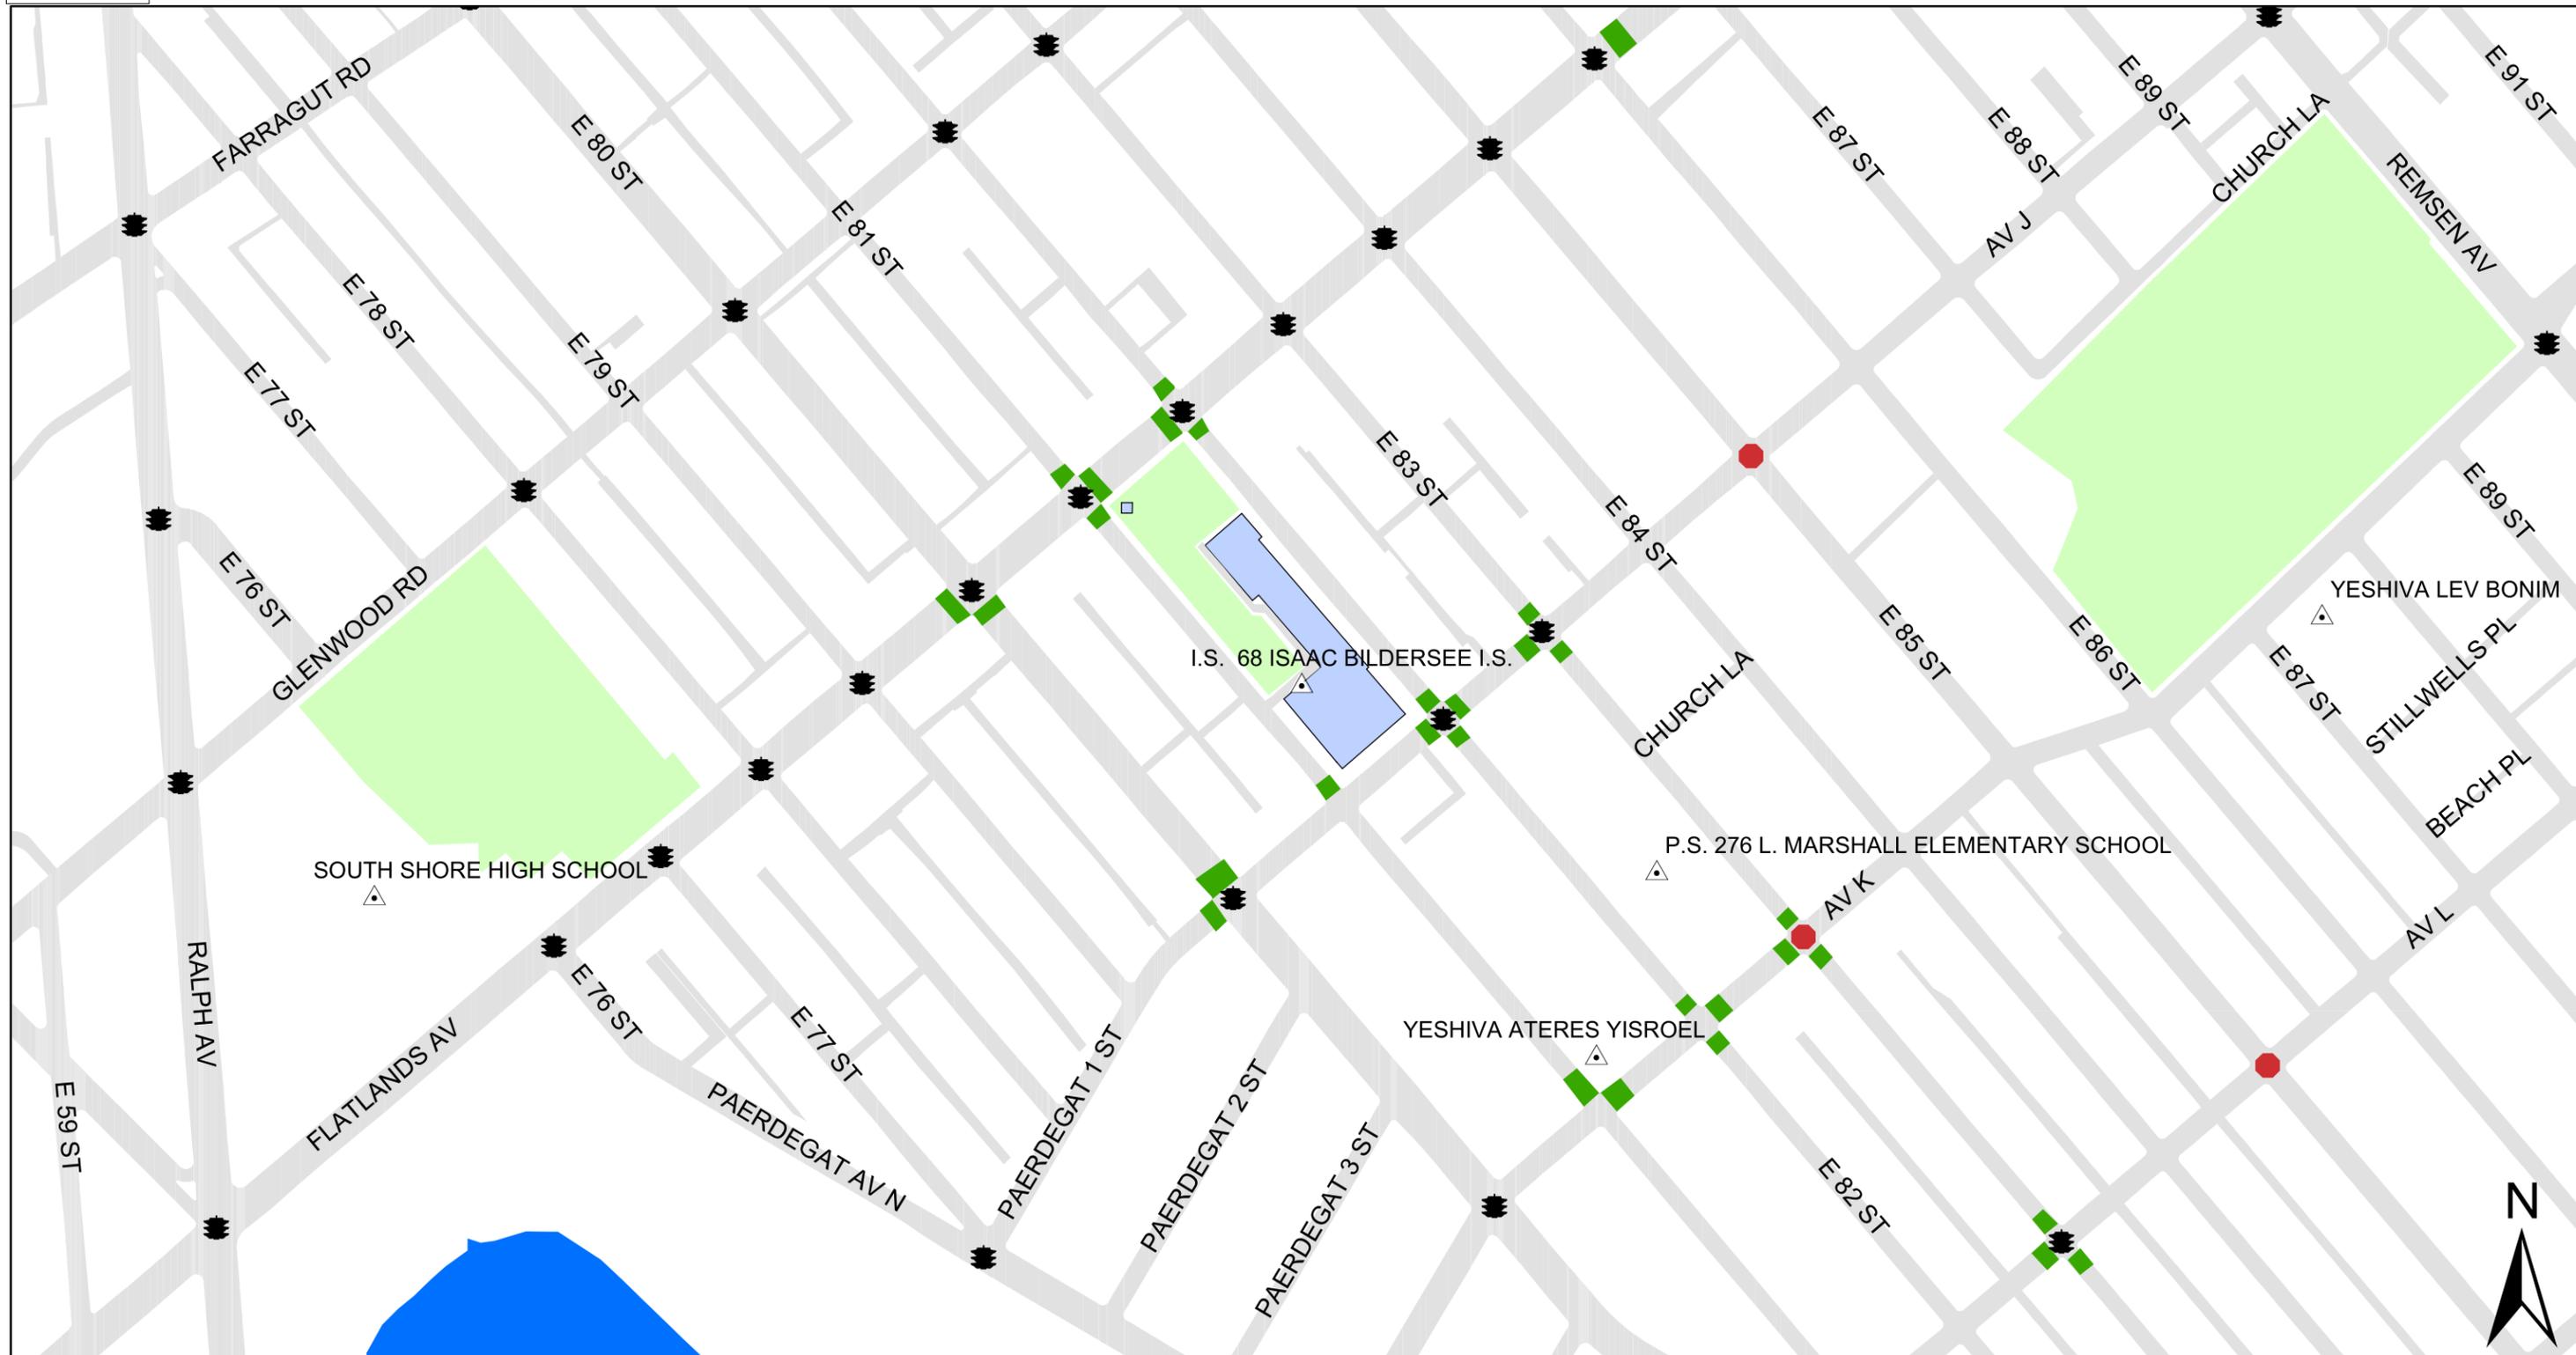
**EXHIBIT 3**

The School Traffic Safety Map was established to help provide the maximum degree of safety for children going to and from school - by indicating the location of speed reducers, school crosswalks and some traffic control devices. (While virtually all intersections in NYC benefit from traffic control devices - such as stop signs, traffic signals, yield signs, and all way stop signs - this map shows only traffic signals and all way stop signs.) The school crosswalks that are shown are ladder striped and make the crosswalk more visible to drivers and help make the intersection safer. These crosswalks are where school children are recommended to cross.

The Traffic Safety Map, Exhibit 3, shows existing signs, signals, and pavement markings as of June 2004. It is noted that a citywide signage program is currently underway to upgrade school signage to current Federal Manual of Uniform Traffic Control Devices (MUTCD) standards of fluorescent yellow-green signs accompanied by downward pointing arrows. Signs scheduled to be installed under this program are shown as “existing” on Exhibit 8.

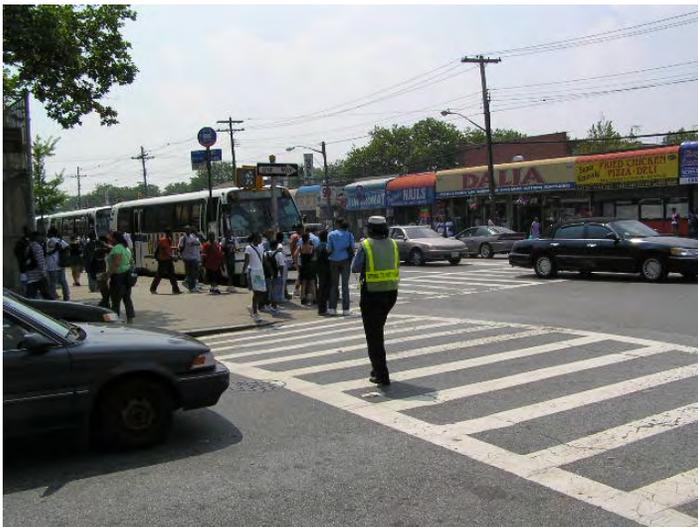
Crossing guards assigned to I.S. 68 are stationed at the following intersections (See Figure 2):

- Avenue J and East 82<sup>nd</sup> Street
- Flatlands Avenue and East 82<sup>nd</sup> Street

*Figure 2: I.S. 68 crossing guard at Flatlands Avenue and E. 82<sup>nd</sup> Street during dismissal time*

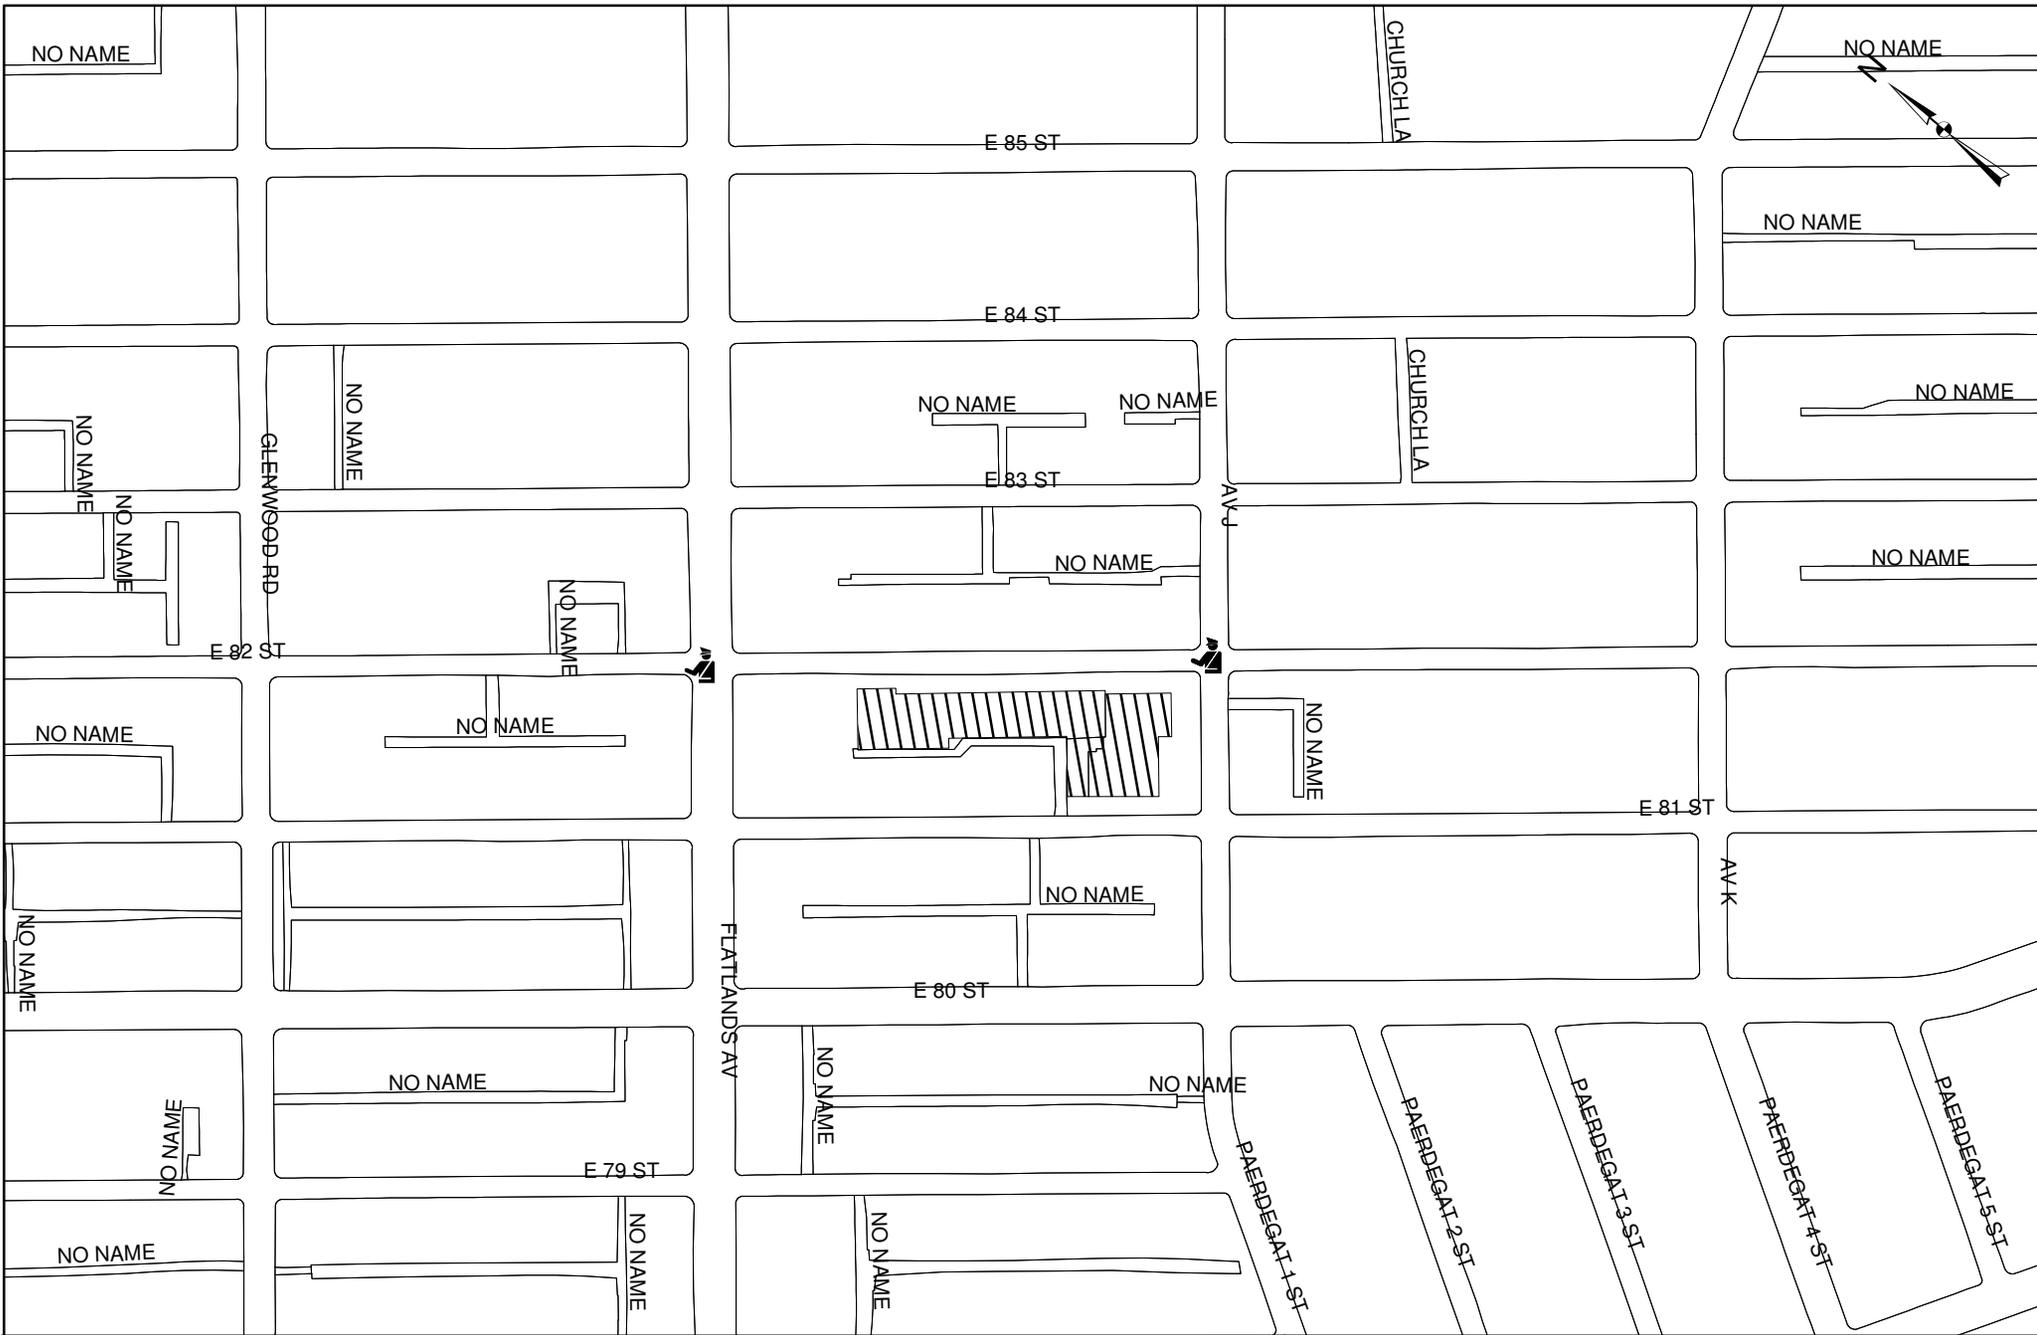
EXHIBIT 4

See Exhibit 4 for crossing guard locations.

Crossing Guards Assigned to I.S. 68

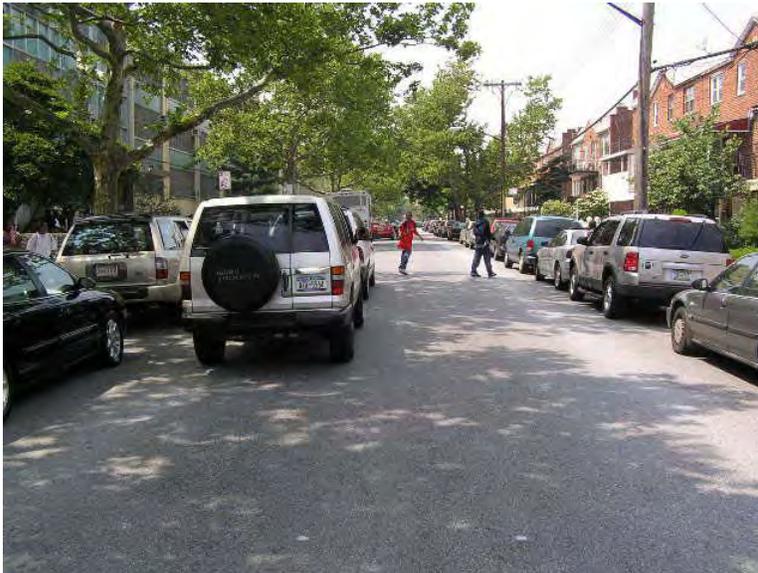
During dismissal, most vehicles are double parked on East 82<sup>nd</sup> Street. Field observations indicate that they do not block moving traffic.

*Figure 3: Vehicles double-parked on East 82<sup>nd</sup> Street during afternoon dismissal time*

“NO STANDING 7 AM – 4 PM, SCHOOL DAYS” parking regulations should be considered in front of the school’s main entrance for a length of 60 feet. This will improve visibility of students arriving to and leaving the school.

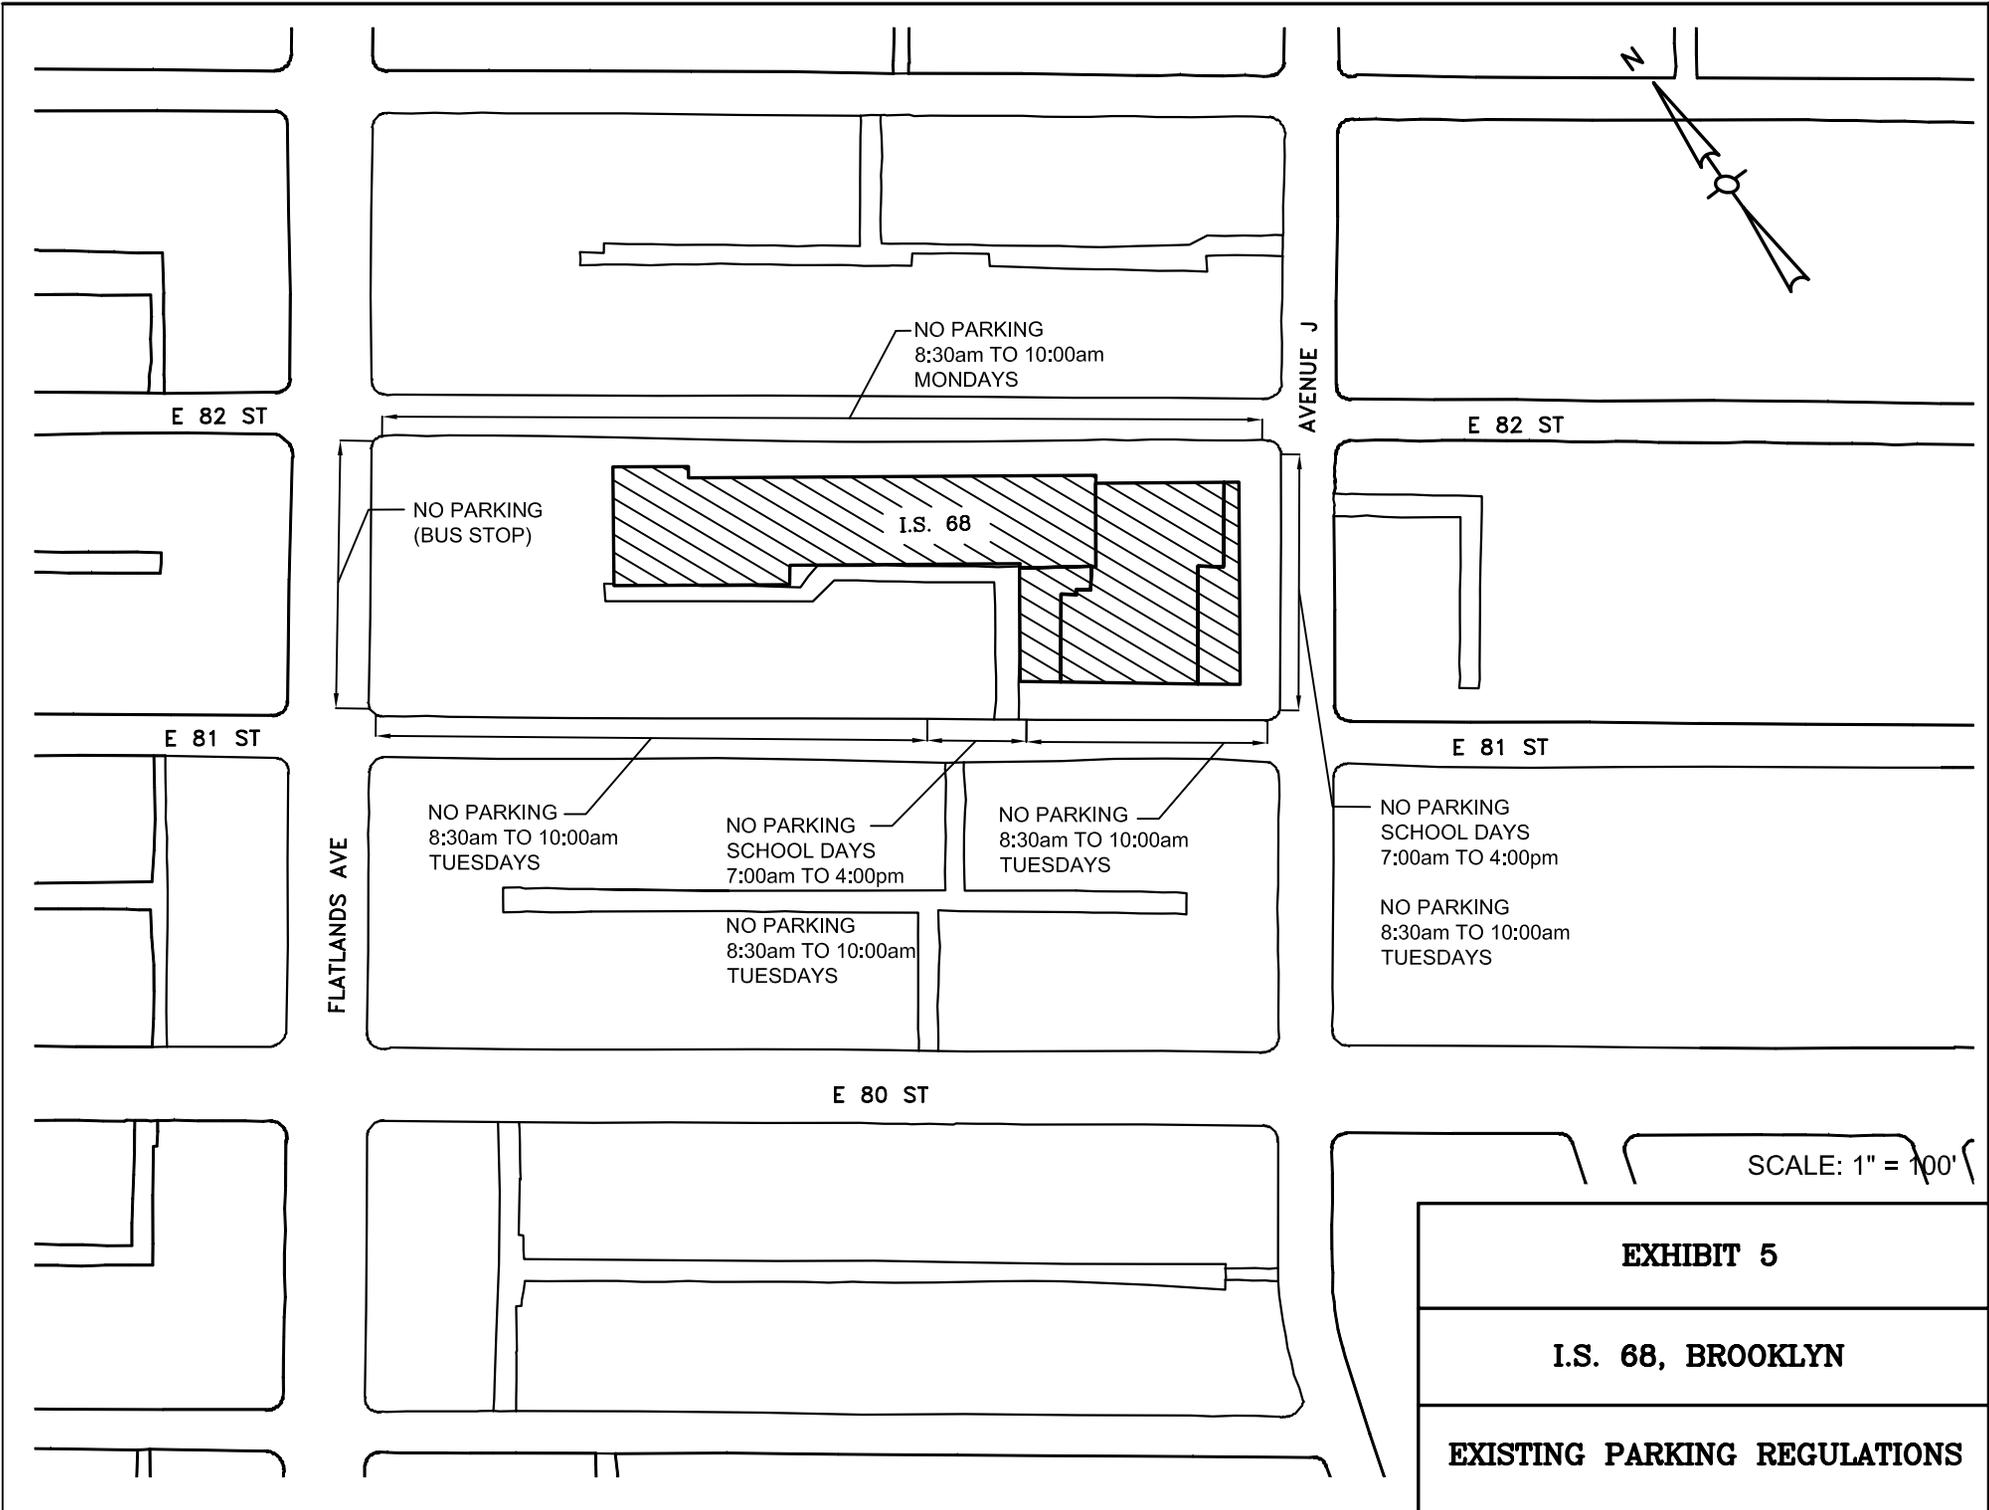
**EXHIBIT 5**

“ NO PARKING, 7 AM – 4:00 PM, SCHOOL DAYS” parking regulations are posted for the full length of Avenue J between East 81<sup>st</sup> Street and East 82<sup>nd</sup> Street, and are also posted on East 81<sup>st</sup> Street in front of the schoolyard entrance. Alternate side parking regulations are in effect 8:30 am – 10:00 am Tuesdays. Exhibit 5 shows parking regulations on the roadways surrounding the school.

Existing “NO PARKING 7 AM – 4 PM, SCHOOL DAYS” parking regulations on East 81<sup>st</sup> Street and Avenue J should be upgraded to “NO STANDING 7 AM – 4 PM, SCHOOL DAYS”. This will allow school buses and parents a place to load and unload students at the curb, and will also improve visibility of those students arriving and leaving the school.

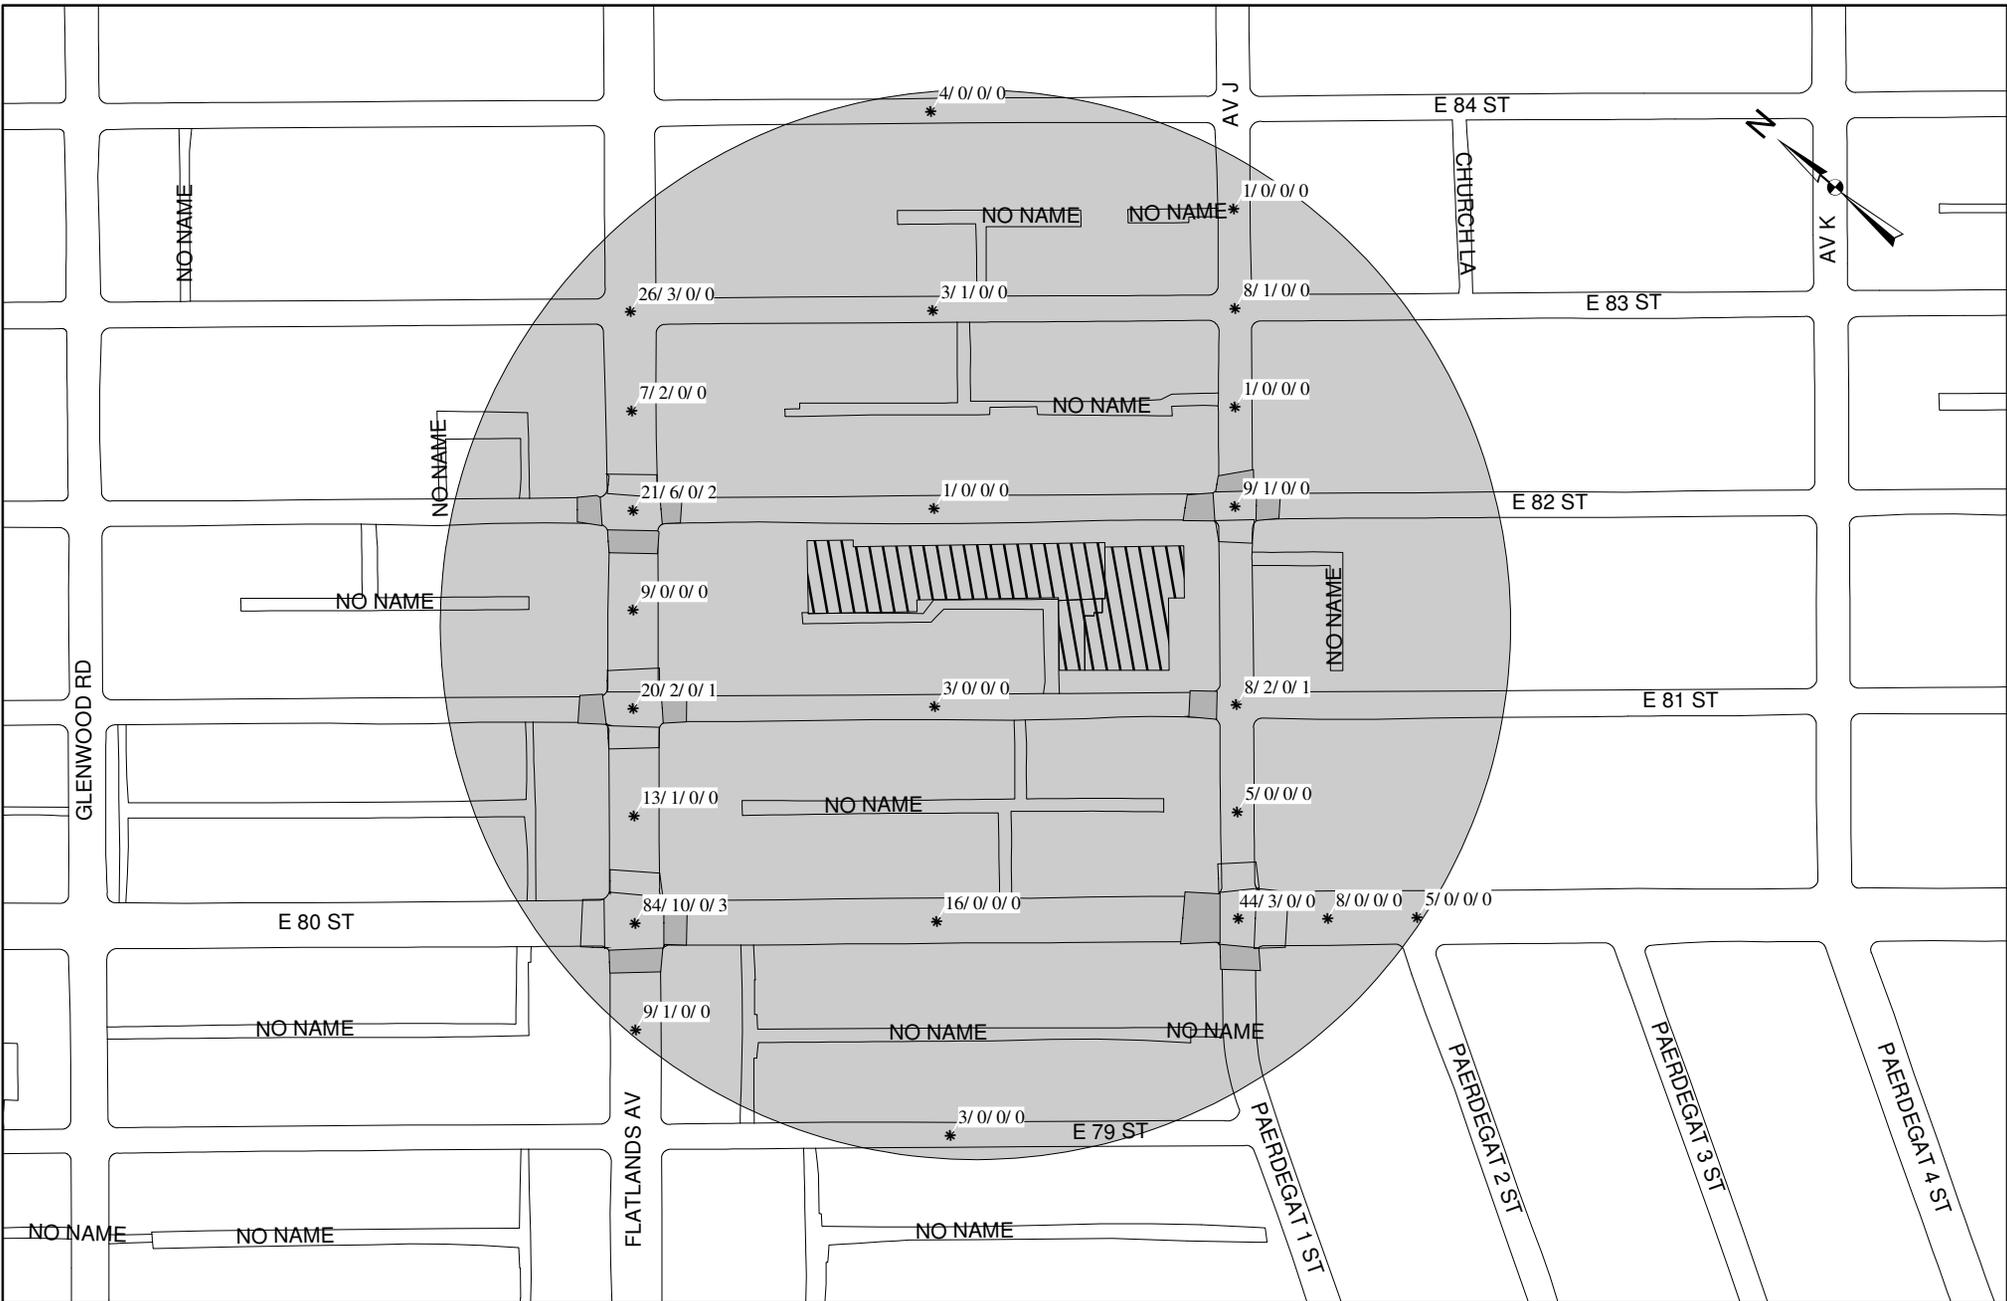
EXHIBIT 6

Exhibit 6 and Table 2 show a summary of accidents, as obtained from the New York State Department of Motor Vehicles (DMV), in the vicinity of I.S. 68 for the three-year period from January 1, 1998 through December 31, 2000. The DMV data provides some detail relating to the circumstances and cause of the accident. Table 3 is a summary of more recent accident data obtained from the NYC Police Department (NYPD). Though current through 2004, the NYPD data does not provide the same level of detail as the DMV data.

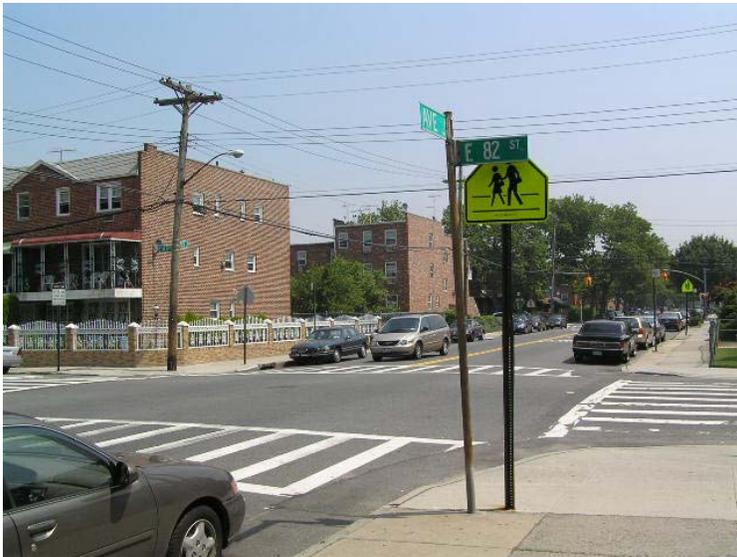
Avenue J is a two-way collector street with one travel lane in each direction and parking allowed on both sides. East 82<sup>nd</sup> Street is a one-way, westbound roadway with two travel lanes and parking permitted on both sides of the roadway. School crosswalks are in place on all legs.

When the consultant team met with the school on June 9, 2004, the school principal had concern for students crossing at this intersection, which was unsignalized (see Figure 5). In response to concerns from the school, DOT conducted an investigation and found that a signal was warranted at this location. Field observations on August 9, 2005 verified that a new traffic signal has been installed at this intersection.

There were nine accidents at this intersection during the 1998-2000 study period, one of which involved a pedestrian. A 70-year-old pedestrian was crossing Avenue J while the driver was traveling north with defective headlights.

*Figure 4: Looking east on Avenue J at East 82<sup>nd</sup> Street*

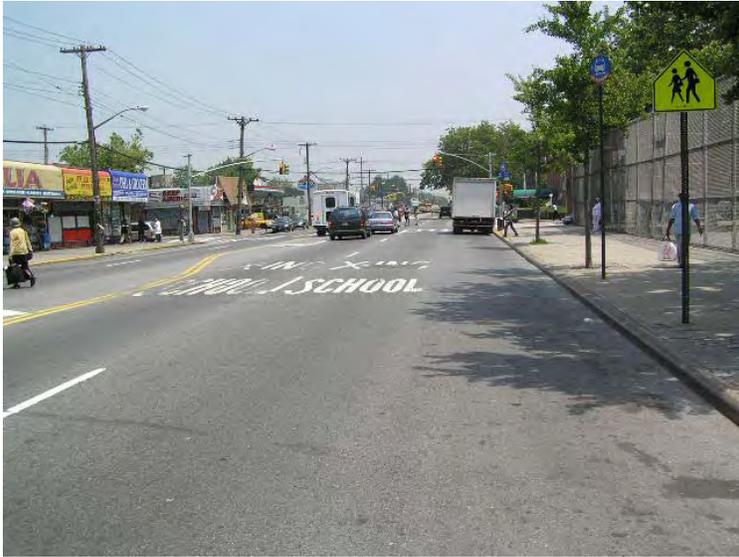
This is a signalized intersection. Flatlands Avenue is a heavily traveled two-way street with two travel lanes in each direction and parking on both sides. Parking is not allowed on Flatlands Avenue between East 81<sup>st</sup> and East 82<sup>nd</sup> Streets due to MTA bus stops. School crosswalks are in place on the east, west, and south legs.

*Figure 5: Looking east at East 82<sup>nd</sup> Street on Flatlands Avenue*

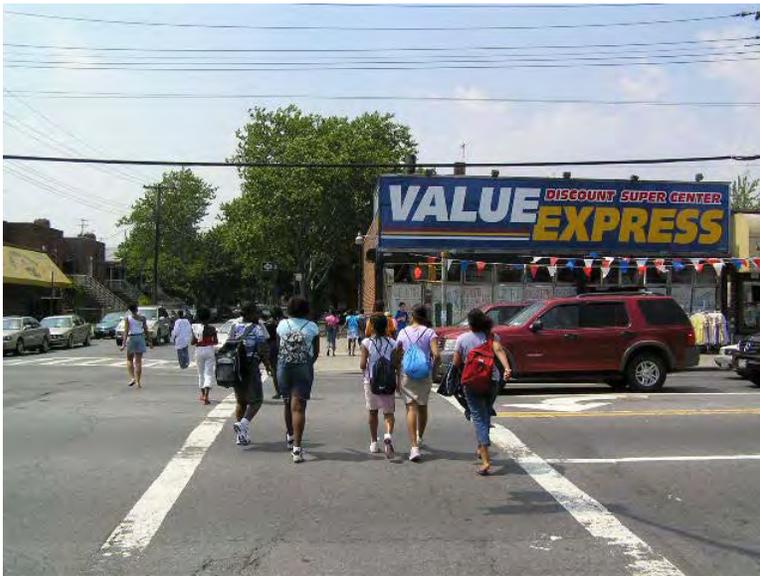
The school principal noted that students did not have enough time to cross Flatlands Avenue at this intersection. However, analysis of the signal timing on Flatlands Avenue determined that there is adequate time for students to cross (see Table 4).

*Figure 6: Students crossing Flatlands Avenue at East 82<sup>nd</sup> Street against the pedestrian signal*

In addition, it is also recommended that the school participate in the NYCDOT Safety Education Program work with the school to educate students on pedestrian safety, including crossing the street with the WALK phase, and the meaning of WALK - FLASHING DON’T WALK - DON’T WALK pedestrian signal sequence. It is also recommended that the students be educated not to cross at mid-block locations.

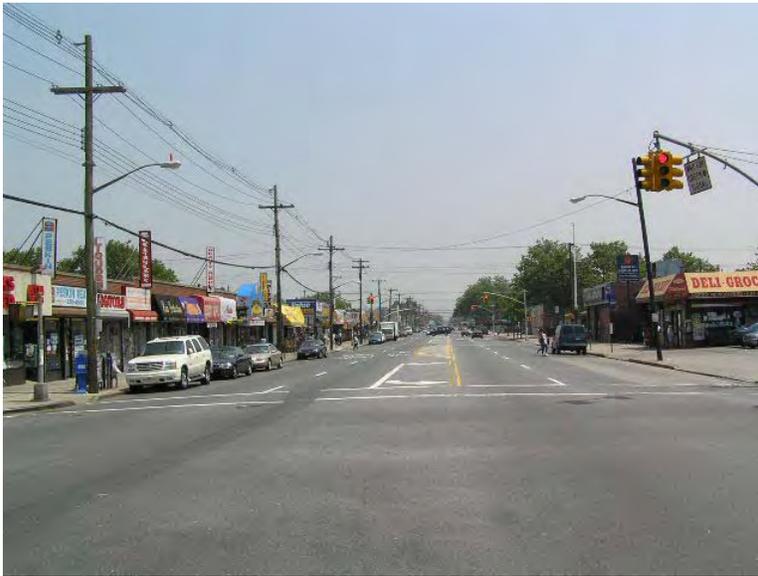
At this signalized intersection, there are exclusive left turn lanes on both sides of Flatlands Avenue for vehicles turning onto East 80<sup>th</sup> Street. School crosswalks are in place on the south and east legs of the intersection.

84 accidents occurred at this intersection during the 1998-2000 study period. Ten of these accidents involved pedestrians, three of which were school related. Seven accidents, including two school-related accidents occurred due to driver's failure to yield. Another accident involved a pedestrian crossing against the signal. There was no detailed information for the last two accidents.

*Figure 7: Looking east on Flatlands Avenue, from East 80<sup>th</sup> Street*

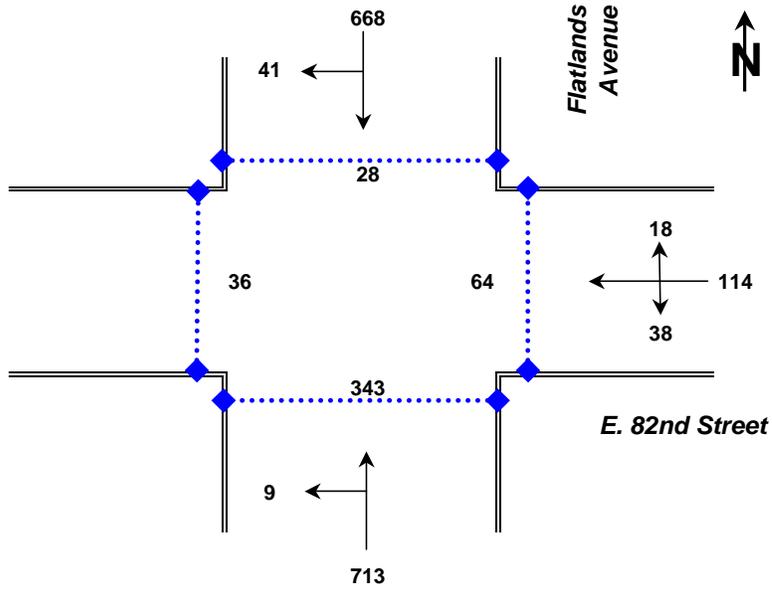
<b>EXHIBIT 7</b>
<b>I.S. 68</b>
<b>TURNING MOVEMENT COUNTS</b>

Traffic counts were performed on Monday, December 9, 2004 to better understand the pedestrian and vehicle conflicts at the intersection (see Figure 7). The counts show that 343 pedestrians utilized the school crosswalk on the south leg across Flatlands Avenue, with a minimal number of turning vehicle-pedestrian conflicts (38). See Exhibit 7 for the details.

**One Hour Traffic Count Volumes**  
 (7:30 AM - 8:30 AM December 9, 2004)

**Intersection of East 82nd Street and Flatlands Avenue**

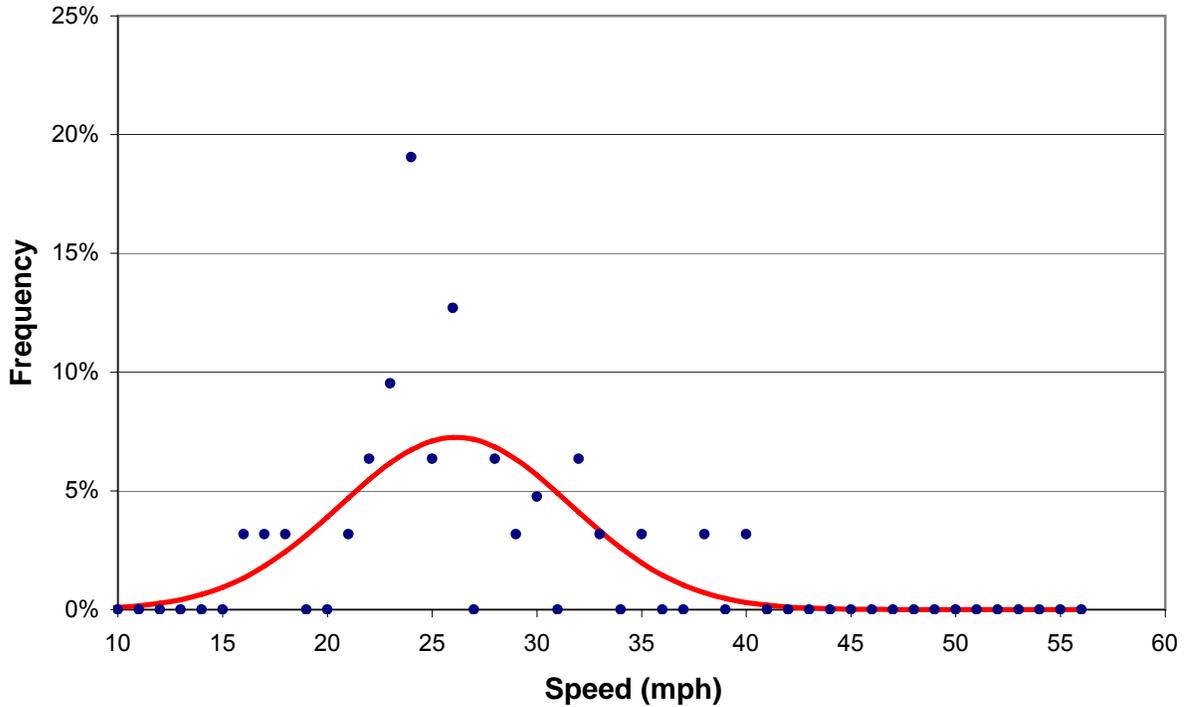
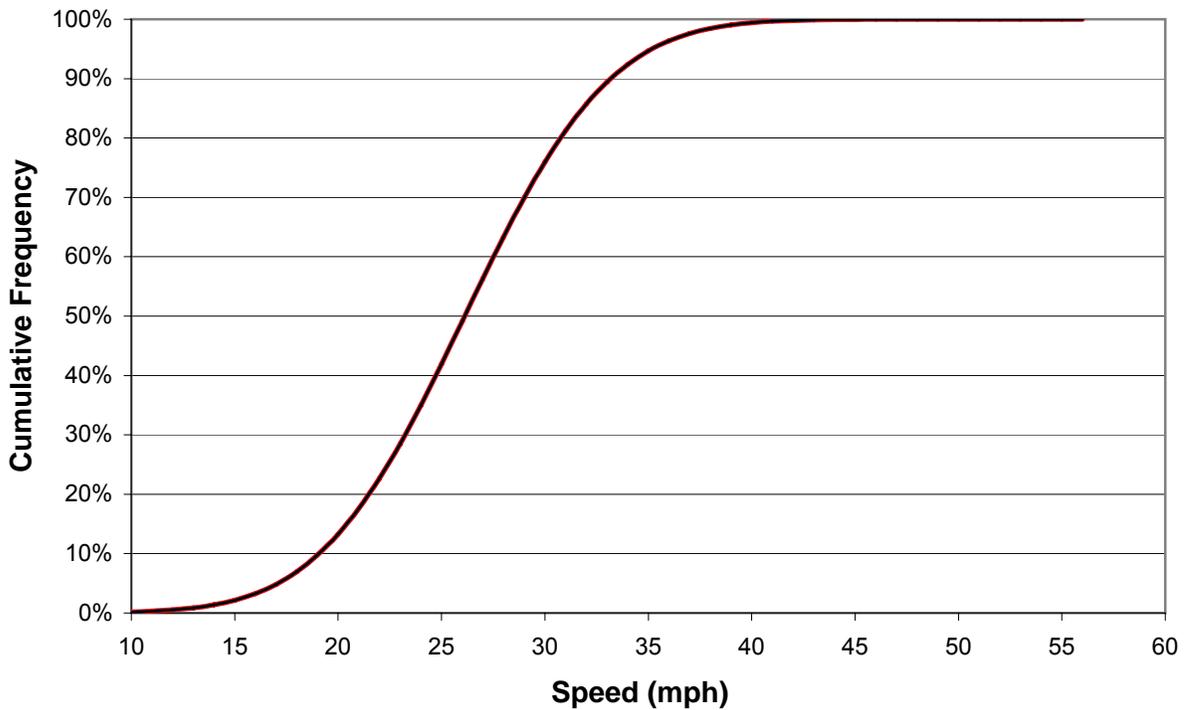
# SPOT SPEED STUDY

The school officials indicated that vehicles were speeding on Avenue J. In response, a spot speed study was conducted on August 9, 2005, between 1:00 pm - 2:00 pm. The spot speed study confirmed that the 85<sup>th</sup> percentile speed was 32 mph, which exceeds the statutory speed limit of 30 mph. See Table 5 for a summary of the results and the Appendix for further detail. Although 85 percentile speeds were above 30 mph, speed reducers (humps) are not feasible for this location since this is an arterial roadway.

Mean Speed = 26.1 mph                      Median Speed = 26.1 mph  
 Standard Deviation = 5.5 mph              15th Percentile Speed = 20.4 mph  
 Margin of Error (95% Confidence) = ± 1.4 mph      85th Percentile Speed = 31.8 mph

As an alternative, it is recommended that a striped center median be painted on Avenue J as shown in Exhibit 8. A striped center median will promote reduced speeds by narrowing the effective width of the moving lanes. By using striping instead of a raised median, the additional width is still available for emergency and other service vehicles.
