**New York City Department of Transportation
Office of School Safety Engineering**

School Safety Engineering Project

FINAL REPORT: P.S. 21 (Philip H. Sheridan School), Bronx

**Prepared by
The RBA Group/Urbitran Associates**

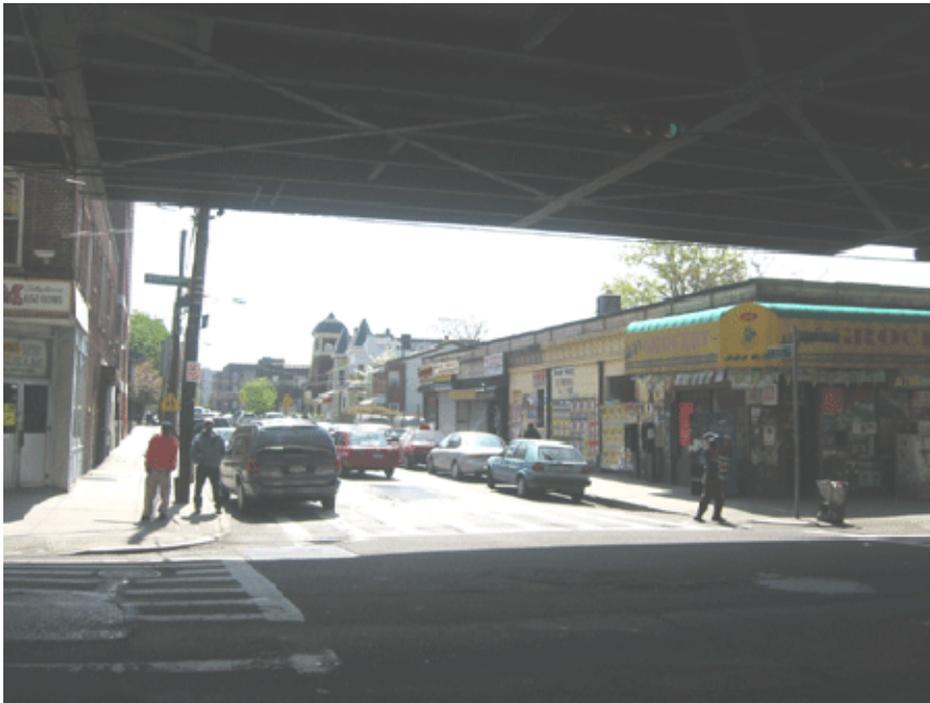
Figure 1: Looking east on East 225th Street across White Plains Road

In addition to a deli on the northeast corner of East 225th Street and White Plains Road (see Figure 1), there is continuous commercial activity located along White Plains Road just west of the school (see Figure 3). In addition, there are various stores and restaurants along White Plains Road that generate pedestrian and vehicular traffic in the vicinity of the school. A park is also located on the same block as the school, immediately adjacent to the schoolyard to the east.

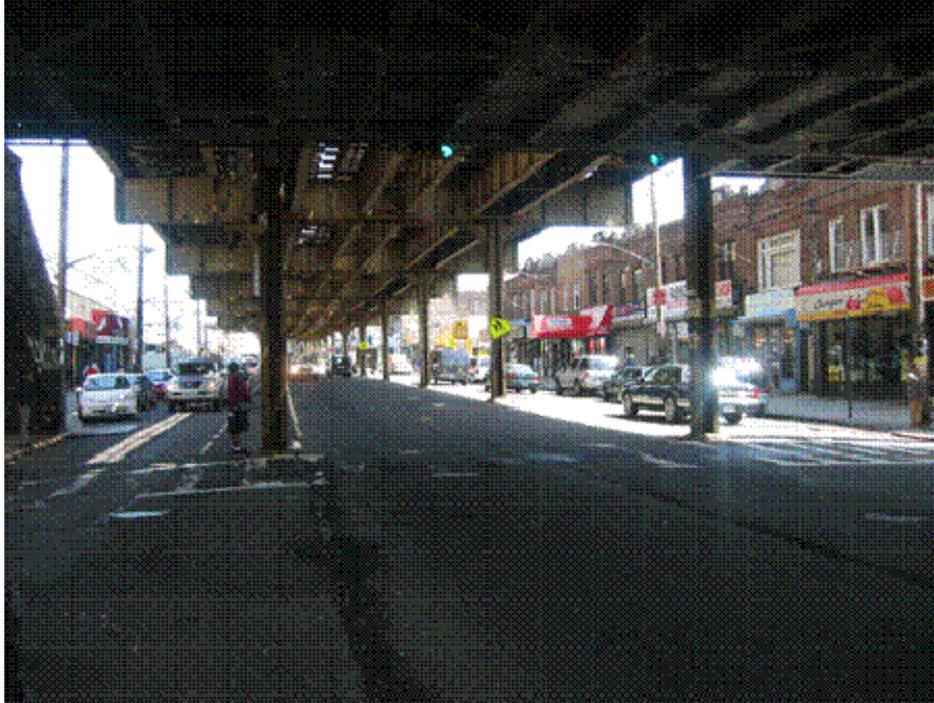
Figure 3: Looking north along White Plains Road, showing stores adjacent to P.S. 21

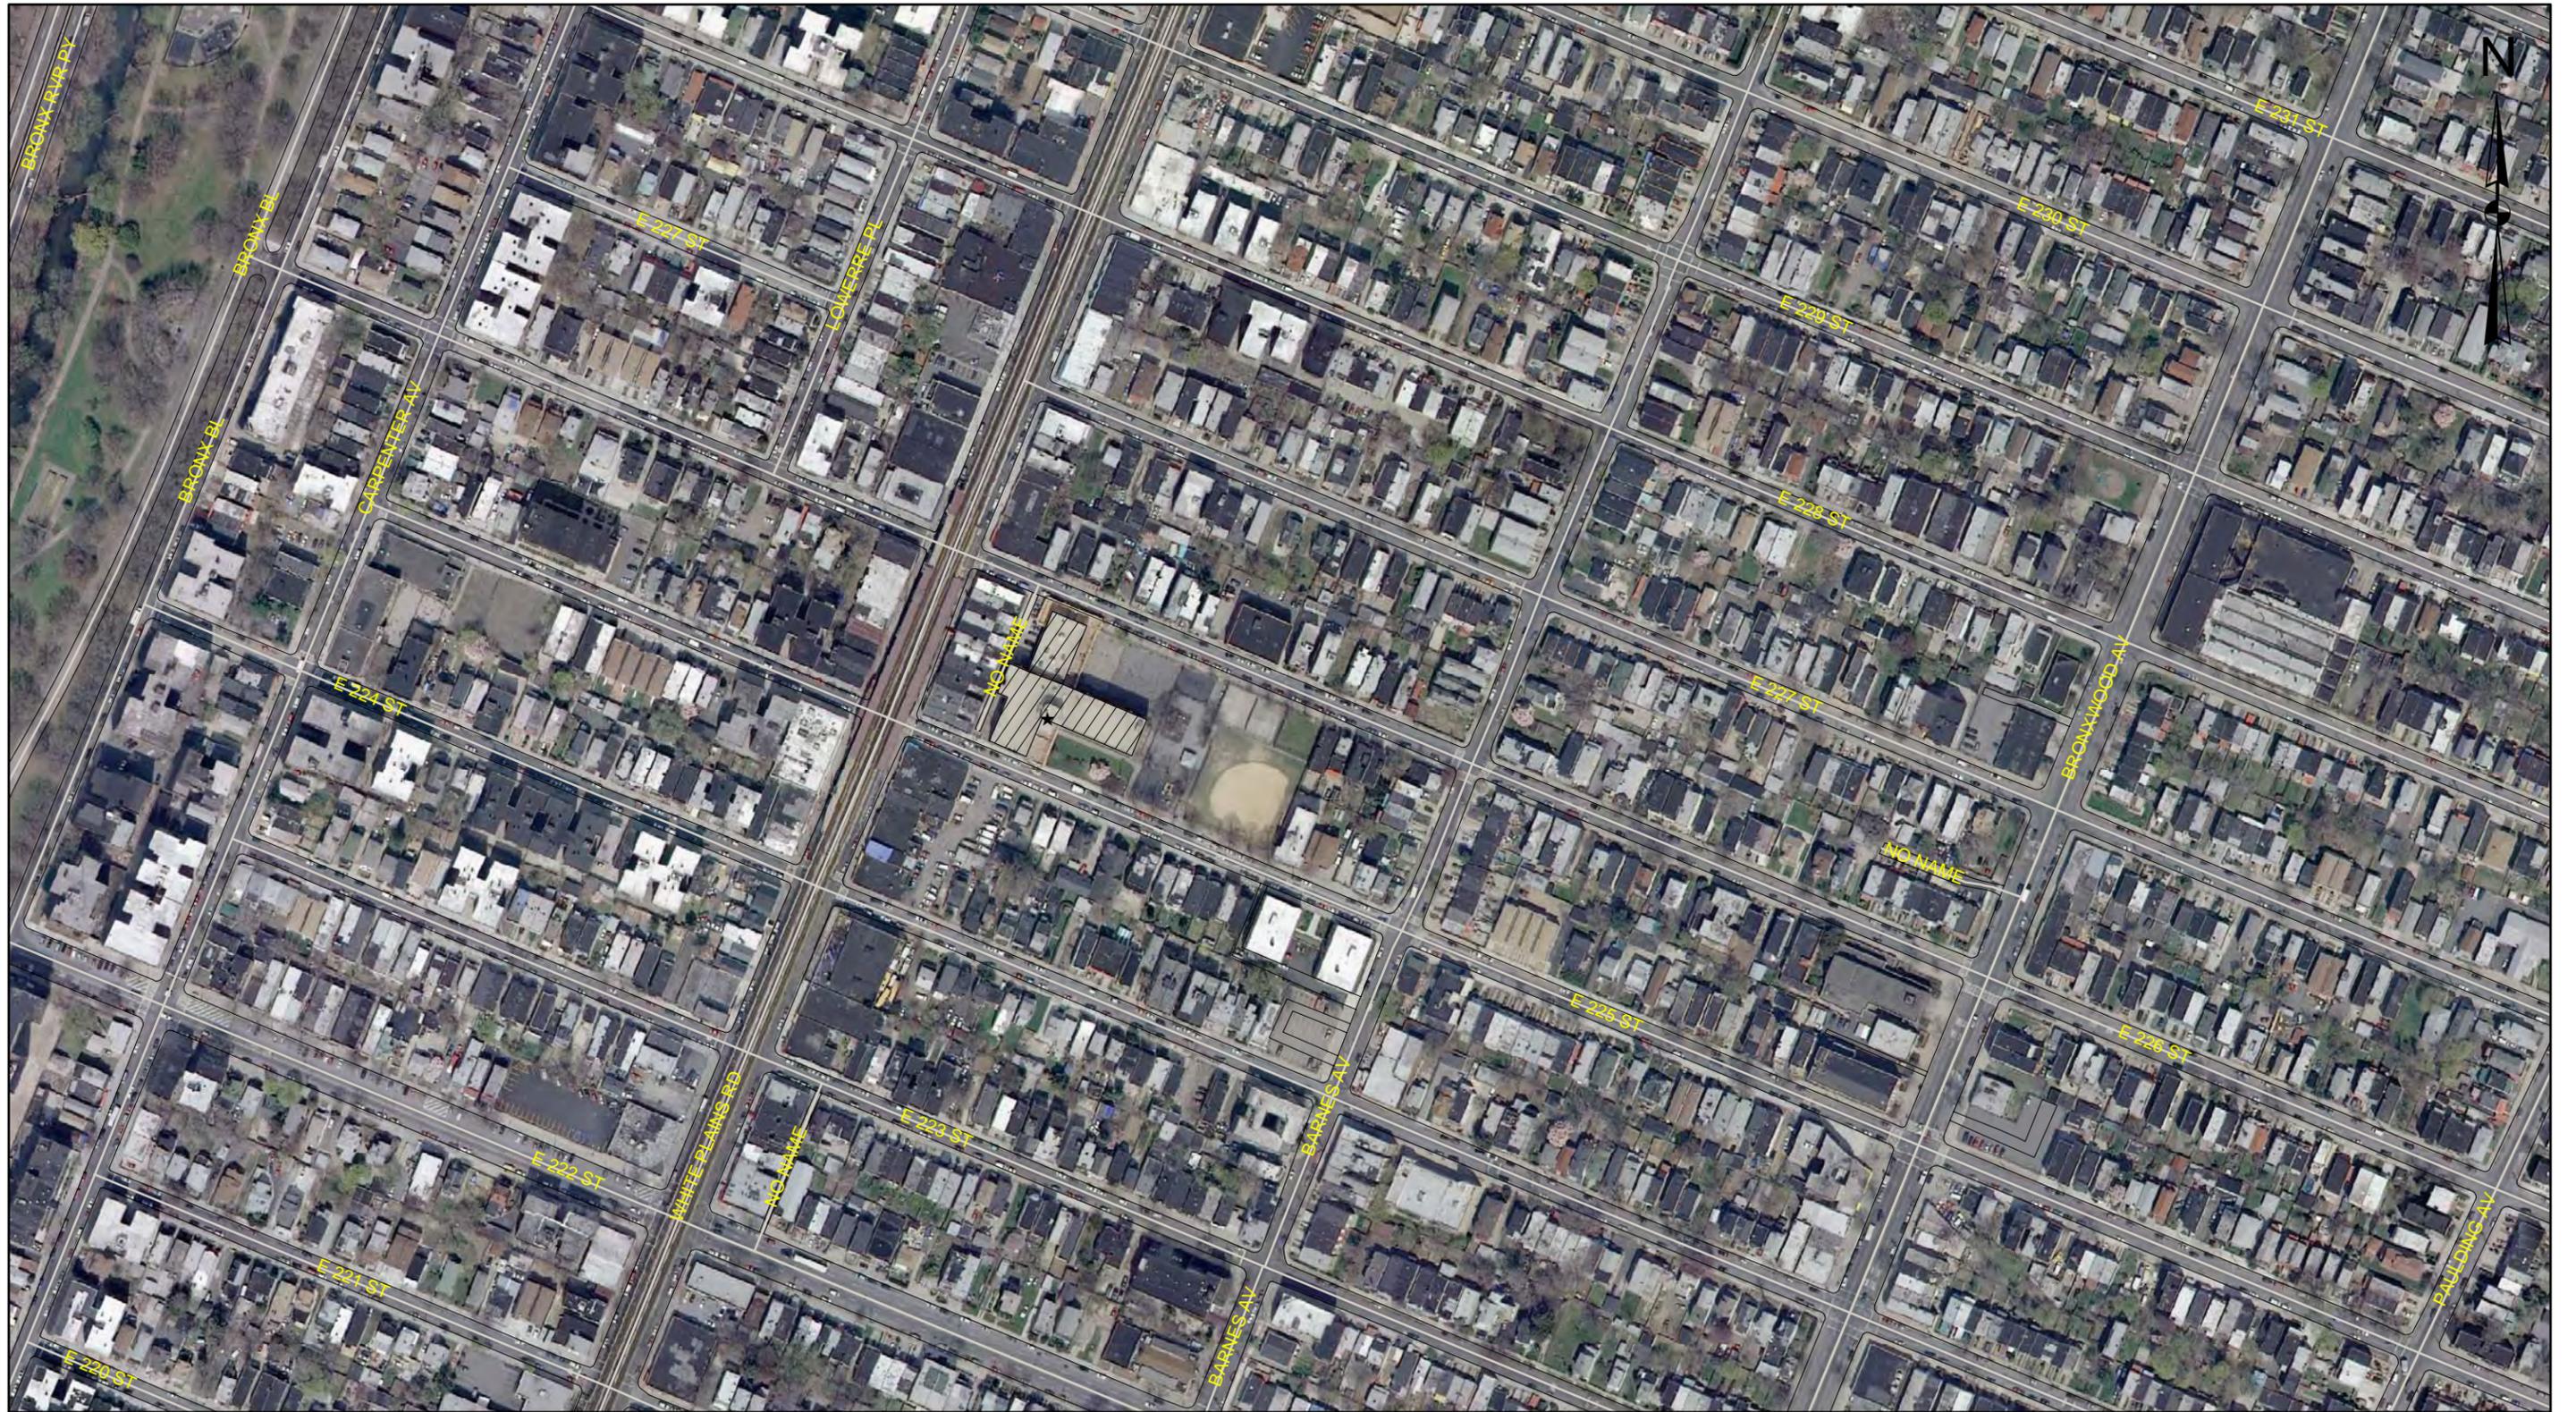
EXHIBIT 1
P.S. 21 BRONX
PHILIP H. SHERIDAN SCHOOL
AERIAL PHOTOGRAPH

Exhibit 1 shows an aerial view of the neighborhood surrounding the school. P.S. 21 is bounded by White Plains Road to the west, East 226th Street to the north, Barnes Avenue to the east, and East 225th Street to the south. The area surrounding the school is primarily residential in character, with a mix of one- and two-family residences and medium- to high-density apartment buildings. White Plains Road has commercial uses and carries significant traffic volumes. A park is adjacent to the schoolyard to the east.

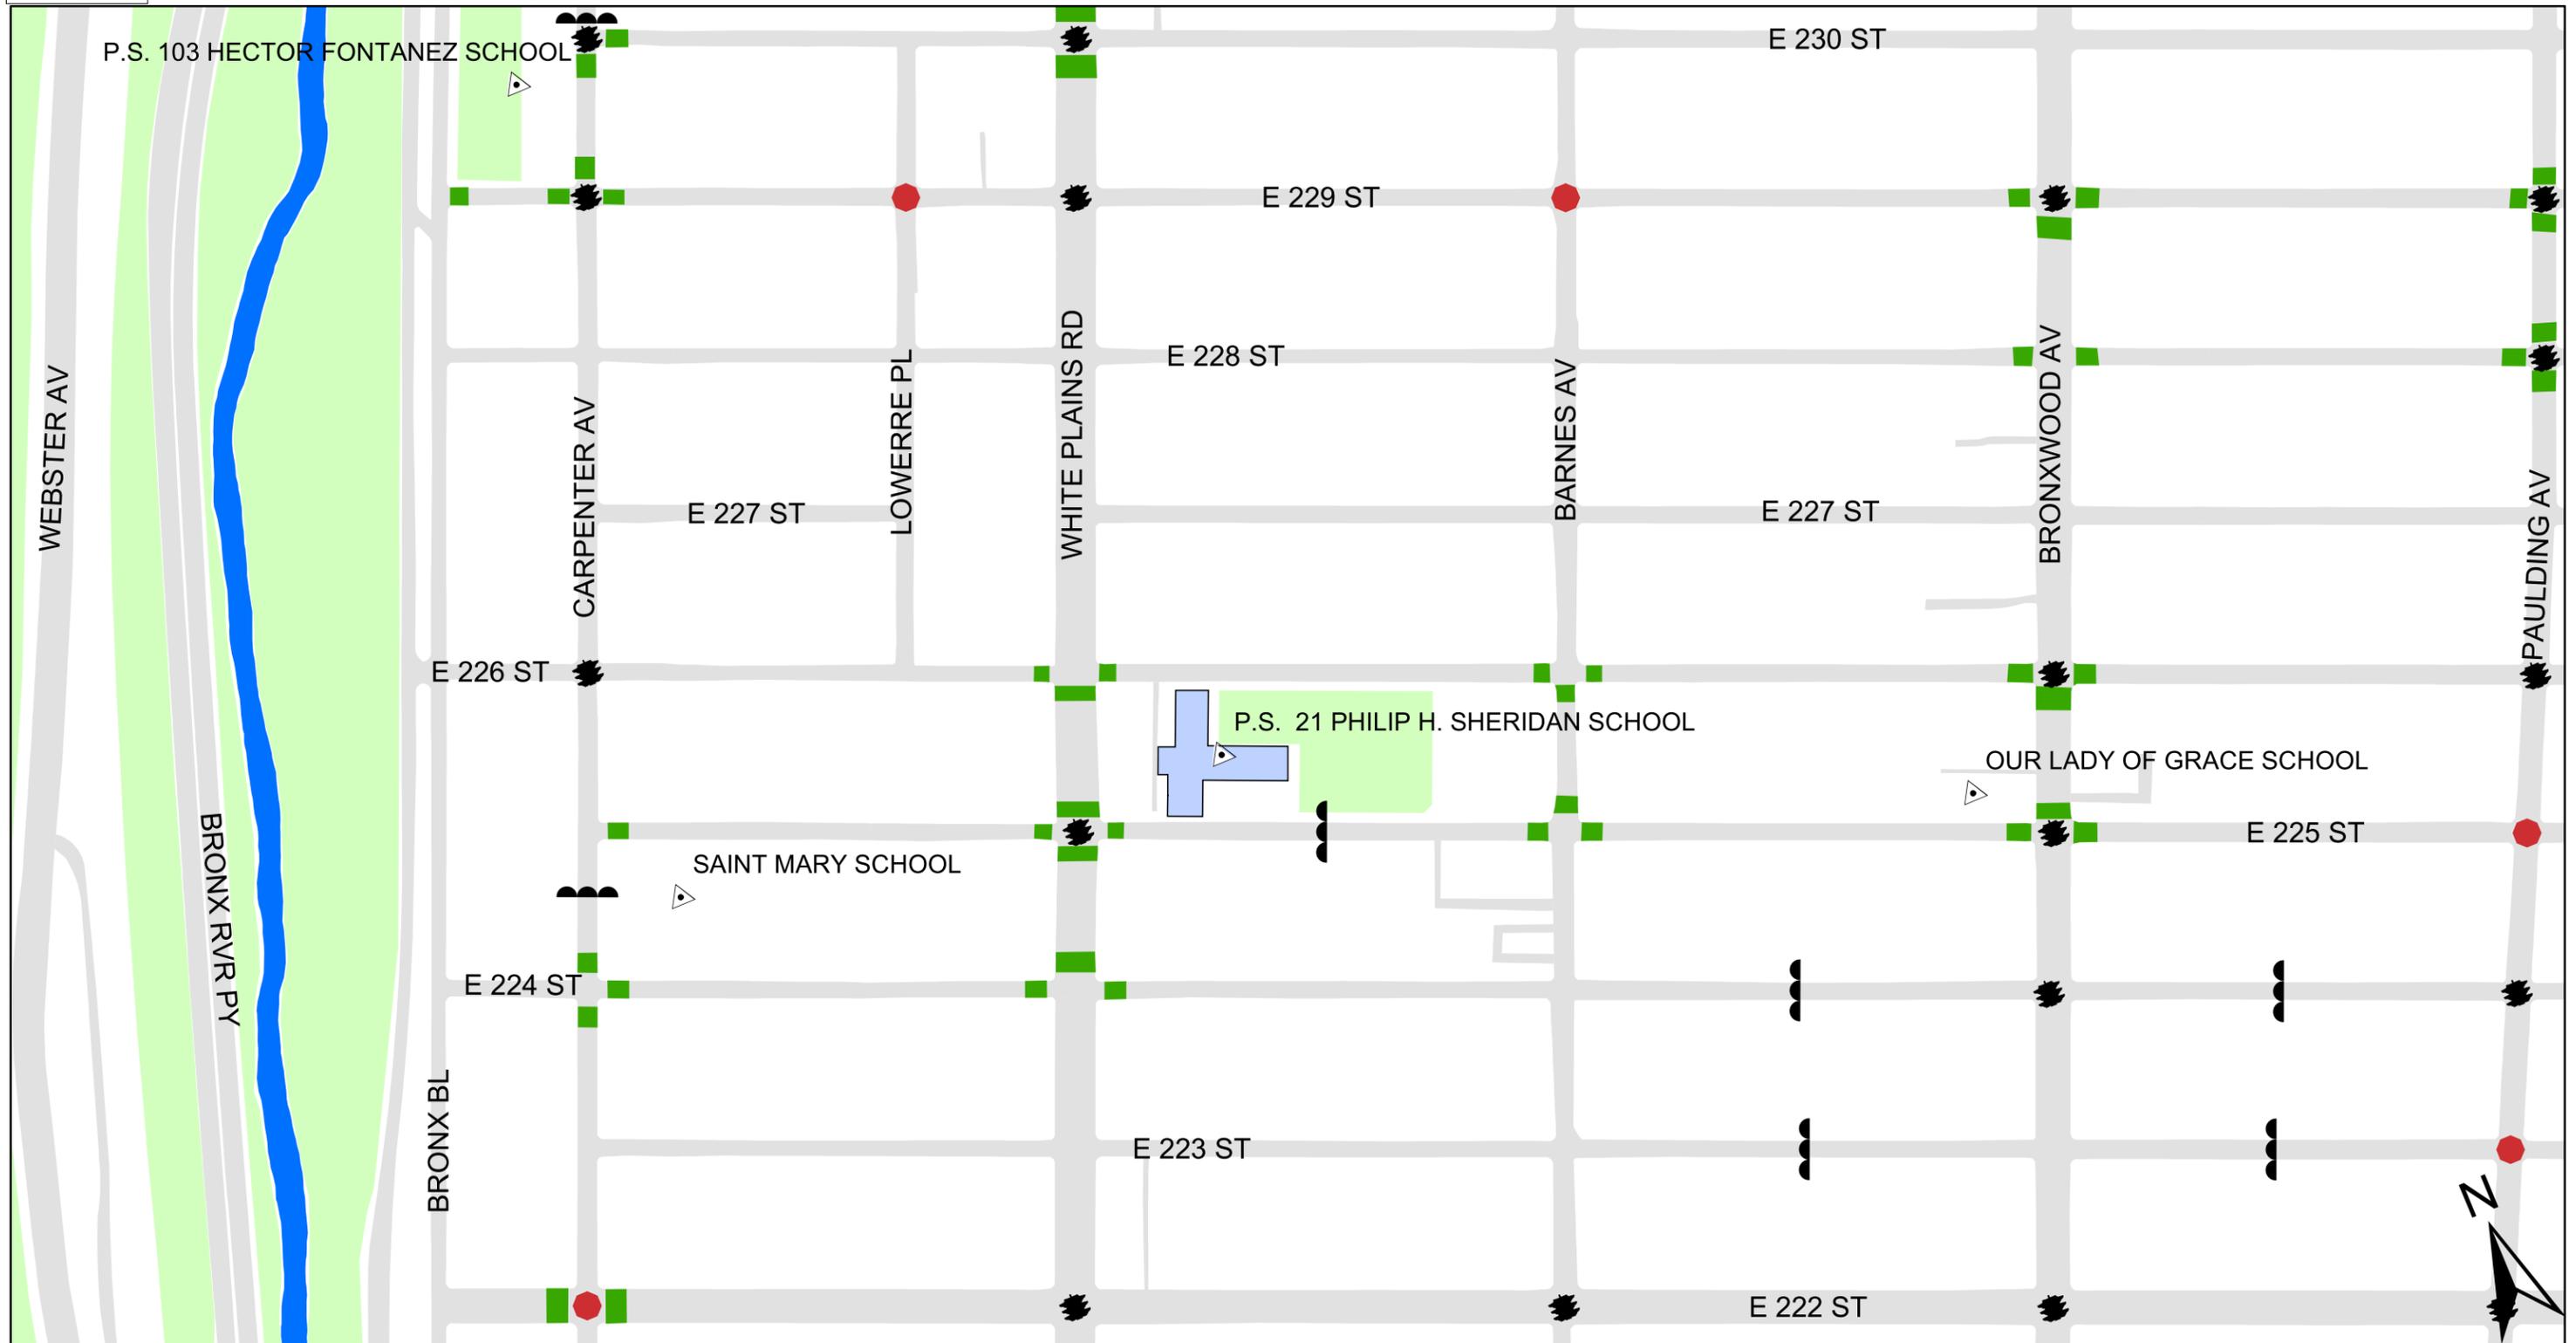
EXHIBIT 3

Exhibit 3 shows the existing school signals and pavement markings around P.S. 21. It should be noted that a citywide signage program is currently underway to upgrade school signage to current Federal Manual on Uniform Traffic Control Devices (MUTCD) standards of fluorescent yellow-green signs accompanied by downward pointing arrows. (Signs scheduled to be installed under this program are shown as “existing” in Exhibit 8.)

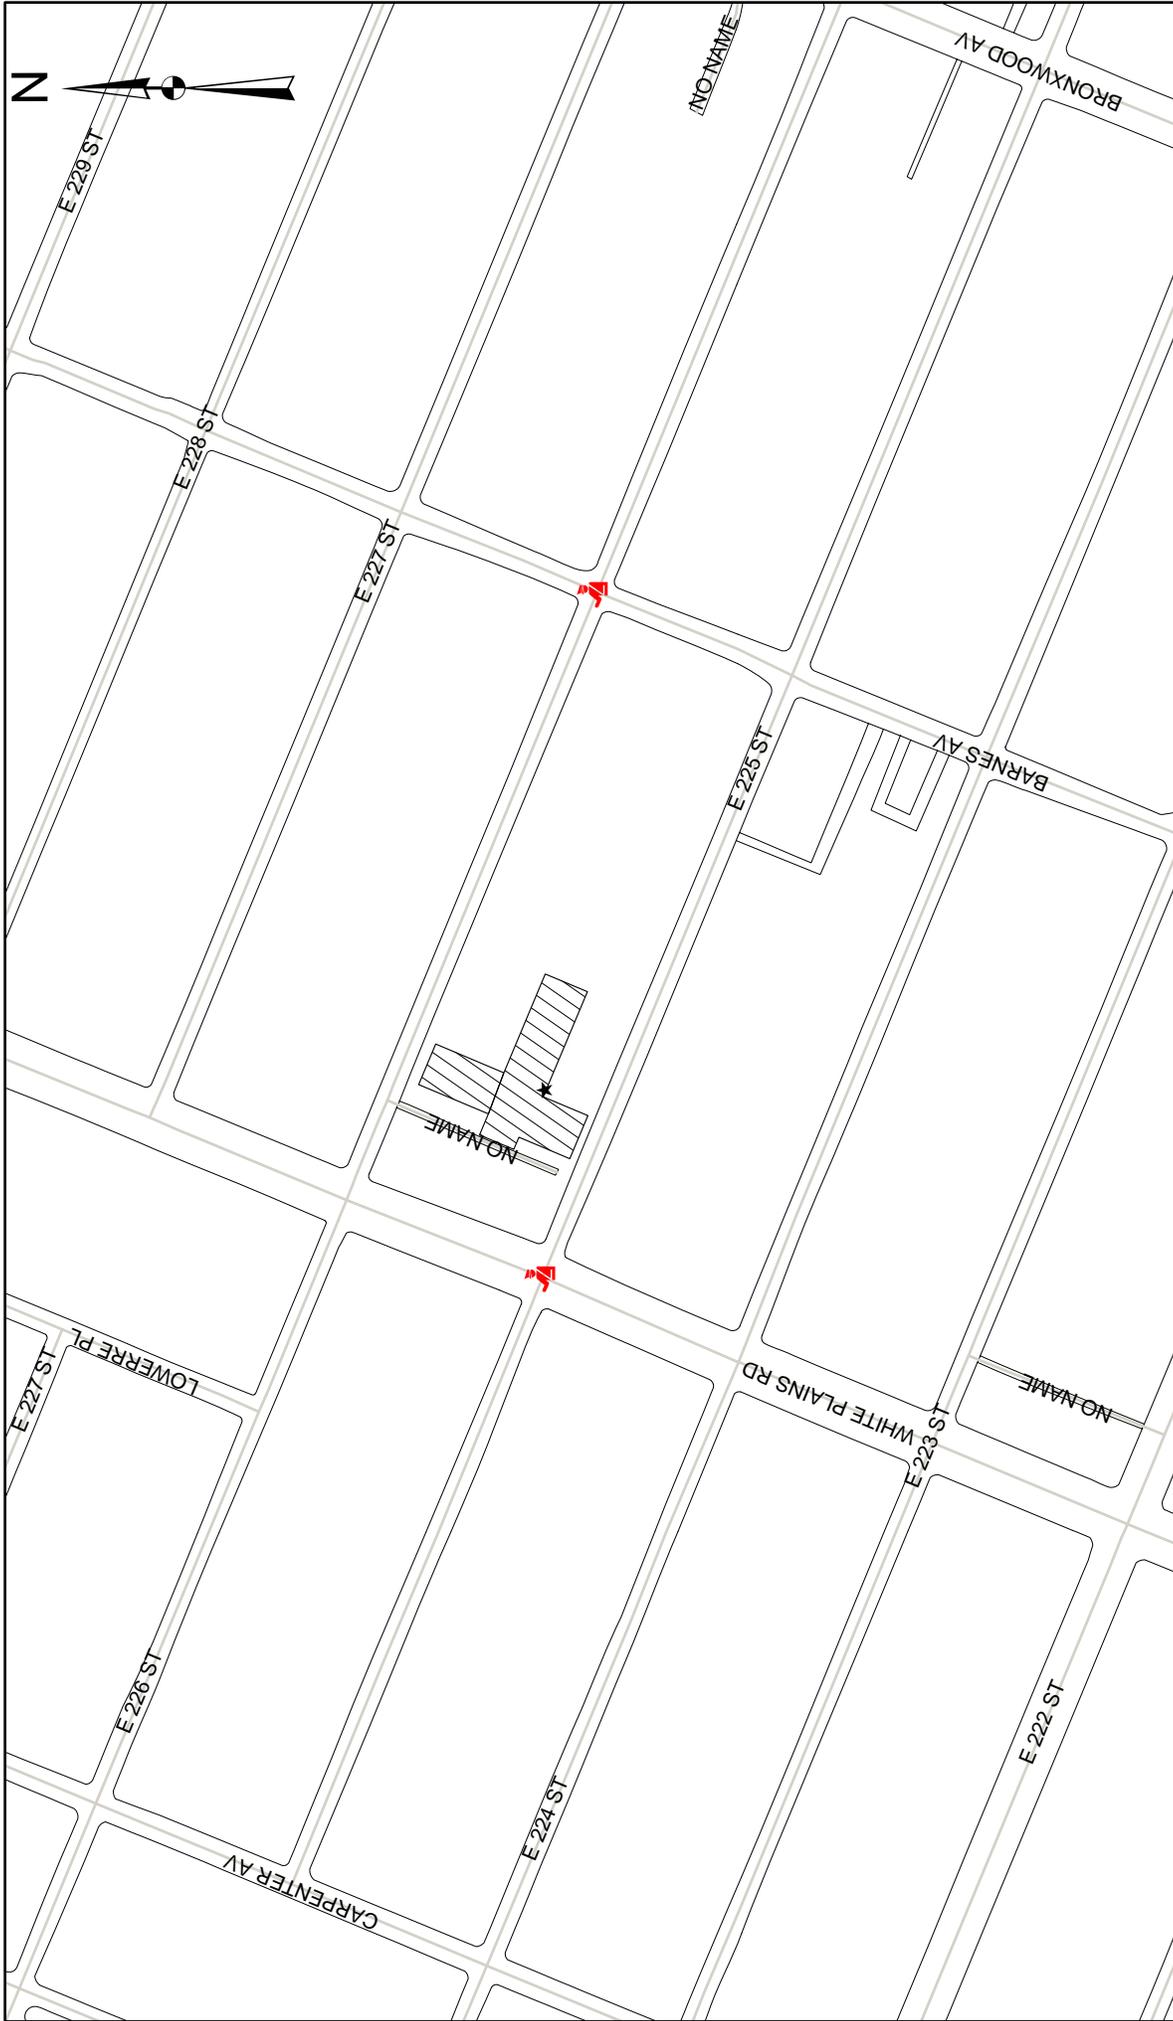
EXHIBIT 4
P.S. 21 BRONX
PHILIP H. SHERIDAN SCHOOL
CROSSING GUARDS LOCATIONS

According to the school principal, there are two crossing guards assigned to P.S. 21. They are situated at the following locations:

- East 225th Street and White Plains Road
- East 226th Street and Barnes Avenue

The crossing guard locations are shown in Exhibit 4.

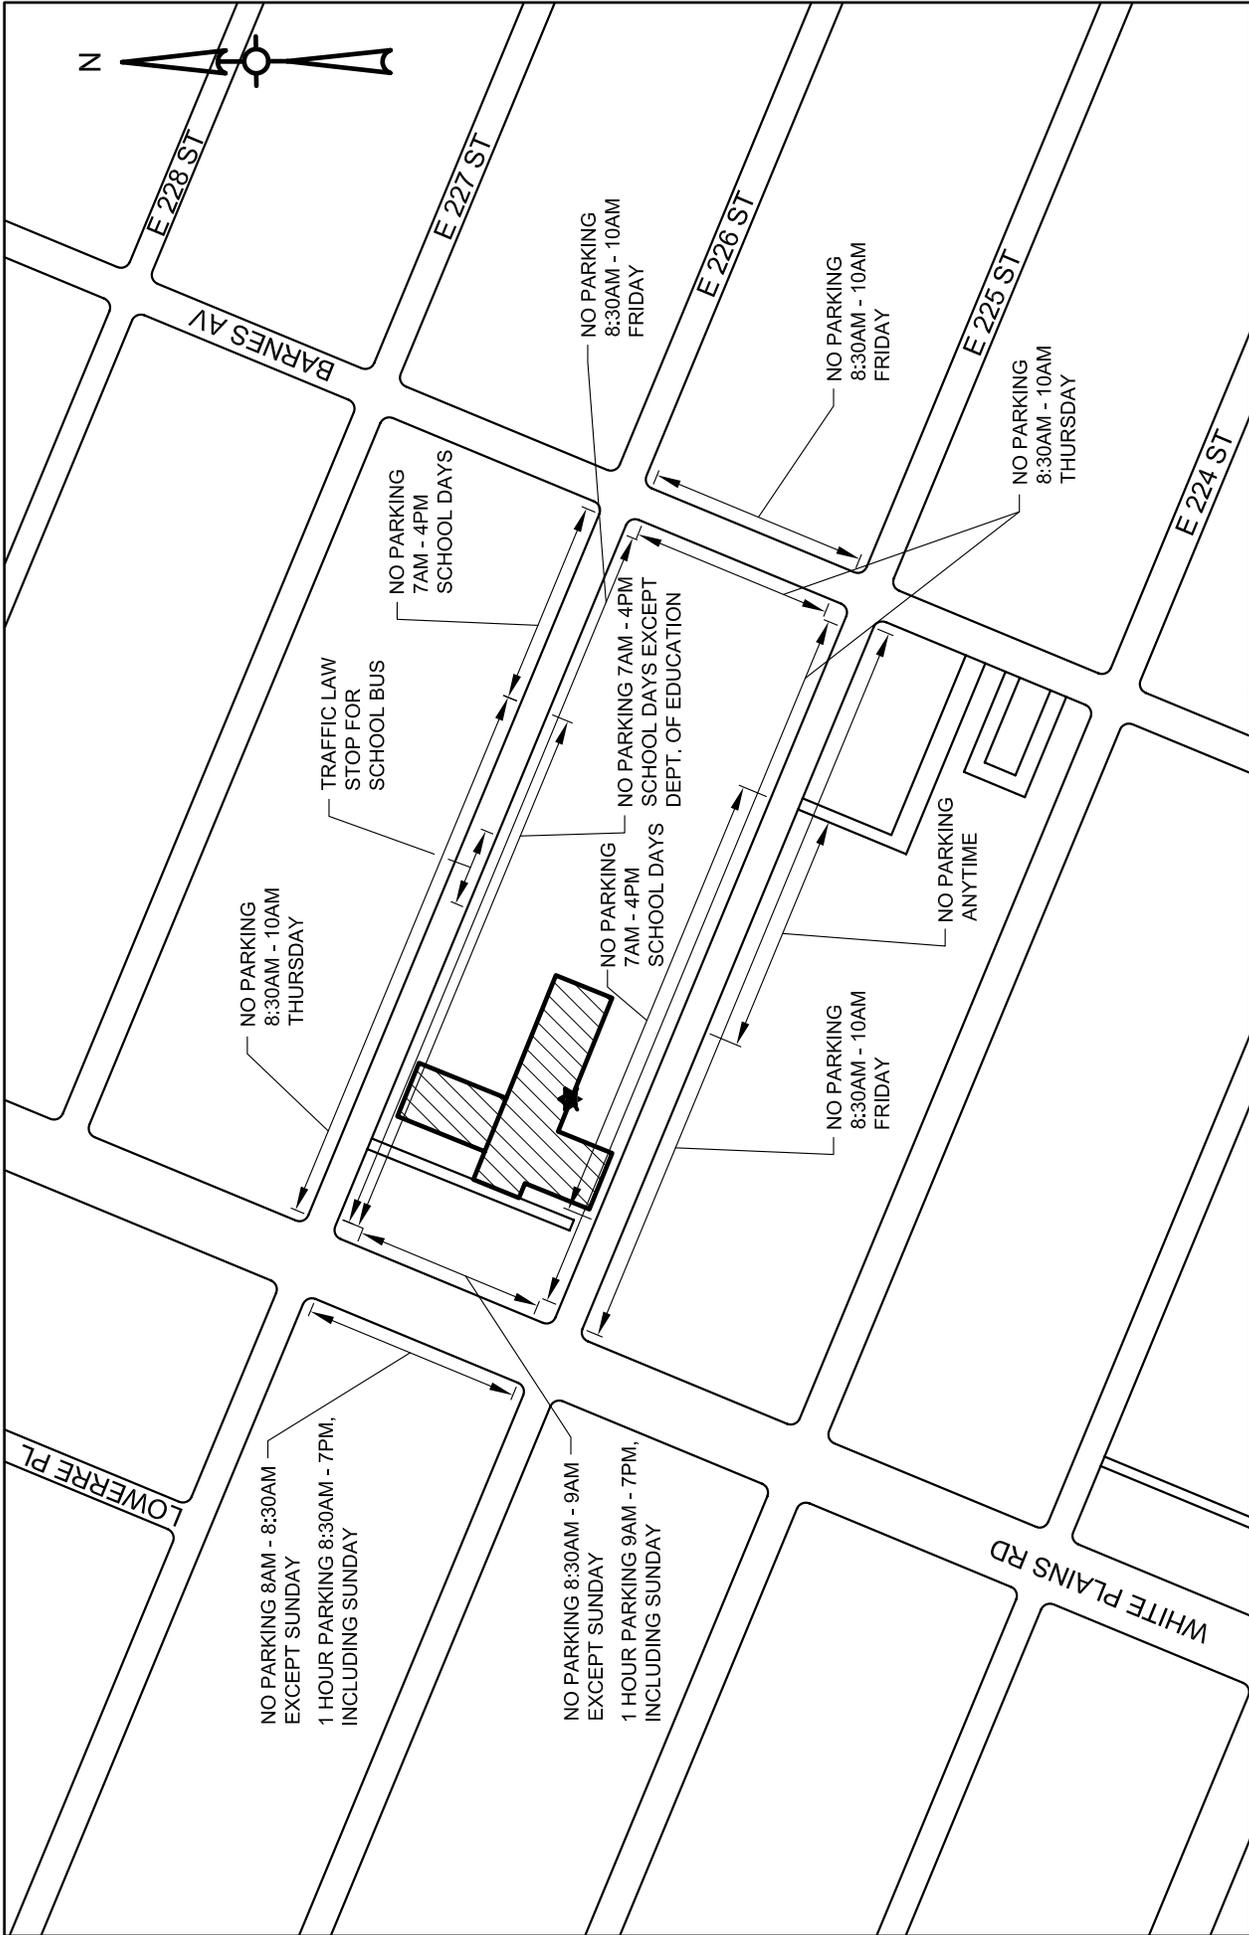
EXHIBIT 5

Parking regulations around the school block are shown in Exhibit 5.

EXISTING PARKING REGULATIONS

Replace the existing “NO PARKING 7AM – 4PM SCHOOL DAYS” signs with “NO STANDING 7AM – 4 PM SCHOOL DAYS” signs or a distance of 240 feet in front of the school main entrance to accommodate the seven school yellow buses. (This is a typical requirement for all NYC schools in order to provide for emergency access to and from the school.)

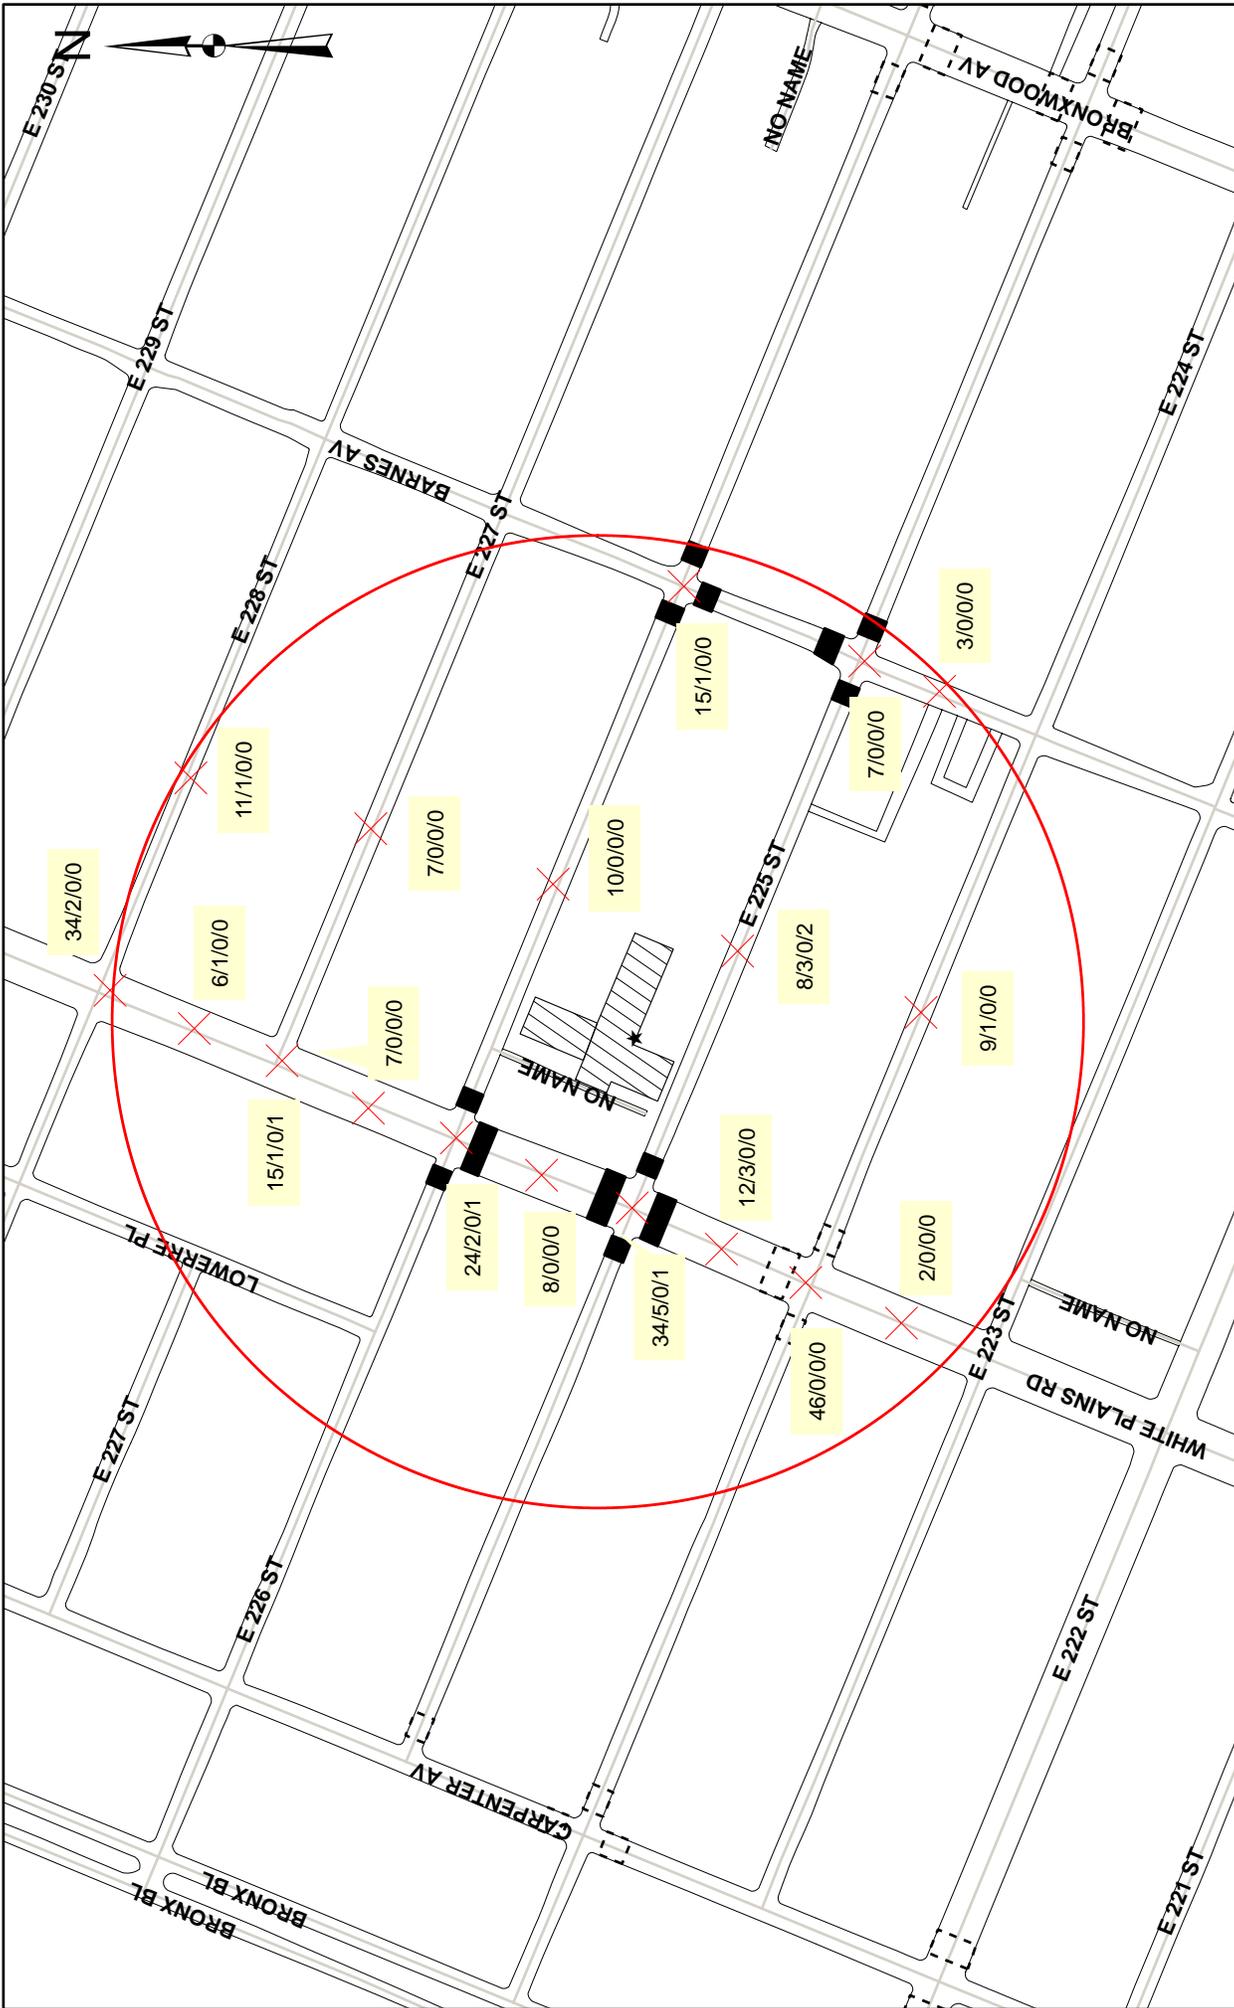
EXHIBIT 6

Exhibit 6 and Table 2 show a summary of accidents, as obtained from the New York State Department of Motor Vehicles (DMV), in the vicinity of P.S. 21 for the three-year period from January 1, 1998 through December 31, 2000. The DMV data provides some detail relating to the circumstances and cause of the accident. Table 3 is a summary of more recent accident data obtained from the NYC Police Department (NYPD). Though current through 2004, the NYPD data does not provide the same level of detail as the DMV data.

ACCIDENT SUMMARY (1998-2000)

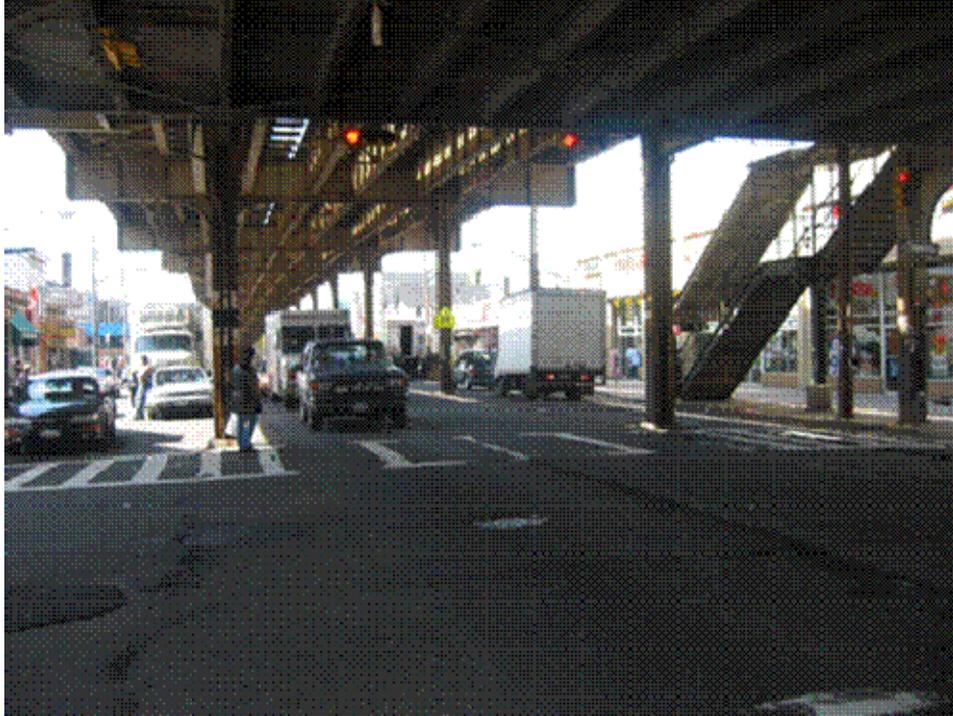
This is a signalized intersection, with school crosswalks located across all four legs. East 225th Street is a one-way eastbound street with one travel lane and parking on both sides of the roadway. White Plains Road is a two-way street with two travel lanes and a parking lane on each side of the roadway. White Plains Road also has an elevated train running over the center of the roadway. The supports for the train are located so that they provide an inner and an outer lane for each direction of travel (see Figures 3 and 5). There is a station for the trains located at this intersection.

Figure 4: Looking south along White Plains Road across East 225th Street

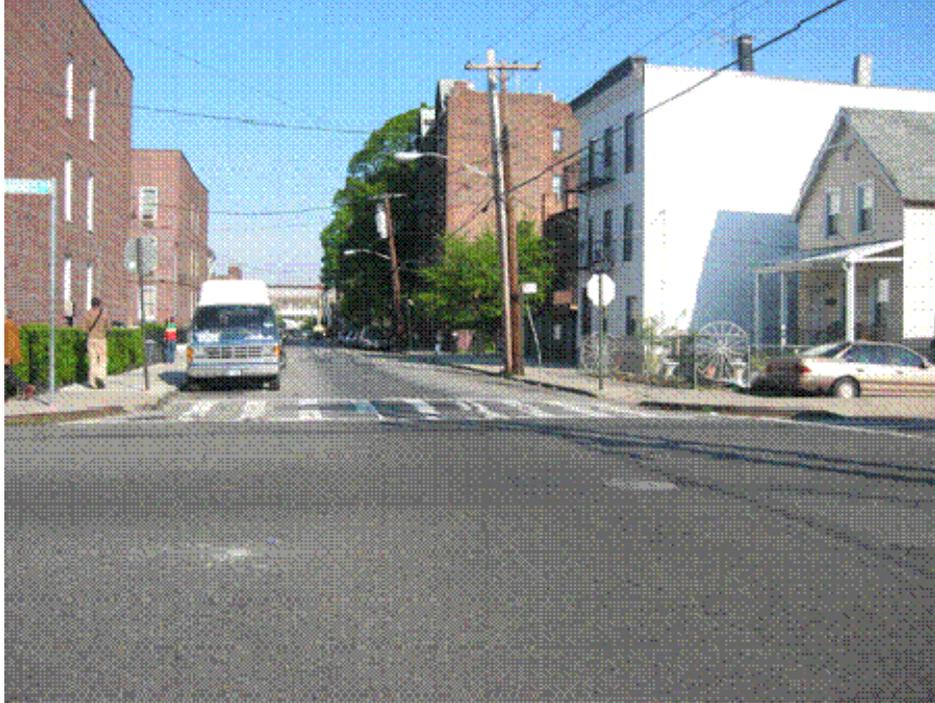
Figure 6: Looking west along East 225th Street across Barnes Avenue

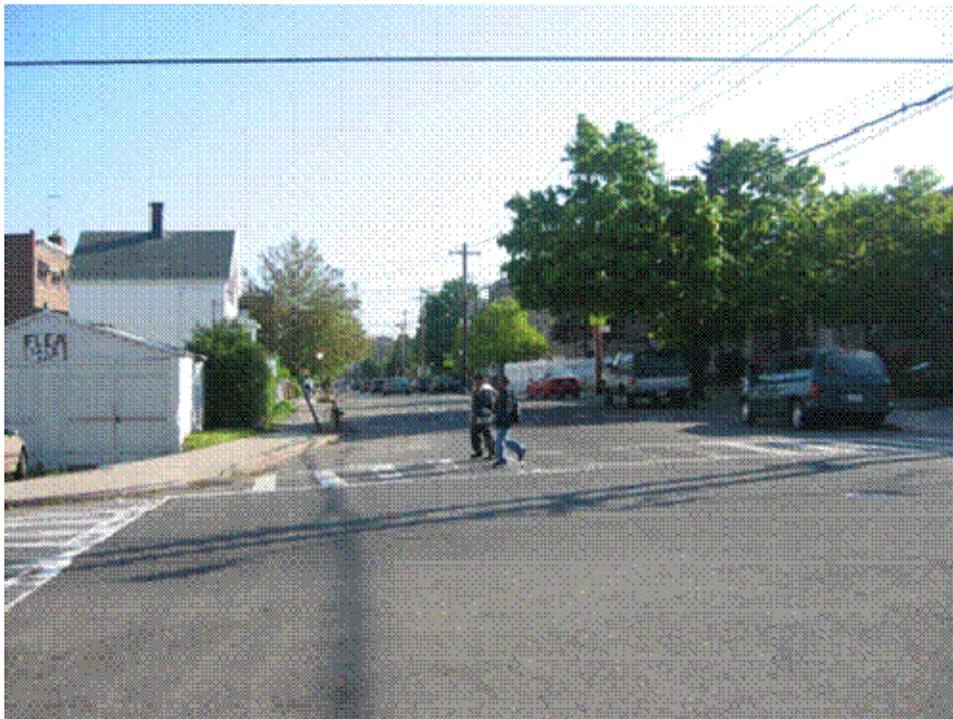
There is an uncontrolled school crosswalk across the north leg of Barnes Avenue at the intersection with East 225th Street. In order to determine the appropriate traffic control for

the school crosswalks, a preliminary traffic signal warrant assessment was performed to assess the traffic situation and determine what type of traffic control devices would be appropriate. A traffic count was at the intersection of Barnes Avenue and East 225th Street from 8:0 to 9:00 am on Wednesday, June 8, 2005. The results of the peak hour (8:00 am to 9:00 am) count are shown in Tables 4, 5, and 6 and in Exhibit 7A at the end of this section.

Figure 7: Students crossing the north leg of Barnes Avenue and East 225th Street

P.S. 21 students were observed crossing Barnes Avenue at East 225th Street. There is crosswalk located across the north leg of Barnes Avenue, which is an uncontrolled location. A preliminary warrant study was performed to assess the situation and determine what type of control would be appropriate. This included pedestrian and vehicle counts, and a pedestrian gap study. The results of this data were inconclusive as to the installation of a traffic signal. The data is shown in Tables 4, 5 and 6 and in Exhibit 7A. The need for the crosswalk appears to exist, and we therefore recommend the following:

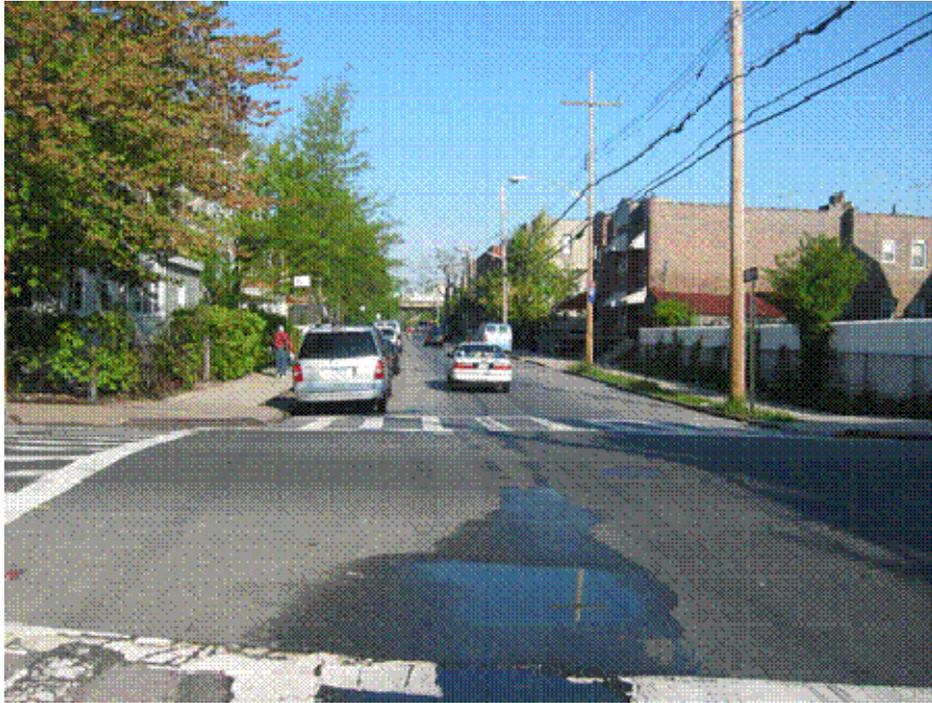
Figure 8: Looking north along Barnes Avenue across East 226th Street

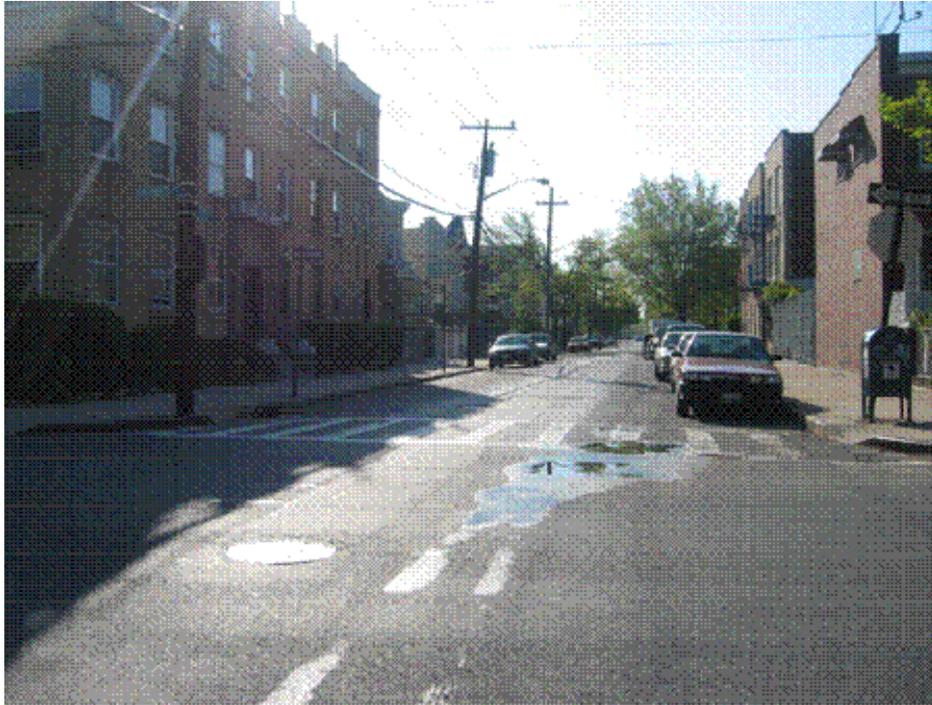
- A utility pole on the northeast corner of the East 226th Street and Barnes Avenue intersection is obstructing the crosswalk path for the crosswalk located across the east leg of East 226th Street (see Figure 10).
- The crosswalk located across the west leg of East 225th Street at Barnes Avenue is missing a pedestrian ramp on the northwest corner (see Figure 11).

Figure 9: Looking east along East 226th Street across Barnes Avenue (note pole obstruction on left)

Curb extensions (neckdowns) should be installed at the corners shown in Exhibit 8. The purpose of the curb extensions is to provide additional refuge space for pedestrians, to shorten the crossing distance for pedestrians, and to reduce the speed of vehicles approaching and turning on school crosswalks. The curb extensions will not eliminate or reduce the width of any travel lanes. Curb extensions are not proposed where they would hinder the ability of a vehicle to turn. The construction of curb extensions also includes the installation of pedestrian ramps.

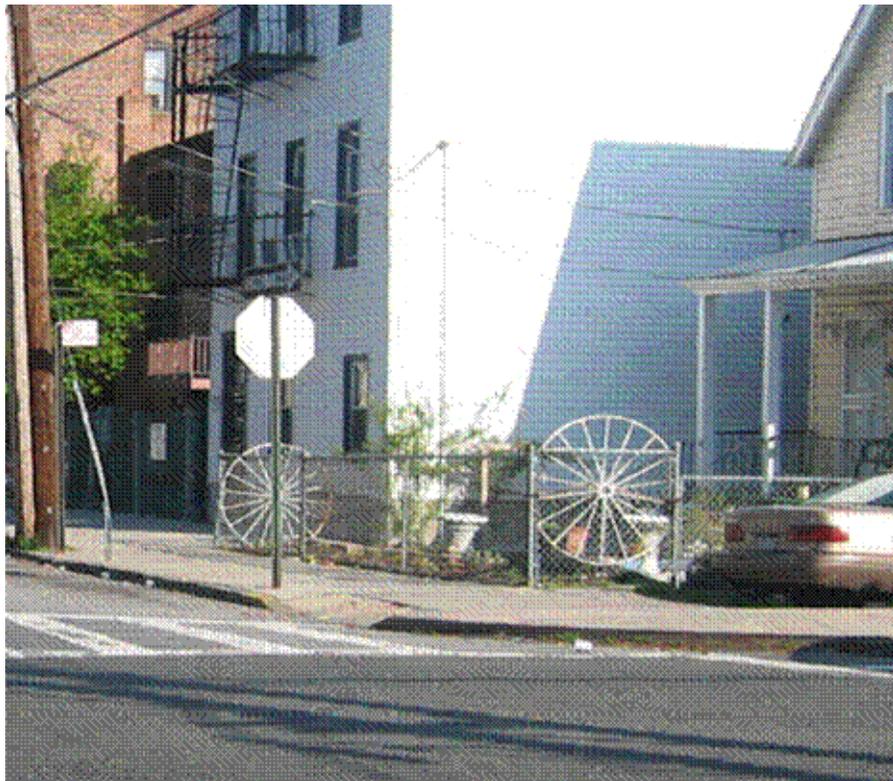
Figure 10: Looking west along East 225th Street across Barnes Avenue (note missing pedestrian ramp on right)

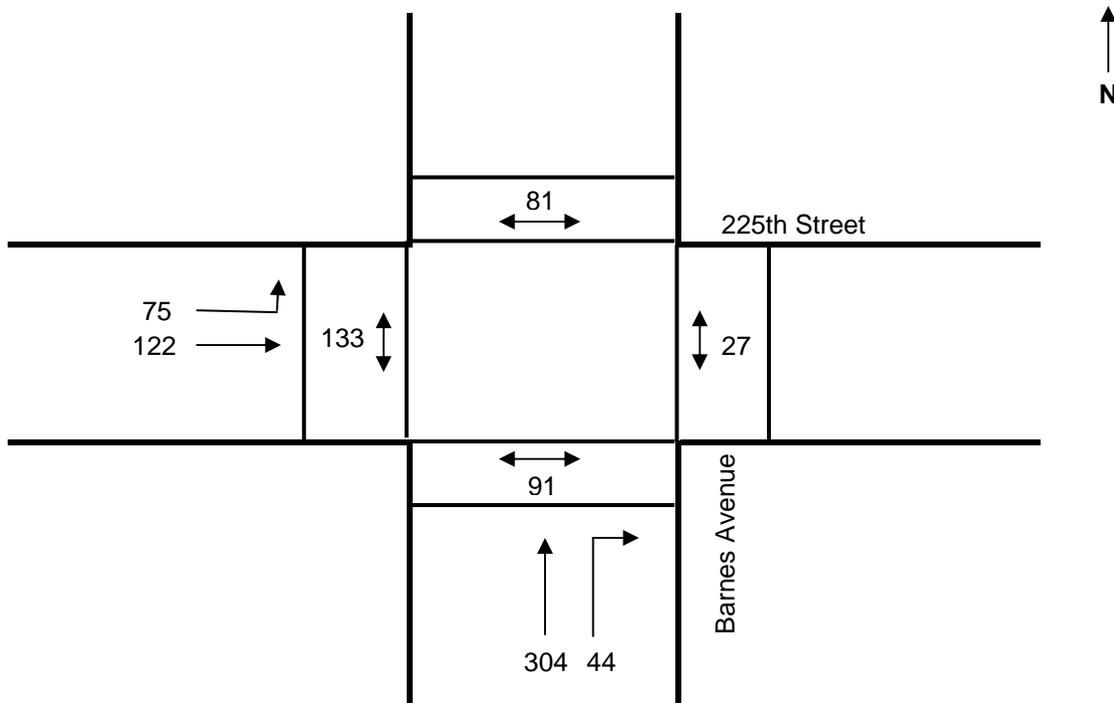
EXHIBIT 7A
P.S. 21 PHILIP H. SHERIDAN SCHOOL
TRAFFIC AND PEDESTRIAN COUNTS

One Hour Traffic Volumes
Wednesday, June 8th, 2005 8:00am - 9:00am

Intersection of 225th Street and Barnes Avenue
