**New York City Department of Transportation
Office of School Safety Engineering**

School Safety Engineering Project

FINAL REPORT: P.S. 21 (Philip H. Sheridan School), Bronx

**Prepared by
The RBA Group/Urbitran Associates**

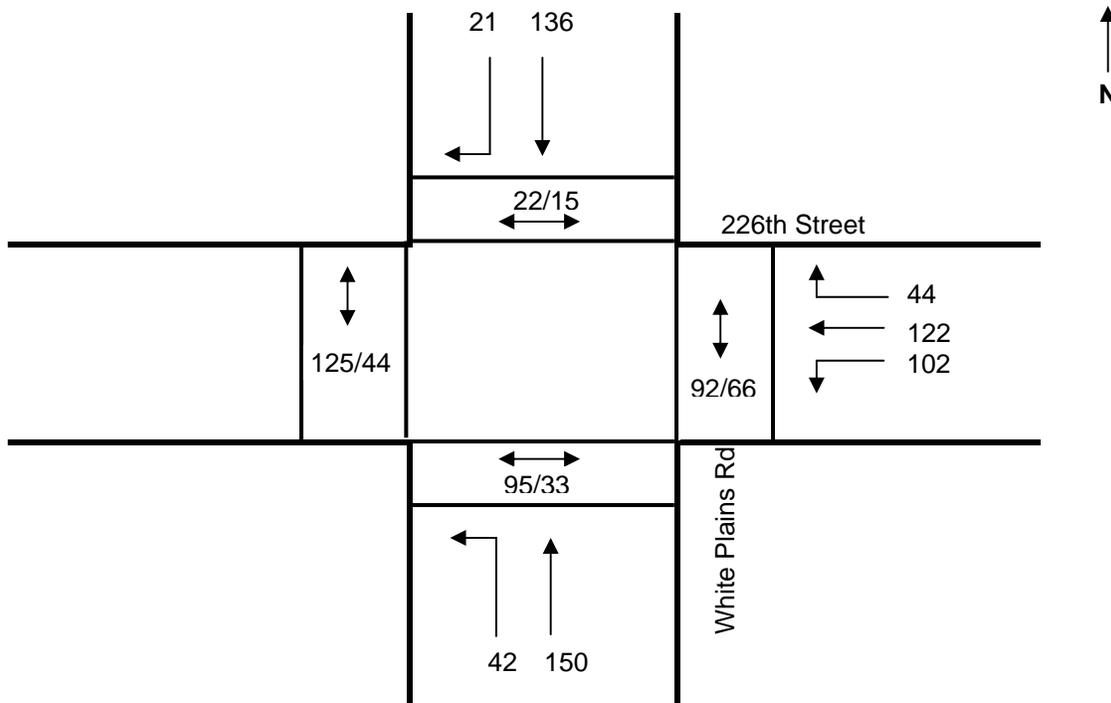
EXHIBIT 7B
P.S. 21 PHILIP H. SHERIDAN SCHOOL
TRAFFIC AND PEDESTRIAN COUNTS

There is an uncontrolled school crosswalk across the south leg of White Plains Road at the intersection with East 226th Street. In order to determine what type of traffic control device would be appropriate, vehicle and pedestrian counts were conducted at this intersection from 7:45 to 8:45 am on Thursday, January 26, 2006. The results of the vehicle and pedestrian counts are shown in Tables 7 and 8, respectively, and in Exhibit 7B at the end of this section. Tables 9 and 10 identify the results of the traffic signal warrant analysis based on the count data. It should be noted that the NYCDOT recently conducted an independent traffic signal warrant analysis for the White Plains Road and East 226th Street intersection. A traffic signal was found to be warranted and NYCDOT currently plans to install a signal at this intersection.

One Hour Traffic Volumes
Thursday, January 26, 2006 7:45am - 8:45am

Intersection of 226th Street and White Plains Rd

- Install a traffic signal at the intersection of White Plains Road and East 226th Street. (It should be noted that the NYCDOT recently conducted an independent traffic signal warrant analysis for the White Plains Road and East 226th Street intersection. A traffic signal was found to be warranted and NYCDOT currently plans to install a signal at this intersection on November 2006.)

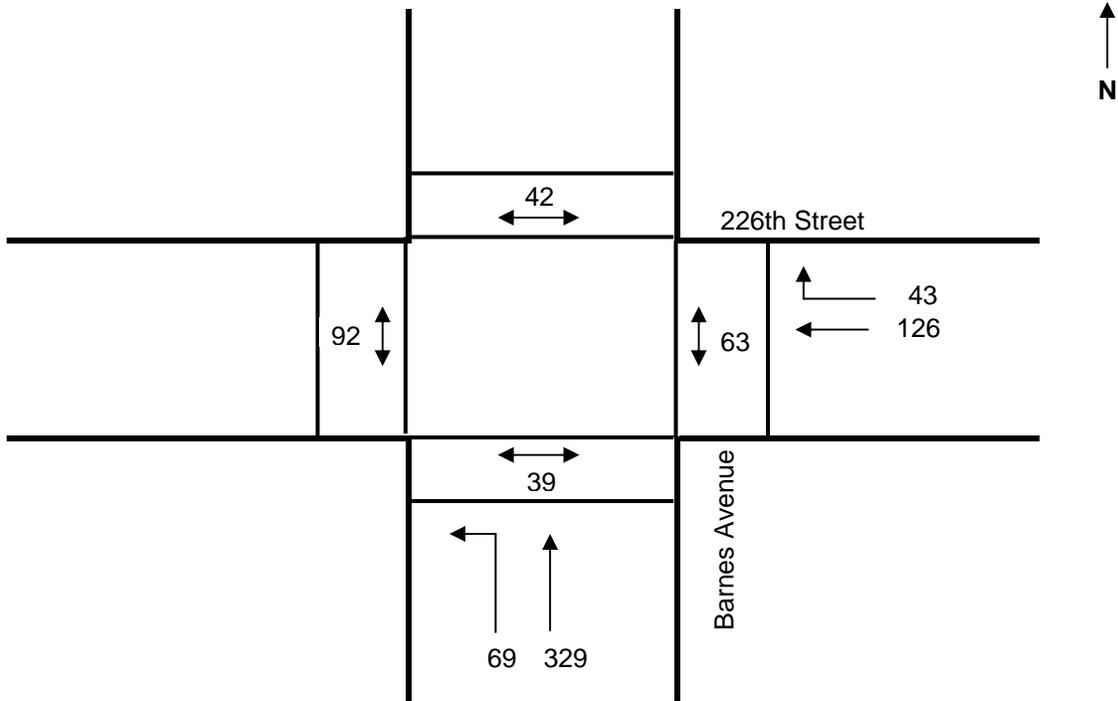
One Hour Traffic Volumes
Thursday, June 9th, 2005 7:30am - 8:30am

Intersection of 226th Street and Barnes Avenue

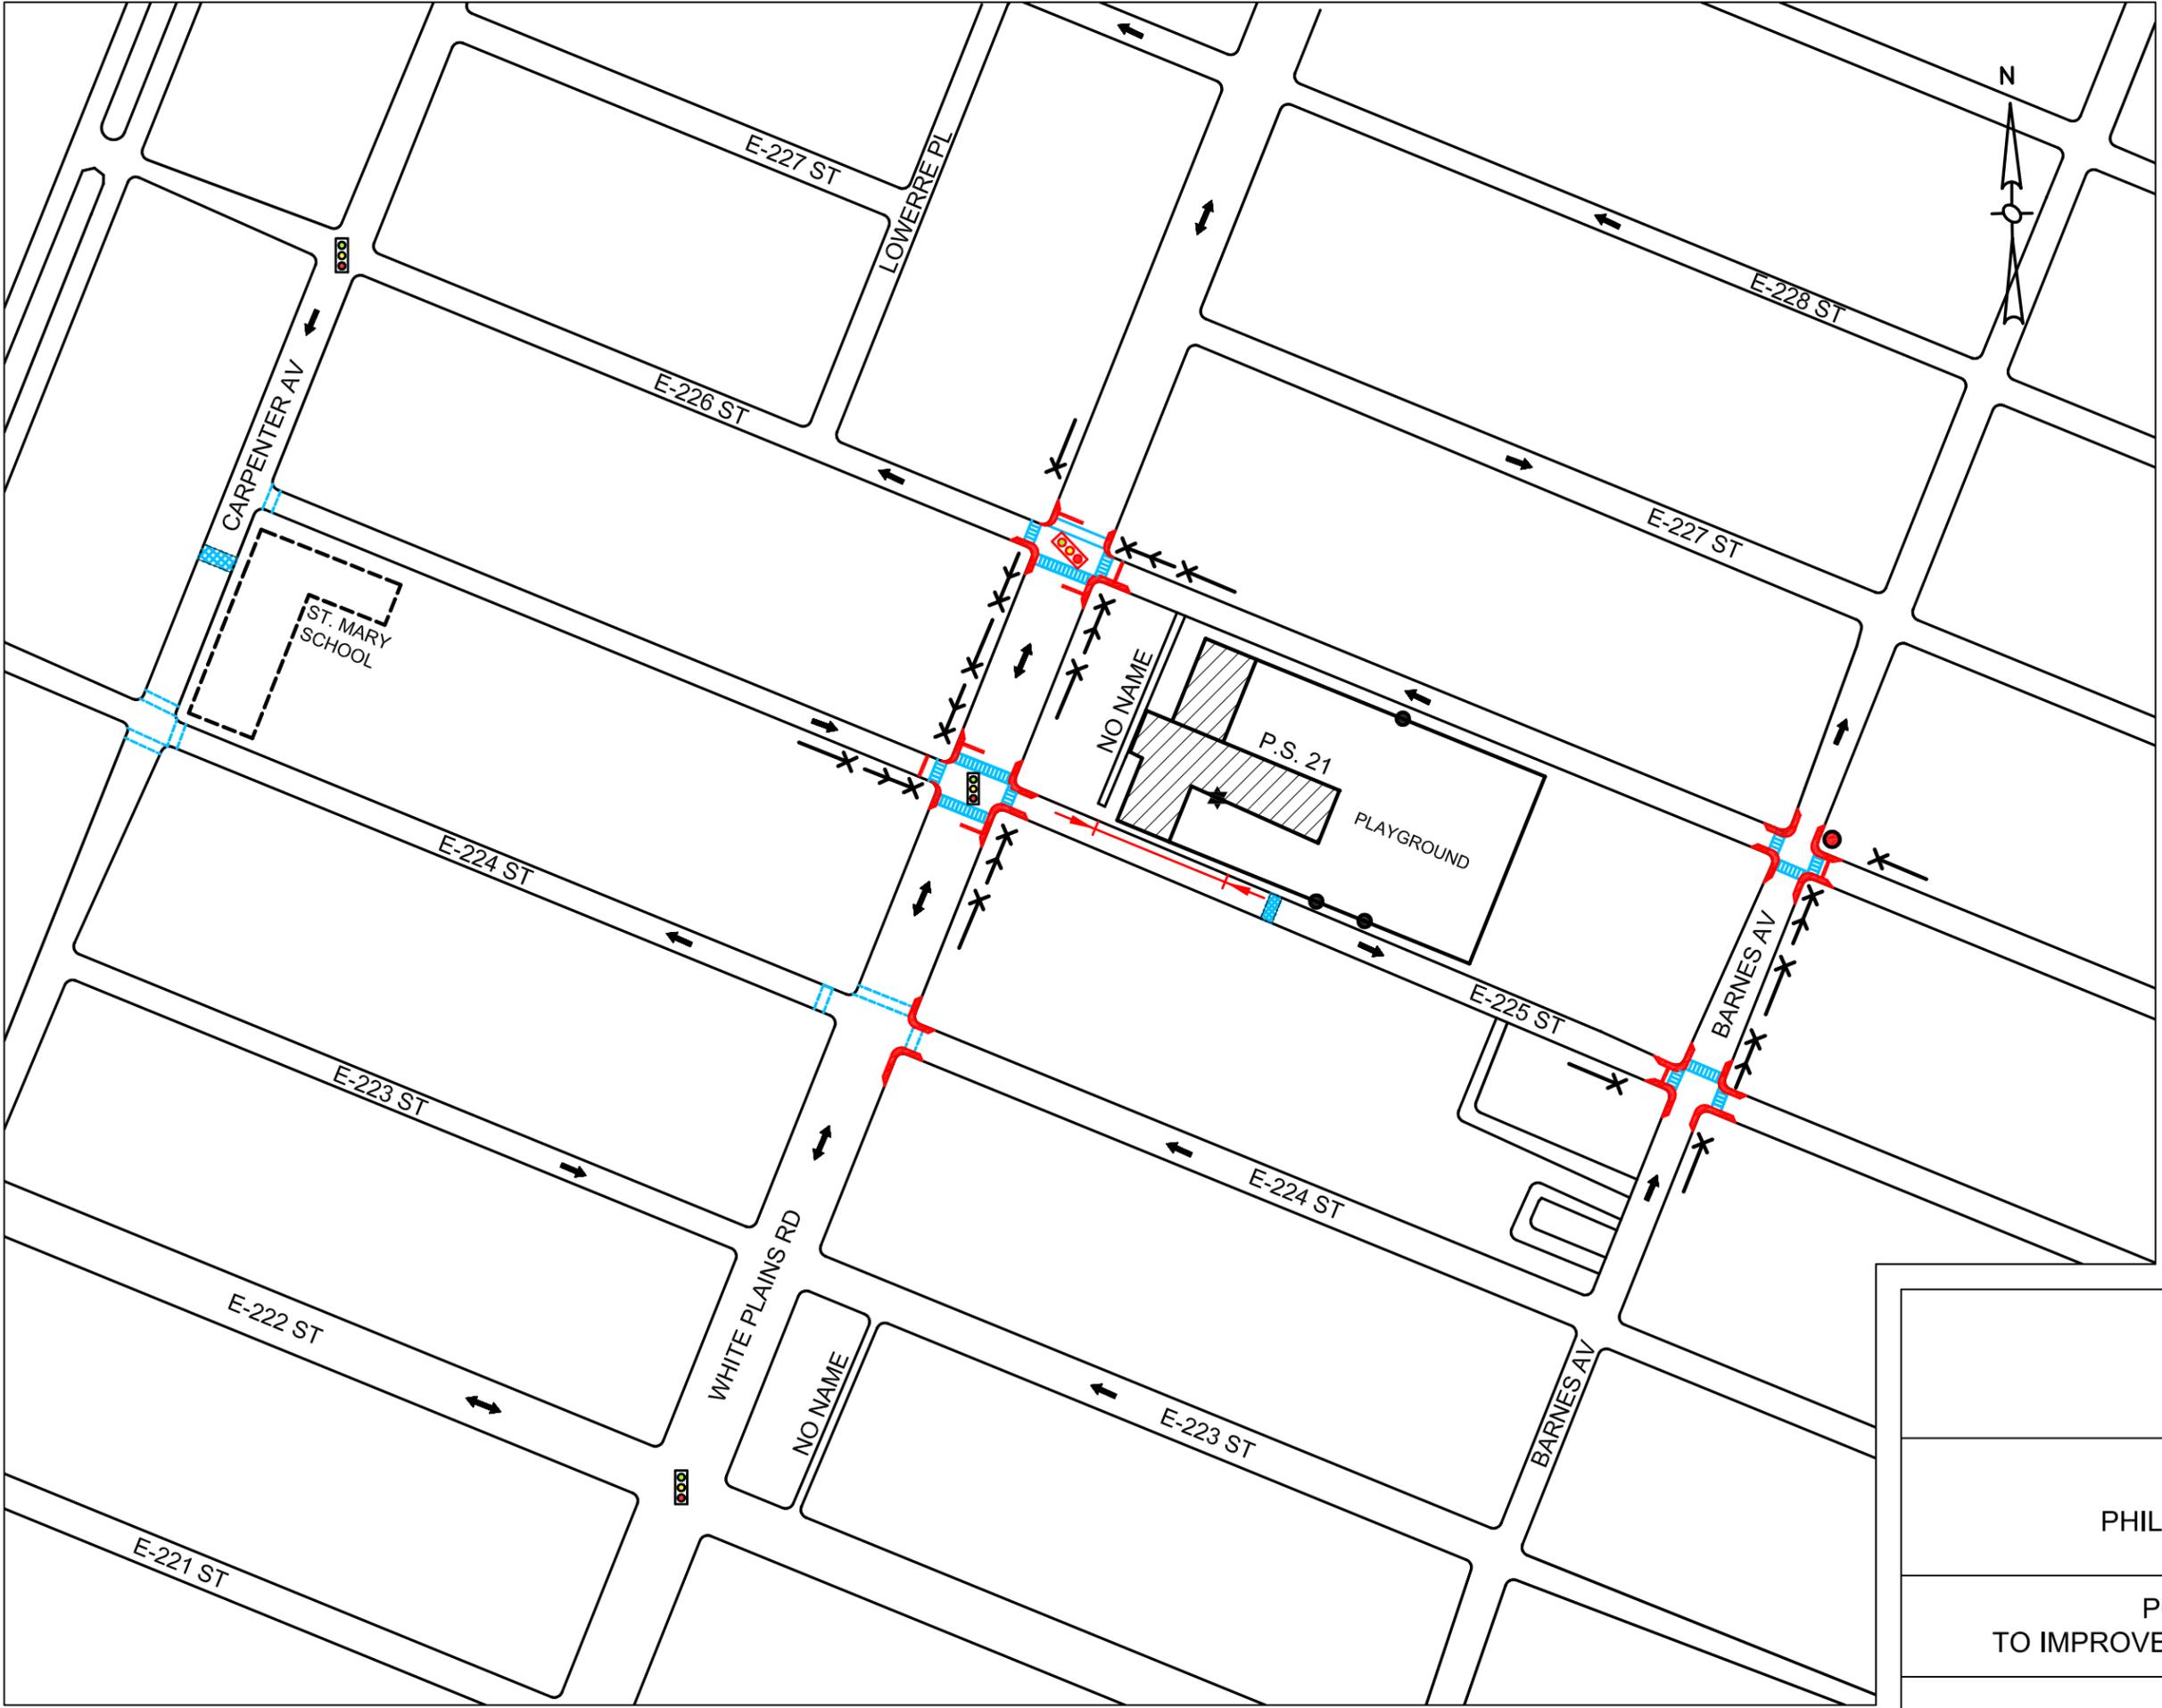
POTENTIAL MEASURES
TO IMPROVE STUDENT PEDESTRIAN SAFETY

This section describes proposed measures to improve school pedestrian safety around P.S. 21. The proposed recommendations are divided into short-term and long-term measures. Short-term measures are those that potentially can be performed in-house. Long-term measures involve capital improvements. Each of the short- and long-term measures recommended for P.S. 21 is discussed as follows, and is shown in more detail in Exhibit 8 at the end of this section.

Curb extensions (neckdowns) should be installed at the corners shown in Exhibit 8. The purpose of the curb extensions is to provide additional refuge space for pedestrians, to shorten the crossing distance for pedestrians, and to reduce the speed of vehicles approaching and turning on school crosswalks. The curb extensions will not eliminate or reduce the width of any travel lanes. Curb extensions are not proposed where they would hinder the ability of a vehicle to turn. The construction of curb extensions also includes the installation of pedestrian ramps.
