**New York City Department of Transportation
Office of School Safety Engineering**

School Safety Engineering Project

FINAL REPORT: P.S. 79 (Creston School), Bronx,

**Prepared by
The RBA Group/Urbitran Associates**

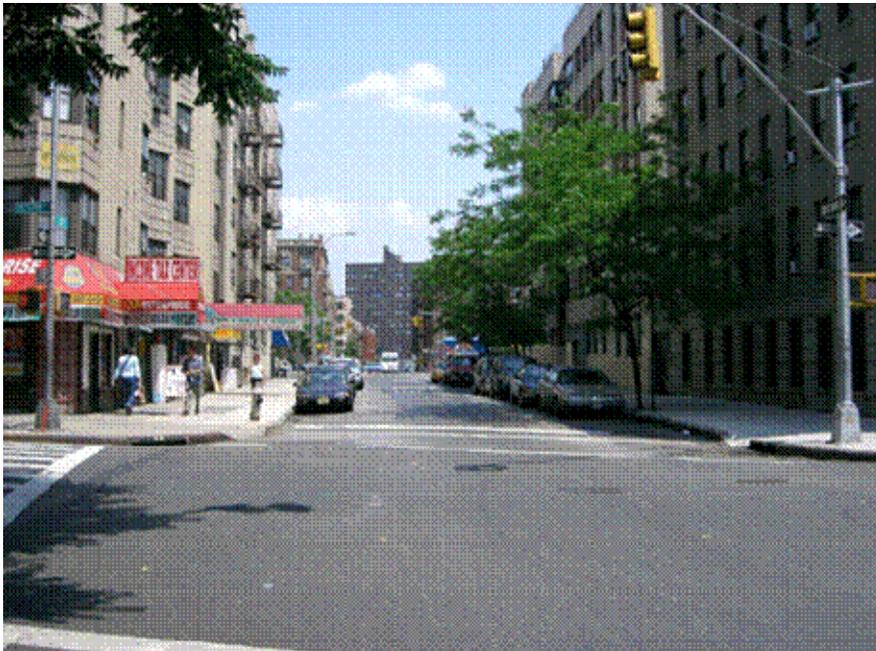
A deli located at the northeast corner of East 181st Street and Creston Avenue (see Figure 2) generates vehicular and pedestrian traffic, including school children and taxi drivers who double-park in front of the store. Local stores on East 181st Street, East 182nd Street, and Grand Concourse generate additional vehicular and pedestrian traffic.

Figure 2: Looking east along East 181st Street at its intersection with Creston Avenue (the deli is on the northeast corner)

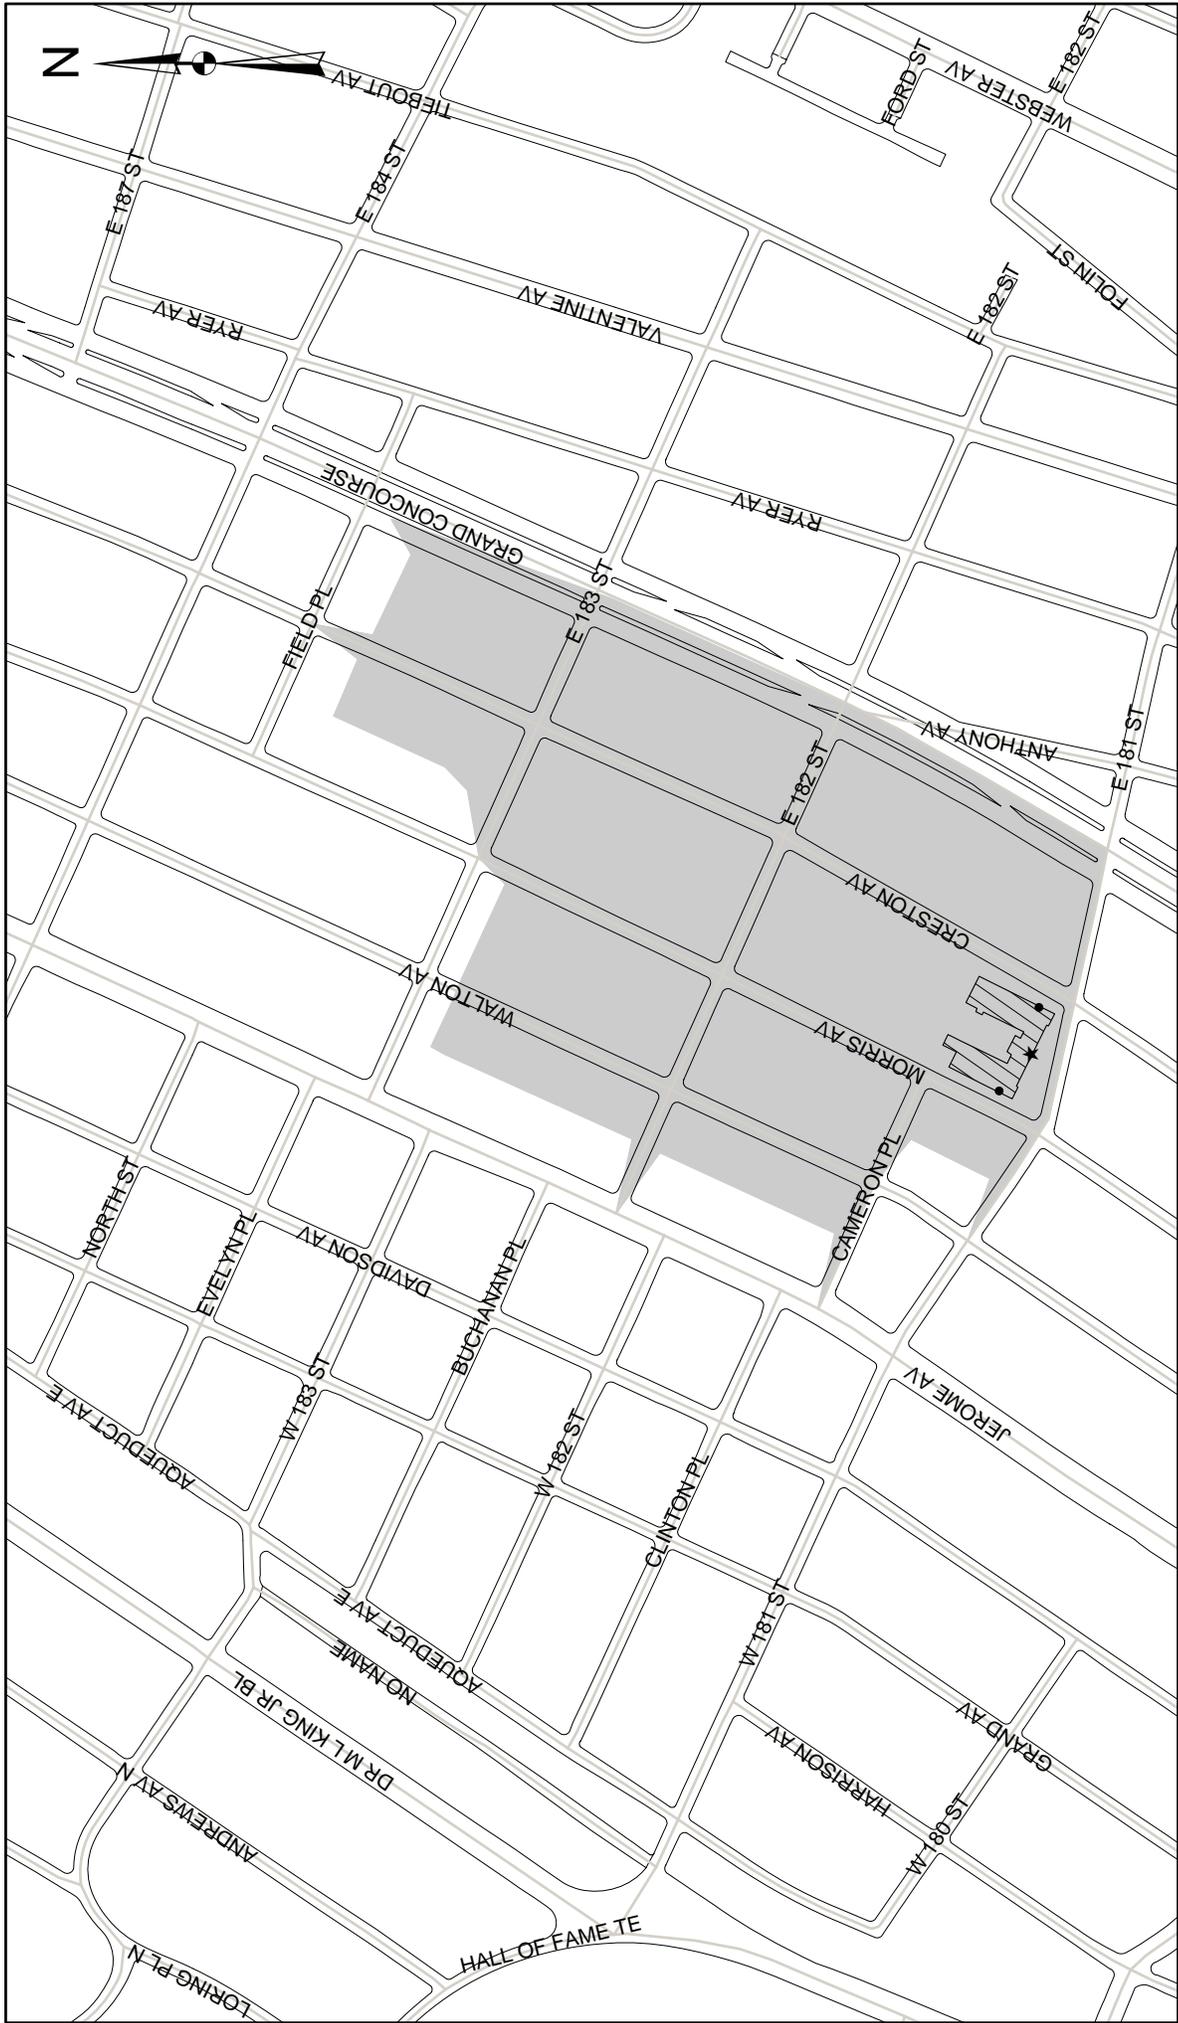
EXHIBIT 2
P.S. 79 BRONX
CRESTON SCHOOL
CATCHMENT AREA

The school’s catchment area as defined by the Department of Education (DOE) is shown in Exhibit 2. Based upon information obtained from the school principal, the catchment area shown in Exhibit 2 is correct for P.S. 79. The school’s catchment area is defined generally by East 183rd Street and Field Place to the north, East 181st Street to the south, Grand Concourse to the east and Jerome Avenue to the west. Table 1 presents the mode of travel for P.S. 79 as identified by school representatives and verified by the DOE website.

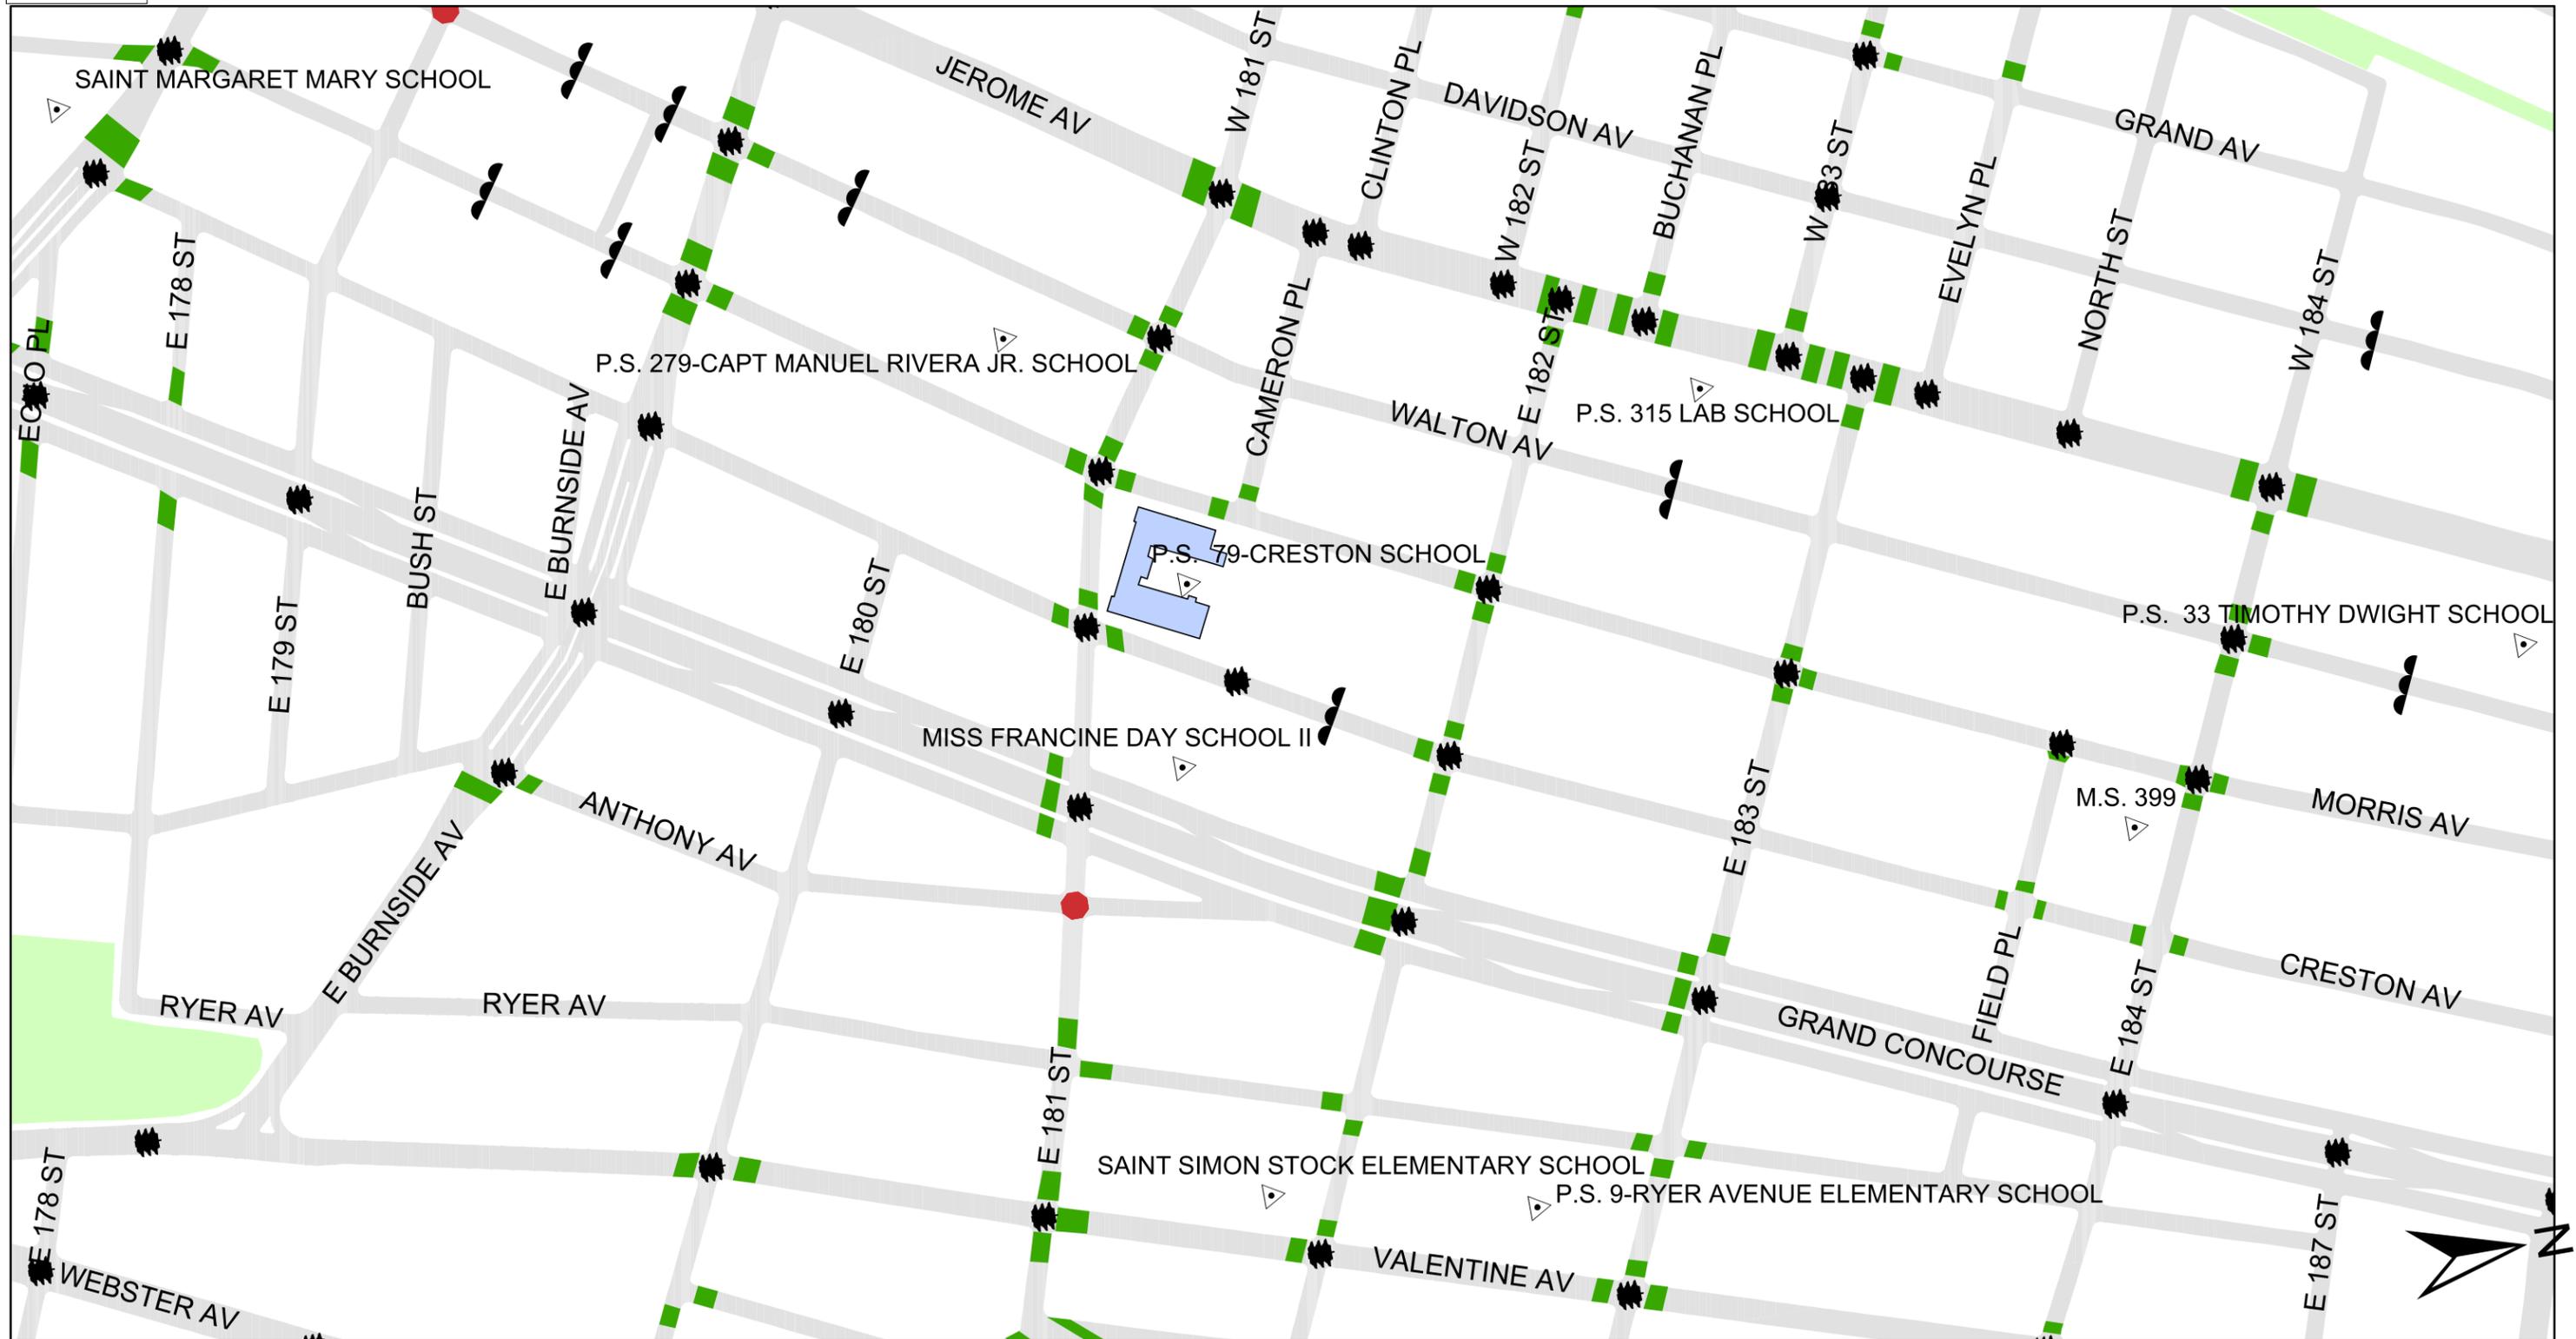
EXHIBIT 3

The School Traffic Safety Map was established to help provide the maximum degree of safety for children going to and from school - by indicating the location of speed reducers, school crosswalks and some traffic control devices. (While virtually all intersections in NYC benefit from traffic control devices - such as stop signs, traffic signals, yield signs, and all way stop signs - this map shows only traffic signals and all way stop signs.) The school crosswalks that are shown are ladder striped and make the crosswalk more visible to drivers and help make the intersection safer. These crosswalks are where school children are recommended to cross.

Exhibit 3 shows the existing school signals and pavement markings around P.S. 79. It should be noted that a citywide signage program is currently underway to upgrade school signage to the current edition of the Federal Manual of Uniform Traffic Control Devices (MUTCD) standards of fluorescent yellow-green signs accompanied by downward pointing arrows. Signs scheduled to be installed under this program are shown as “existing” in Exhibit 8.

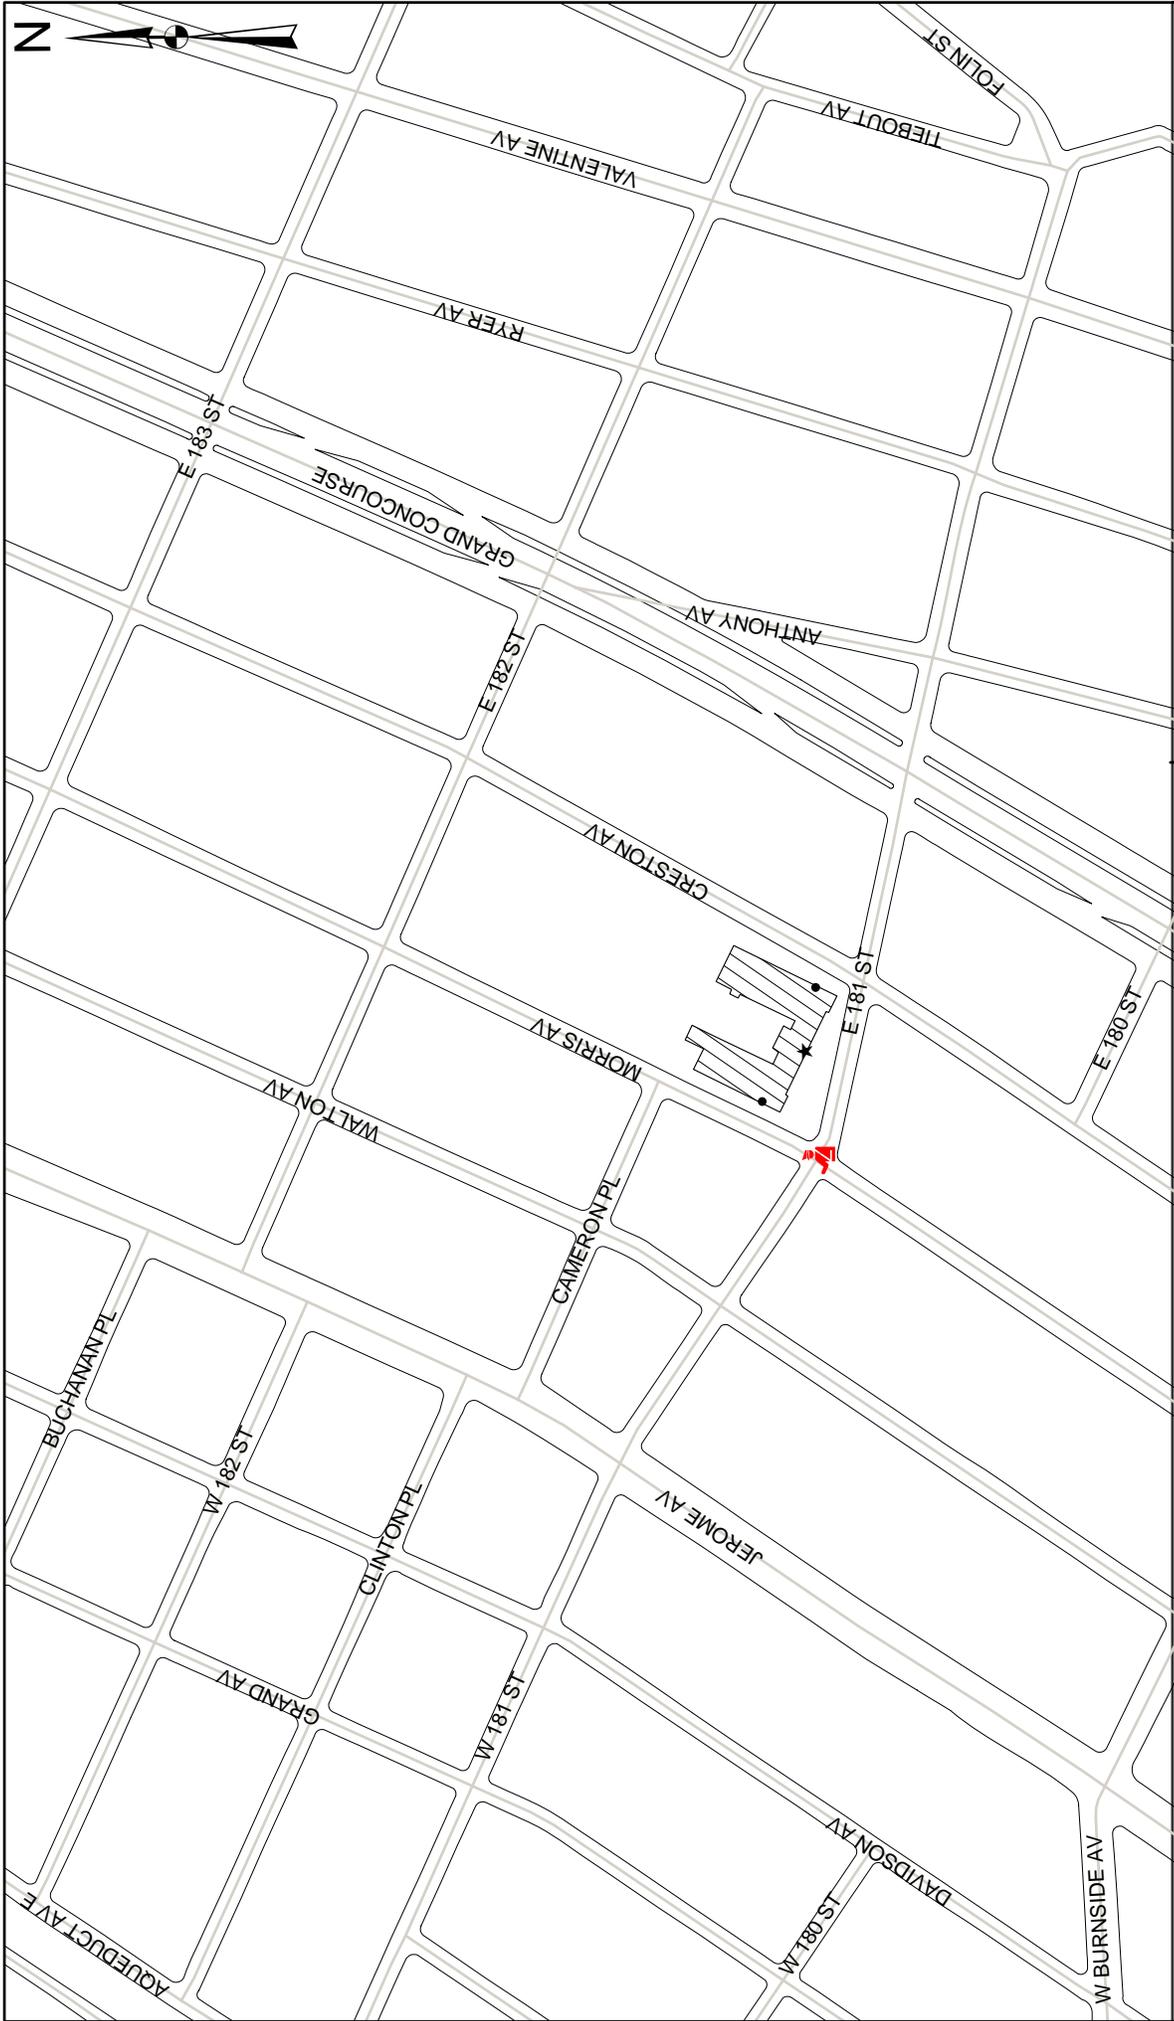
EXHIBIT 4
P.S. 79 BRONX
CRESTON SCHOOL
CROSSING GUARDS LOCATIONS

According to the school principal, a crossing guard is assigned to P.S. 79 at the intersection of East 181st Street and Morris Avenue. The school crossing guard is also assigned to P.S. 279, located at 2100 Walton Avenue between West Burnside Avenue and East 181st Street. The crossing guard location is shown in Exhibit 4.

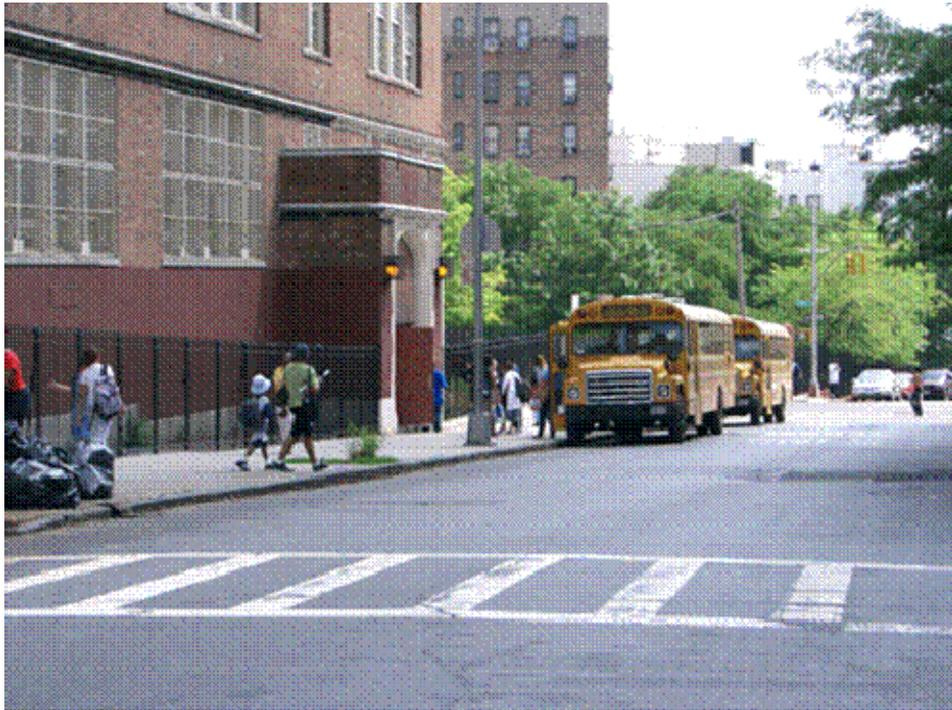
According to the school representatives, there are approximately thirty (30) students who ride a MTA bus to school, and approximately seventy (70) who ride a yellow school bus to school (Table 1 in Section 2). School bus transportation for the students consists of two yellow buses and one special bus (mini-wagon). School buses load and unload students on Morris Avenue (see Figure 3). According to school representatives, school bus operations are not an issue at P.S. 79. Consultant observations concur that there is sufficient block-face on Morris Avenue for school bus operations.

Figure 3: Looking south at school buses on Morris Avenue at dismissal time

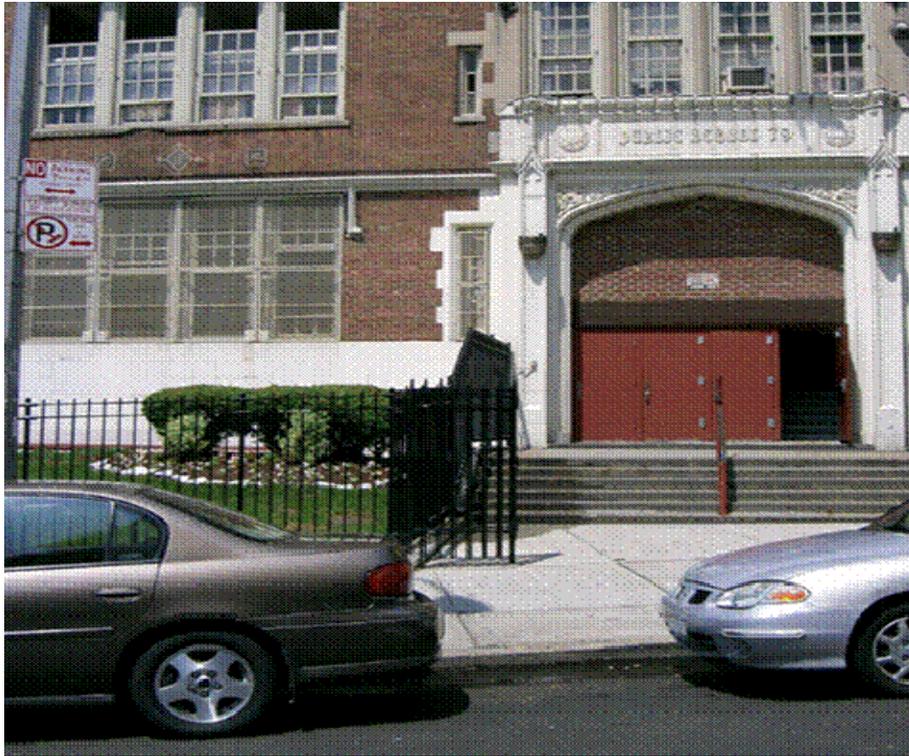
Parking regulations around the school block are shown in Exhibit 5. Figure 4 shows parking regulations (NO PARKING 7AM – 4PM SCHOOL DAYS EXCEPT BOARD OF EDUCATION and NO PARKING 9-10:30 AM MONDAY AND THURSDAY) on the north side of East 181st Street in front of P.S. 79.

Figure 4: Parking regulations on north side of East 181st Street in front of P.S. 79

“NO PARKING 7AM – 4PM SCHOOL DAYS / EXCEPT BOARD OF EDUCATION” signs are installed currently on the block-faces near the entrances/exits to P.S. 79. However, it is recommended to install “NO STANDING 7AM-4PM SCHOOL DAYS” signs for a distance of thirty feet (30’) in front of the main entrance of the school. (This is a typical requirement for all NYC schools in order to provide for emergency access to and from the school.)

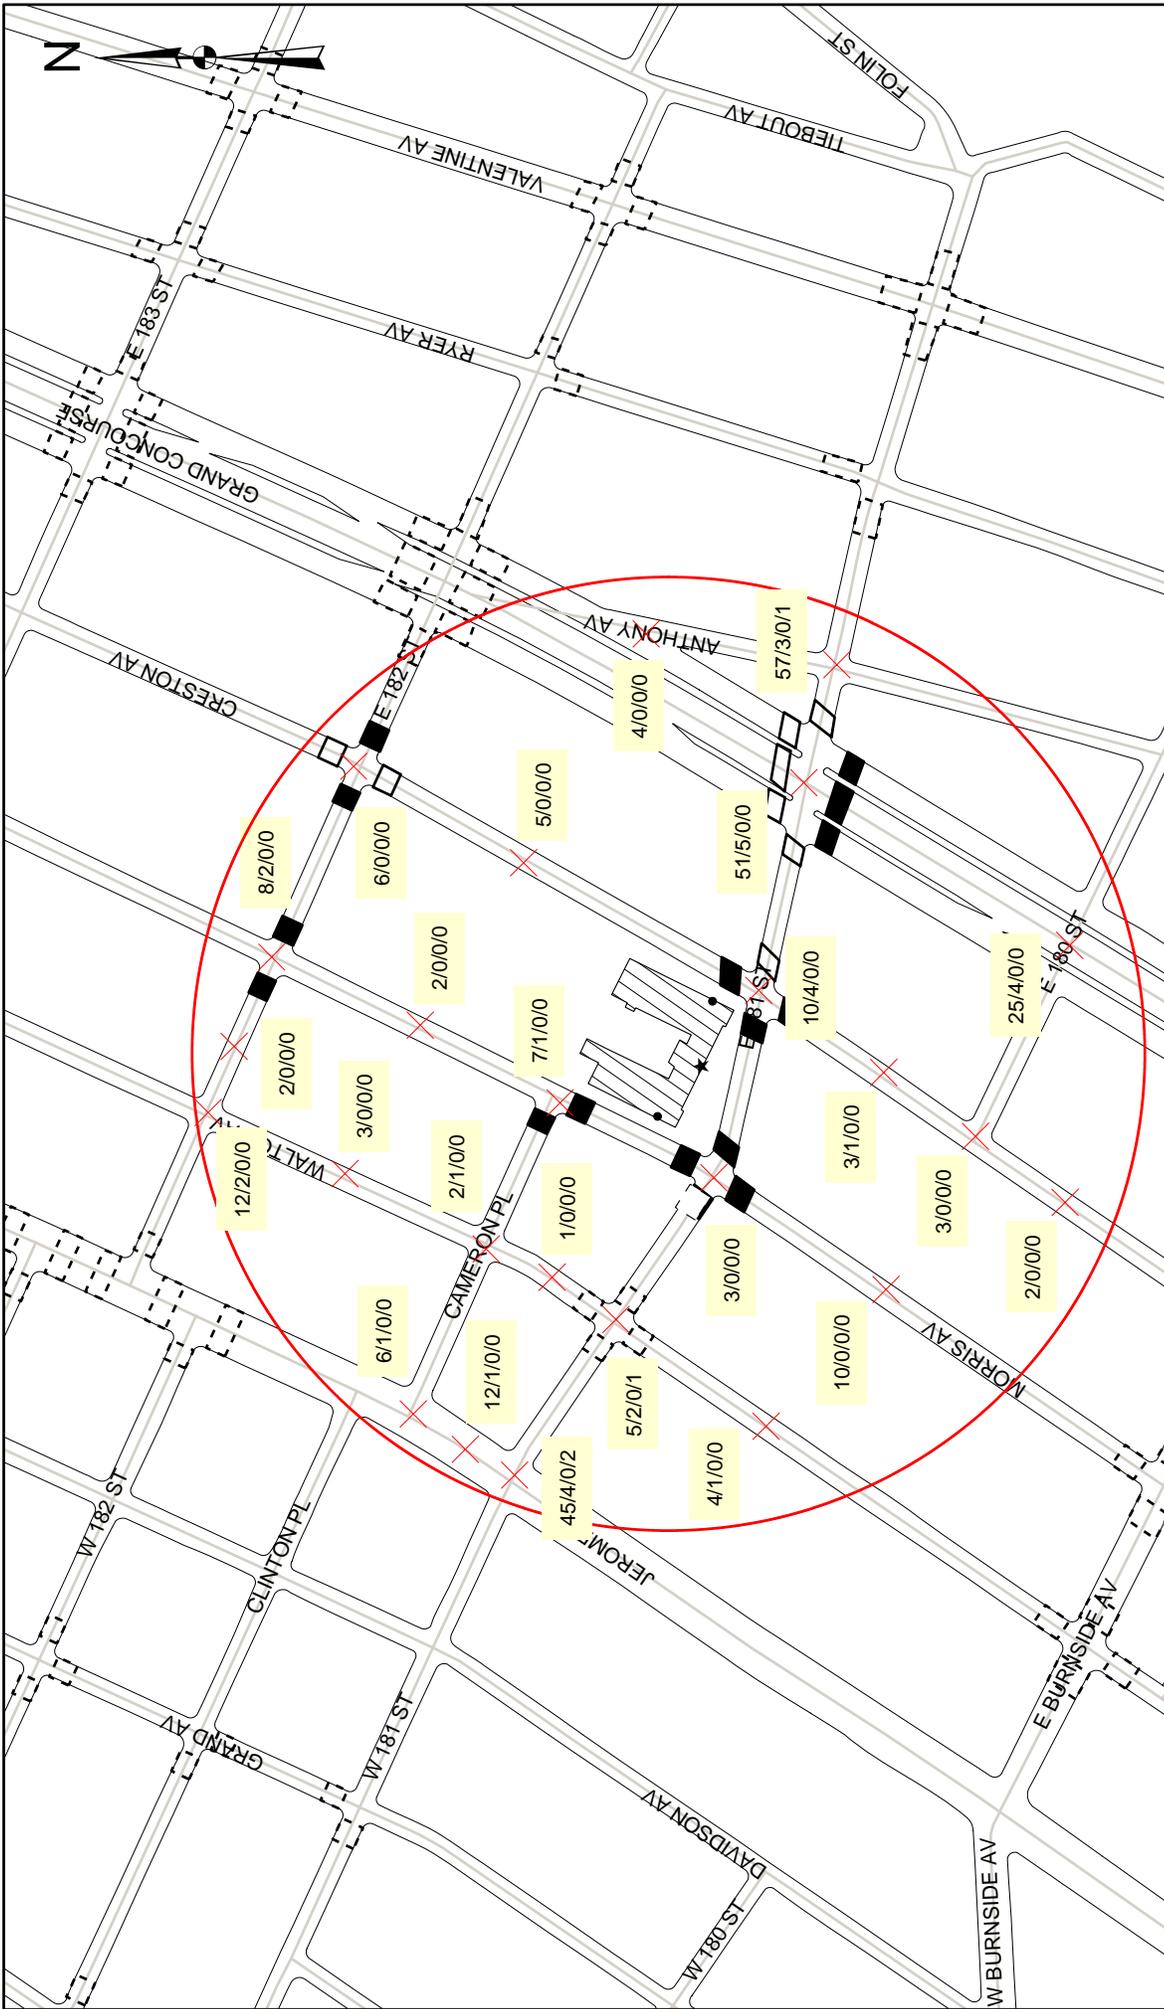
EXHIBIT 6
P.S. 79 BRONX
CRESTON SCHOOL
ACCIDENT SUMMARY (1998-2000)

Exhibit 6 and Table 2 show a summary of accidents, as obtained from the New York State Department of Motor Vehicles (DMV), in the vicinity of P.S. 79 for a three-year period from January 1, 1998 through December 31, 2000. The DMV data provides some detail relating to the circumstances and cause of an accident. Table 3 is a summary of more recent accident data obtained from the NYC Police Department (NYPD). Though current through 2004, the NYPD data does not provide the same level of detail as the DMV data.

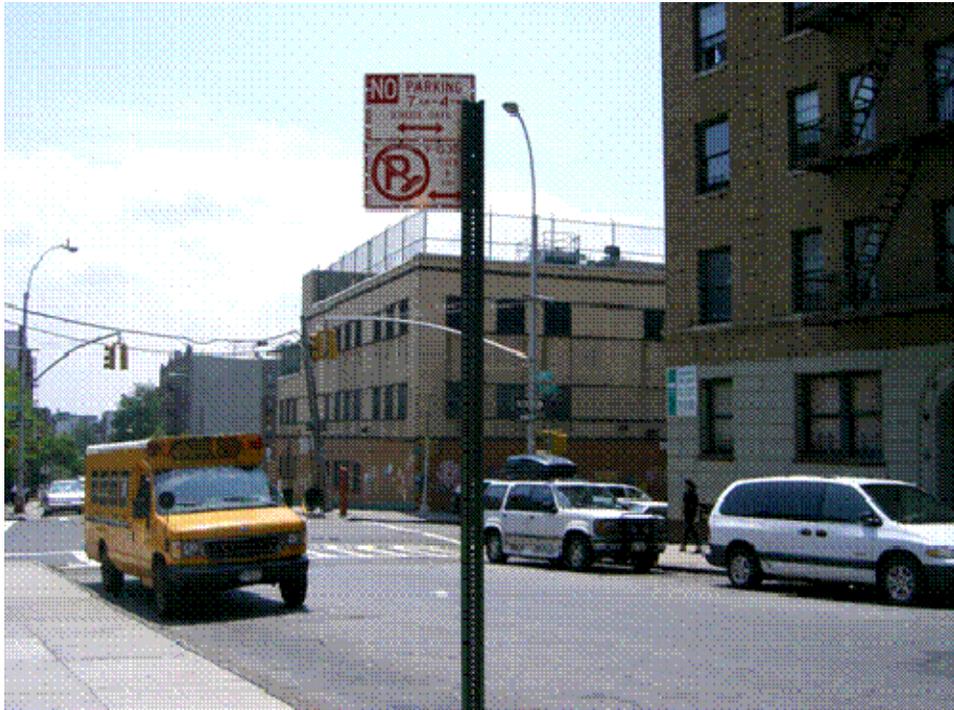
There were three accidents reported at this intersection between 1998 and 2000 (Table 2); none were pedestrian accidents. There were no pedestrian fatalities reported at this intersection.

Figure 5: Looking south along Morris Avenue towards its intersection with East 181st Street

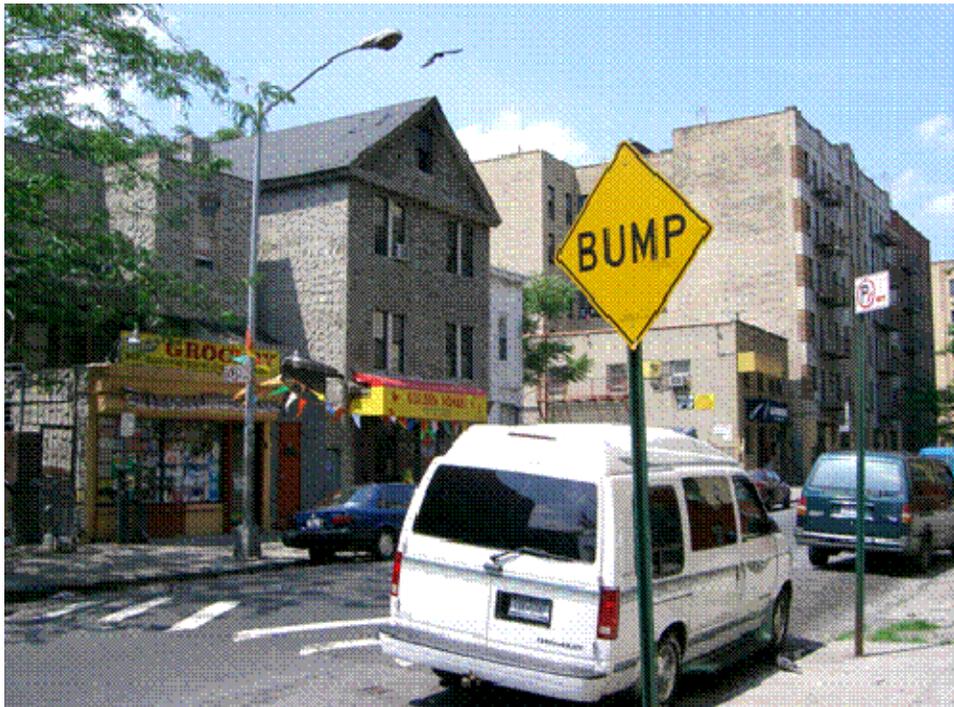
Figure 6: Looking north along Morris Avenue at speed reducer between Cameron Pace and East 182nd Street

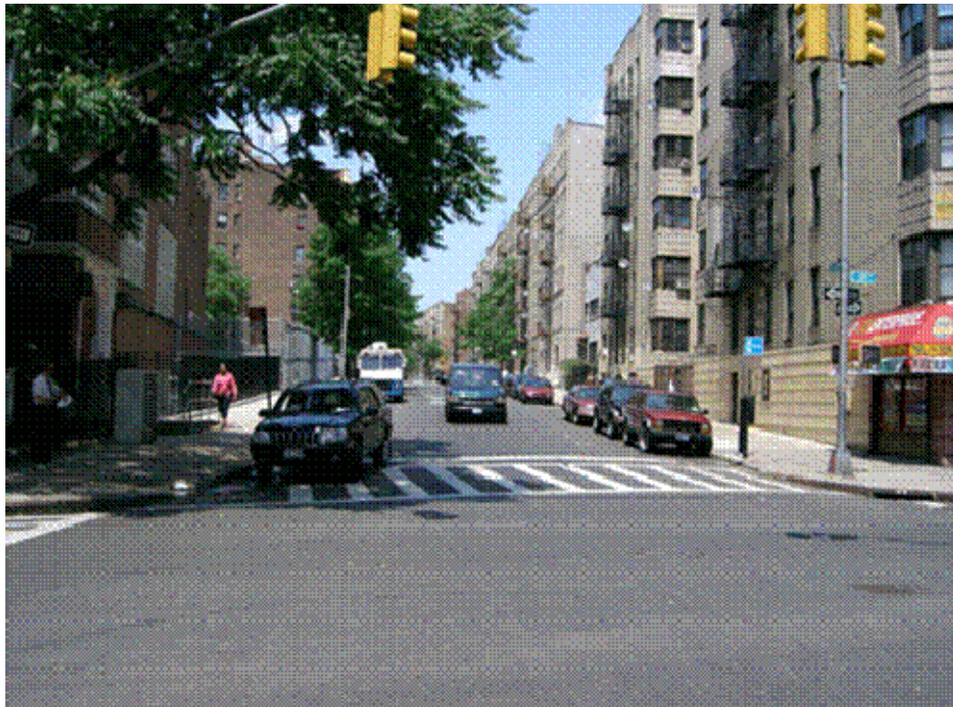
There were ten accidents reported at this intersection between 1998 and 2000 (Table 2). There were four pedestrian accidents reported during the same three-year period; none of the pedestrian accidents were school-related. There were no pedestrian fatalities reported at this intersection.

Figure 7: Looking north along Creston Avenue at its intersection with East 181st Street (school is on left)

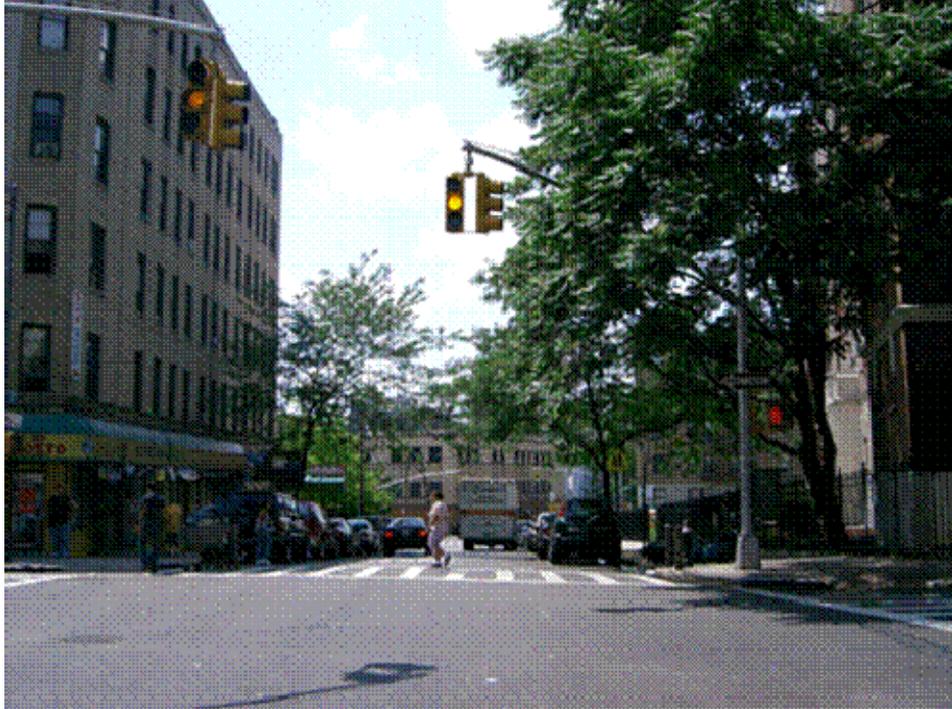
In summary, the westbound vehicles on East 181st Street, between Creston Avenue and Morris Avenue, were found to be traveling with an 85th percentile speed of 30.5 mph. The 85th percentile speed is considered to be the representative speed of the street segment. Speeds above the 30 mph threshold would indicate a speeding problem and may require appropriate traffic calming measures. The 85th percentile speeds indicate that speeding is an issue on East 181st Street, however speed reducers (humps) are not feasible because the block lengths are too short (approximately 200 ft) between signalized intersections. In order to minimize the effects of speeding, traffic calming measures such as neckdowns and advanced stop bars are recommended for this street.

According to school representatives, traffic issues on East 181st Street include double-parking, speeding and uncoordinated signals. They further report a former speeding problem has been alleviated since a speed reducer (hump) was installed on Creston Avenue, approximately mid-block between East 181st and East 182nd streets (See Section 3.6.1 - East 181st Street and Creston Avenue for discussion of the spot speed survey on East 181st Street between Creston Avenue and Morris Avenue.).

Figure 8: Looking west along East 181st Street between Creston Avenue and Morris Avenue (school is on the right)

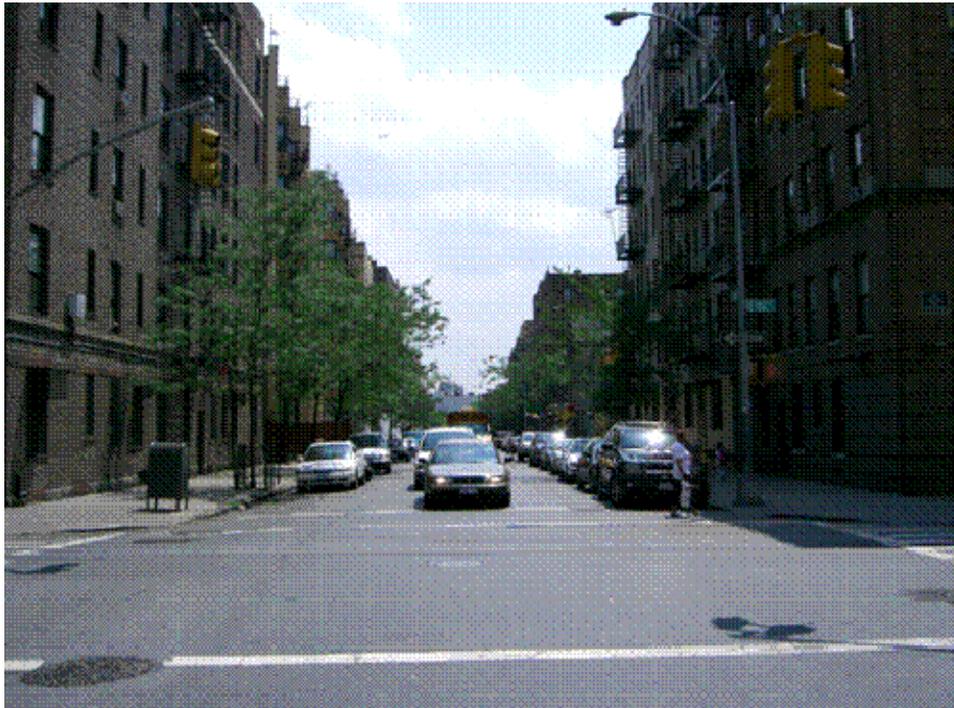
There were eight accidents reported at this intersection between 1998 and 2000 (Table 2), including two pedestrian accidents. Neither of the pedestrian accidents was school-related. There were no pedestrian fatalities reported at this intersection.

Figure 9: Looking south along Morris Avenue at its intersection with East 182nd Street

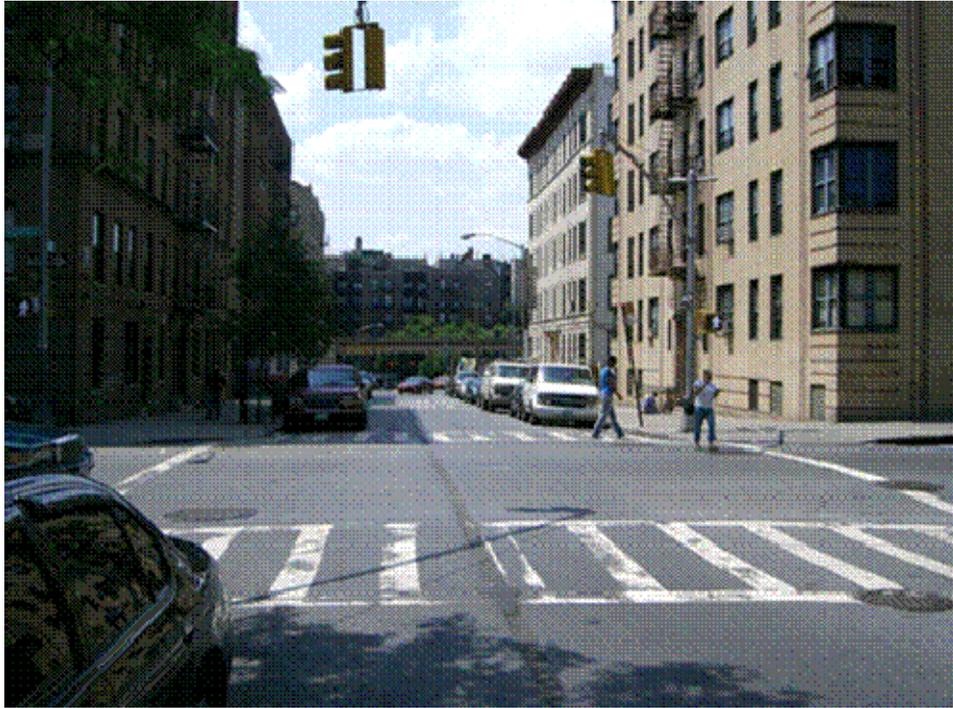
Figure 10: Looking west along East 182nd Street at its intersection with Morris Avenue

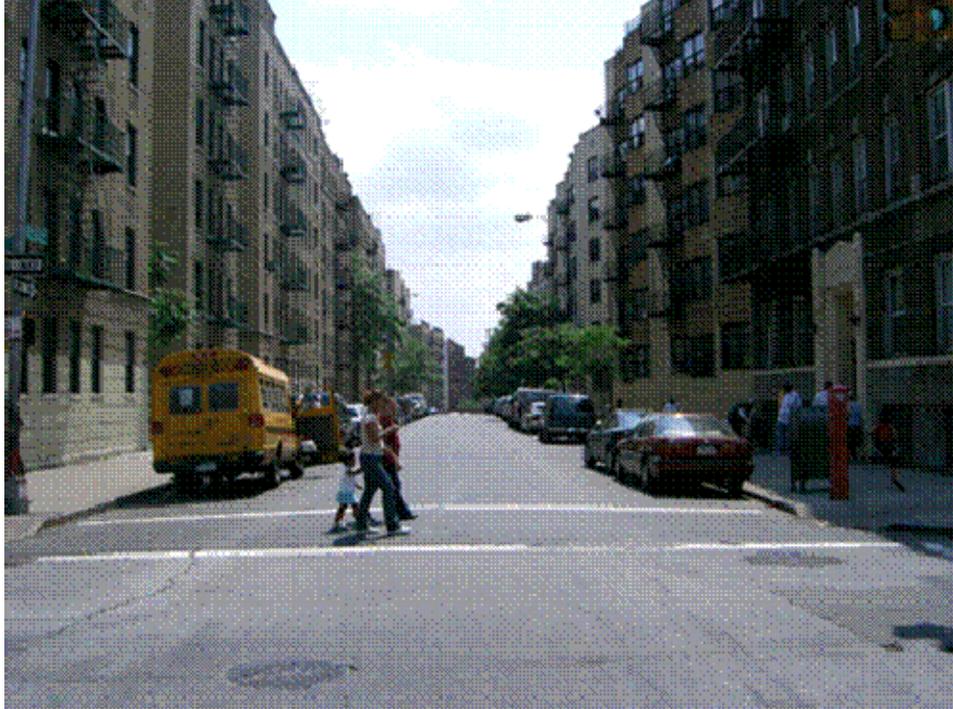
This is a four-leg signalized intersection with school crosswalks located across the east and west legs of East 182nd Street, and pedestrian crosswalks across the north and south legs of Creston Avenue. East 182nd Street is a one-way eastbound street with one travel lane and on-street parking permitted on both sides of the roadway. Creston Avenue is a one-way southbound street with one travel lane and on-street parking permitted on both sides of the roadway.

There were six accidents reported at this intersection between 1998 and 2000 (Table 2); none were pedestrian accidents. There were no pedestrian fatalities reported at this intersection during the same four-year period.

Figure 11: Looking south along Creston Avenue at its intersection with East 182nd Street

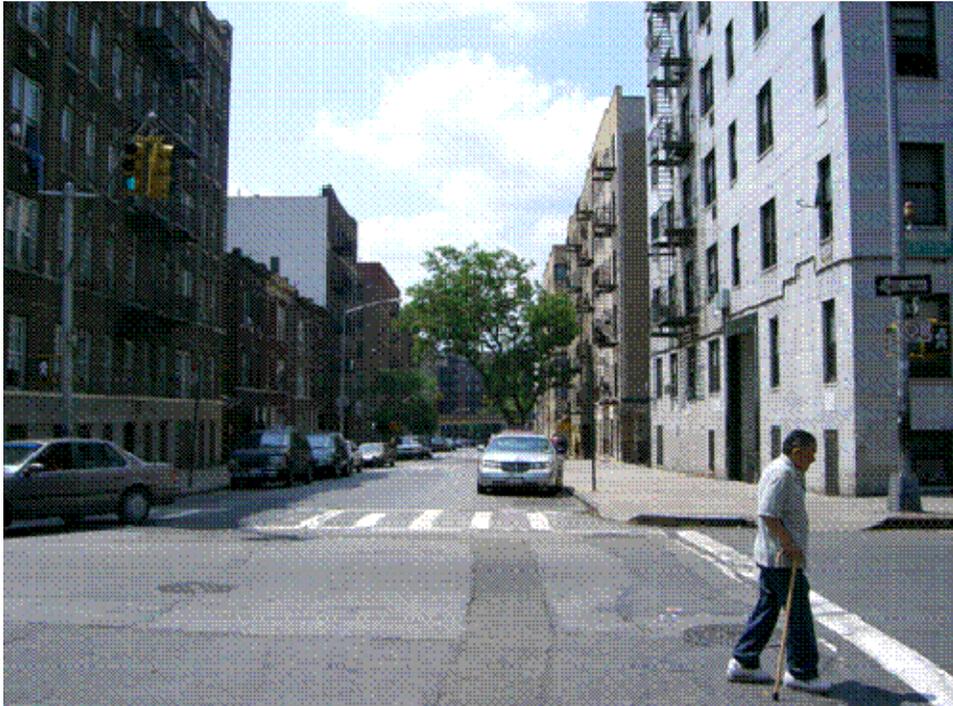
Figure 12: Looking west along East 182nd Street between Creston Avenue and Morris Avenue

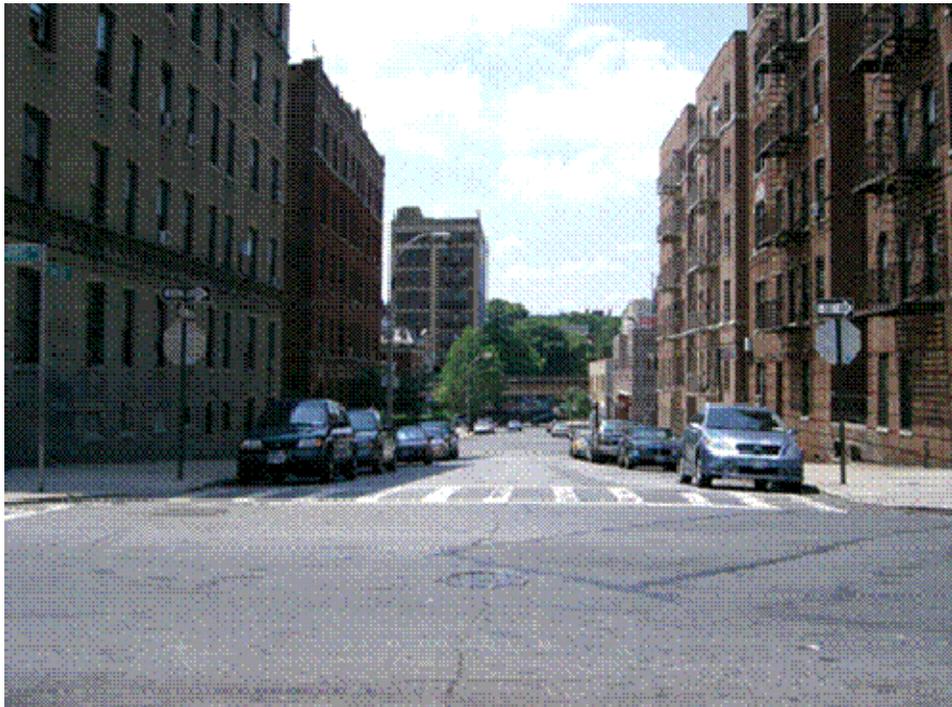
This is an unsignalized T-intersection with school crosswalks located across the south leg of Morris Avenue and the west leg of Cameron Place. Morris Avenue is a one-way northbound street with one travel lane and on-street parking permitted on both sides of the roadway. Cameron Place is a one-way eastbound street with one travel lane and on-street parking permitted on both sides of the roadway. The eastbound approach of Cameron Avenue is stop-controlled at its intersection with Morris Avenue.

There were seven accidents reported at this intersection between 1998 and 2000 (Table 2); one was a pedestrian accident that was not school-related. There were no pedestrian fatalities reported during the same three-year period.

Figure 13: Looking west along Cameron Place at its intersection with Morris Avenue

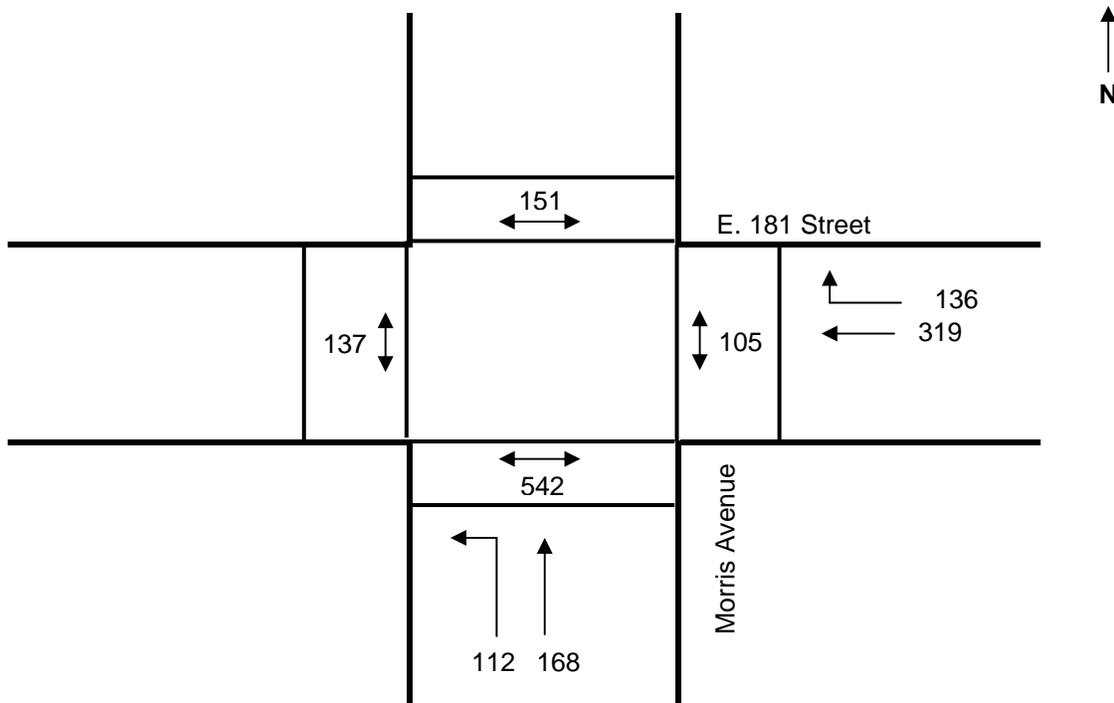
Intersection of E. 181st Street and Morris Avenue

TABLE 5: PEDESTRIAN VOLUMES (7:30-9:00 AM)				
INTERSECTION	CROSSING East 181ST STREET EAST-LEG X-WALK	CROSSING East 181ST STREET WEST-LEG X-WALK	CROSSING MORRIS AVENUE NORTH-LEG X-WALK	CROSSING MORRIS AVENUE SOUTH-LEG X-WALK
East 181 st Street and Morris Avenue	105	137	151	542

One Hour Traffic Volumes
Thursday, May 19th, 2005 7:30am - 9am
