**New York City Department of Transportation
Office of School Safety Engineering**

School Safety Engineering Project

FINAL REPORT: P.S. 79 (Creston School), Bronx,

**Prepared by
The RBA Group/Urbitran Associates**

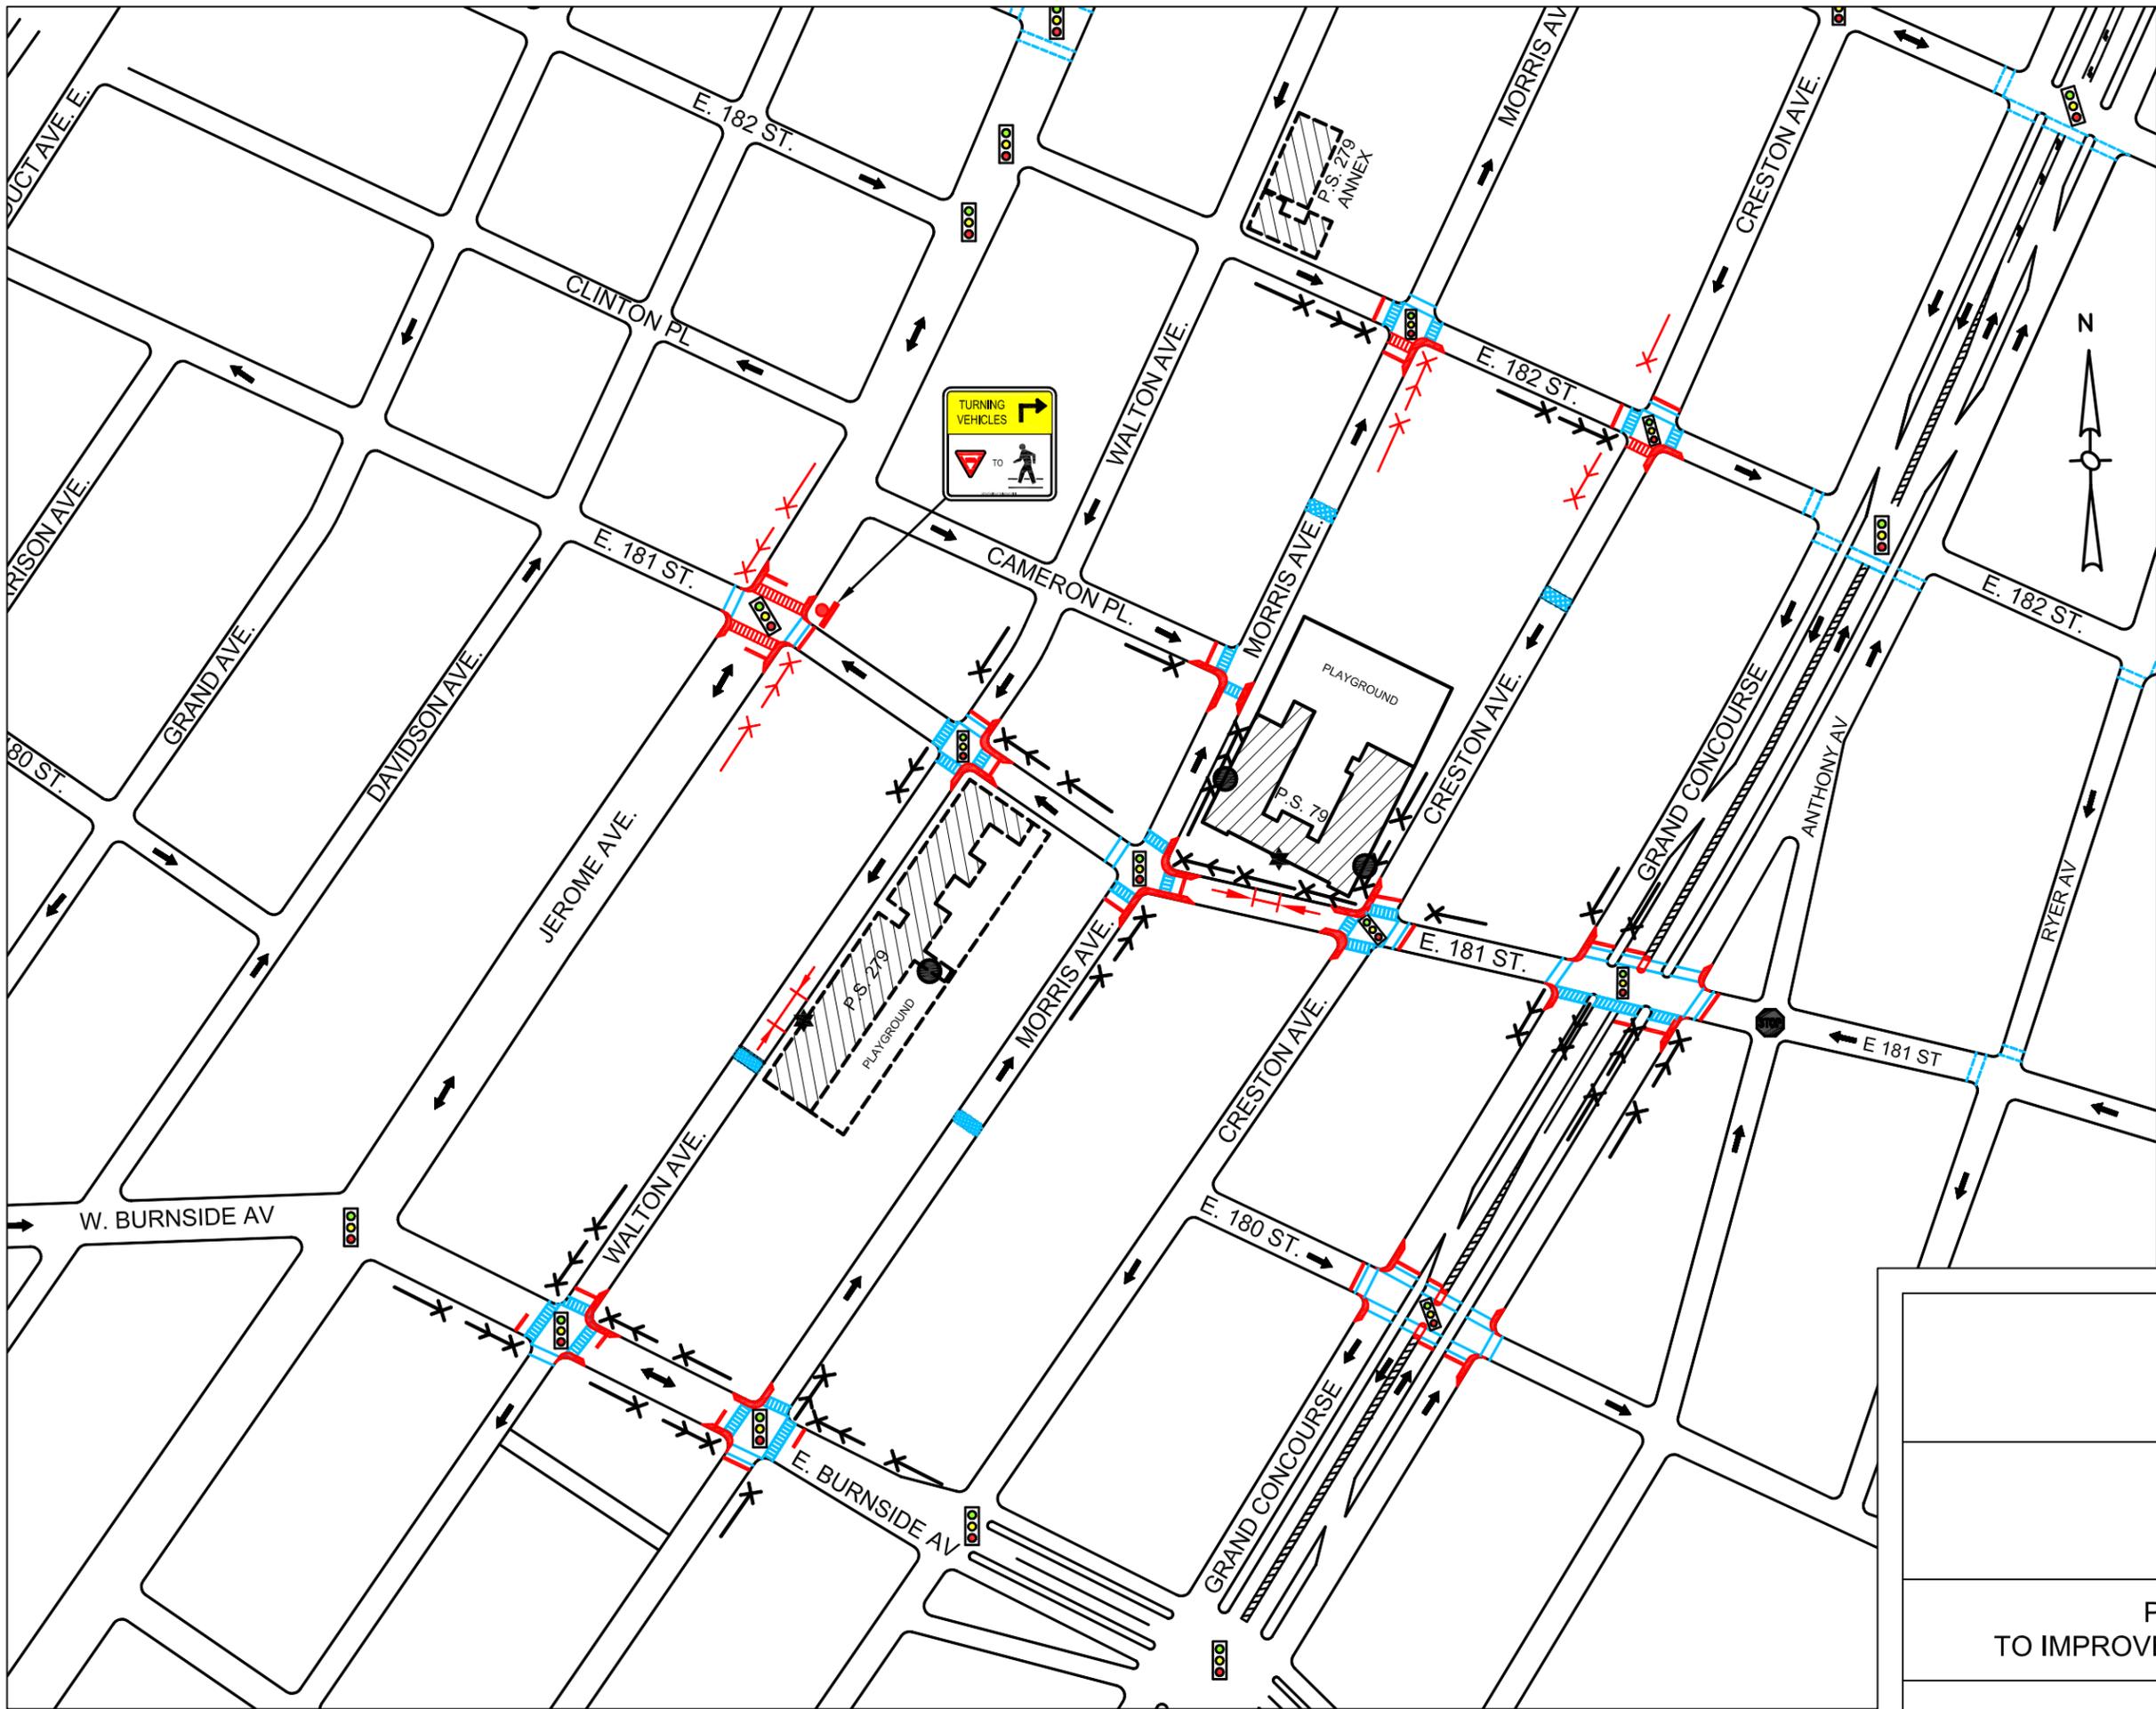
POTENTIAL MEASURES
TO IMPROVE STUDENT PEDESTRIAN SAFETY

This section describes the proposed measures to improve school pedestrian safety around P.S. 79. The proposed recommendations are divided into short-term and long-term measures. Short-term measures are those that potentially can be performed in-house. Long-term measures involve capital improvements. Each of the short- and long-term measures recommended for P.S. 79 is discussed as follows, and is shown in more detail in Exhibit 8 at the end of this section. See section 4.3 for additional recommendations for this area from the report on P.S. 279, a nearby priority school.

For school crosswalks with significant potential for vehicular / pedestrian conflicts, it is recommended that the advance stop bar be placed ten feet (10’) in advance of the crosswalk to maximize the safety benefit for school-aged pedestrians. (This would improve visibility of pedestrians to motorists, and allow pedestrians to proceed in a crosswalk before motor vehicles turn.)

The purpose of the curb extension is to shorten the crossing distance for pedestrians, and to reduce the speed of vehicles approaching and turning on school crosswalks. The curb extension will not eliminate or reduce the width of any travel lanes. Curb extensions are not proposed where they would hinder the ability of a vehicle to turn.
