**New York City Department of Transportation  
Office of School Safety Engineering**

**School Safety Engineering Project**

**FINAL REPORT: St. Anselm School, Bronx**

**Prepared by  
The RBA Group and URBITRAN Associates Inc.**

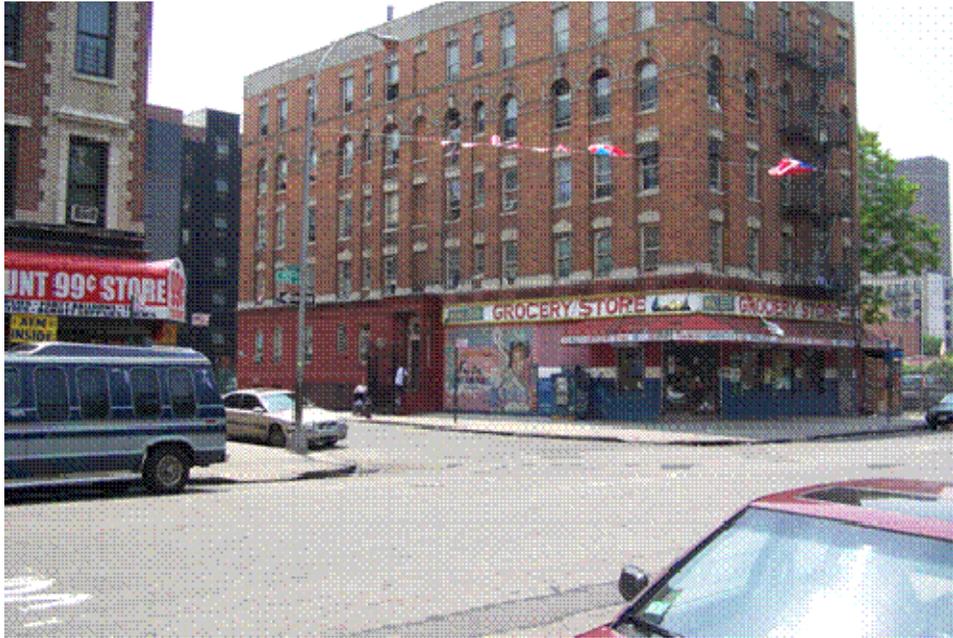
There are several stores in the neighborhood that serve to attract students along East 152<sup>nd</sup> Street between Wales Avenue and Westchester Avenue and along Union Avenue, one block to the east (see Figures 2 and 3). There is another school (P.S. 161 Ponce De Leon) located a short distance away at 628 Tinton Avenue, on the block to the south of

*Figure 2: Stores on East 152nd Street at Wales Avenue near St. Anselm School*

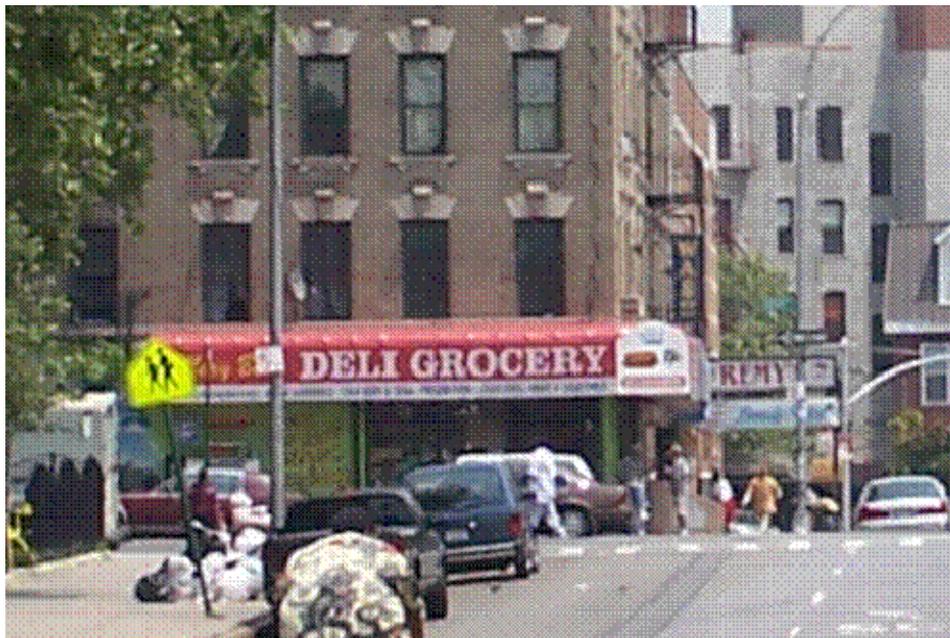
*Figure 3: Deli on Union Avenue at East 152nd Street intersection*

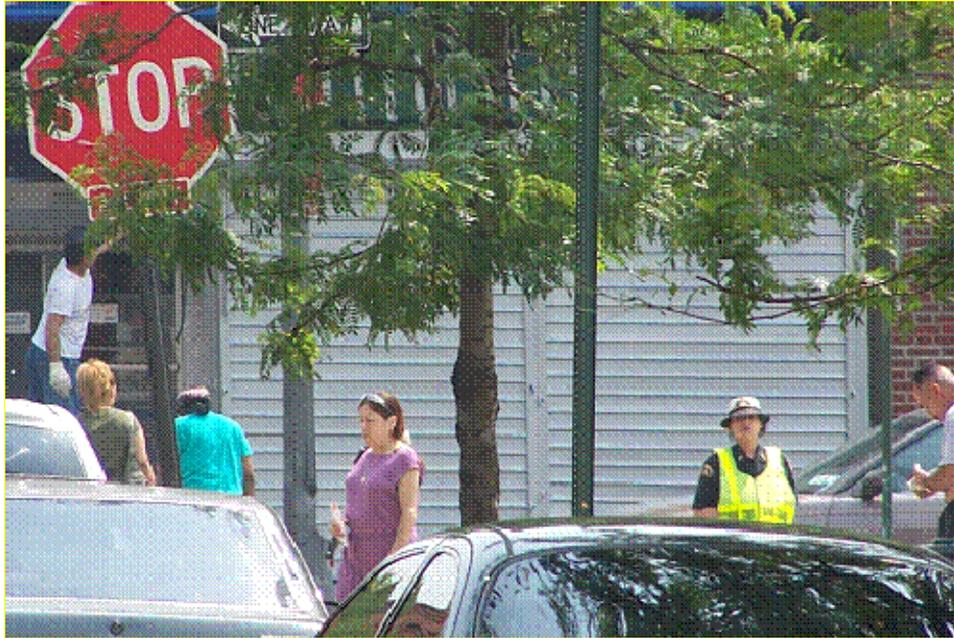
According to school officials, a school crossing guard is assigned to the intersection of Tinton Avenue and East 152<sup>nd</sup> Street (see Figure 4).

*Figure 4: Looking south at crossing guard at intersection of Tinton Avenue & East 152<sup>nd</sup> Street.*

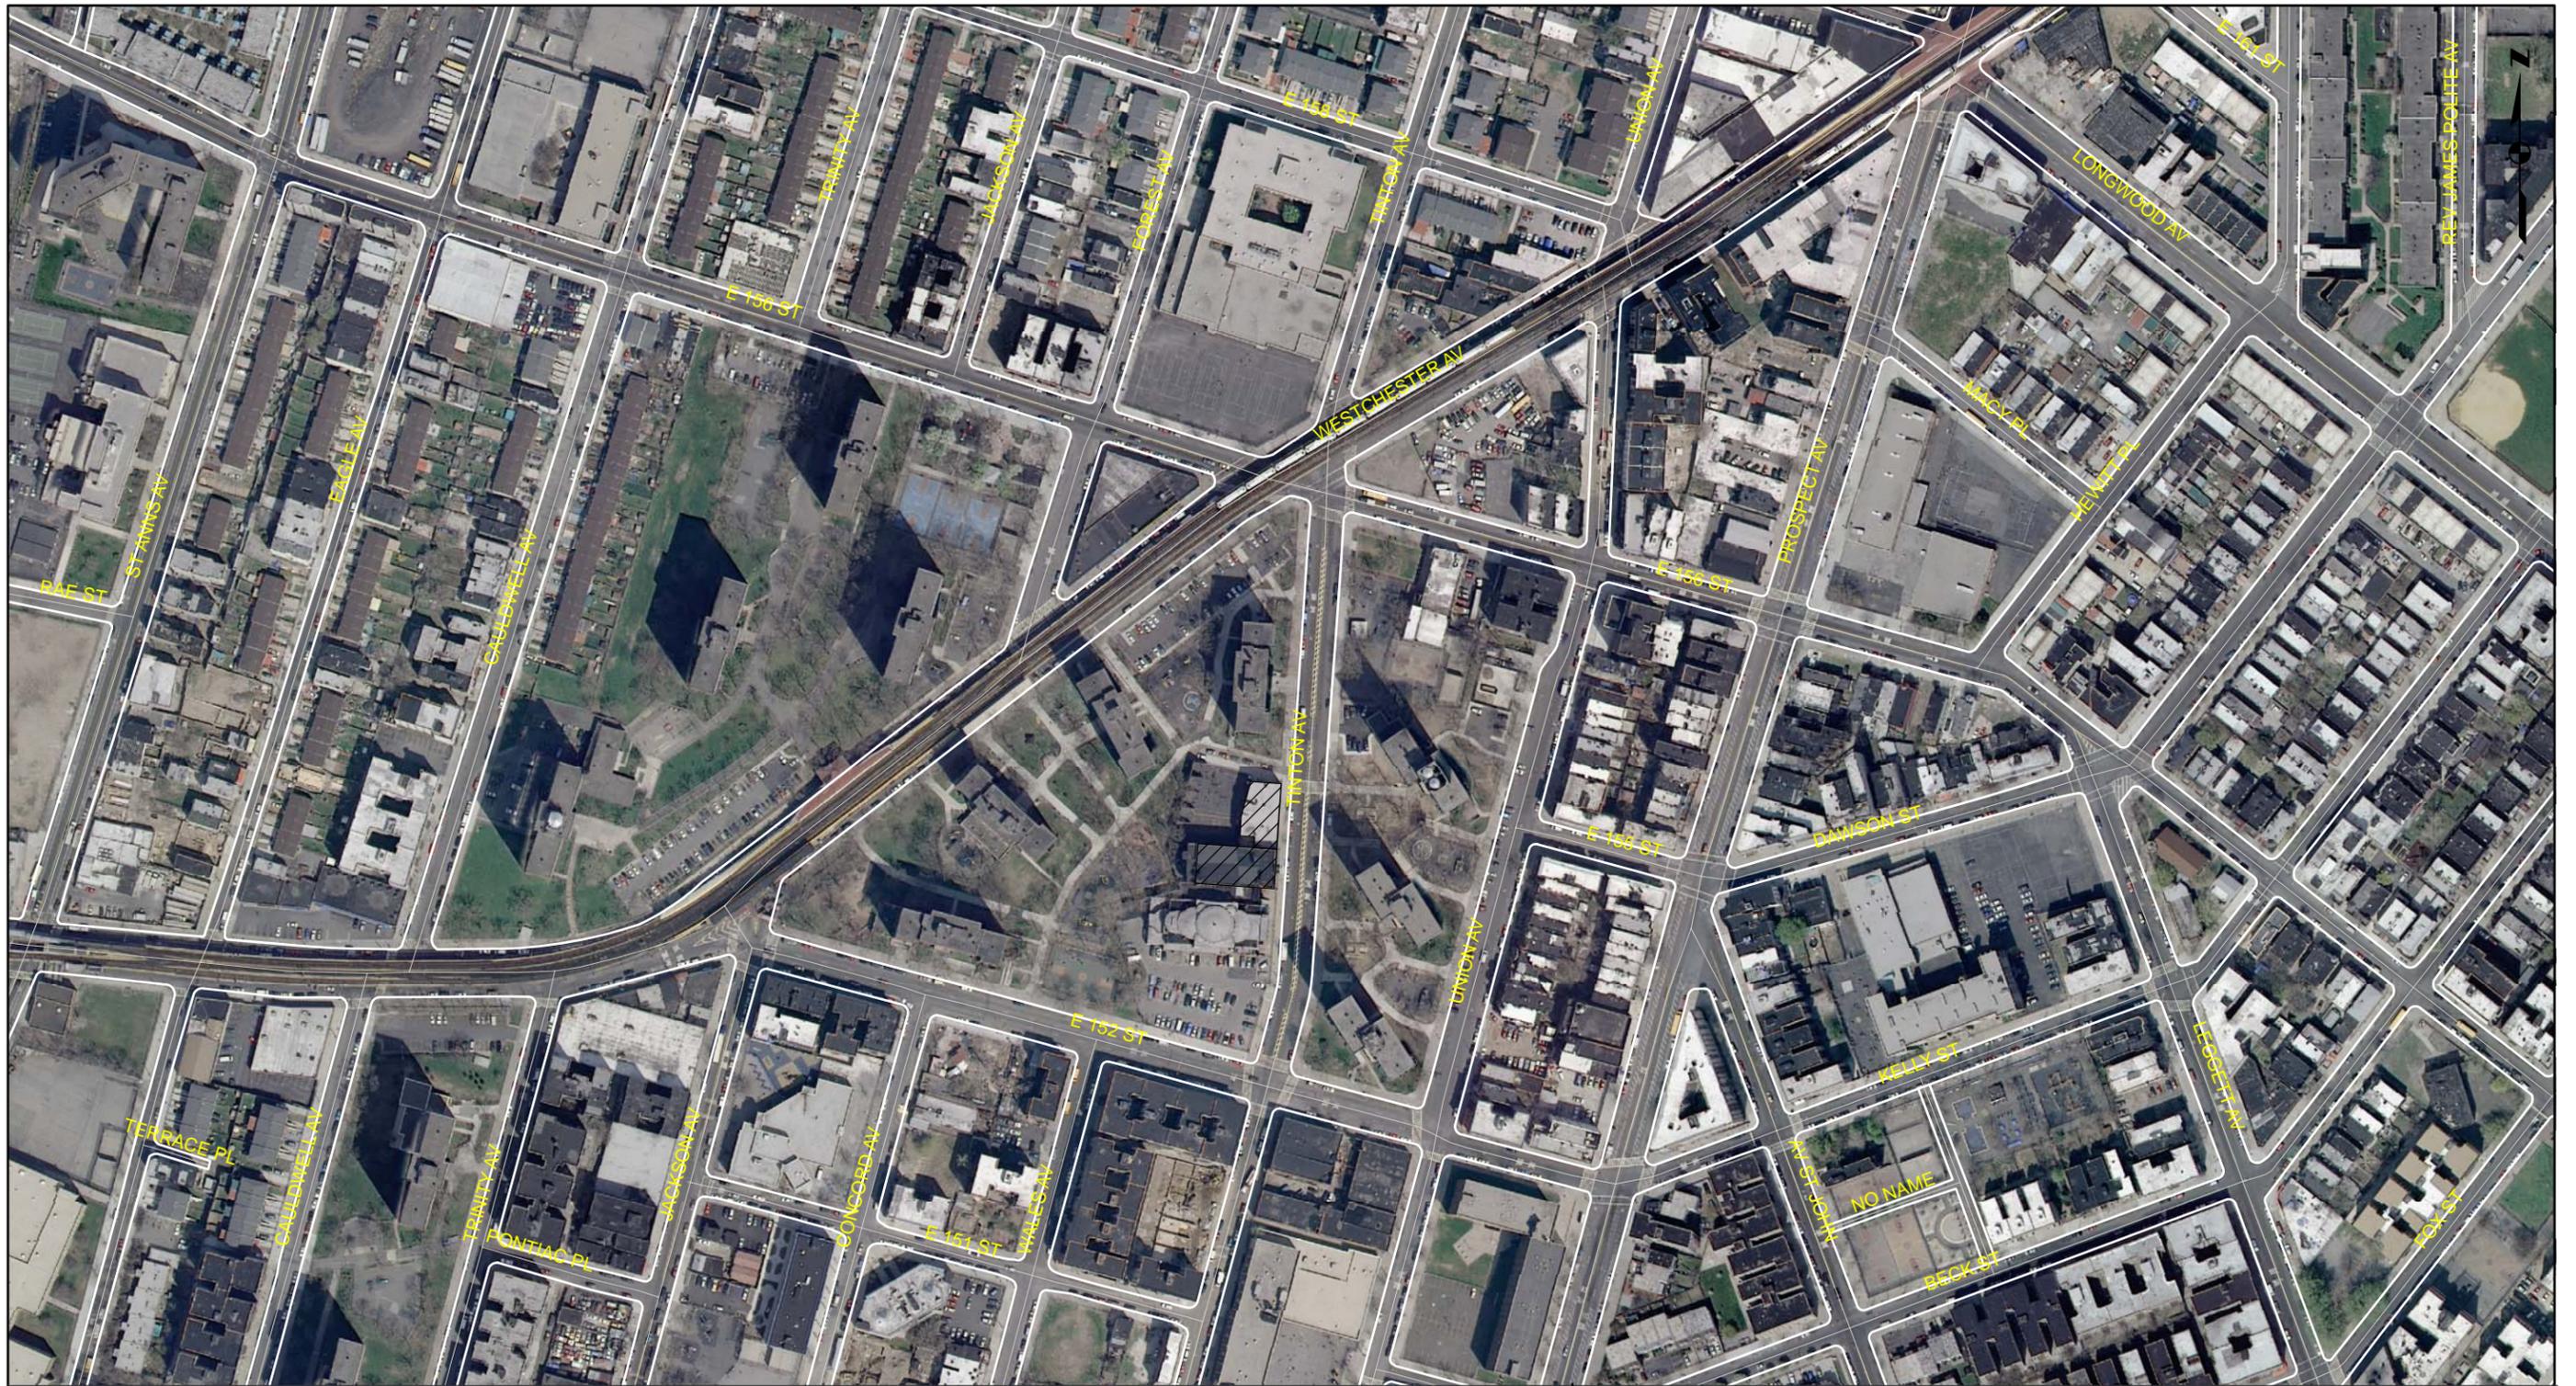
**EXHIBIT 1**

Exhibit 1, at the end of this section, shows an aerial view of the neighborhood surrounding the St. Anselm School, which is generally high density residential in character. St. Anselm is situated on the west side of Tinton Avenue, north of East 152<sup>nd</sup> Street, and is also bounded by Westchester Avenue to the northwest.

**AERIAL PHOTOGRAPH**

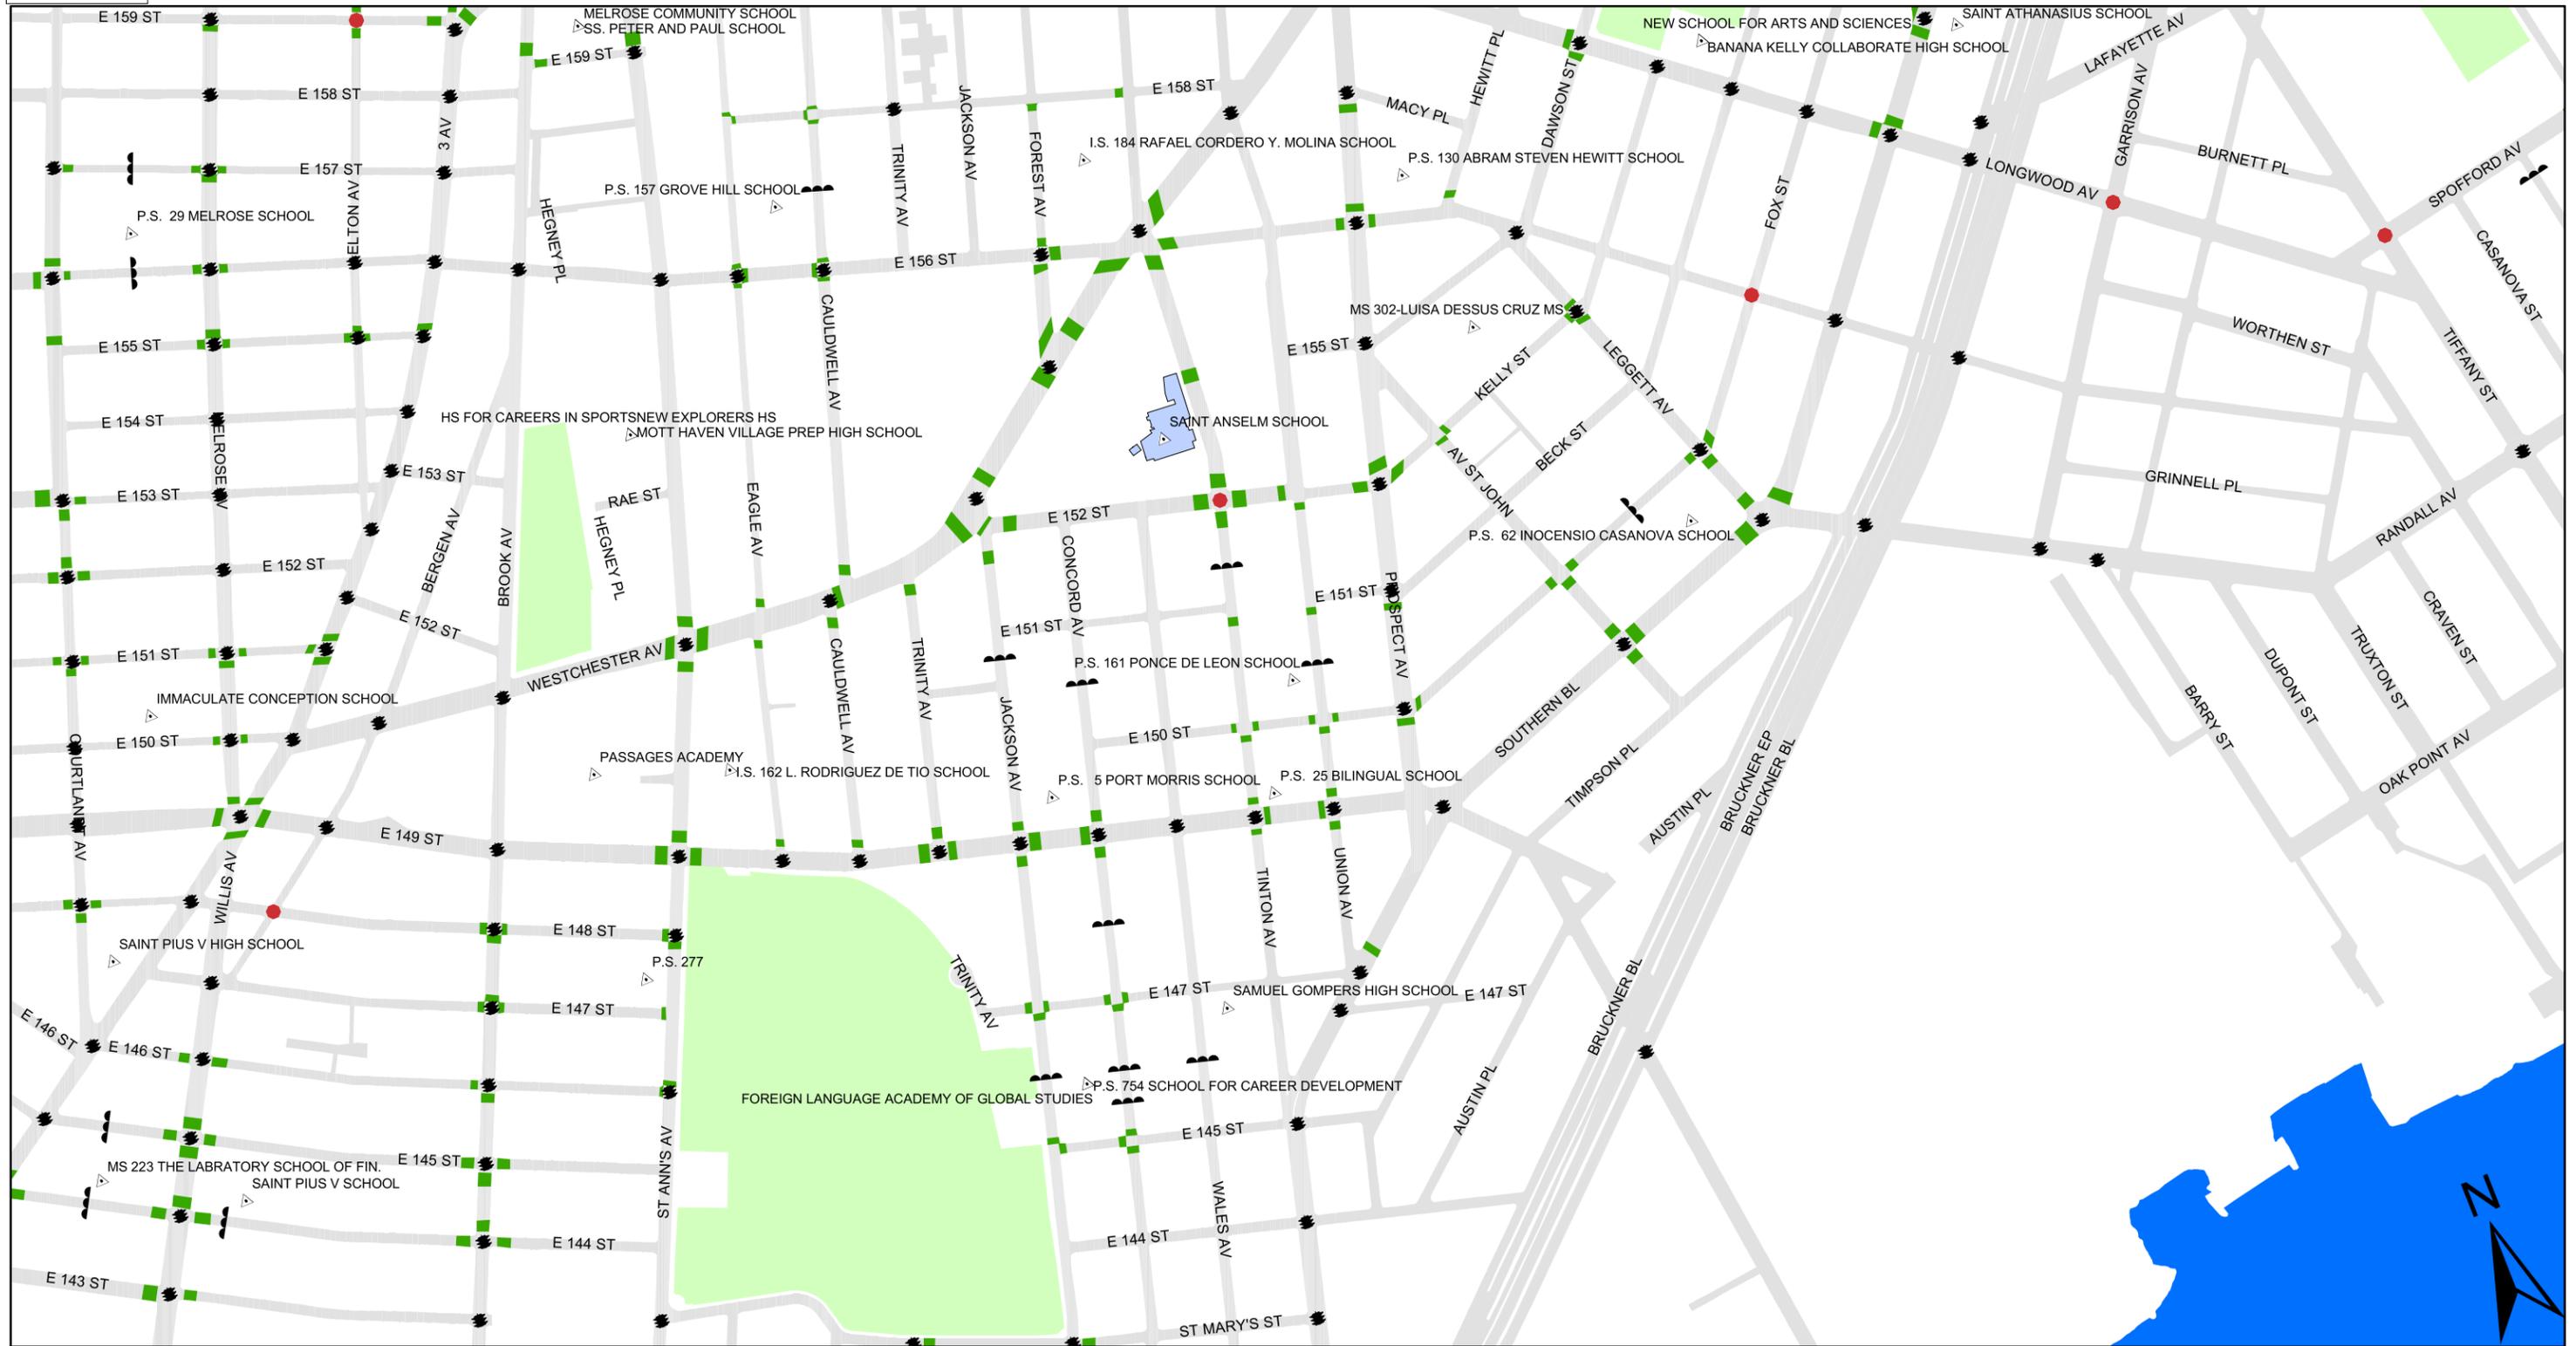
**EXHIBIT 2**

The School Traffic Safety Map was established to help provide the maximum degree of safety for children going to and from school - by indicating the location of speed reducers, school crosswalks and some traffic control devices. (While virtually all intersections in NYC benefit from traffic control devices - such as stop signs, traffic signals, yield signs, and all way stop signs - this map shows only traffic signals and all way stop signs.) The school crosswalks that are shown are ladder striped and make the crosswalk more visible to drivers and help make the intersection safer. These crosswalks are where school children are recommended to cross.

Exhibit 2, at the end of Section 2, shows the existing signals, and school signs and markings assigned to Saint Anselm School. It should be noted that a citywide signage program is currently underway to upgrade school signage to current Federal Manual on Uniform Traffic Control Devices (MUTCD) standards of fluorescent yellow-green accompanied by downward pointing arrows. Signs scheduled to be installed under this program are shown as “existing” in Exhibit 6.

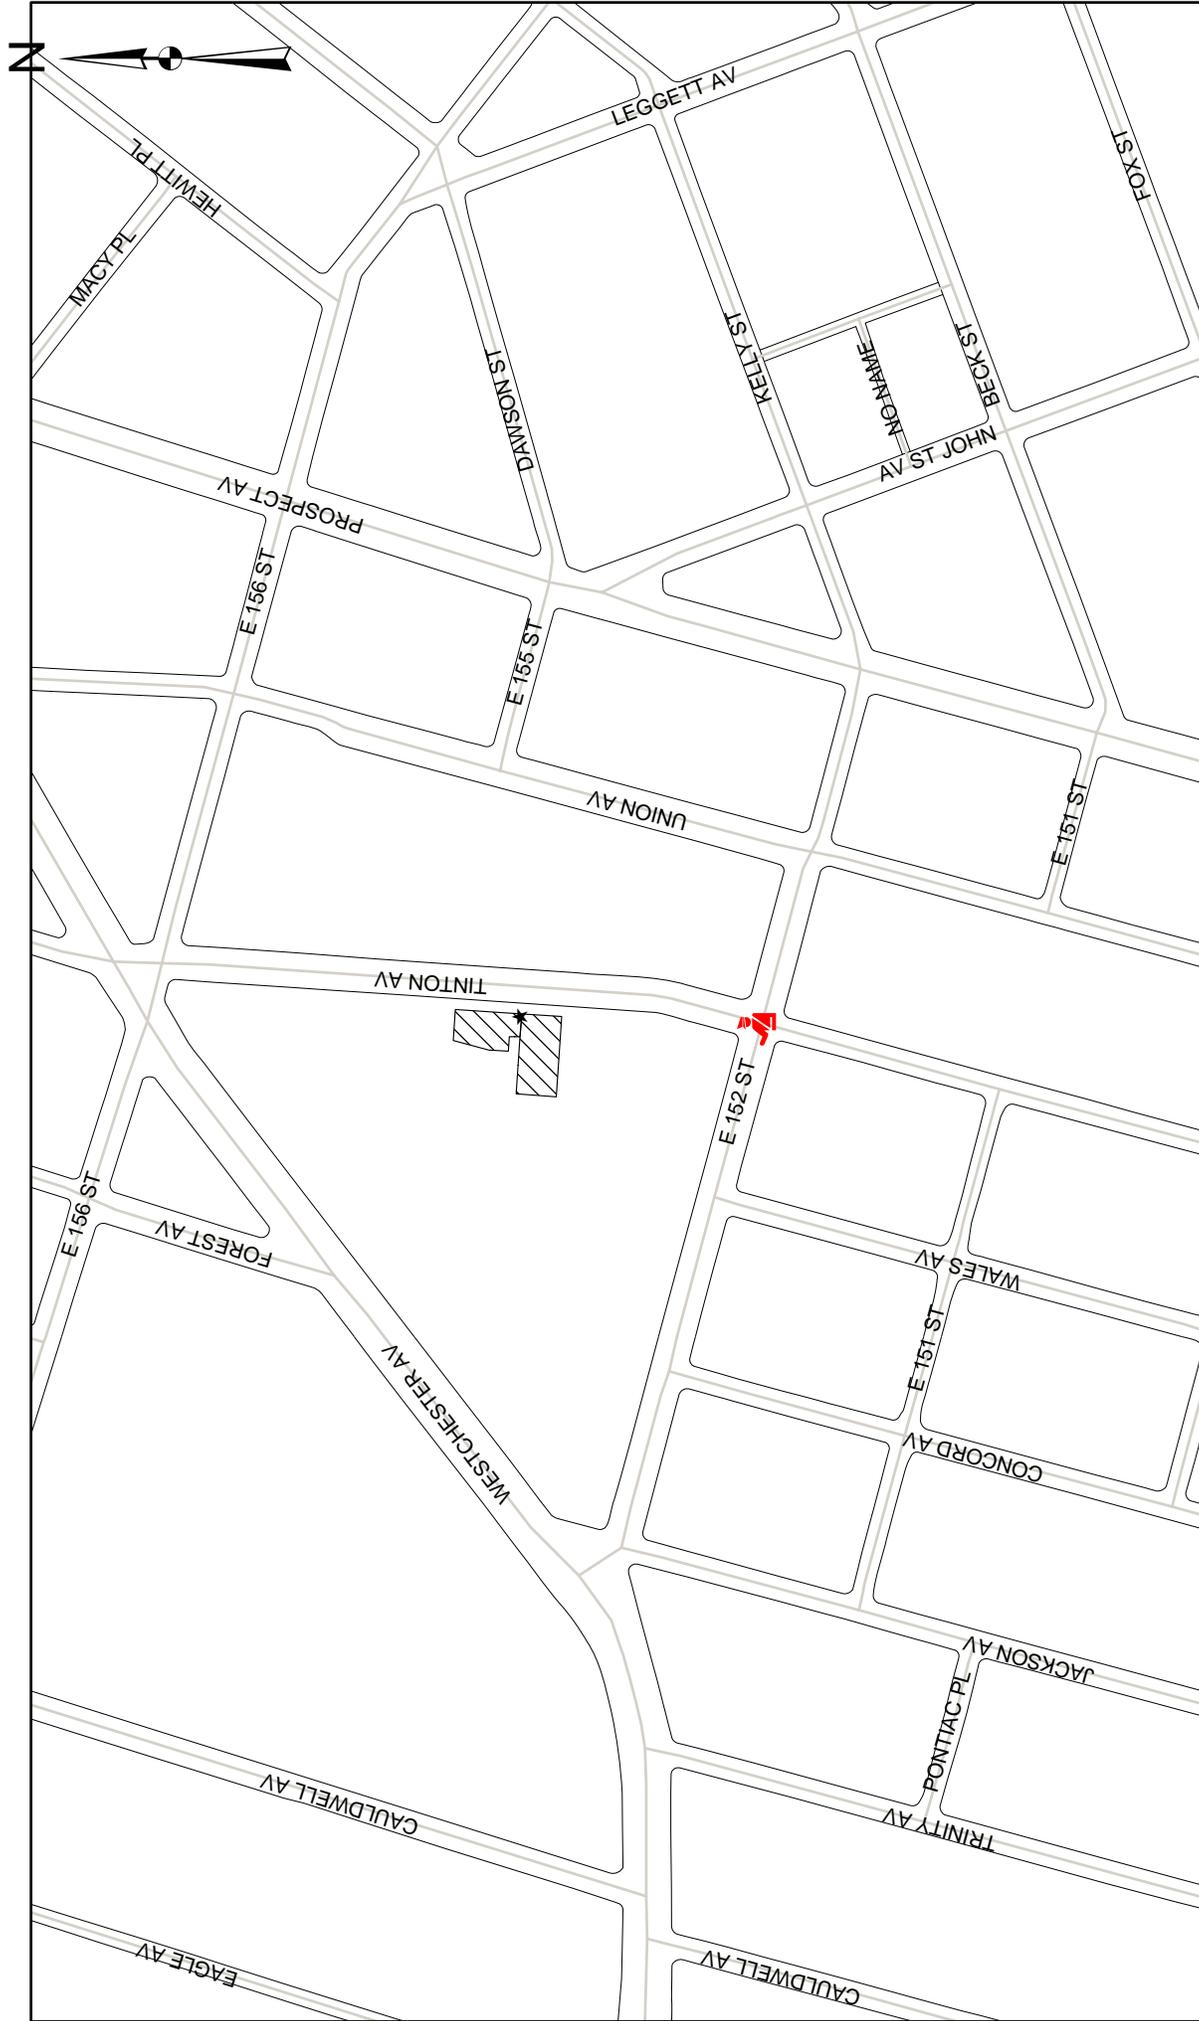
**EXHIBIT 3**

The crossing guard location is shown in Exhibit 3 at the end of this section.

**CROSSING GUARDS LOCATION**

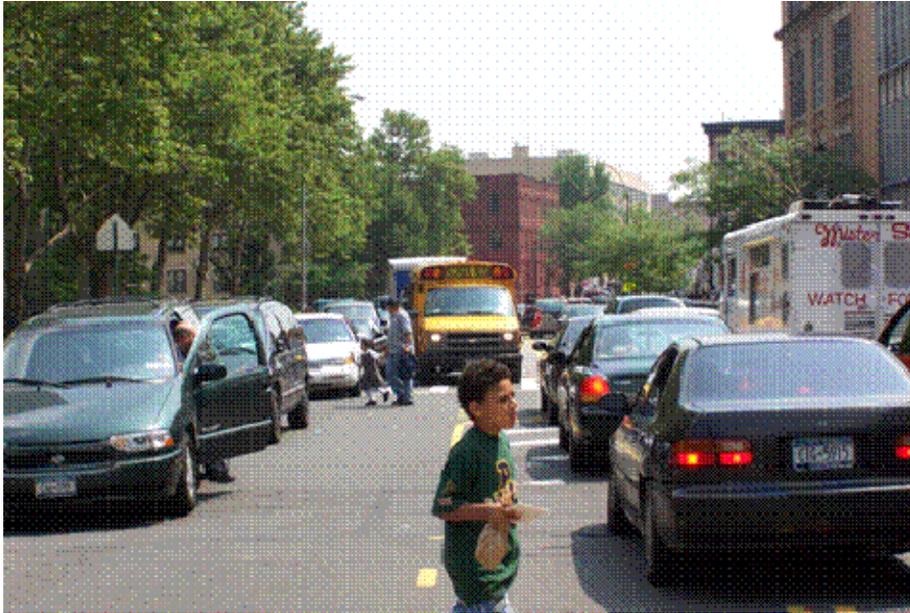
Double parking was observed in both directions on Tinton Avenue during afternoon dismissal. Congestion was observed during the morning arrival period.

*Figure 5: Looking south at congestion and double-parking at dismissal time along Tinton Ave in front of St. Anselm School*

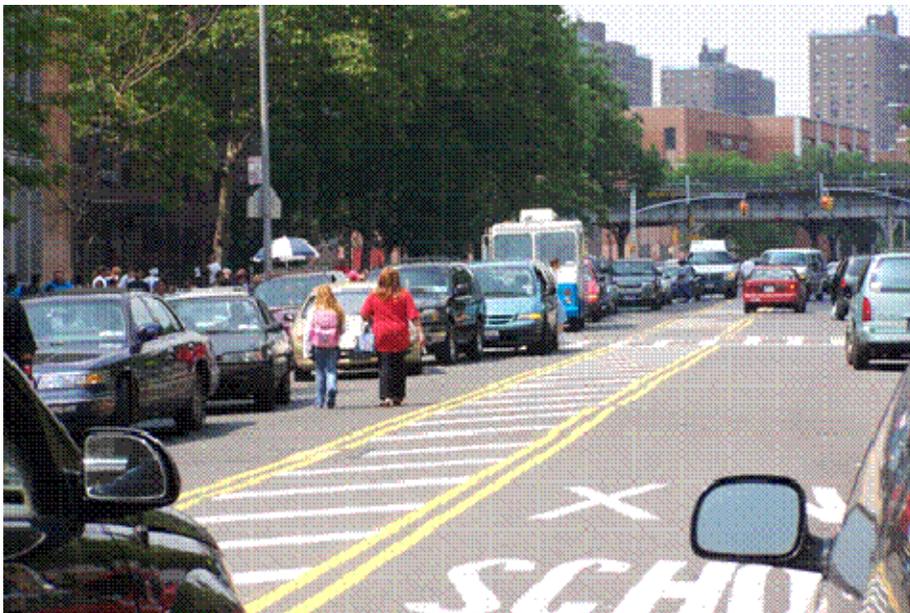
*Figure 6: Looking north along Tinton Avenue at double-parking at dismissal time at St. Anselm School*

the roadway in front of the school. There is a painted median along the center of the roadway on Tinton Avenue, separating northbound and southbound traffic. This median further serves as a speed reducer by narrowing the traffic lanes (see Figure 6).

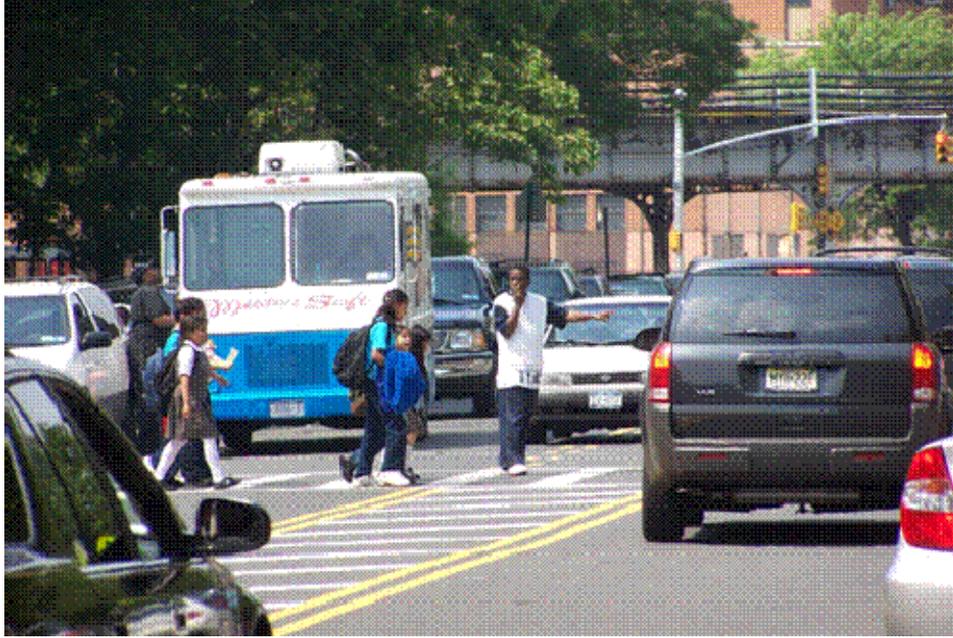
*Figure 7: Students using mid-block crosswalk at dismissal time in front of St. Anselm School*

The pedestrian ramp on the west side of Tinton Avenue for the mid-block crosswalk in front of the school is missing.

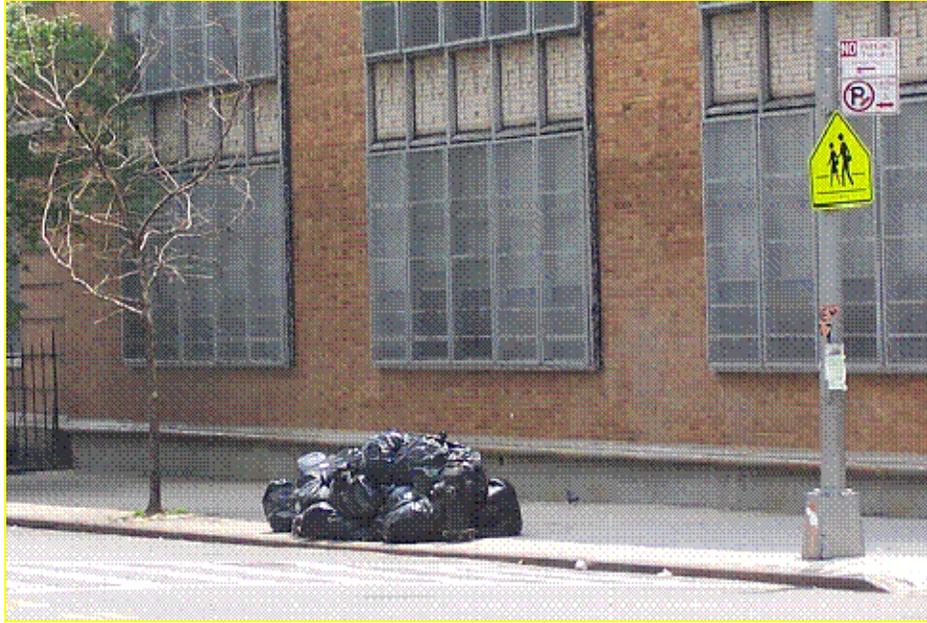
Figure 8: School mid-block crosswalk and sign on Tinton Avenue in front of St. Anselm School

Replace the existing “No Parking 7AM - 4PM School Days” signs with “No Standing 7AM - 4PM School Days” in front of the school and in particular at the main entrance of the school. (This is a typical requirement for all NYC schools in order to provide for emergency access to and from the school.)

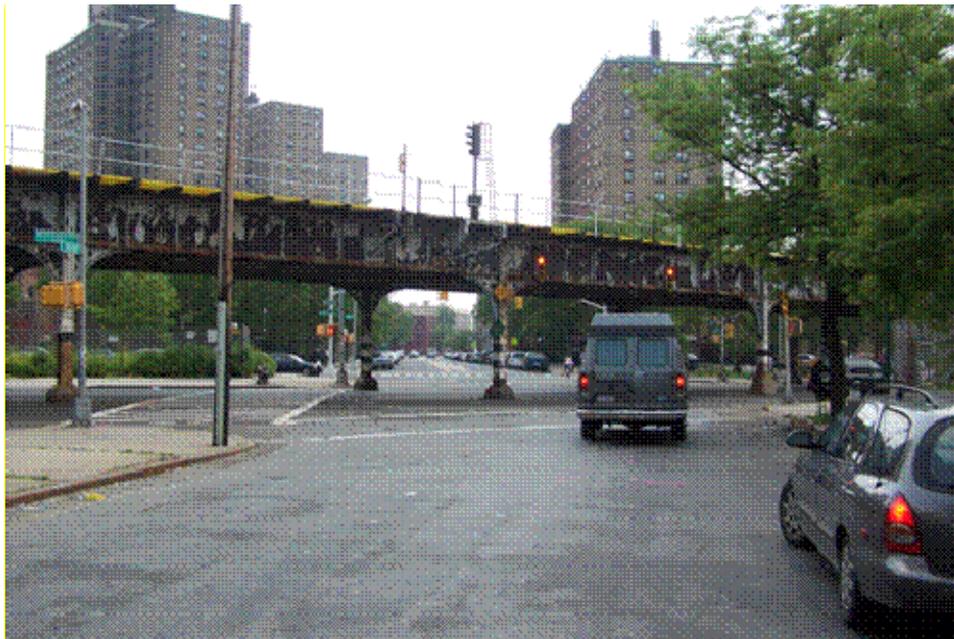
Westchester Avenue is a two-way street with two travel lanes and a parking lane on each side of the roadway. Westchester Avenue also has an elevated train (No. 2 Train, Seventh Avenue Express and No. 5 Train Lexington Avenue Express) running over the center of the roadway. The supporting columns for the train tracks are located so that they provide an inner and an outer lane for each direction of travel (see Figures 9 and 10). Tinton Avenue is two-way street with one travel lane and a parking lane on each side of

This intersection has been the site of four (4) accidents between 1998 and 2000 with no pedestrian accidents. The NYPD accident data (Table 3) shows sixteen (16) accidents between 2001 and 2004 including one pedestrian accident that was not a school-related accident.

*Figure 9: Looking south on Tinton Ave toward Westchester Ave /East 156<sup>th</sup> Street intersection*

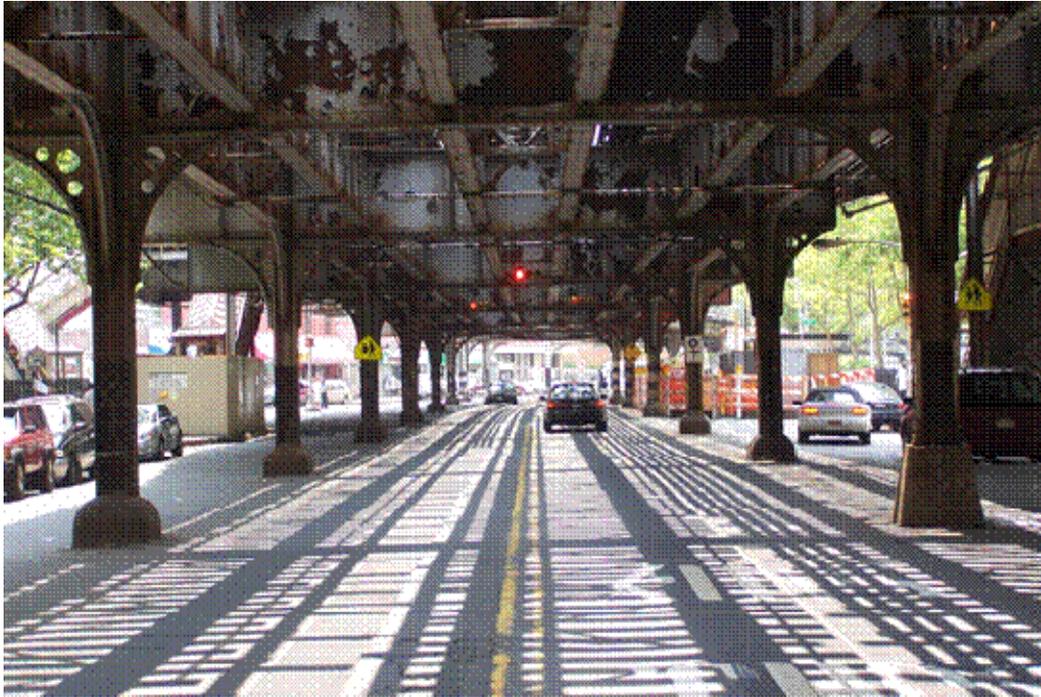
Figure 10: Looking west along Westchester Avenue toward Tinton Ave / East 156<sup>th</sup> St intersection

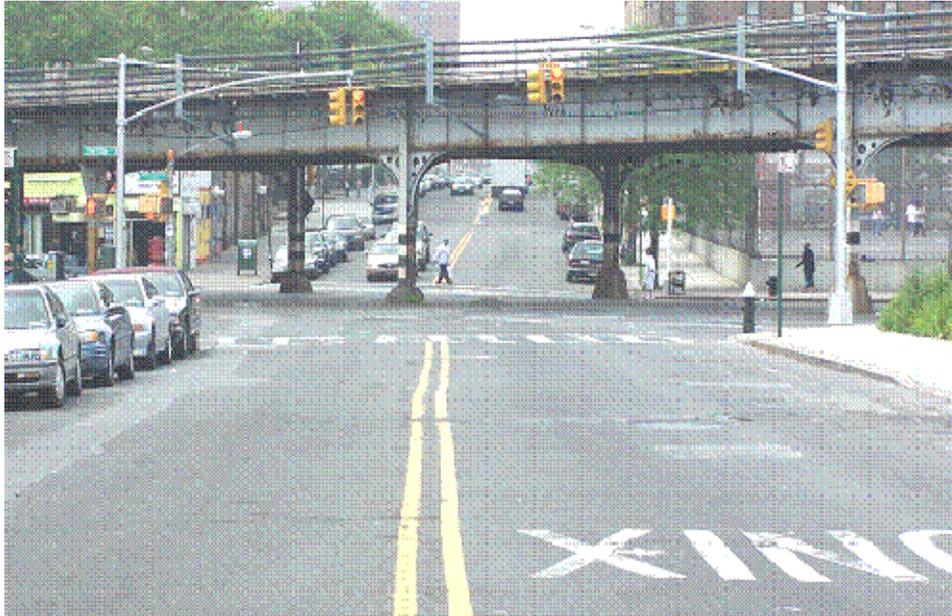
Westchester Avenue is a two-way street with two travel lanes and a parking lane on each side of the roadway. Westchester Avenue also has an elevated train (No. 2 Train, Seventh Avenue Express and No. 5 Train, Lexington Avenue Express) running over the center of the roadway. The supports for the train are located so that they provide an inner and an outer lane for each direction of travel (see Figures 10 and 11). East 156<sup>th</sup> Street is a two-way street, with one travel lane and a parking lane on each side of the roadway. It is generally residential in character (see Figure 11).

This intersection has been the site of twenty-two (22) accidents between 1998 and 2000, one (1) of which was a pedestrian accident that was also a school-related accident. The school-related accident occurred on Thursday, February 5, 1998 at 8:00 am and involved a thirteen-year-old pedestrian, whose actions were not reported. The specific accident location was also not reported. The weather was rainy and the road was wet. The reported type of injury was “possible injury.” The NYPD accident data (Table 3) shows twenty-nine (29) accidents between 2001 and 2004 including five (5) pedestrian accidents, one (1) of which was a school-related accident. No further information about the school-related accident is available. There were no pedestrian fatalities during the same four-year period.

*Figure 11: Looking west on East 156th Street toward Westchester Avenue/Tinton Avenue intersection*

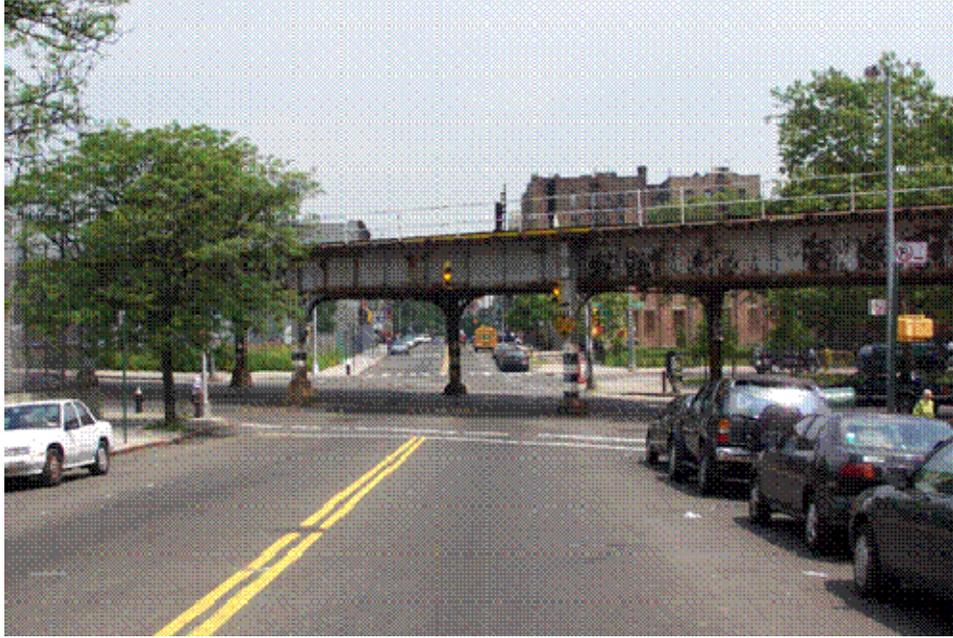
Tinton Avenue is two-way street with one travel lane and a parking lane on each side of the roadway. East 156<sup>th</sup> Street is a two-way street, with one travel lane and a parking lane on each side of the roadway. It is generally residential in character (see Figures 11 and 12).

This intersection has been the site of six (6) accidents between 1998 and 2000; two (2) of these were pedestrian accidents, neither of which was a school-related accident. The NYPD accident data (Table 3) shows sixteen (16) accidents including two (2) pedestrian accidents, neither of which was school-related, between 2001 and 2004.

*Figure 12: Looking east on East 156th Street toward Tinton Avenue/Westchester Avenue intersection*

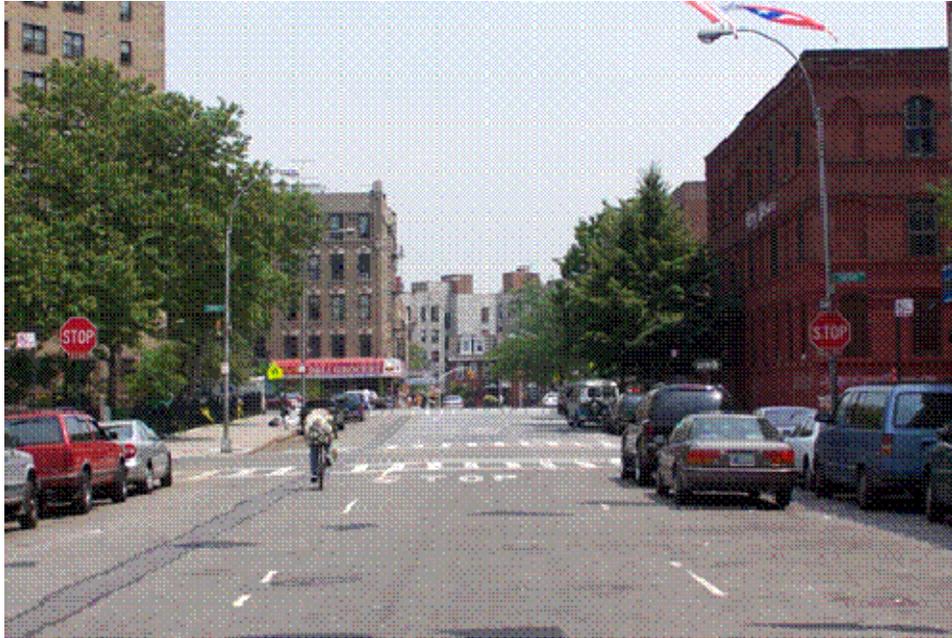
Tinton Avenue, north of East 152<sup>nd</sup> Street, is a two-way street with one travel lane and a parking lane on each side of the roadway. South of East 152<sup>nd</sup> Street, Tinton Avenue is a one-way southbound street (away from the intersection) with one travel lane and parking on both sides of the roadway. East 152<sup>nd</sup> Street is a one-way eastbound street, with three moving lanes and parking on both sides of the roadway (see Figures 13 and 14).

This intersection has been the site of five (5) accidents between 1998 and 2000; one (1) of these was a pedestrian accident that was also a school-related accident. In the school-related accident, an eleven-year-old pedestrian sustained a “non-incapacitating injury” on Friday, May 1, 1998 at 3:00 pm. The pedestrian was reported as crossing against the signal, although there is no signal at this location. The light condition was daylight, the road was dry, and the weather was cloudy. The NYPD accident data (Table 3) shows twelve (12) accidents during the four-year period between 2001 and 2004 including two (2) pedestrian accidents, neither of which was a school-related accident.

*Figure 13: Looking east along East 152<sup>nd</sup> Street toward Tinton Avenue intersection*

- Provide curb extensions (neckdowns) at all four corners of East 152<sup>nd</sup> Street at its intersection with Tinton Avenue.
- Extend the east and west sidewalks by six (6) feet at the mid-block pedestrian crossing on Tinton Avenue in order to reduce the crossing distance.
- Provide curb extensions (neckdowns) at northwest and southwest, and northeast corners of Union Avenue and East 152<sup>nd</sup> Street intersection.
- Provide curb extension (neckdowns) at the northwest, southwest, and northeast corners of East 152<sup>nd</sup> Street and Prospect Street intersection.
- Provide curb extensions (neckdowns) at the southeast and southwest corners of Westchester Avenue at its intersection with E. 156<sup>th</sup> Street.

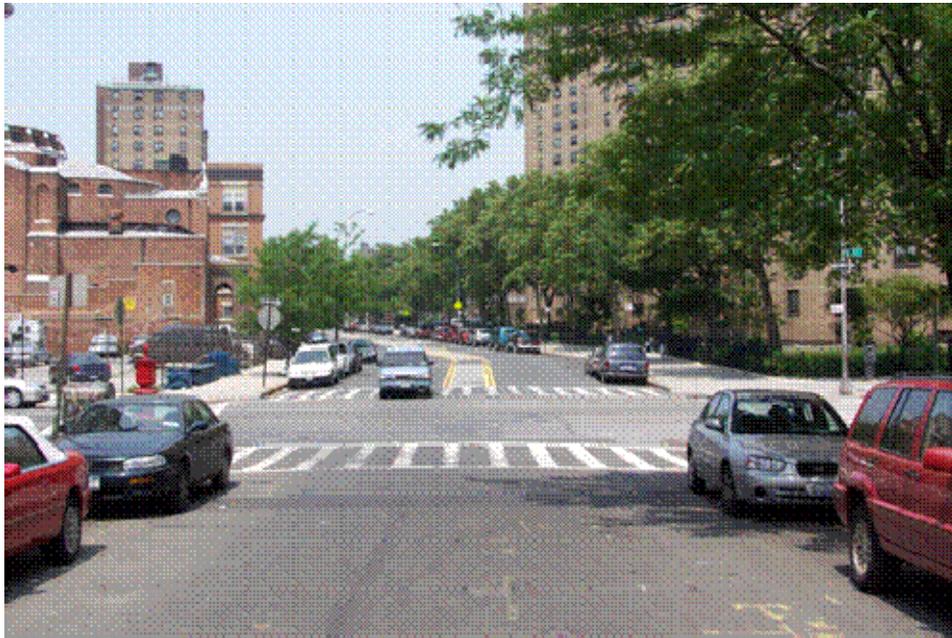
*Figure 14: Looking north on Tinton Avenue at intersection of East 152<sup>nd</sup> Street*

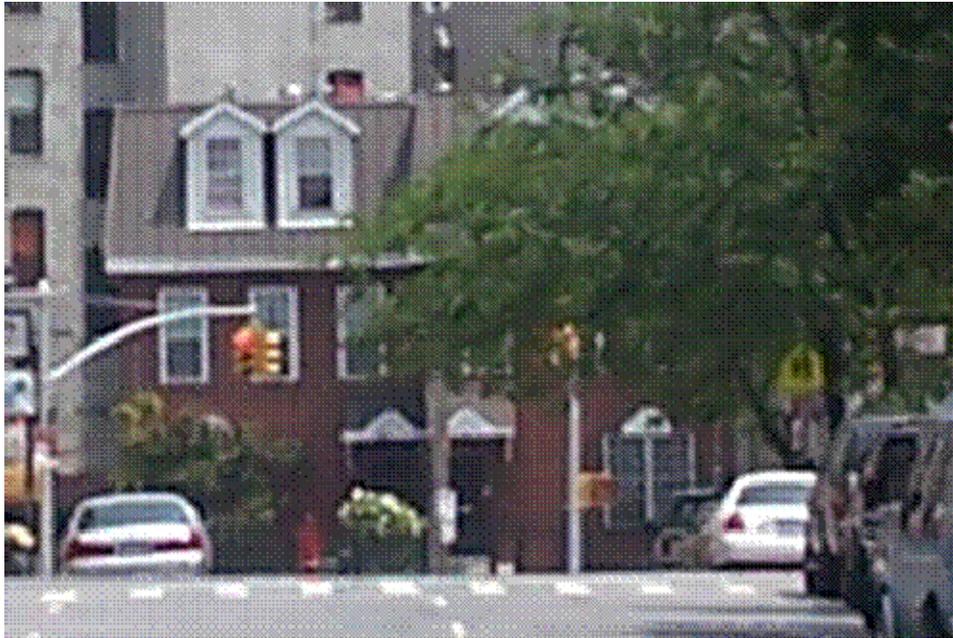
*Figure 16: Looking east along East 152nd Street across Union Avenue toward Prospect Avenue*

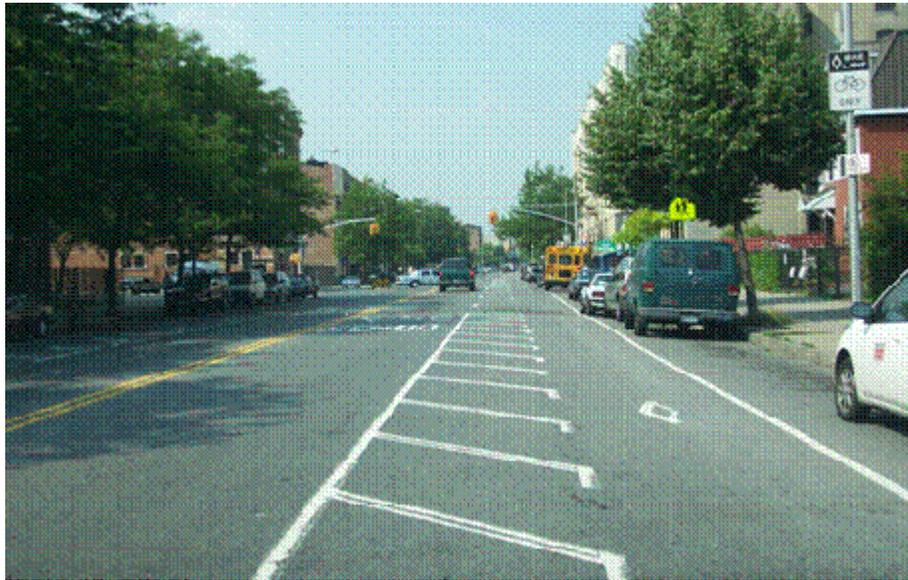
Prospect Avenue is a two-way street with a travel lane, a bicycle lane, and a parking lane on each side of the roadway, and a painted median separating the bicycle lane and the

travel lane in each direction (see Figure 17). East 152<sup>nd</sup> Street is a one-way eastbound street, with one traffic lane and parking on both sides of the roadway between Union Avenue and Prospect Avenue (see Figure 16). Kelly Street is also a one-way eastbound street, with one traffic lane and parking on both sides of the roadway.

*Figure 17: Looking north along Prospect Avenue toward intersection of East 152nd Street*

The pedestrian ramp on the east side of Prospect Avenue for the pedestrian crosswalk on the south side of East 152<sup>nd</sup> Street / Kelly Street is missing.

- A pedestrian ramp be installed on the east side of Prospect Avenue for the pedestrian crosswalk on the south side of Kelly Street.

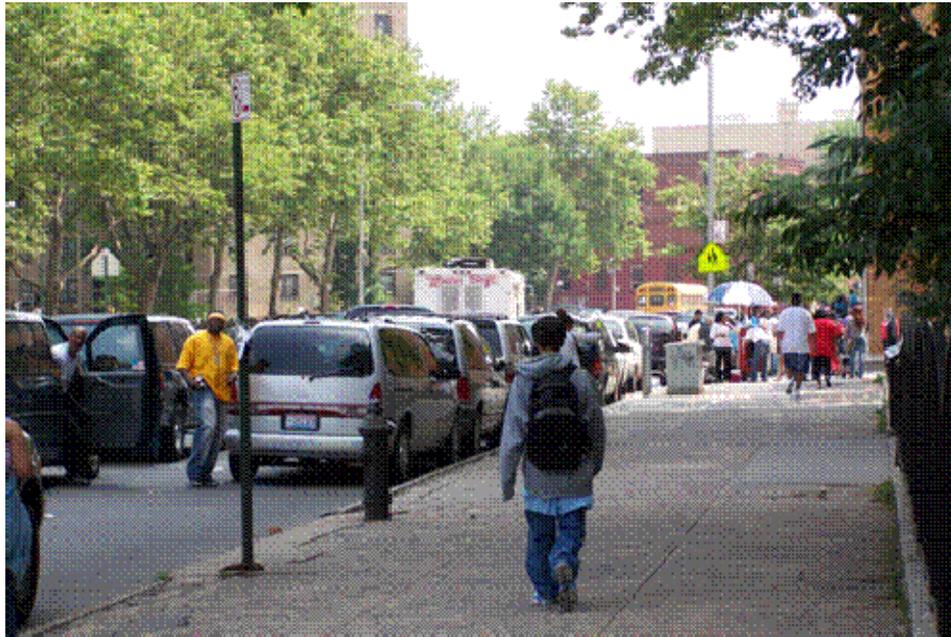
The sidewalks in the vicinity of St. Anselm School are generally ten to twelve feet wide and in fair condition (see Figure 18).

*Figure 18: Looking south along sidewalk in area of St. Anselm School on Tinton Avenue*
