**New York City Department of Transportation  
Office of School Safety Engineering**

**School Safety Engineering Project**

**FINAL REPORT: St. Anselm School, Bronx**

**Prepared by  
The RBA Group and URBITRAN Associates Inc.**

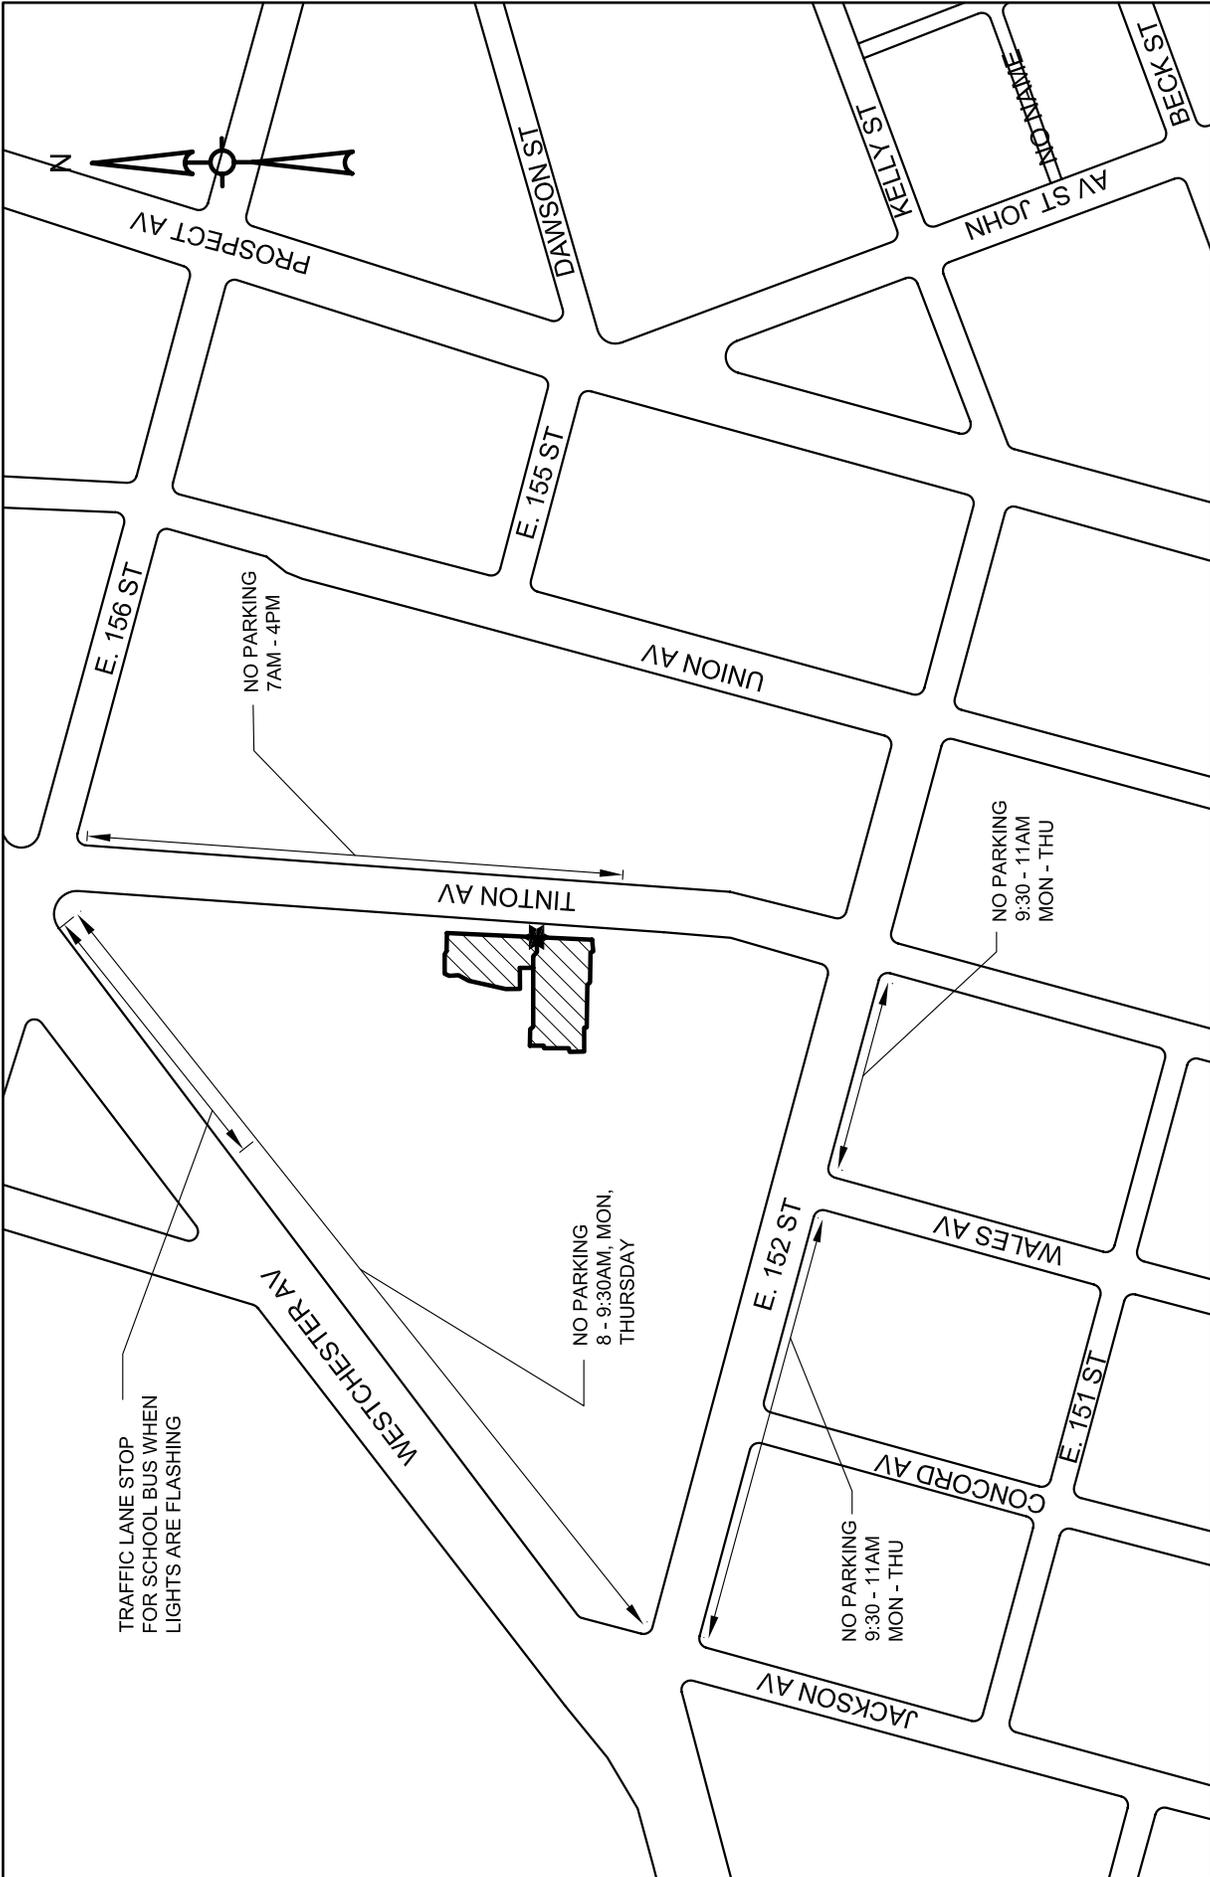
**EXHIBIT 4**  
**ST. ANSELM SCHOOL BRONX**

Parking regulations around the school block are shown in Exhibit 4, at the end of this section.

EXISTING PARKING REGULATIONS

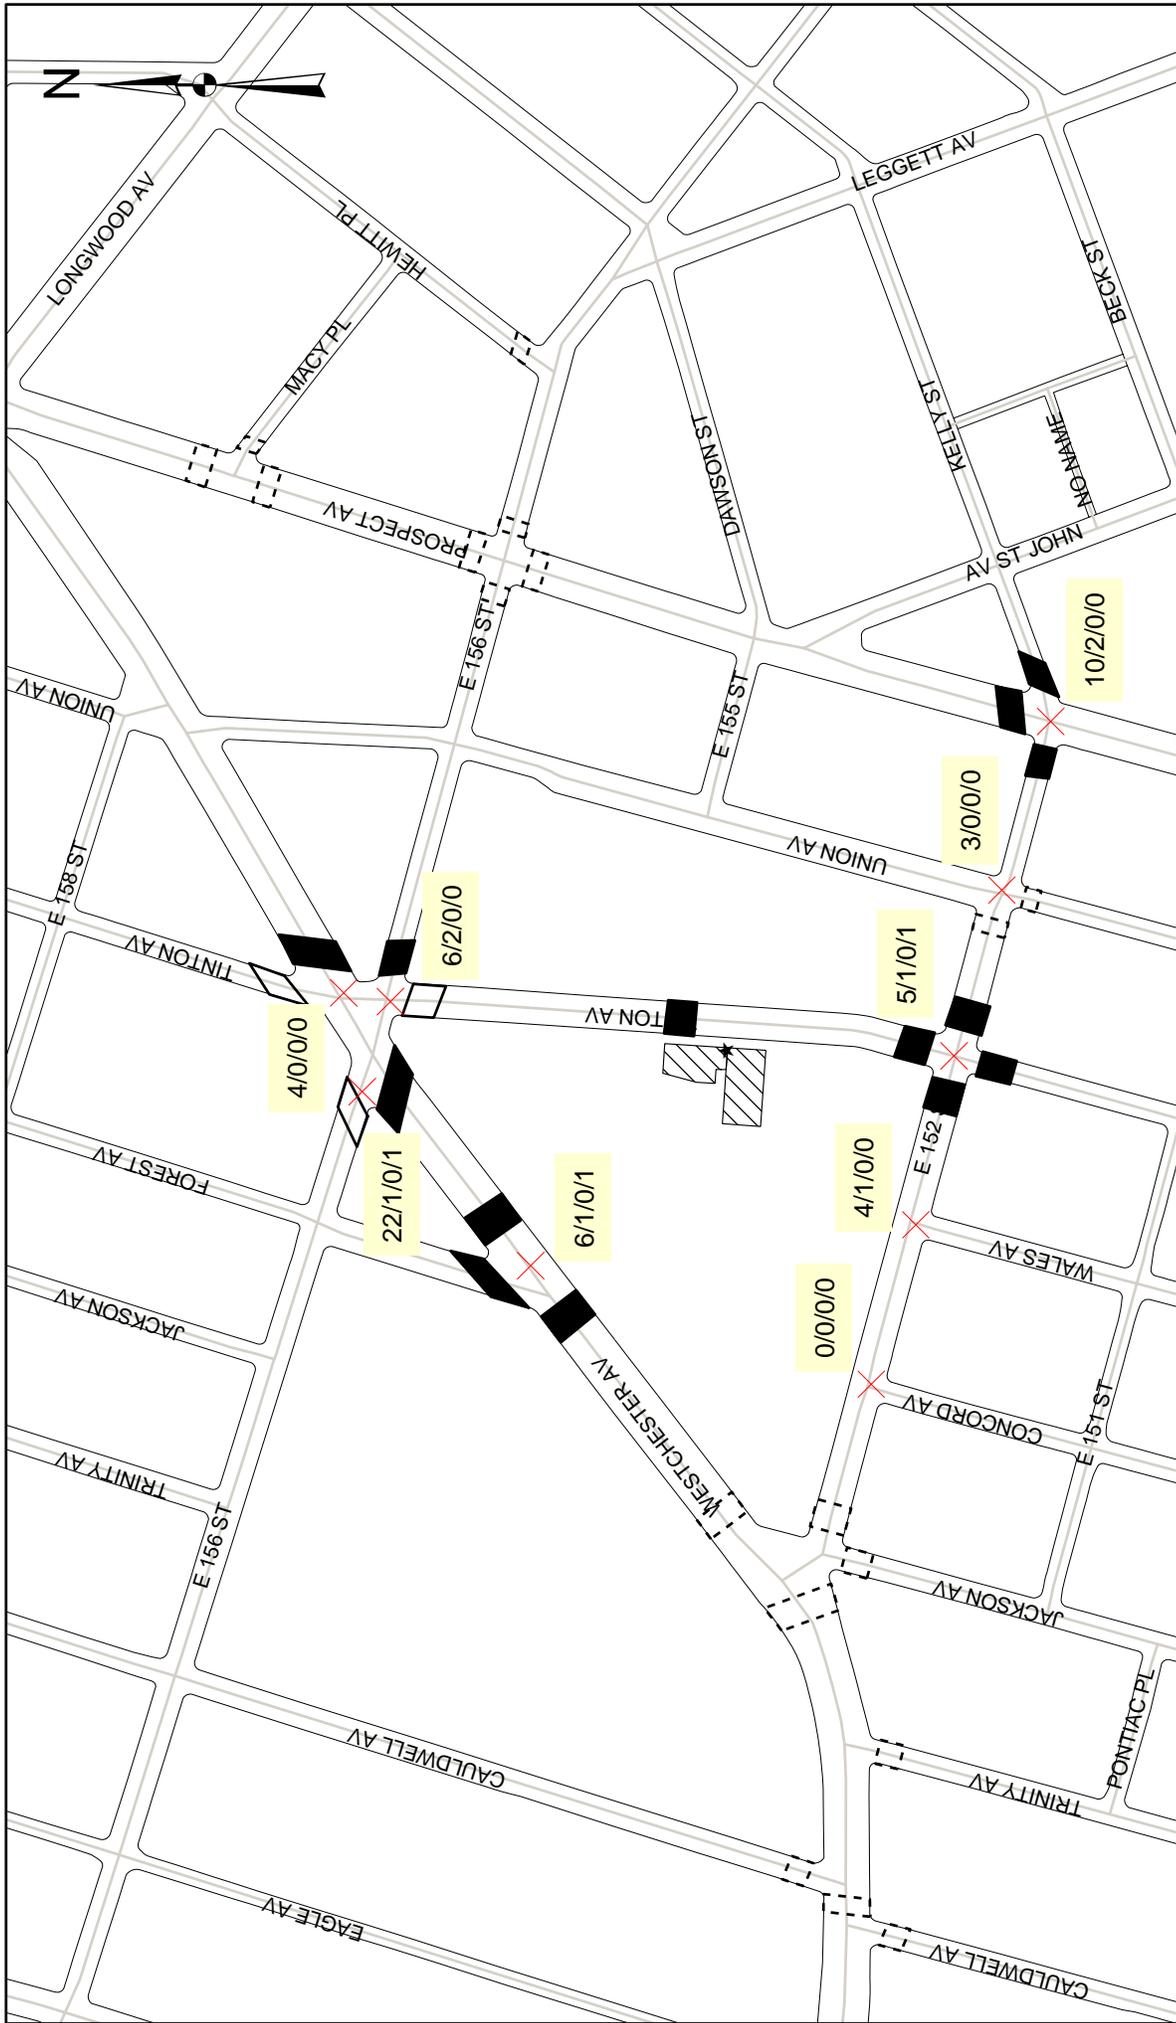
**EXHIBIT 5**

Exhibit 5, at the end of this section, and Table 2 show a summary of accidents, as obtained from the New York State Department of Motor Vehicles (DMV) in the vicinity of Saint Anselm School, for the three-year period from January 1, 1998 through December 1, 2000. The DMV data provides some detail relating to the cause of the accident. Table 3 is a summary of more recent accident data obtained from the New York City Police Department (NYPD). Though current through 2004, the NYPD data does not provide the same level of detail as the DMV data. Further discussions of accidents are included in Section 3.6, Traffic Operations and Issues.

**ACCIDENT SUMMARY (1998-2000)**

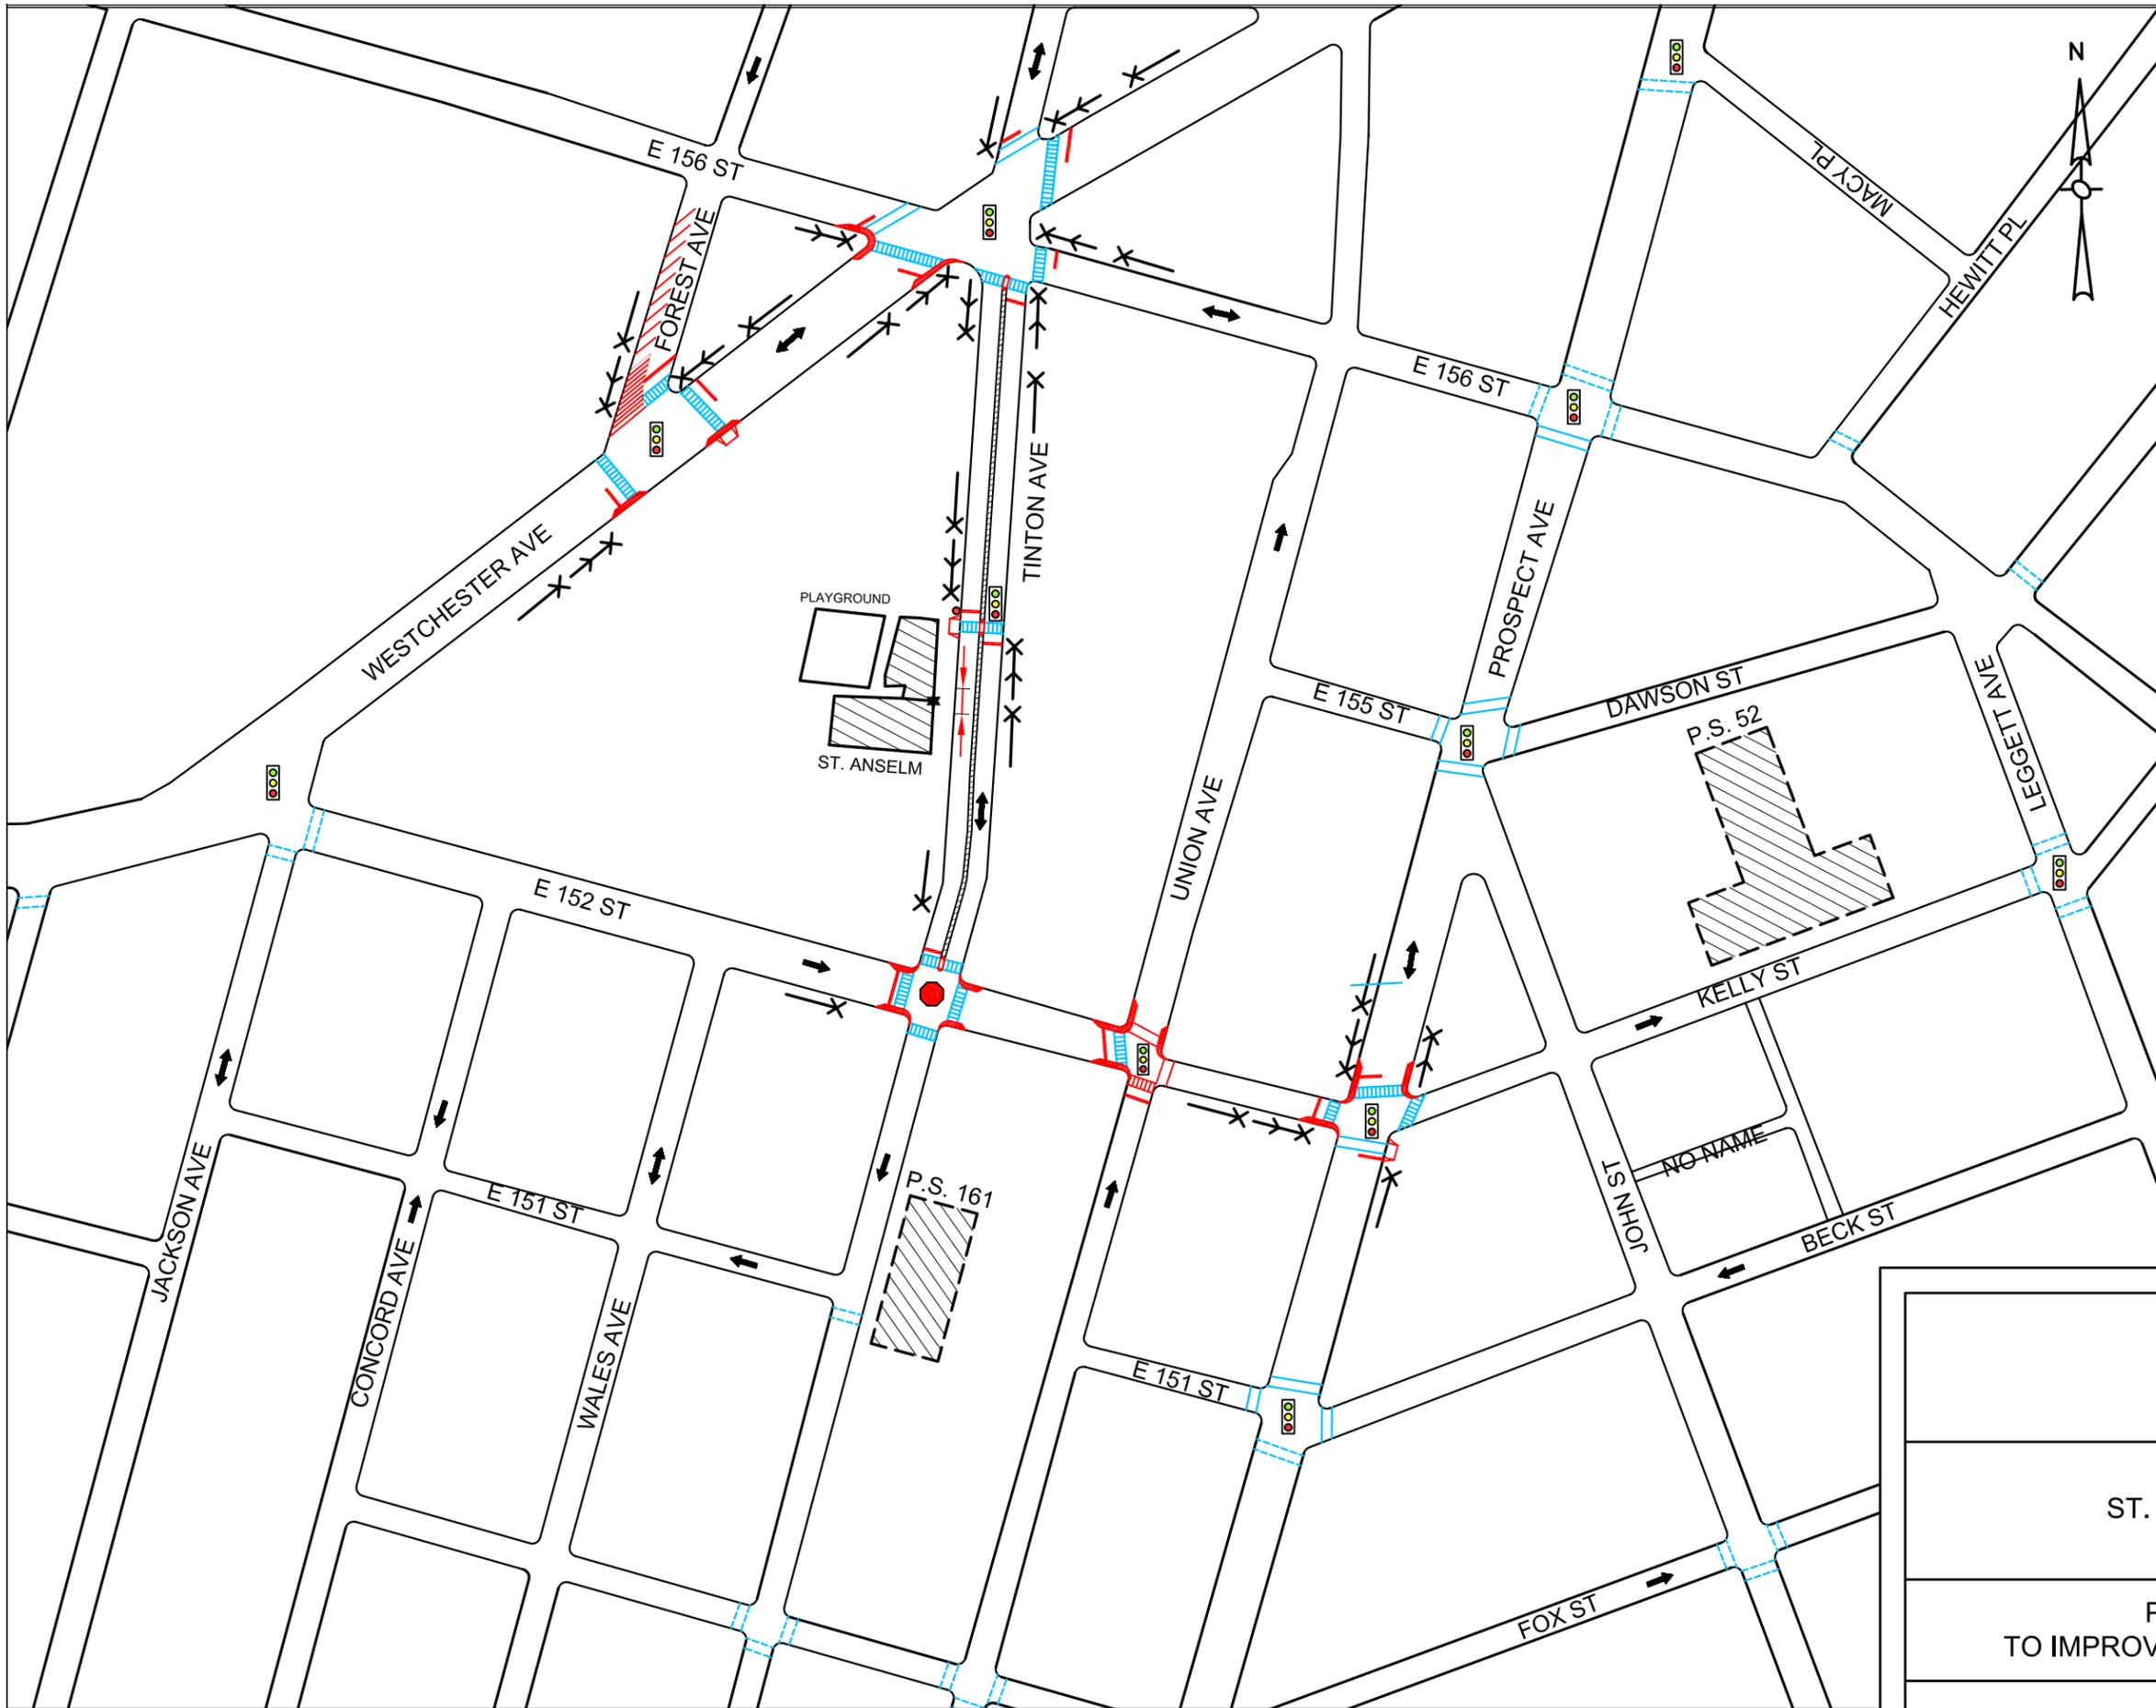
PROPOSED MEASURES TO IMPROVE SCHOOL PEDESTRIAN SAFETY

This section describes the proposed measures to improve student pedestrian safety around Saint Anselm School. The proposed recommendations are divided into short-term and long-term measures. Short-term measures are those that potentially can be performed in-house. Long-term measures involve capital improvements. Each of the short- and long-term measures recommended for Saint Anselm School is discussed as follows, and is shown in more detail in Exhibit 6 at the end of this section.

Curb extensions (neckdowns) should be installed at the corners as shown in Exhibit 6. The purpose of the curb extension is to provide additional reservoir space for pedestrian, to shorten the crossing distance for pedestrians, and to reduce the speed of vehicles approaching and turning on school crosswalks. The curb extension will not eliminate or reduce the width of any travel lanes. Curb extensions are not proposed where they would hinder the ability of a vehicle to turn.
