**New York City Department of Transportation
Office of School Safety Engineering**

School Safety Engineering Project

FINAL REPORT: I.S. 131, Dr. Sun Yat Sen School, Manhattan

**Prepared by
The RBA Group/Urbitrans Associates**

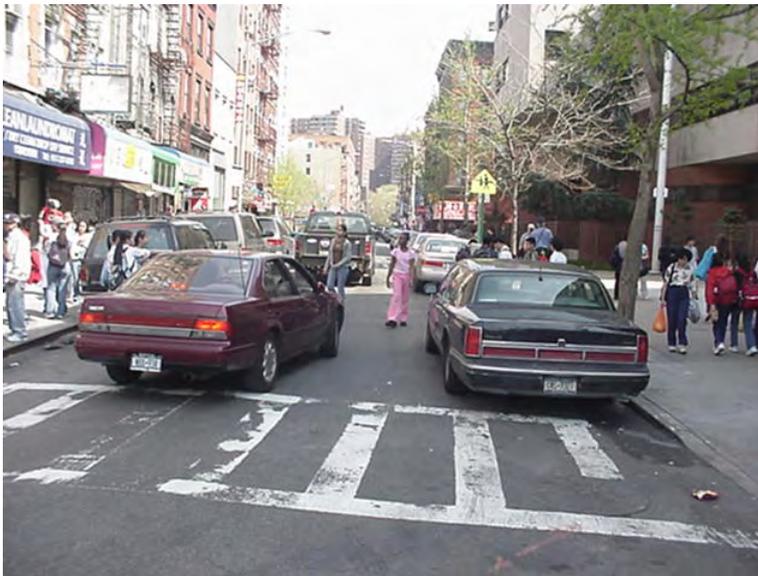
Figure 2: Congestion in front of I.S. 131 on Hester Street

- Vehicles disregard the stop sign at the intersection of Hester Street and Forsyth Street;
- Severe vehicle congestion and speeding near the school entrance on Hester Street;
- Illegally parked cars on Hester Street that narrow the travel lane;
- School buses blocking traffic while double parked on Hester Street to drop off and pick up students, or while waiting on Forsyth Street;
- There are no crossing guards assigned to I.S. 131;
- Students do not have enough time to cross Chrystie Street at Hester Street;
- Students cross mid-block on Hester Street between Forsyth Street and Eldridge Street;
- Sidewalks surrounding the school are generally missing, damaged, or not wide enough

“NO PARKING 7 AM- 4 PM, SCHOOL DAYS” parking regulations on Hester Street should be upgraded to “NO STANDING 7 AM- 4 PM, SCHOOL DAYS”. This will allow school buses a place to load and unload students at the curb, and also improve visibility of those students arriving to and leaving the school.

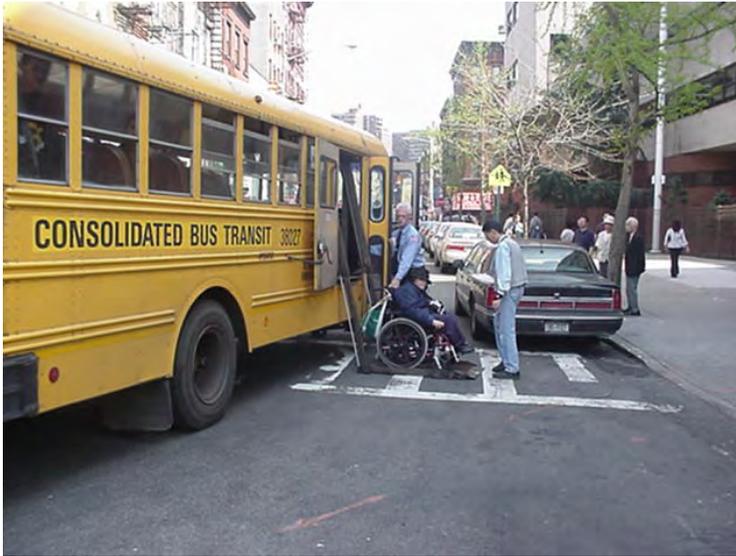
Figure 5: Handicapped student's bus access on Hester Street

School buses drop off and pick up students on Hester Street, near the school's main entrance. Buses line up on Forsyth Street before loading or unloading students. According to school officials, the double-parked buses block moving traffic on Hester Street and Forsyth Street.

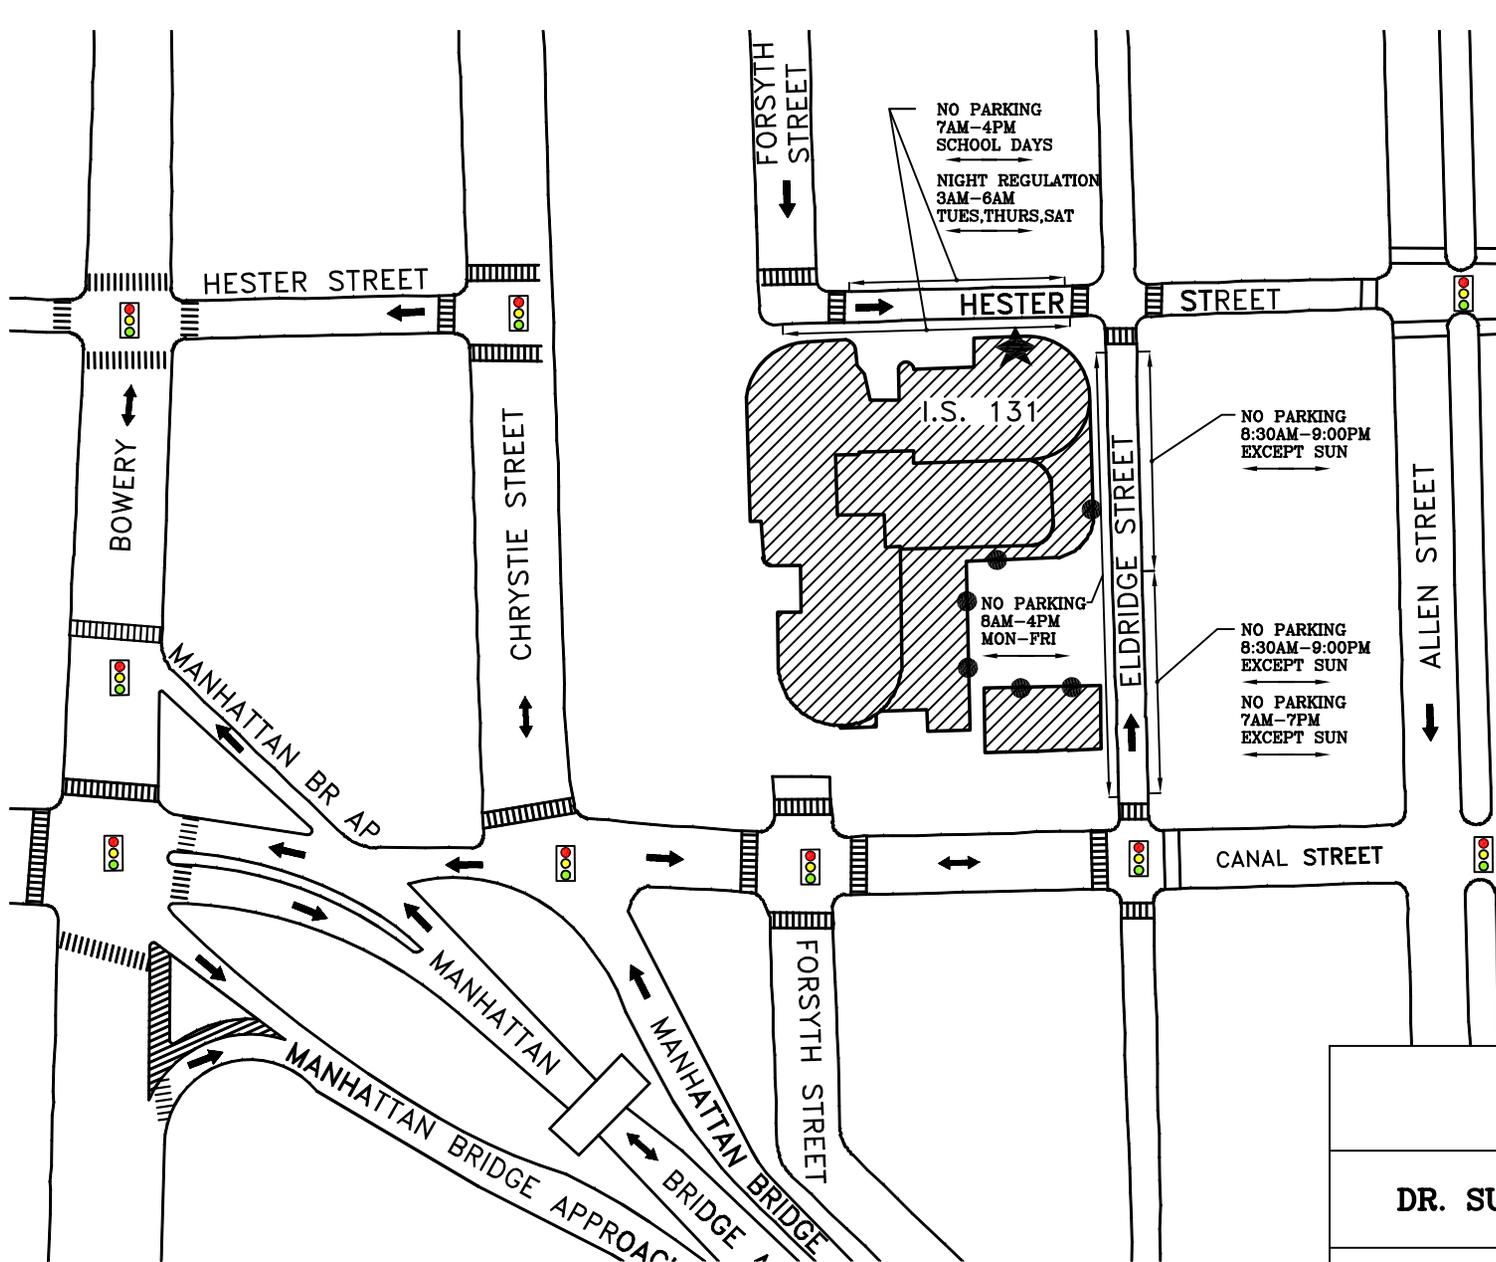
EXHIBIT 5

“NO PARKING 7:00 AM – 4 PM, SCHOOL DAYS” parking regulations are posted for the full length of the block on the south side of Hester Street.

“NO PARKING 8:00 AM – 9 PM, EXCEPT SUNDAY ” parking regulations are posted for the full length of the block on the both sides of Eldridge Street.

Exhibit 5 shows the existing parking regulations on the roadways surrounding I.S. 131.

EXISTING PARKING REGULATIONS

In addition, “NO PARKING 8:30 AM - 9:00 PM, EXCEPT SUNDAYS” parking regulations on the west side of Eldridge Street should be supplemented with “NO STANDING 7 AM- 4 PM, SCHOOL DAYS” from Hester Street for a length of 120 feet south of the intersection (see Exhibit 8).

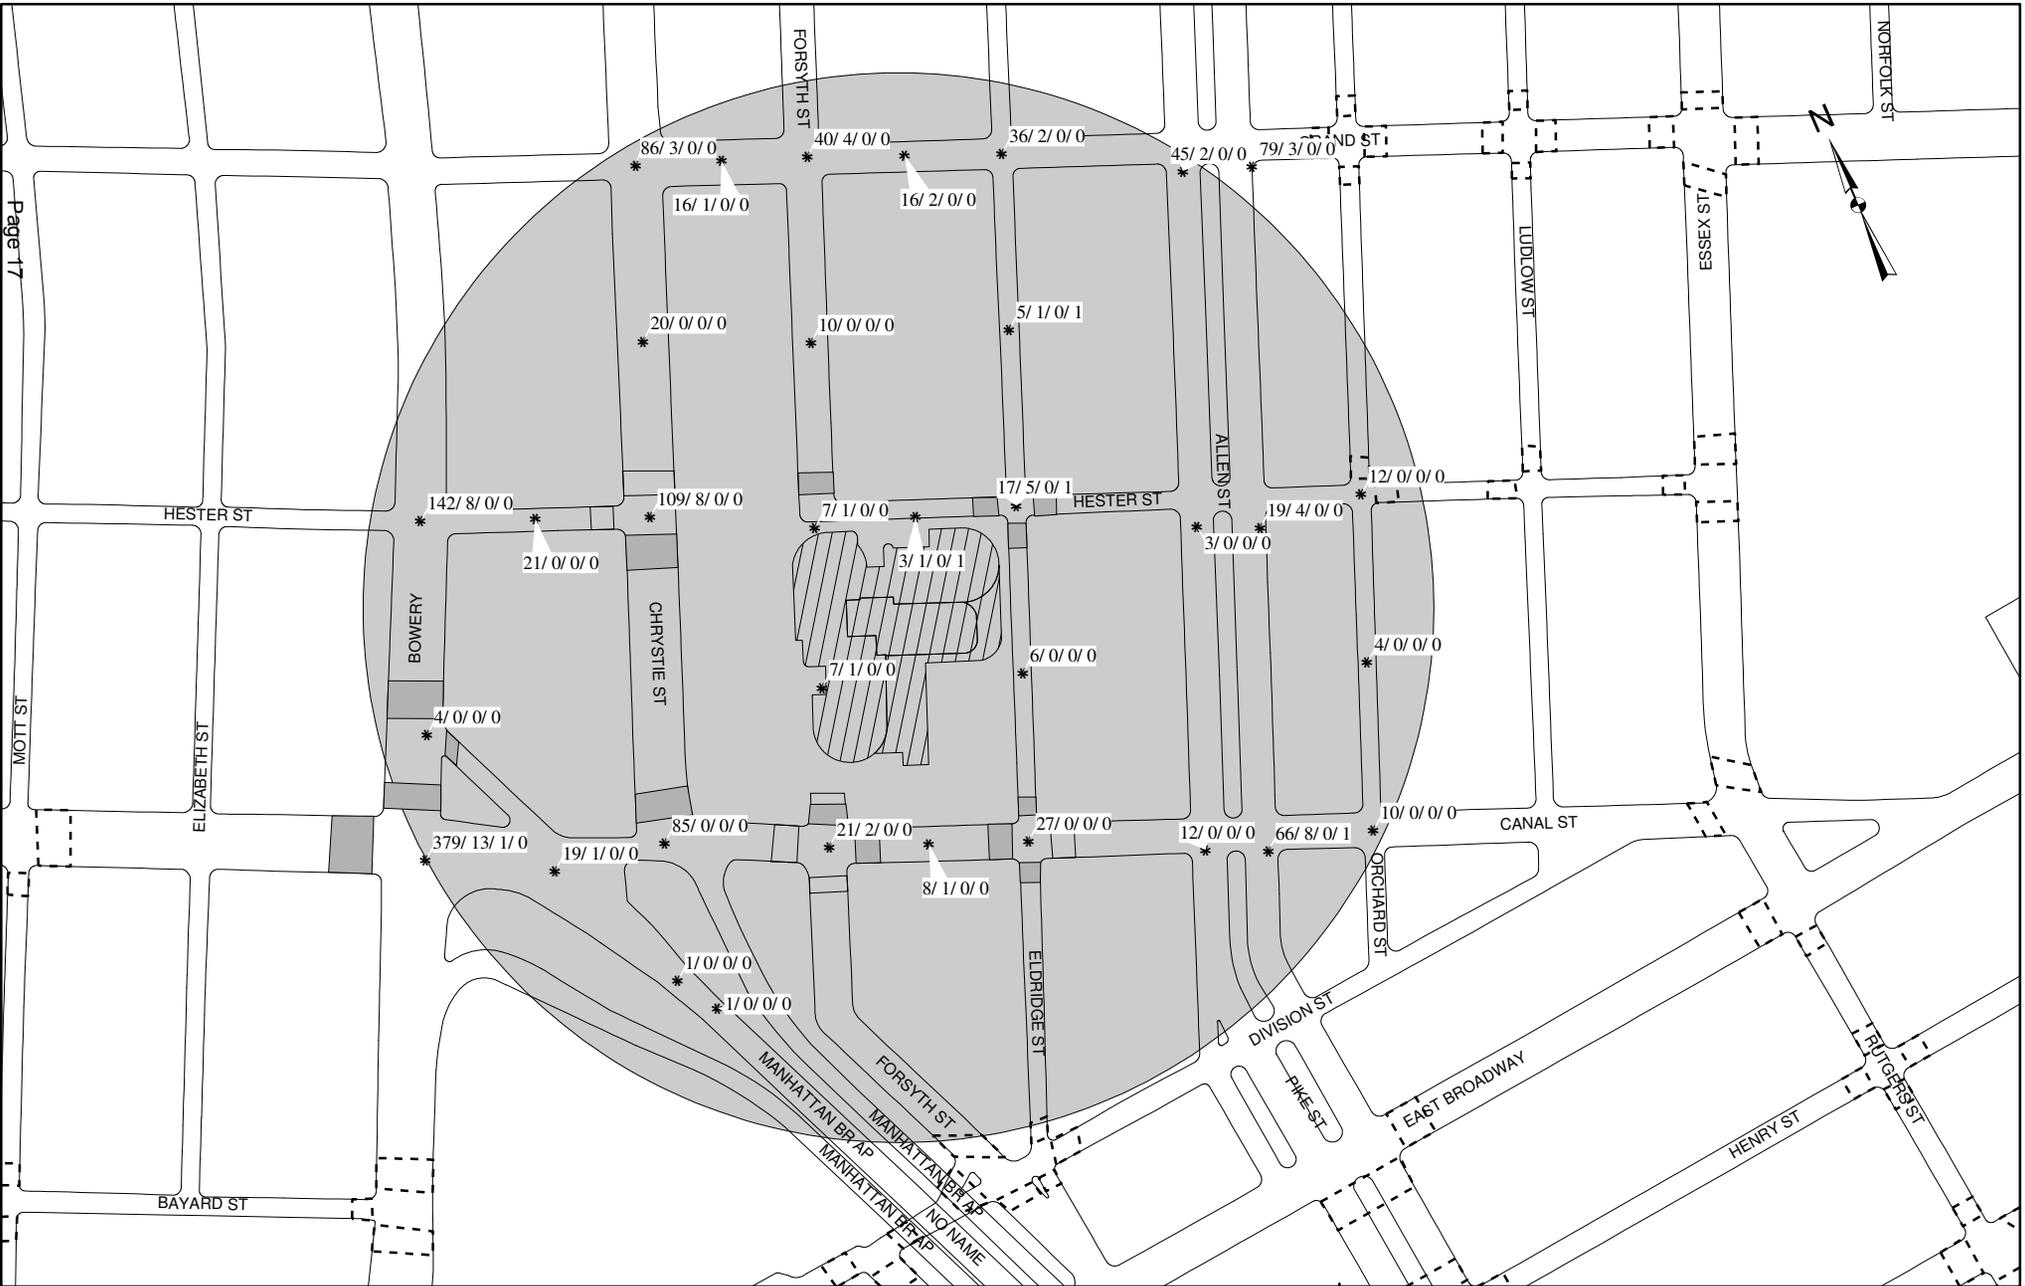
EXHIBIT 6
I.S. 131, MANHATTAN
DR. SUN YAT SEN SCHOOL

Exhibit 6 and Table 2 show a summary of accidents, as obtained from the New York State Department of Motor Vehicles (DMV), in the vicinity of I.S. 131 for the three-year period from January 1, 1998 through December 31, 2000. The DMV data provide some detail relating to the circumstances and cause of the accidents. Table 3 is a summary of more recent accident data obtained from the NYC Police Department (NYPD). Though current through 2004, the NYPD data do not provide the same level of detail as the DMV data.

ACCIDENT SUMMARY
THREE YEAR PERIOD
(1998-2000)

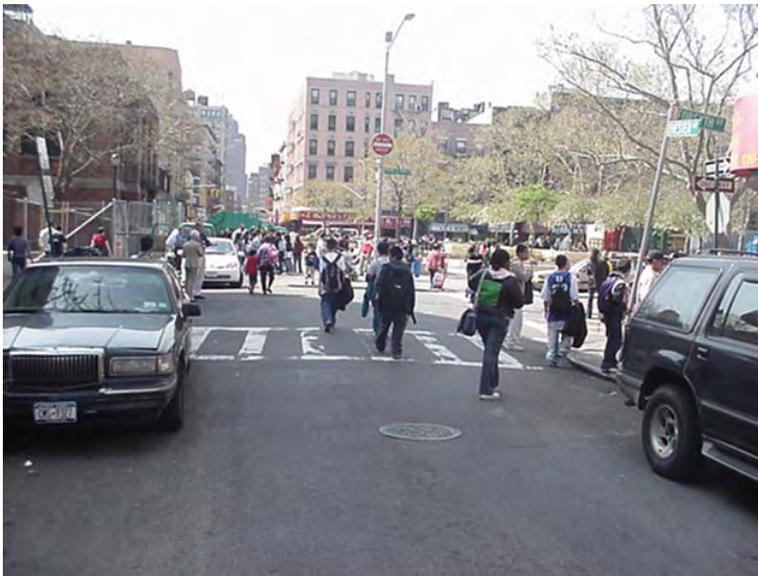
Figure 6: Looking west on Hester Street at Forsyth Street

Forsyth Street is a one-way southbound roadway with one travel lane. Parallel parking is on the west side and angled parking is on the east side of Forsyth Street. Hester Street is a one-way eastbound roadway east of Forsyth Street with parking on both sides. This intersection, which is adjacent to S.D. Roosevelt Park, is not signalized. Forsyth Street is stop-controlled with a school crosswalk on the north leg. There is an un-controlled school crosswalk on the east leg (see Figure 6).

Seven accidents occurred at this intersection during the 1998-2000 study period, one of which was a non school-related pedestrian accident. The driver struck a pedestrian while backing up his vehicle.

- Hester Street and Forsyth Street
- Hester Street and Eldridge Street

As noted in sections 3.6.2 and 3.6.3, these two intersections are un-signalized and have uncontrolled school crosswalks. According to school officials, some I.S. 131 students cross these uncontrolled school crosswalks en route to school. Therefore,

it is recommended that a crossing guard be requested at each of these two intersections.

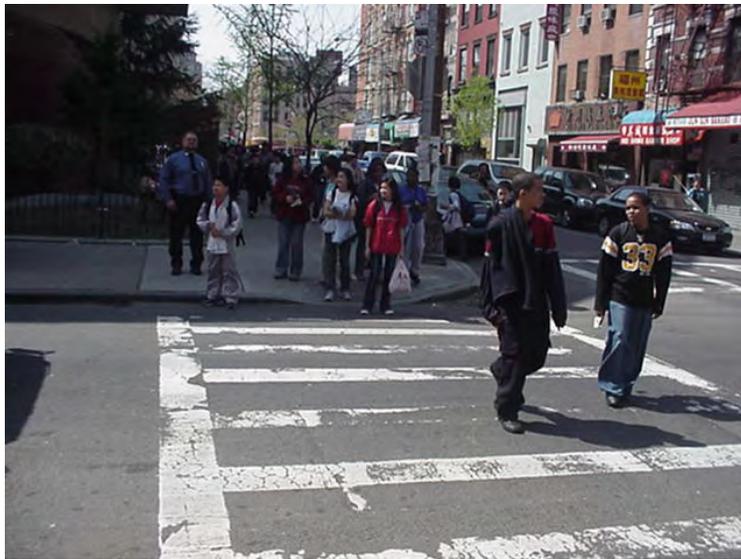
Figure 7: Looking west on Hester Street at Eldridge Street

Eldridge Street is a one-way northbound roadway with parking on both sides. Hester Street and Eldridge Street is an un-signalized intersection with a stop sign on Hester Street for eastbound traffic. There are school crosswalks on the south, east and west legs. The crosswalk on Eldridge Street is an uncontrolled school crosswalk.

School representatives noted that vehicles speed on Hester Street in the vicinity of the school. A spot speed study was conducted on October 4, 2005 from 12:00 pm to 1:00 pm on Hester Street between Forsyth Street and Eldridge Street. The 85th percentile speed was 23 mph, which is below the legal speed limit of 30 mph. See Table 4 for a summary of the results and the Appendix for further detail.

There were 17 accidents at this intersection during the 1998-2000 study period. Five accidents involved pedestrians, one of which was school-related. A pedestrian was struck while emerging from behind a parked vehicle. The other four accidents, including the school-related accident, were due to driver inattention, although two of these accidents involved pedestrians crossing Eldridge Street at the uncontrolled crosswalk or without crosswalk.

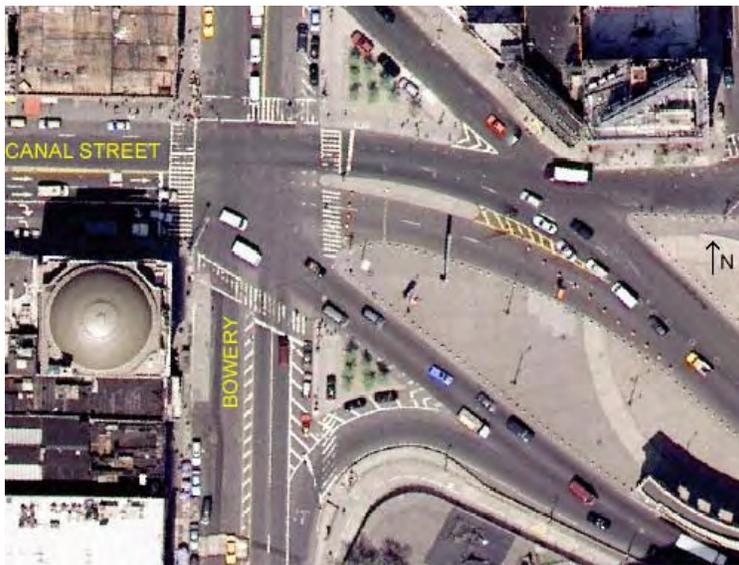
Figure 8: Intersection of Canal Street and Bowery

Canal Street and Bowery is a signalized intersection, which serves as the entrance to the Manhattan Bridge and has heavy traffic volumes. Bowery is a two-way collector roadway with two travel lanes in each direction and parking on both sides. West of Bowery, Canal Street has two through lanes and two right turn only lanes for eastbound traffic and one travel lane for westbound traffic. Parking is permitted on both sides. East of the Bowery, Canal Street is divided to facilitate vehicles entering and exiting the Manhattan Bridge (see Figure 8). There is no parking permitted on Canal Street between the Bowery and Chrystie Street.

There are school crosswalks on the north and west legs of the intersection. High visibility pedestrian crosswalks are installed on the east and south legs.

A total of 379 accidents occurred at this intersection during the 1998-2000 study period. Thirteen accidents involved pedestrians, none of which were school-related. There was a pedestrian fatality at this location. An 87-year-old pedestrian was struck and killed while crossing against the signal. The driver was traveling east. Five accidents at this

intersection occurred while the pedestrian was crossing against the signal or outside of the crosswalk. Six accidents involved driver's failure to yield to pedestrians when making a left or right turn. Two other drivers struck pedestrians while backing up their vehicles.

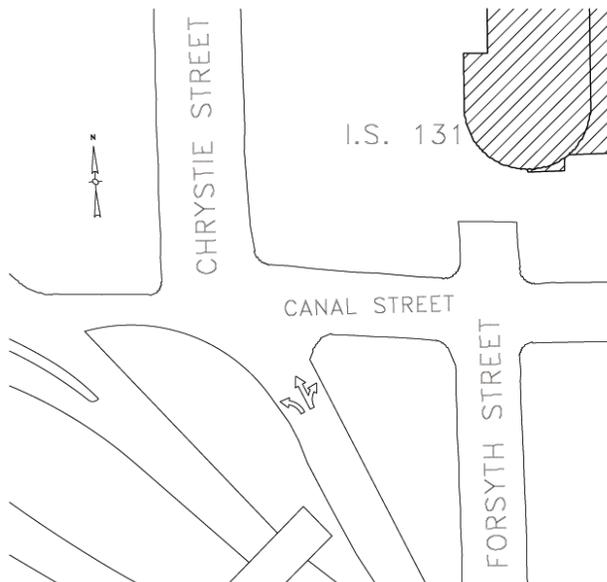
Figure 9: Intersection of Canal Street and Chrystie Street

Canal Street and Chrystie Street is a signalized intersection. Traffic exiting the Manhattan Bridge can turn left and travel westbound to Canal Street via the left-turn-only lane, or travel northbound to Chrystie Street, or travel eastbound to Canal Street via the through and right turn lane (see Figure 9). Parking is permitted on both sides of Chrystie Street north of Canal Street, and on the north side of Canal Street between Chrystie Street and Forsyth Street. There is a school crosswalk on the north leg of the intersection.

A total of 85 accidents occurred at this intersection during the 1998-2000 study period. None of these accidents involved pedestrians.

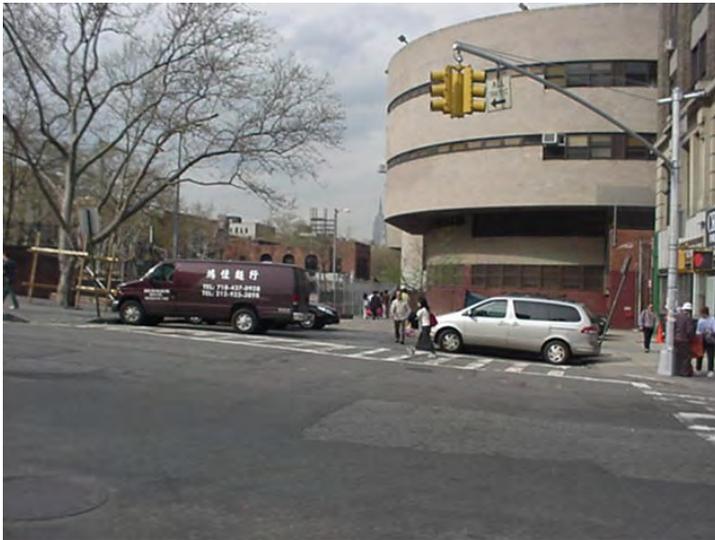
Figure 10: Looking north at Forsyth Street and Canal Street

Canal Street and Forsyth Street is a signalized intersection. North of Canal Street, Forsyth Street dead-ends into I.S. 131, creating a small area for parking adjacent to the school (See Figure 10). There are school crosswalks in place on all four approaches.

There were 21 accidents at this intersection during 1998-2000 study period. Two accidents involved pedestrians, none of which were school-related. Both accidents were due to pedestrians crossing against the signal.

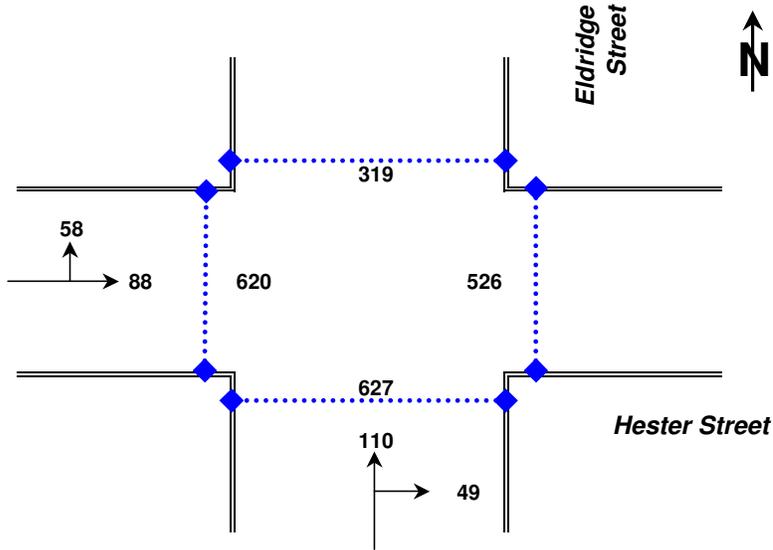
EXHIBIT 7
I.S. 131 (MANHATTAN) DR. SUN YAT SEN SCHOOL
TRAFFIC COUNTS

To better understand pedestrian and vehicle conflicts at this intersection traffic counts were performed on Thursday, May 16, 2005 between 2:30 pm to 3:30 pm (see Exhibit 7). The traffic counts indicated that a total of 305 vehicles per hour and 2092 pedestrians per hour utilized this intersection during the study hour, when students were being dismissed from I.S. 131. Many of the pedestrians were I.S. 131 students. In addition, 159 (110+49) uncontrolled vehicles per hour traveled northbound on Eldridge Street, while conflicting with 946 pedestrians crossing Eldridge Street. The number of pedestrians per hour

crossing Eldridge Street exceeds the required MUTCD Warrant 4 – Pedestrian Volume requirement of a minimum of 190 pedestrians during any given hour. However, the gap study performed on August 17, 2006 shows that more than 60 gaps of 12 seconds (the time required to cross a 25-foot wide street at three feet per second plus three seconds of reaction time) were available for pedestrians to cross Eldridge Street. Therefore, the intersection does not meet the warrants for a traffic signal.

One Hour Traffic Count Volumes
 (2:30 PM - 3:30 PM May 16, 2005)

Intersection of Eldridge Street and Hester Street

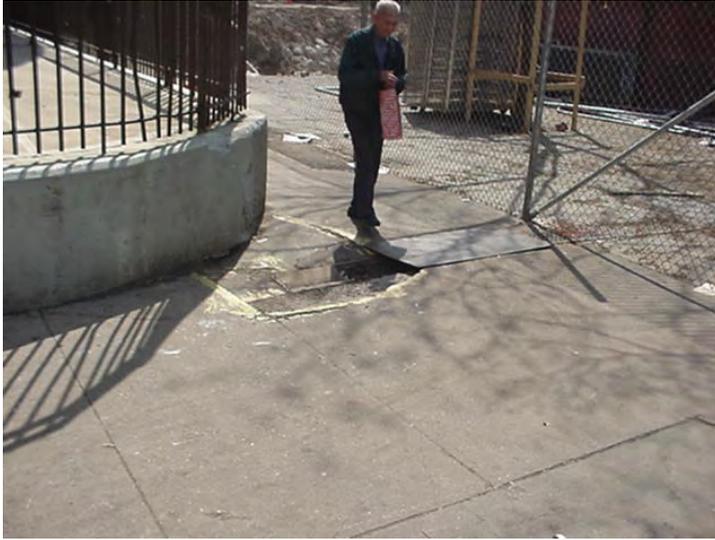
Figure 11: Sidewalk settlement at the northwest corner of the school

- Settled sidewalk at the northwest corner of the school (see Figure 11)

It is recommended to install new sidewalks at Eldridge Street and Hester Street to correct settled sidewalk area.

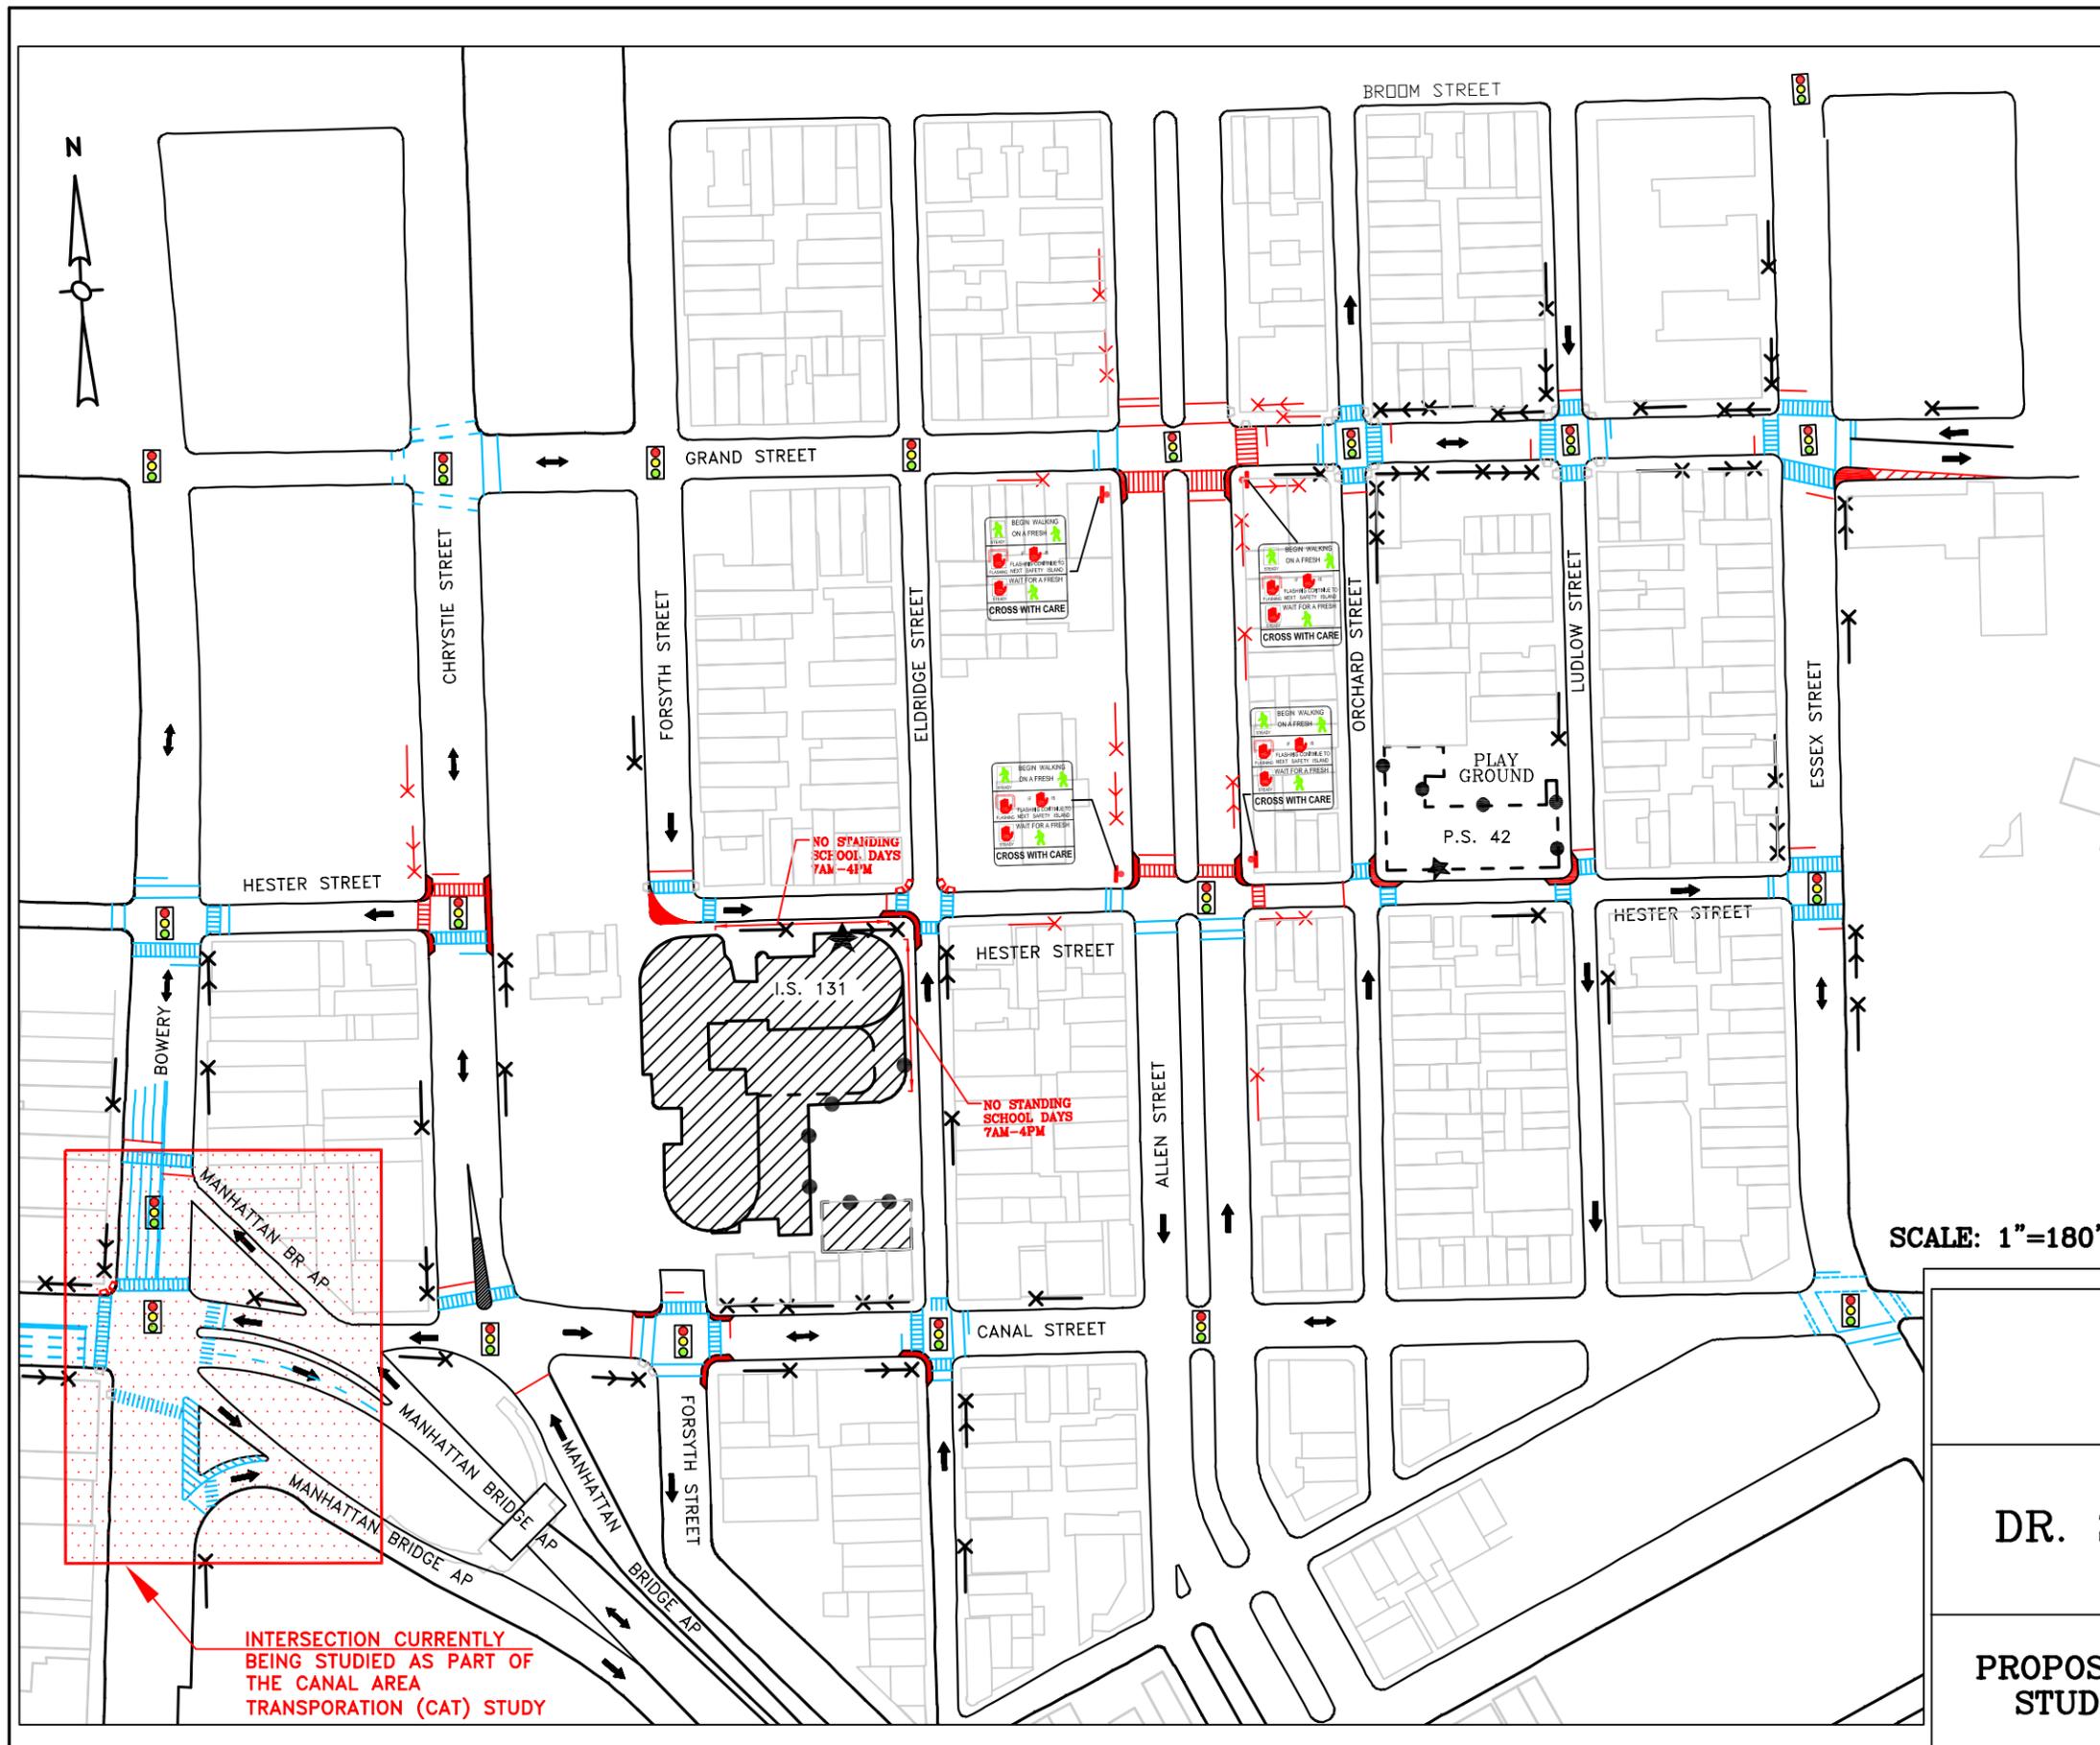
Curb extensions should be considered at the corners as shown in Exhibit 8.

- Upgrade No Parking Zone to No Standing Zone on Hester Street and Eldridge Street

Consideration should be given to installing a curb extension at the following locations, provided that the Final Design confirms that construction of the recommended curb extension would be feasible and would not interfere with traffic operations. Final details pertaining to the number, location and geometry of curb extensions will be developed during the Final Design/Contract Document preparation.

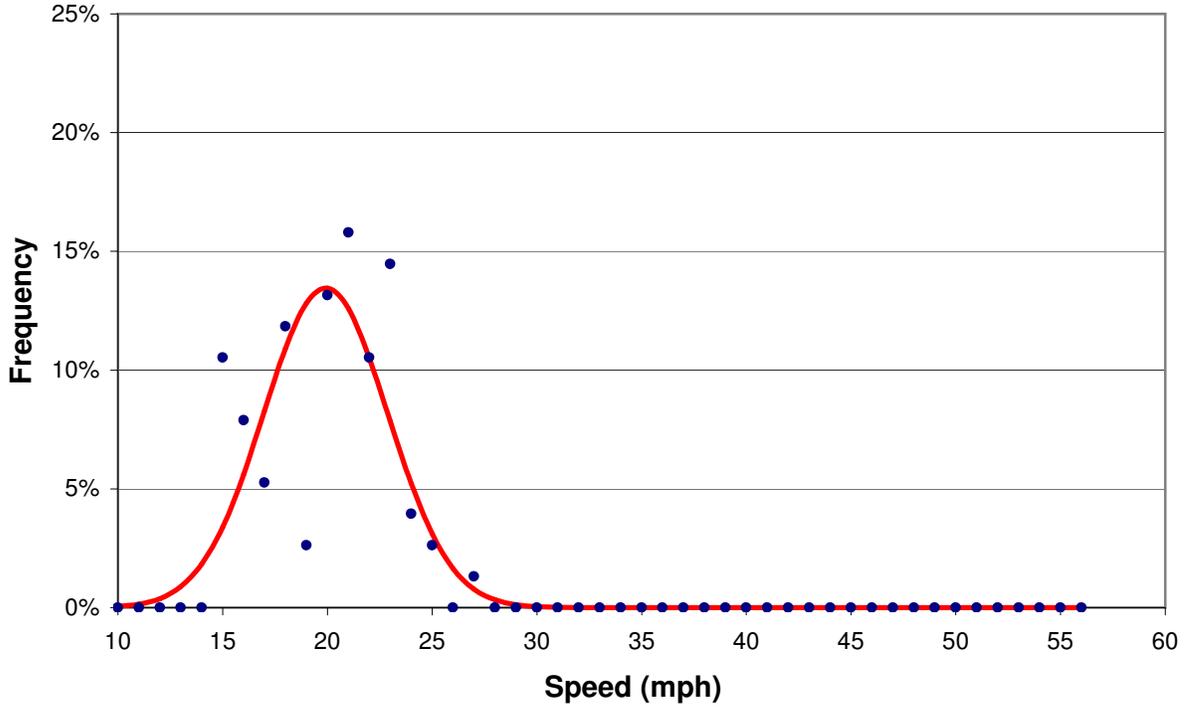
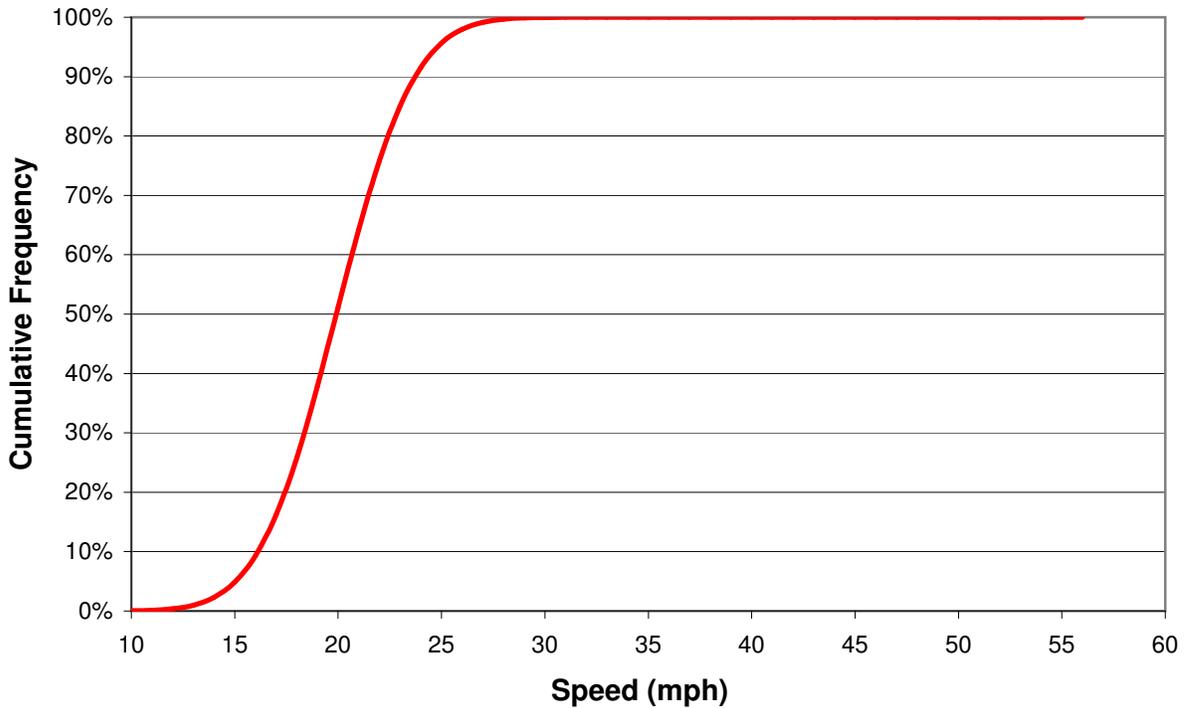
Mean Speed = 19.9 mph
Standard Deviation = 3.0 mph
Margin of Error (95% Confidence) = ± 0.7 mph

Median Speed = 19.9 mph
15th Percentile Speed = 16.8 mph
85th Percentile Speed = 23.0 mph
