**New York City Department of Transportation
Office of School Safety Engineering**

**School Safety Engineering Project
FINAL REPORT: M.S. 54, Booker T. Washington School, Manhattan**

**Prepared by
The RBA Group/Urbitran Associates**

JUNE 15, 2006

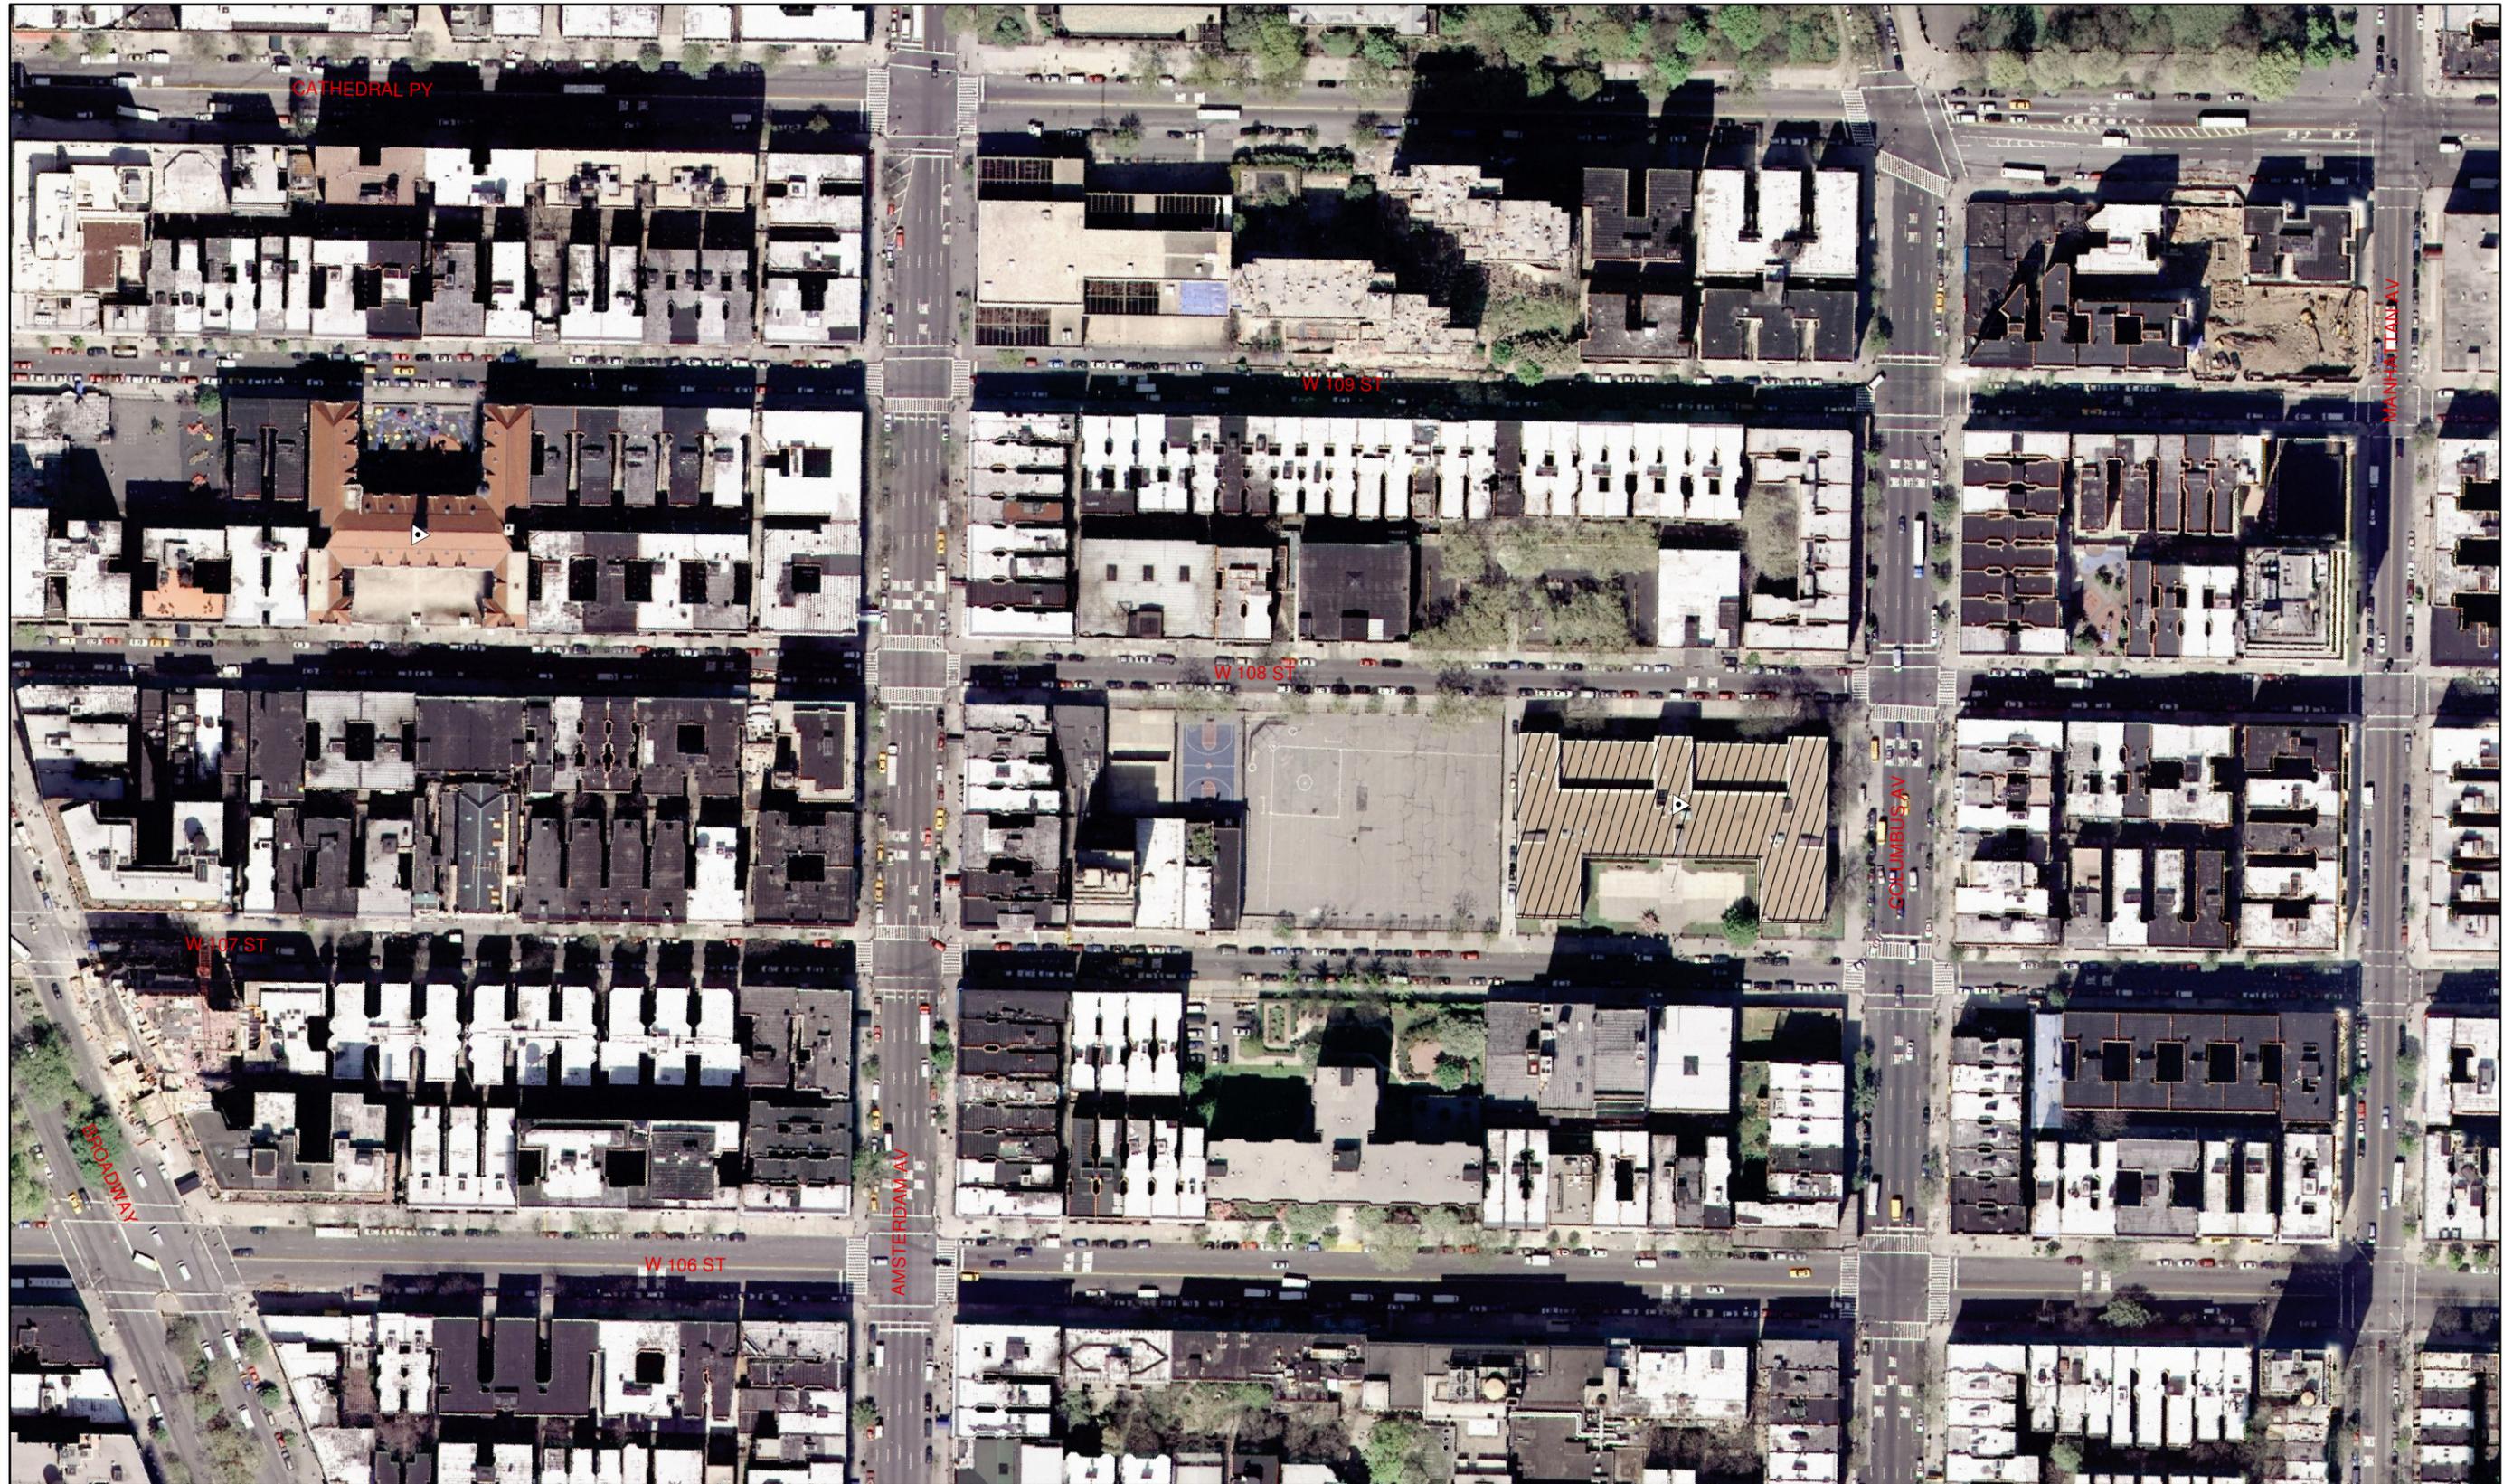
EXHIBIT 1
M.S. 54, MANHATTAN
BOOKER T. WASHINGTON SCHOOL
AERIAL PHOTOGRAPH

M.S.54 is located at 103 West 107th Street, situated along Columbus Avenue and occupying the entire block from West 107th Street to West 108th Street (see Exhibit 1 for Aerial Photograph). There is a schoolyard west of the school building.

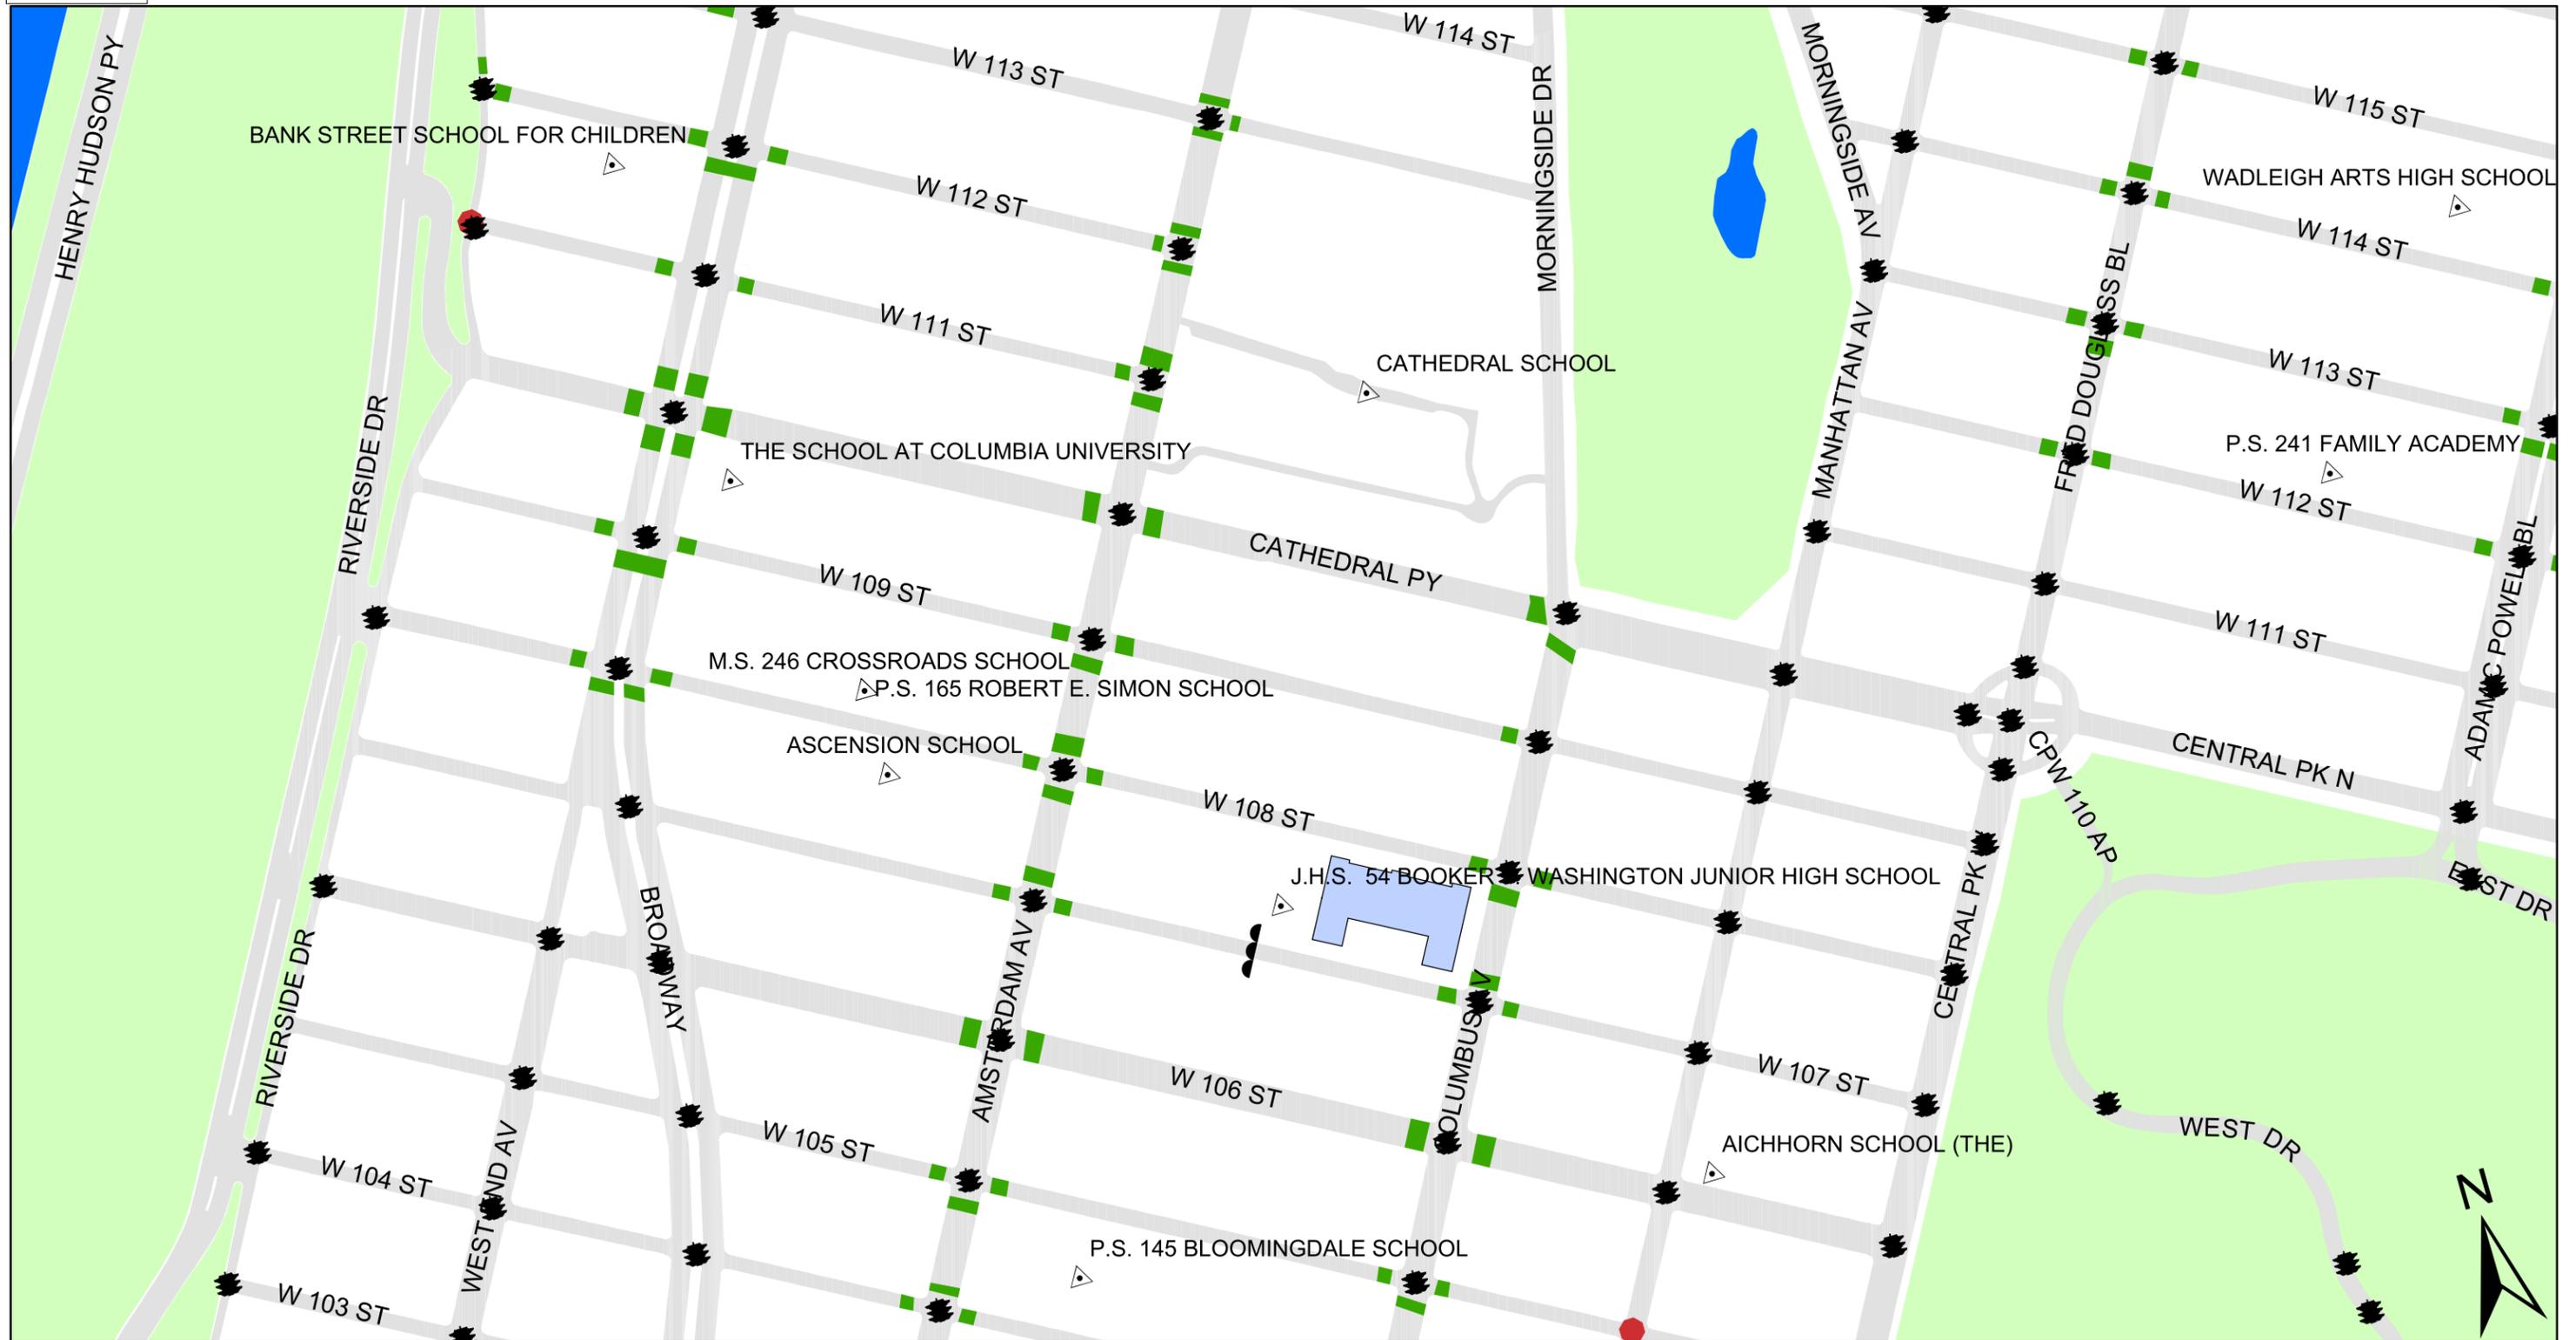
Map created on 11/16/2006 **EXHIBIT 3** COMM. BOARD: 107
PRECINCT: 24

The School Traffic Safety Map was established to help provide the maximum degree of safety for children going to and from school - by indicating the location of speed reducers, school crosswalks and some traffic control devices. (While virtually all intersections in NYC benefit from traffic control devices - such as stop signs, traffic signals, yield signs, and all way stop signs - this map shows only traffic signals and all way stop signs.) The school crosswalks that are shown are ladder striped and make the crosswalk more visible to drivers and help make the intersection safer. These crosswalks are where school children are recommended to cross.

The Traffic Safety Plan, Exhibit 3, shows existing signs, signals and pavement markings. It is noted that a citywide signage program is currently underway to upgrade school signage to current MUTCD standards of fluorescent yellow-green with downward pointing arrows. Signs scheduled to be installed under this program are shown as “existing” on Exhibit 7.

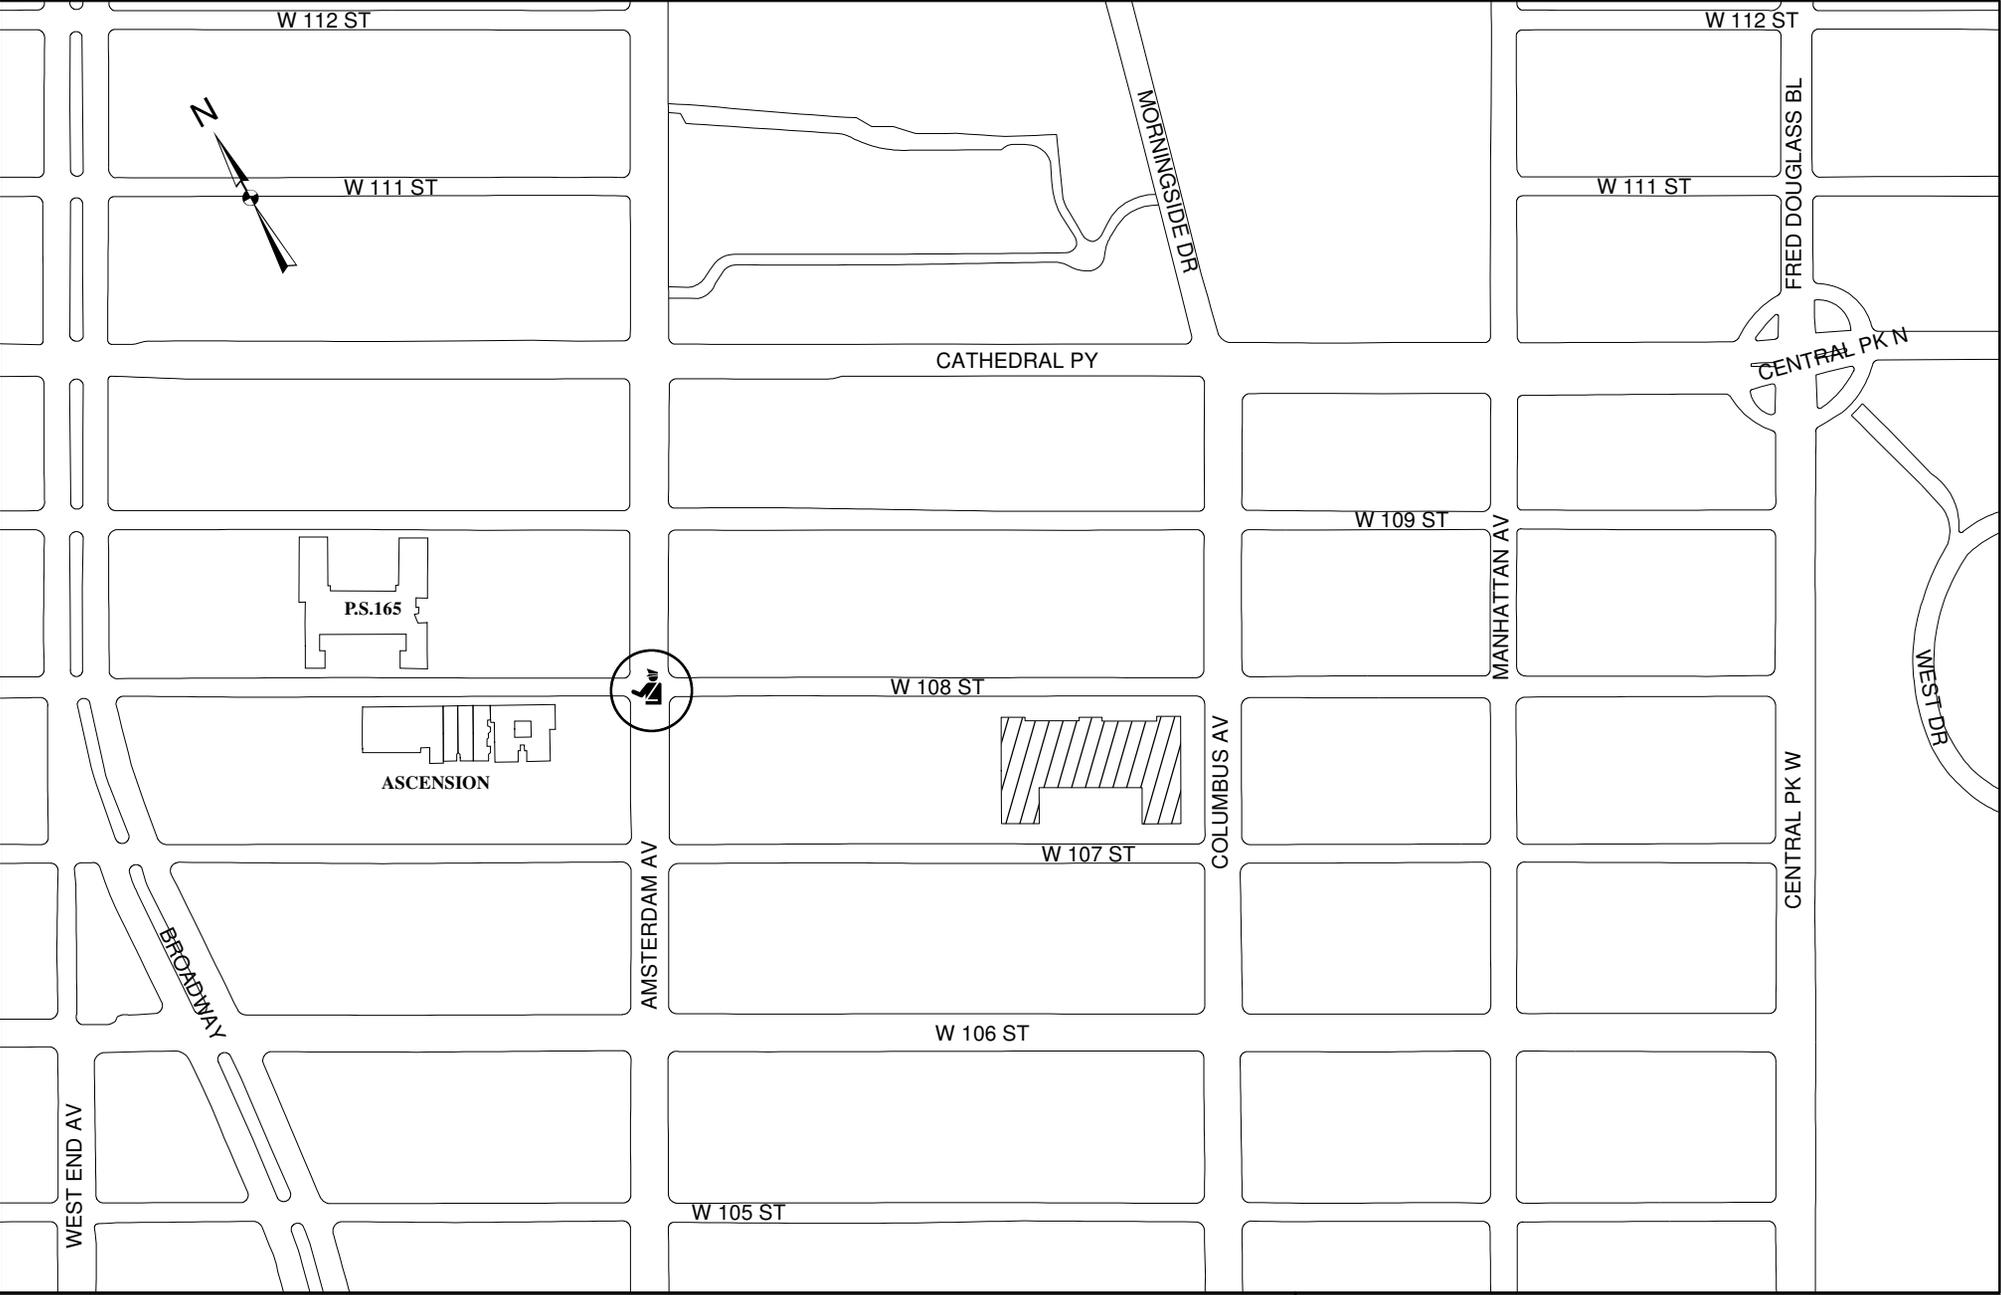
EXHIBIT 4

According to the school principal, there are no crossing guards assigned to M.S. 54. However, a crossing guard from P.S. 165 is assigned to West 108th Street and Amsterdam Avenue.

It is recommended that crossing guards be requested for the following intersections:

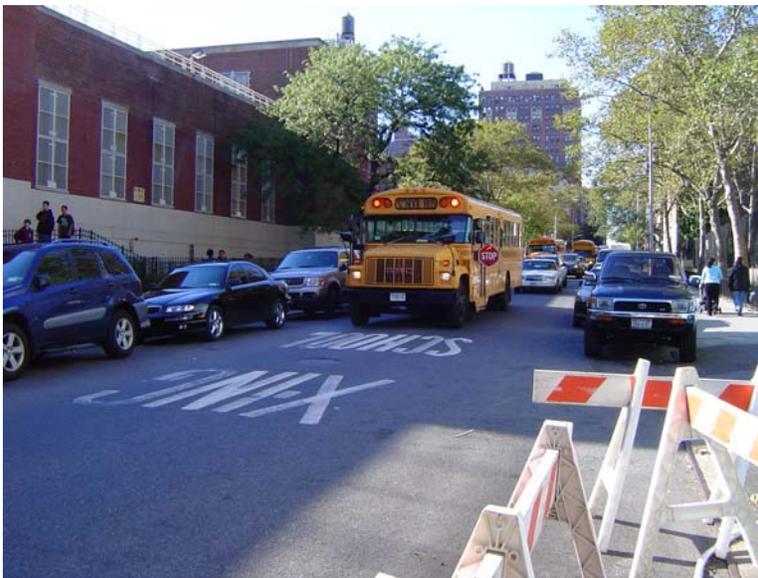
Figure 3: School bus double-parked on West 108th Street

Due to the relatively narrow width of West 108th Street (30 feet), and parking on both sides of the roadway, a double-parked bus or car will block through traffic and cause queues that can approach the intersection of West 108th Street and Amsterdam Avenue (Figure 3).

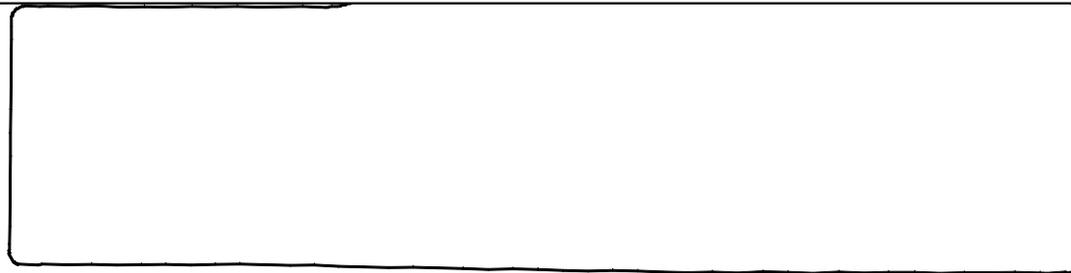
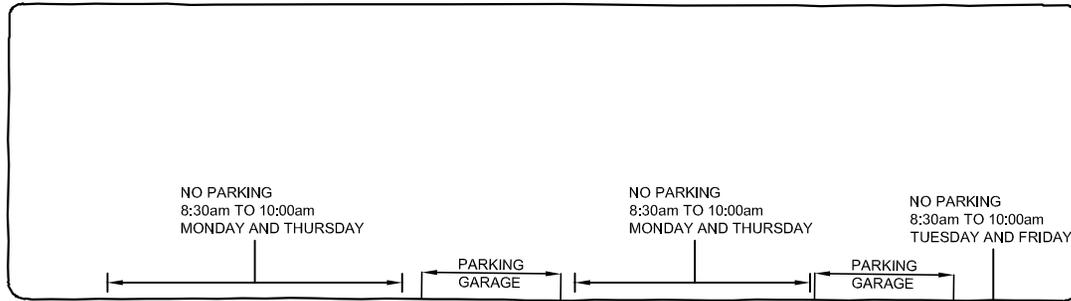
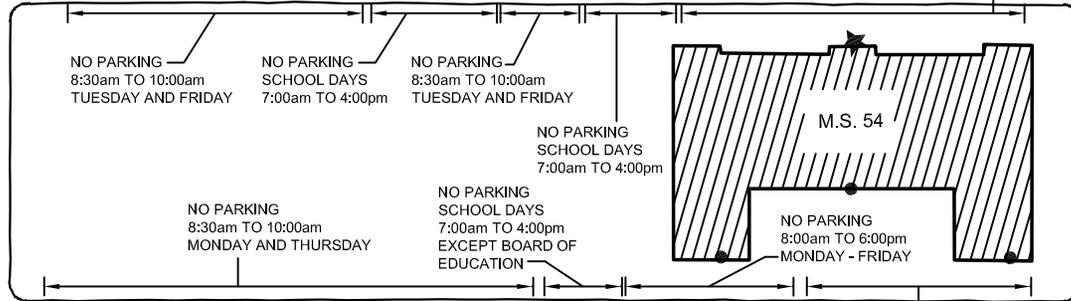
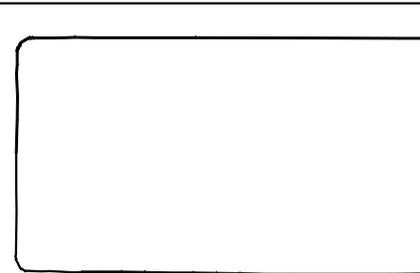
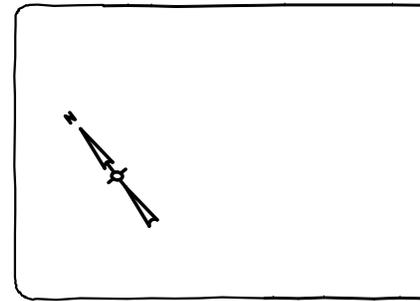
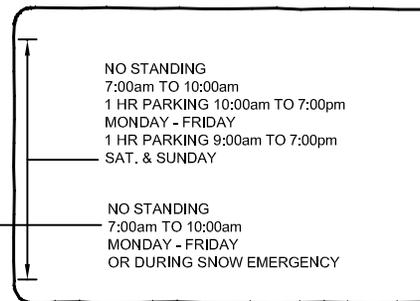
EXHIBIT 5

On the south side of West 108th Street, parking regulations are posted as “NO PARKING SCHOOL DAYS 7:00 AM - 4:00 PM” in front of the playground. However, street cleaning regulations are posted in front of school’s main entrance.

On the north side of West 107th Street, “NO PARKING, SCHOOL DAYS, 7:00 AM – 4:00 PM, EXCEPT BOARD OF EDUCATION” regulations are posted in front of the school. Further west, parking regulations are posted as “NO PARKING, 8:00 AM – 6:00 PM, MONDAY - FRIDAY”. “NO PARKING, SCHOOL DAYS, 7:00 AM – 4:00 PM, EXCEPT BOARD OF EDUCATION” is posted at the east corner of the playground.

On the west side of Columbus Avenue, parking regulations are posted as “NO STANDING 7:00 AM – 10:00 AM, MONDAY - FRIDAY OR DURING SNOW EMERGENCY”.

Exhibit 5 shows the existing parking regulations on the roadways surrounding M.S. 54.

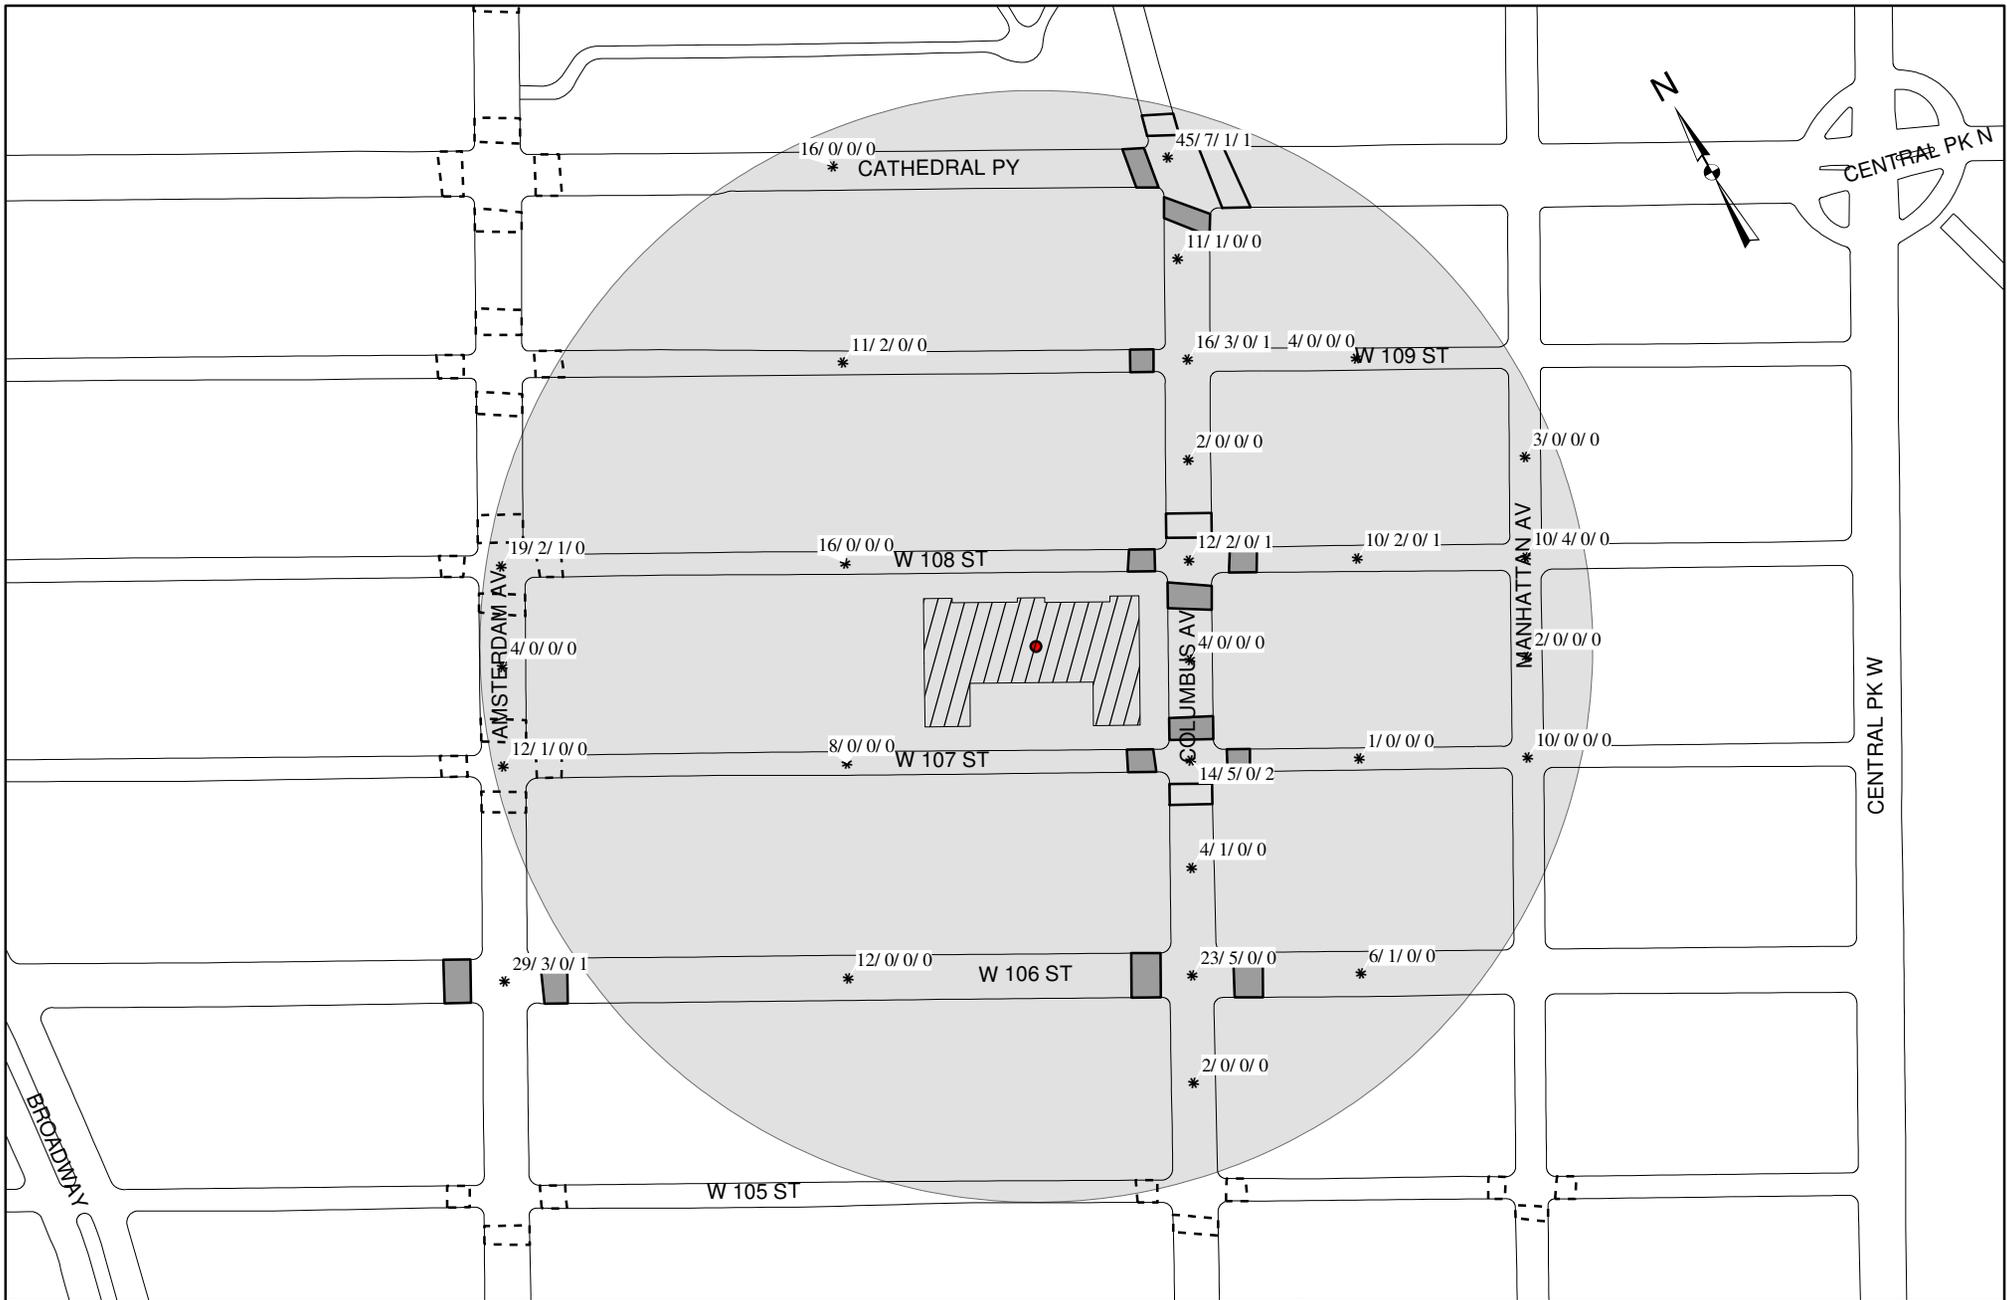
EXHIBIT 6

Exhibit 6 and Table 2 show a summary of accidents, as obtained from the New York State Department of Motor Vehicles (DMV), in the vicinity of M.S. 54 for the three-year period from January 1, 1998 through December 31, 2000. The DMV data provides some detail relating to the circumstances and cause of the accident. Table 3 is a summary of more recent accident data obtained from the NYC Police Department (NYPD). Though current through 2004, the NYPD data does not provide the same level of detail as the DMV data.

**ACCIDENT SUMMARY
THREE YEAR PERIOD
(1998-2000)**

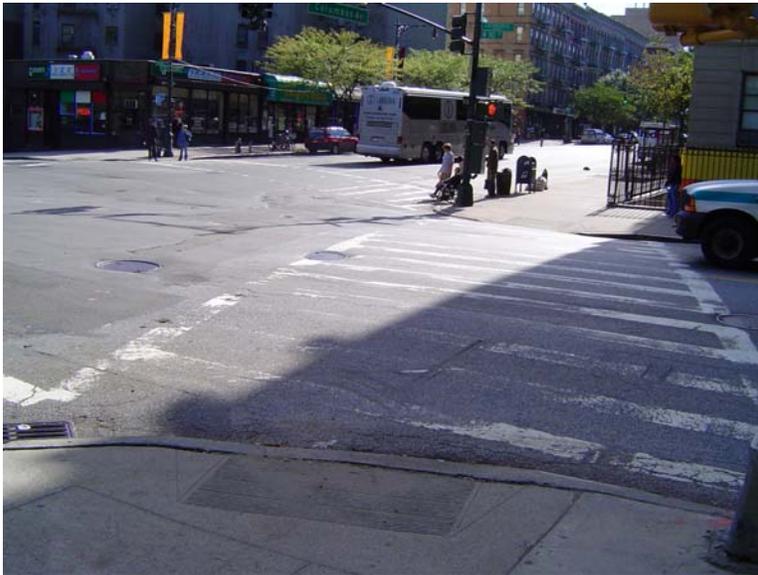
Figure 5: Looking south on Columbus Avenue, at the intersection of Columbus Avenue and Cathedral Parkway

The intersection is controlled by a three-phase traffic signal. School crosswalks are striped across the west and south legs. All four corners have standard pedestrian ramps. There is a bus shelter for the M11 line on Columbus Avenue south of the intersection.

The westbound traffic on Cathedral Parkway has a left turn signal onto Columbus Avenue. Therefore, pedestrians utilizing the south leg school crosswalk to cross Columbus Avenue have a delayed pedestrian walk signal. During the field check, 20 seconds of crossing time were provided for pedestrians to cross the south leg of Columbus Avenue, which was not sufficient for student pedestrians to cross at a speed of 3 feet per second (23 seconds are needed for this distance). DOT has since added an additional three seconds to provide the required 23 seconds of crossing time.

Forty-five accidents occurred at this location between 1998 and 2000. Seven pedestrians were struck during this period, and there was one school-related fatality. A thirteen-year old student was crossing with the signal when struck and killed by a vehicle making a right turn. It was raining on the day of the accident, and the cause was cited as driver's error and a slippery roadway. Four more pedestrians were struck and injured by vehicles making left turns or right turns. Two other accidents were attributed to driver's inattention.

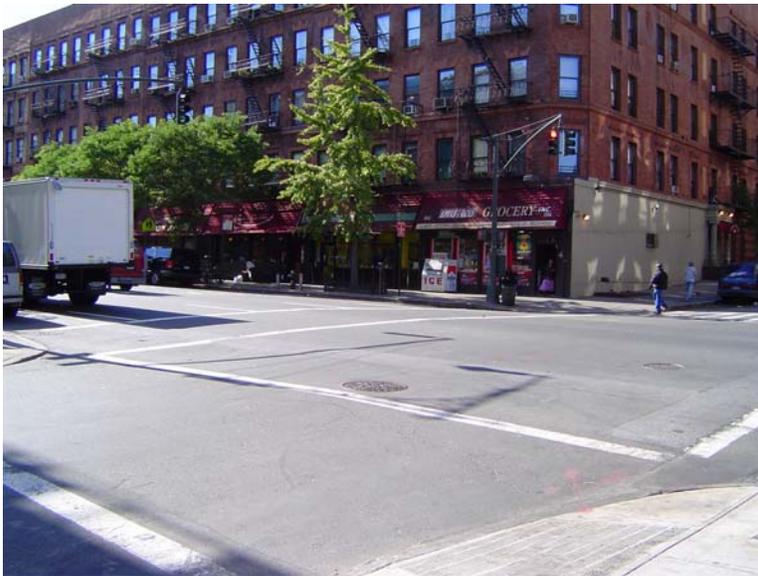
Figure 6: Looking southwest at the intersection of Columbus Avenue and West 109th Street

West 109th Street is a 30-foot wide, one-way westbound roadway with one travel lane and parking along both sides of the street. The intersection of Columbus Avenue and West 109th Street is controlled by a two-phase traffic signal (Figure 6). A school crosswalk is striped across the west leg. All four corners have standard pedestrian ramps.

There were sixteen accidents at this location between 1998 and 2000. Three accidents included pedestrians, one of which was school related. A twelve-year old child was crossing against the signal when struck. Two other accidents were attributed to drivers unsafely backing up their vehicles.

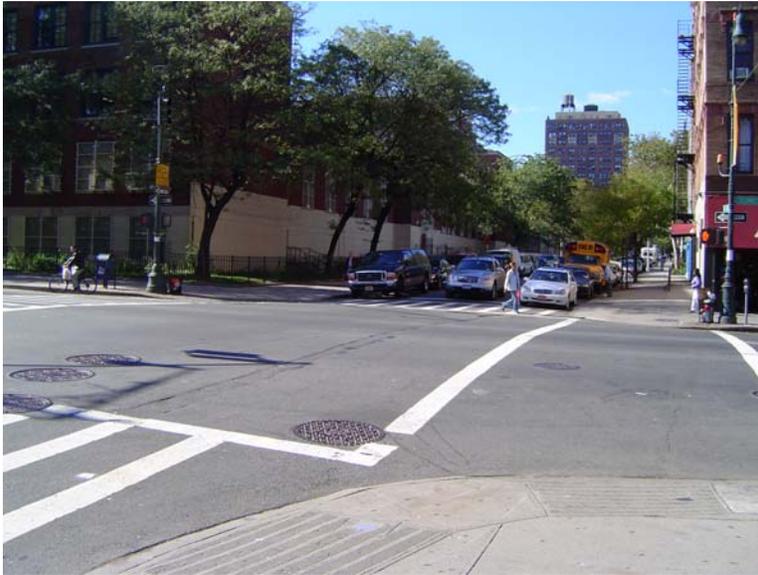
Figure 7: Looking West on West 108th Street, at the intersection of Columbus Avenue and West 108th Street

West 108th Street is a 30-foot wide, one-way eastbound roadway with one travel lane and parking along both sides of the street. The intersection of Columbus Avenue and West 108th Street is controlled by a two-phase traffic signal. School crosswalks are striped on the west, east, and south legs. All four corners have pedestrian ramps. A bus shelter is located on Columbus Avenue south of the intersection.

There were twelve accidents at this location between 1998 and 2000. Two accidents included pedestrians, one of which was school related. A fourteen-year old pedestrian was crossing against the signal when struck. Another pedestrian was crossing with the signal when struck by a driver making a right turn and failing to yield. (According to school officials, in June 2005, an M.S. 54 student was crossing with the signal when struck. No details on this accident are available at this time).

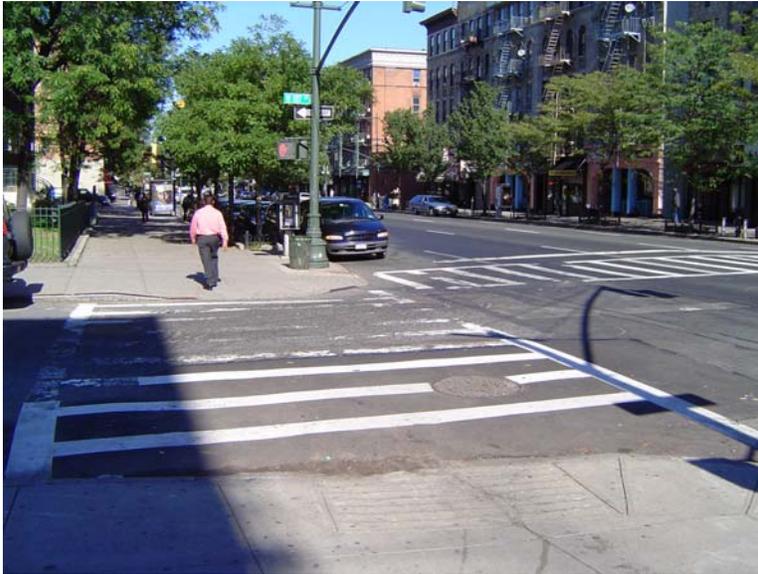
Figure 8: Looking north on Columbus Avenue, at the intersection of Columbus Avenue and West 107th Street

West 107th Street is a 30-foot wide, one-way westbound roadway with one travel lane and parking along both sides of the street. The intersection of Columbus Avenue and West 107th Street is controlled by a two-phase traffic signal. School crosswalks are striped on the west, east, and north legs. All four corners have pedestrian ramps.

There were fourteen accidents at this location between 1998 and 2000. Five accidents included pedestrians, two of which were school related. A twelve-year old pedestrian was crossing against the signal when struck. Another seven-year old child was struck during the school day, however no further information is available. The third accident was attributed to a driver backing up unsafely. Two other accidents were cited as pedestrian

errors: one was a left turn accident and the other one involved a pedestrian with a physical disability crossing against the signal.

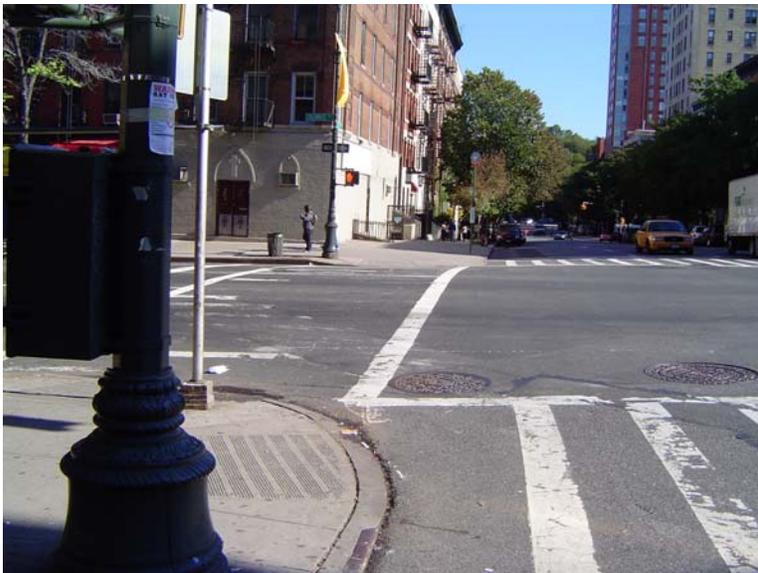
Figure 9: Looking east on Columbus Avenue, at the intersection of Columbus Avenue and West 106th Street

West 106th Street is a 60-foot wide, two-way roadway with two travel lanes in each direction and parking along both sides of the street (Figure 9). The intersection of Columbus Avenue and West 106th Street is controlled by a two-phase traffic signal. School crosswalks are striped across all four legs. All four corners have pedestrian ramps.

There are two bus stops on West 106th Street east of the intersection. The existing graphic “YIELD TO PEDESTRIAN” signs at this intersection remind drivers that pedestrians have the right of way within the crosswalk.

There were twenty-three accidents at this location between 1998 and 2000. Five accidents included pedestrians, none of which were school related. Three pedestrians were crossing Columbus Avenue against the signal when struck. Another pedestrian was crossing Columbus Avenue outside of the crosswalk when struck by a vehicle backing up. The last accident was attributed to a driver making an improper left turn. According to school officials, one of the accidents involved an M.S. 54 student who was crossing with the signal when struck by a non-medallion cab. In addition, the NYPD data shows a fatality at this intersection, where a 56-year old pedestrian was struck and killed in November of 2002 (NYPD accident data does not provide detailed accident information).

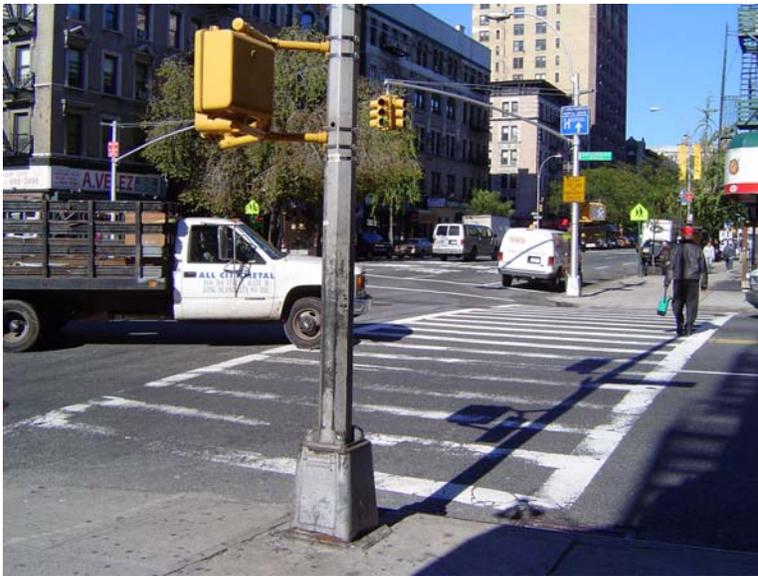
Figure 10: Looking north on Amsterdam Avenue, at the intersection of Amsterdam Avenue and West 106th Street

Amsterdam Avenue is a major 60-foot wide one-way roadway in the northbound direction with four traveling lanes and metered parking along both sides of the street. The intersection of Amsterdam Avenue and West 106th Street is controlled by a two-phase traffic signal (Figure 10). School crosswalks are striped on the east and west legs. All four corners have pedestrian ramps. There is a bus shelter for the M11 line on Amsterdam Avenue north of the intersection.

There were twenty-nine accidents at this location between 1998 and 2000. Three accidents included pedestrians, one of which was school related. A 41-year old pedestrian with a six-year old child was crossing with the signal when struck by a vehicle making a

left turn. The second accident also involved a driver making a left turn and failing to yield to a pedestrian. The third accident was attributed to a driver backing up unsafely.

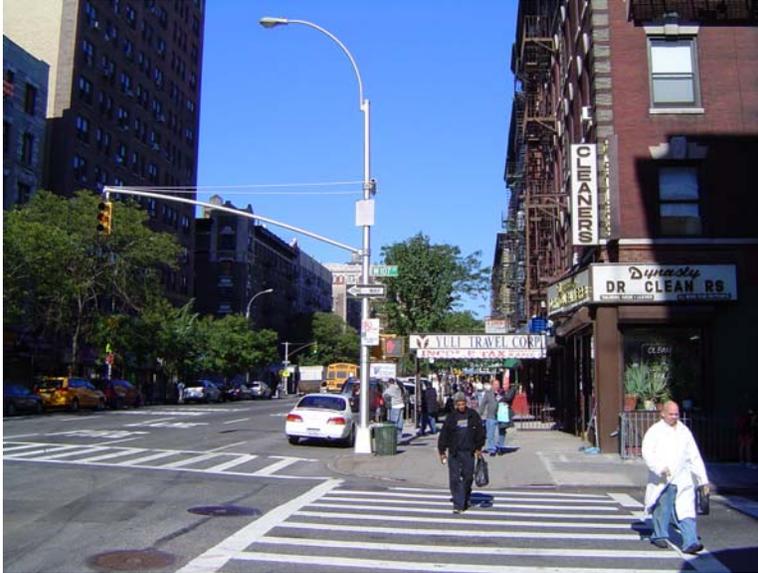
Figure 11: Looking north on Amsterdam Avenue, at the intersection of Amsterdam Avenue and West 107th Street

The intersection of Amsterdam Avenue and West 107th Street is controlled by a two-phase signal (Figure 11). School crosswalks are striped across the west, east and north legs of the intersection, all of which are assigned to another school.

Twelve accidents occurred at this intersection between 1998 and 2000, one of which was pedestrian accident. A 63-year old pedestrian was crossing against the signal when struck.

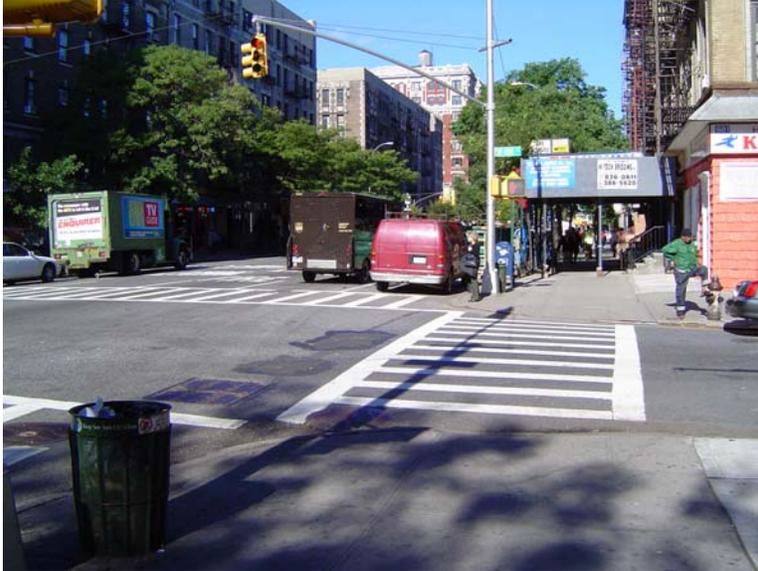
Figure 12: Looking north on Amsterdam Avenue, at the intersection of Amsterdam Avenue and West 108th Street

The intersection of Amsterdam Avenue and West 108th Street is controlled by a two-phase signal (Figure 12). School crosswalks are delineated on all four legs of the intersection and all of them are assigned to another school. Two city blocks north of West 108th Street, Amsterdam Avenue becomes a two-way street.

There were nineteen accidents at this intersection between 1998 and 2000. Two accidents involved pedestrians. One incident involved an intoxicated pedestrian who was struck and killed at 4:00 am. No further information on pedestrian or vehicle action and direction is available. The other accident occurred when a driver failed to yield to a pedestrian while making a left turn onto Amsterdam Avenue. There were no school related accidents at this location.

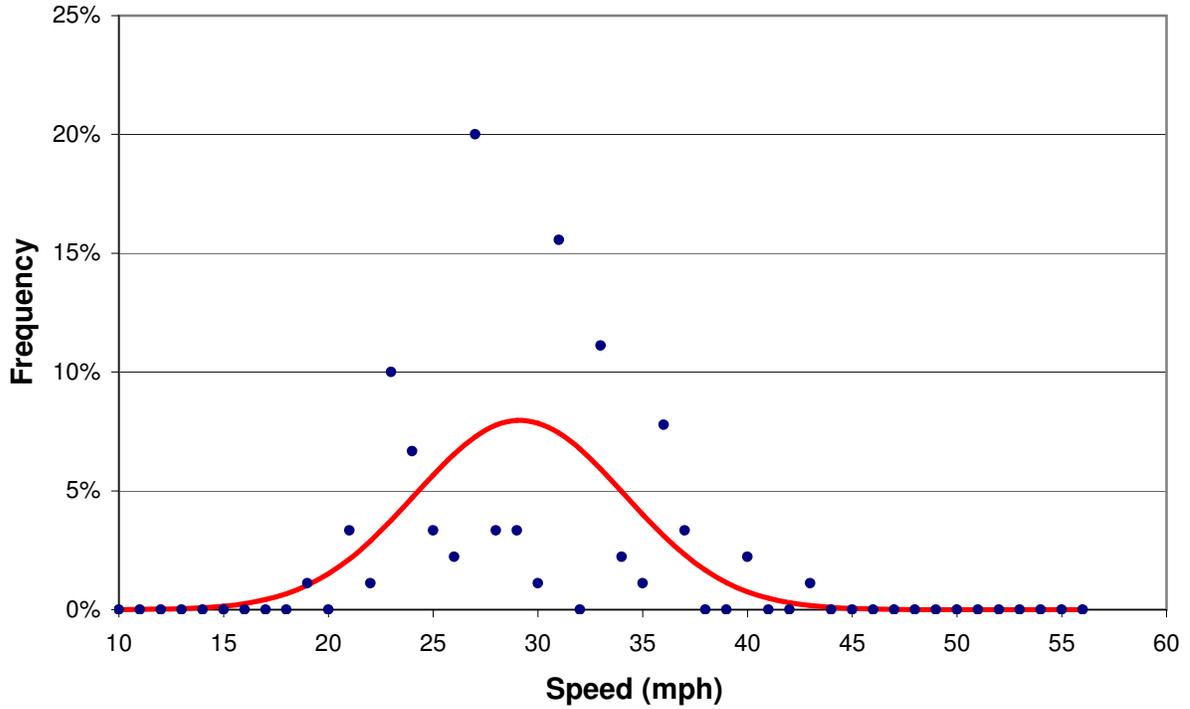
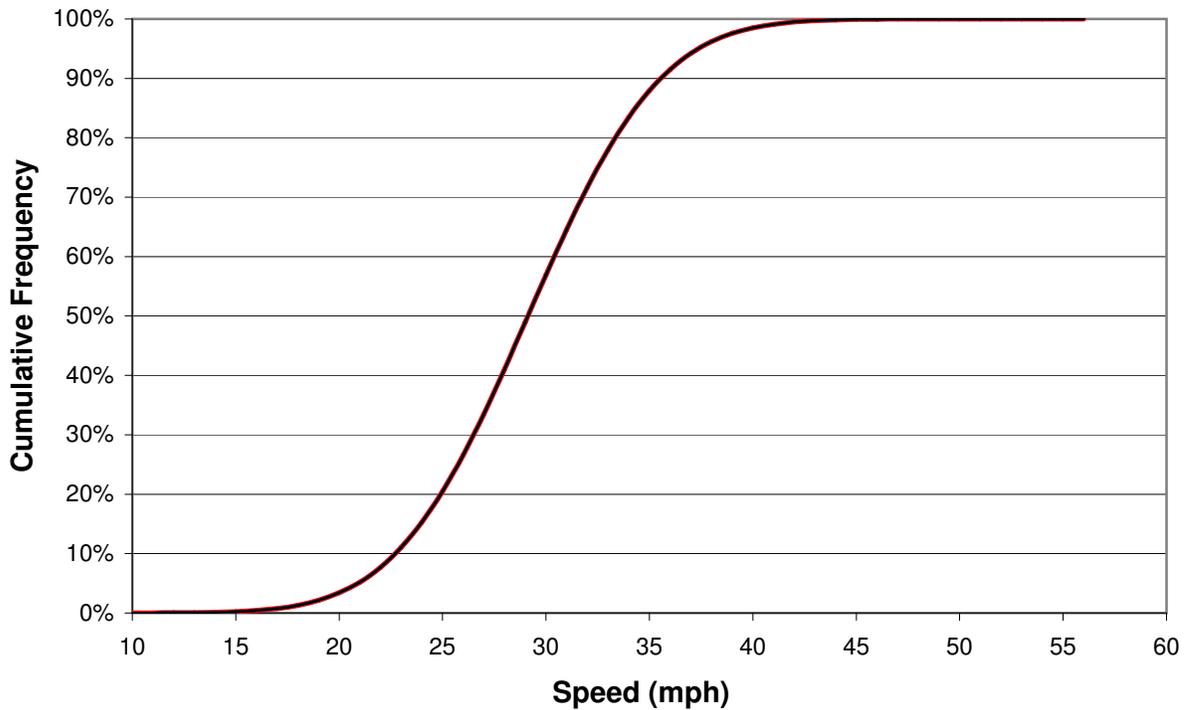
SPOT SPEED STUDY

Date: **September 19, 2005** Time: **3:15 pm - 4:15 pm**
 Location: **West 107th Street between Amsterdam Avenue and Columbus Avenue**
 Surveyor:

Mean Speed = 29.1 mph
Standard Deviation = 5.0 mph
Margin of Error (95% Confidence) = ± 1.0 mph

Median Speed = 29.1 mph
15th Percentile Speed = 23.9 mph
85th Percentile Speed = 34.3 mph
