**New York City Department of Transportation
Office of School Safety Engineering**

**School Safety Engineering Project
FINAL REPORT: M.S. 54, Booker T. Washington School, Manhattan**

**Prepared by
The RBA Group/Urbitran Associates**

JUNE 15, 2006

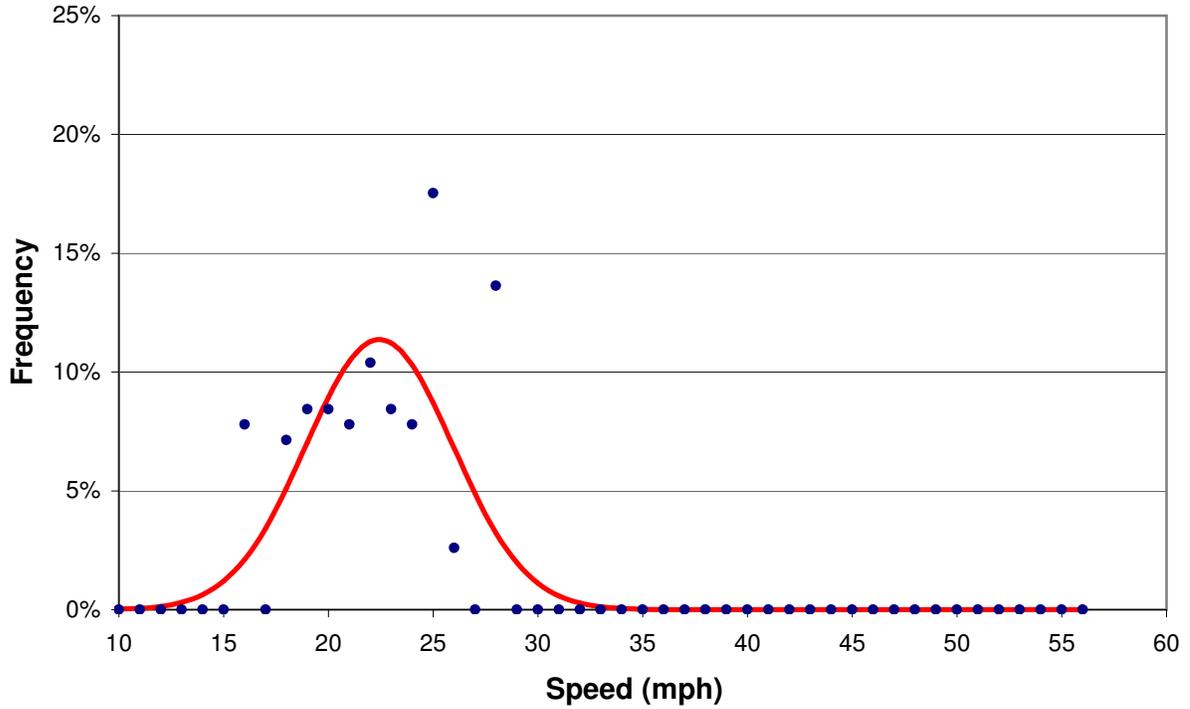
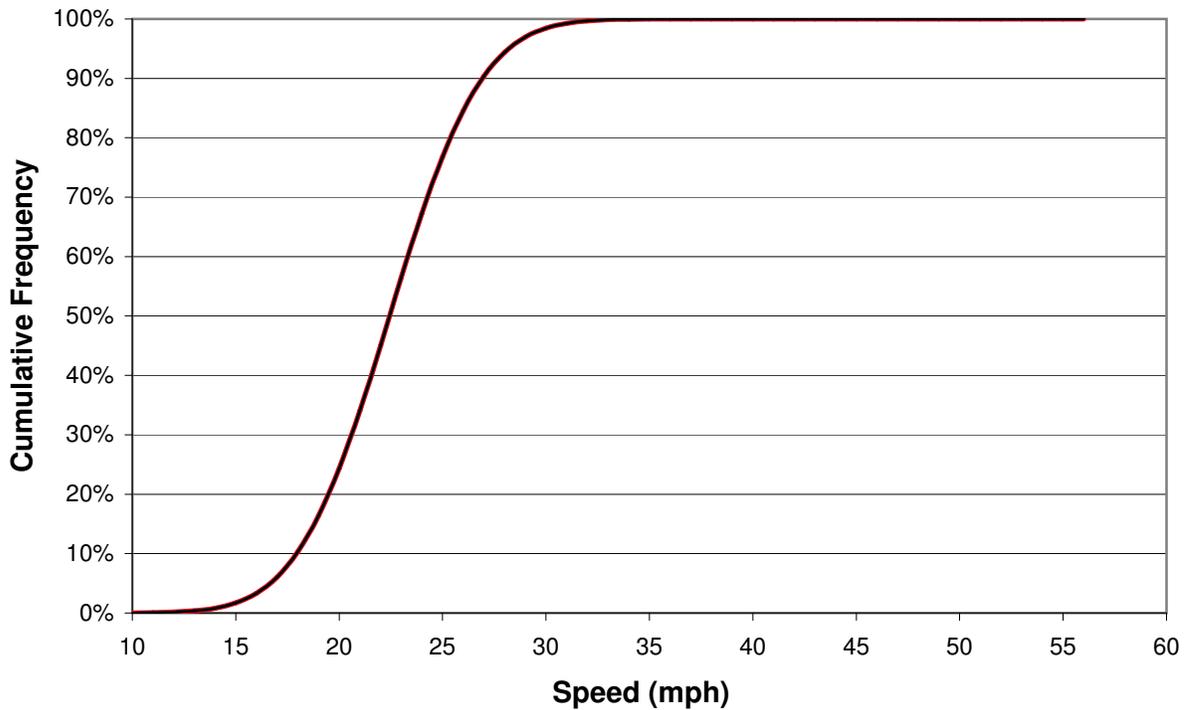
SPOT SPEED STUDY

The principal also noted that vehicles were speeding along West 108th Street. A spot speed was conducted on Monday, September 19, 2005 between 2:30 pm and 3:15 pm. The spot speed study showed that the 85th percentile speed on West 108th Street was 26 mph, which was below the statutory speed limit of 30 mph. See Table 4 for a summary of the results and the Appendix for further detail.

Date: **September 19, 2005** Time: **2:30 pm - 3:15 pm**
 Location: **West 108th Street between Amsterdam Avenue and Columbus Avenue**
 Surveyor:

Mean Speed = 22.4 mph
Standard Deviation = 3.5 mph
Margin of Error (95% Confidence) = ± 0.6 mph

Median Speed = 22.4 mph
15th Percentile Speed = 18.8 mph
85th Percentile Speed = 26.1 mph
