**New York City Department of Transportation
Office of School Safety Engineering**

School Safety Engineering Project

FINAL REPORT: I.S 250 (Robert F. Kennedy Community Middle School), Queens

October 4, 2006

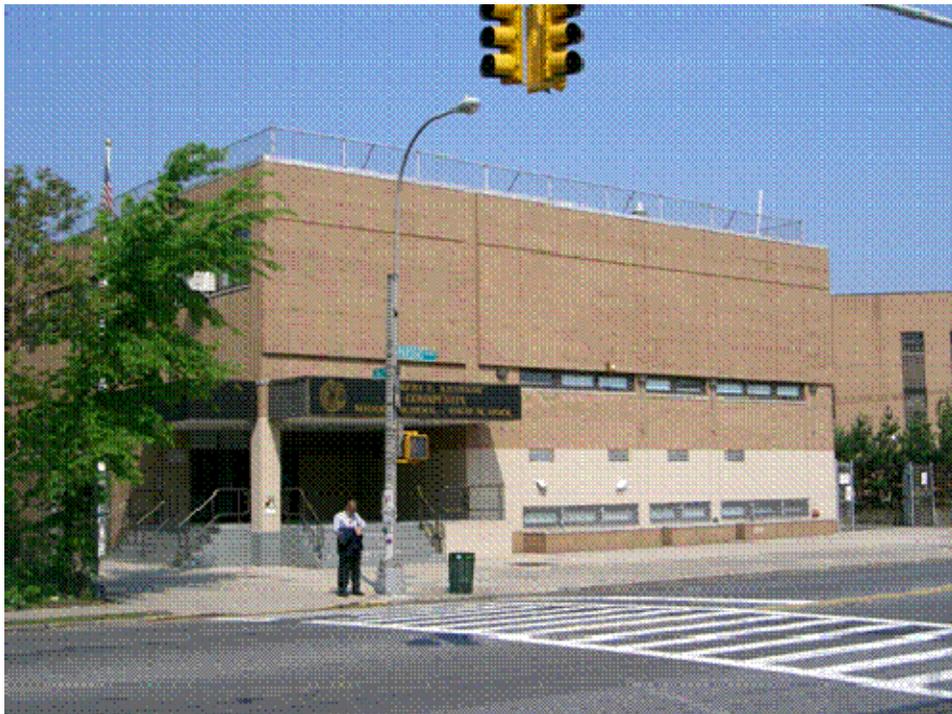
Exhibit 1 shows an aerial view of the neighborhood surrounding I.S. 250. The school is located on the northwest corner of the signalized Parsons Boulevard and 76th Avenue intersection (see Figure 1). The neighborhood surrounding the school is primarily residential, with some commercial uses located opposite the school on the east side of Parsons Boulevard between 76th Avenue and 75th Avenue, as well as along Kissena Boulevard. Both Parsons Boulevard and Kissena Boulevard are collector-level streets in the vicinity of I.S. 250.

Figure 1: Looking northwest to I.S. 250 from across Parsons Boulevard at the intersection with 76th Avenue

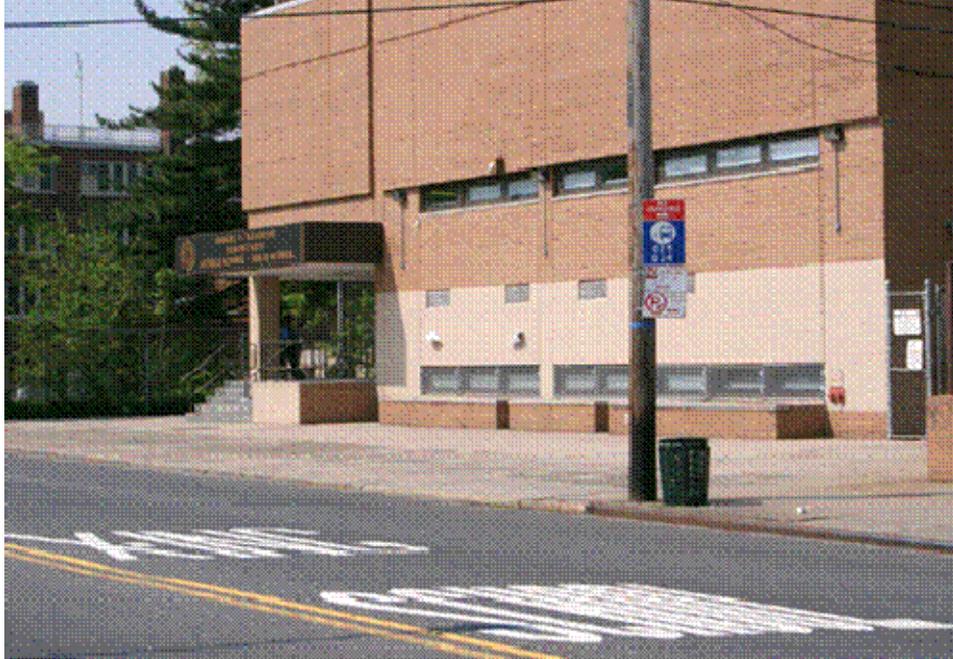
Figure 2: Looking southwest to the main entrance to I.S. 250 from the east side of Parsons Boulevard

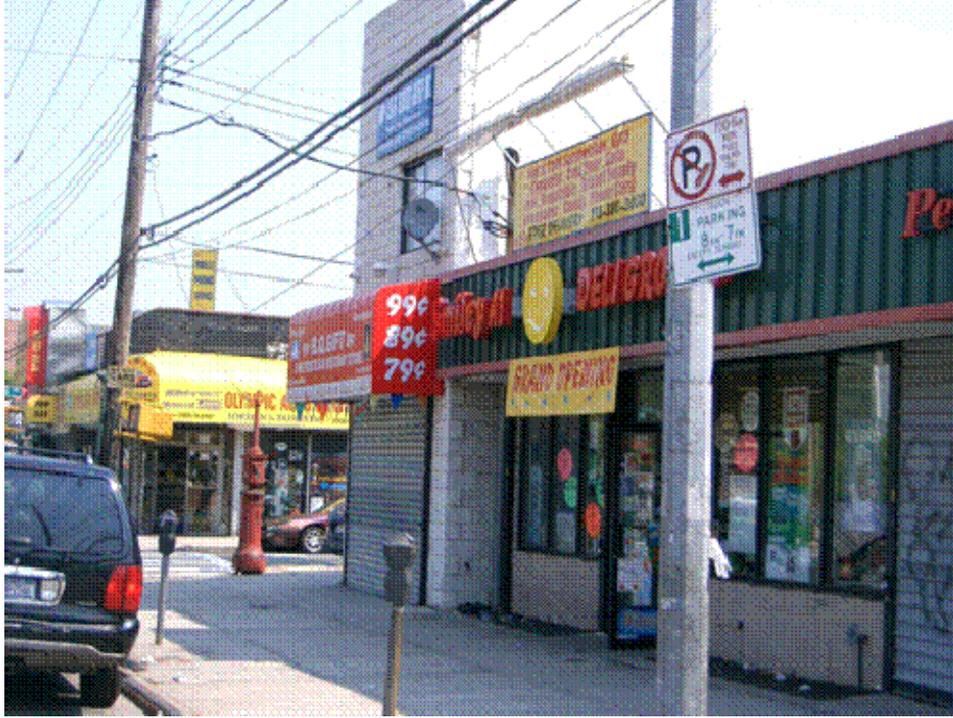
Commercial land uses located opposite the school on the east side of Parsons Boulevard generate pedestrian and vehicular traffic in the vicinity of the school (see Figure 3). In addition, there are three schools located one block south of I.S. 250 that also generate pedestrian and vehicular traffic in the area. The first of these is the Solomon Schechter School, located on the west side of Parsons Boulevard, south of I.S. 250. The other

Figure 3: Commercial uses opposite I.S. 250 on the east side of Parsons Boulevard

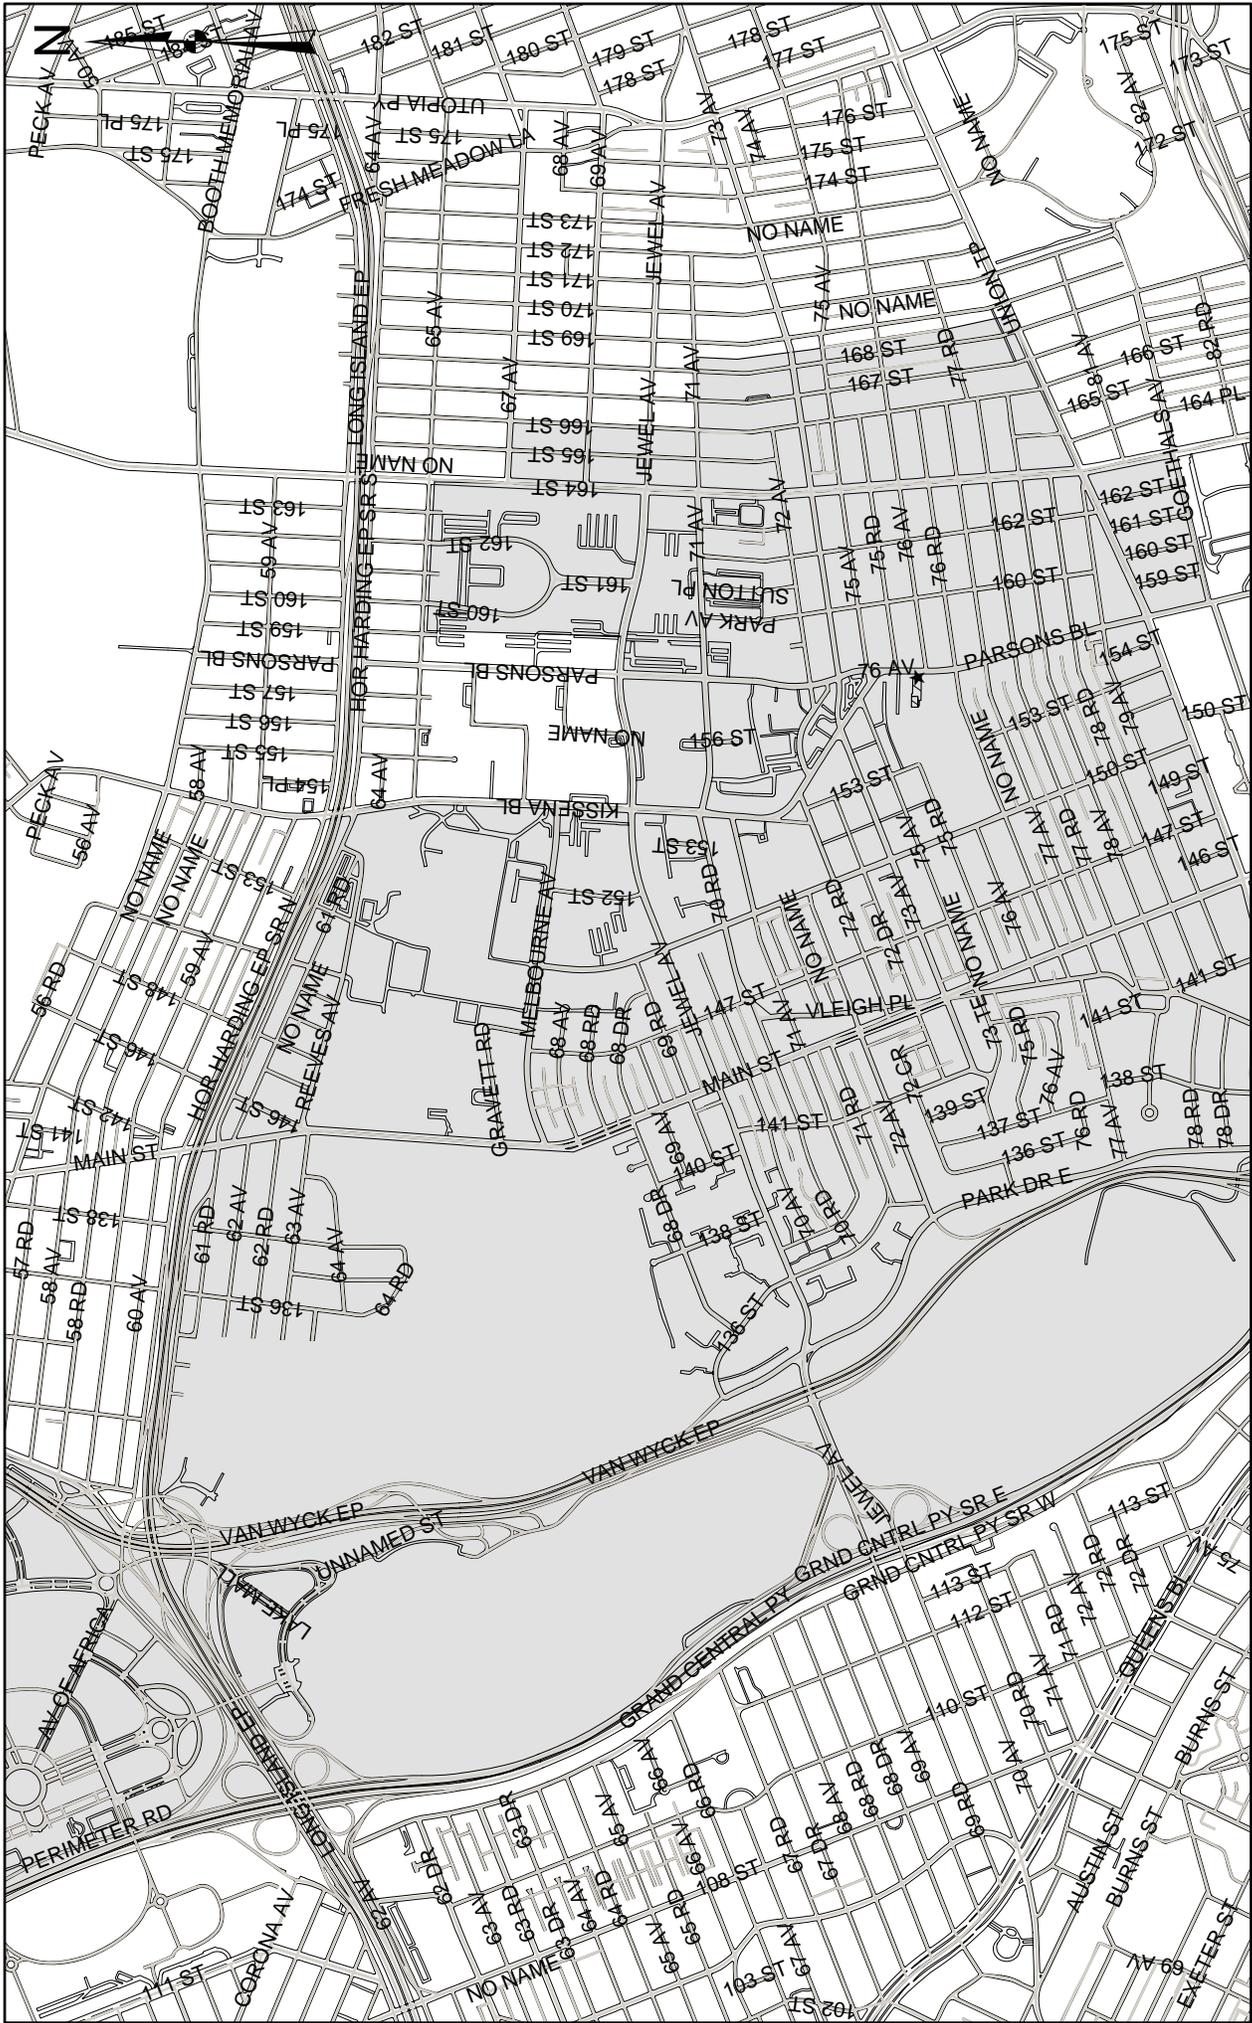
EXHIBIT 2
I.S. 250 QUEENS
ROBERT F. KENNEDY COMMUNITY MIDDLE SCHOOL
CATCHMENT AREA

The school’s “catchment area,” as defined by the Department of Education, is shown in Exhibit 2. The boundaries are roughly Long Island Expressway to the north, Grand Central Parkway to the west, Union Turnpike to the south and Utopia Parkway to the east.

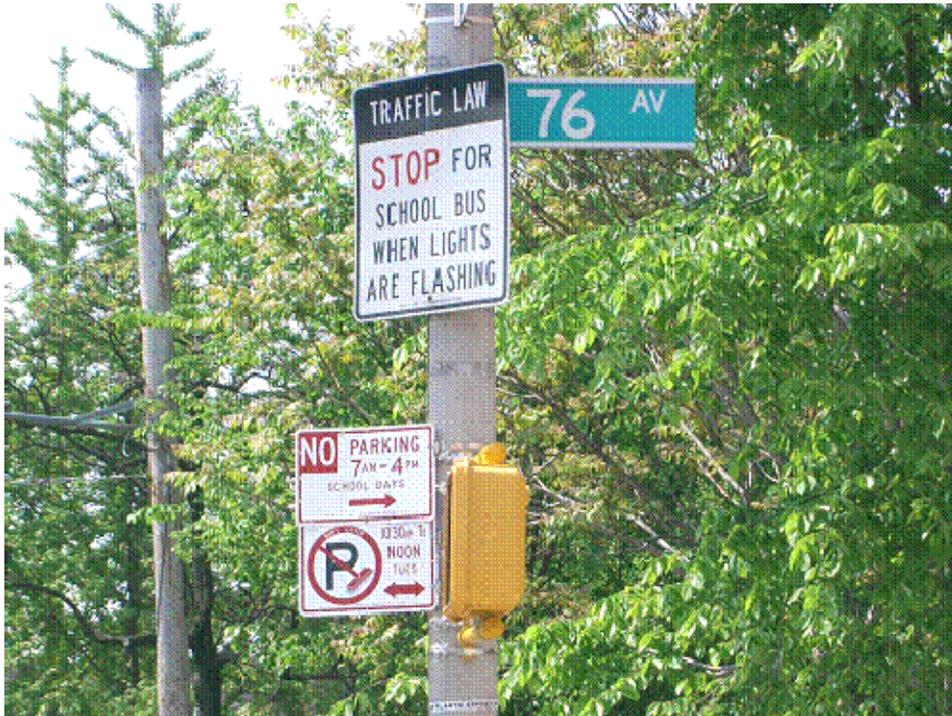
Parking regulations around the school block are shown in Exhibit 4 (also see Figure 4). Parsons Boulevard is a designated snow route. As such, no standing is allowed during declared snow-related emergencies.

Figure 4: Parking regulation signs on the west side of Parsons Boulevard at the intersection with 76th Avenue

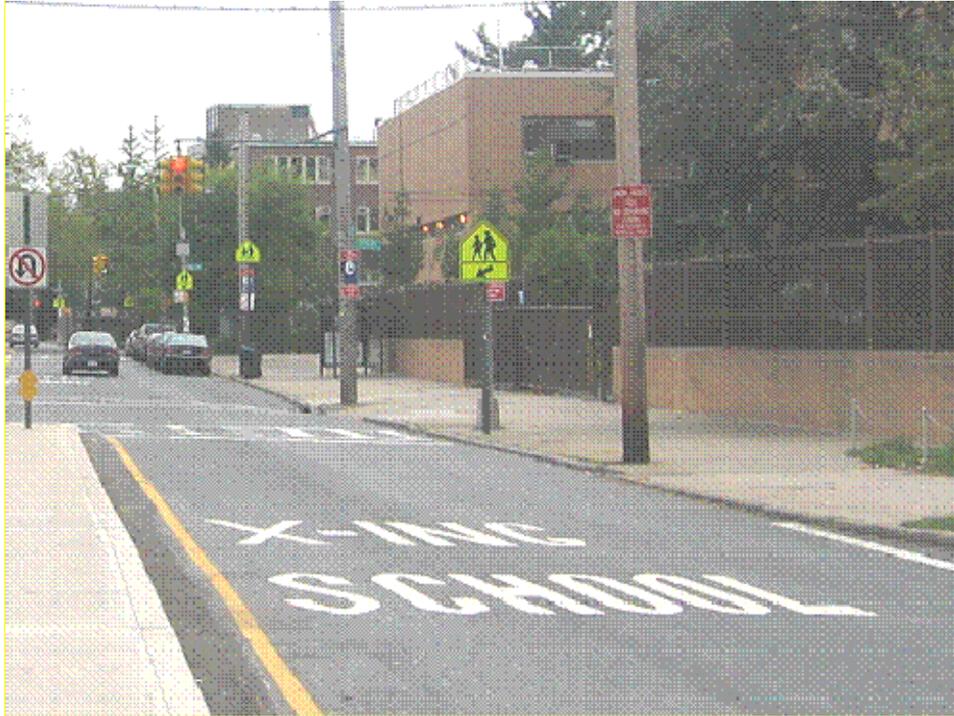
Exhibit 3 shows the existing signals, school crosswalks, and speed reducers in the vicinity of I.S. 250. It should be noted that a citywide signage program is currently underway to upgrade school signage to current Federal Manual on Uniform Traffic Control Devices (MUTCD) standards of fluorescent yellow-green signs accompanied by downward pointing arrows. Signs scheduled to be installed under this program are shown as “existing” in Exhibit 6.

Figure 5: Existing school signs and pavement markings on Parsons Boulevard in the vicinity of I.S. 250

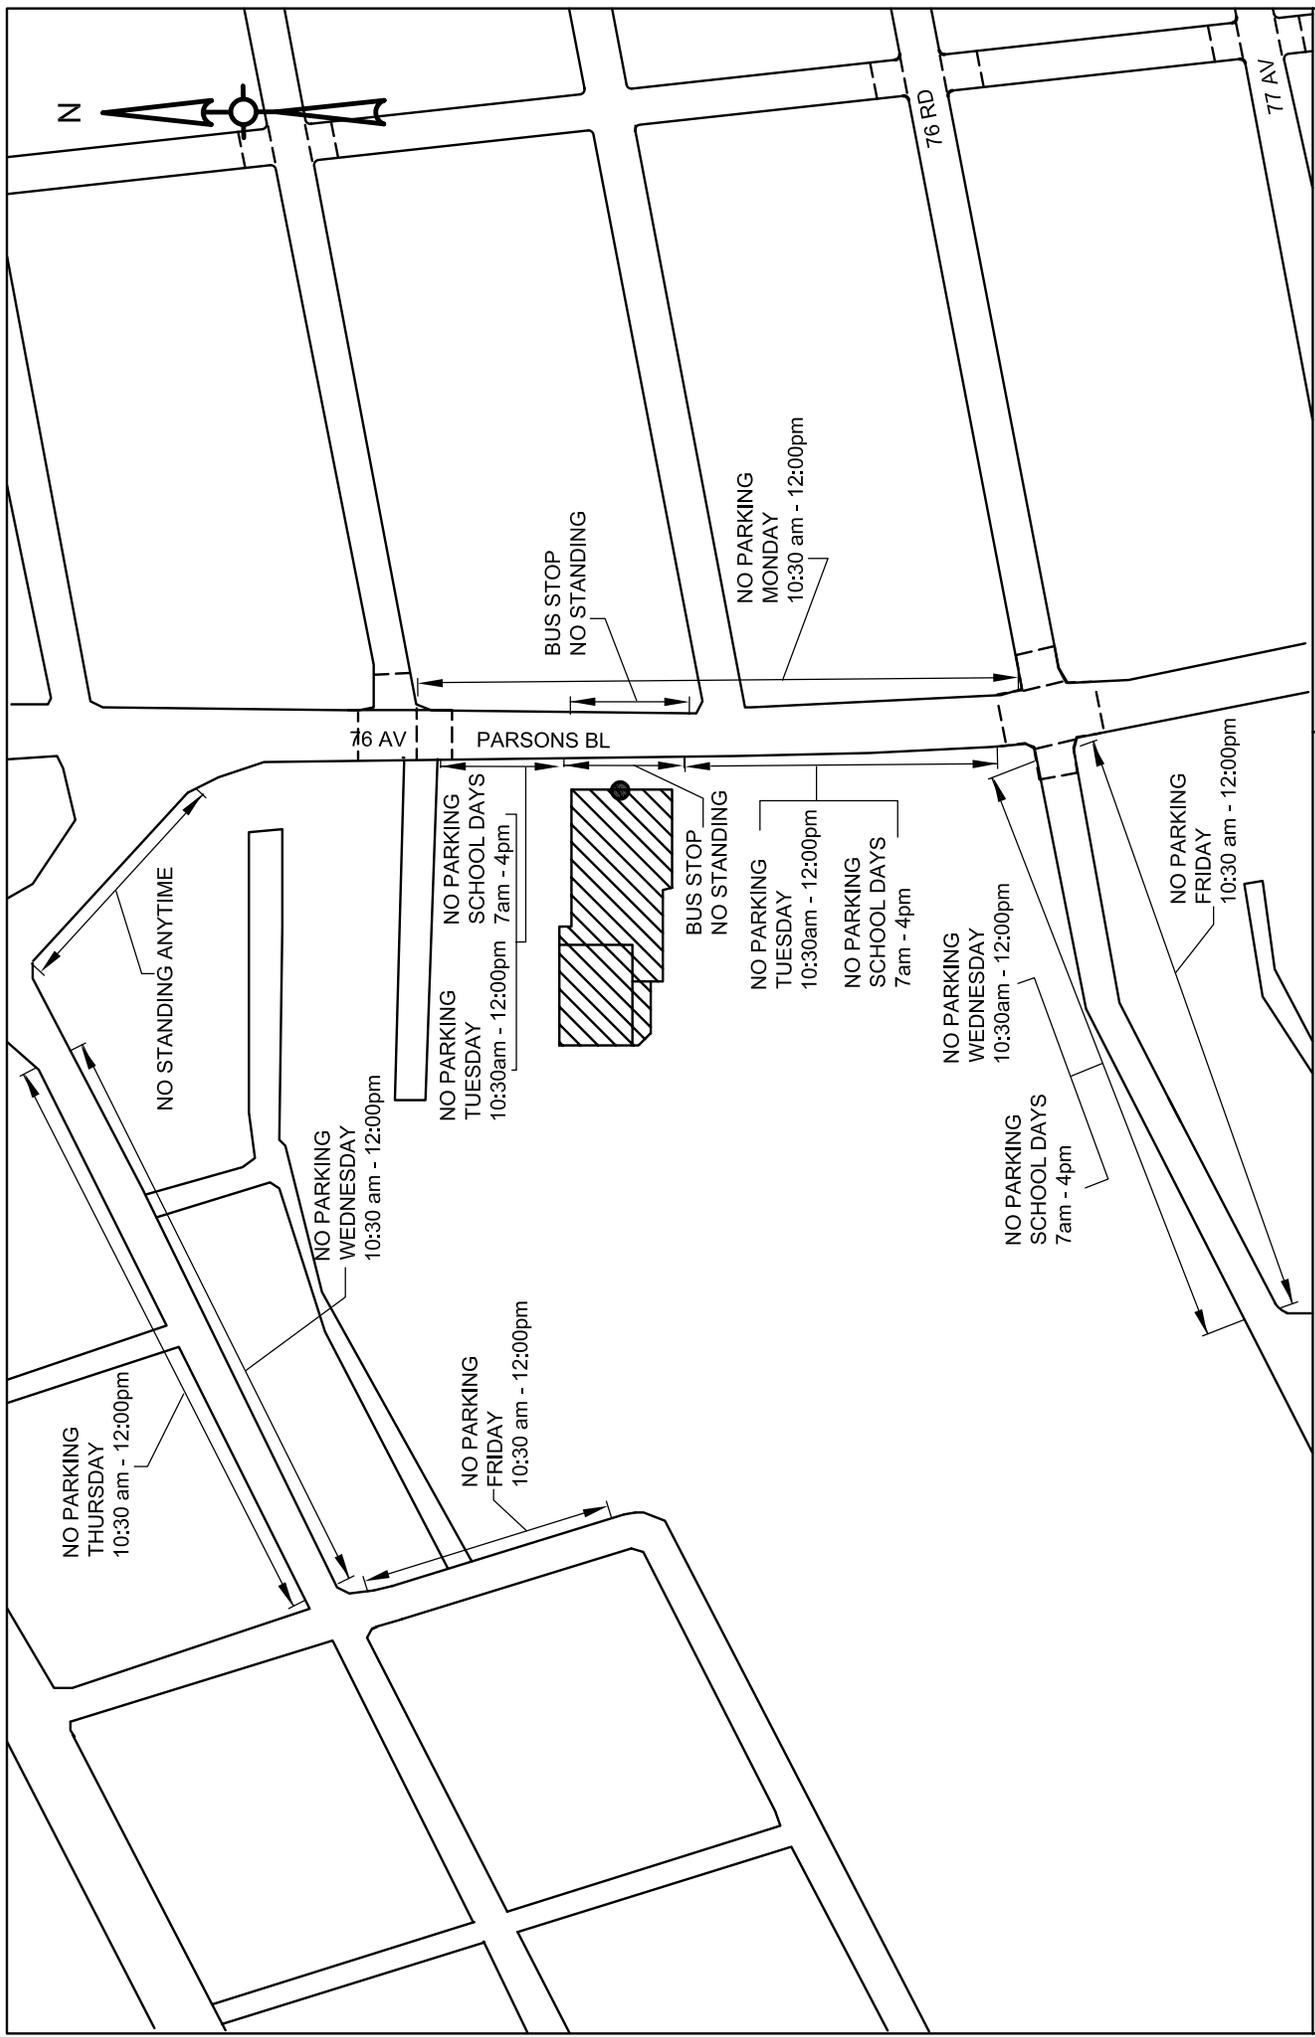
EXHIBIT 4

EXISTING PARKING REGULATION

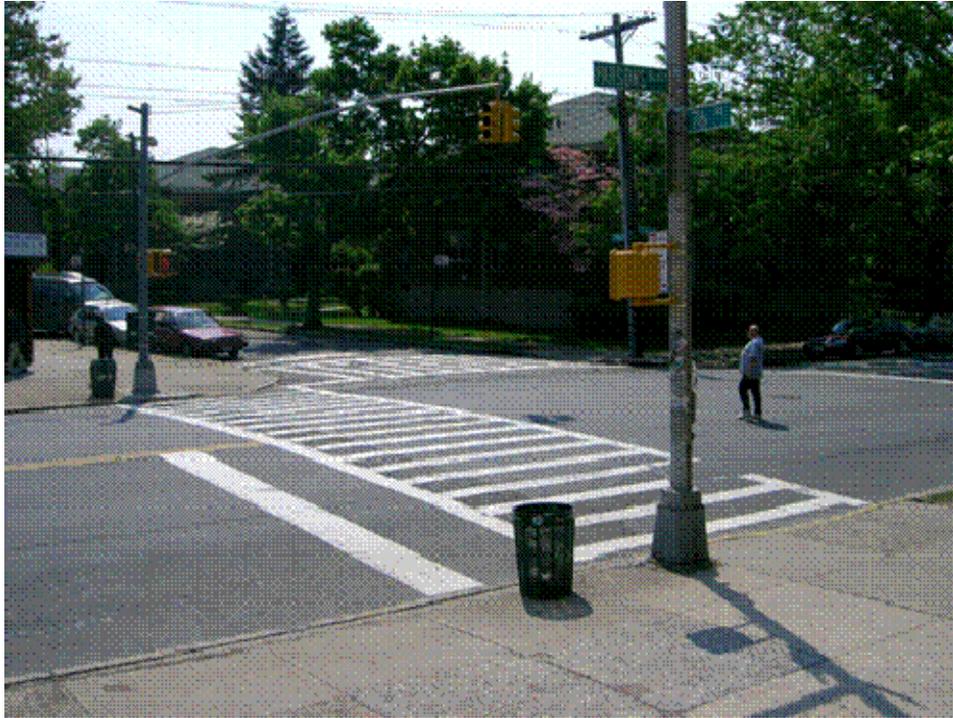
This is a signalized "T"-intersection, with school crosswalks located across the north leg of Parsons Boulevard and the east leg of 76th Avenue, and a pedestrian crosswalk located across the south leg of Parsons Boulevard. Parsons Boulevard is a two-way north-south street with one travel lane and one on-street parking lane on each side of the roadway. 76th Avenue is a two-way east-west street with one travel lane and one on-street parking lane on each side of the roadway (see Figures 6 and 7).

Figure 6: Looking southeast across Parsons Boulevard at the intersection with 76th Avenue

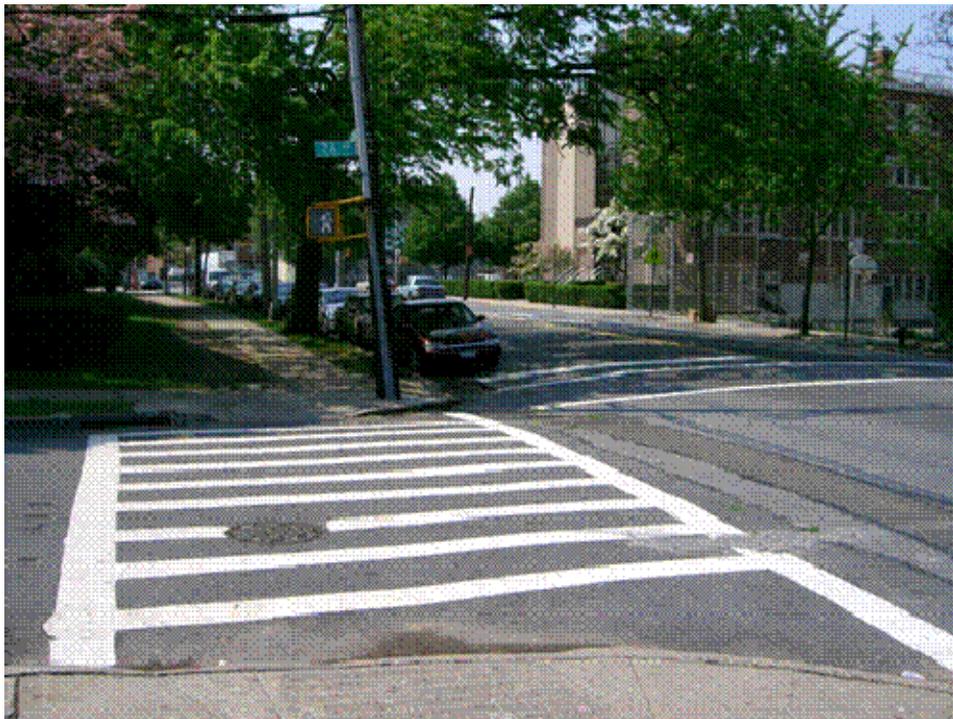
Figure 7: Looking southwest across the intersection of Parsons Boulevard and 76th Avenue

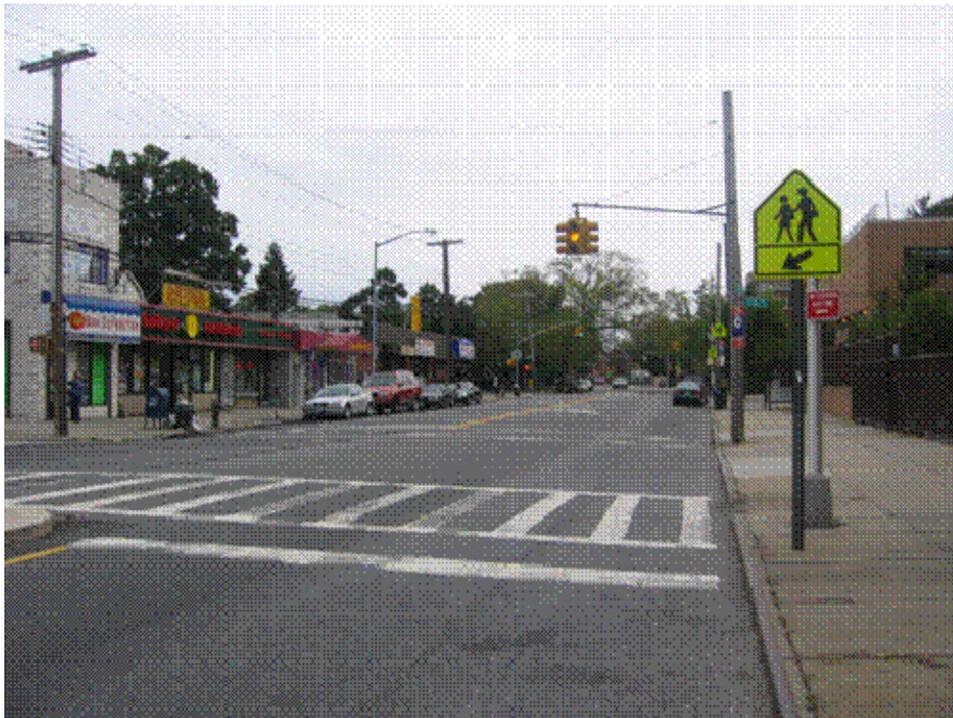
Parsons Boulevard is a two-way north-south street with one travel lane and one on-street parking lane on each side of the roadway. There is a raised concrete median, approximately five feet wide, located along the center of Parsons Boulevard, north of the intersection with 75th Road. 75th Road is a two-way east-west street with one travel lane and one on-street parking lane on each side of the roadway (see Figures 8 and 9).

Figure 8: Looking south on Parsons Boulevard at the intersection with 75th Road

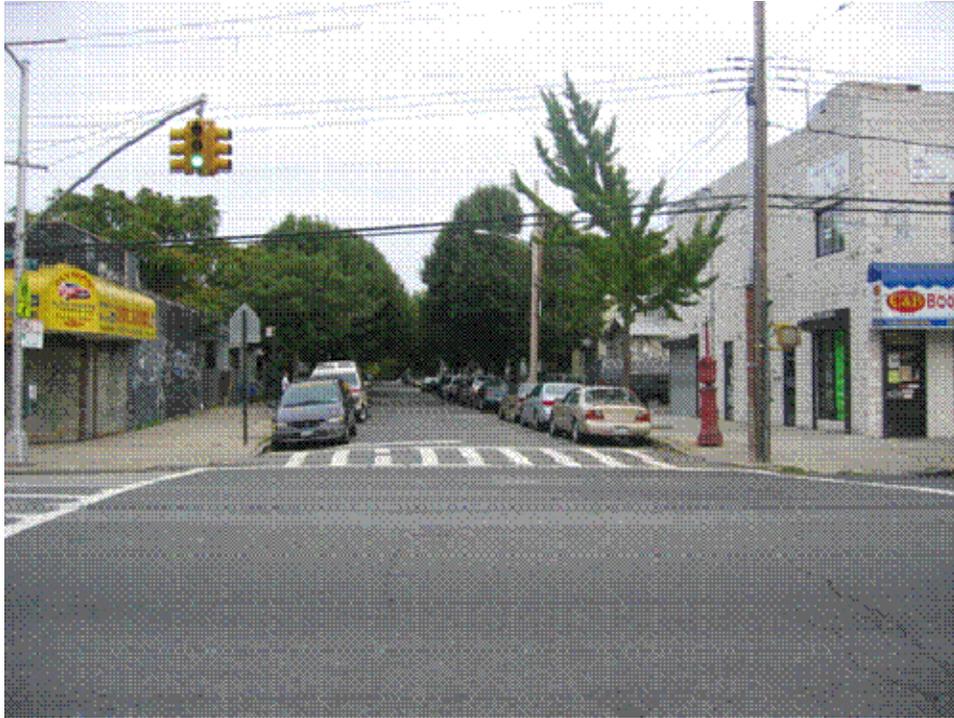
Figure 9: Looking east at 75th Road from across the intersection with Parsons Boulevard

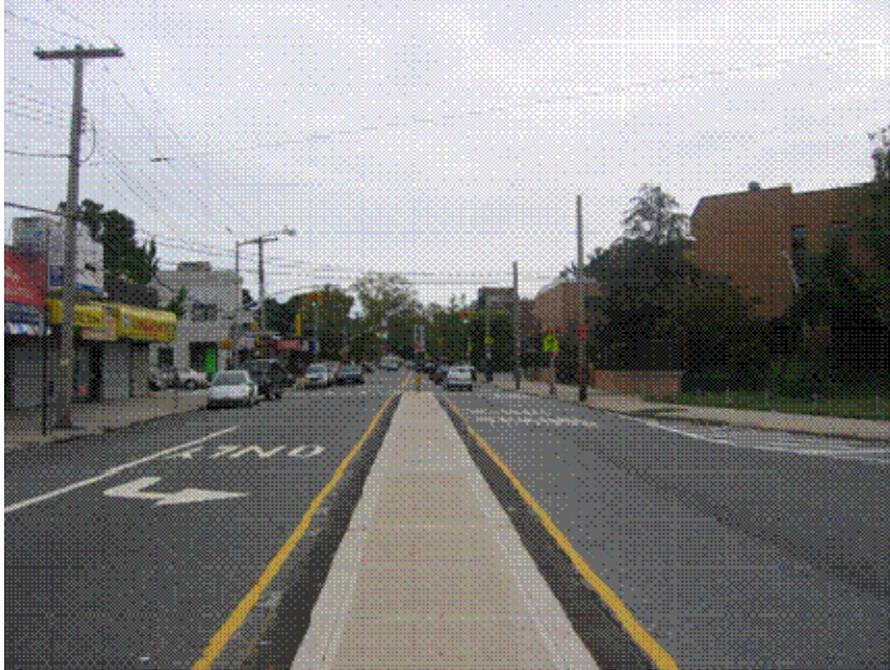
Figure 10: Looking south on Parsons Boulevard from the intersection with 75th Avenue.

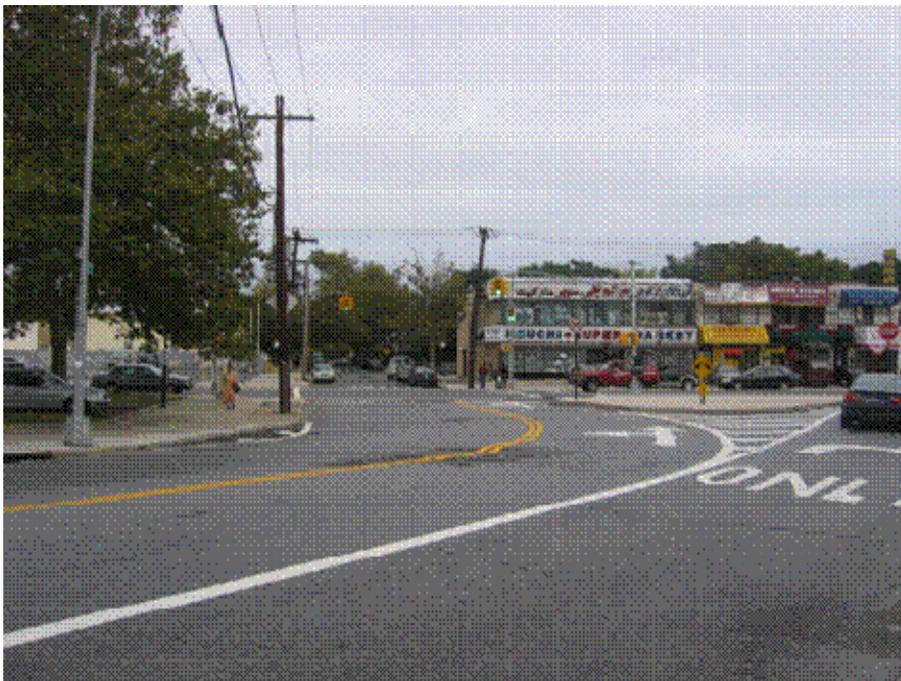
Figure 11: Looking east on Kissena Boulevard to the intersection of Parsons Boulevard and 75th Avenue/Kissena Boulevard

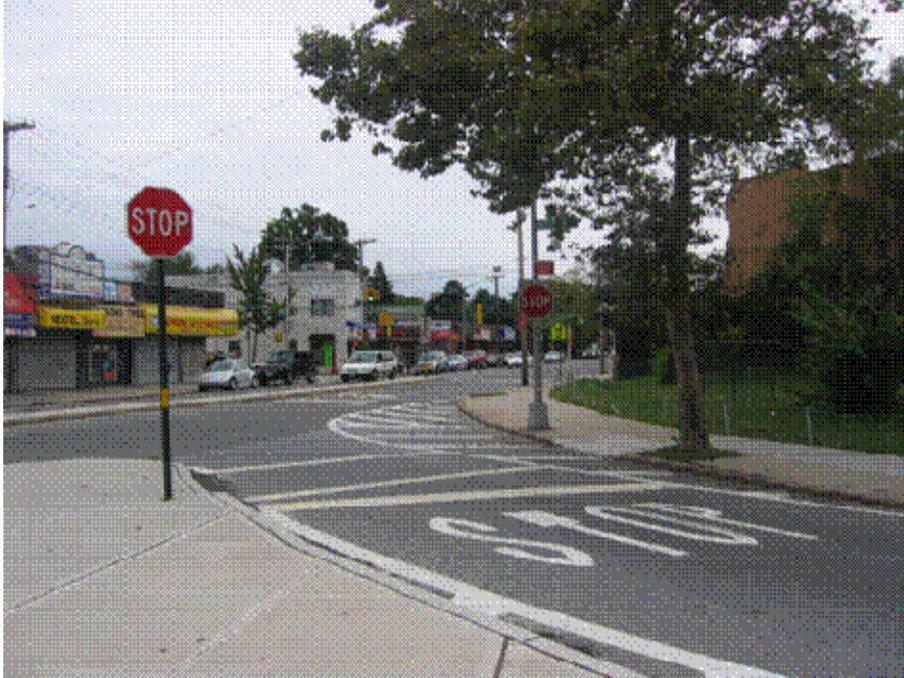
In the vicinity of I.S. 250, Parsons Boulevard is a two-way north-south street with one travel lane and one on-street parking lane on each side of the roadway. At the signalized intersection with 75th Avenue/Kissena Boulevard, the northbound approach on Parsons Boulevard has one exclusive left-turn lane and one shared through/right-turn lane (see Figure 10) and the southbound approach on Parsons Boulevard has one shared left-turn/through/right-turn lane. The westbound approach on 75th Avenue accommodates one shared left-turn/through/right-turn lane, and the eastbound approach on Kissena Boulevard accommodates one shared left-turn/through lane, and one channelized right-turn lane (see Figure 11). There is a raised concrete median, approximately five feet wide, located along the center of Parsons Boulevard, between 75th Avenue and 75th Road to prevent motorists in the right-turn lane from making left-turns from eastbound Kissena Boulevard onto northbound Parsons Boulevard (see Figure 12).

Figure 12: Looking south at the channelized right-turn lane from eastbound Kissena Boulevard to southbound Parsons Boulevard.

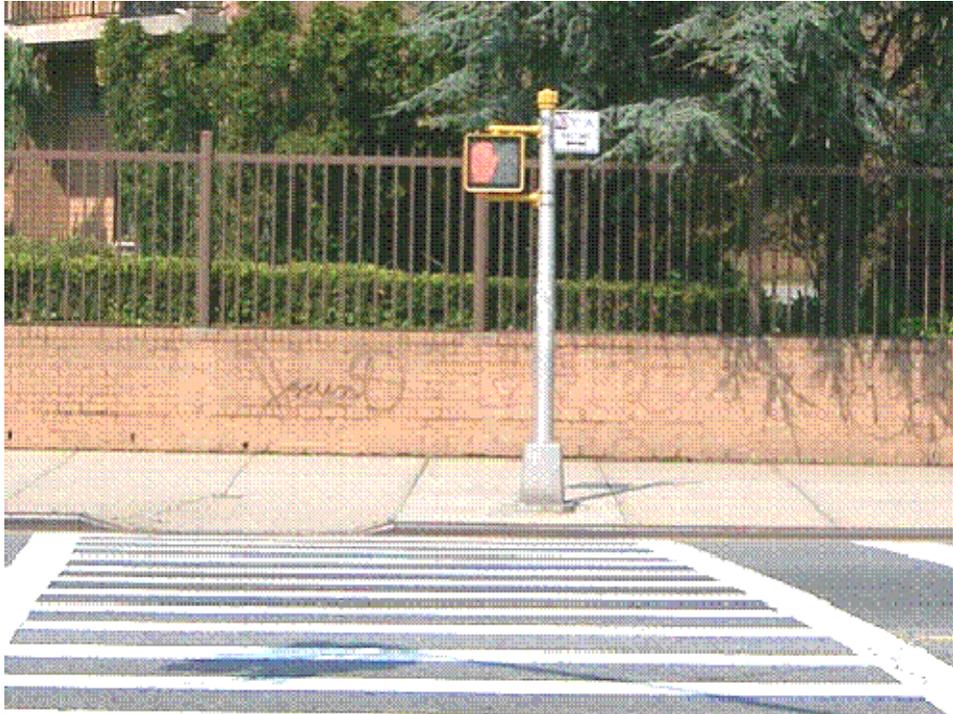
Pedestrian ramps in the vicinity of the school were observed to be standard, with two exceptions. The first of these is the pedestrian ramp on the west side of Parsons Boulevard at the intersection with 75th Road, where there is a pedestrian signal pole located in the path for the crosswalk located across the north leg of the intersection (see Figure 13). The second location is also on the west side of Parsons Boulevard at the intersection of 75th Road, where there is a drainage inlet located in the path for the pedestrian crosswalk across the south leg of the intersection (see Figure 14).

Figure 13: Looking to the west side of Parsons Boulevard at the intersection with 75th Road (note the pedestrian signal pole located in the path of the north crosswalk)

On the west side of Parsons Boulevard, at the intersection with 75th Road, there is a pedestrian signal pole located in the path for the school crosswalk across the north leg of Parsons Boulevard. Therefore, the following action is recommended:

- Relocate the pedestrian signal pole on the west side of Parsons Boulevard, at the intersection with 75th Road, outside the path of the school crosswalk located across the north leg of Parsons Boulevard.

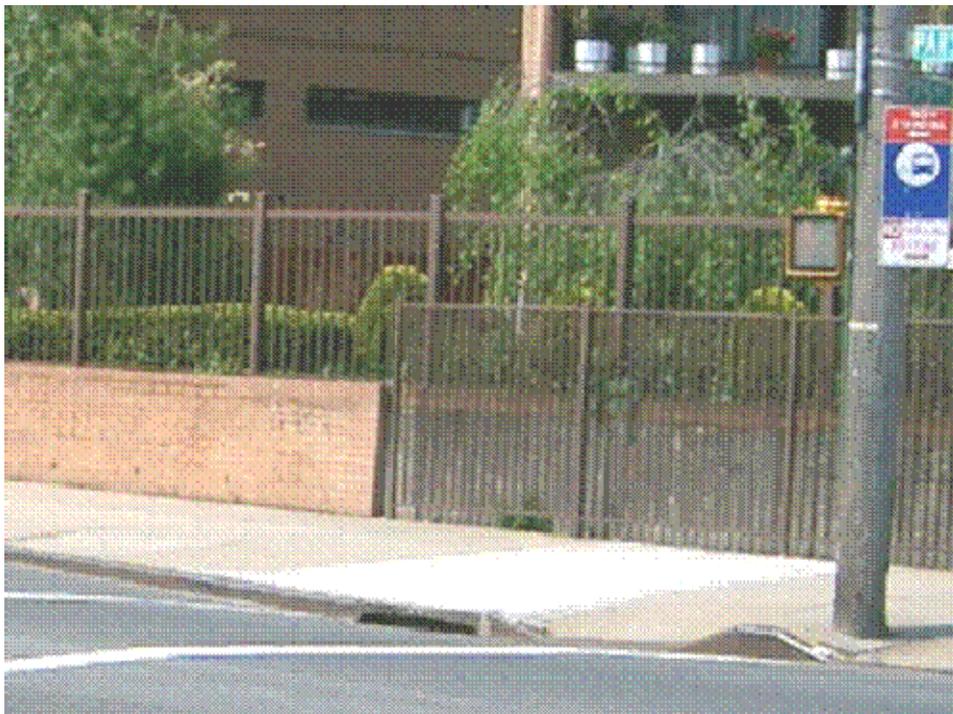
Figure 14: Looking to the west side of Parsons Boulevard at the intersection with 75th Road (note the drainage inlet located in the path for the south crosswalk)

On the west side of Parsons Boulevard, at the intersection with 75th Road, there is a drainage inlet located in the path for the pedestrian crosswalk across the south leg of Parsons Boulevard. Therefore, the following action is recommended:

- Relocate the drainage inlet on the west side of Parsons Boulevard, at the intersection with 75th Road, outside the path of the pedestrian crosswalk located across the south leg of Parsons Boulevard.
