**New York City Department of Transportation
Office of School Safety Engineering**

School Safety Engineering Project

FINAL REPORT: P.S. 149 (Christa McAuliffe School), Queens

**Prepared by
The RBA Group and URBITRAN Associates Inc.**

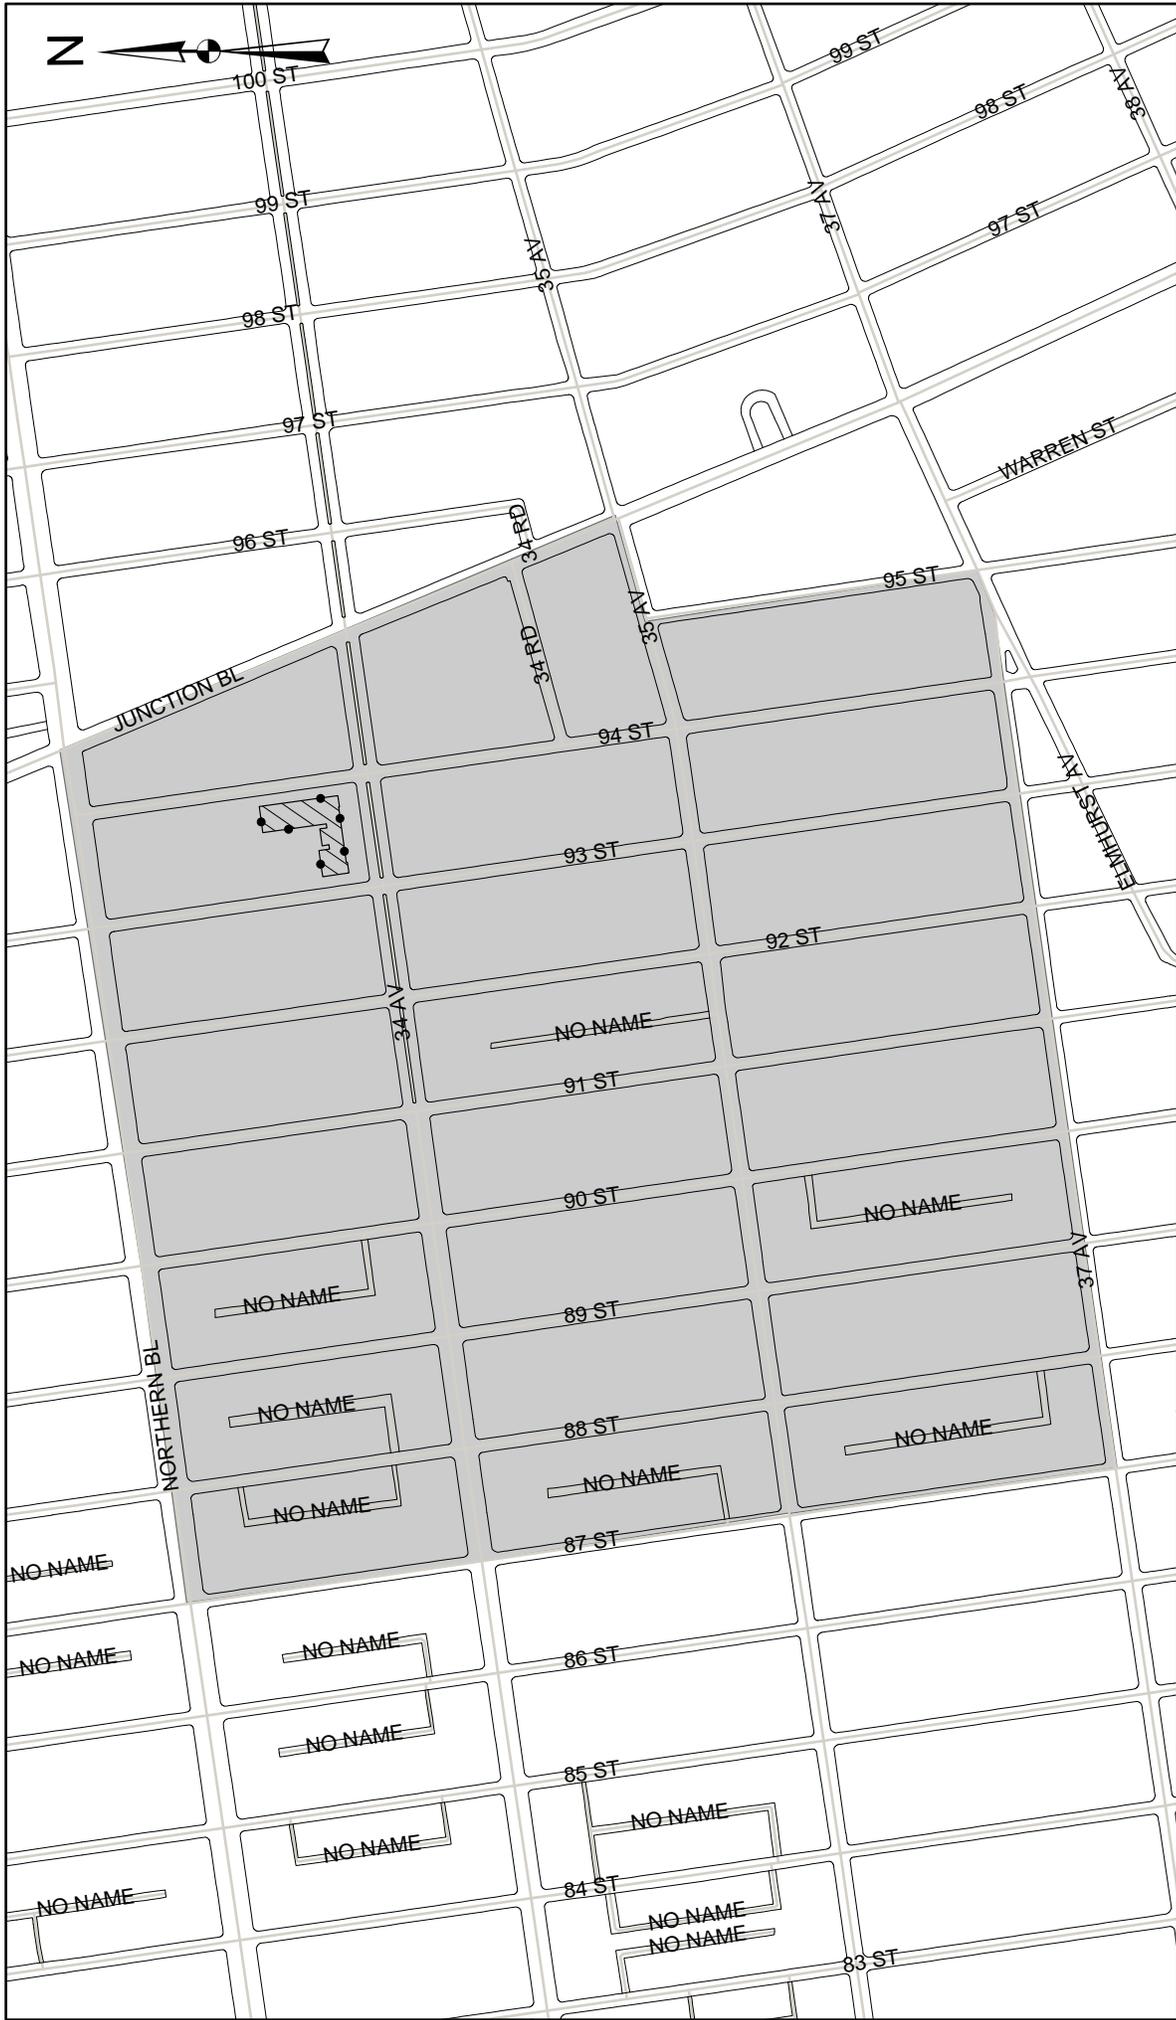
EXHIBIT 2
P.S. 149 QUEENS
CHRISTA MCAULIFFE SCHOOL
CATCHMENT AREA

LEGEND:
 CATCHMENT AREA, (DEPARTMENT OF EDUCATION DESIGNATED AREA FROM WITHIN WHICH STUDENTS ARE ENTITLED TO ATTEND P.S. 149)

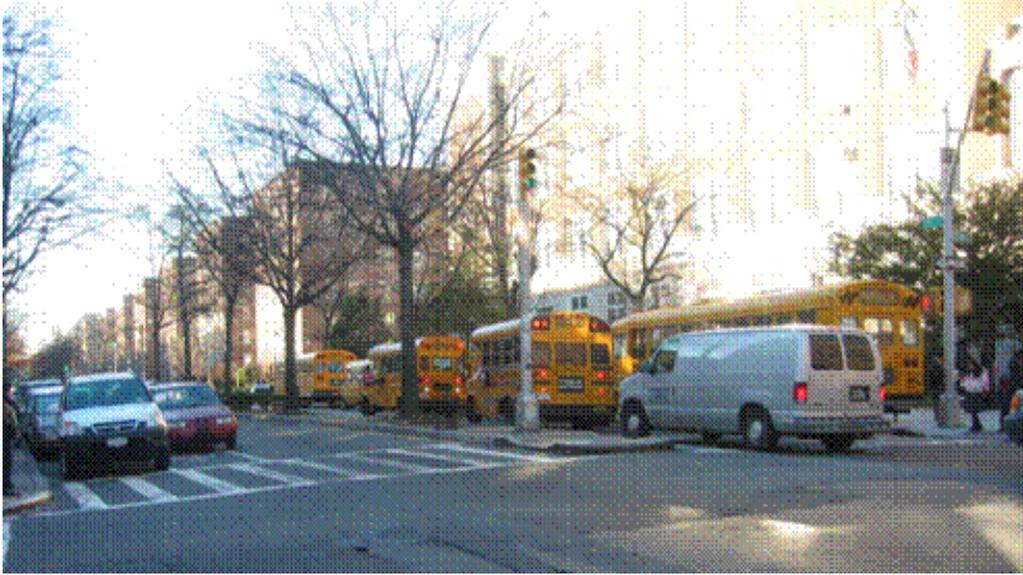
Figure 1: Looking northwest across the 34th Avenue and 94th Street intersection (note congestion due to the presence of buses in front of P.S. 149)

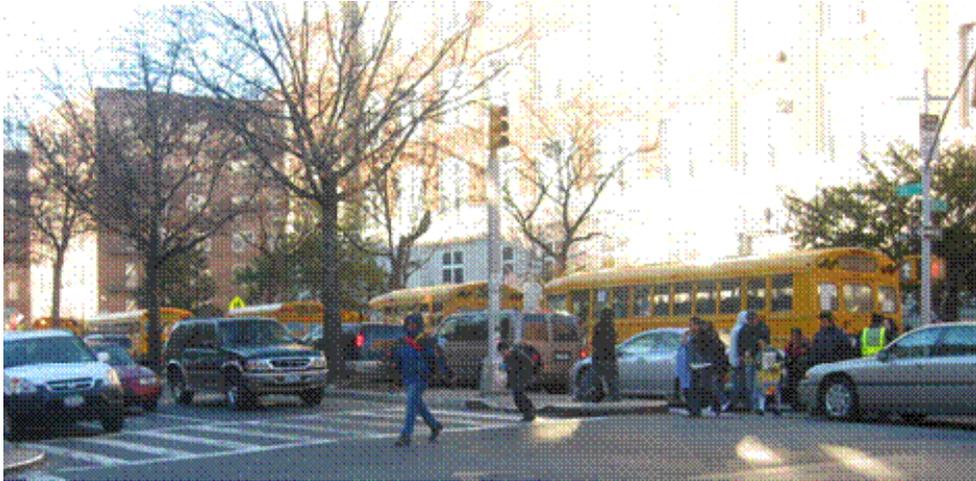
Figure 2: Looking northwest across the 34th Avenue and 94th Street intersection (note congestion due to the presence of buses and student pedestrian activity in front of P.S. 149)

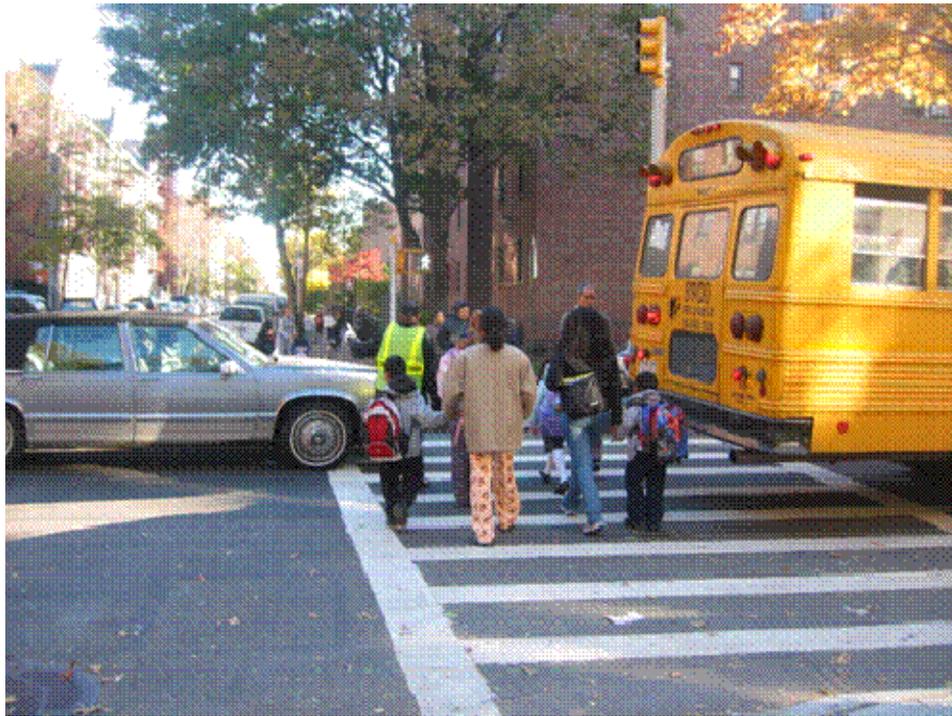
Figure 3: Looking south across the westerly crosswalk at the intersection of 34th Avenue and 94th Street (note vehicles blocking school crosswalk)

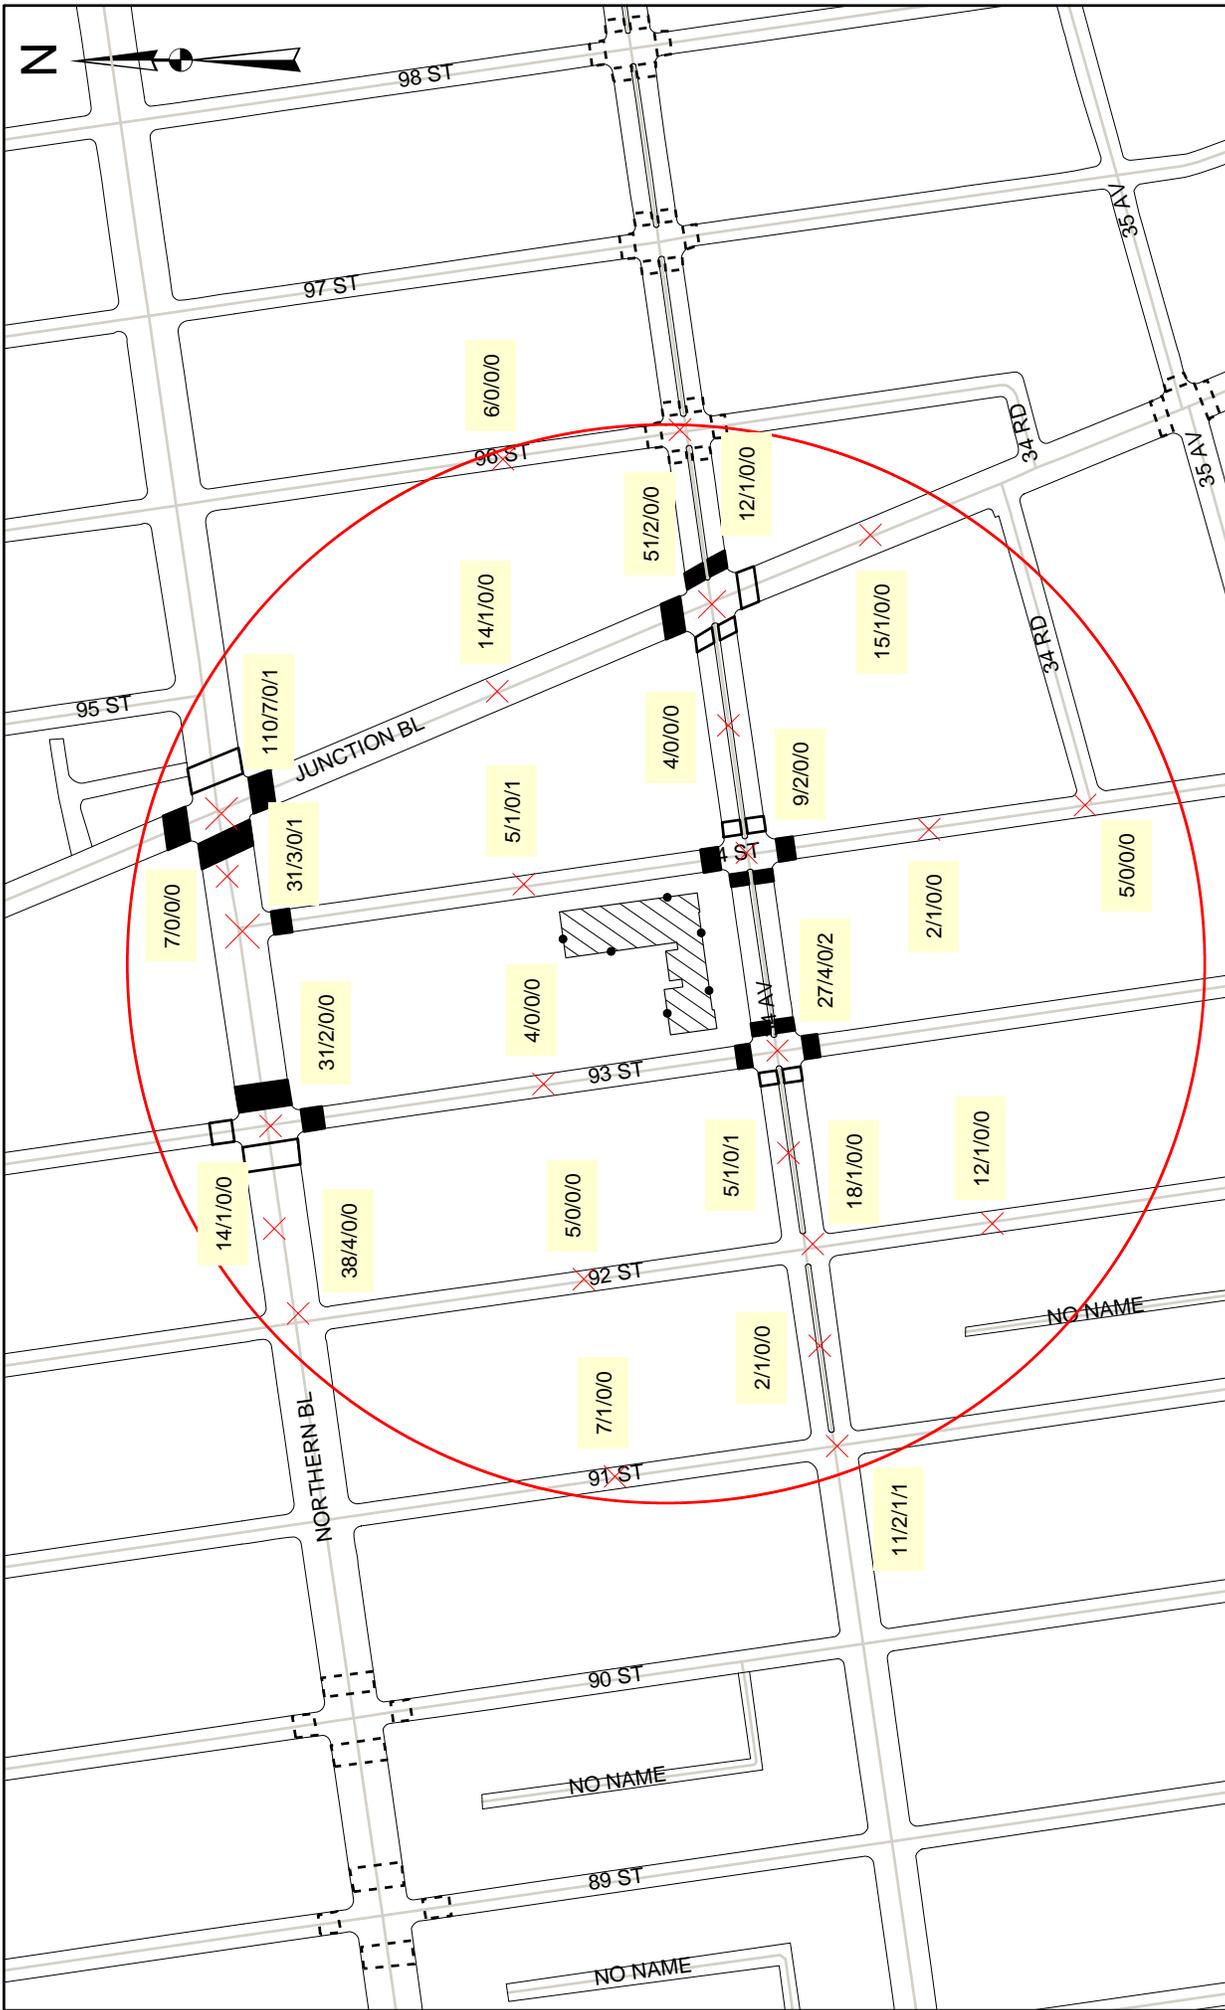
EXHIBIT 6
P.S. 149 QUEENS
CHRISTA MCAULIFFE SCHOOL
ACCIDENT SUMMARY (1998-2000)

Exhibit 6 and Table 2 show a summary of accidents, as obtained from the New York State Department of Motor Vehicles (DMV), in the vicinity of P.S 149 for the three-year period from January 1, 1998 through December 31, 2000. The DMV data provides some detail relating to the circumstances and cause of the accident. Table 3 is a summary of more recent accident data obtained from the NYC Police Department (NYPD). Though current through 2004, the NYPD data does not provide the same level of detail as the DMV data.

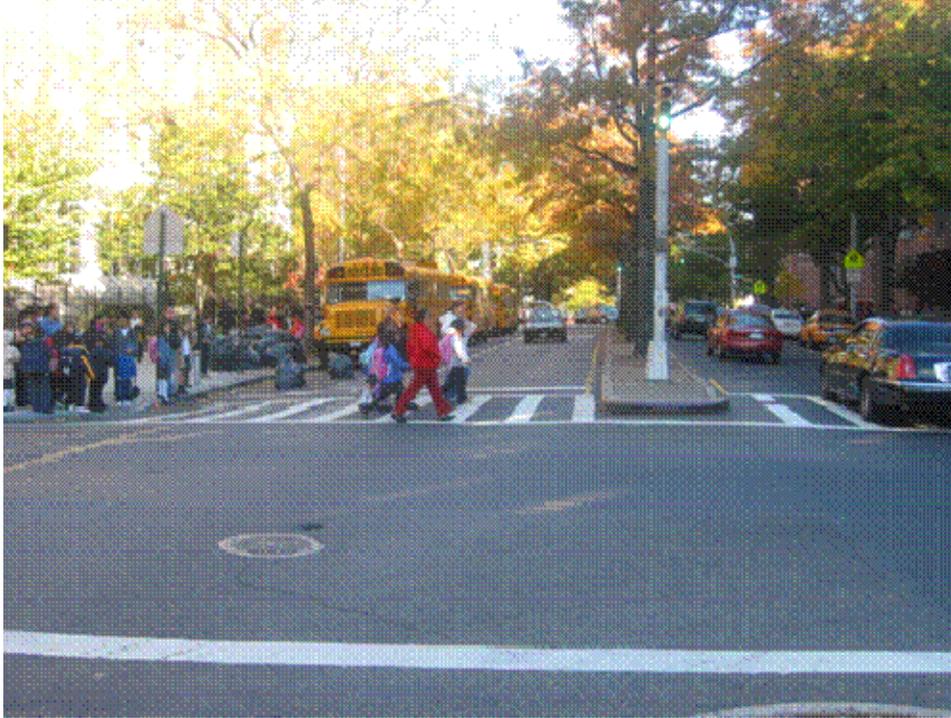
There was a total of 27 accidents reported at this intersection between 1998 and 2000, including four pedestrian accidents, two of which were school-related (Table 2). In the first school-related accident, a six-year-old pedestrian sustained an "incapacitating injury" at approximately 8:00 am on October 21, 1998 while crossing with the signal at this intersection. At the time of the accident, the roadway surface was dry and the weather was cloudy. The accident occurred during daylight conditions.

Figure 4: Looking east on 34th Avenue at the intersection with 93rd Street during the afternoon dismissal period

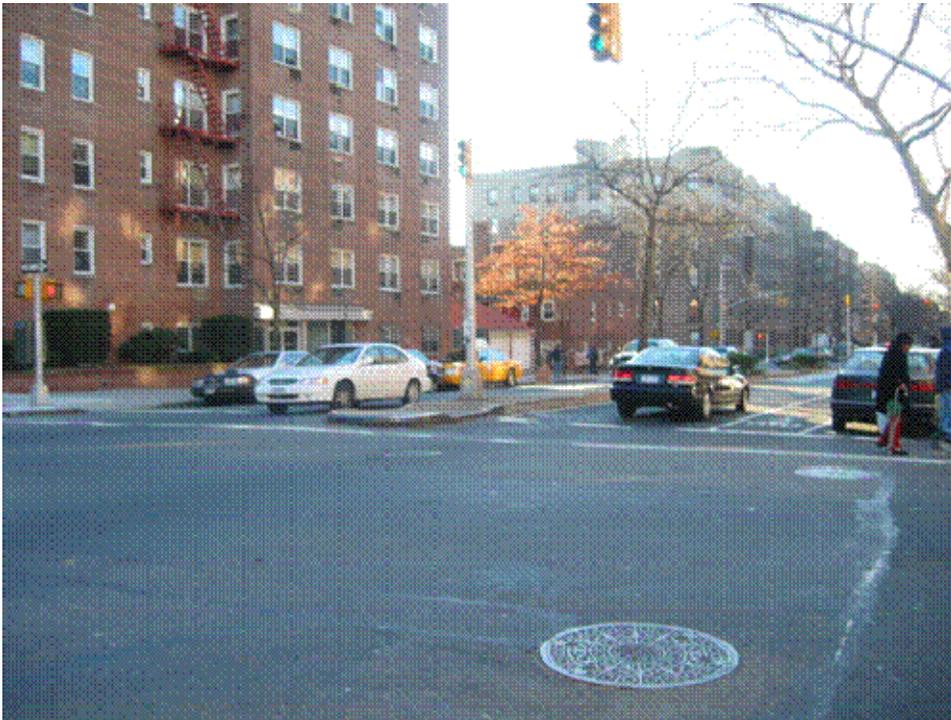
Figure 5: Looking west on 34th Avenue at the intersection with 93rd Street

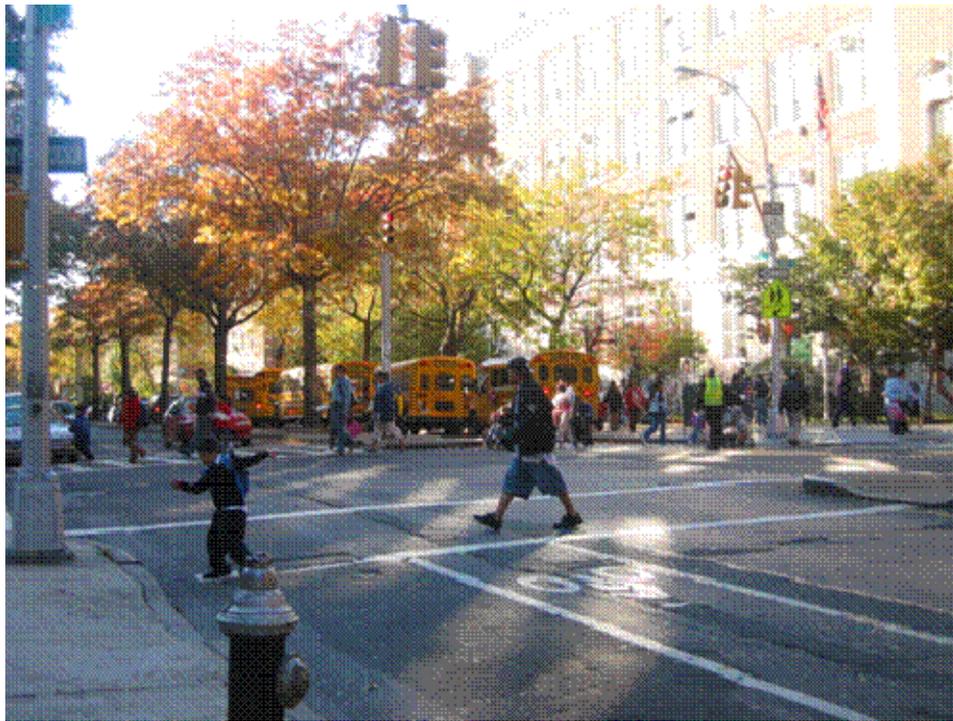
This is a four-leg signalized intersection with school crosswalks located across the north and south legs of 94th Street and the west leg of 34th Avenue, and a pedestrian crosswalk located across the east leg of 34th Avenue. 34th Avenue is a two-way east-west street with one travel lane, one on-street parking lane, and one bicycle lane on each side of the roadway. A raised concrete median approximately six feet wide is located along the center of 34th Avenue, separating eastbound and westbound traffic. 94th Street is a one-way southbound street with one travel lane and on-street parking permitted on both sides of the roadway (see Figure 6).

Figure 6: Looking west on 34th Avenue at the intersection with 94th Street during the afternoon dismissal period

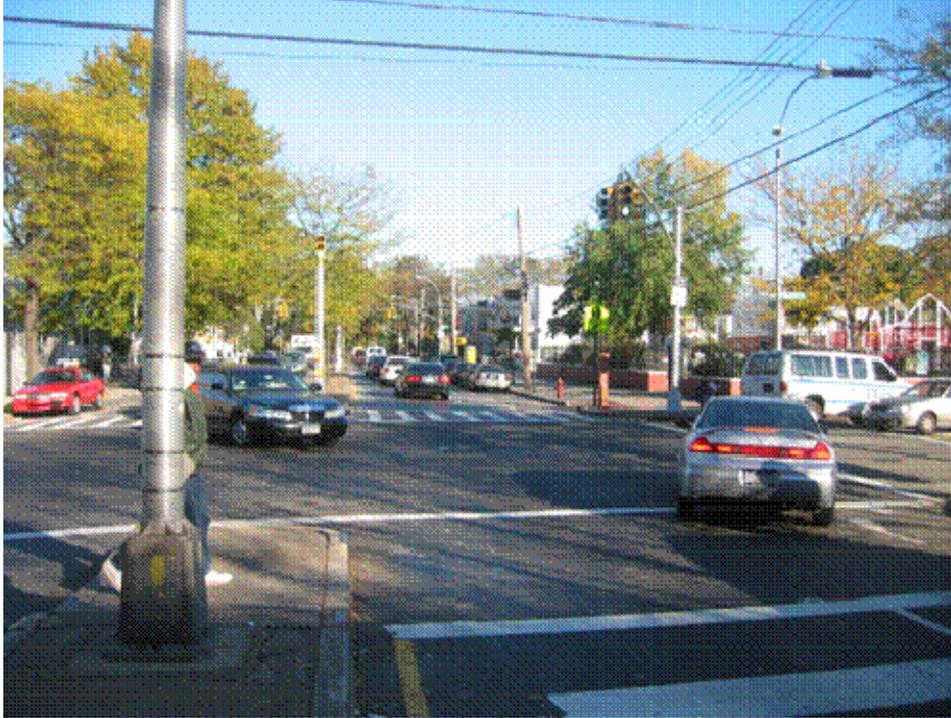
This is a four-leg signalized intersection with school crosswalks located across the north leg of Junction Boulevard and the east leg of 34th Avenue. Pedestrian crosswalks are located across the south leg of Junction Boulevard and the west leg of 34th Avenue. Junction Boulevard is a two-way north-south street with one travel lane and one on-street parking lane on each side of the roadway. 34th Avenue is a two-way east-west street with one travel lane, one on-street parking lane, and one bicycle lane on each side of the roadway. A raised concrete median approximately six feet wide is located along the center of 34th Avenue, separating eastbound and westbound traffic (see Figures 7 and 8).

Figure 7: Looking east on 34th Avenue at the intersection with Junction Boulevard

The landscaped median along the center of 34th Avenue separates eastbound and westbound traffic, but does not extend through the crosswalks. Therefore, it is recommended to:

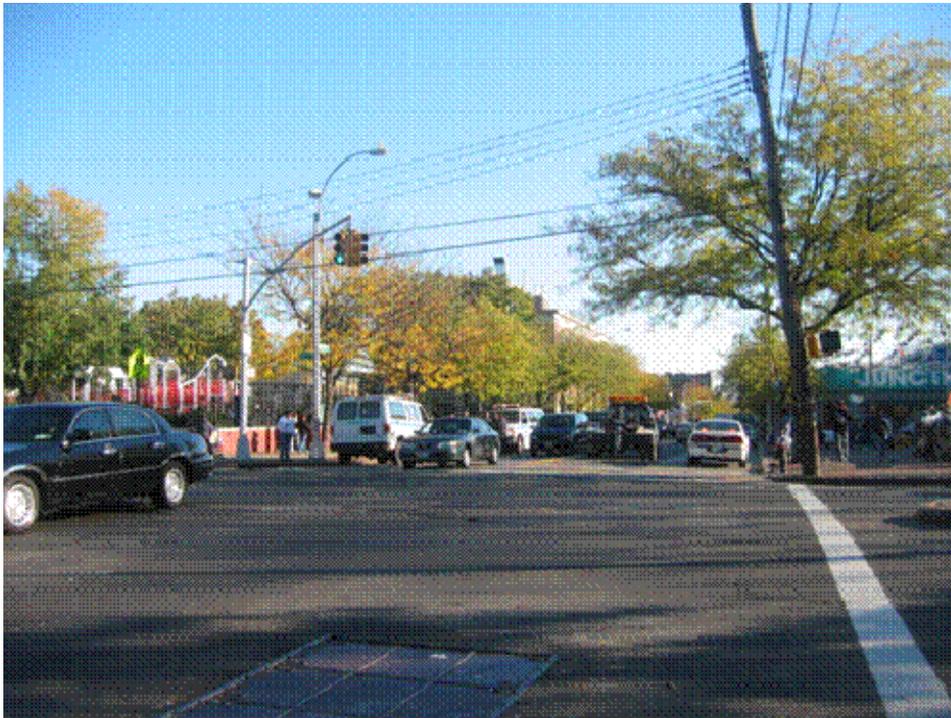
Figure 8: Looking south on Junction Boulevard at the intersection with 34th Avenue

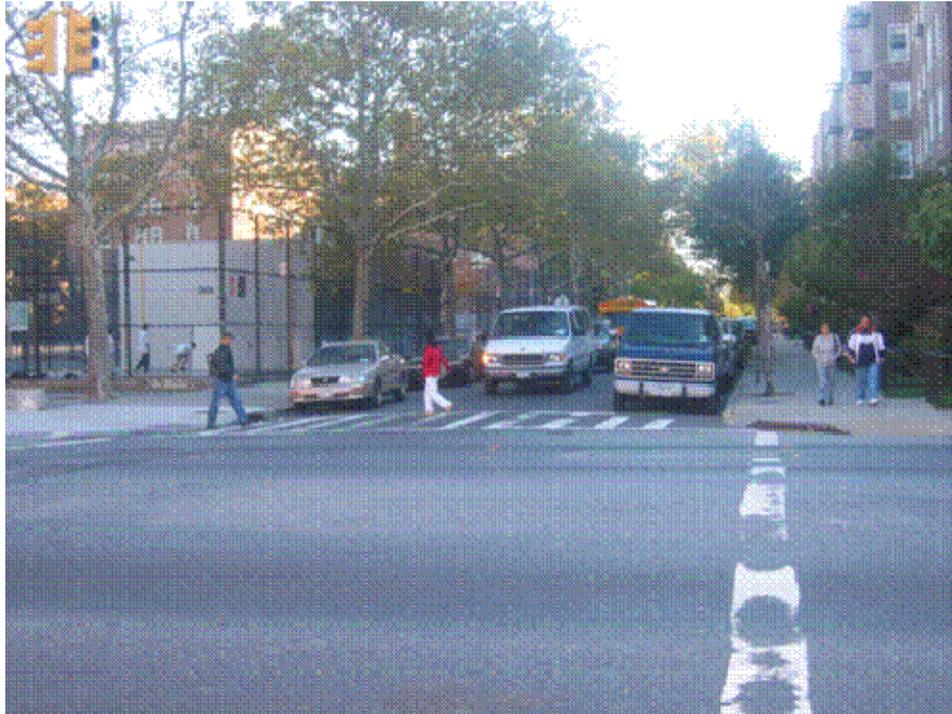
This is a four-leg signalized intersection with school crosswalks located across the north and south legs of 93rd Street, and the east leg of Northern Boulevard. A pedestrian crosswalk is located across the west leg of Northern Boulevard. Northern Boulevard, also known as State Highway Route 25A, is a major east-west arterial roadway through Queens. Northern Boulevard extends approximately 23 miles between Queens Boulevard (near the Queensborough Bridge, where it connects directly with Jackson Avenue) and Nassau County at the city line. Northern Boulevard is also a designated “through” truck route. In the vicinity of P.S. 149, Northern Boulevard has two travel lanes and one on-street parking lane in each direction, plus an approximate 12 foot wide median striped along the center of the roadway separating eastbound and westbound traffic. 93rd Street is a one-way northbound street with one travel lane and on-street parking permitted on both sides of the roadway. There is an exclusive eastbound left-turn lane in the median of Northern Boulevard at its intersection with 93rd Street (see Figures 9 and 10).

Figure 9: Looking south along 93rd Street at the intersection with Northern Boulevard (P.S. 149 can be seen to the left)

There is a canalized center median along Northern Boulevard, separating eastbound and westbound traffic. A school crosswalk is located across the east leg of the Northern Boulevard and 93rd Street intersection. Therefore, it is recommended to:

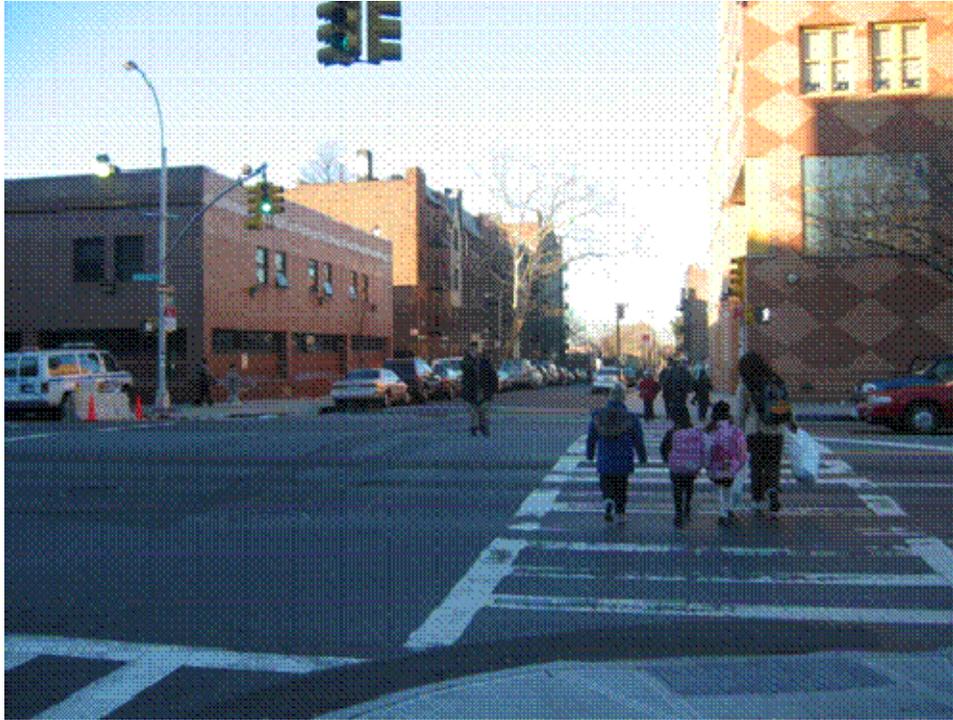
Figure 10: Looking north along 93rd Street at the intersection with Northern Boulevard

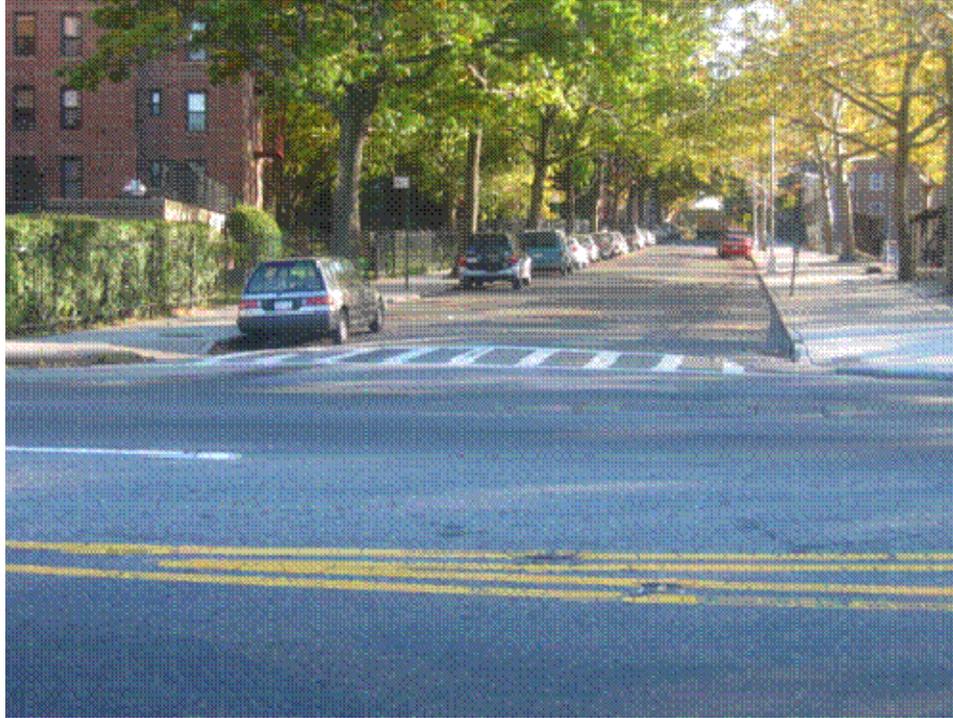
This is an unsignalized “T”-intersection with a school crosswalk located across the south leg of 93rd Street. Northern Boulevard has two travel lanes and one on-street parking lane in each direction, plus an approximate 12 foot wide median striped along the center of the roadway separating eastbound and westbound traffic. 93rd Street is a one-way southbound street with one travel lane and on-street parking permitted on both sides of the roadway (see Figure 11).

Figure 11: Looking south along 94th Street at the intersection with Northern Boulevard

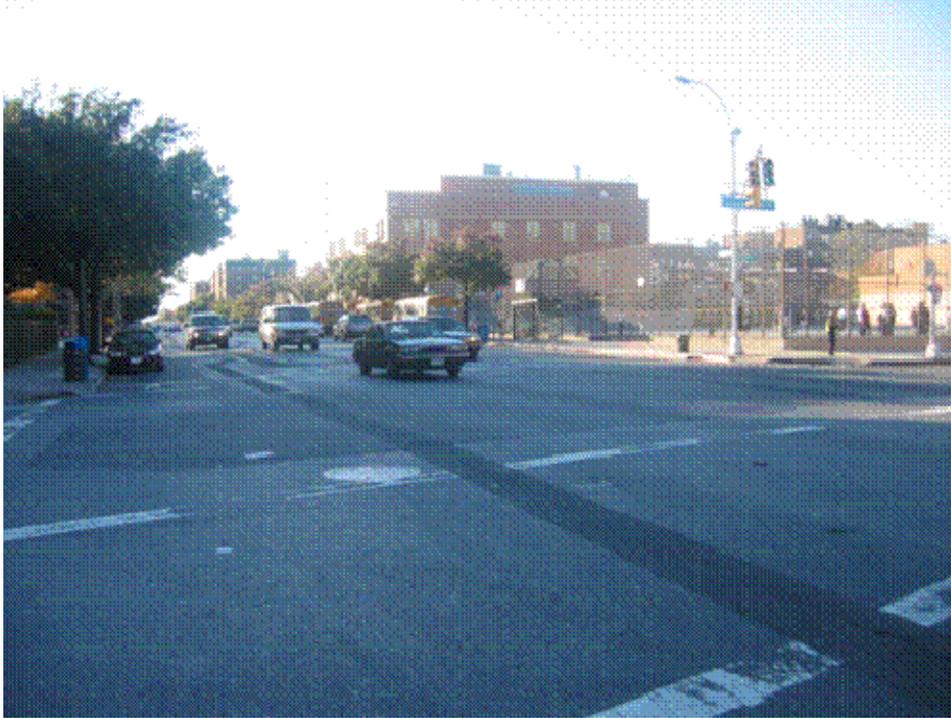
Figure 12: Looking west on Northern Boulevard at the intersection with Junction Boulevard

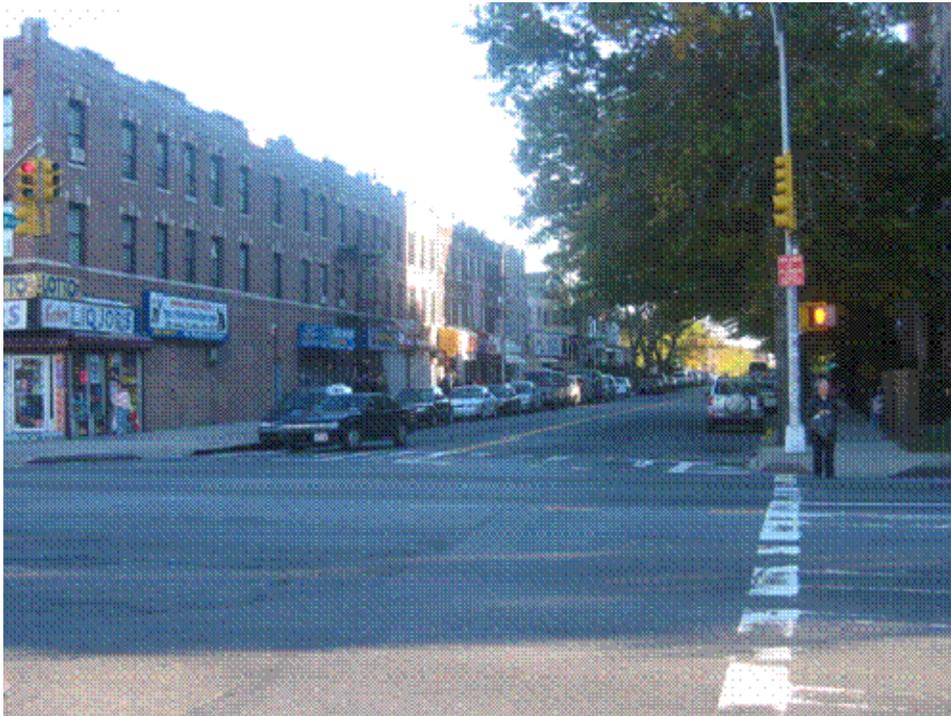
Figure 13: Looking south along Junction Boulevard at the intersection with Northern Boulevard

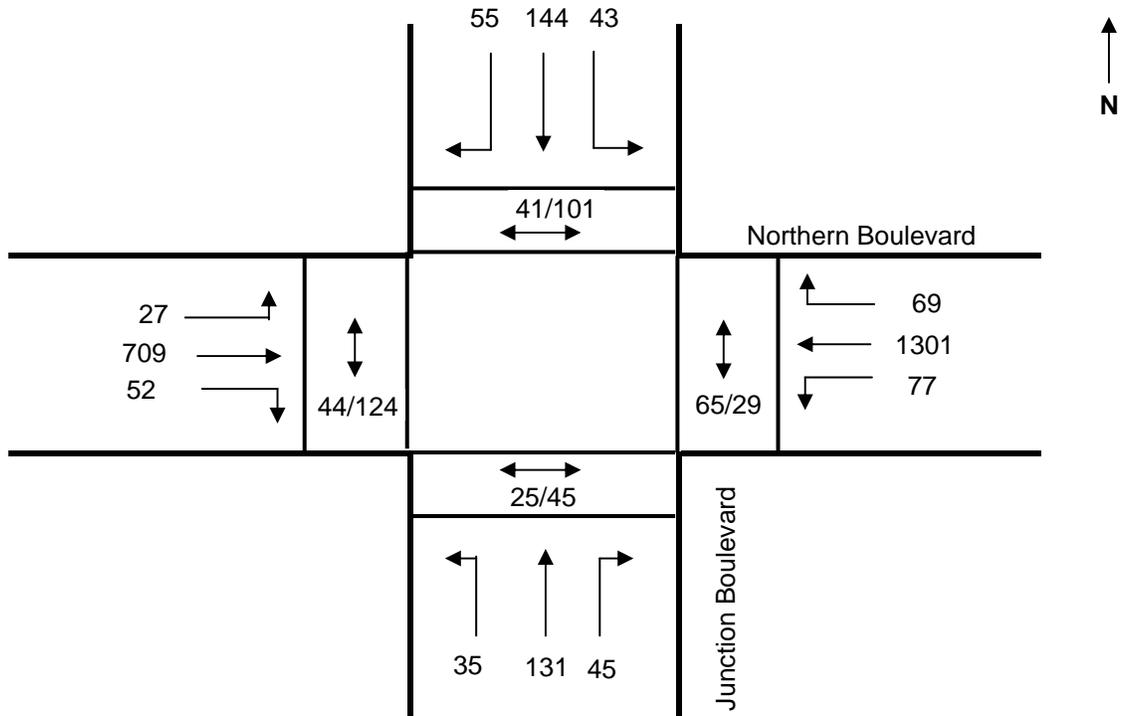
Intersection of Northern Boulevard and Junction Boulevard

One Hour Traffic Volumes
Friday, June 17th, 2005 7:30am - 8:30am

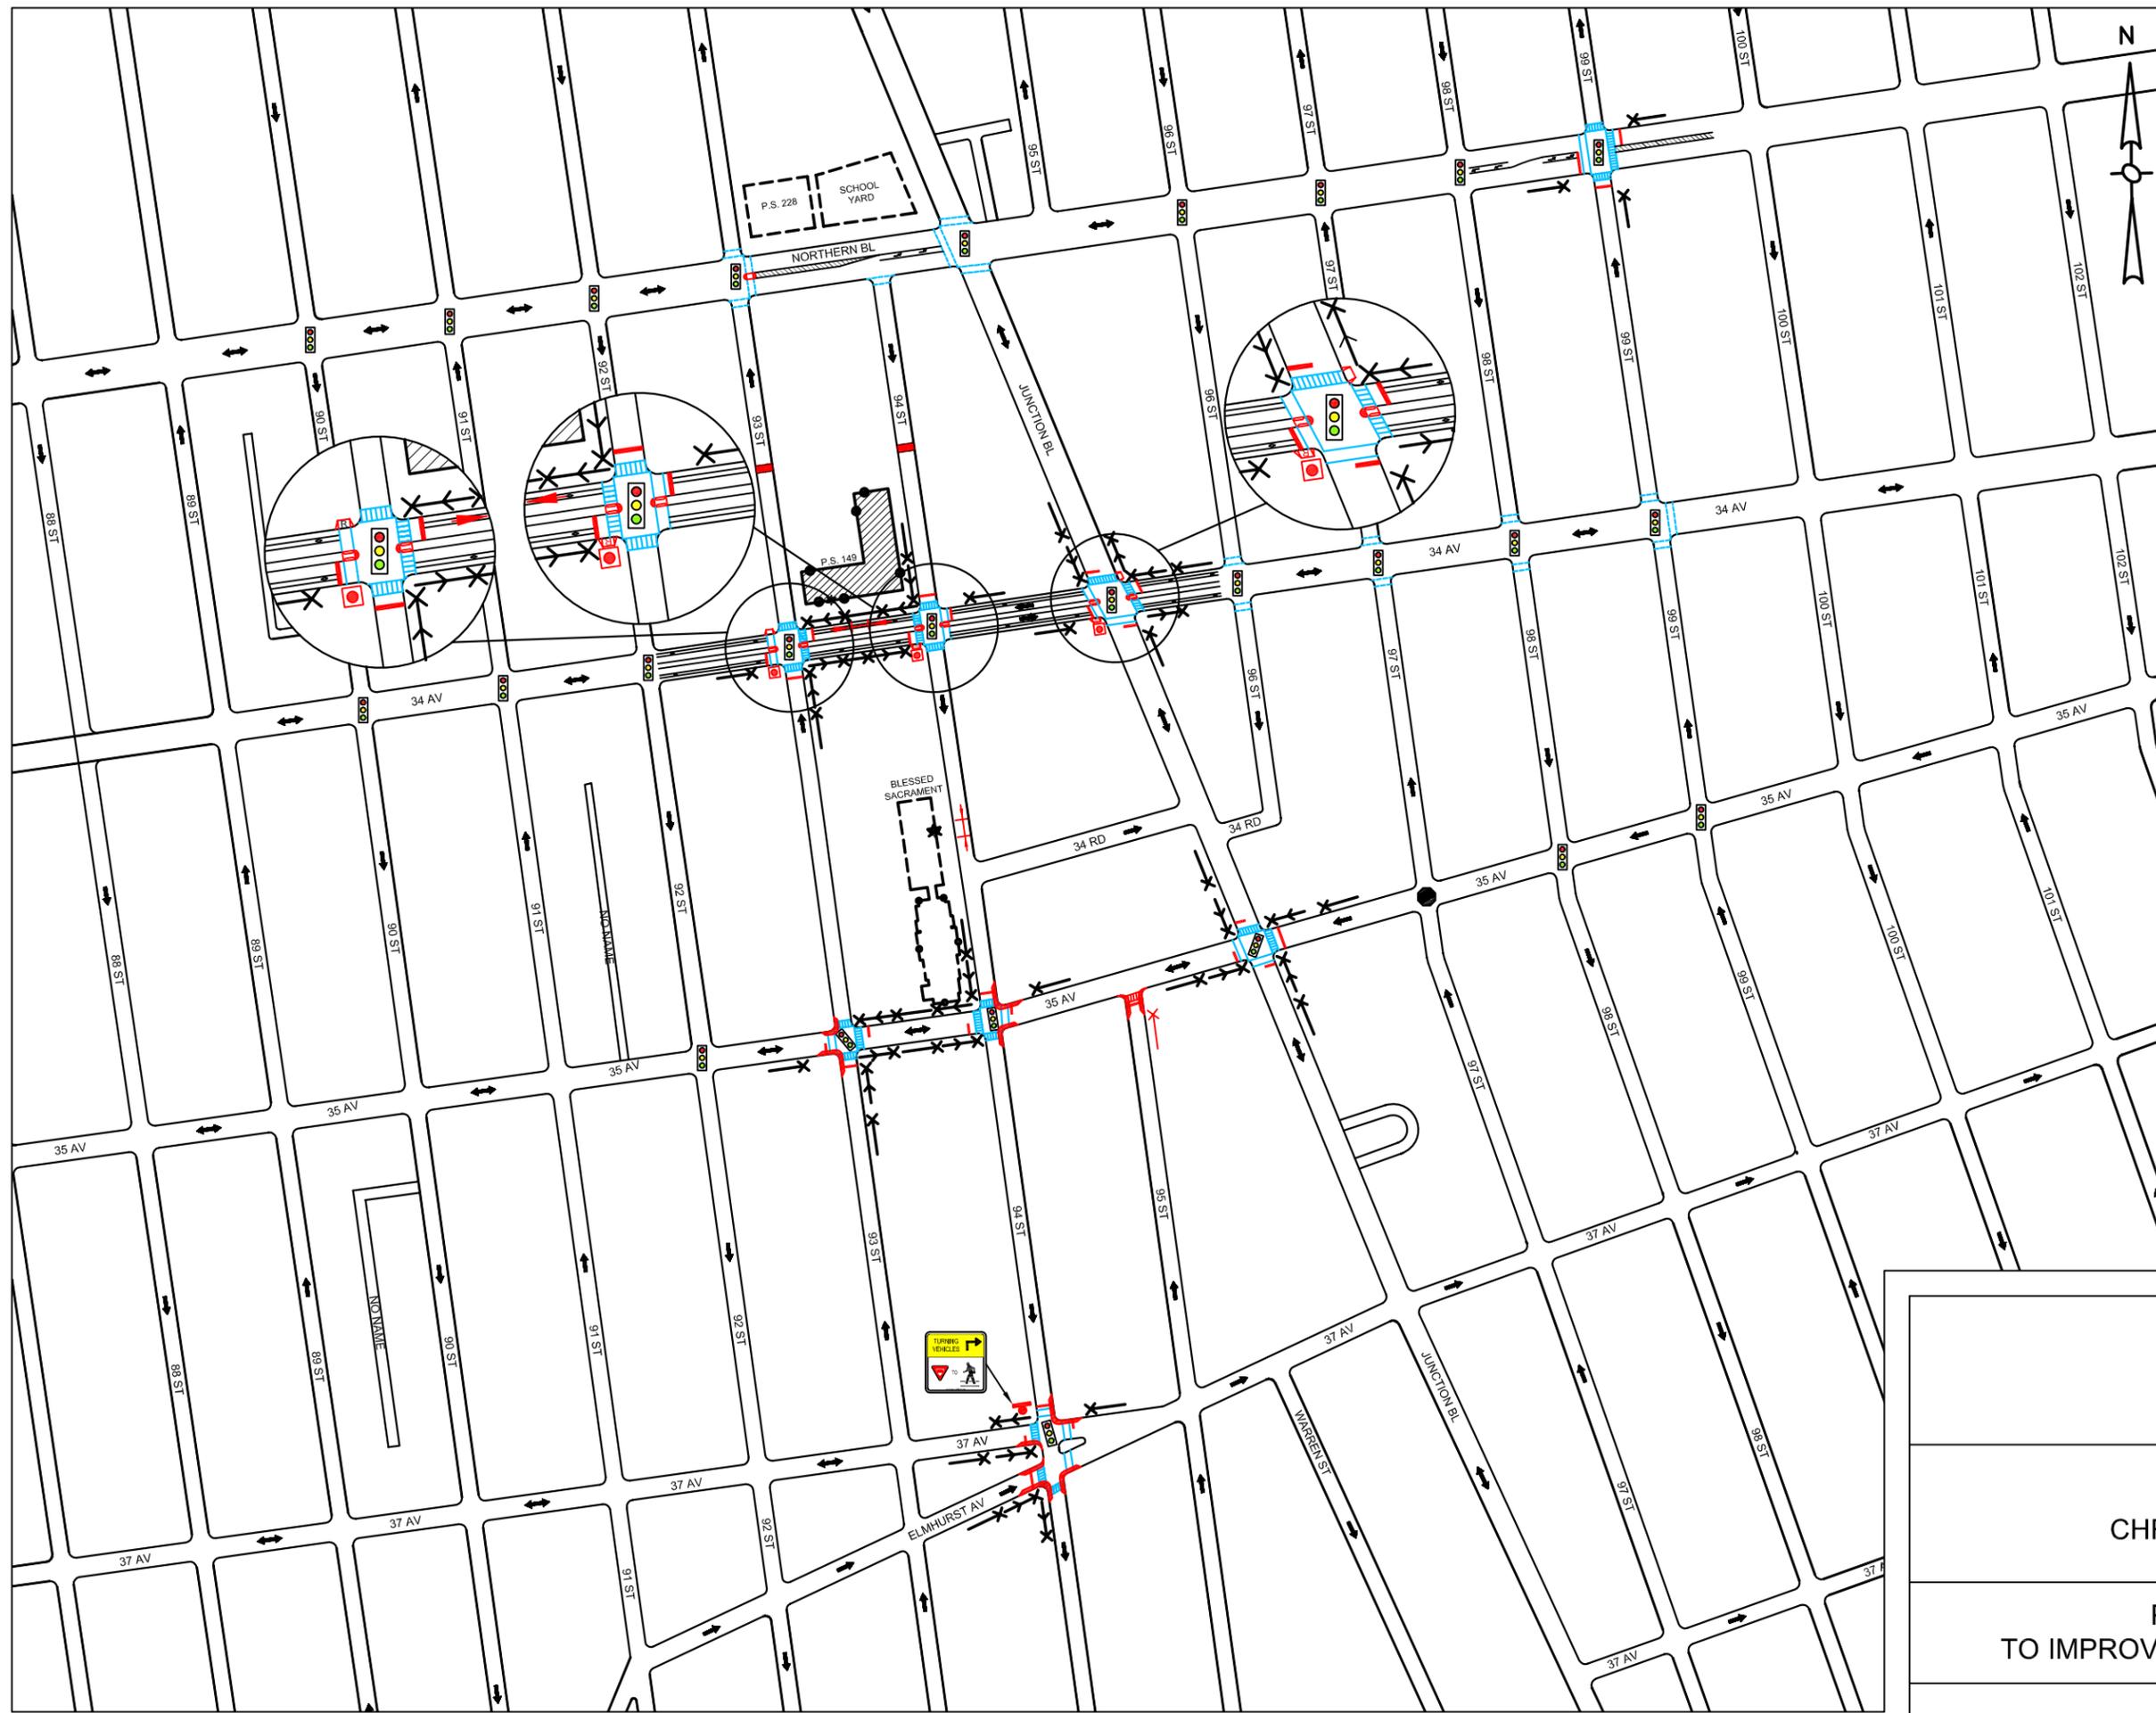
POTENTIAL MEASURES
TO IMPROVE STUDENT PEDESTRIAN SAFETY

This section describes the proposed measures to improve school pedestrian safety around P.S. 149. The proposed recommendations are divided into short-term and long-term measures. Short-term measures are those that potentially can be performed in-house. Long-term measures involve capital improvements. Each of the short- and long-term measures recommended for P.S. 149 is discussed as follows, and is shown in more detail in Exhibit 8 at the end of this section. See Section 4.3 for additional recommendations for this area from the report on Blessed Sacrament School, a nearby priority school.

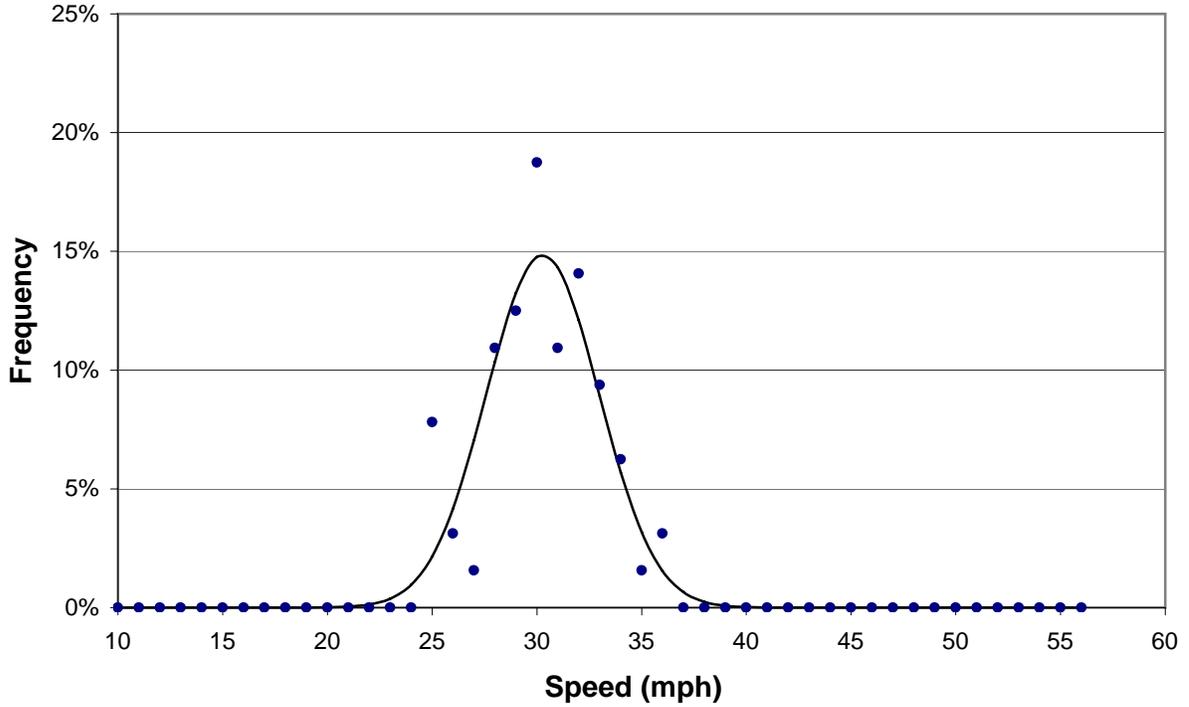
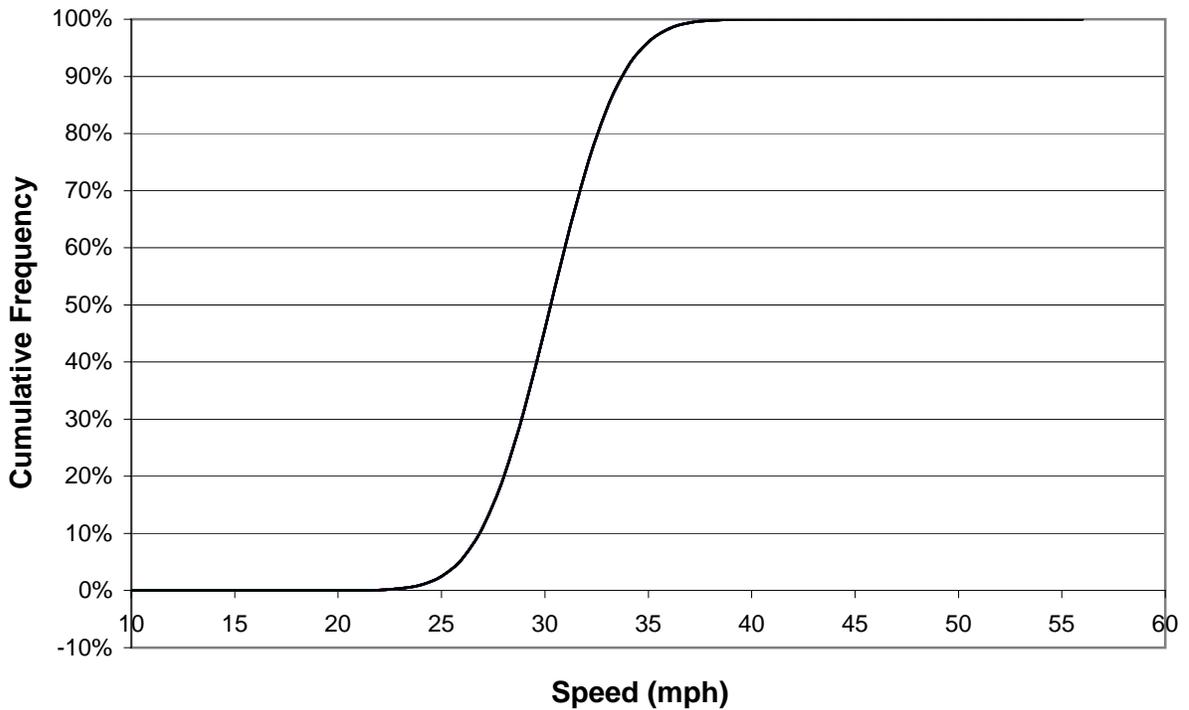
Date: 10/27/05
Location: 34 Ave between 94 Ave and 93 Ave
Surveyor: Richard Calvache

Mean Speed = 30.3 mph
Standard Deviation = 2.7 mph
Margin of Error (95% Confidence) = ± 0.7 mph

Median Speed = 30.3 mph
15th Percentile Speed = 27.5 mph
85th Percentile Speed = 33.1 mph
