**New York City Department of Transportation
Office of School Safety Engineering**

School Safety Engineering Project

FINAL REPORT: P.S. 149 (Christa McAuliffe School), Queens

**Prepared by
The RBA Group and URBITRAN Associates Inc.**

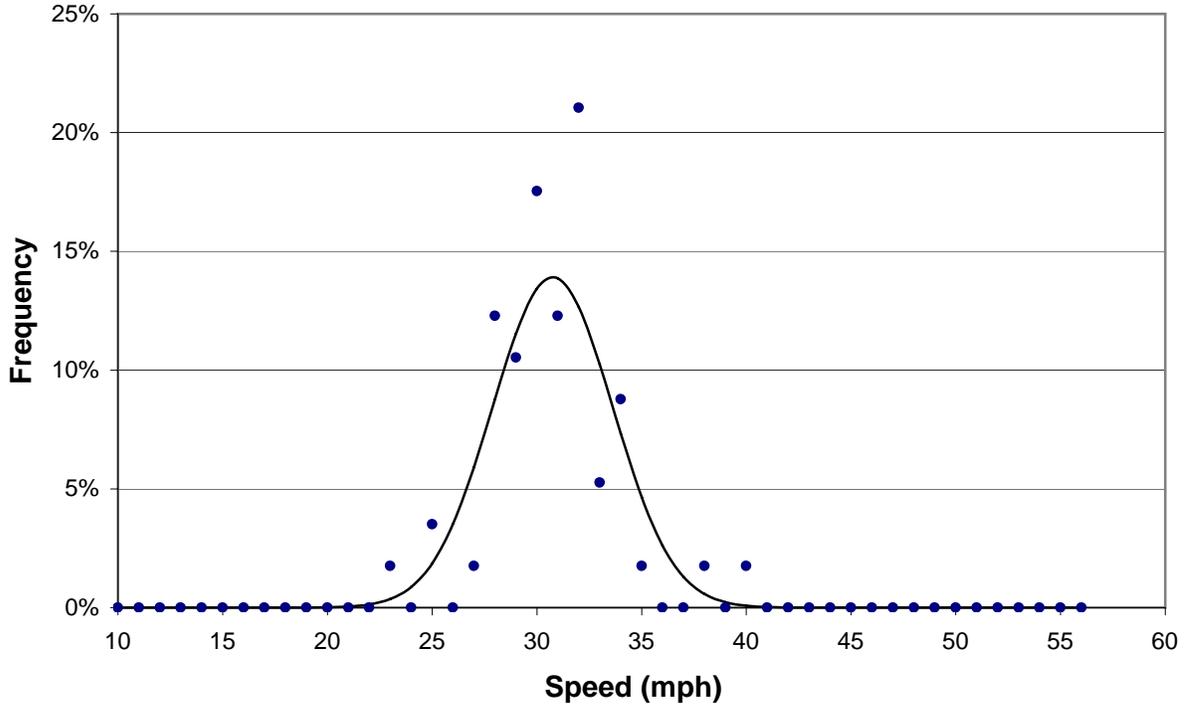
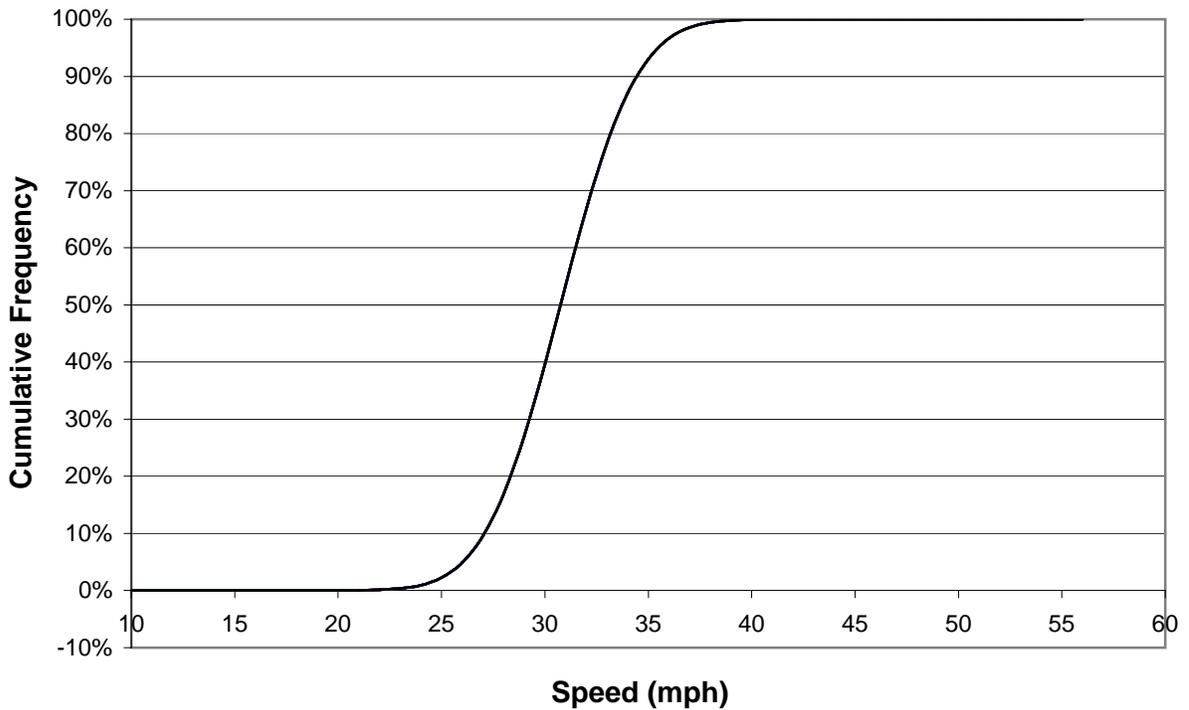
Date: 10/27/05
 Location: 93 St between Northern Blvd and 34 Ave
 Surveyor: Richard Calvache

Mean Speed = 30.8 mph
Standard Deviation = 2.9 mph
Margin of Error (95% Confidence) = ± 0.7 mph

Median Speed = 30.8 mph
15th Percentile Speed = 27.8 mph
85th Percentile Speed = 33.7 mph
