**New York City Department of Transportation
Office of School Safety Engineering**

School Safety Engineering Project

FINAL REPORT: School of the Transfiguration, Queens

October 4, 2006

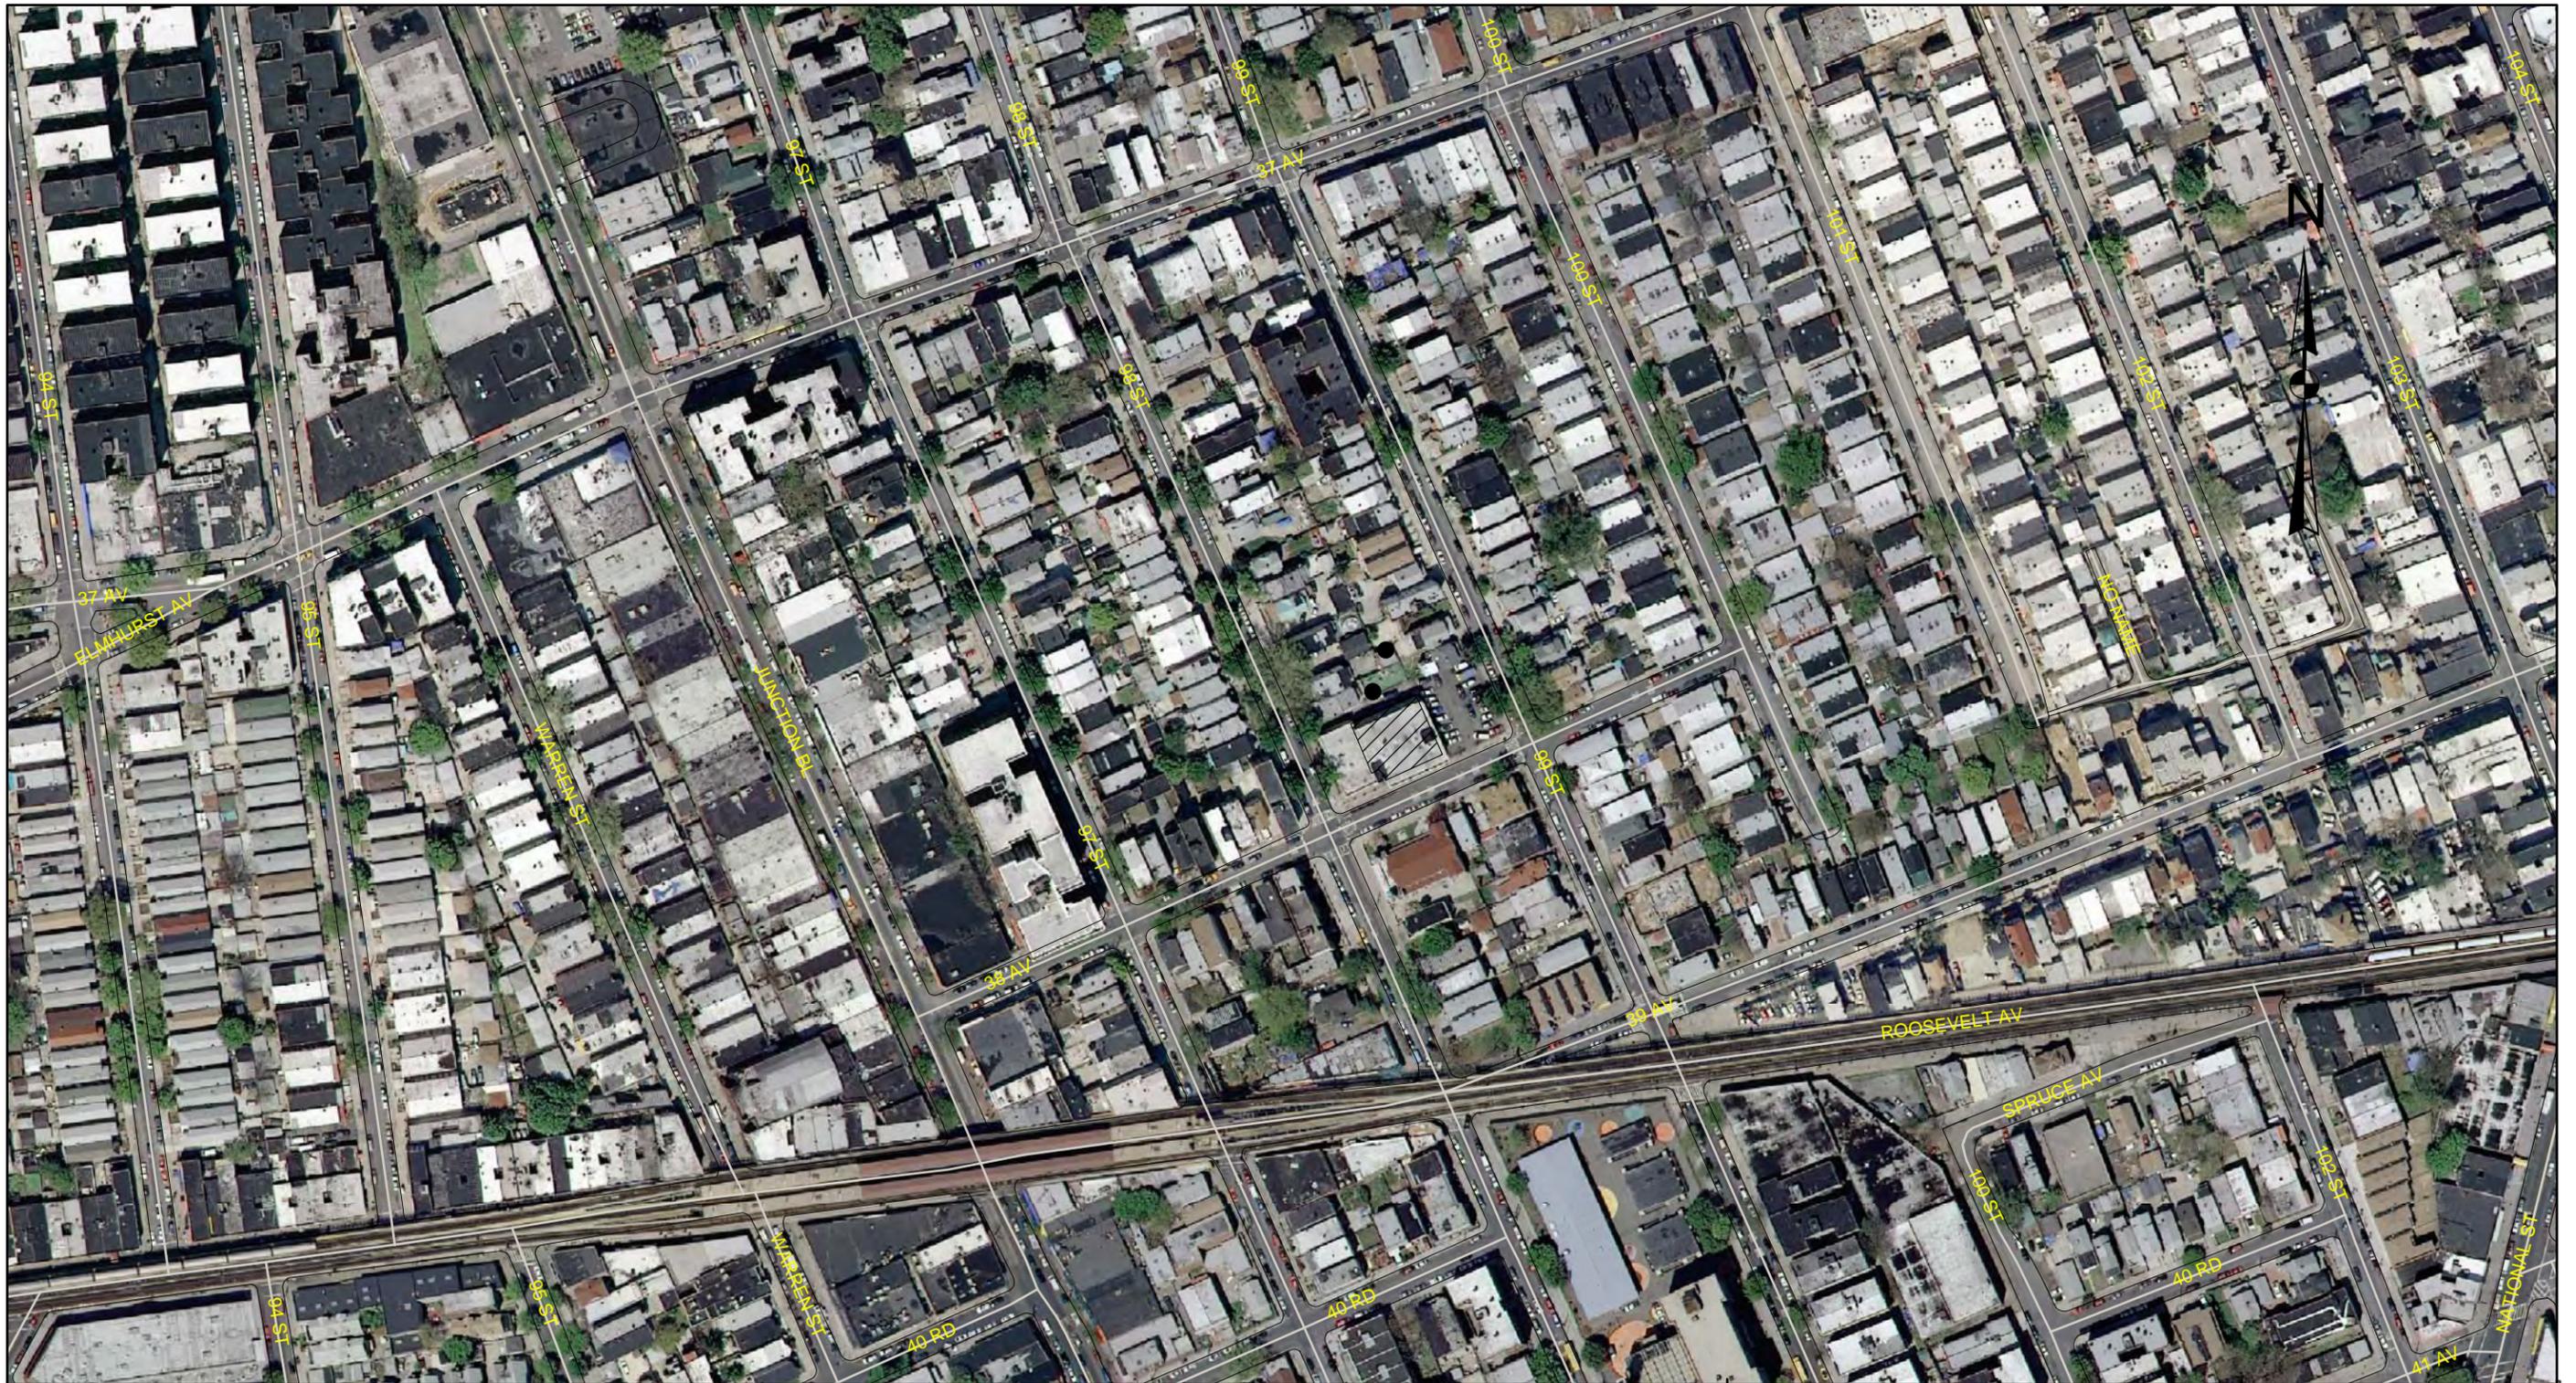
EXHIBIT 1
SCHOOL OF TRANSFIGURATION QUEENS

Exhibit 1 shows an aerial view of the neighborhood surrounding the school. School of the Transfiguration is bounded by 37th Avenue to the north, 38th Avenue to the south, 99th Street to the east, and 98th Street to the west. The neighborhood in the vicinity of the school consists primarily of low-rise, multi-family apartment buildings. Commercial uses are found one block north of the school along 37th Avenue, one block south of the school along Roosevelt Avenue, and two blocks west of the school along Junction Boulevard.

AERIAL PHOTOGRAPH

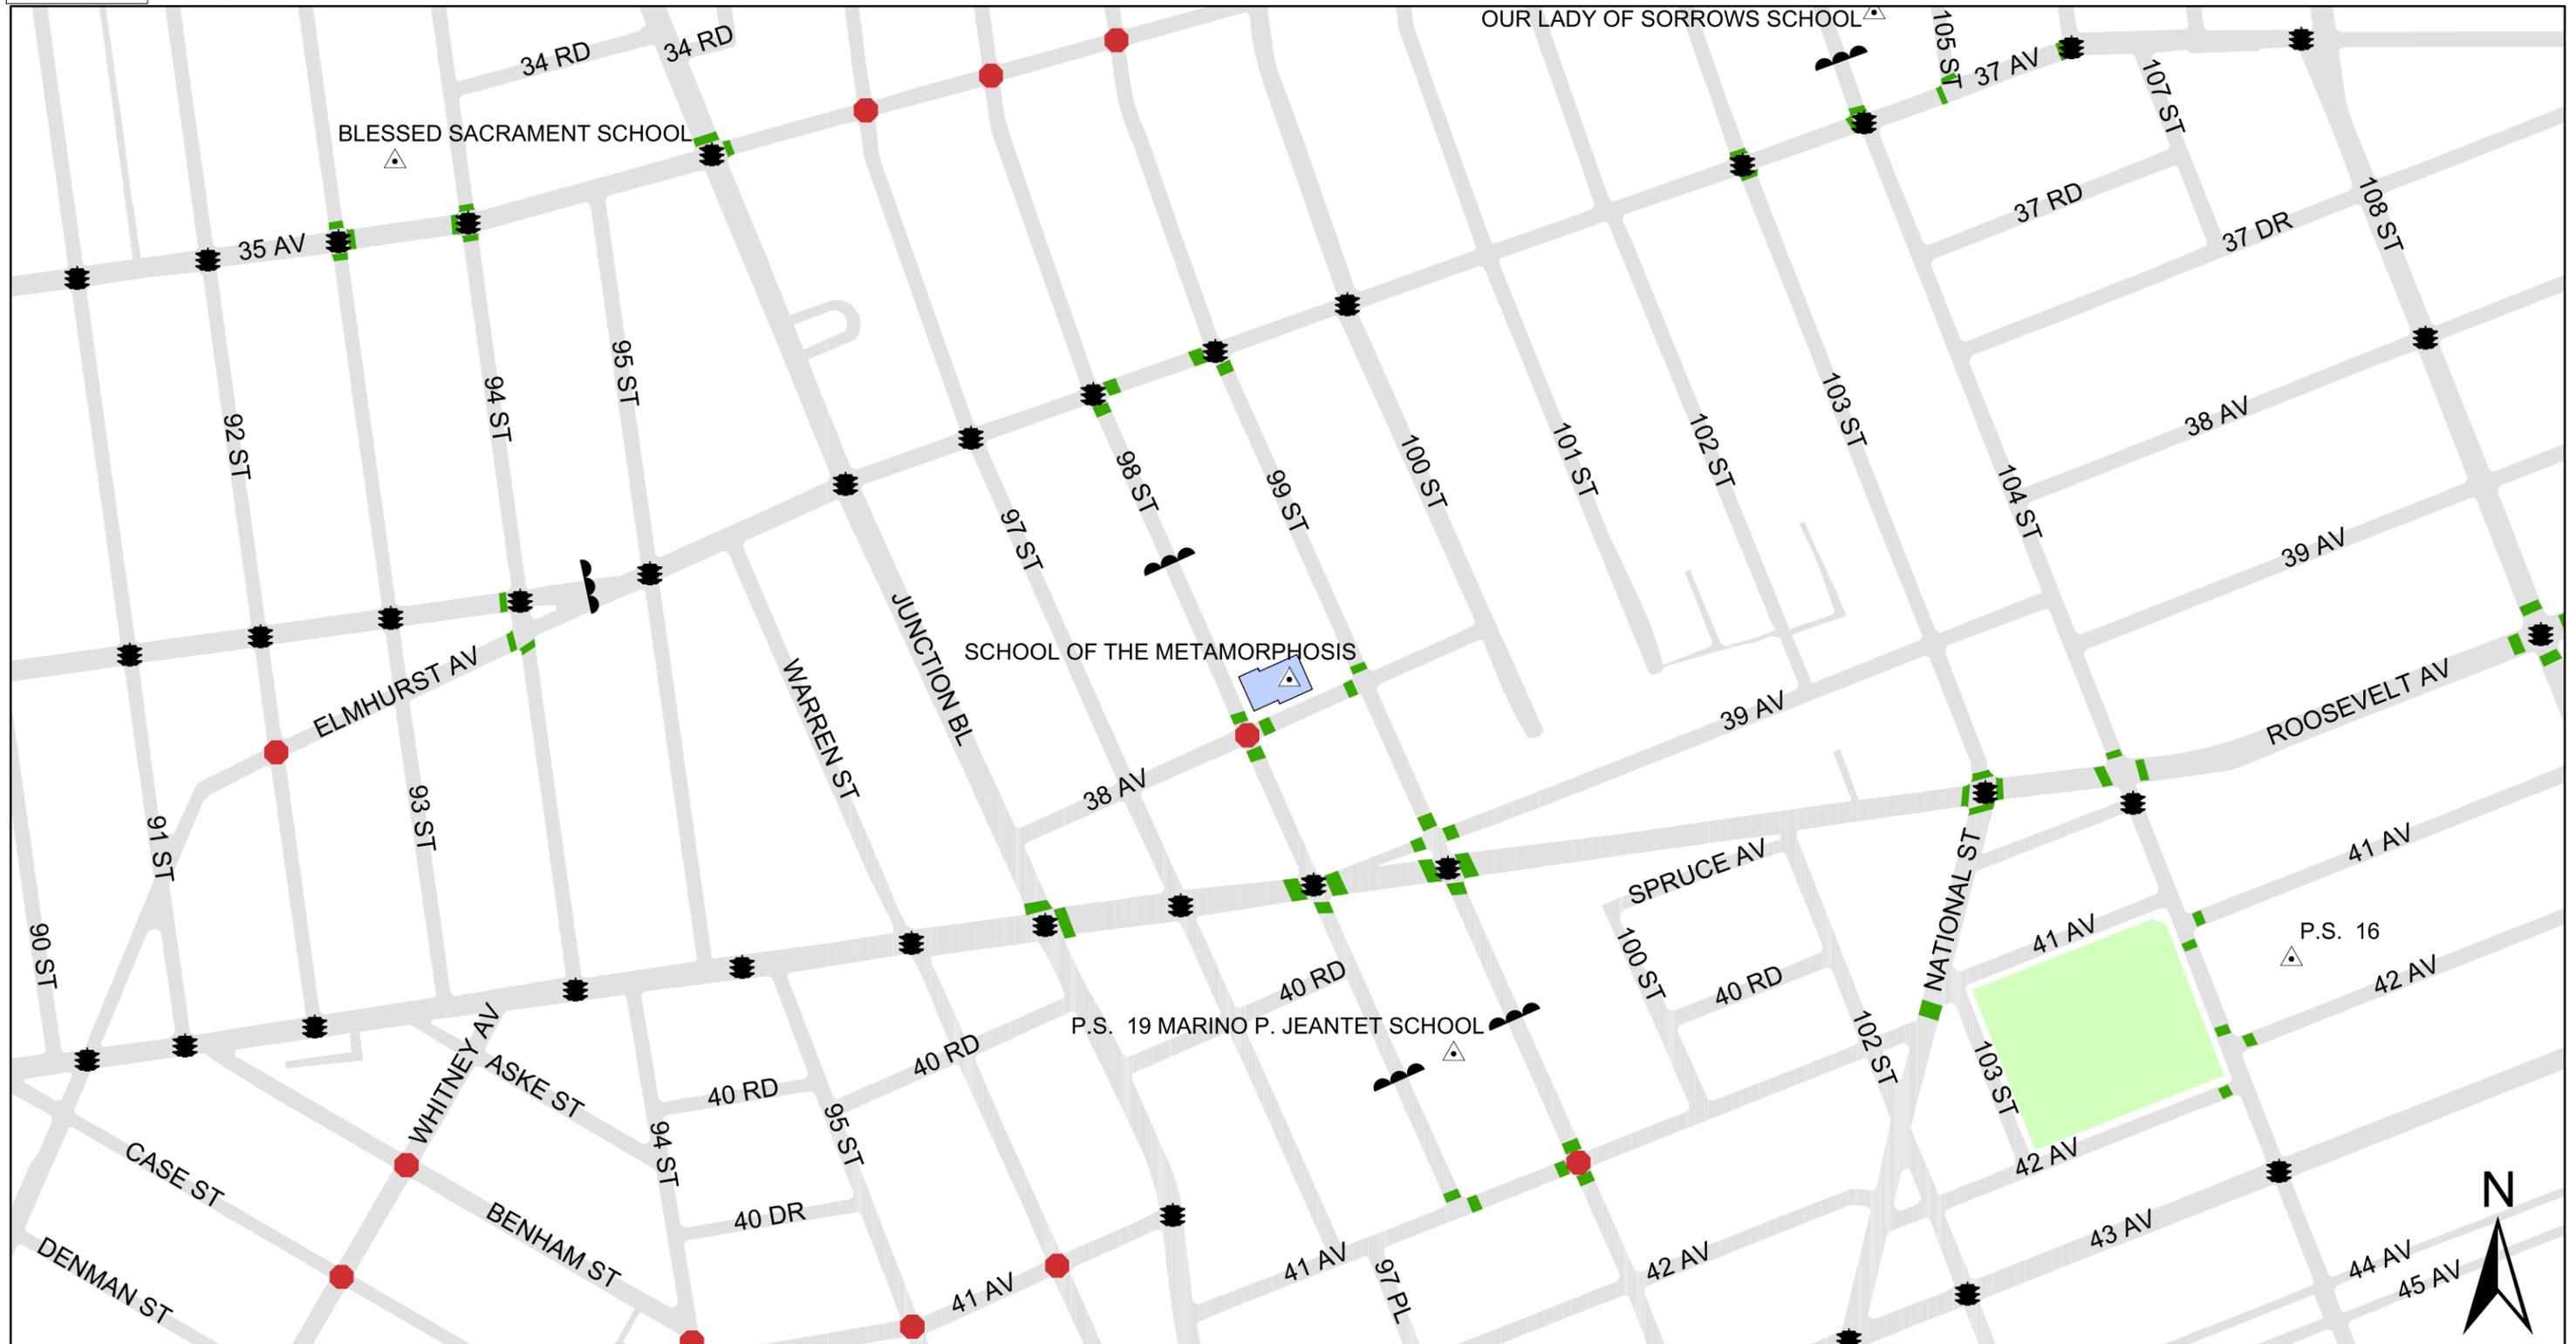
EXHIBIT 2

The School Traffic Safety Map was established to help provide the maximum degree of safety for children going to and from school - by indicating the location of speed reducers, school crosswalks and some traffic control devices. (While virtually all intersections in NYC benefit from traffic control devices - such as stop signs, traffic signals, yield signs, and all way stop signs - this map shows only traffic signals and all way stop signs.) The school crosswalks that are shown are ladder striped and make the crosswalk more visible to drivers and help make the intersection safer. These crosswalks are where school children are recommended to cross.

Exhibit 2 shows the existing school signals and pavement markings around the School of the Transfiguration as of May 2005. It should be noted that a citywide signage program is currently underway to upgrade school signage to current Federal Manual on Uniform Traffic Control Devices (MUTCD) standards of fluorescent yellow-green signs accompanied by downward pointing arrows. Signs scheduled to be installed under this program are shown as “existing” in Exhibit 6.

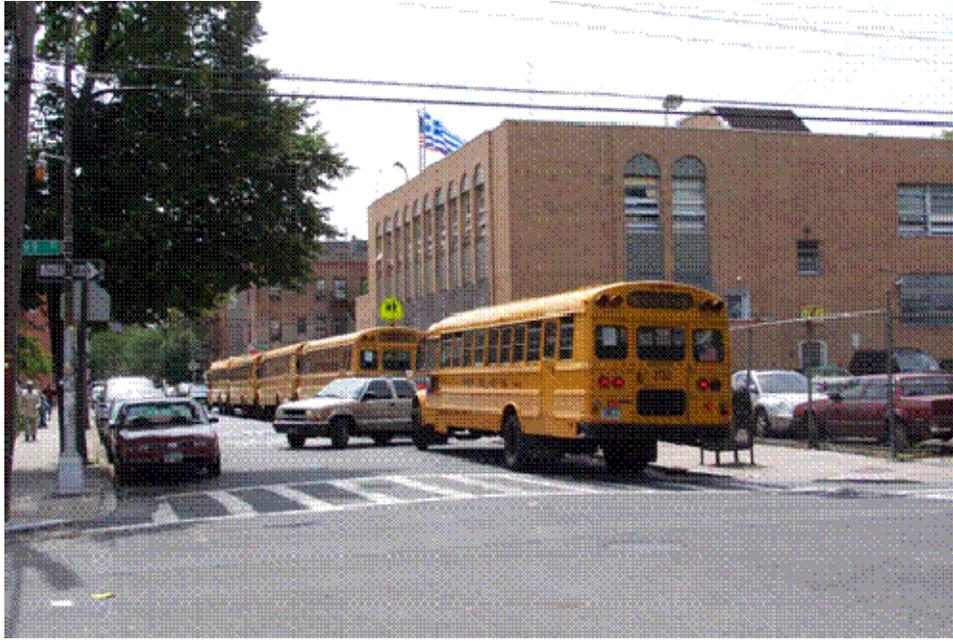
According to the principal, approximately 60 percent of the students ride a yellow school bus to and from school. School bus operations consist of six school buses arriving in the morning and five buses departing in the afternoon. The buses park on 38th Avenue in front of the school to pick-up and drop-off students (see Figure 1).

Figure 1: School buses parked along north side of 38th Avenue, between 98th Street and 99th Street at dismissal time

There are “NO STANDING 7AM - 4PM SCHOOL DAYS EXCEPT MIU VEHICLES” signs along the north side of 38th Avenue between 98th and 99th Streets, in front of the main entrance to the school. As the program has ended, it is recommended that the no standing exception for MIU vehicles be eliminated in front of the main entrance to the school. (This is a typical requirement for all NYC schools in order to provide for emergency access to and from the school).

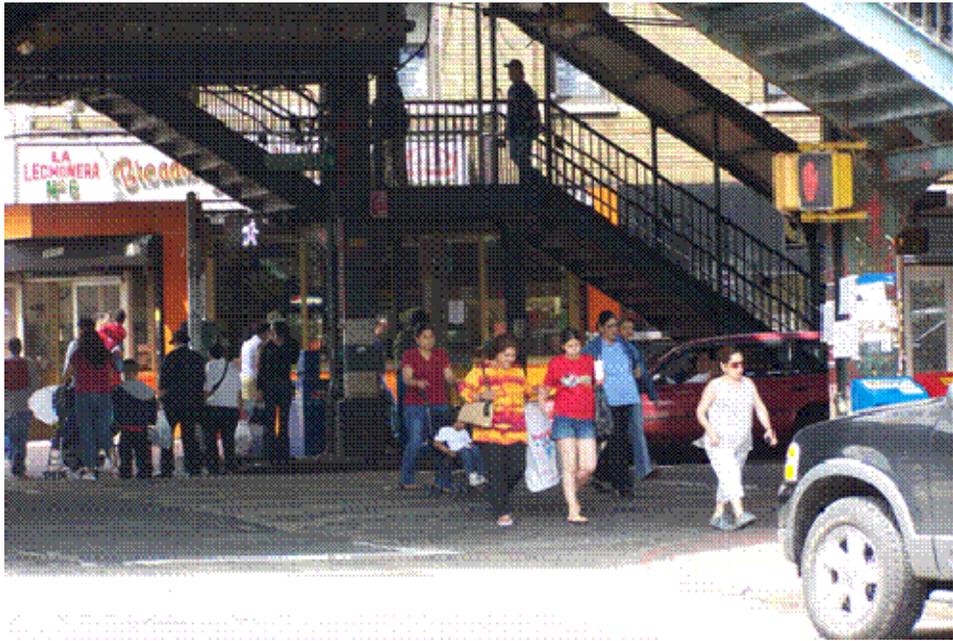
In the vicinity of the school, public bus service is provided along Junction Boulevard via the Q72 bus, and along 103rd and 104th Streets via the Q23 bus. The nearest subway stop is a stop for the No. 7 subway line, located on Roosevelt Avenue at the intersection with Junction Boulevard (see Figure 2).

Figure 2: Subway station for the No. 7 line at the Roosevelt Avenue/Junction Boulevard intersection

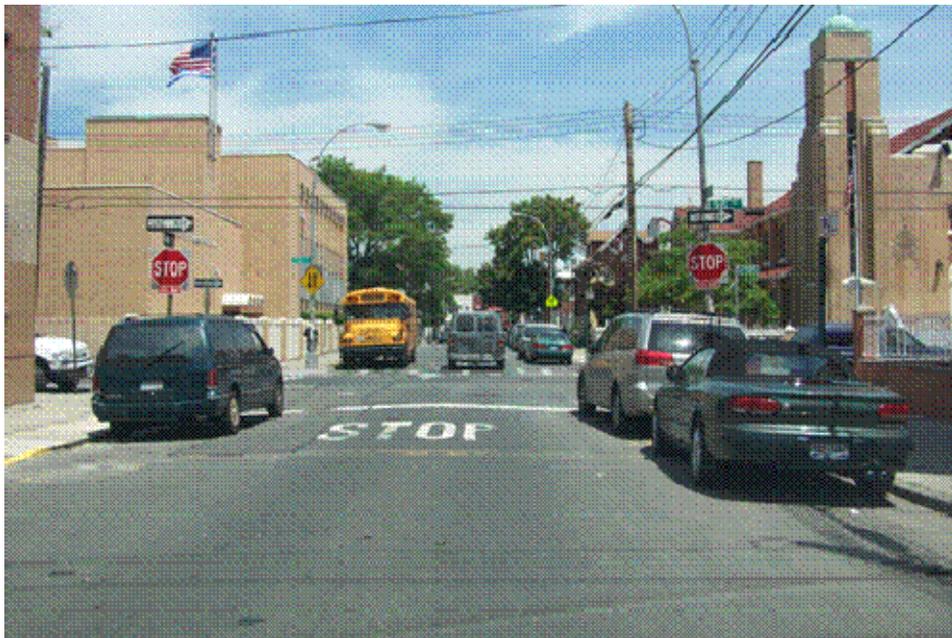
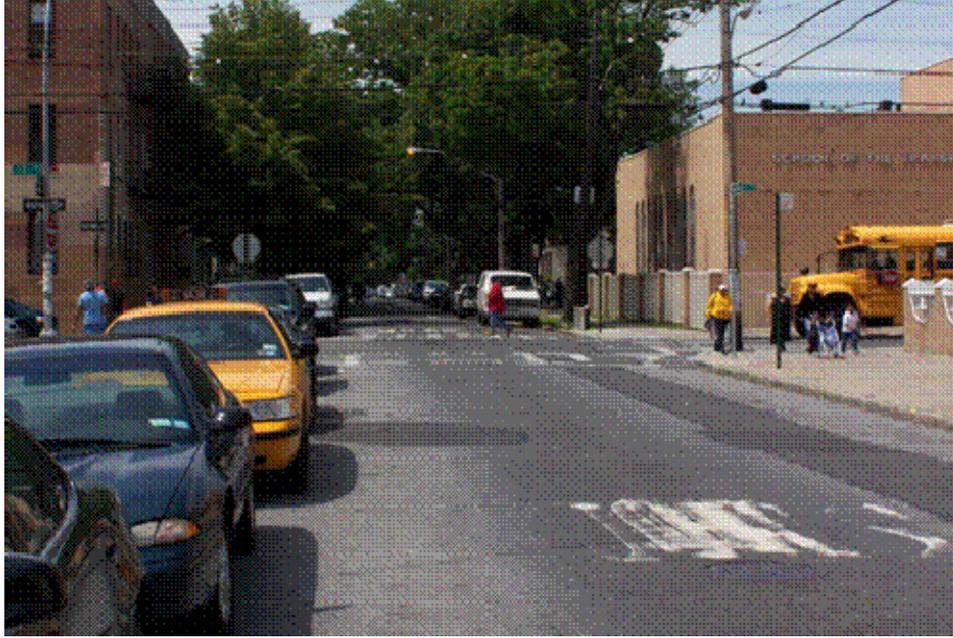
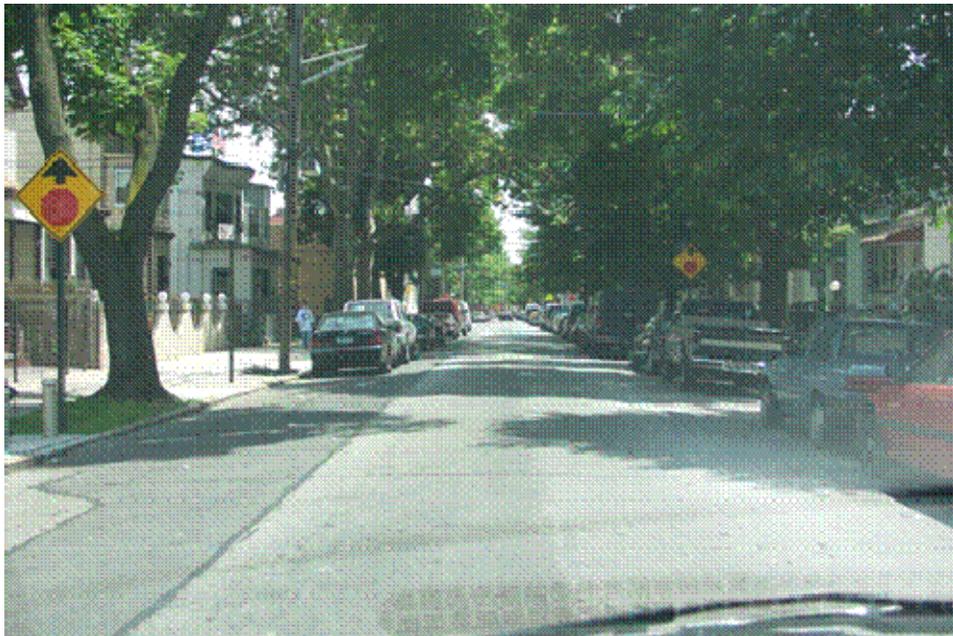
This is a four-leg all-way stop-controlled intersection with school crosswalks located across the east leg of 38th Avenue, and the north and south legs of 98th Street. West of 98th Street, 38th Avenue is a one-way eastbound street with one travel lane and on-street parking permitted on both sides of the roadway. East of 98th Street, 38th Avenue is a two-way street with one travel lane and one on-street parking lane on each side of the roadway. 98th Street is a one-way southbound street with one travel lane and on-street parking permitted on both sides of the roadway (see Figures 3 through 5).

There was a total of seven accidents reported at this intersection between 1998 and 2000 (Table 2), but none of these accidents involved pedestrians. However, one school-related accident, involving a six-year-old pedestrian, occurred mid-block on 98th Street between 37th Avenue and 38th Avenue, on May 3, 1998. The pedestrian was not killed or injured. No additional details regarding this accident were reported.

Figure 3: Looking east along 38th Avenue to the intersection with 98th Street (the school is shown to the left and the church is shown to the right)

Figure 4: Looking north along 98th Street to the intersection with 38th Avenue

Figure 5: Looking south on 98th Street between 37th Street and 38th Street

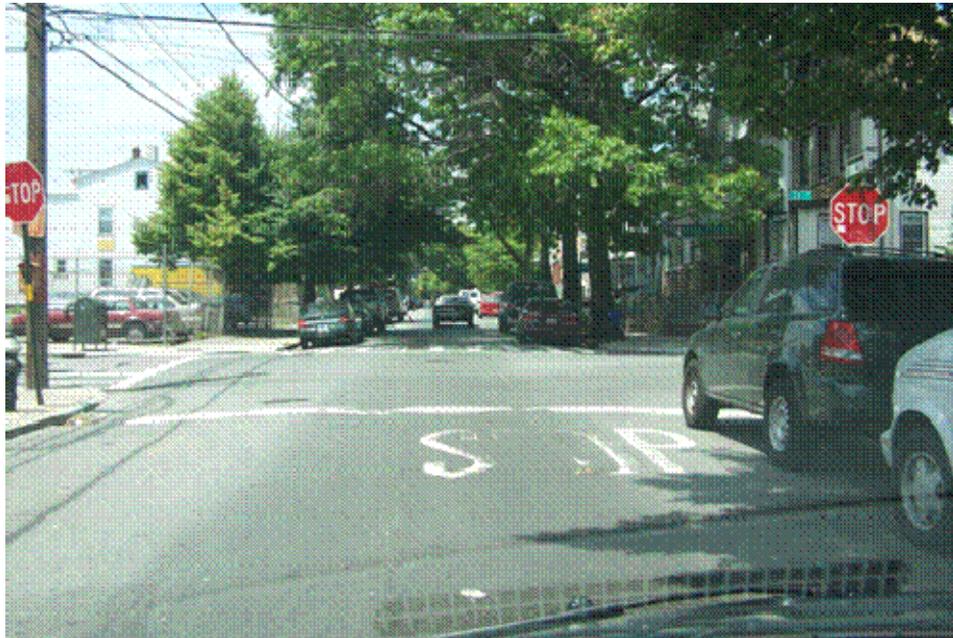
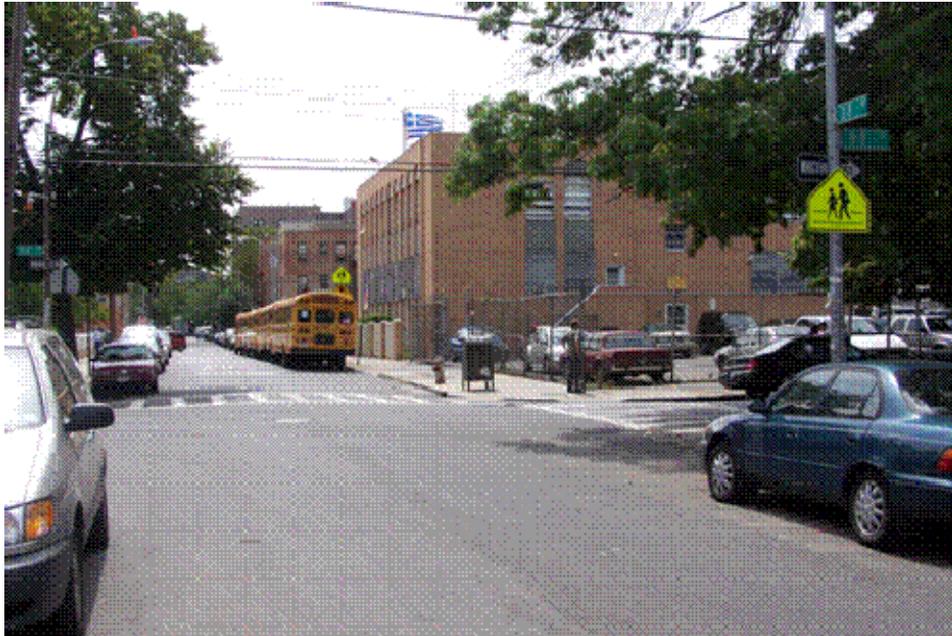
This is a four-leg all-way stop-controlled intersection with school crosswalks located across the west leg of 38th Avenue and the north leg of 99th Street. 38th Avenue, east of 98th Street, is a two-way street with one travel lane and one on-street parking lane on each side of the roadway. 99th Street is a one-way northbound street with one travel lane and on-street parking permitted on both sides of the roadway (see Figures 6 and 7).

There was a total of 11 accidents reported at this intersection between 1998 and 2000 (Table 2), but none of these were pedestrian accidents.

Figure 6: Looking north on 99th Street at the intersection with 38th Avenue

Figure 7: Looking west on 38th Avenue at the intersection with 99th Street

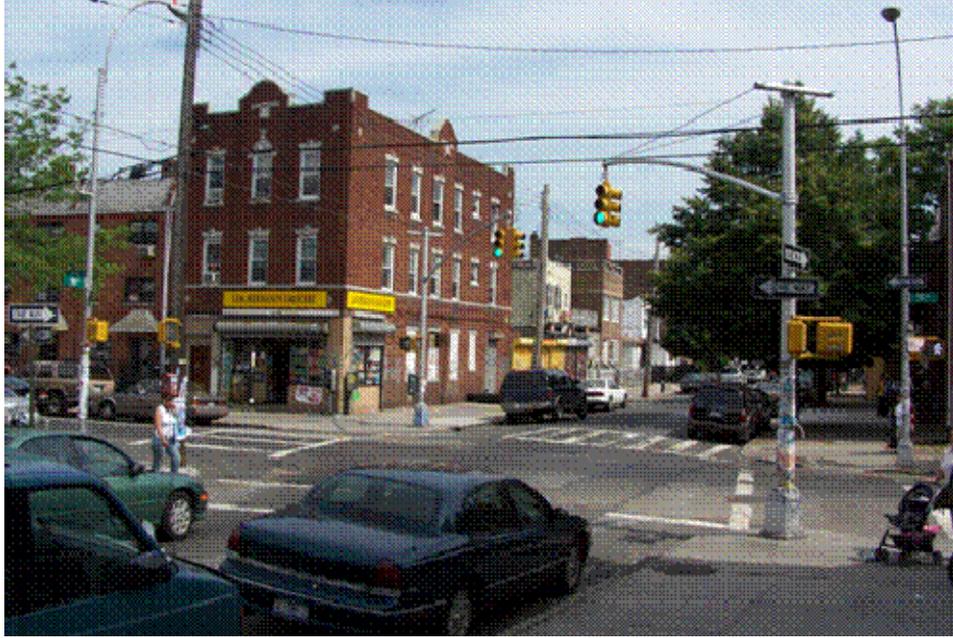
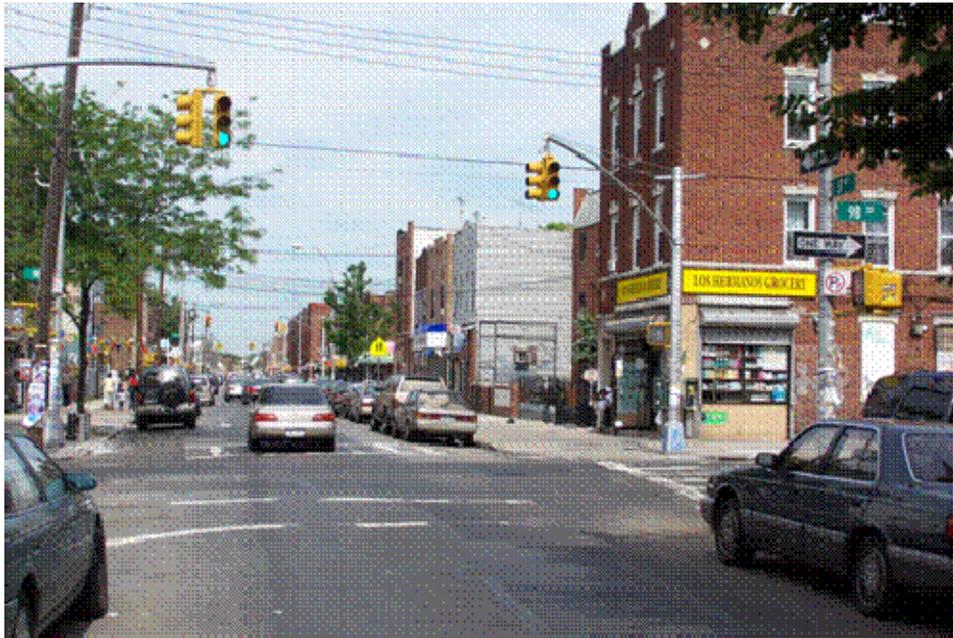
This is a four-leg signalized intersection with school crosswalks located across the east leg of 37th Avenue and the south leg of 98th Street. Pedestrian crosswalks are located across the west leg of 37th Avenue and the north leg of 98th Street. In the vicinity of the School of the Transfiguration, 37th Avenue is a one-way eastbound street with one travel lane and on-street parking permitted on both sides of the roadway. 98th Street is a one-way southbound street with one travel lane and on-street parking permitted on both sides of the roadway.

There was a total of 12 accidents reported at this intersection between 1998 and 2000 (Table 2), but none of these involved pedestrians.

Figure 8: Looking south at the intersection of 37th Avenue and 98th Street

Figure 9: Looking east along 37th Avenue to the intersection with 98th Street

- All four corners of the 37th Avenue and 98th Street intersection.
- Northwest and southwest corners of the 37th Avenue and 99th Street intersection.
- Northeast corner of the 38th Avenue and Junction Boulevard intersection.
- All four corners of the 38th Avenue and 97th Street intersection.
- All four corners of the 38th Avenue and 98th Street intersection.
- Northwest and southwest corners of the 38th Avenue and 99th Street intersection.
- Northeast and southeast corners of the 39th Avenue and 99th Street intersection.

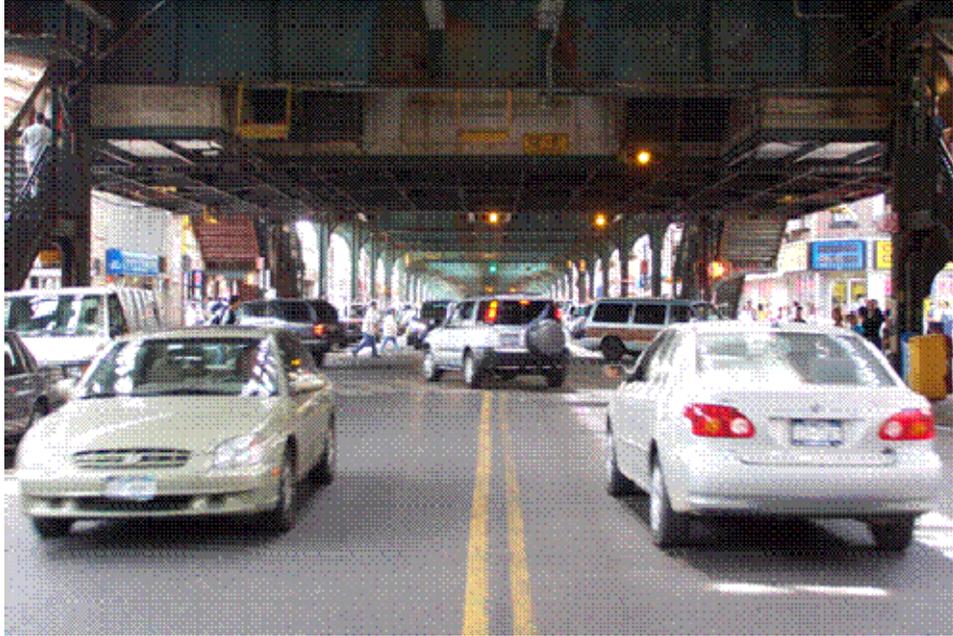
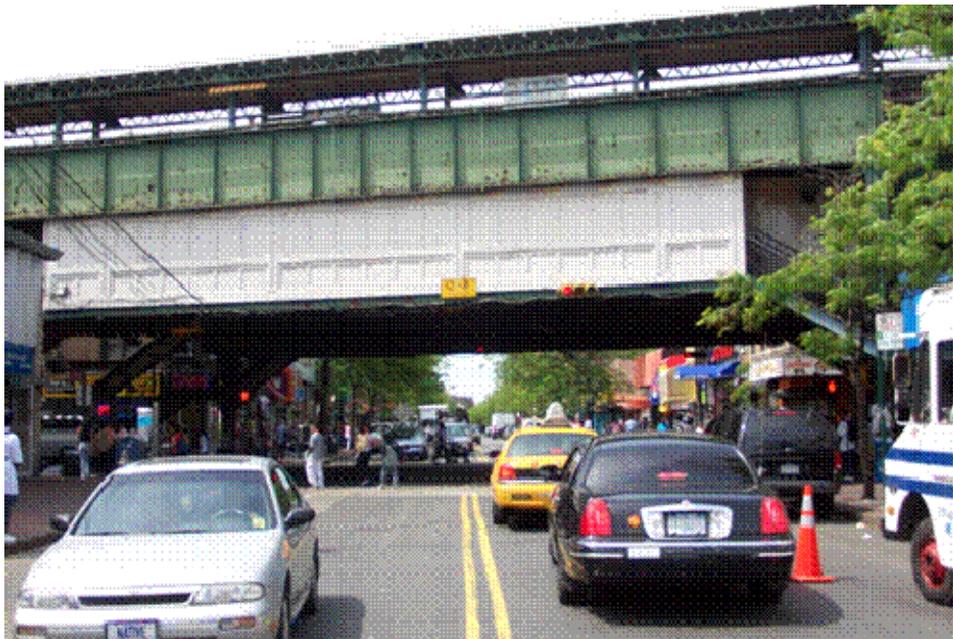
This is a four-leg signalized intersection with school crosswalks located across the east leg of Roosevelt Avenue and the north leg of Junction Boulevard. Pedestrian crosswalks are located across the west leg of Roosevelt Avenue and the south leg of Junction Boulevard. In the vicinity of the School of the Transfiguration, Roosevelt Avenue is a two-way east-west street with one travel lane and one on-street parking lane on each side of the roadway (see Figure 10). Roosevelt Avenue also has elevated tracks for the No. 7 subway train aligned over the center of the roadway. The supports for this elevated structure are located outside of the roadway. Junction Boulevard is a two-way north-south street with one travel lane and one on-street parking lane on each side of the roadway (see Figure 11). Both Roosevelt Avenue and Junction Boulevard are designated truck and snow emergency routes.

There was a total of 53 accidents reported at this intersection between 1998 and 2000 (Table 2), including seven pedestrian accidents, one of which was school-related. The school-related accident occurred at approximately 4:00 pm on Thursday, October 1, 1998, when a 13-year-old pedestrian sustained a “possible injury” was after being struck by a vehicle while crossing the intersection in compliance with the traffic signal. The accident occurred on a straight and level segment during daylight conditions. At the time of the accident, the roadway and weather conditions were reported as dry and clear, respectively.

Figure 10: Looking west along Roosevelt Avenue to the intersection with Junction Boulevard

Figure 11: Looking north along Junction Boulevard to the intersection with Roosevelt Avenue

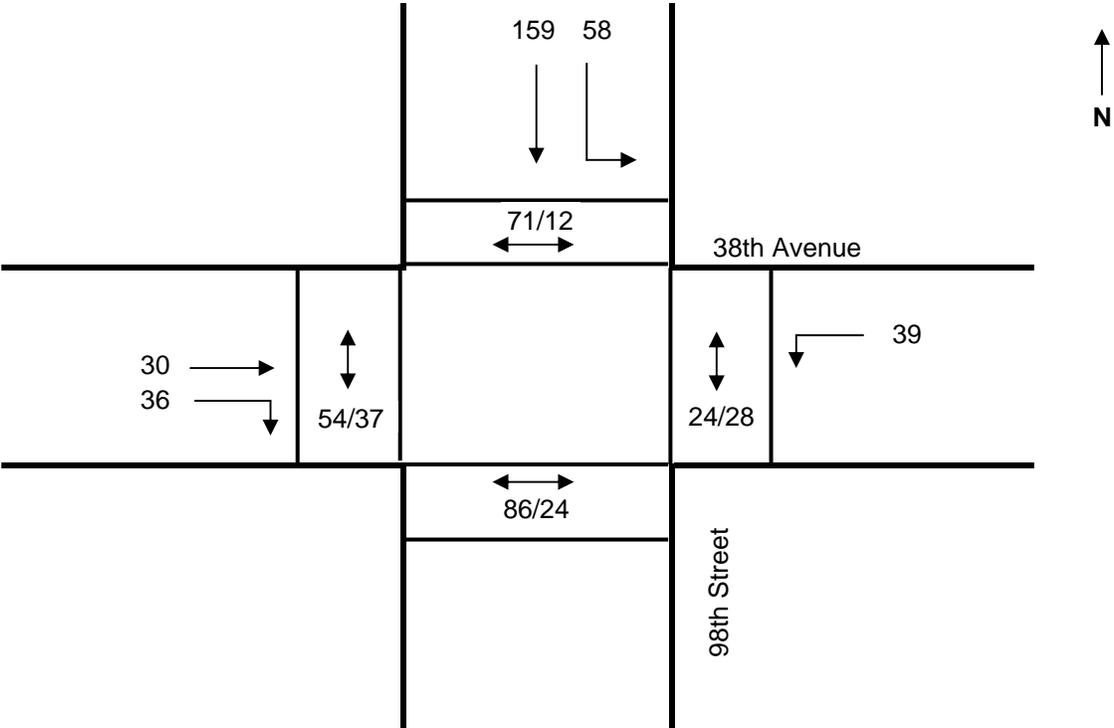
EXHIBIT 5A
SCHOOL OF TRANSFIGURATION QUEENS
TRAFFIC AND PEDESTRIAN COUNTS

During the meeting with the consultant team, the school principal suggested the installation of a traffic signal at the intersection of 38th Avenue and 98th Street to help improve pedestrian safety. To determine if a traffic signal is warranted at this location, manual counts of both vehicle and pedestrian volumes were conducted from 7:30 to 9:00 am on Tuesday, October 25, 2005. The results of these counts during the peak hour (7:30 to 8:30 am) are shown in Tables 4 and 5, and in Exhibit 5A at the end of this section.

Using the traffic and pedestrian count data described above, a preliminary traffic signal warrant analysis was performed for the intersection of 38th Avenue and 98th Street to determine the need for a traffic signal installation at this location. The results of this preliminary analysis—based on traffic signal warrant 4 (Pedestrian Volumes) and warrant 5 (School Crossing) of the Federal MUTCD—are presented in Tables 6 and 7, respectively. Since neither warrant is satisfied, a traffic signal installation does not appear to be warranted at this time.

One Hour Traffic Volumes
Tuesday, October 25th, 2005 7:30am - 8:30am

Intersection of 38th Avenue and 98th Street

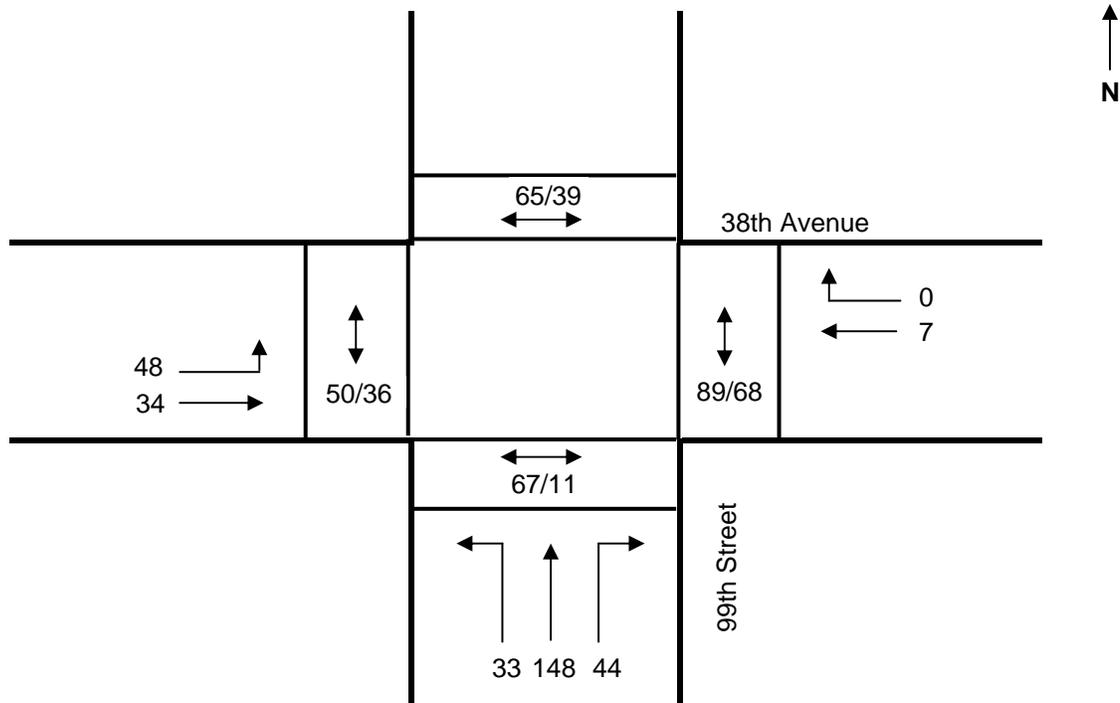
EXHIBIT 5B
SCHOOL OF TRANSFIGURATION QUEENS
TRAFFIC AND PEDESTRIAN COUNTS

To assess pedestrian safety at the intersection of 38th Avenue and 99th Street, manual counts of both vehicle and pedestrian volumes were conducted from 7:30 to 9:00 am on Thursday, November 3, 2005. The results of these counts during the peak hour (7:45 to 8:45 am) are shown in Tables 8 and 9, and in Exhibit 5B at the end of this section.

Using the traffic and pedestrian count data described above, a preliminary traffic signal warrant analysis was performed to determine the need for a traffic signal installation at this intersection. The results of this preliminary analysis—based on traffic signal warrant 4 (Pedestrian Volumes) and warrant 5 (School Crossing) of the Federal MUTCD—are presented in Tables 10 and 11, respectively. Since neither warrant is satisfied, a traffic signal installation does not appear to be warranted at this time.

One Hour Traffic Volumes
Thursday, November 3rd, 2005 7:45am - 8:45am

Intersection of 38th Avenue and 99th Street

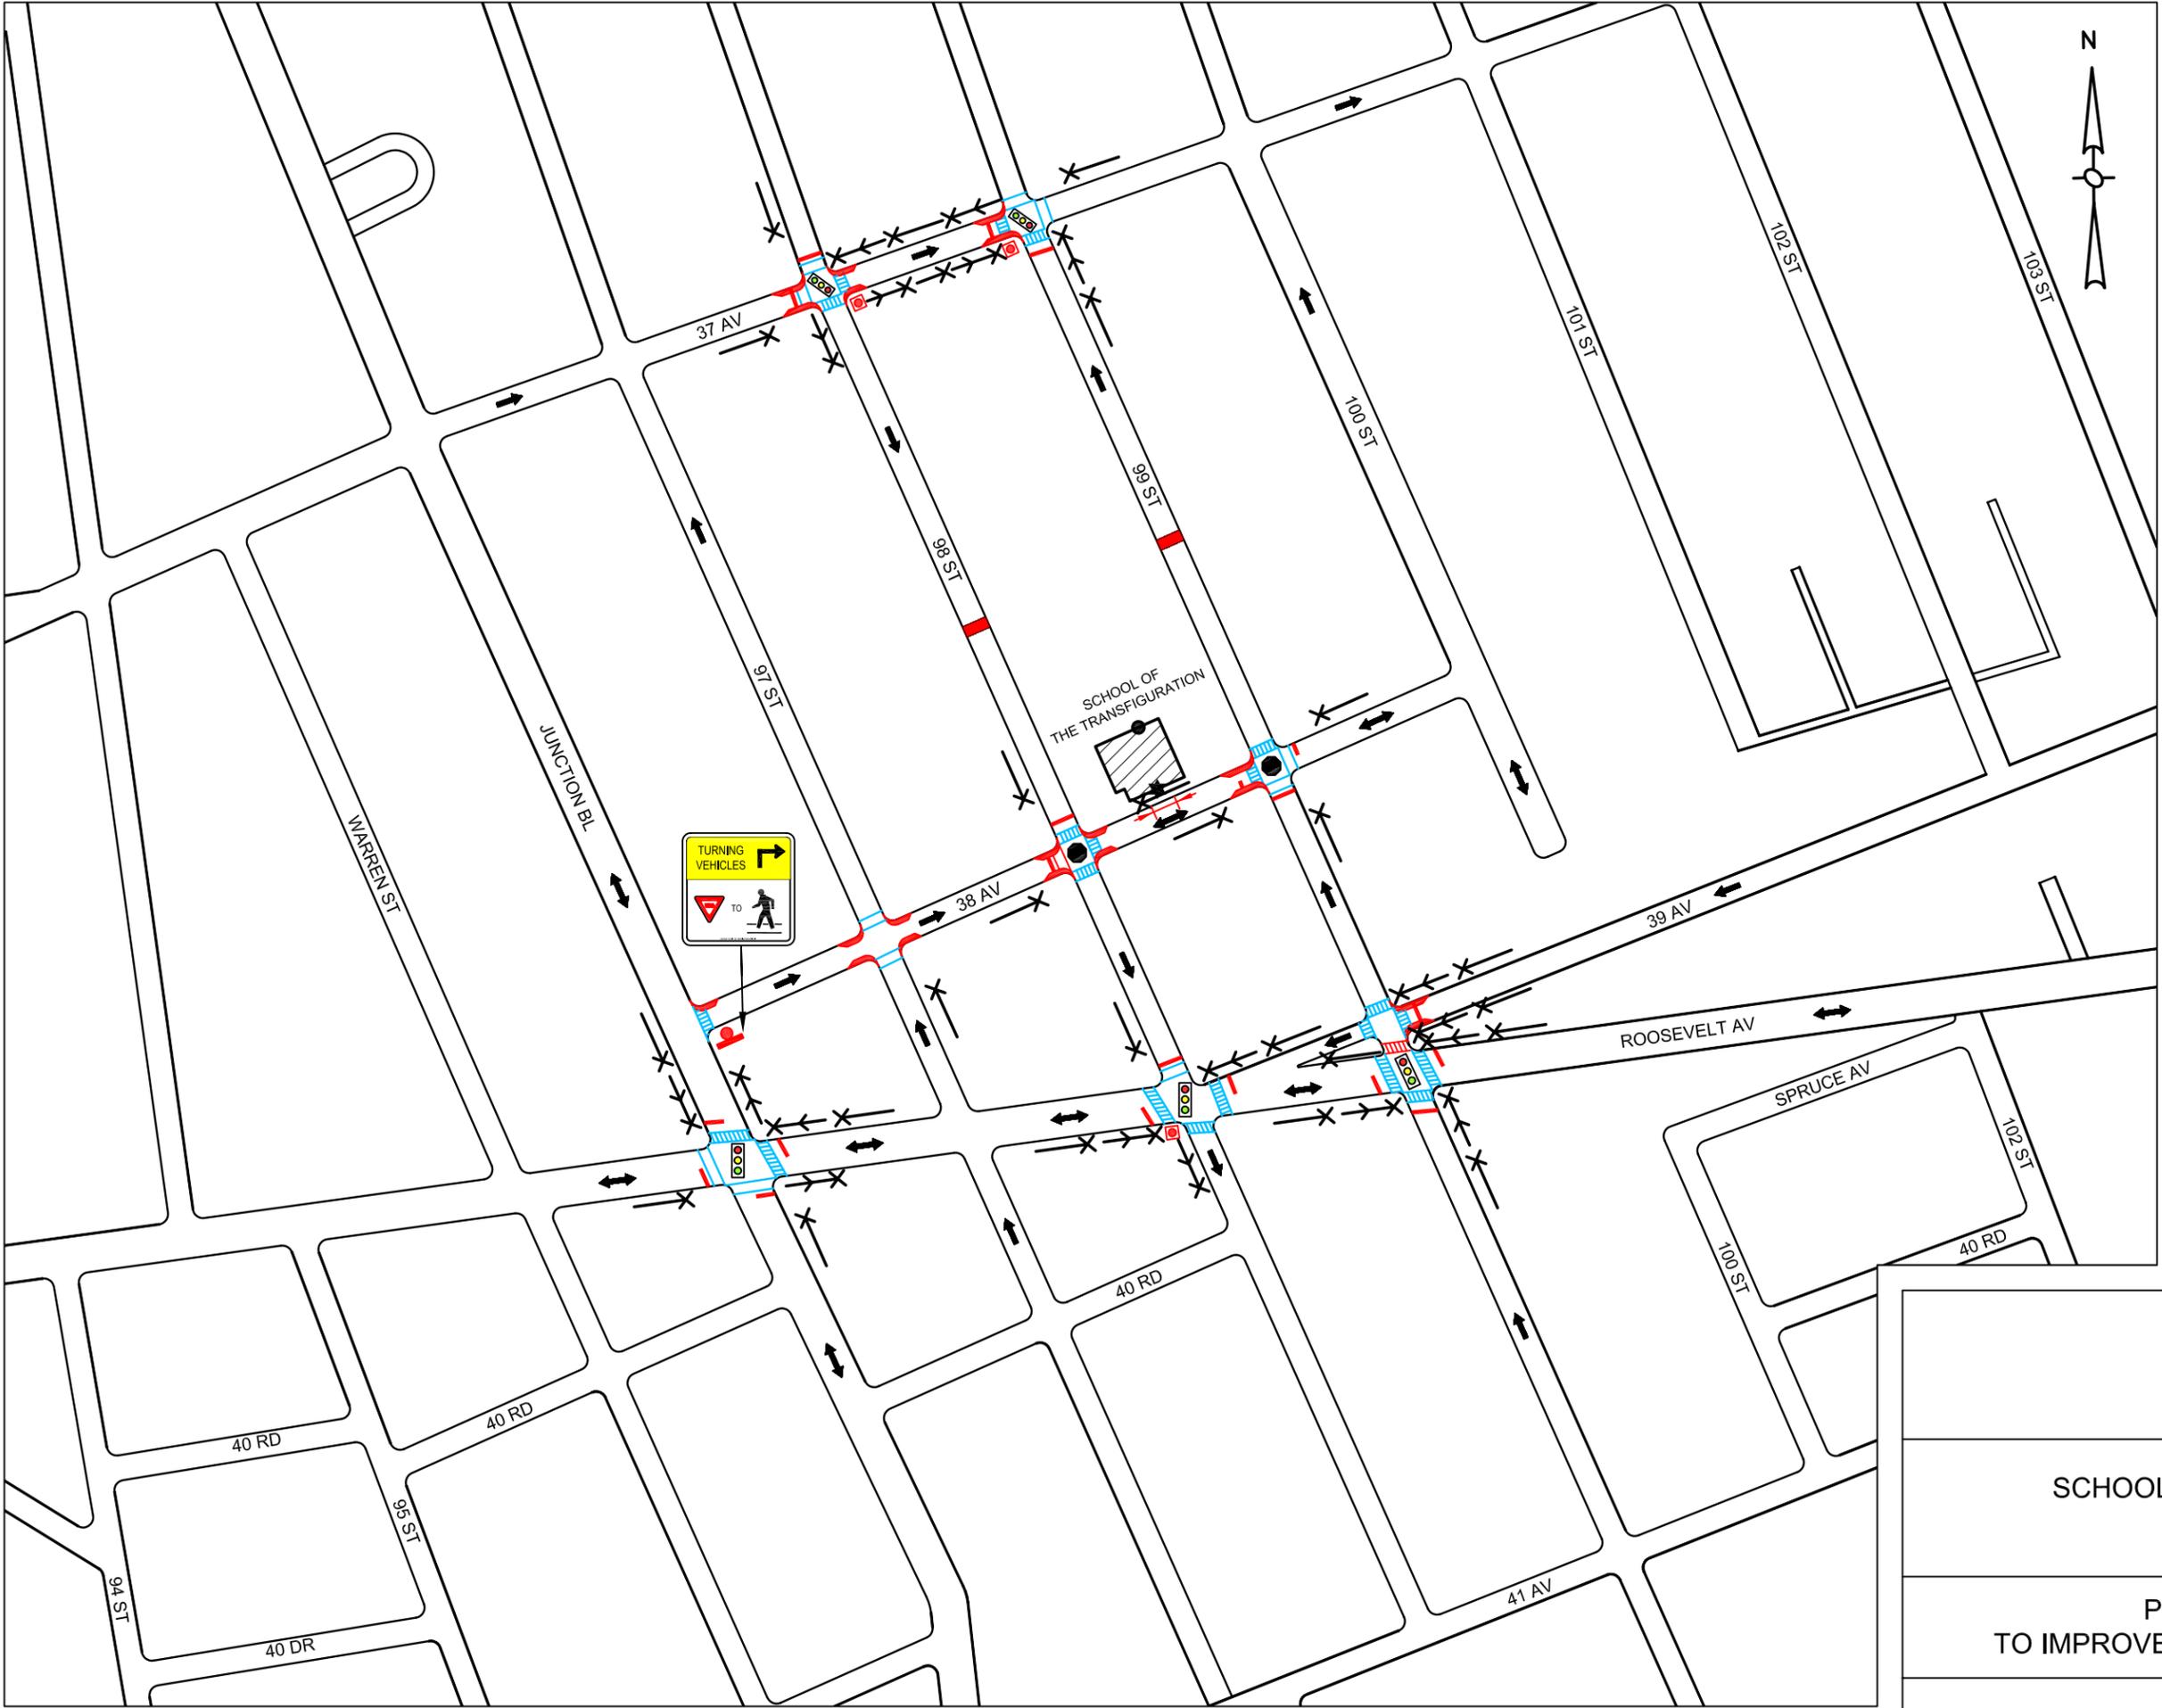
POTENTIAL MEASURES
TO IMPROVE STUDENT PEDESTRIAN SAFETY

This section describes the proposed measures to improve school pedestrian safety around the School of the Transfiguration. The proposed recommendations are divided into short-term and long-term measures. Short-term measures are those that potentially can be performed in-house by DOT. Long-term measures involve capital improvements. Each of the short- and long-term measures recommended for the School of the Transfiguration is shown in more detail in Exhibit 6 at the end of this section.

Consideration should be given to installing curb extensions at the following locations, provided that the Final Design confirms that construction of the recommended curb extensions would be feasible and not interfere with traffic operations. Final details pertaining to the number, location and geometry of curb extensions will be developed during the Final Design/Contract Document preparation

The purpose of the curb extensions is to shorten the crossing distance for pedestrians, and to reduce speeds of vehicles approaching and turning at these heavily utilized school crosswalks [or intersections]. These curb extensions would not eliminate or reduce the width of any moving lanes.
