**New York City Department of Transportation
Office of School Safety Engineering**

School Safety Engineering Project

FINAL REPORT: School of the Transfiguration, Queens

October 4, 2006

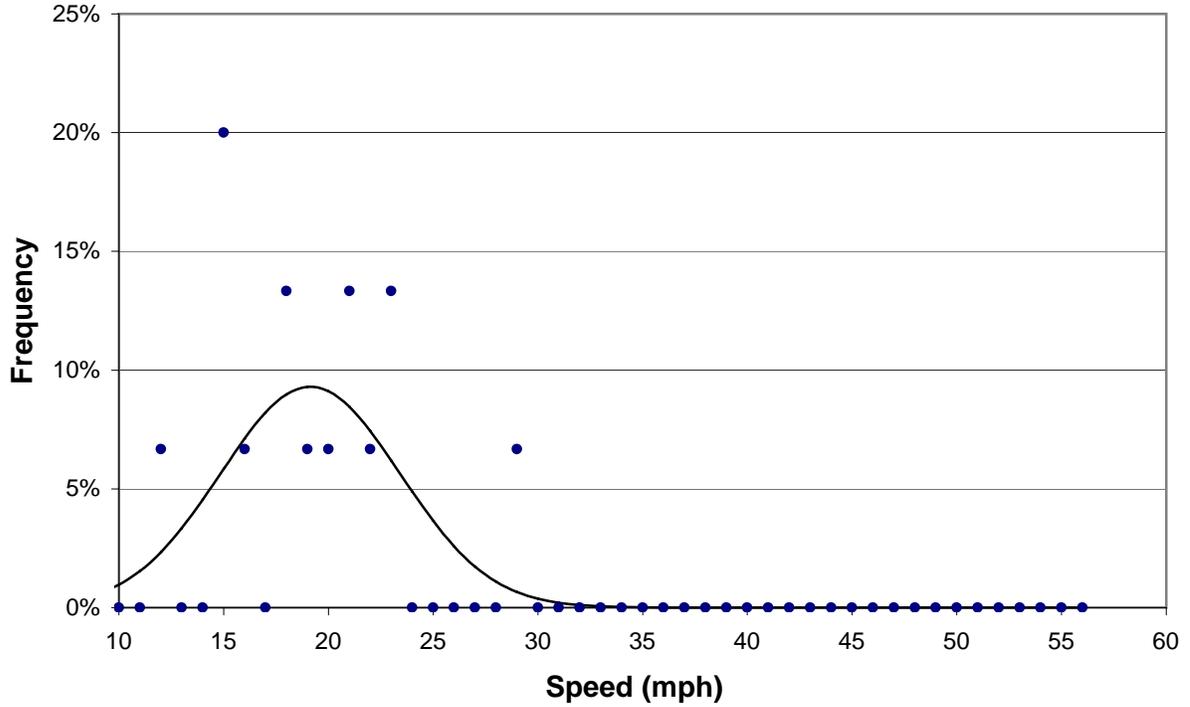
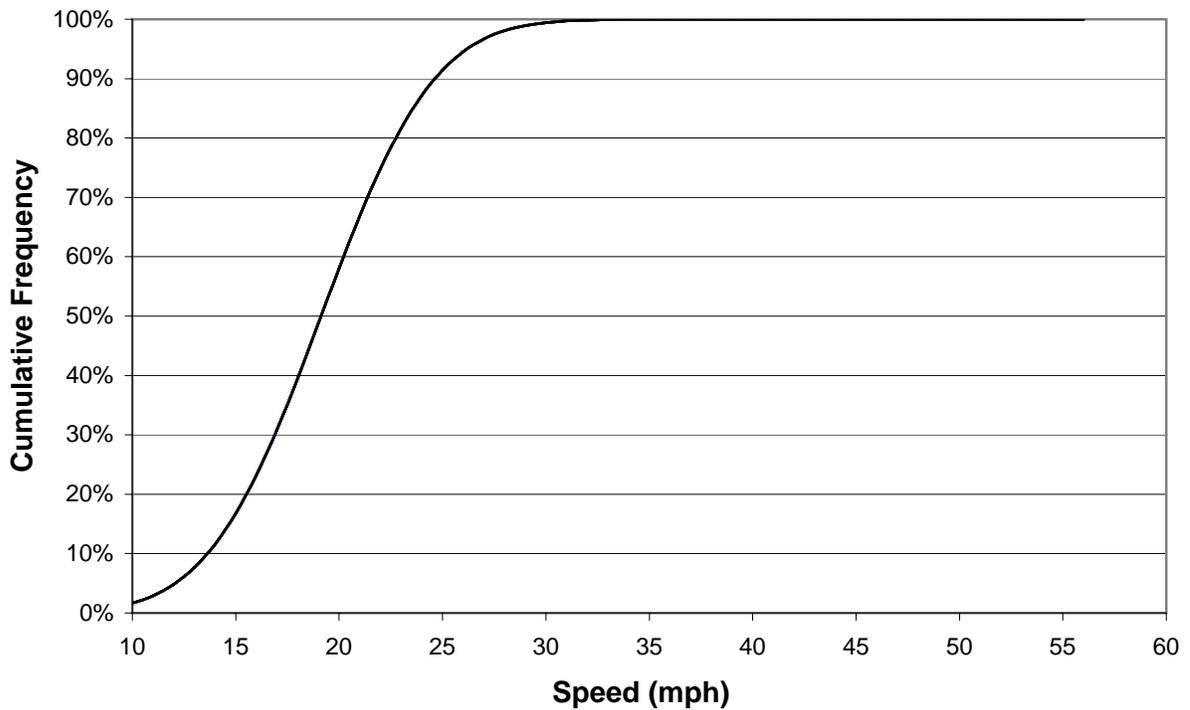
SPOT SPEED STUDY

Date: 10/25/05
 Location: 38 Ave between 98 St and 99 St
 Surveyor: Richard Calvache

Mean Speed = 19.1 mph
Standard Deviation = 4.3 mph
Margin of Error (95% Confidence) = ± 2.2 mph

Median Speed = 19.1 mph
15th Percentile Speed = 14.7 mph
85th Percentile Speed = 23.6 mph

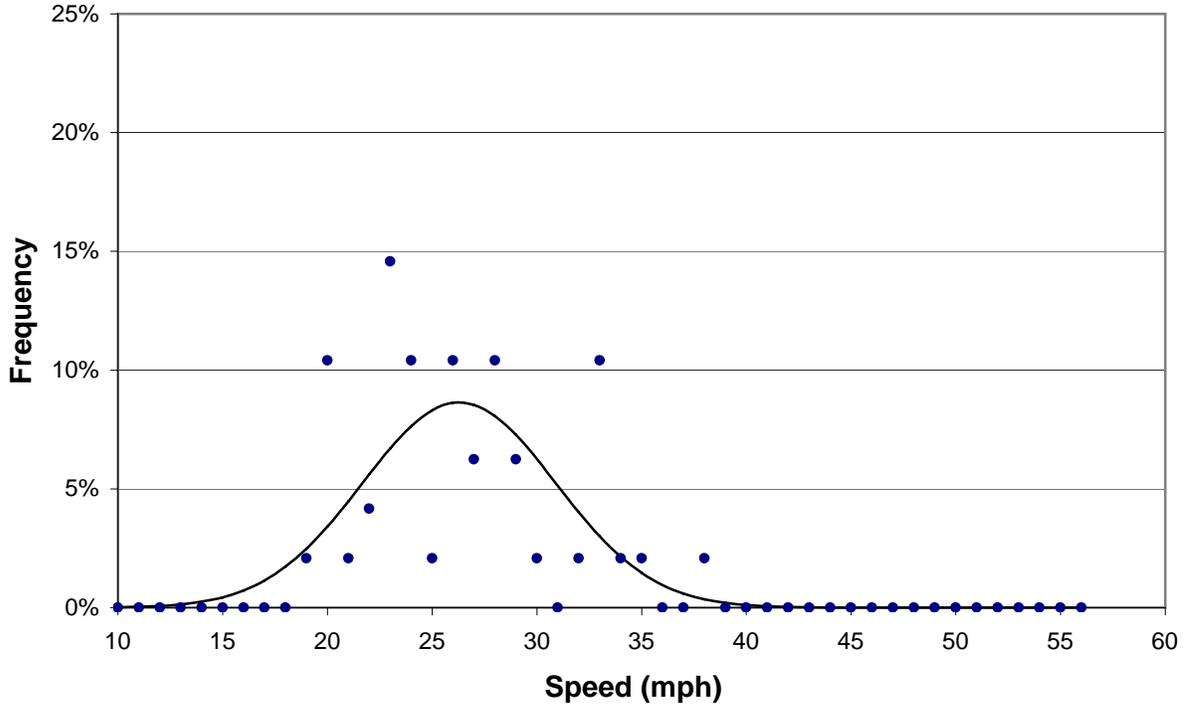
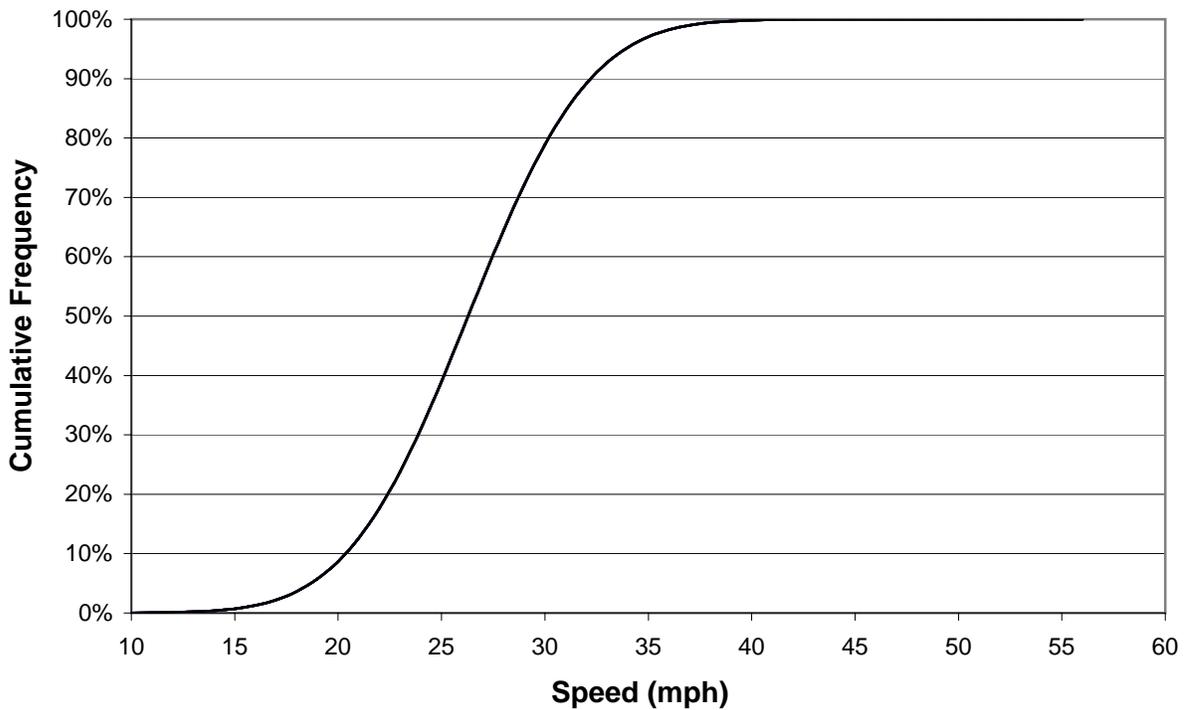
SPOT SPEED STUDY

Date: 11/3/05
 Location: 98 St between 37 Ave and 38 Ave
 Surveyor: Richard Calvache

Mean Speed = 26.3 mph
Standard Deviation = 4.6 mph
Margin of Error (95% Confidence) = ± 1.3 mph

Median Speed = 26.3 mph
15th Percentile Speed = 21.5 mph
85th Percentile Speed = 31.1 mph

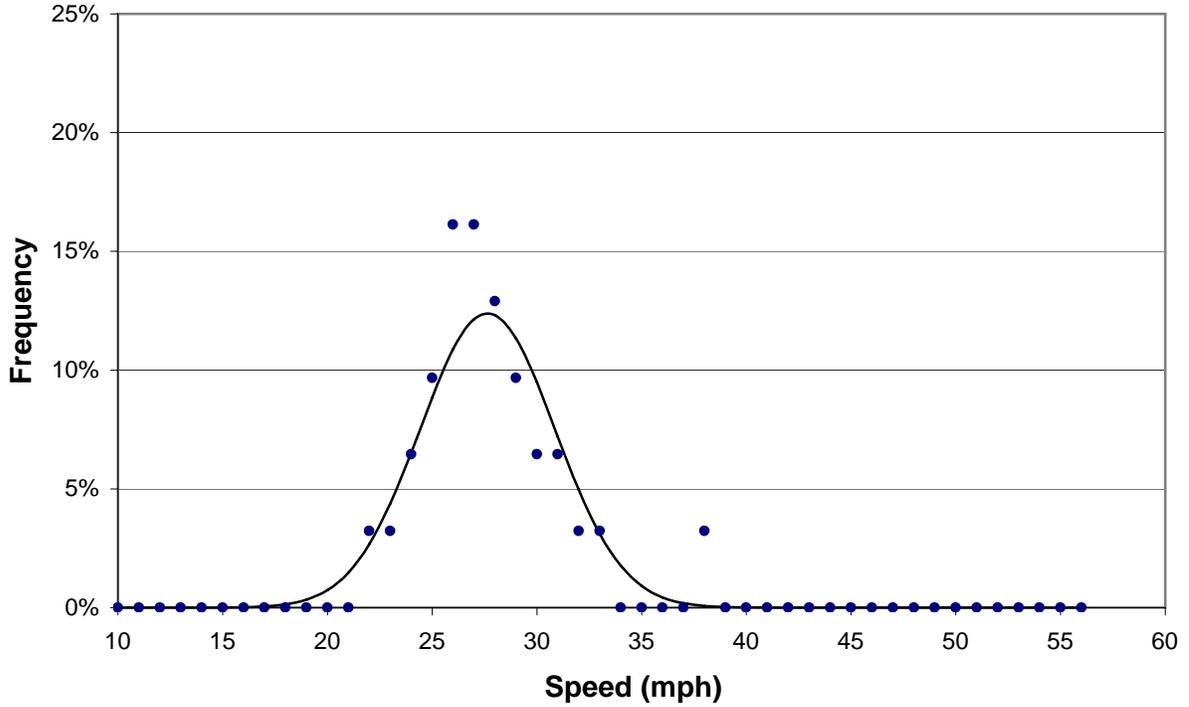
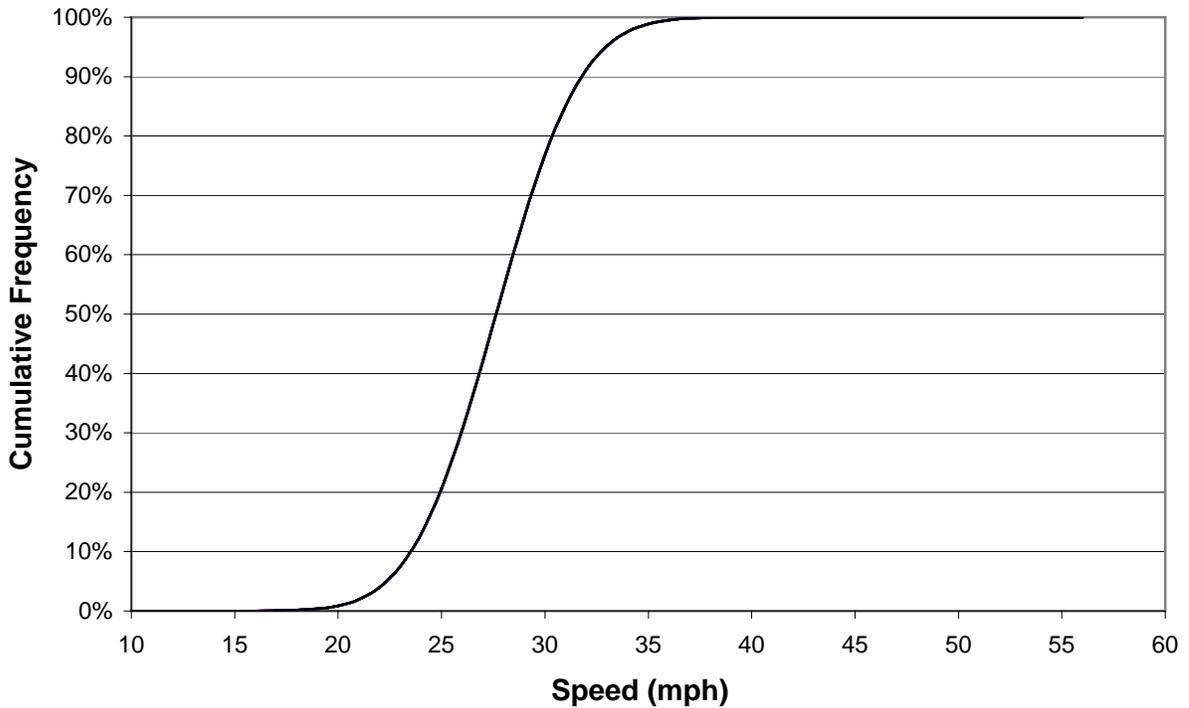
SPOT SPEED STUDY

Date: 11/3/05
 Location: 99 St between 37 Ave and 38 Ave
 Surveyor: Richard Calvache

Mean Speed = 27.6 mph
Standard Deviation = 3.2 mph
Margin of Error (95% Confidence) = ± 1.1 mph

Median Speed = 27.6 mph
15th Percentile Speed = 24.3 mph
85th Percentile Speed = 31.0 mph
