**New York City Department of Transportation
Office of School Safety Engineering**

School Safety Engineering Project

FINAL REPORT: St. Charles School, Staten Island

**Prepared by
The RBA Group/Urbitran Associates**

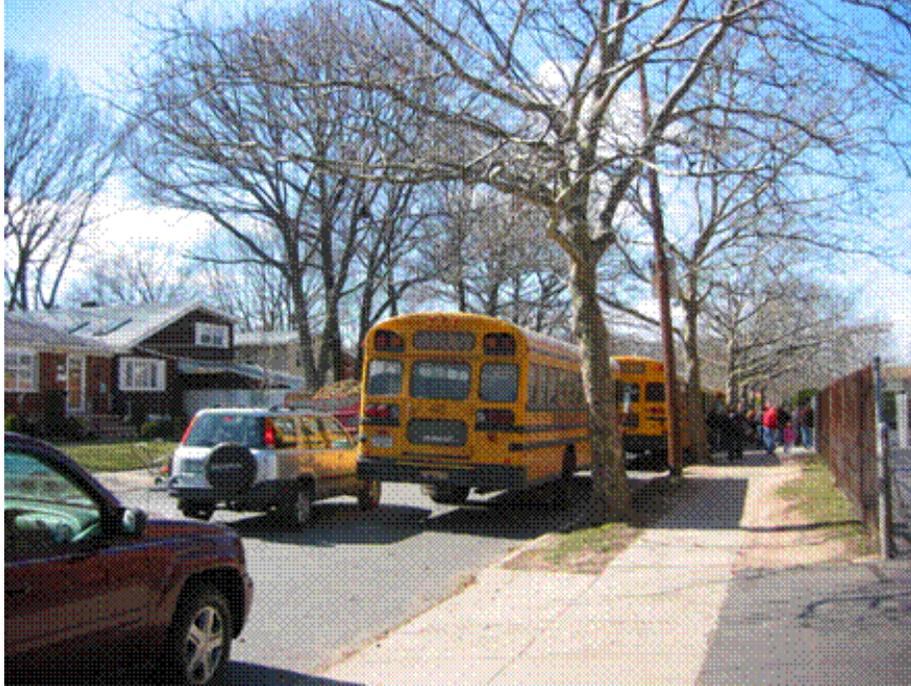
Figure 3: School busses on Peter Avenue at dismissal time

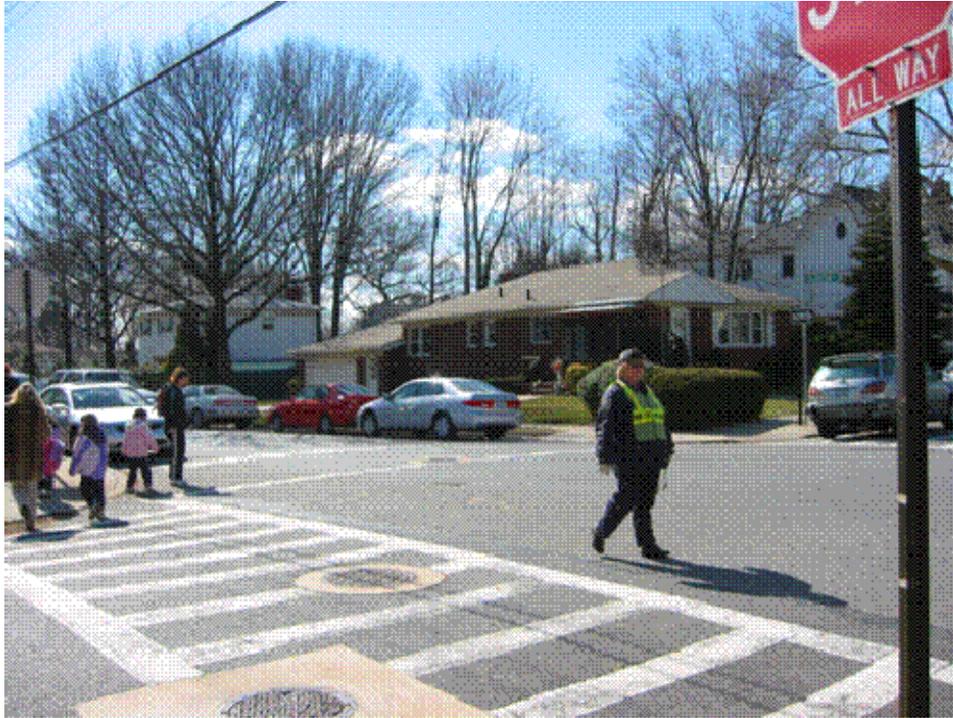
According to school officials, there are four (4) school crossing guards assigned to the school (See Figure 4):

Figure 4: School crossing guard at the intersection of Peter Avenue and Clawson Street

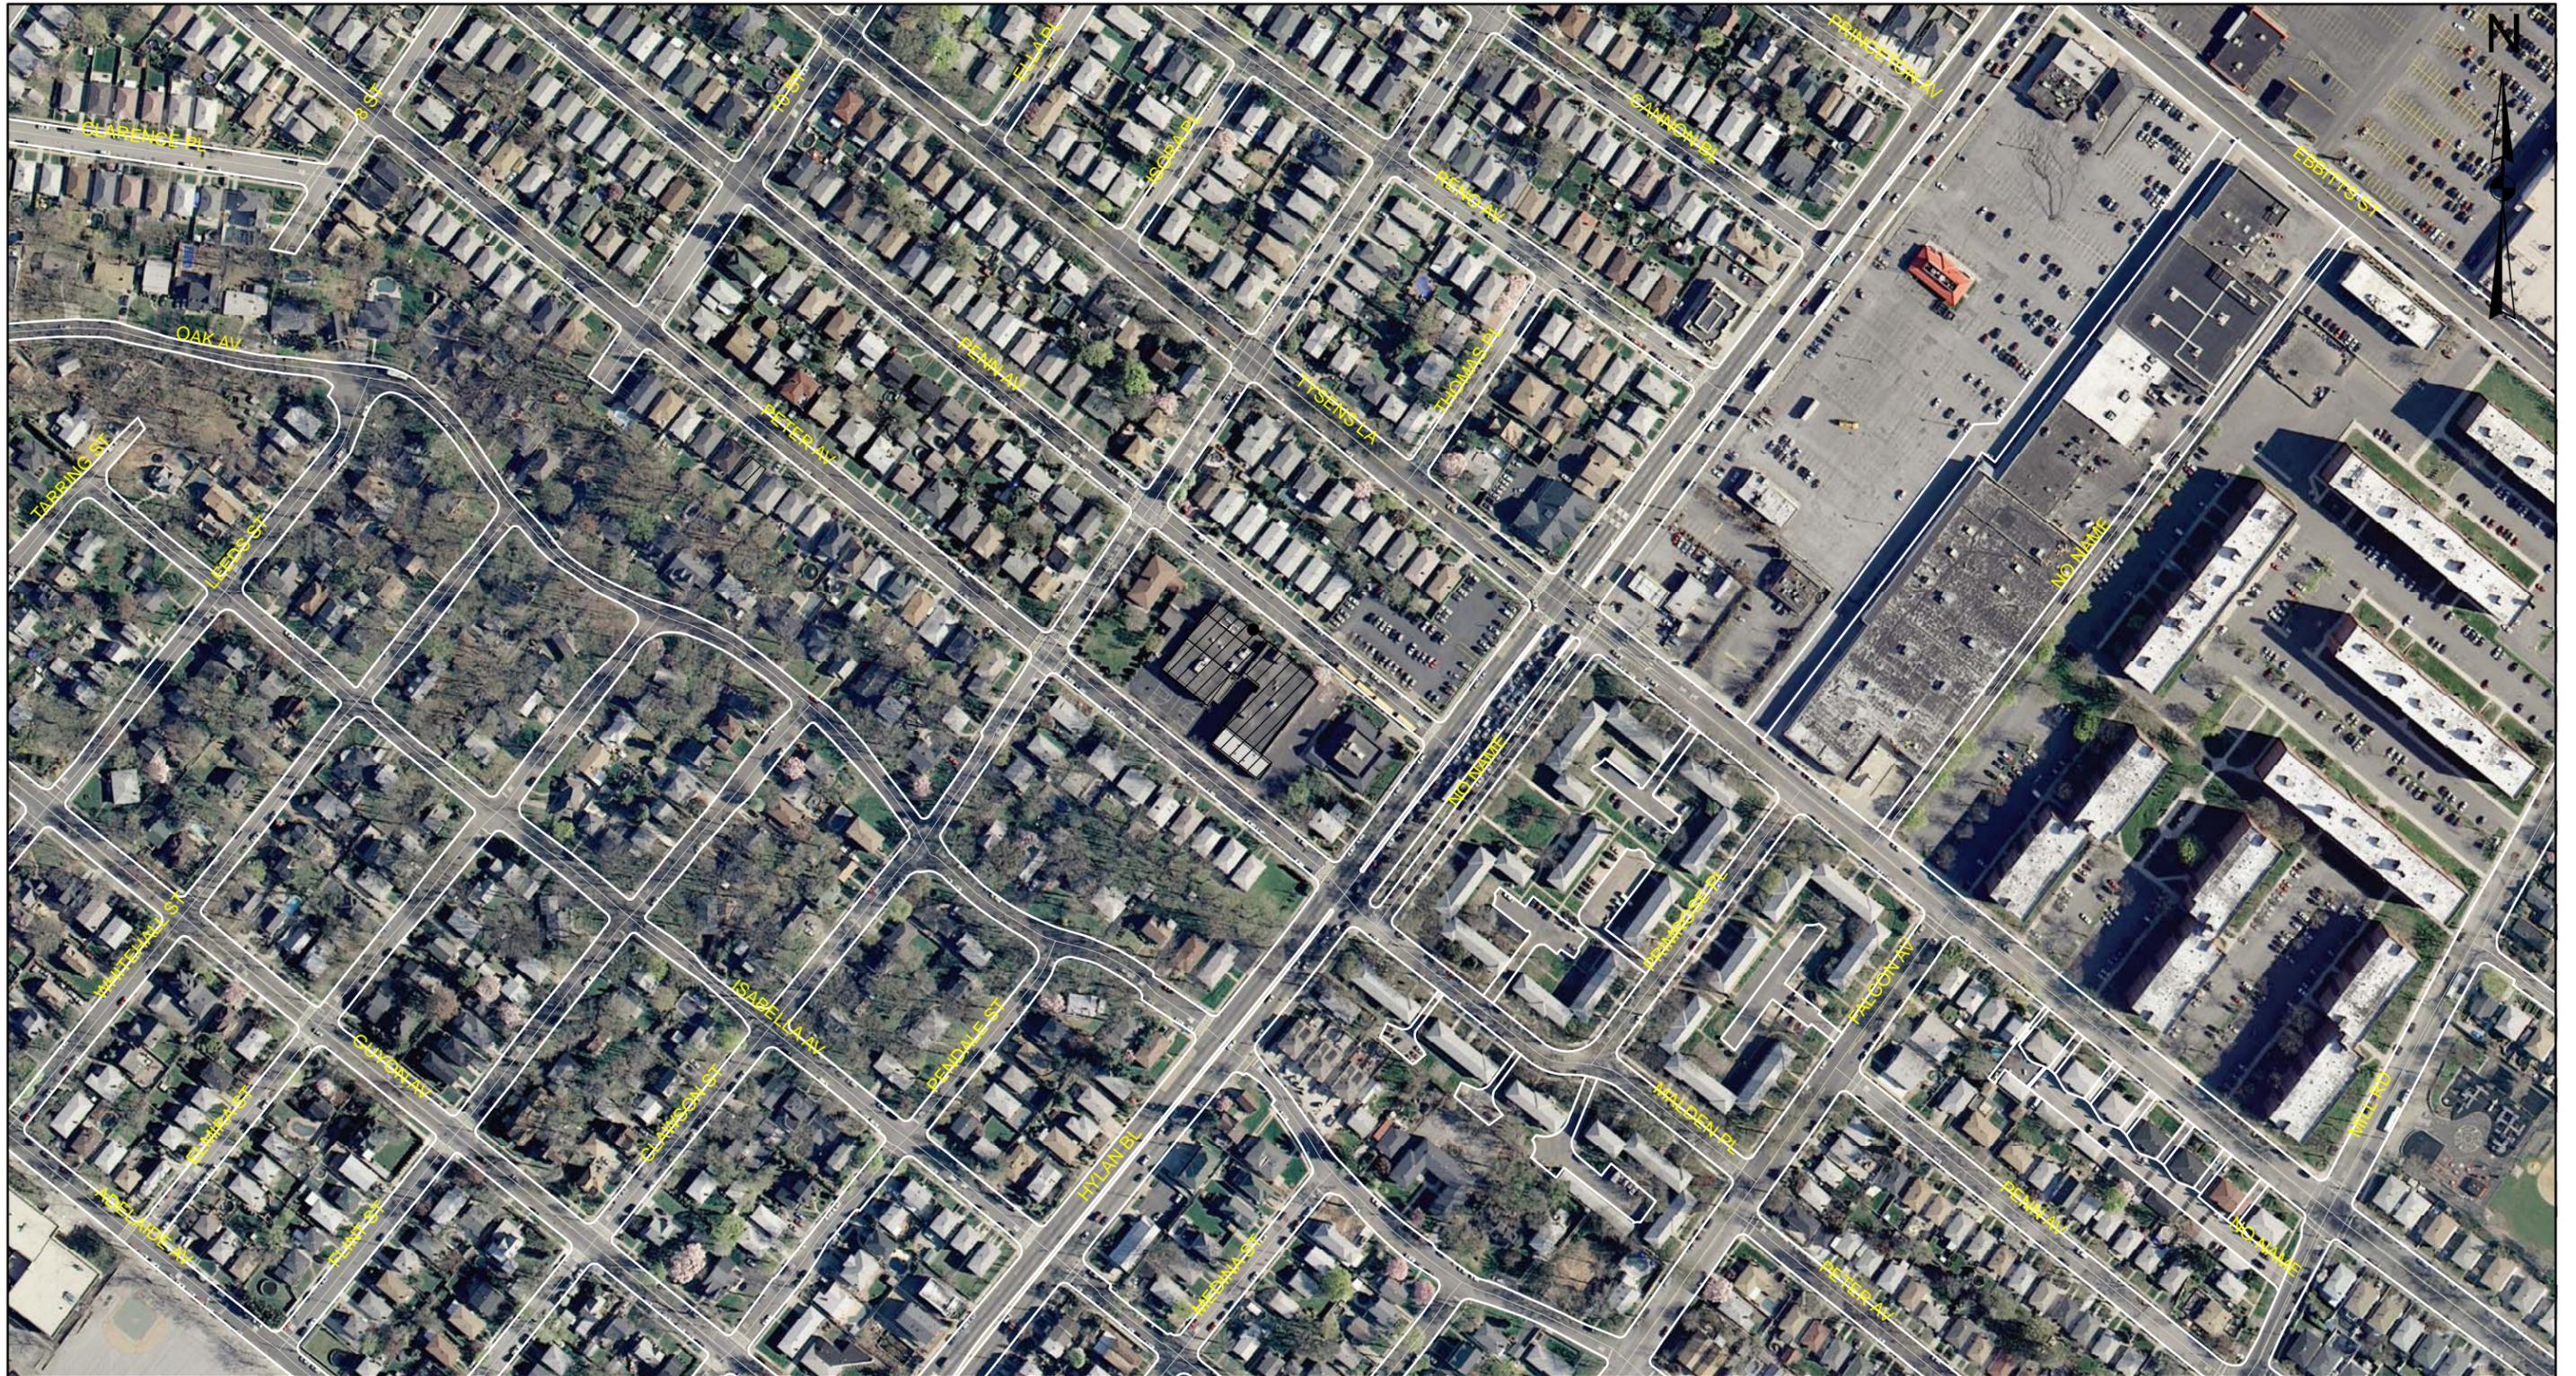
EXHIBIT 1
ST. CHARLES SCHOOL
STATEN ISLAND
AERIAL PHOTOGRAPH

Exhibit 1, at the end of this section, shows an aerial view of the neighborhood surrounding Saint Charles School, which is generally residential in character. The school is bounded by Penn Avenue to the north, Hylan Boulevard to the east, Peter Avenue to the south, and Clawson Street to the west. Hylan Boulevard is a major, north-south, arterial in the borough of Staten Island. Tysens Lane, a major east-west connector street, is located one block to the north of Hylan Boulevard. The intersection of Tysens Lane and Hylan Boulevard is consequently a busy intersection.

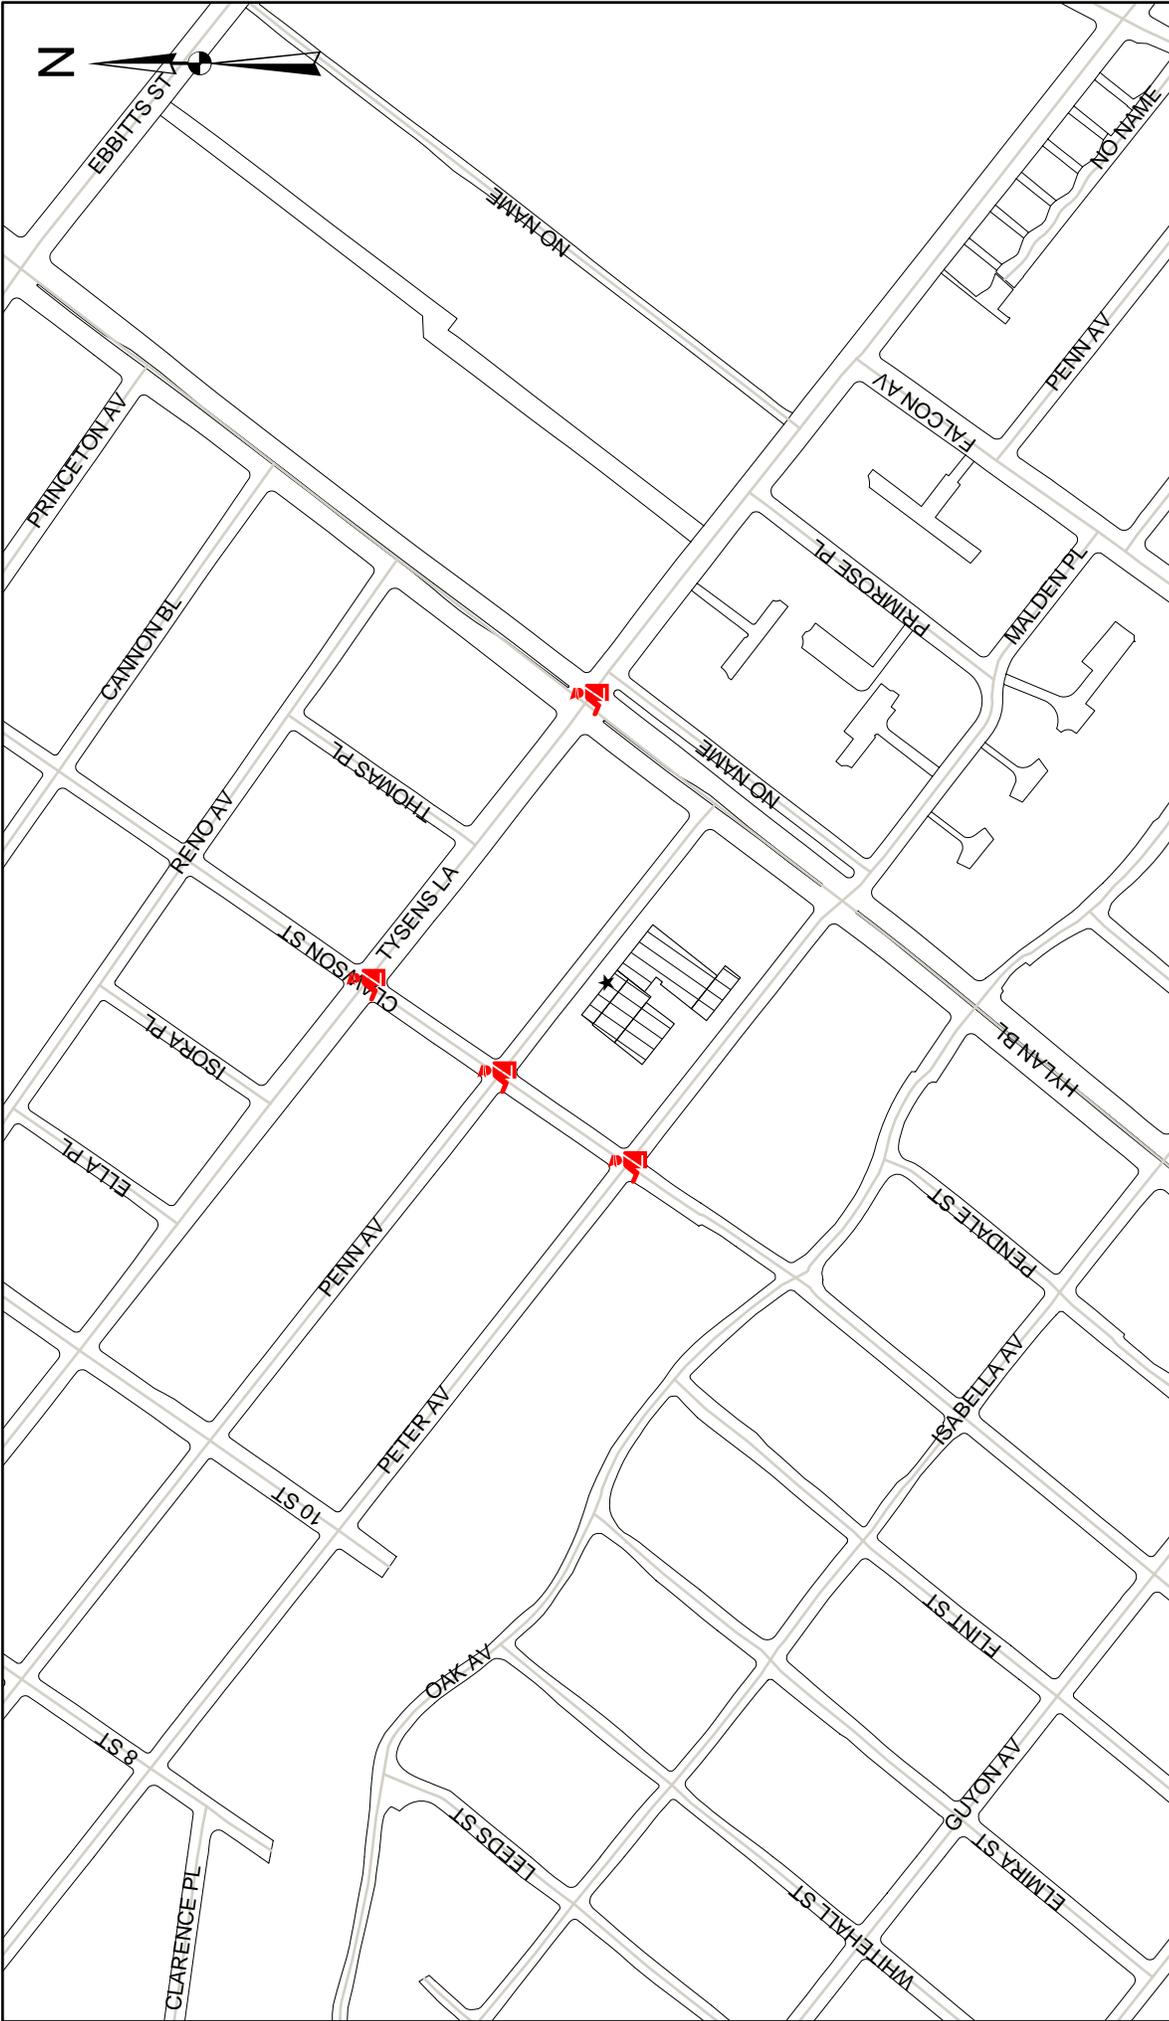
EXHIBIT 3
ST. CHARLES SCHOOL
STATEN ISLAND

- Clawson Street and Penn Avenue
- Clawson Street and Peter Avenue
- Clawson Street and Tysens Lane
- Hylan Boulevard and Tysens Lane

The crossing guard locations are shown in Exhibit 3 at the end of this section.

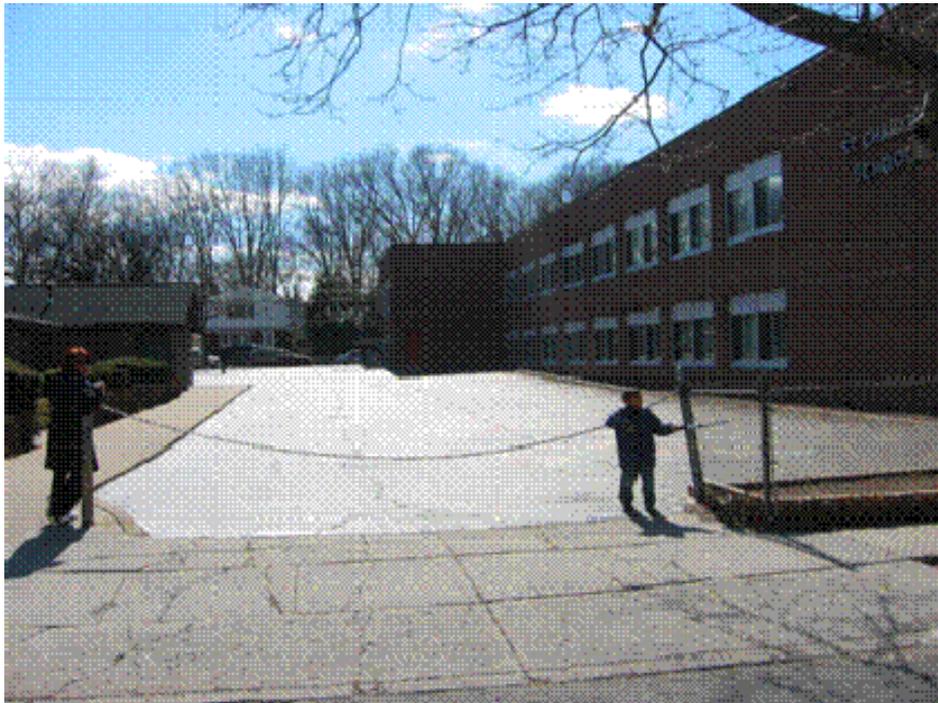
Figure 5: Schoolyard connecting between Penn Avenue and Peter Avenue

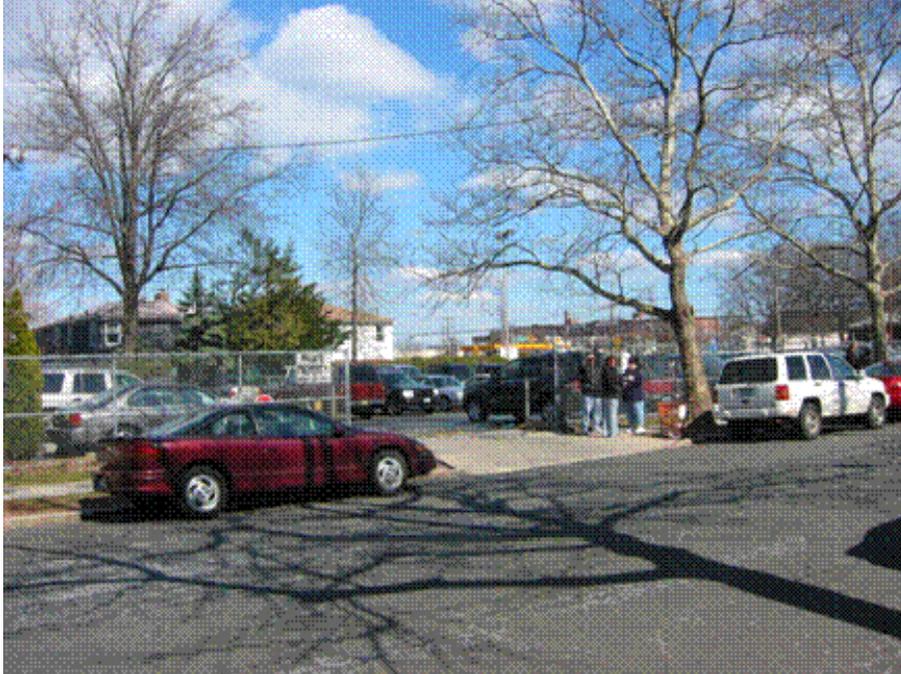
According to school representatives, about 64 percent (64%) of the students are dropped-off by cars. Parents drop-off and pick-up students at two main locations: the main entrance on Penn Avenue and the back entrance on Peter Avenue. In the morning, parents also drop-off students at schoolyard located east of the school building when weather is good. Parents use Penn Avenue to access the yard and leave via Peter Avenue (see Figure 5). In the afternoon, at the dismissal time, Penn Avenue is closed for traffic between 2:00 and 2:20 pm. During the dismissal time, when Penn Avenue is closed for traffic, parents park on the surrounding streets or arrive earlier (before 2:00 pm) and park on Penn Avenue and in the school parking lot (see Figure 6).

Figure 6: Parish parking lot used by parents, on Penn Avenue in front of the school's main entrance

There is a parking lot on Penn Avenue across from the school. The parking lot entrance is just west of Hylan Boulevard. The school officials reported cars making illegal right-turn from Hylan Boulevard onto Penn Avenue to get to the parking lot. (It should be noted that Penn Avenue is a one-way eastbound street.)

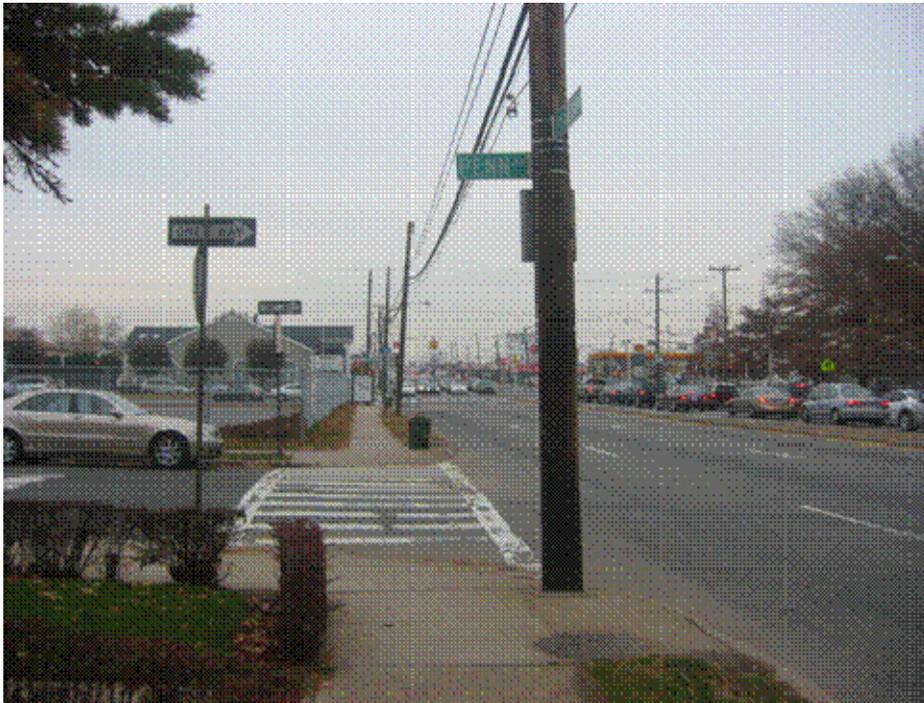
This is an unsignalized T-intersection with a school crosswalk located across the west leg of Penn Avenue (see Figure 7). The eastbound approach of Penn Avenue is stop-controlled. Hylan Boulevard is a two-way street with two travel lanes and a parking lane on each side of the roadway. A four-foot wide raised concrete median divides the north and southbound roadways. Monday through Friday, on-street parking is prohibited from

The NYS DMV accident data (Table 1) shows that there were three (3) accidents at this intersection between 1998 and 2000; none of which were pedestrian accidents. There were no school-related accidents during the same three-year period. The NYPD accident data (Table 2) shows that there were seven (7) accidents at this intersection between 2001 and 2004; none were pedestrian accidents.

Figure 7: Looking north along west side of Hylan Boulevard across its intersection with Penn Avenue (school is off to the left)

- Provide curb extension at the northwest corner of Penn Avenue at its intersection with Hylan Boulevard, as shown in Exhibit 6. In addition, provide “No Right Turn” sign for southbound vehicles approaching at Penn Avenue.

The purpose of the curb extension is to prohibit illegal right turns from southbound Hyland Boulevard onto Penn Avenue. The curb extension will not eliminate or reduce the width of the travel lane on Penn Avenue. Curb extension is not proposed where it would hinder the ability of a vehicle to turn.

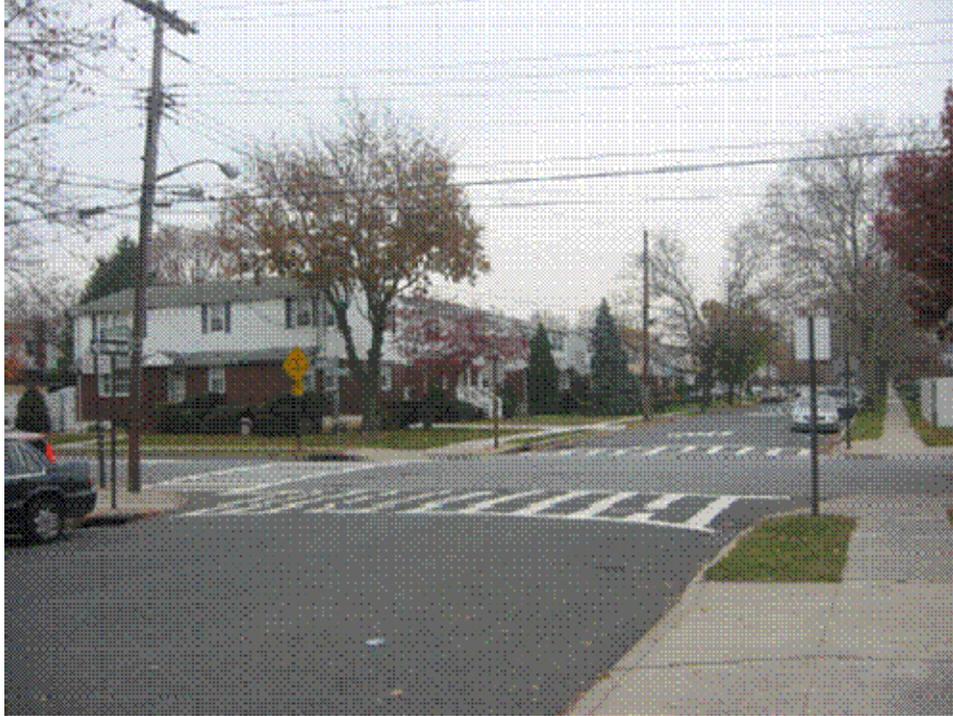
This is an unsignalized, four-leg intersection with school crosswalks located across the east, west, and south legs (see Figure 8). A stop sign is located on the eastbound approach of Penn Avenue. Penn Avenue is a one-way eastbound street, toward Clawson Street. It has one travel lane with parking on both sides of the roadway. Penn Avenue is closed for traffic between 12:00 noon and 1:00 pm during the lunch time and also between 2:00 and 2:20 pm during the dismissal time.

There is an uncontrolled school crosswalk located across the south leg of Clawson Street at the Penn Avenue intersection. In order to determine the appropriate traffic control for the uncontrolled school crosswalk, a preliminary traffic signal warrant assessment was performed to assess the traffic situation and to determine what type of traffic control devices would be appropriate. A vehicular traffic count and a pedestrian count were conducted at the intersection from 7:30 to 9:00 am on Wednesday, September 21, 2005. The results of the peak hour (7:30 to 8:30 am) counts are shown in Tables 4 and 5, and in Exhibit 5 at the end of this section.

The vehicular volume count determined there were 419 vehicles on Clawson Street (352 northbound and 67 southbound) and 114 vehicles eastbound on Penn Avenue. The pedestrian volume count determined there were 12 pedestrians (8 adults and 4 students) utilizing the north leg of Clawson Street that does not have any pedestrian crosswalk, and 53 pedestrians (23 adults and 30 students) utilizing the school crosswalk located across the south leg of Clawson Street. This is a total of 65 pedestrians crossing Clawson Street at Penn Avenue (31 adults and 34 students) during the 7:30-8:30 a.m. time period.

Figure 8: Looking west along Penn Avenue toward its intersection with Clawson Street

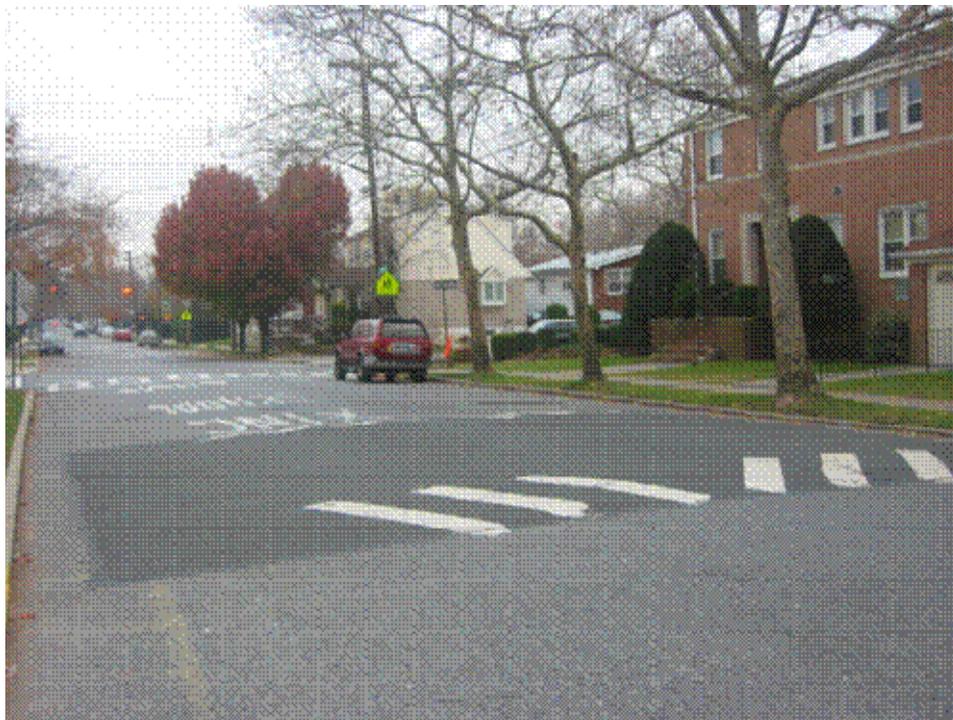
Clawson Street is a two-way street with one travel lane and a parking lane on each side of the roadway. There is an existing speed reducer (hump) located across Clawson Street, south of this intersection, between Penn Avenue and Peter Avenue (see Figure 9).

Figure 9: Looking north along Clawson Street at speed hump between Peter and Penn Avenues

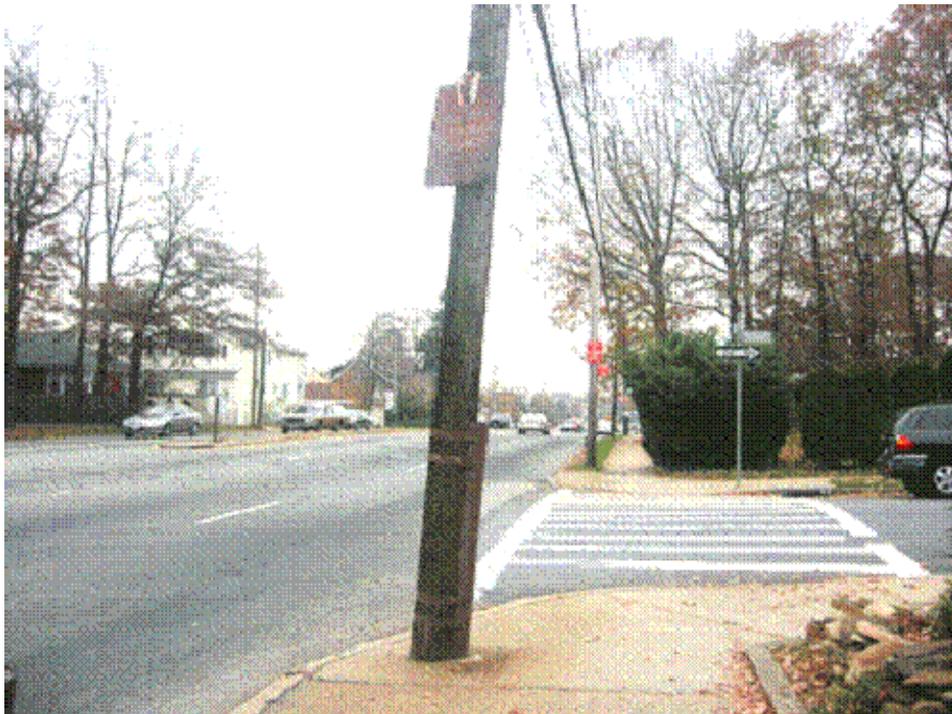
This is an unsignalized T-intersection with a school crosswalk located across the west leg of Peter Avenue (see Figure 10). Hylan Boulevard is a two-way street with two travel lanes and a parking lane on each side of the roadway. A four-foot wide raised concrete median divides the north and southbound roadways. Monday through Friday, on-street parking is prohibited from 7:00 am to 10:00 am in the northbound direction and 4:00 pm to 7:00 pm in the southbound direction to allow for a third travel lane during the morning and evening peak periods, respectively. Peter Avenue is a one-way westbound street, away from Hylan Boulevard. It has one travel lane with parking on both sides of the roadway.

The NYS DMV accident data (Table 1) shows that there were eleven (11) accidents at this intersection between 1998 and 2000, which included two (2) pedestrian accidents. One of the pedestrian accidents was reported as a fatality. There were no school-related accidents during the same three-year period. The pedestrian fatality occurred about 3:00 pm on April 26, 1999. It was reported that the eighty-one year old individual was struck and killed by a vehicle while crossing at the intersection, but not within the designated crosswalk. The accident location was on a straight and level segment, and the roadway and weather conditions were dry and clear, respectively. The NYPD accident data (Table 2) shows that there were twelve (12) accidents at this intersection between 2001 and 2004; none were pedestrian accidents.

Figure 10: Looking south along west side of Hylan Boulevard across its intersection with Peter Avenue (school off is to the right)

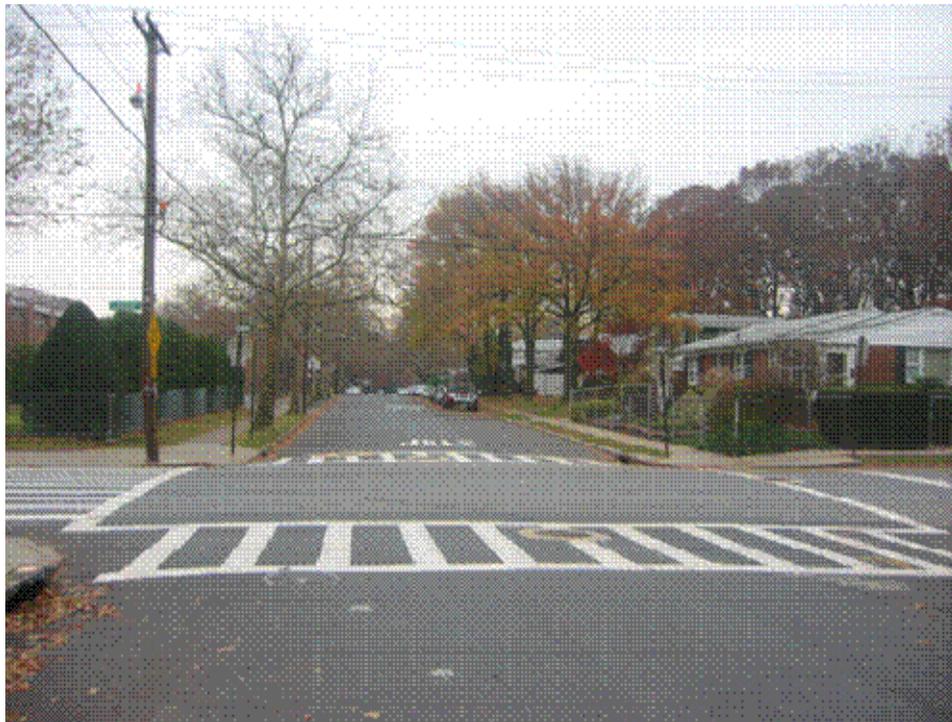
This is a four-leg all-way stop-controlled intersection with school crosswalks located across the north, east, and west legs of the intersection (see Figure 11). There is a pedestrian crosswalk across the south leg of Clawson Street. Clawson Street is a two-way street with one travel lane and a parking lane on each side of the roadway. Peter Avenue is a one-way westbound street. It has one travel lane with parking on both sides of the roadway.

The NYS DMV accident data (Table 1) shows that there were no accidents at this intersection between 1998 and 2000. The NYPD accident data (Table 2) shows that there were two (2) accidents at this intersection between 2001 and 2004; neither of these was a pedestrian accident.

Figure 11: Looking east along Peter Avenue across its intersection with Clawson Street (school is up and to the left)

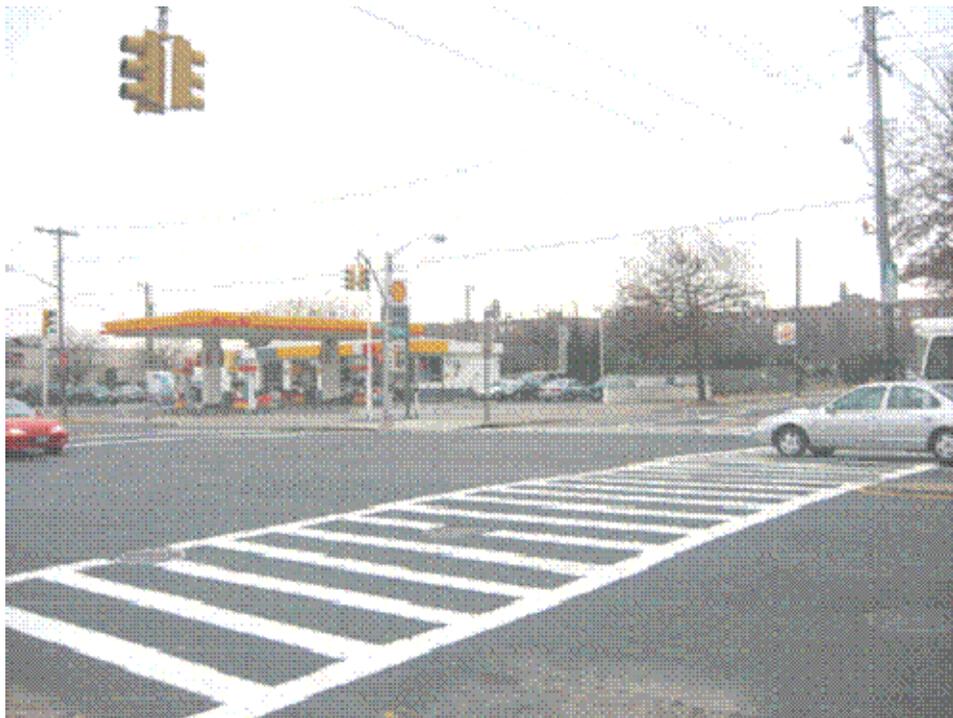
This is a signalized four-leg intersection with school crosswalks located across the south, east, and west legs (see Figure 12). Hylan Boulevard is a two-way street that has two shared through/right-turn lanes, a left turn lane, and a parking lane on each side of the roadway. A four-foot wide raised concrete median divides the northbound and southbound roadways. Monday through Friday, on-street parking is prohibited from 7:00 am to 10:00 am in the northbound direction and 4:00 pm to 7:00 pm in the southbound direction to allow for a third travel lane during the morning and evening peak periods, respectively. Tysens Lane has three approach lanes on each side of the roadway with the eastbound approach consisting of a left turn lane and two shared through/right-turn lanes.

There is a Leading Pedestrian Interval (LPI) of ten seconds for the Hylan Boulevard pedestrian crossing.

The NYS DMV accident data (Table 1) shows that there were seventy (70) accidents at this intersection between 1998 and 2000; this includes six (6) pedestrian accidents, one of which was a fatality. One of the pedestrian accidents was a school-related accident. The school-related accident occurred at the intersection around 4:00 pm on Wednesday, June 16, 1999. The accident involved a twelve-year old pedestrian who was reported as using a designated crosswalk while crossing the street. The extent of injuries was reported as “possible injury”. The accident location was on a straight and level segment, and the roadway and weather conditions were dry and clear, respectively. The pedestrian fatality accident occurred around 10:00 am on Friday, September 1, 2000. The eighty-two year old individual was struck and killed by a vehicle at the intersection. It was reported that the individual emerged from behind a parked vehicle. The accident location was on a straight and level segment, and the roadway and weather conditions were dry and cloudy, respectively. The NYPD accident data (Table 2) shows that there were one hundred and eight (108) accidents at this intersection between 2001 and 2004; which included five pedestrian accidents. None of the pedestrian accidents was school-related, and there were no pedestrian fatalities reported during the same four-year period.

*Figure 12:
Looking northeast
across the Tysens
Lane and Hylan
Boulevard
intersection*

- Southbound approach of Hylan Boulevard at Tysens Lane
- Eastbound approach of Tysens Lane at Clawson Street

- Relocate stop bars 10 feet in advance of the school crosswalks at the signalized intersection of Hylan Boulevard and Tysens Lane.
- Provide stop bar 10 feet in advance of the school crosswalk at the northbound and westbound approaches of Tysens Lane and Clawson Street intersection.
- Relocate stop bars 10 feet in advance of the school crosswalk at the southbound approach of Hylan Boulevard at its intersection with Guyon Avenue.

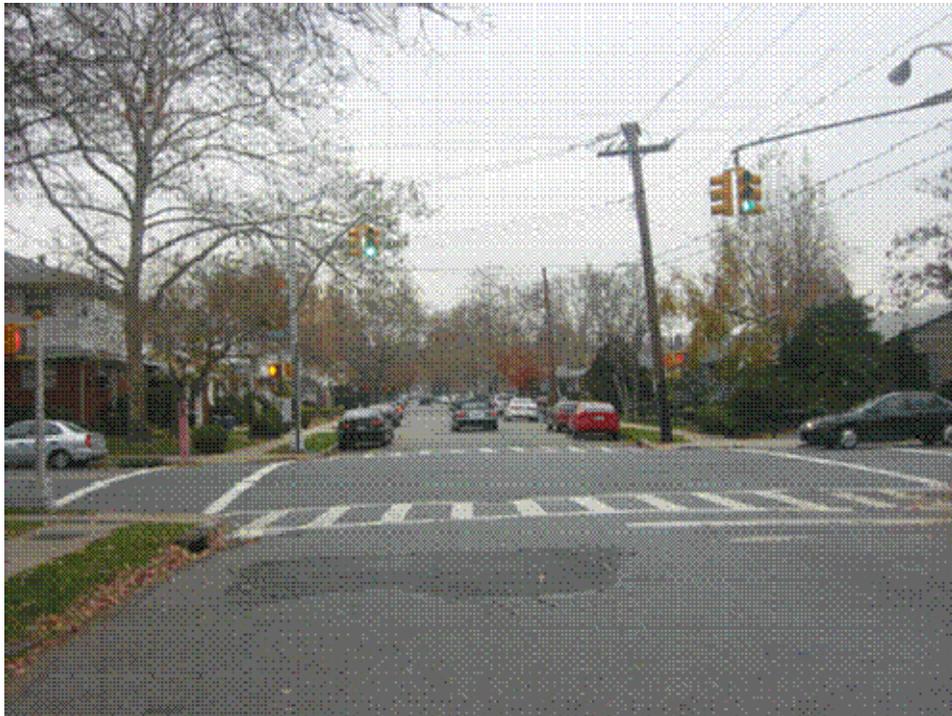
This is a signalized four-leg intersection with school crosswalks located across the north, south, and east legs (see Figure 13). Tysens Lane is a two-way street with one travel lane and a parking lane on each side of the roadway. South of the intersection, Clawson Street is a two-way street with one travel lane and a parking lane on each side of the roadway. North of the intersection, Clawson Street is a one-way northbound street, with one travel lane and parking on both sides of the roadway.

The NYS DMV accident data (Table 1) shows that there were ten (10) accidents at this intersection between 1998 and 2000, none were pedestrian accidents. The NYPD accident data (Table 2) shows that there were eleven (11) accidents at this intersection between 2001 and 2004, which included two pedestrian accidents. None of the pedestrian accidents were school-related or a fatality.

Figure 13: Looking north along Clawson Street across its intersection with Tysens Lane

- Designate the pedestrian crosswalks along the east side of Clawson Street across the east leg of Tysens Lane as a school crosswalk.

- Prohibit parking on the east side of Clawson Street for 100 feet to provide two northbound approach lanes (one shared through/left-turn and one exclusive right-turn lane). In addition, prohibit parking on the west side of Clawson Avenue for 25 feet to provide enough clear space for vehicles turning left or right from Tysens Lane onto Clawson Street.

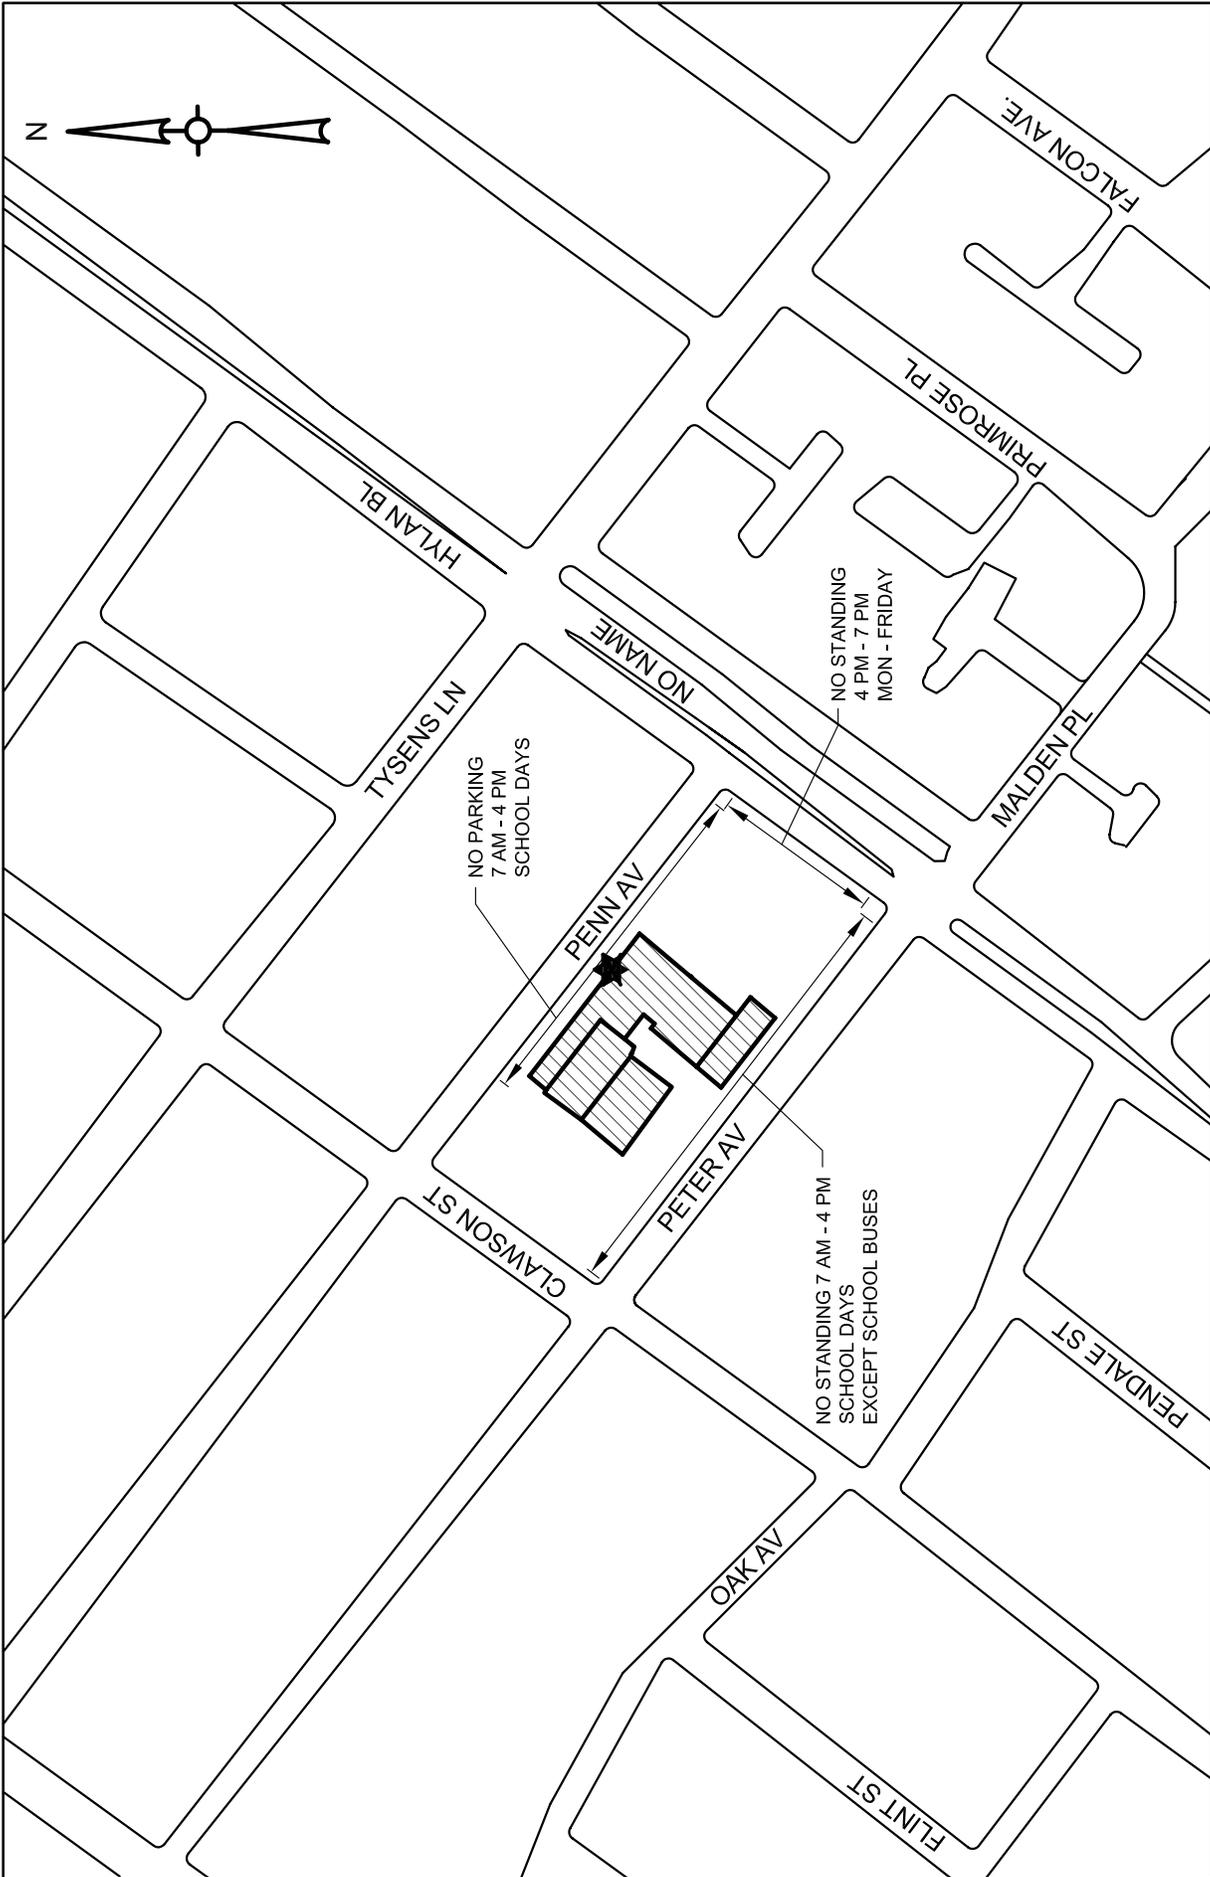
EXHIBIT 4
 ST. CHARLES SCHOOL
 STATEN ISLAND
 EXISTING PARKING REGULATIONS

Parking regulations around the school are shown in Exhibit 4 at the end of this section.

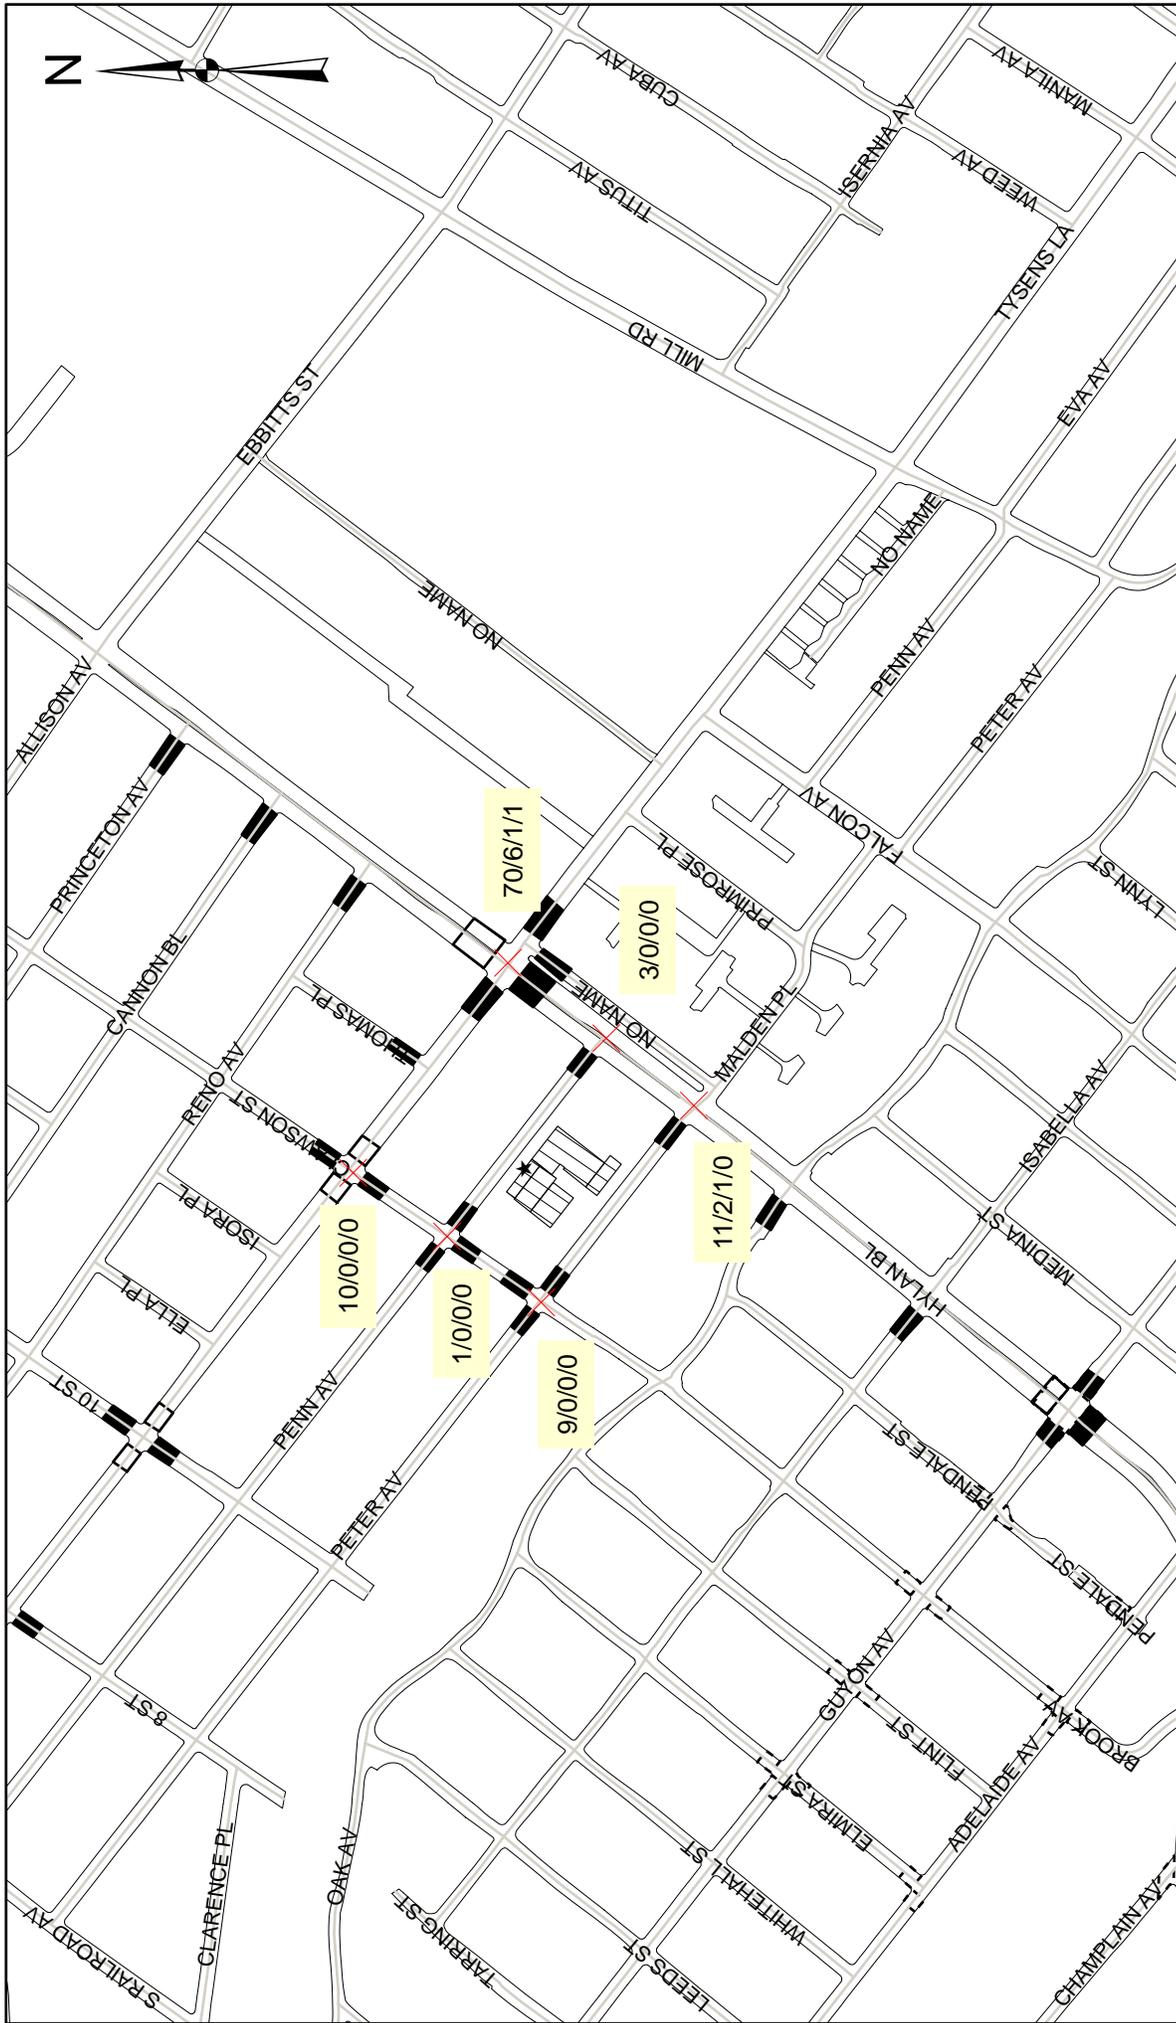
EXHIBIT 5
ST. CHARLES SCHOOL
STATEN ISLAND
ACCIDENT SUMMARY (1998-2000)

Exhibit 5, at the end of this section, and Table 2 show a summary of accidents, as obtained from the New York State Department of Motor Vehicles (NYS DMV) in the vicinity of Saint Charles School for a three-year period from January 1, 1998 through December 1, 2000. The NYS DMV data provides some detail relating to the cause of an accident. Table 3 is a summary of more recent accident data obtained from the New York City Police Department (NYPD). Though current through 2004, the NYPD data does not provide the same level of detail as the NYS DMV data.
