**New York City Department of Transportation
Office of School Safety Engineering**

School Safety Engineering Project

FINAL REPORT: St. Charles School, Staten Island

**Prepared by
The RBA Group/Urbitran Associates**

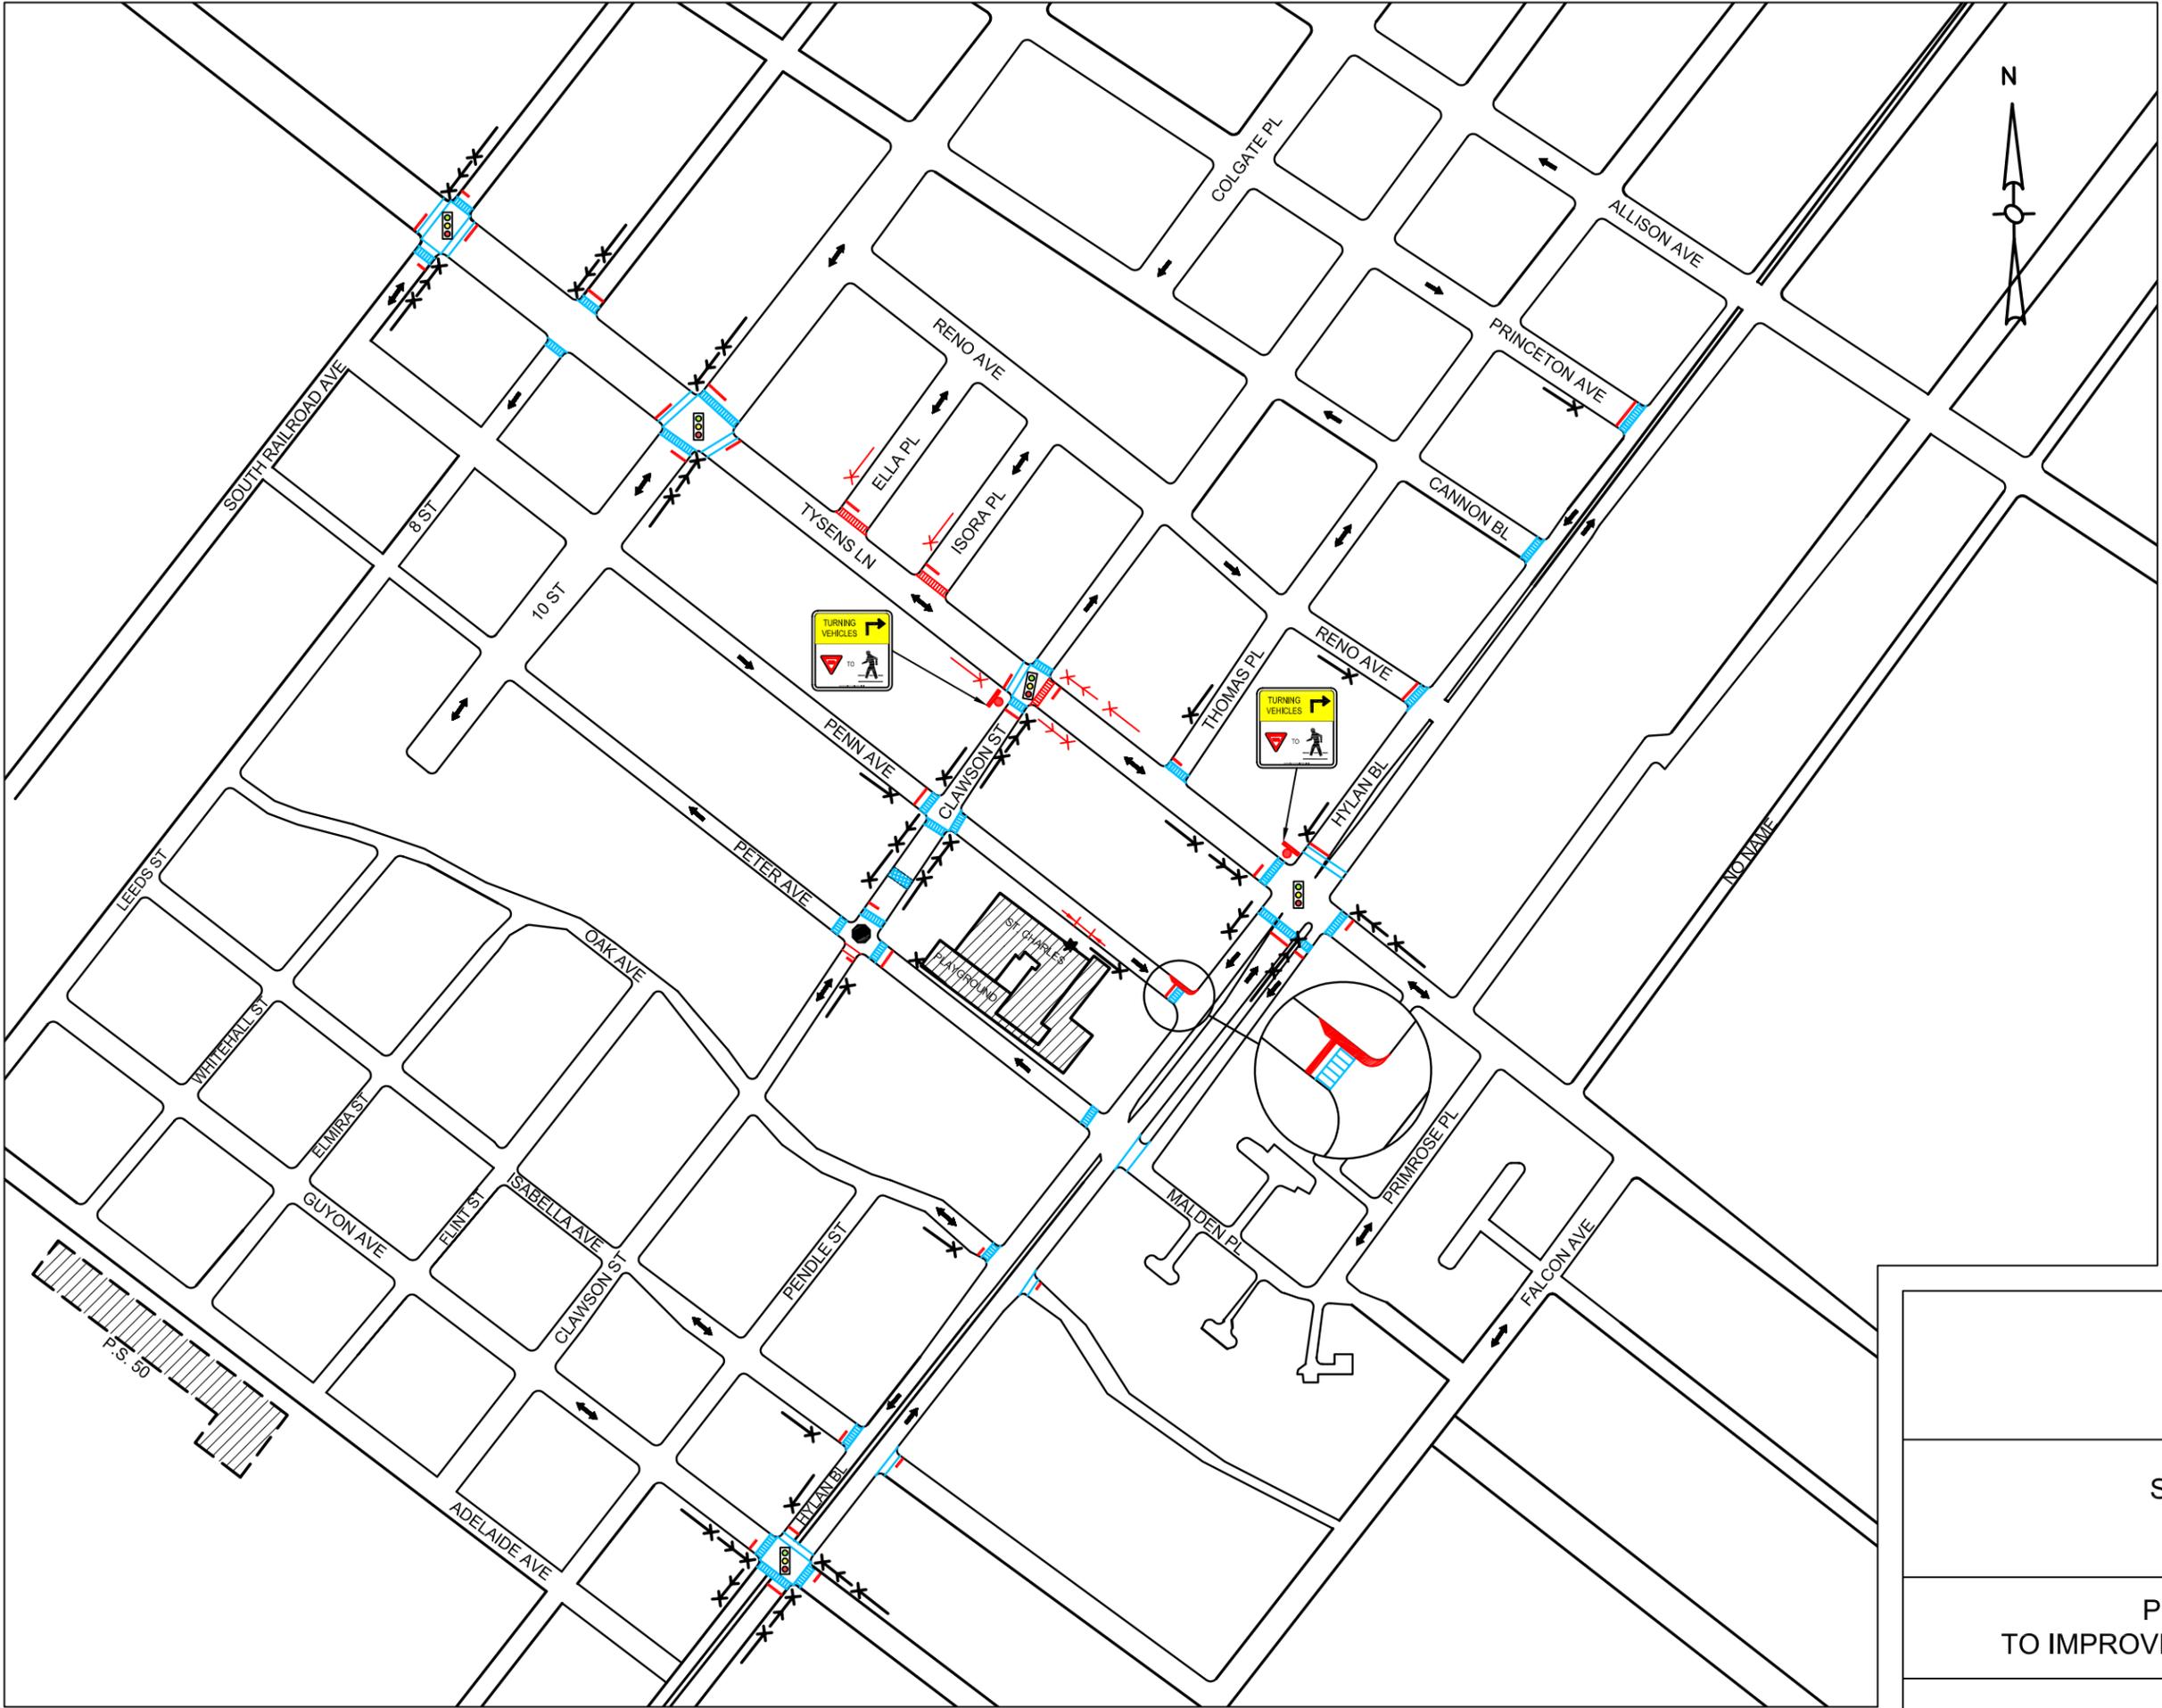
EXHIBIT 6

This section describes the proposed measures to improve student pedestrian safety around Saint Charles School. The proposed recommendations are divided into short-term and long-term measures. Short-term measures are those that potentially can be performed in-house. Long-term measures involve capital improvements. Each of the short- and long-term measures recommended for Saint Charles School is discussed as follows, and is shown in more detail in Exhibit 6 at the end of this section.

**PROPOSED MEASURES
TO IMPROVE SCHOOL PEDESTRIAN SAFETY**

- Provide curb extension at the northwest corner of Penn Avenue at its intersection with Hylan Boulevard, as shown in Exhibit 6. In addition, provide “No Right Turn” sign for southbound vehicles approaching at Penn Avenue.
