Queens Boulevard at Broadway

Purpose

- Provide safer pedestrian crossings and enhance overall safety
- Improve traffic operations

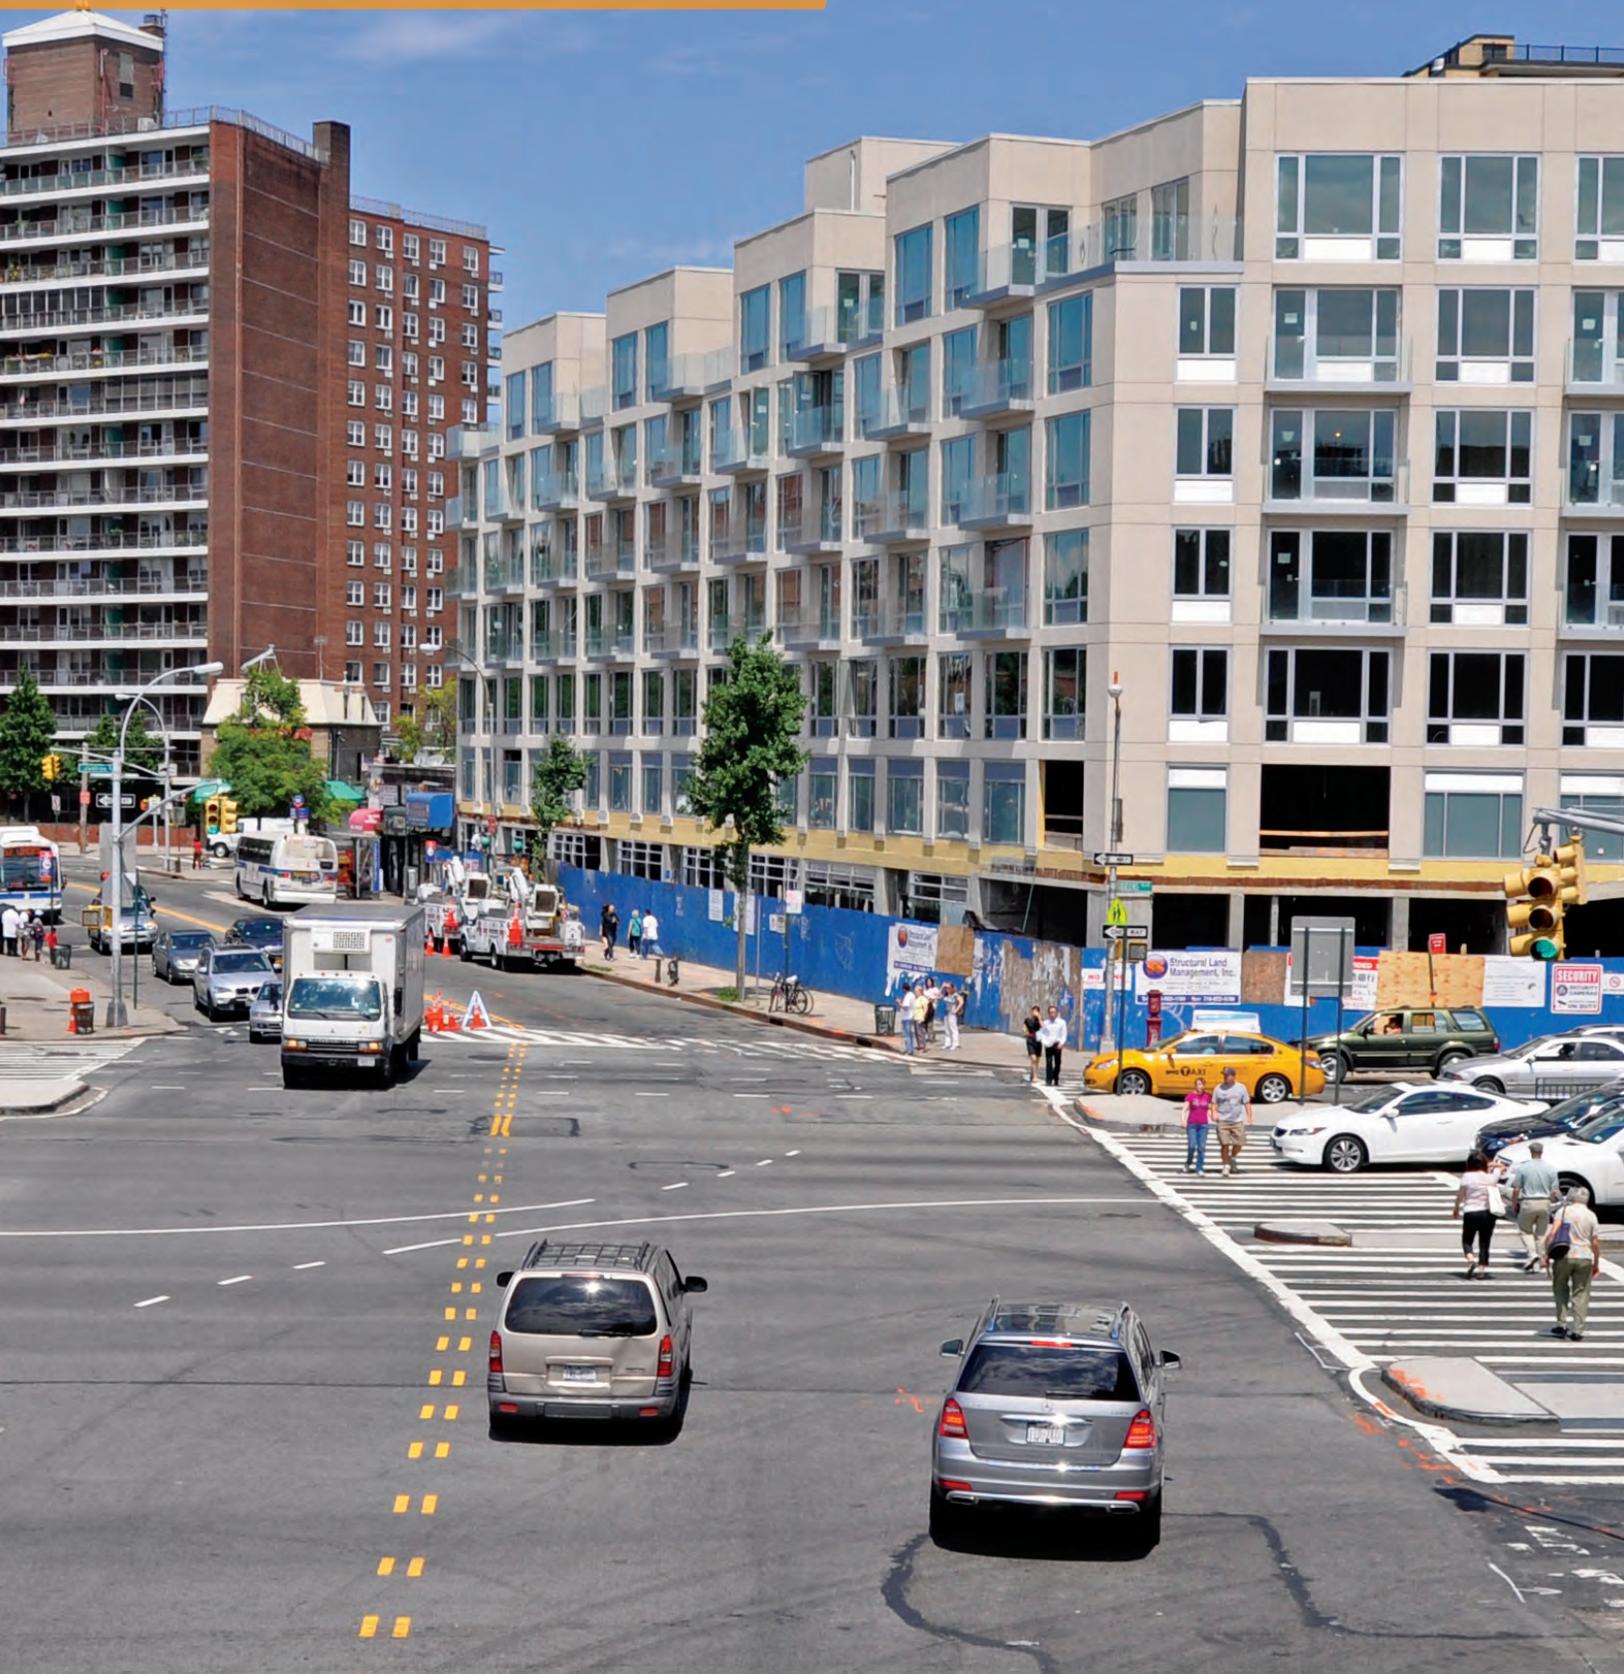
- Extended all six medians at the intersection to improve pedestrian safety
- Widened three service road medians to improve safety by slowing turning vehicles
- Retimed signals at the intersection to give pedestrians more time to cross the street
- Removed parking on the westbound service road to enable vehicles to make safer turns
- Aligned north crosswalk with new extensions

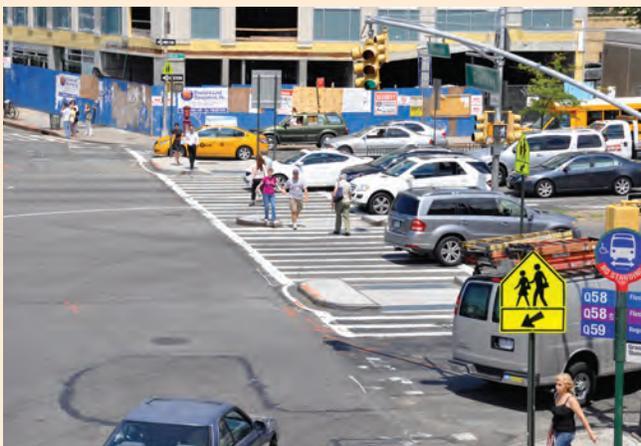
Extending and widening the median tips at Queens Boulevard and Broadway reduced crossing distance for pedestrians.

traffic and improve safety, DOT extended all six medians at the intersection to offer pedestrians who cannot make it across the nearly 200-foot roadway a safe refuge. DOT widened three service road medians, two in the west crosswalk and one in the east crosswalk, to improve safety by slowing turning vehicles. Traffic signals were retimed at the intersection to give pedestrians more time to cross the street. On the north crosswalk, DOT aligned crosswalks with the new extensions.

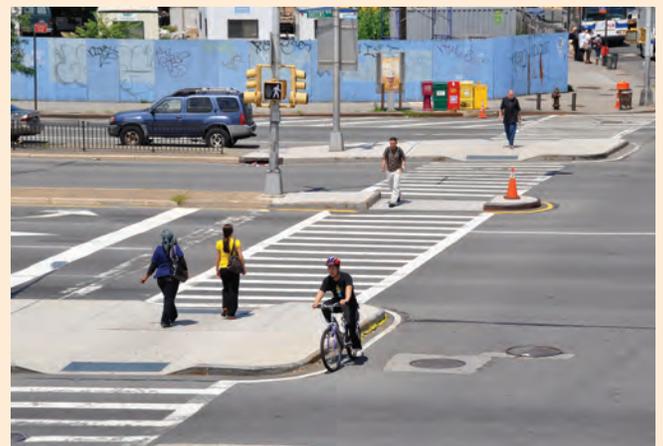
DOT increased pedestrian walk time to cross Queens Boulevard at Broadway to help pedestrians safely cross the wide street.
