43 WEST 27TH ST · COVER

SCALE Not To Scale  
CLIENT 43 WEST 27TH - ICON  
PROJECT NUMBER 14.30  
DATE March 1, 2015

NON-HISTORIC DOUBLE-HUNG WINDOWS TO BE REPLACED

43 WEST 27TH ST · SOUTH FACADE HISTORIC WINDOW AND OPENING PHOTOS

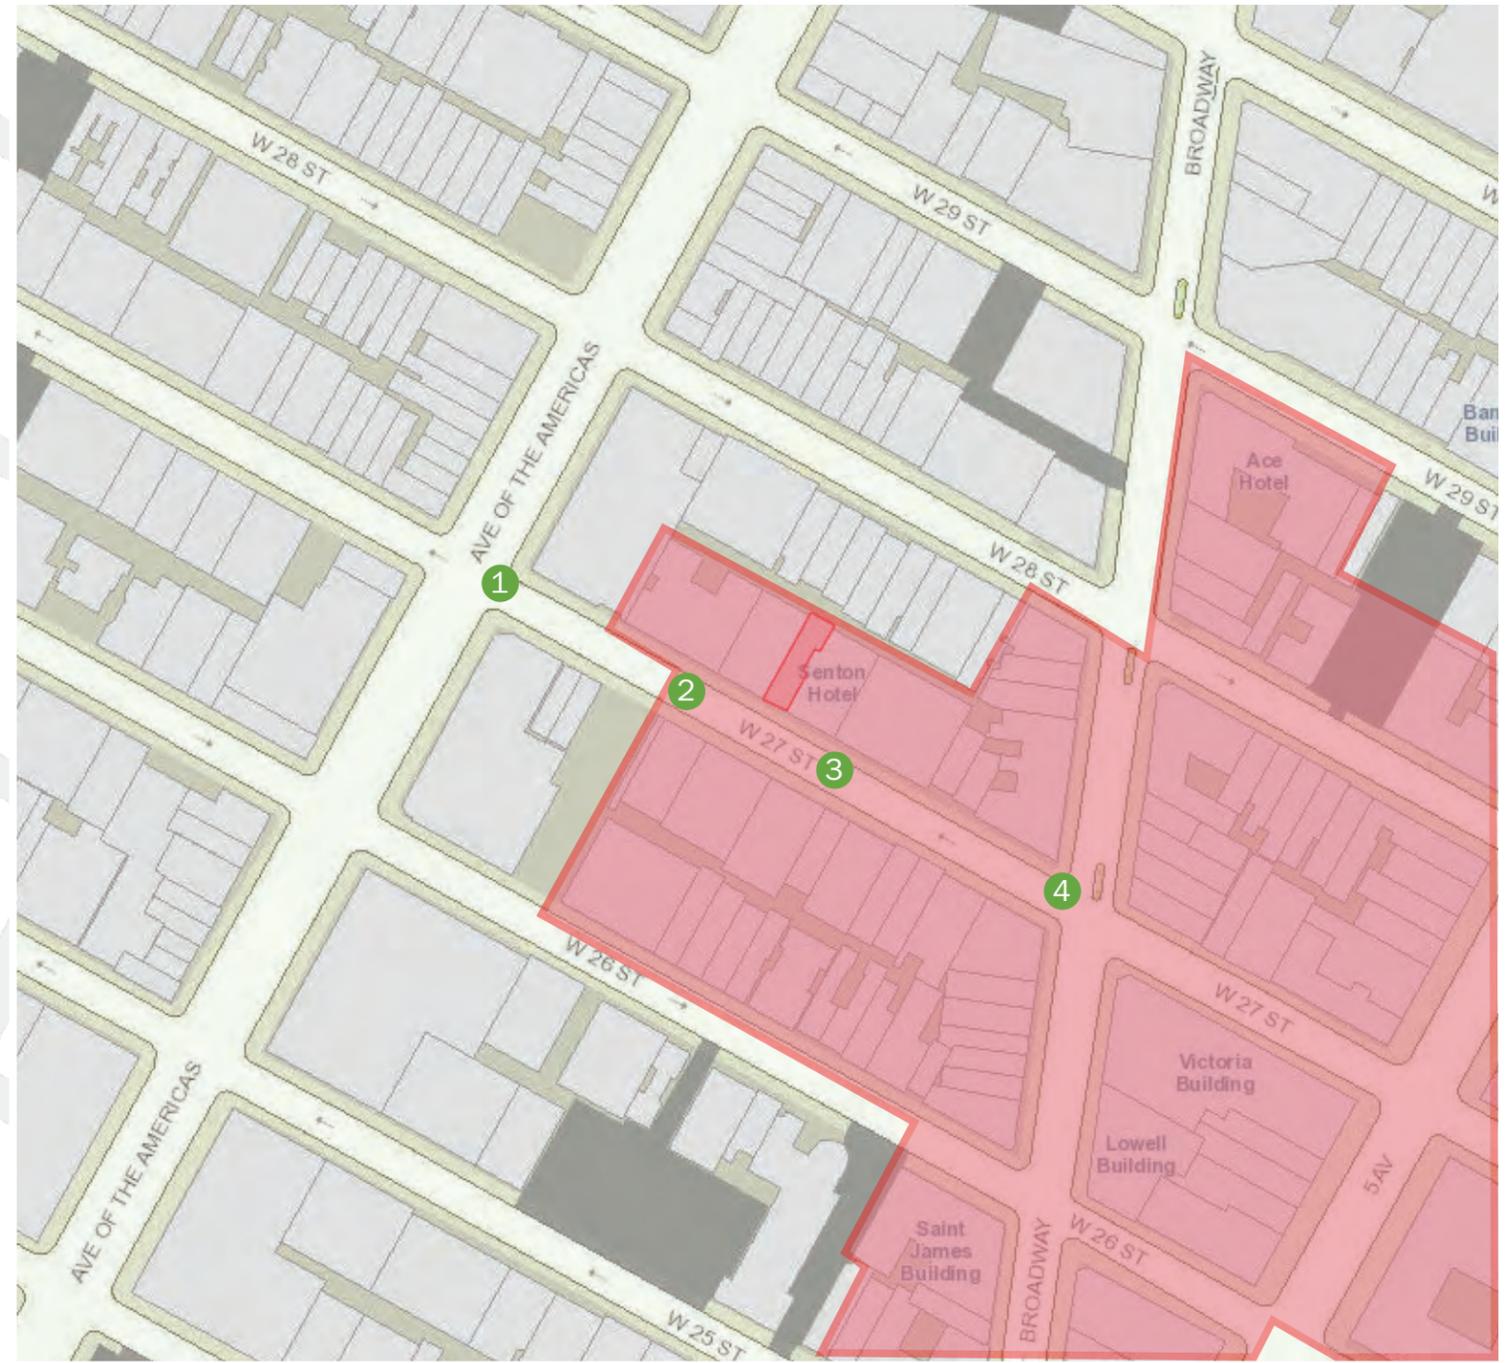
SITE PLAN: Window Replacement Visibility Study Views

- # NOT VISIBLE
- # MODERATELY VISIBLE (FRONT ONLY)
- # MINIMALLY VISIBLE (PARTIAL BACK ONLY)

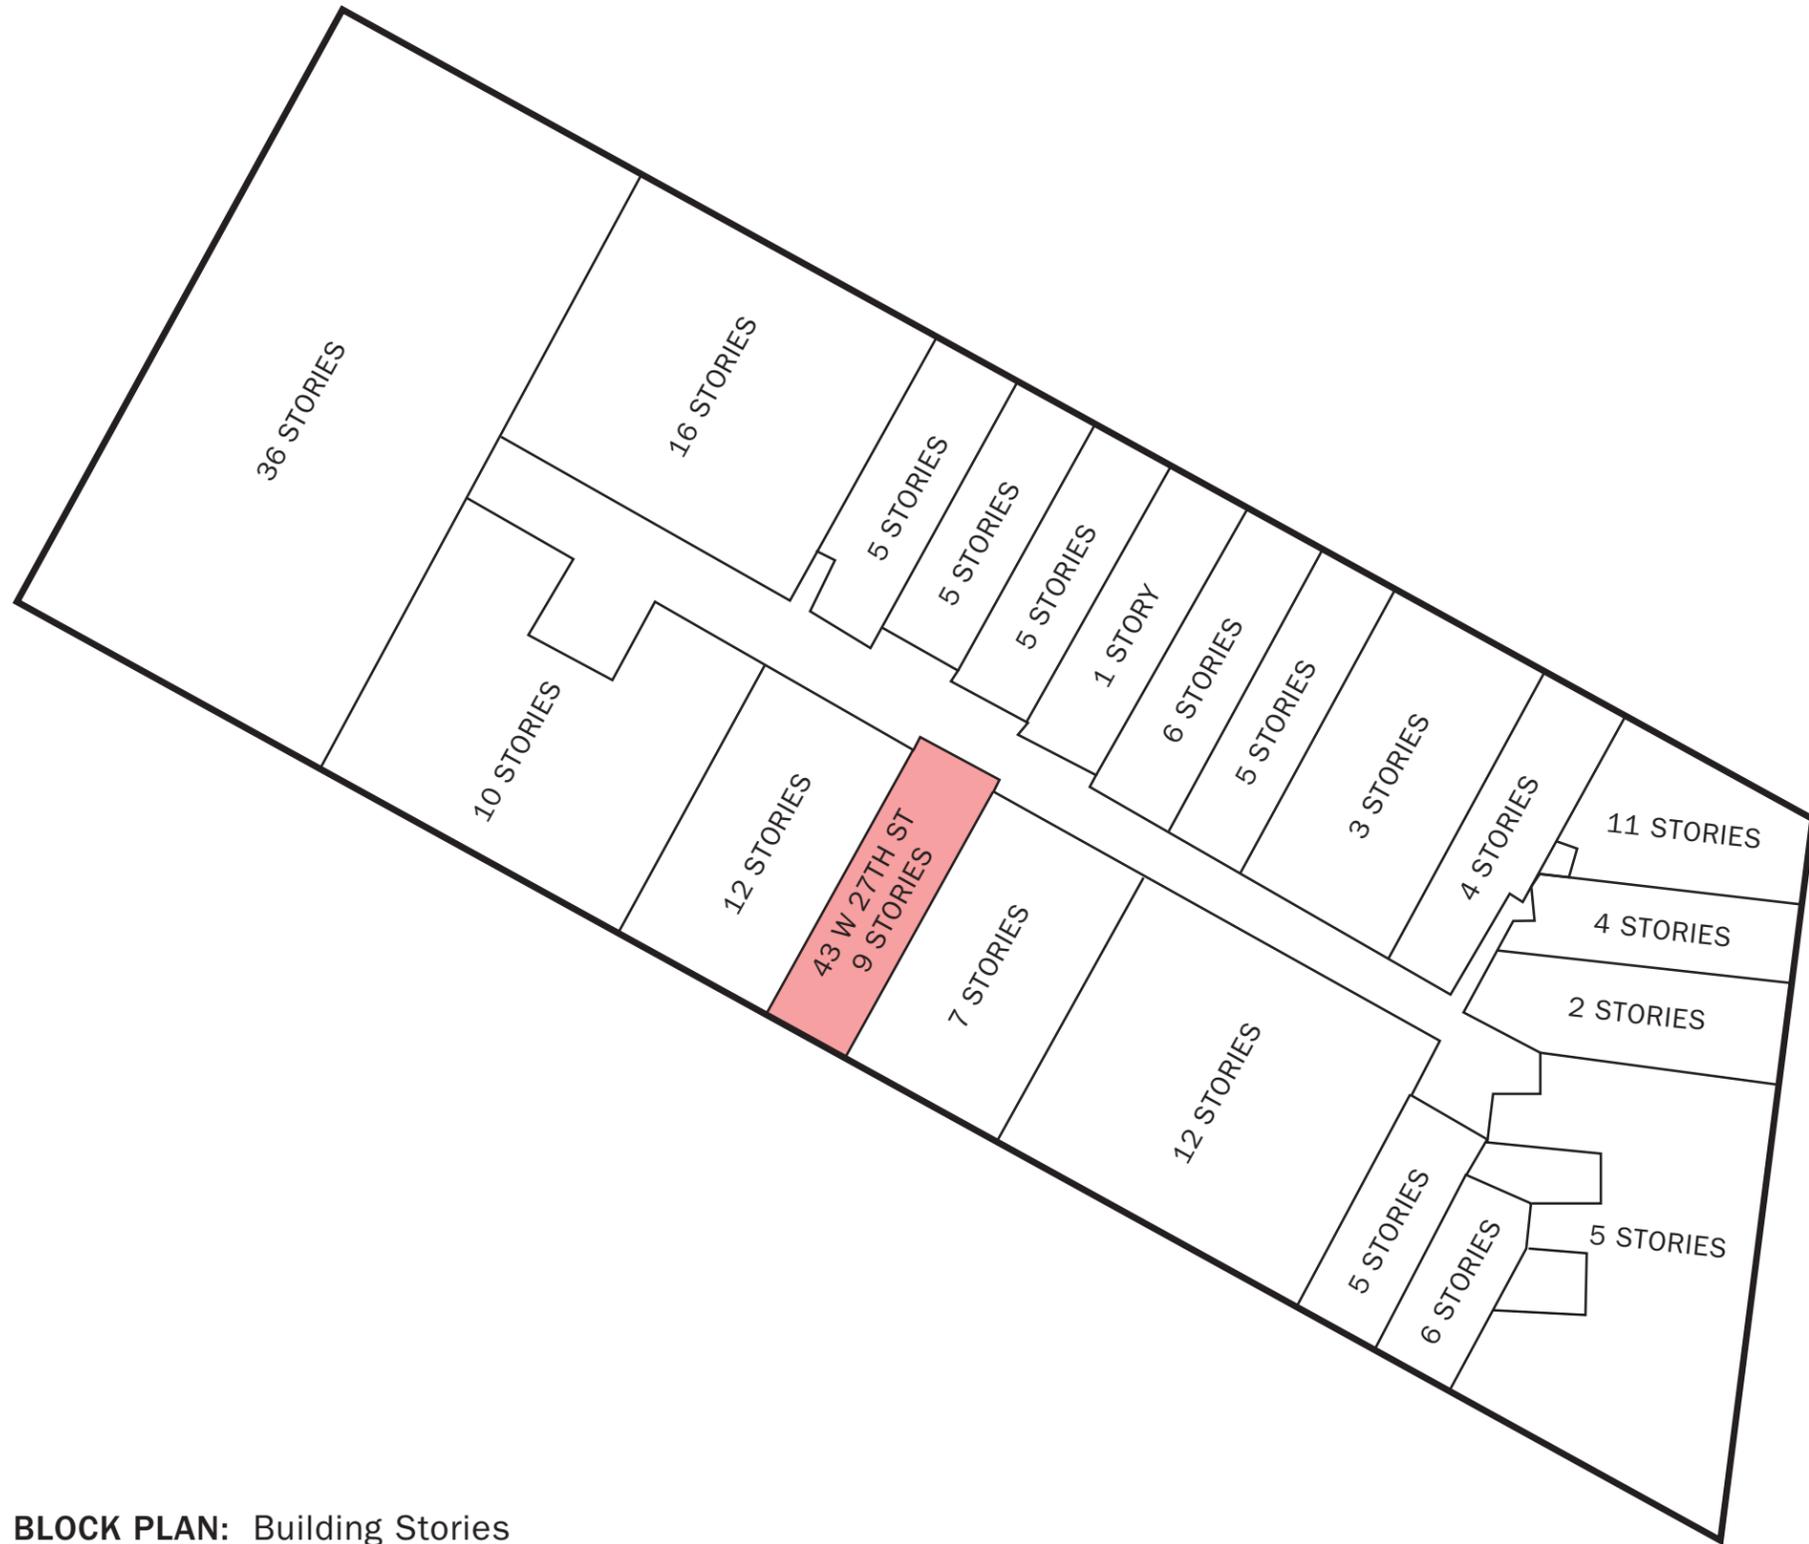
**BLOCK PLAN:** Building Stories

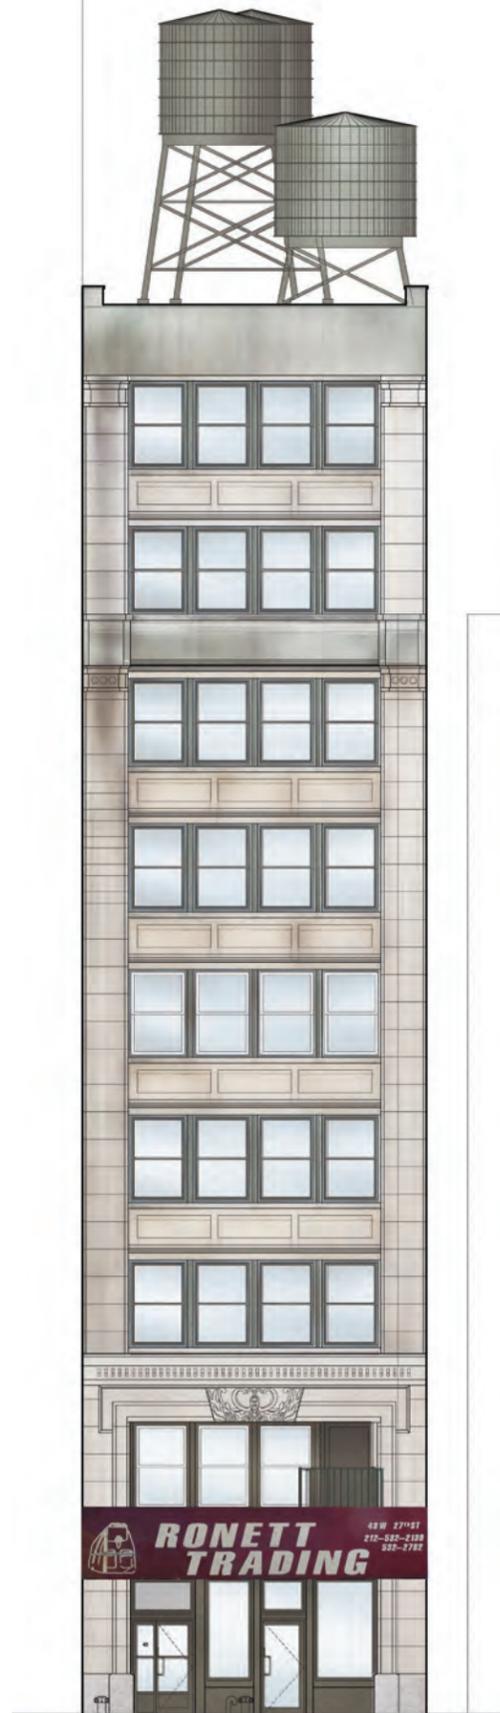
EXISTING

43 WEST 27TH ST · COMPARATIVE SOUTH ELEVATIONS

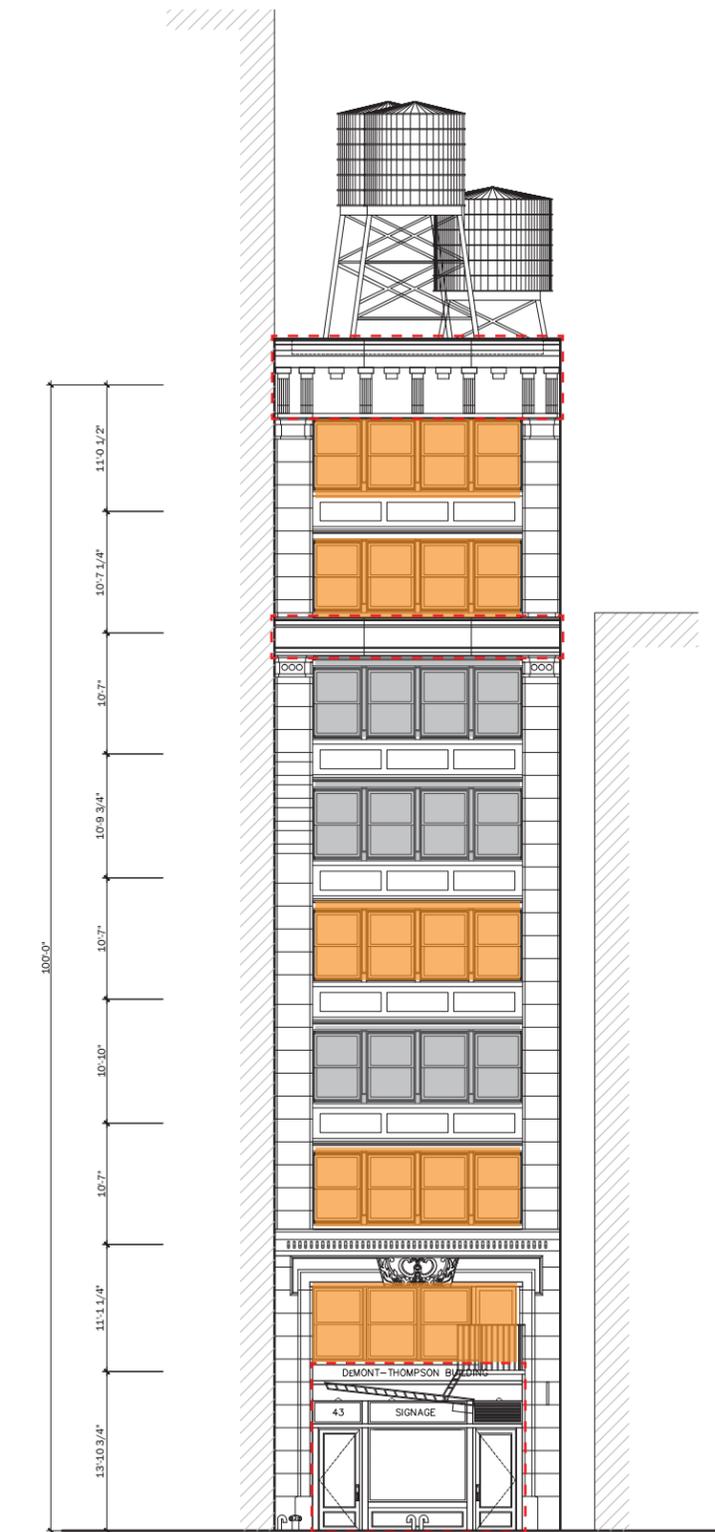
STOREFRONT, CORNICE AND WATER TABLE RESTORATION UNDER LPC APPLICATION LP16-7940

EXISTING TO BE RESTORED

43 WEST 27TH ST · ELEVATION WINDOW DIAGRAM

EXISTING HISTORIC  
WINDOWS  
(7TH FLOOR)

EXISTING HISTORIC  
WINDOWS  
(6TH FLOOR)

EXISTING NON-HISTORIC  
WINDOWS  
(5TH FLOOR)

EXISTING HISTORIC  
WINDOWS  
(4TH FLOOR)

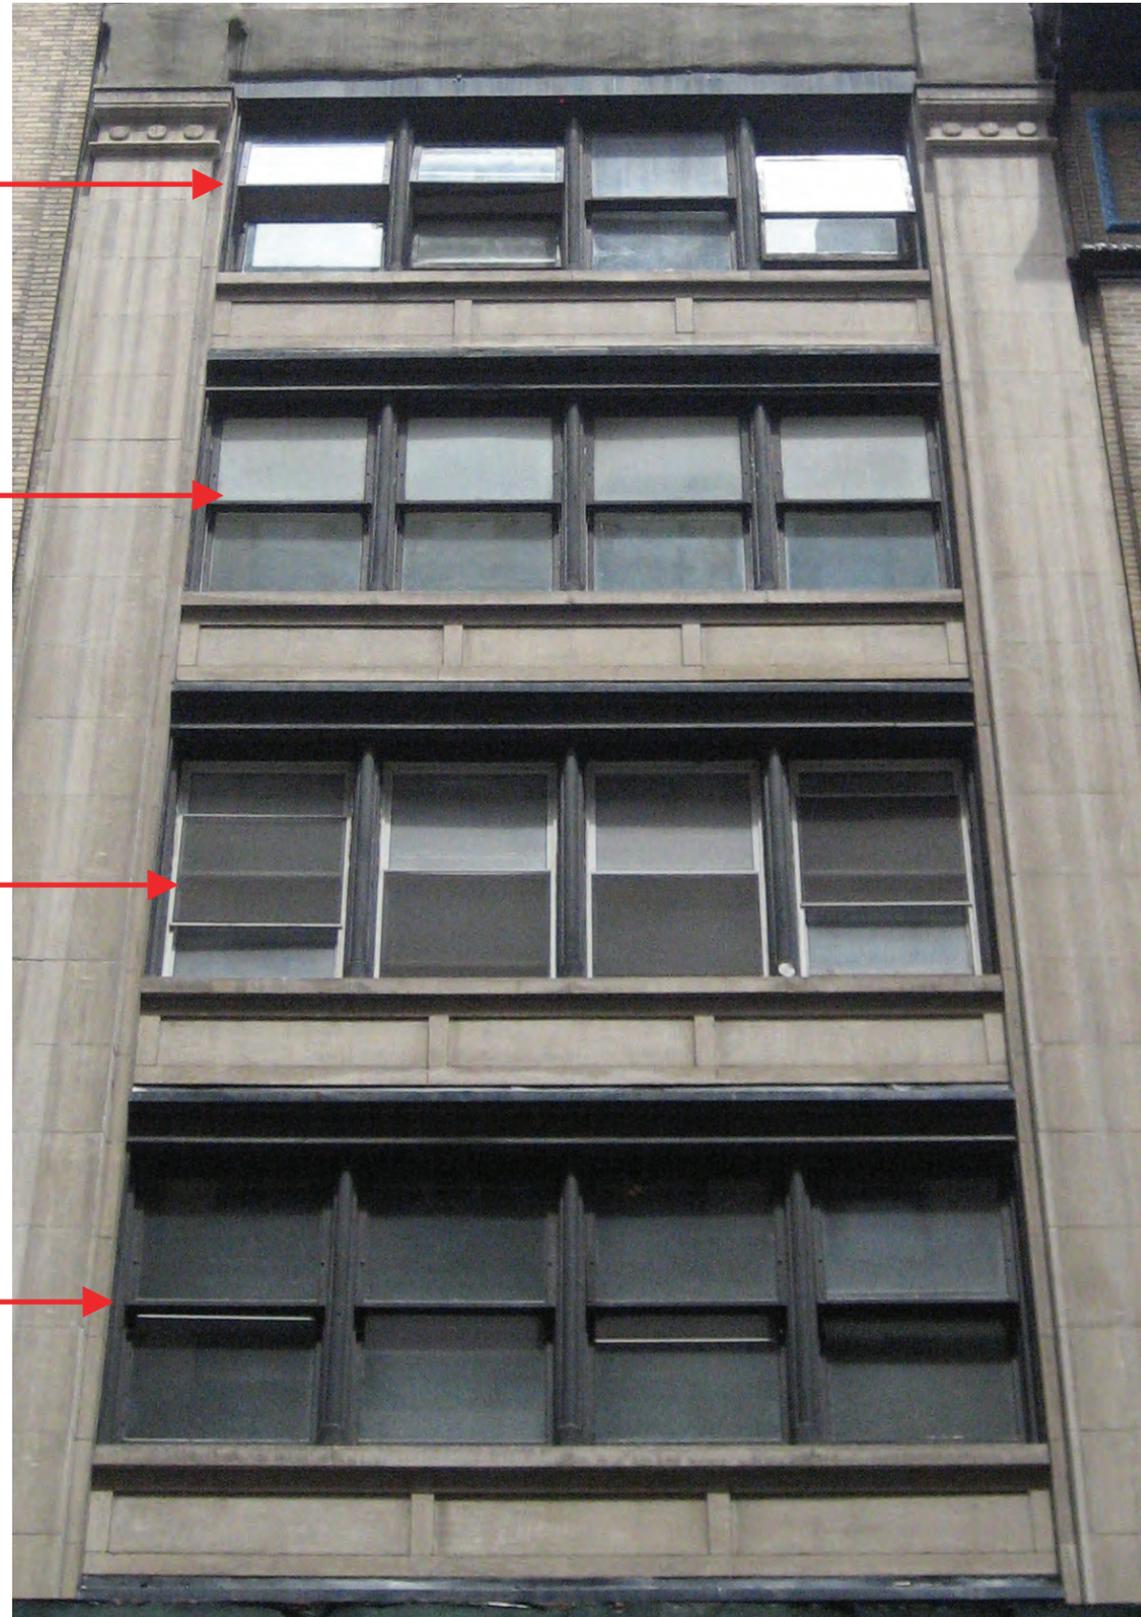
PHOTO - HISTORIC AND NON-HISTORIC WINDOW CLOSE-UPS

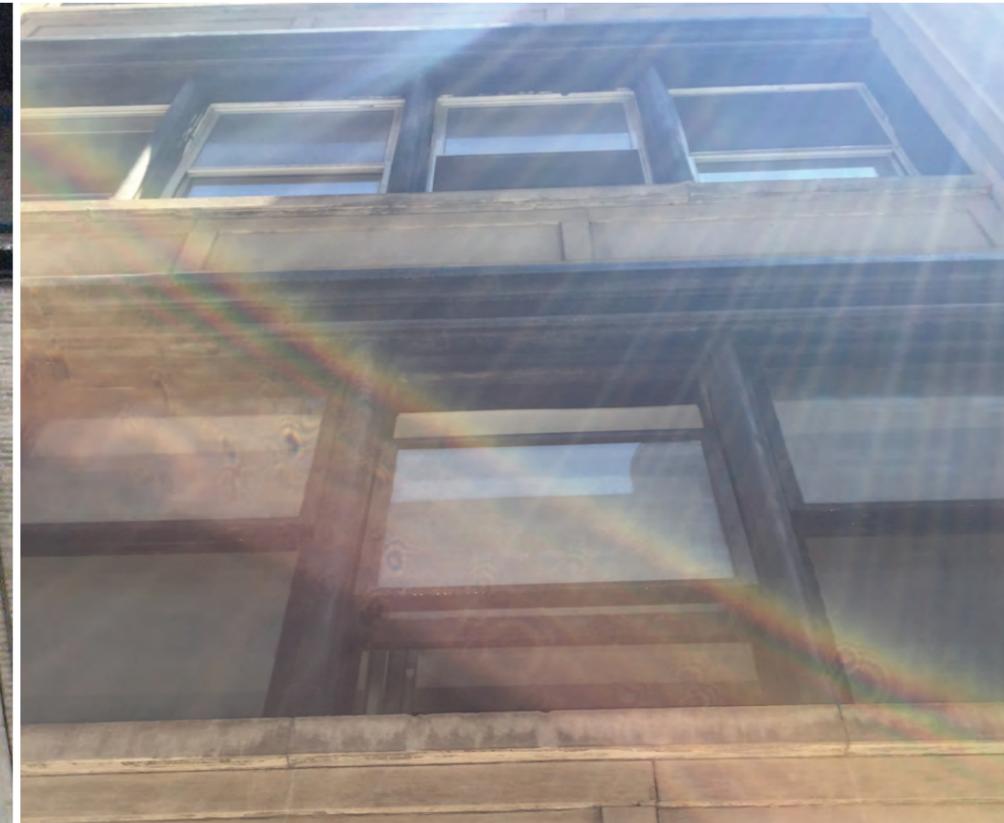
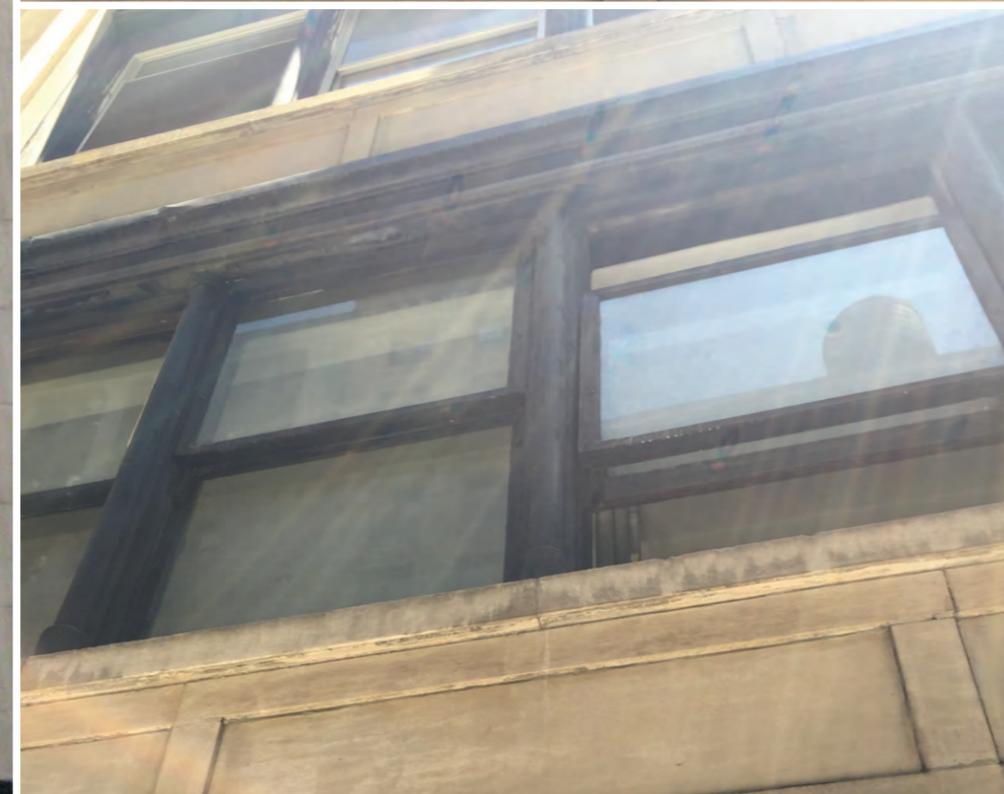
DETAIL PHOTOS - HISTORIC WINDOW CLOSE-UPS (4TH FLOOR)

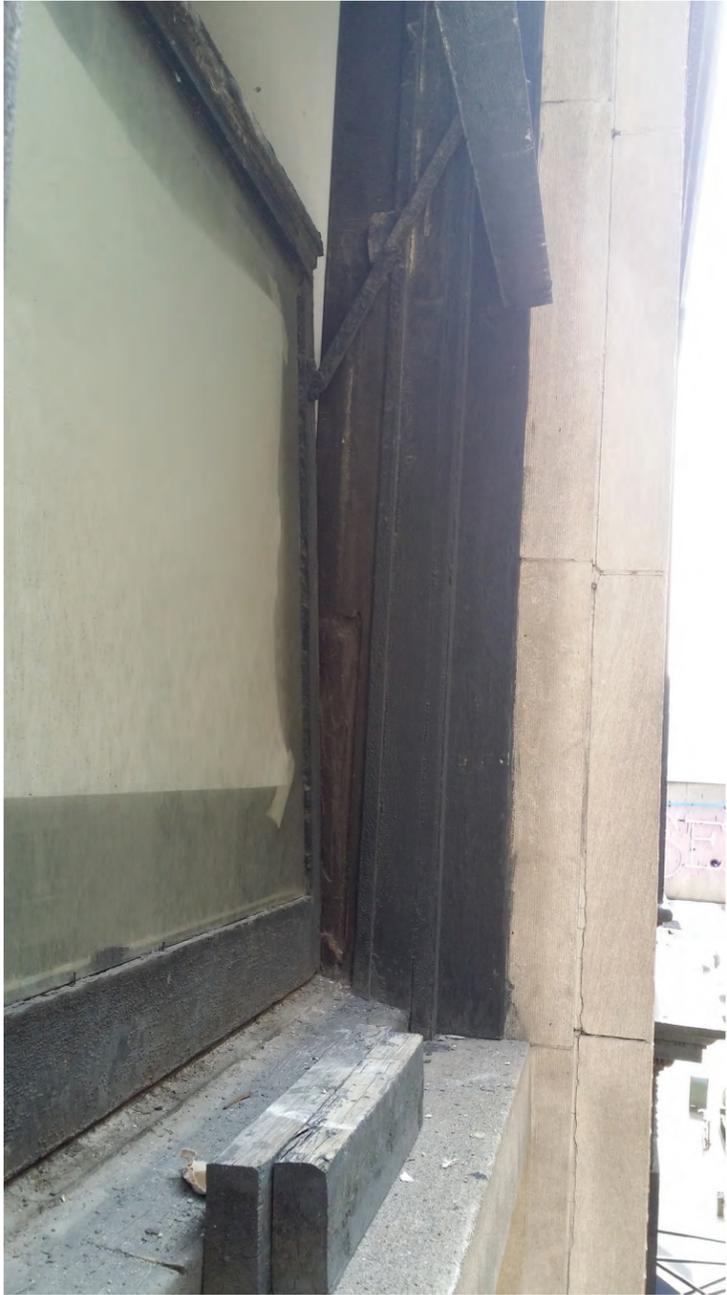
JAMB AND SILL DETAIL PHOTO

**NOTE: PROPOSED REPLACEMENT WINDOWS ARE TO MATCH THE DIMENSIONS AND FINISH OF EXISTING HISTORIC WINDOWS. PROPOSAL WILL REFURBISH (12) EXISTING HISTORIC WINDOWS. ALL REPLACEMENT WINDOWS TO REPLACE NON-HISTORIC WINDOWS TO BE DOUBLE HUNG.**

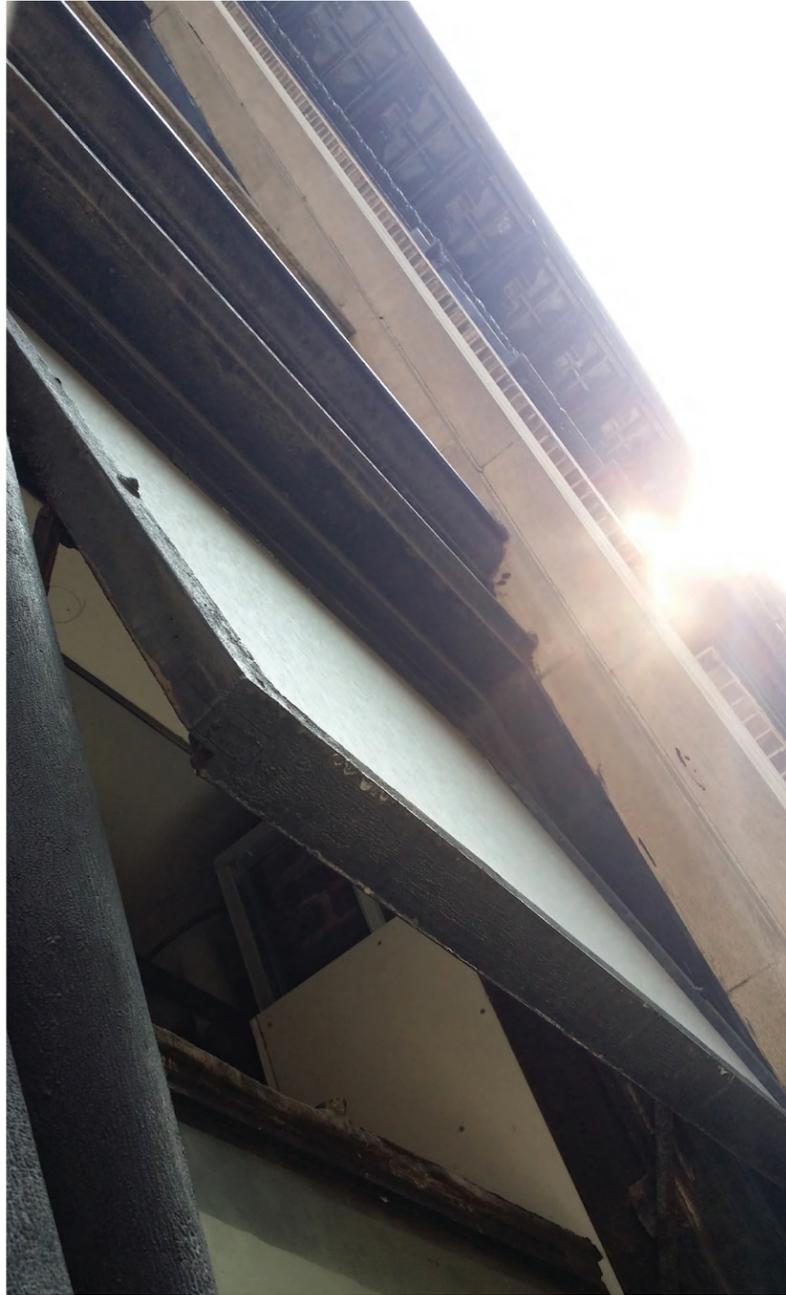
HEADER DETAIL PHOTO

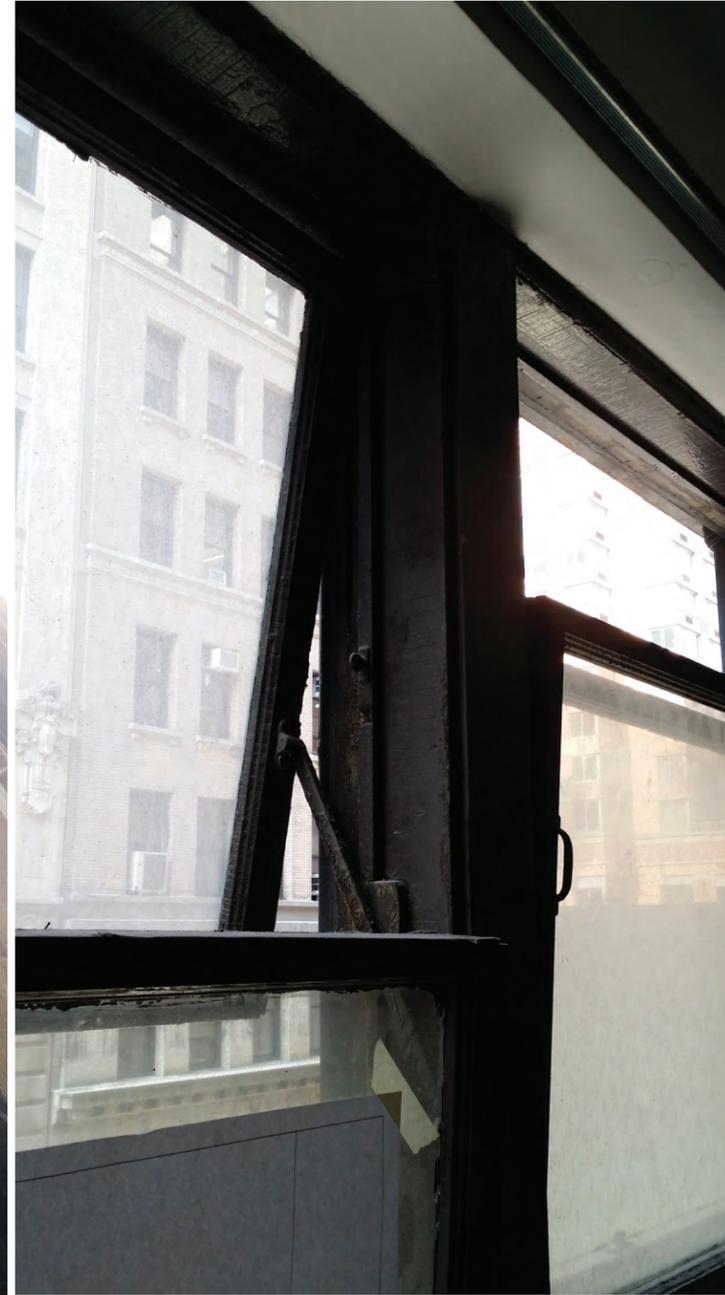
INTERIOR PHOTO SHOWING MECHANISM AND JAMB

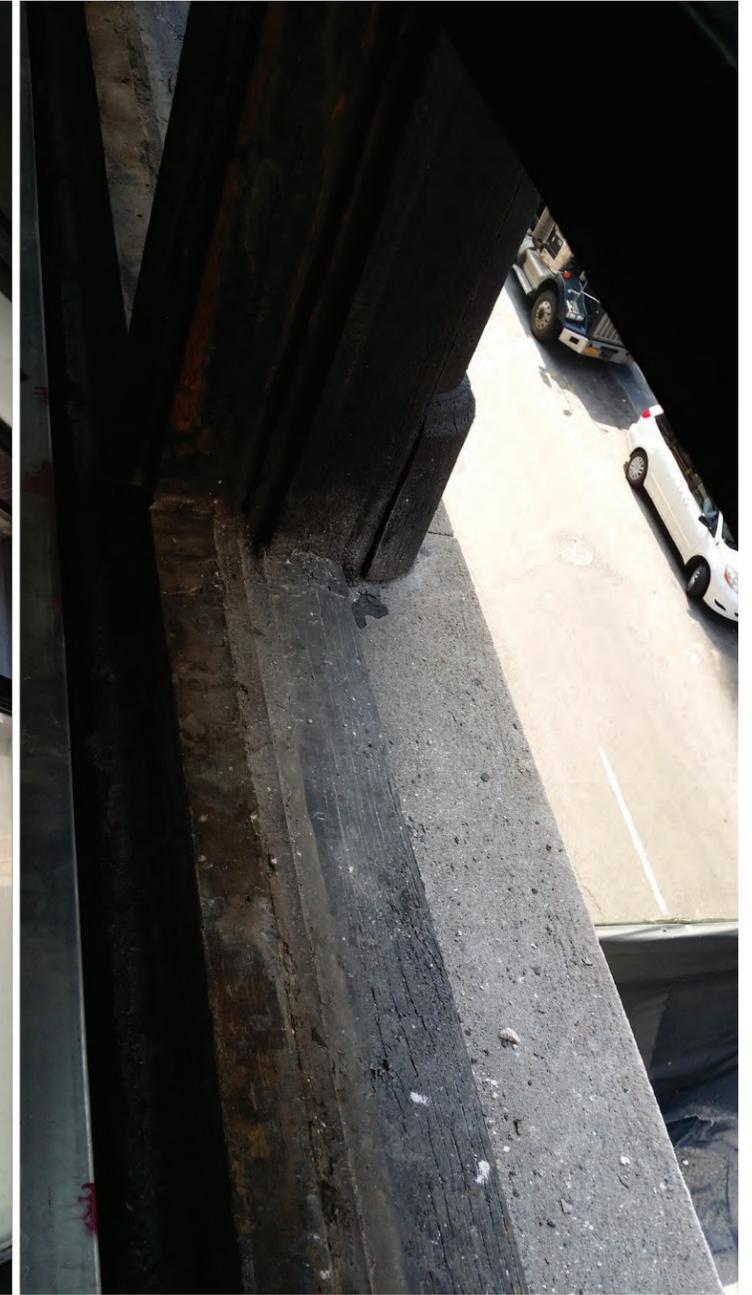
SILL DETAIL PHOTO

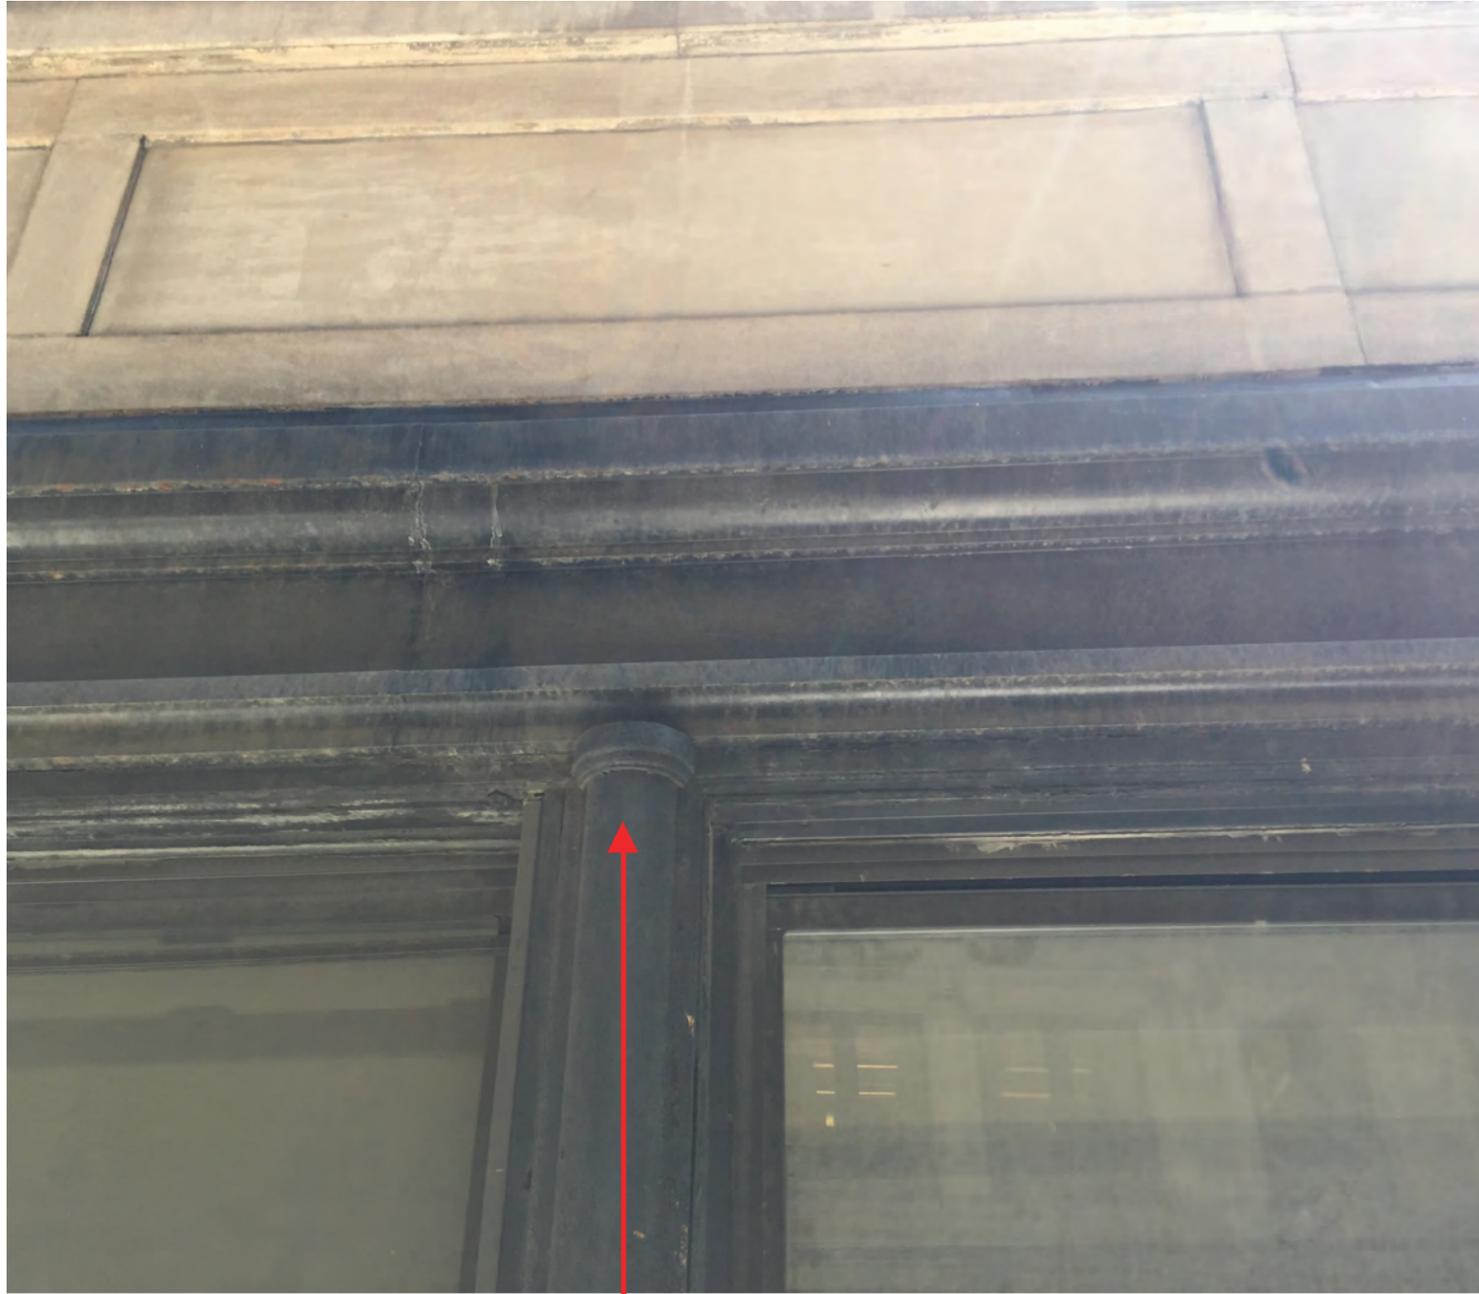
EXISTING HISTORIC MULLION IN POOR CONDITION, STRIP FILL AS NEEDED TO MATCH HISTORIC PROFILE AND DIMENSION, REPAINT

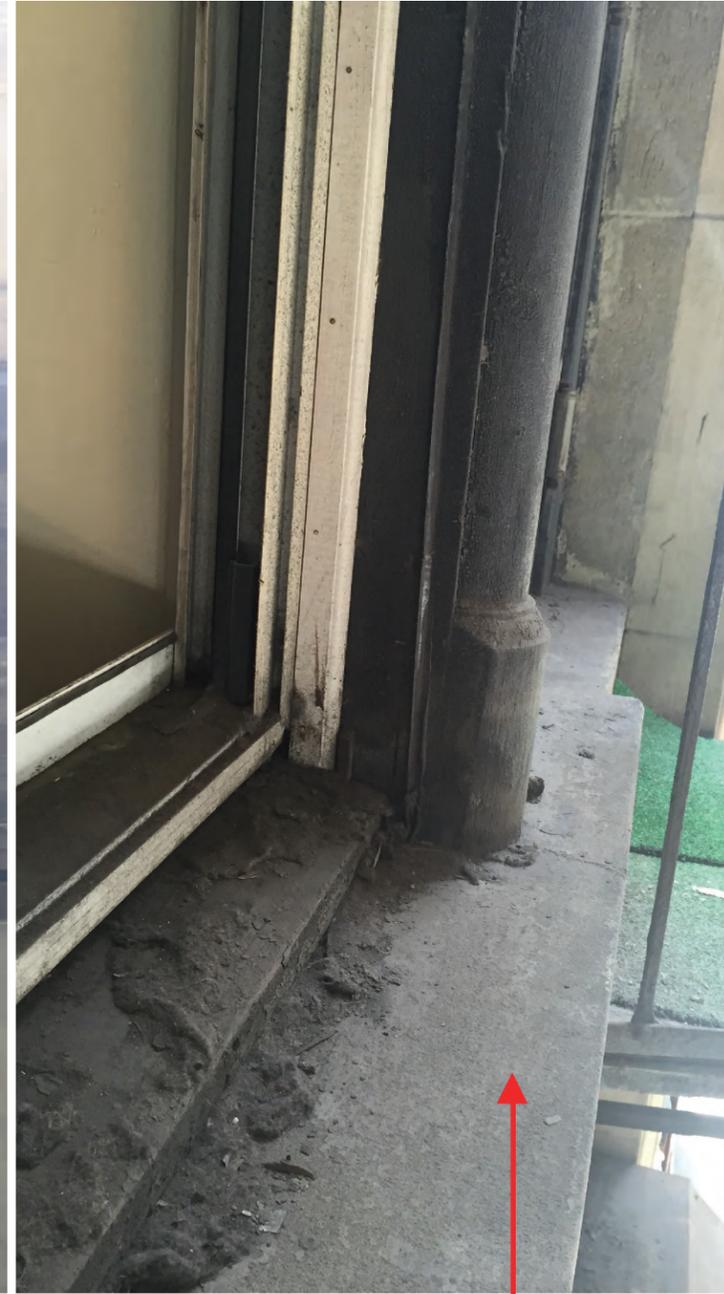
EXISTING HISTORIC SILL IN POOR CONDITION, RESTORE AS NEEDED

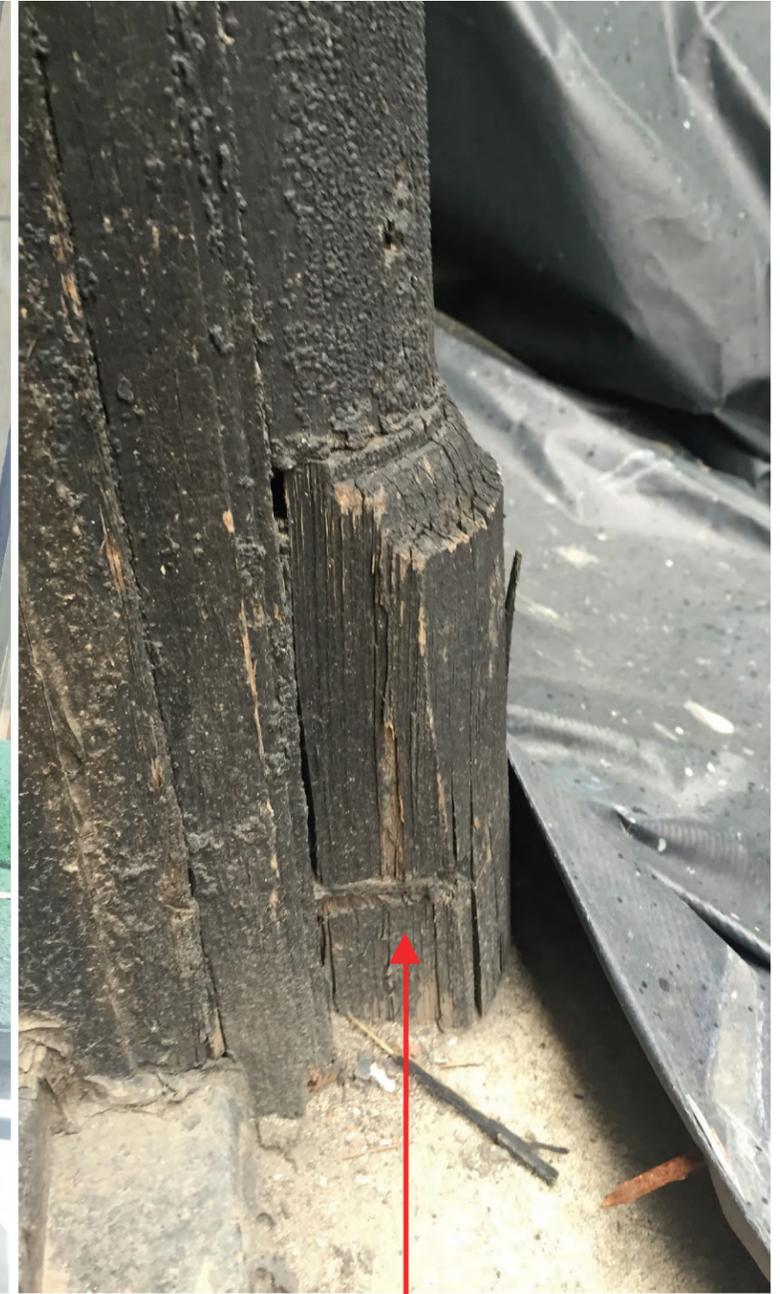
EXISTING HISTORIC MULLION IN POOR CONDITION, STRIP FILL AS NEEDED TO MATCH HISTORIC PROFILE AND DIMENSION, REPAINT

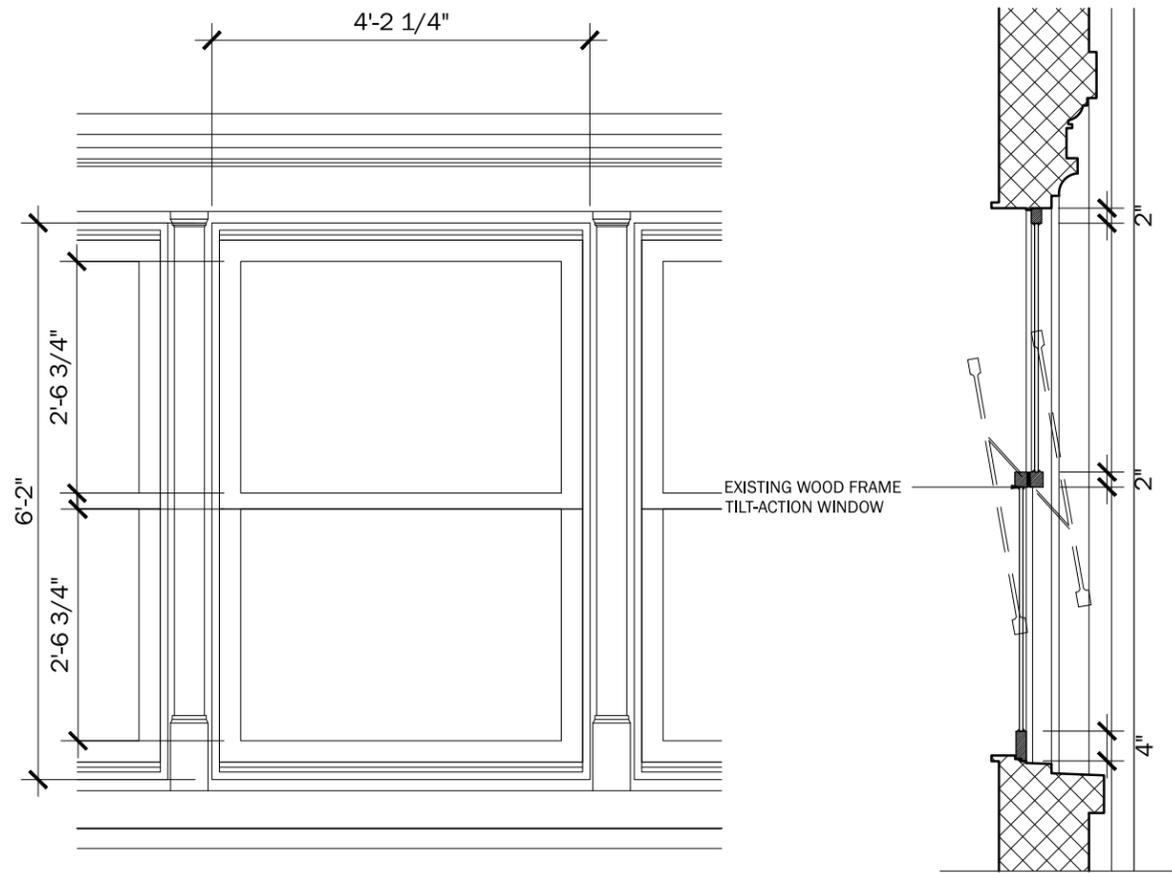
1 EX'G SOUTH HISTORIC WDW ELEVATION 1/2" = 1'-0"  
FLOORS 4, 6, 7

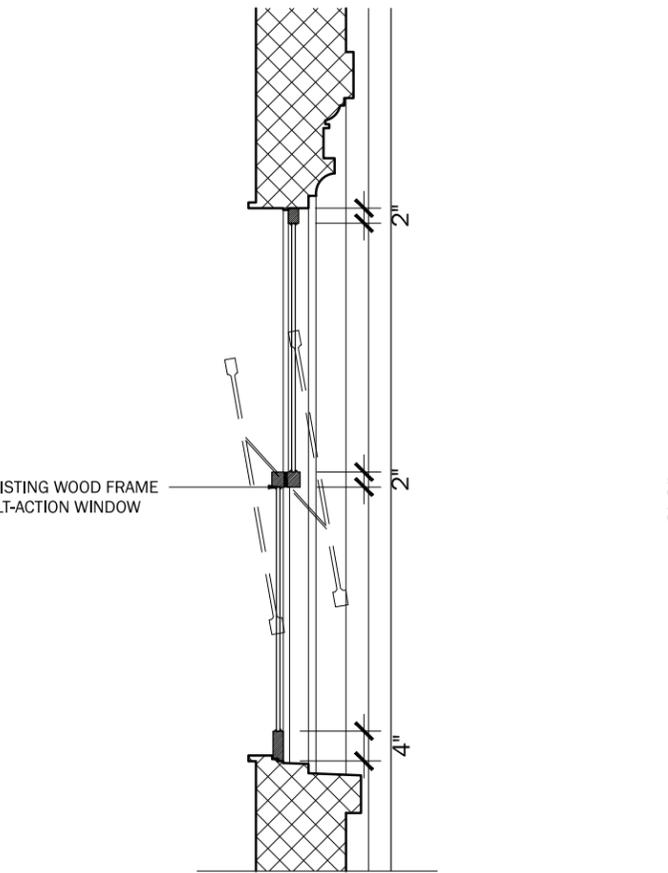
2 EX'G SOUTH HISTORIC WDW VERTICAL SECTION 1/2" = 1'-0"  
FLOORS 4, 6, 7

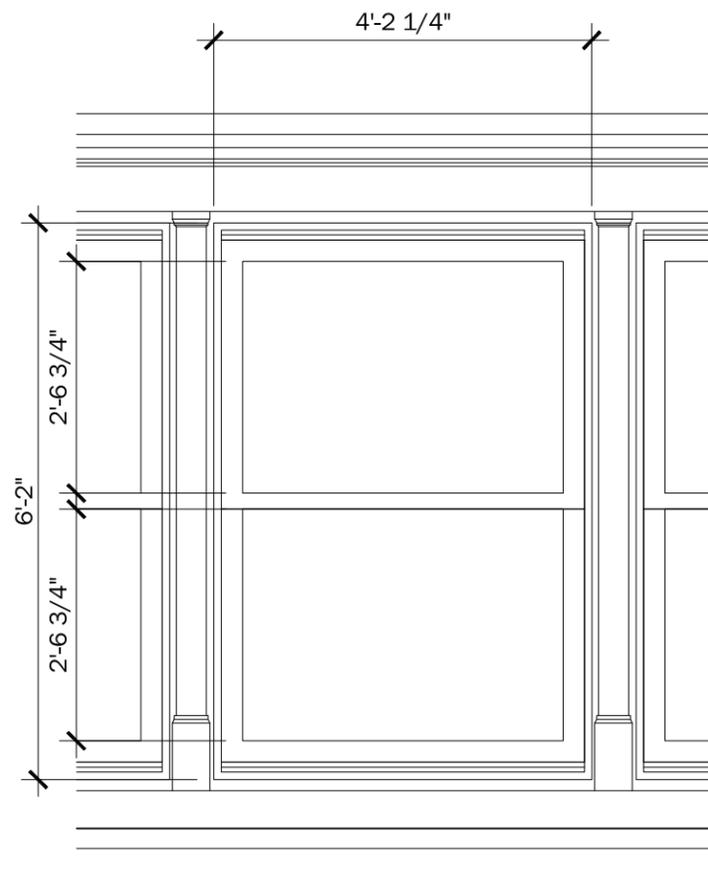
4 PROPOSED SOUTH WDW ELEVATION 1/2" = 1'-0"  
FLOORS 2, 3, 5, 8, 9

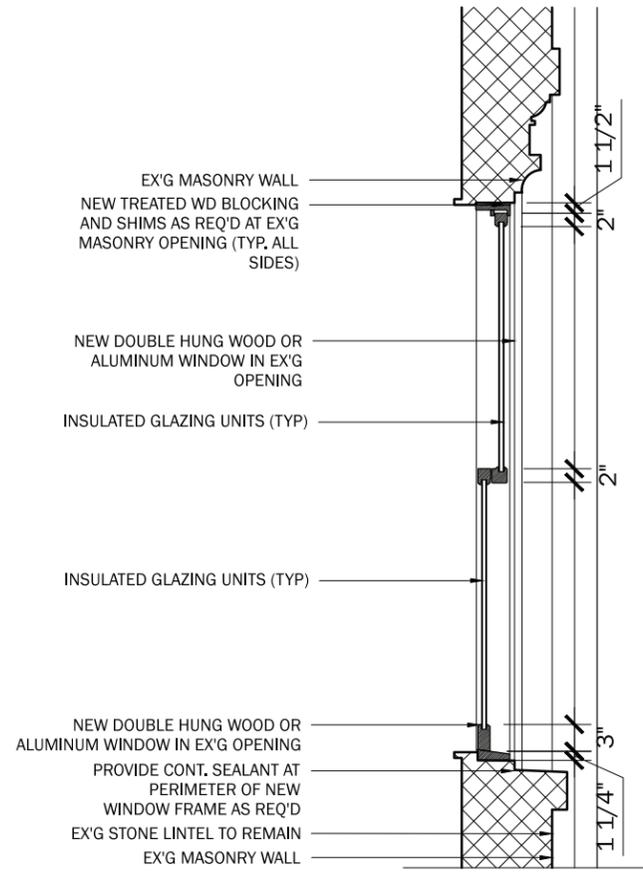
5 PROPOSED SOUTH WDW VERTICAL SECTION 1/2" = 1'-0"  
FLOORS 2, 3, 5, 8, 9

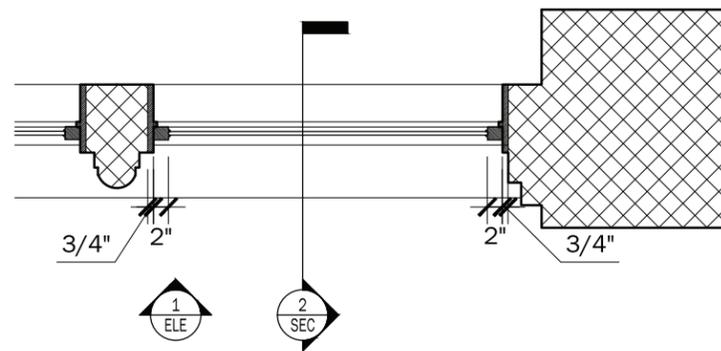
3 EX'G SOUTH HISTORIC WDW HORIZONTAL SECTION 1/2" = 1'-0"  
FLOORS 4, 6, 7

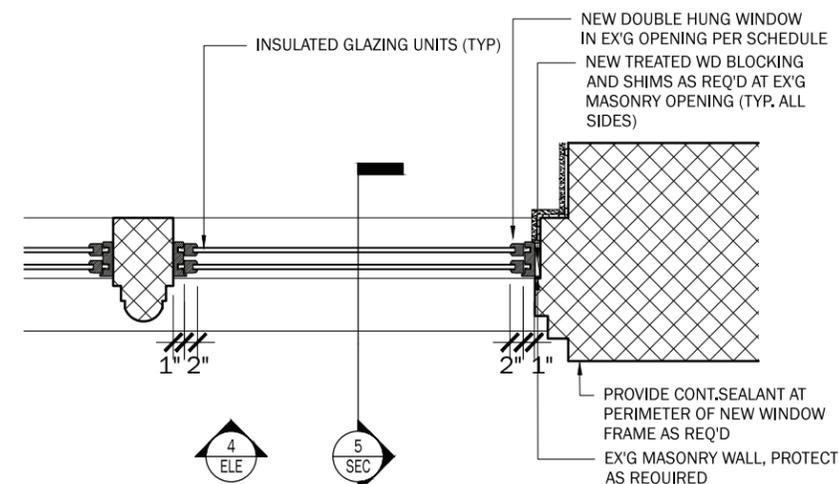
6 PROPOSED SOUTH WDW HORIZONTAL SECTION 1/2" = 1'-0"  
FLOORS 2, 3, 5, 8, 9

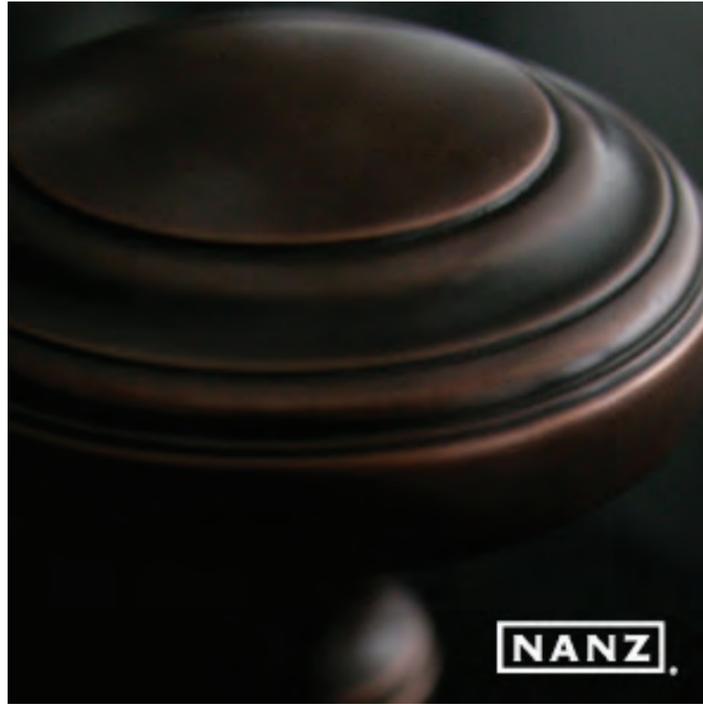
HARDWARE FINISH: ANTIQUE BRONZE
