City Island Historical Society
Application for window
replacement

Application LPC # 17-7631

P. S. 17, 190 Fordham Street, Bronx NY 10464

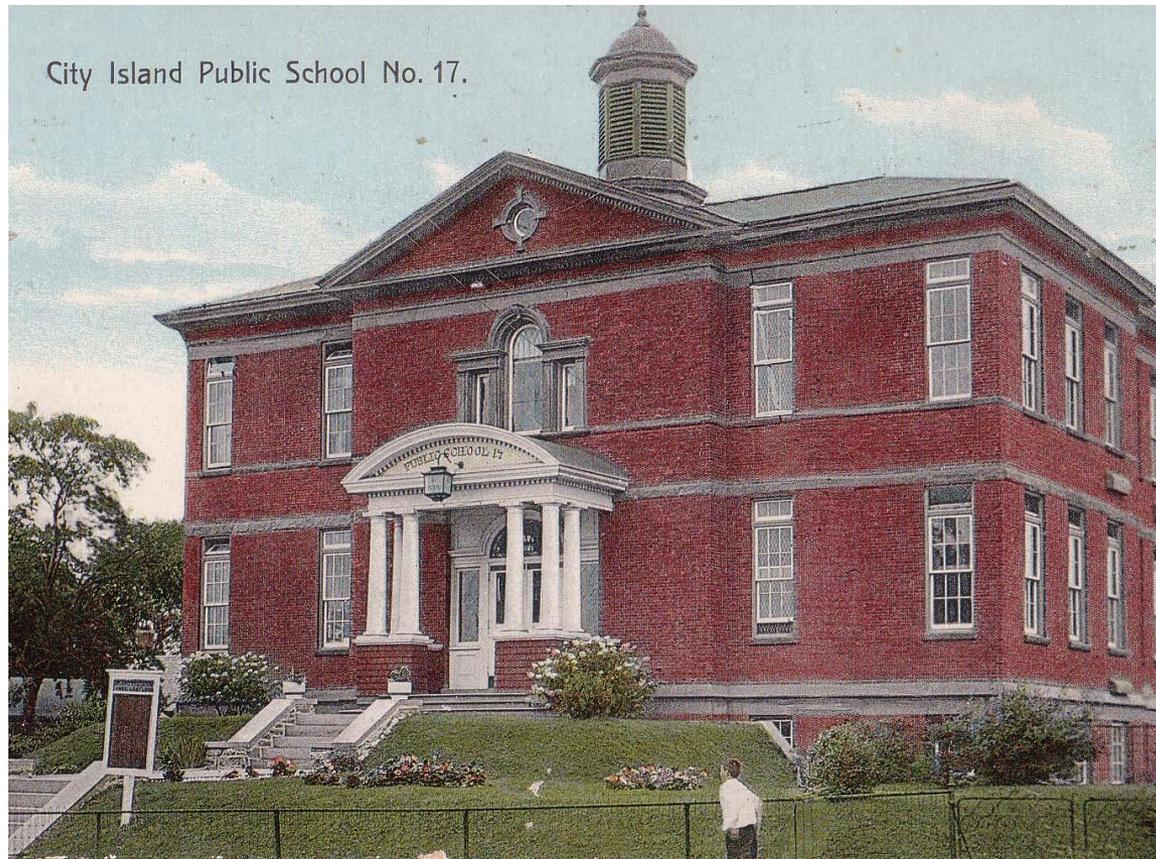
This photograph shows the building in 1903. Designed by CBJ Snyder, it was built in 1897-98 as P.S. 103; the name was changed in January 1903 to P.S. 17. The windows are six-over-six double-hung wood sash windows with tripartite transoms on the first and second stories. We don't know how they were constructed , although it appears the transoms opened in rather than out.

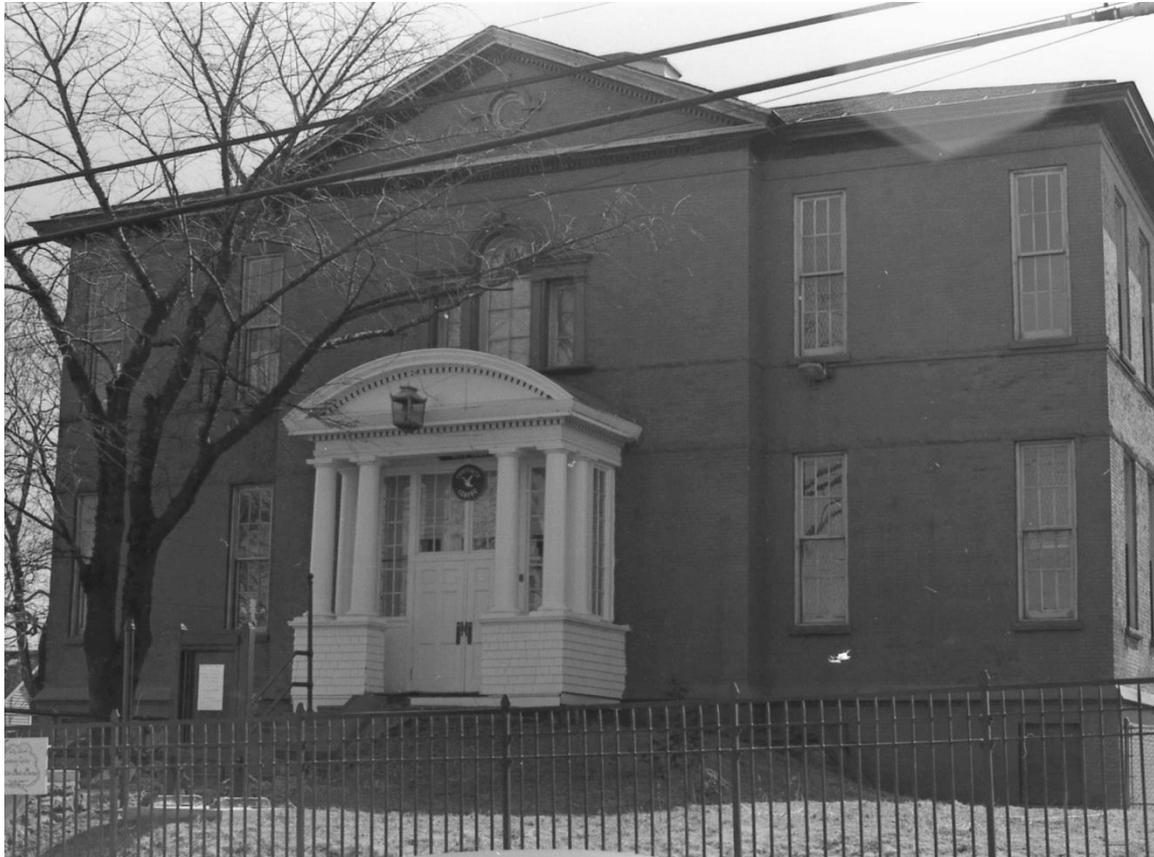
The P. S. 17 building in 1979-80

The windows in this photograph appear to be the same as those in the 1939 photograph. The building at this time was no longer a school but was used by the community as a meeting place, a museum, and a community center.

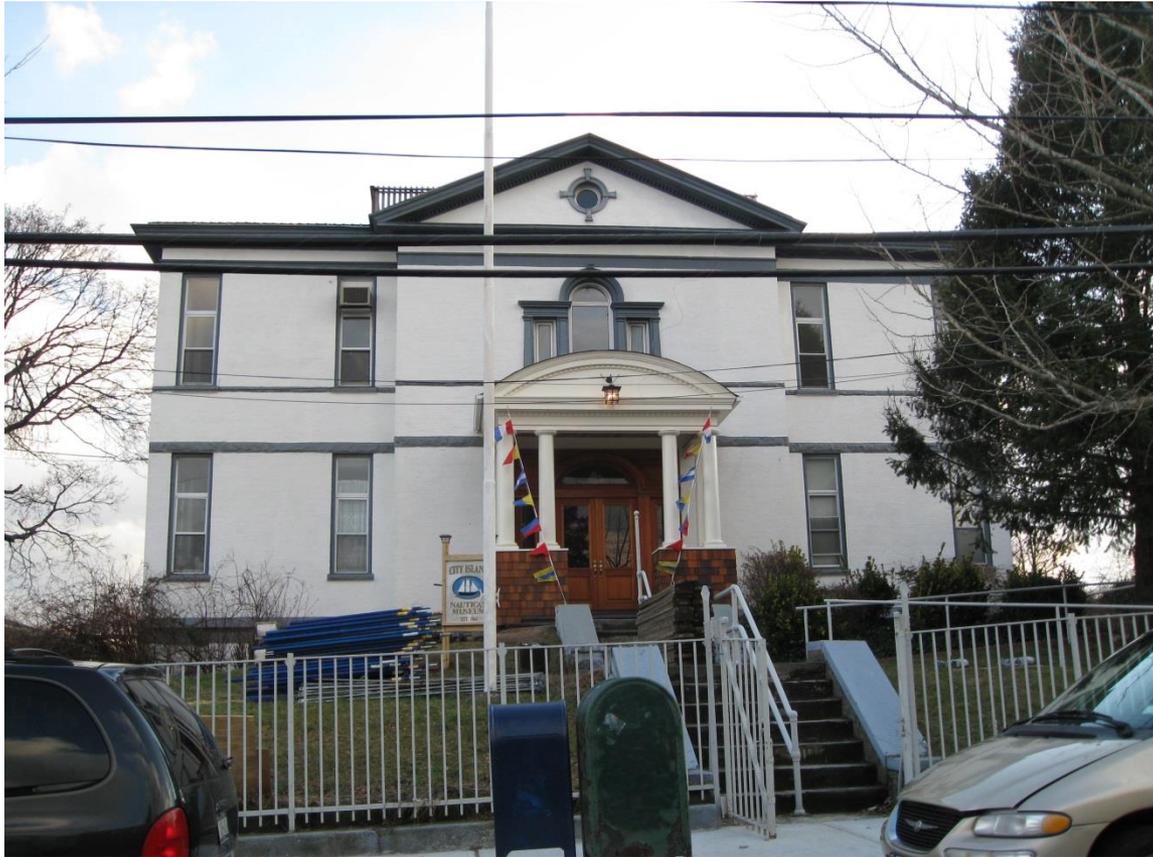
The P.S. 17 building in 2010

The building was sold to a developer in 1988, and a 99-year lease was granted to the City Island Historical Society, which occupies six rooms on the first floor of the building and is accessed through the portico, which was restored by the museum after a fire in 2008. Between 1988 and 1995 the developer installed vinyl windows throughout the building in the configuration visible here. As you can see, the developer painted the red brick a flat white paint, which cannot be easily removed.

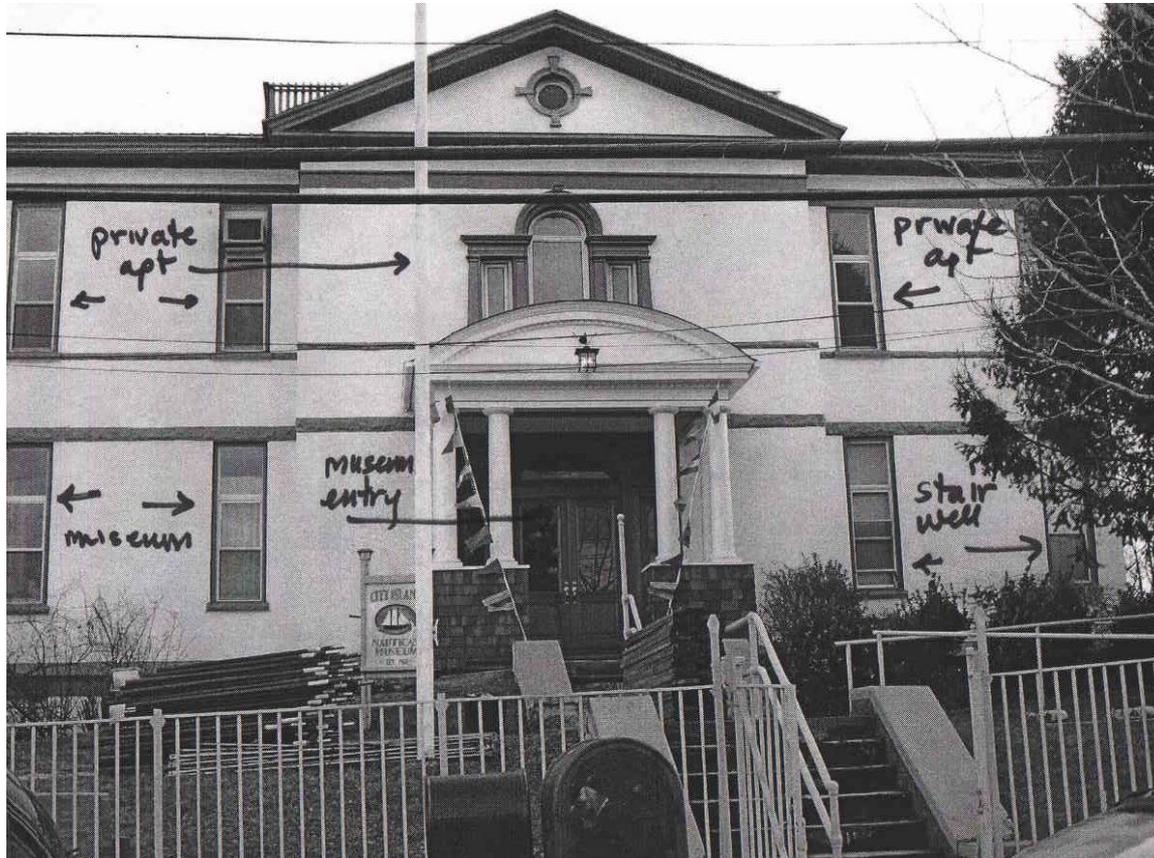
Nautical Museum premises at 190 Fordham Street

As indicated above, the Nautical Museum occupies only the first floor of the museum, of which two windows and the entrance are visible from the street. The other windows are in private apartments or in a stairwell that is not part of the museum.

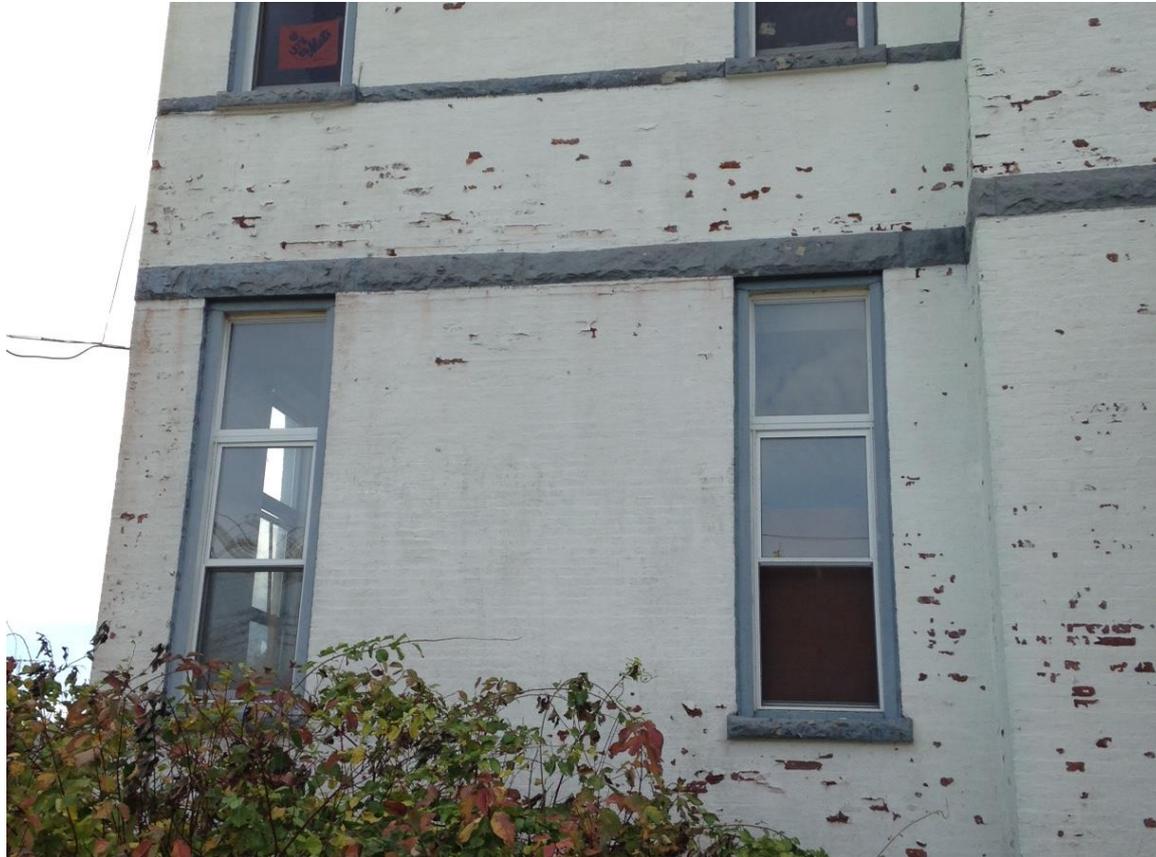
Façade windows on east side of 190 Fordham Street

In October 2015, a northeast storm blew in the window to the right, and it is now covered with plywood, awaiting a replacement. The window to the left is insecure and rattles when the wind blows.

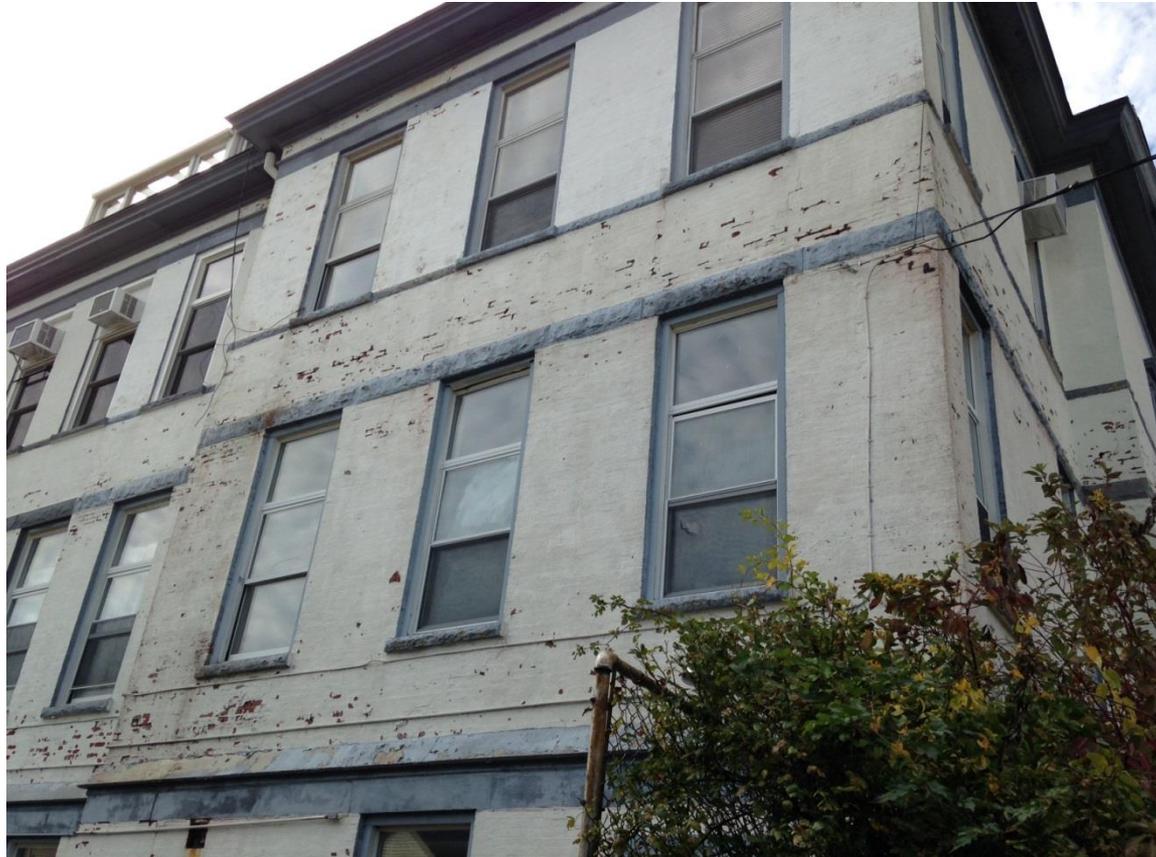
East side of 190 Fordham Street facing driveway

The three windows on the main floor visible here (which are the museum's windows) are in poor condition and shake when touched. It is likely that the next serious storm will blow them in, like the window in front. There are two private apartments on the top floor.

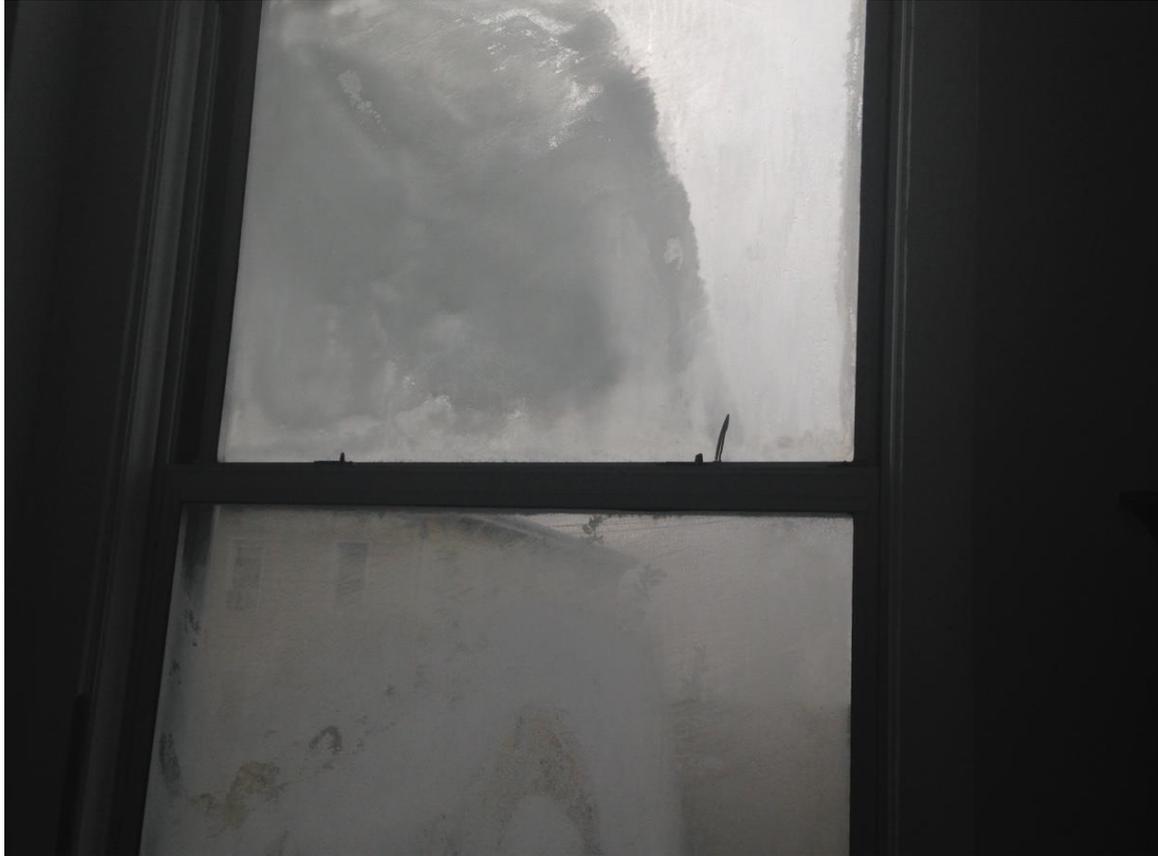
Damaged museum window facing east

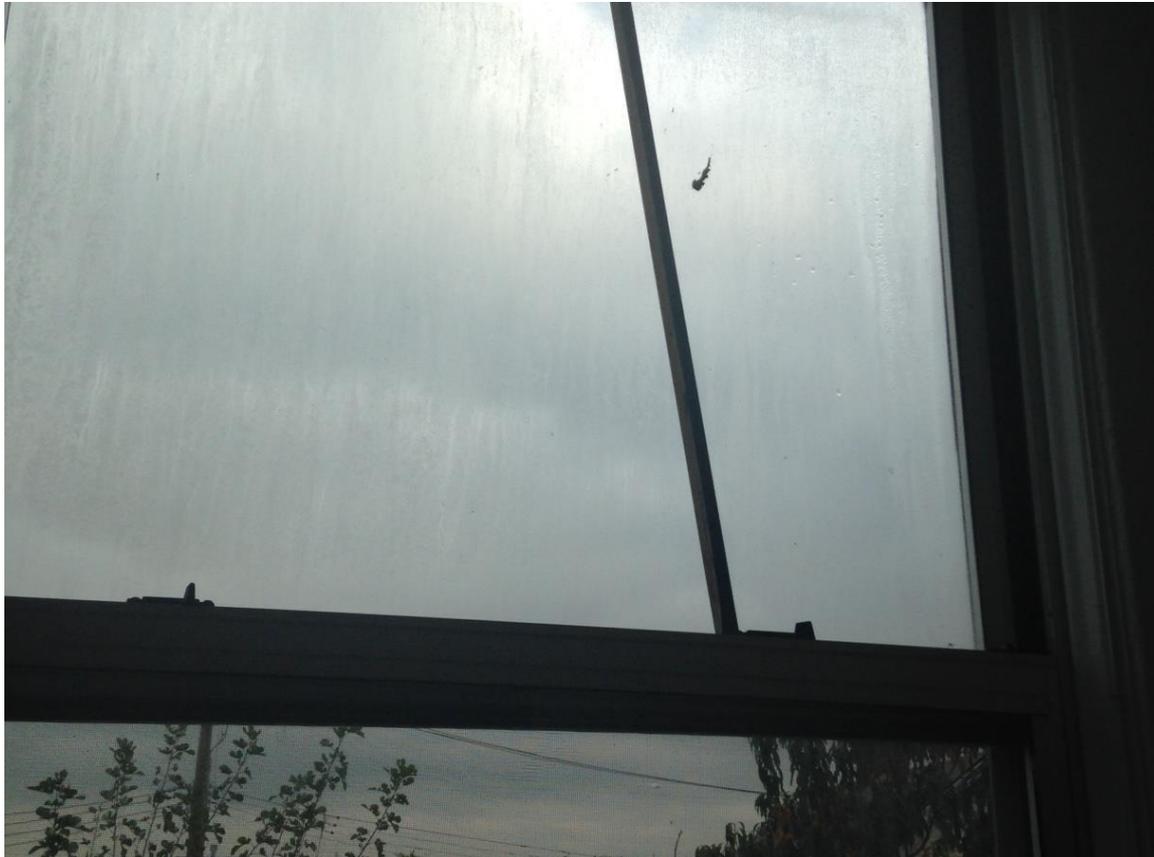
Damaged window on east side

The dark stripe is actually tape covering a break in the glass.

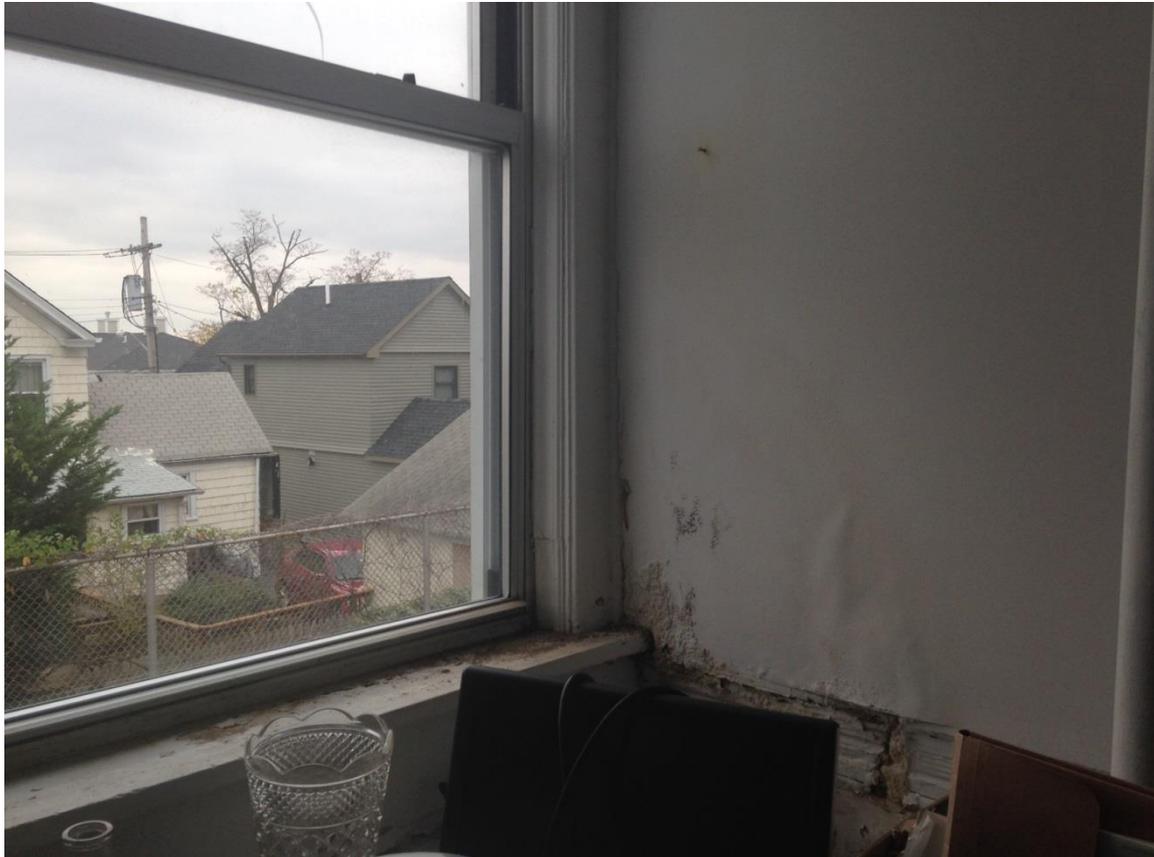
The third damaged window facing east

Note the damage to the plaster and paint inside the window; this is the result of leaks that take place during major storms when the wind blows the rain through the window frame.

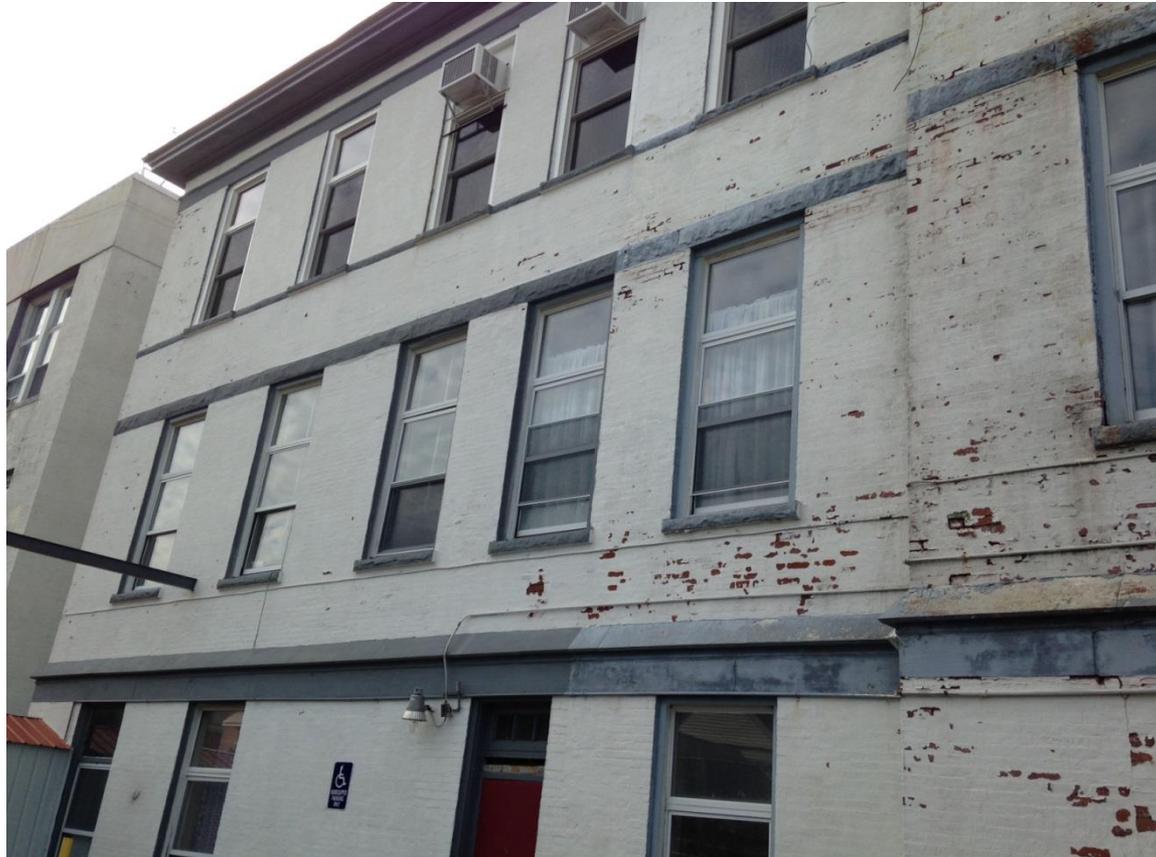
Windows on the east side of 190 Fordham Street

This view shows the remaining five windows on the east side of the museum floor. The windows on the top floor belong to the residential apartments. The windows and doors below the museum windows are part of the Community Center, which is in the basement.

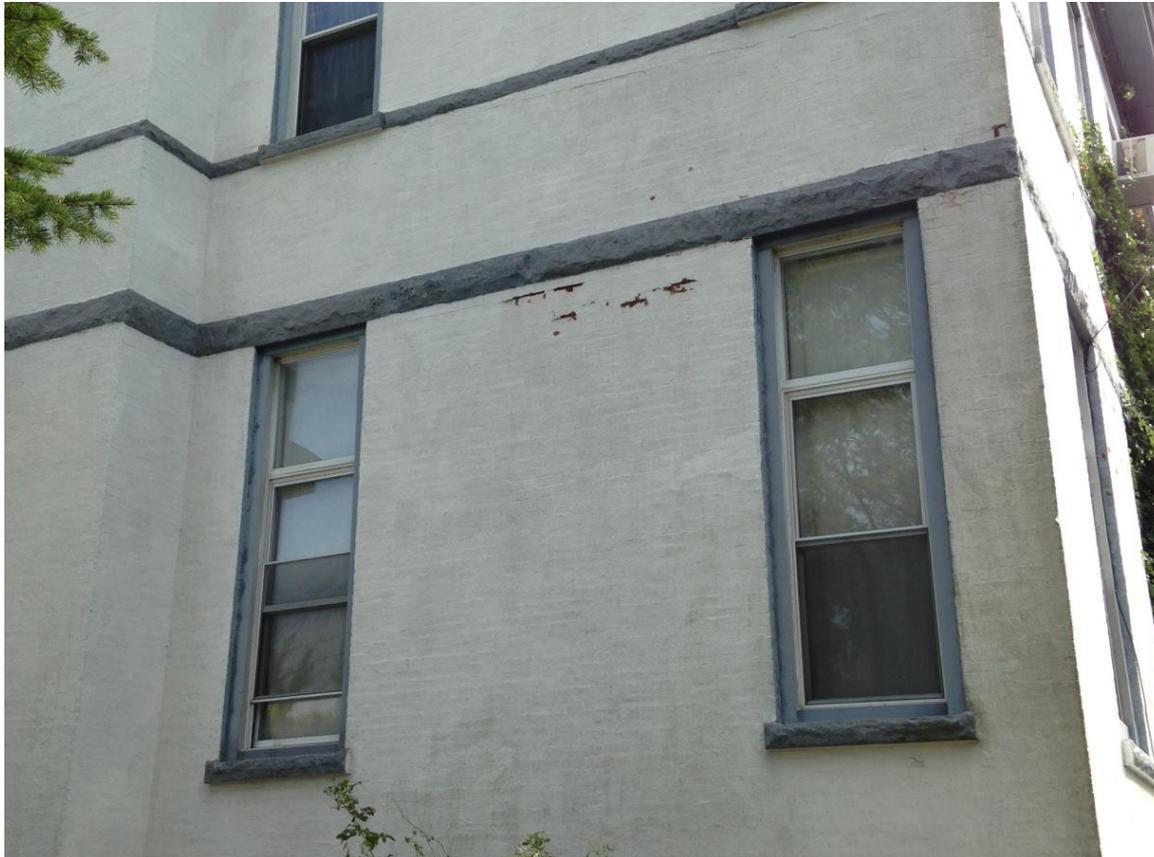
Front windows at the right facing Fordham Street

These are the same design and format as the windows to the left of the façade. They are in a stairwell that is common property with the Community Center below. They are not used by the museum but if we replace all of the museum windows with a six-over-six design, we would feel obligated to replace these as well.

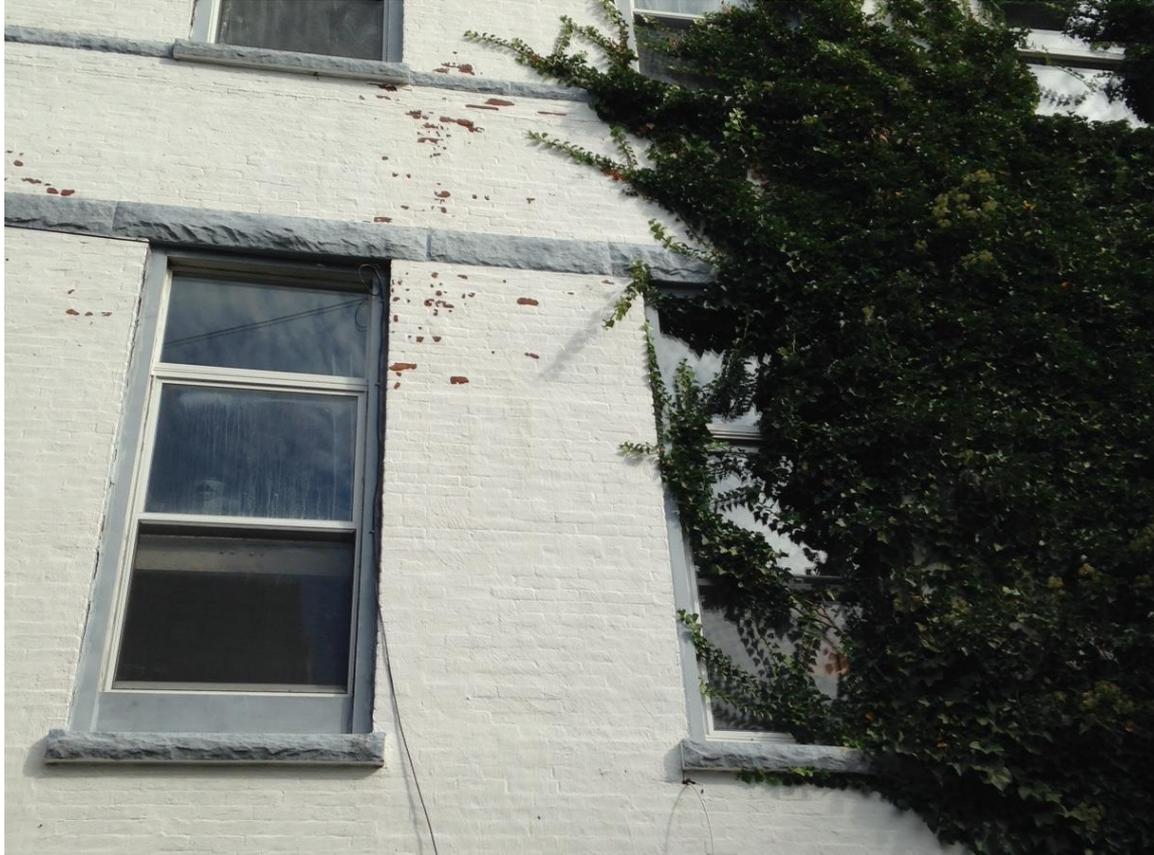
Windows on the west side of 190 Fordham Street

These are the first two museum windows in from the street on the west side of the building; they face a walkway that leads to the condominium units and to the Community Center.

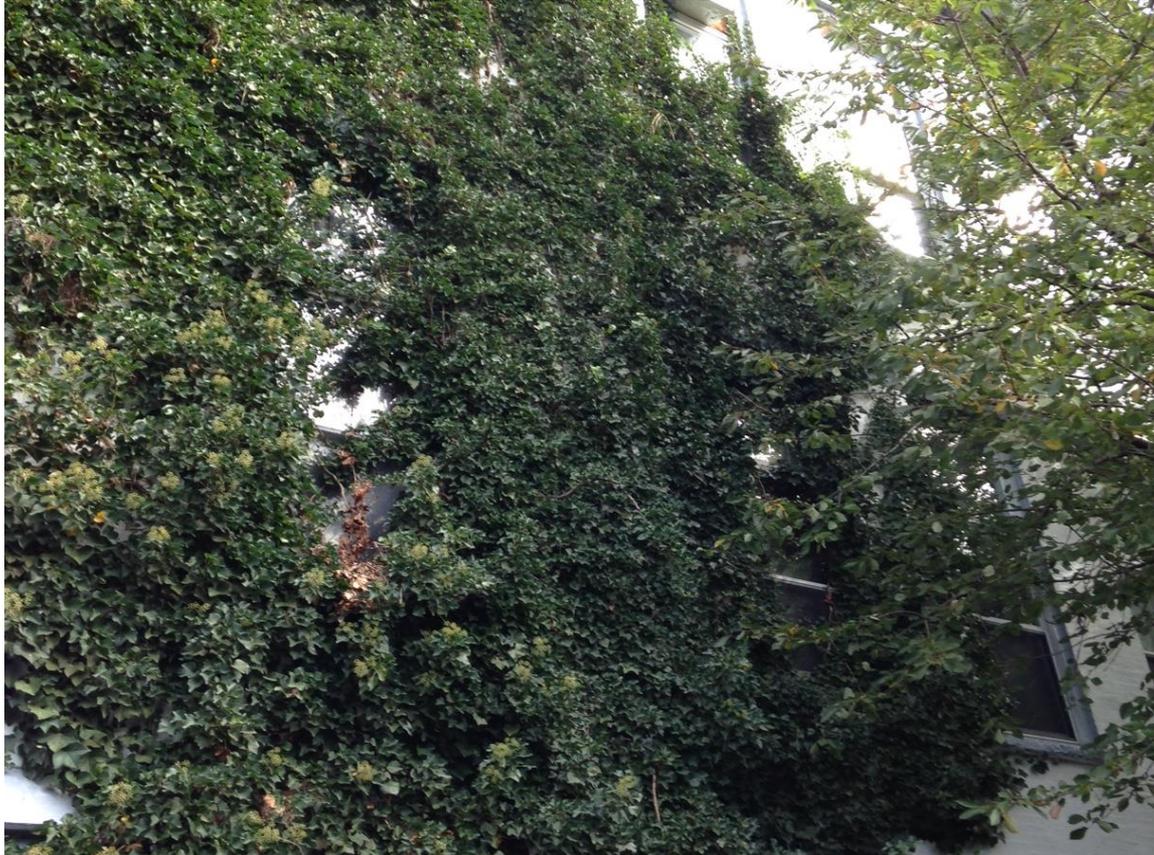
Windows on the west side of 190 Fordham Street

These windows are not easily visible from the outside, but they are the same as those in the previous slide. Ivy is beginning to damage these windows. Replacing the windows will give us the opportunity to eliminate the ivy.

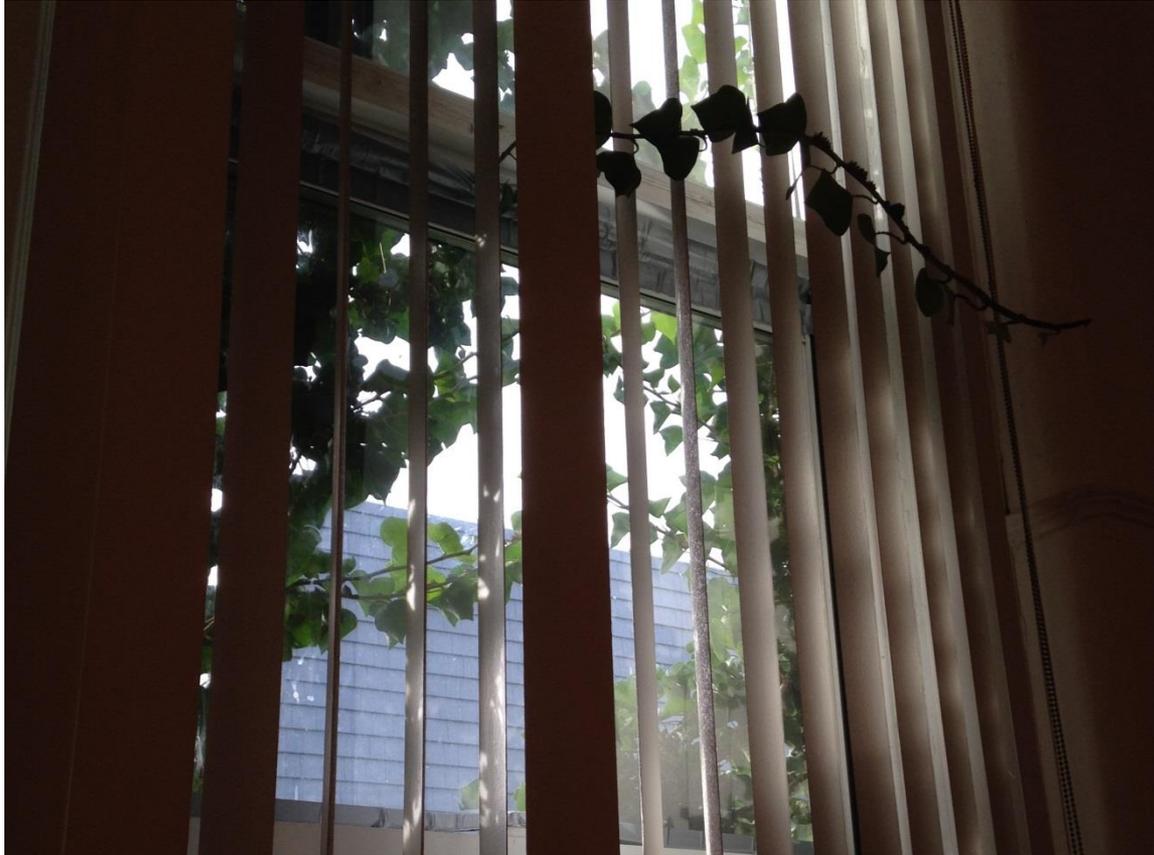
West window in the museum library

This ivy plant has worked its way through one of the windows in the library on the west side of the building.

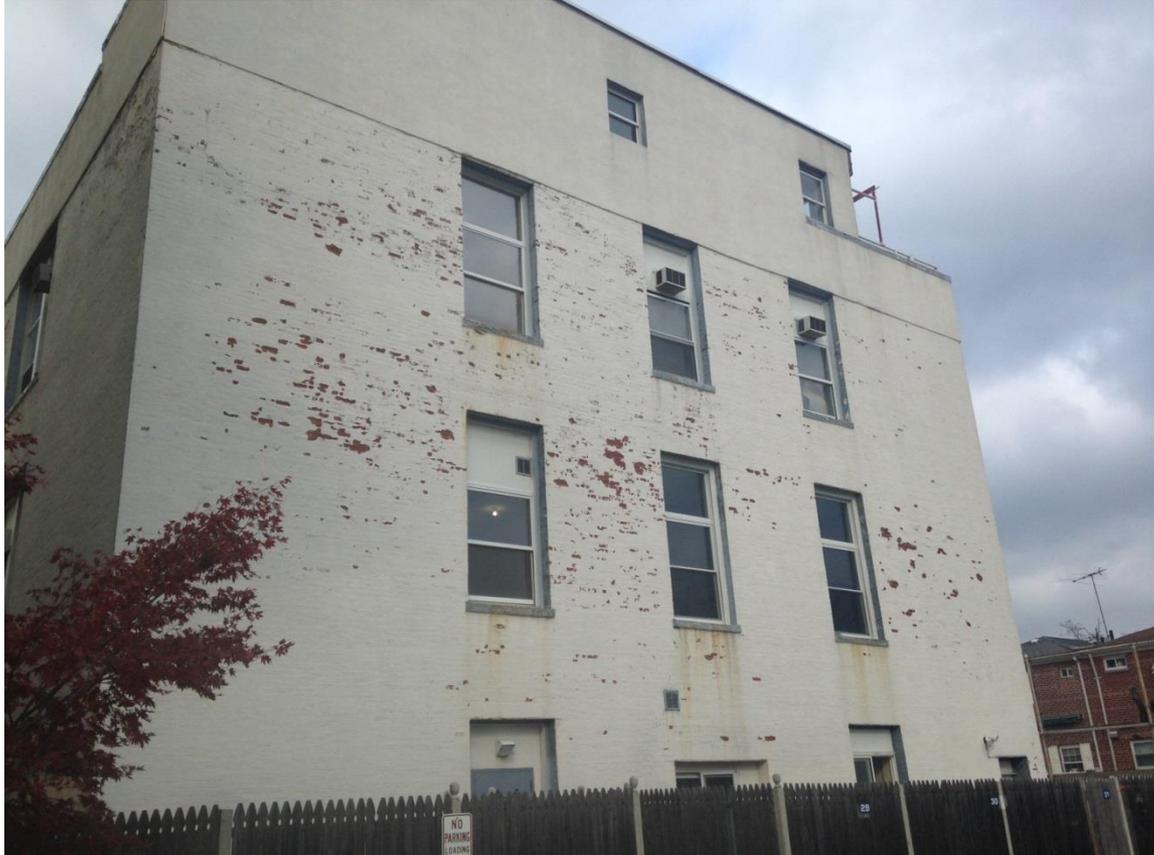
190 Fordham Street, 1930s addition

This building, which is attached to the 1898 school building, was constructed in the 1930s to provide additional schoolrooms. It is not part of the landmark designation.
