Alterations to:  
32 W. 76th St. New York, NY 10023  
Block: 1128 Lot: 51  
LPC Docket #: 17-3088

**Landmarks Preservation Commission**

Alterations to:  
32 West 76th Street, New York, NY 10023  
Landmarks Preservation Commission Preliminary Review

ZIVKOVIC CONNOLLY ARCHITECTS P.C.  
1133 BROADWAY, SUITE 1330, NEW YORK, NY 10010

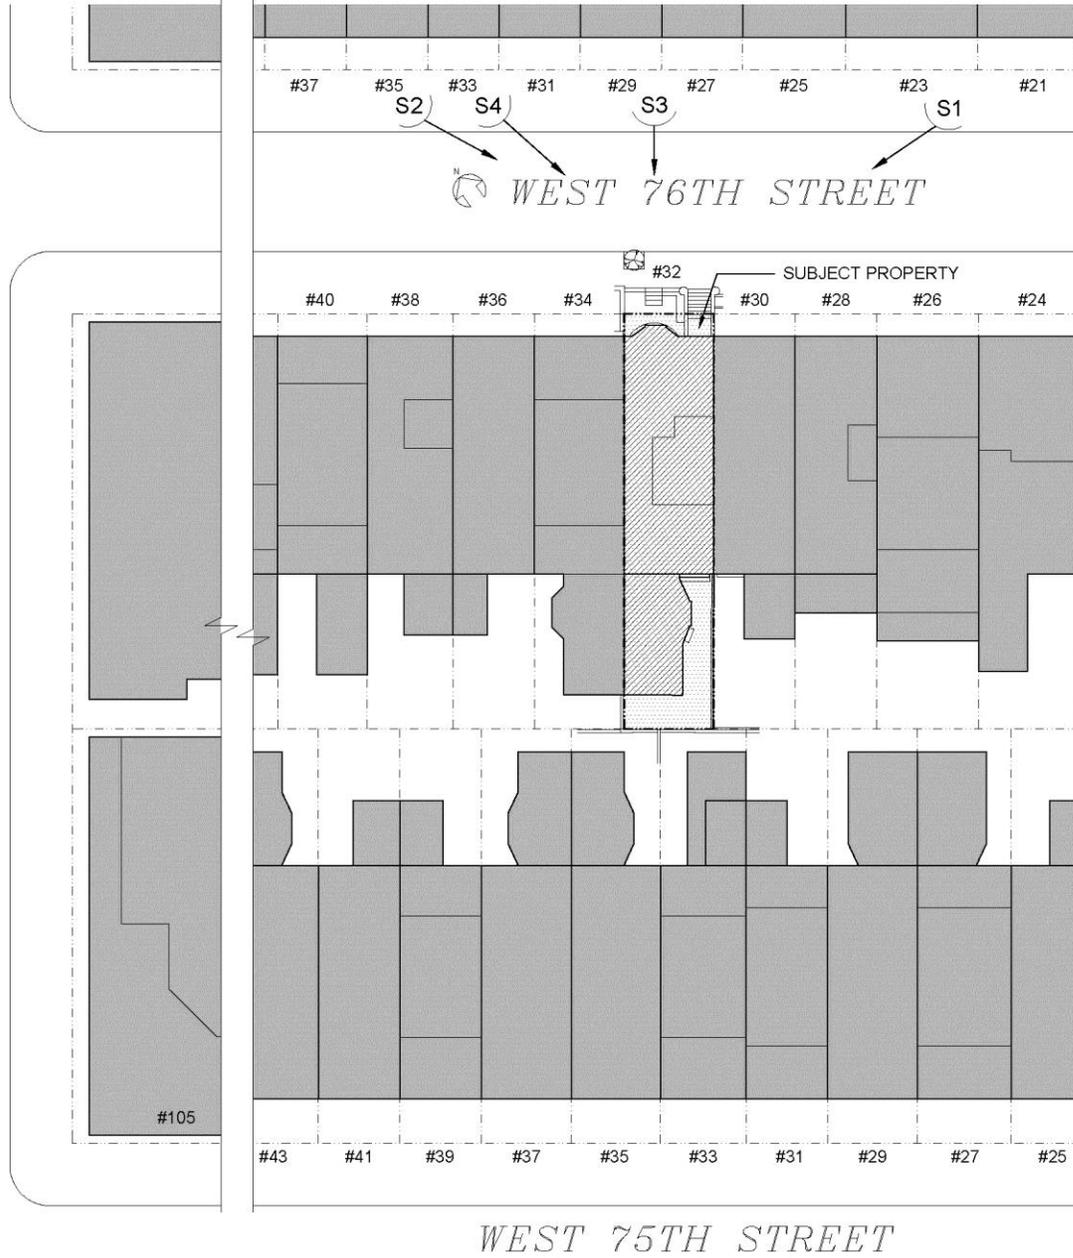
LPC-01.00

1 Street View Diagram  
Scale : 1/32" = 1'-0"

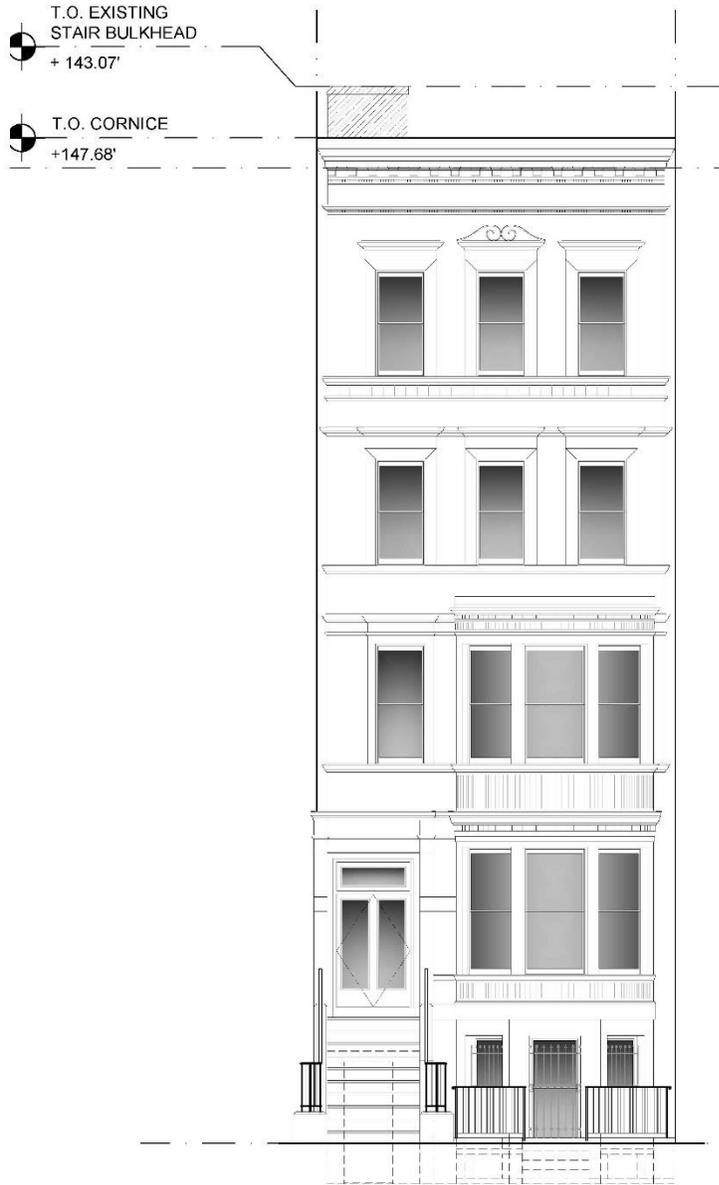
**1 Existing West 76th Street Elevation**  
Scale : 1/8" = 1'-0"

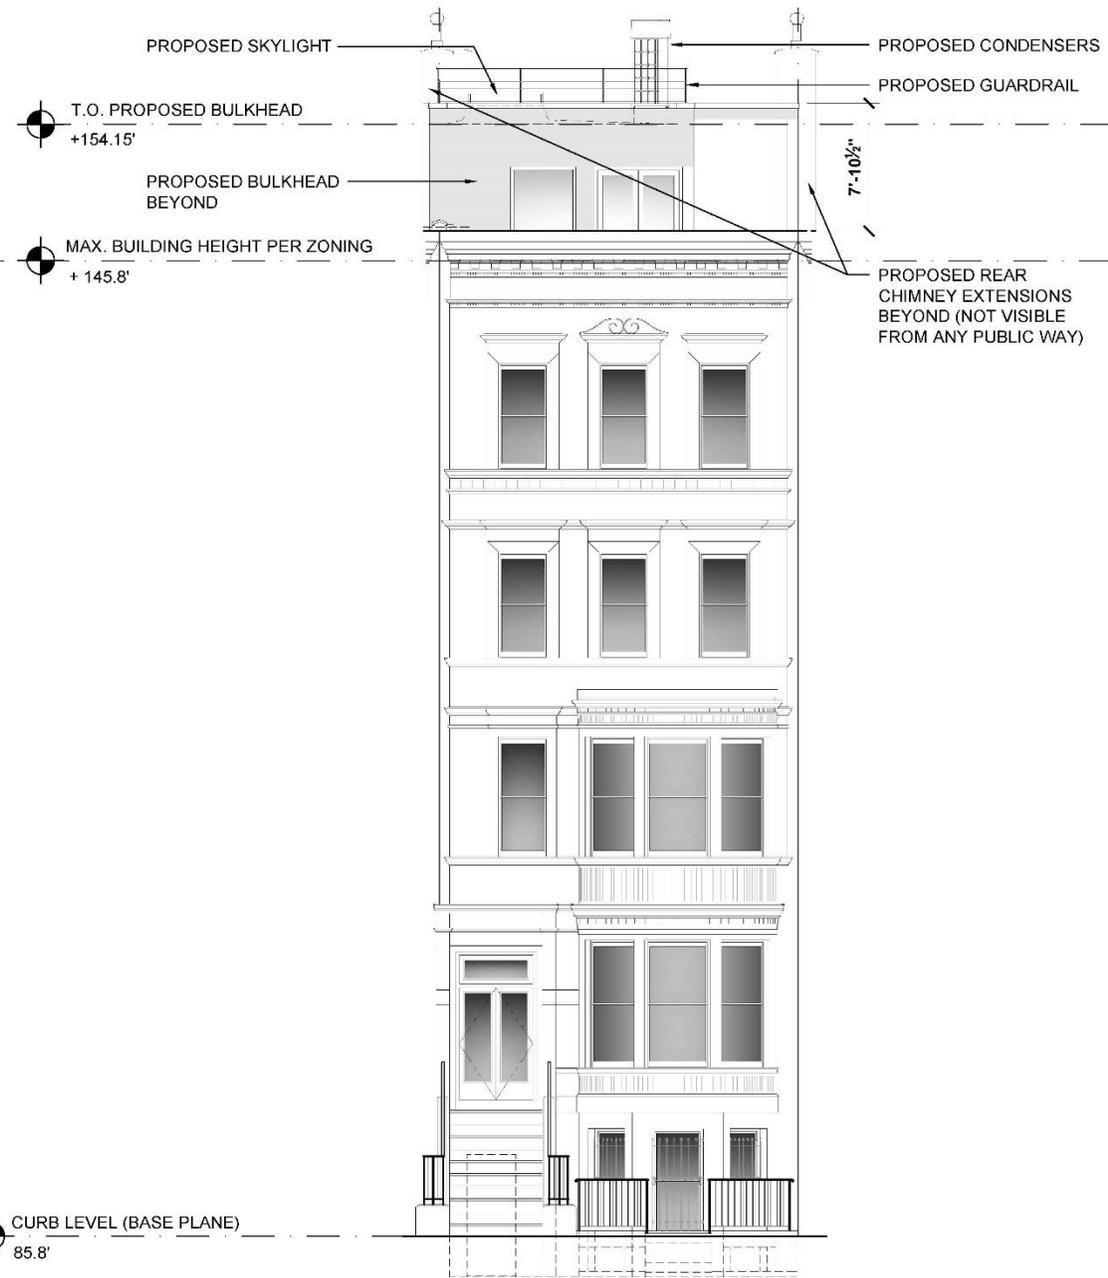
**2 Proposed West 76th Street Elevation**  
Scale : 1/8" = 1'-0"

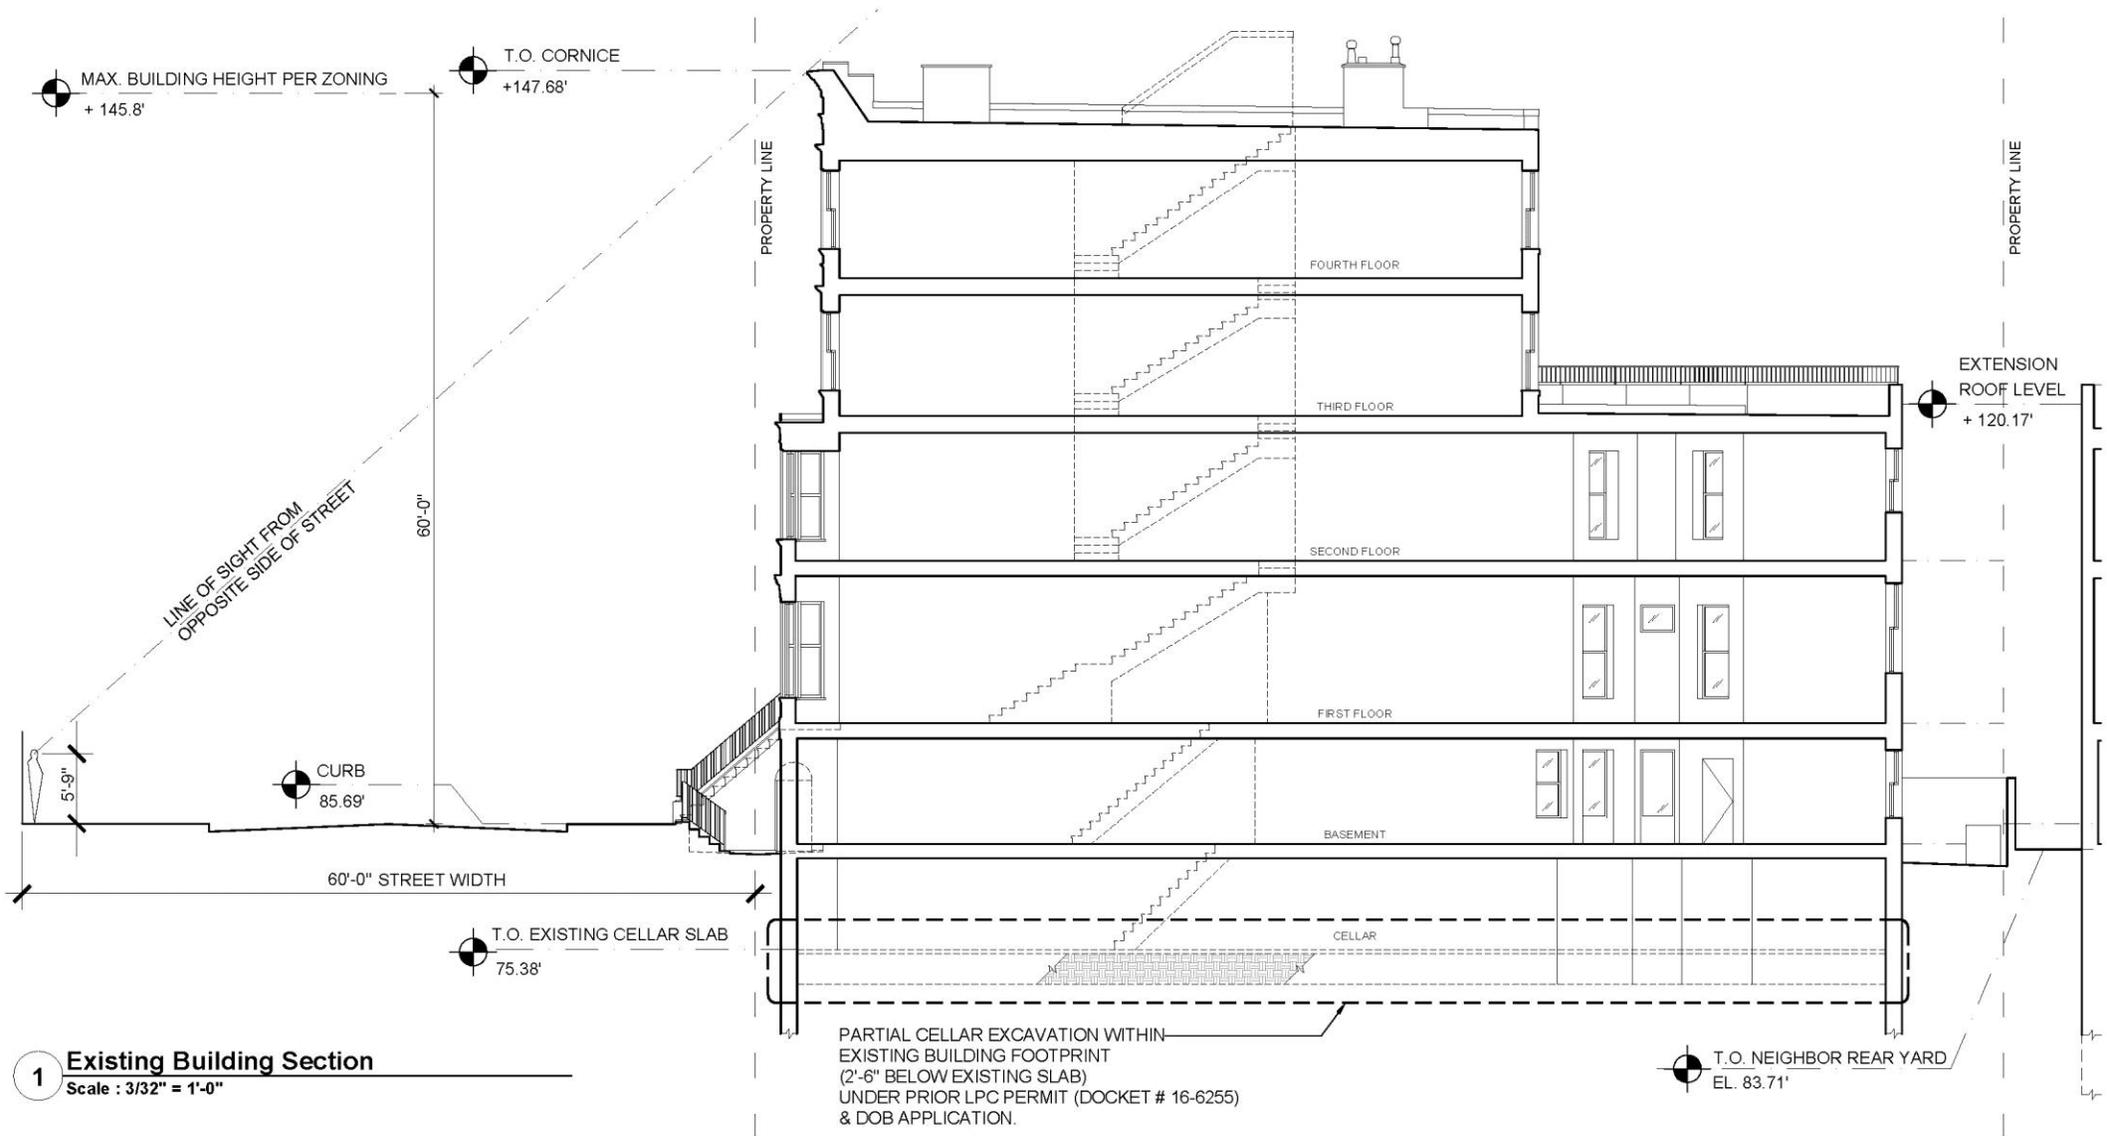
LPC-04.00

**1 Existing Building Section**  
 Scale : 3/32" = 1'-0"

PARTIAL CELLAR EXCAVATION WITHIN  
 EXISTING BUILDING FOOTPRINT  
 (2'-6" BELOW EXISTING SLAB)  
 UNDER PRIOR LPC PERMIT (DOCKET # 16-6255)  
 & DOB APPLICATION.

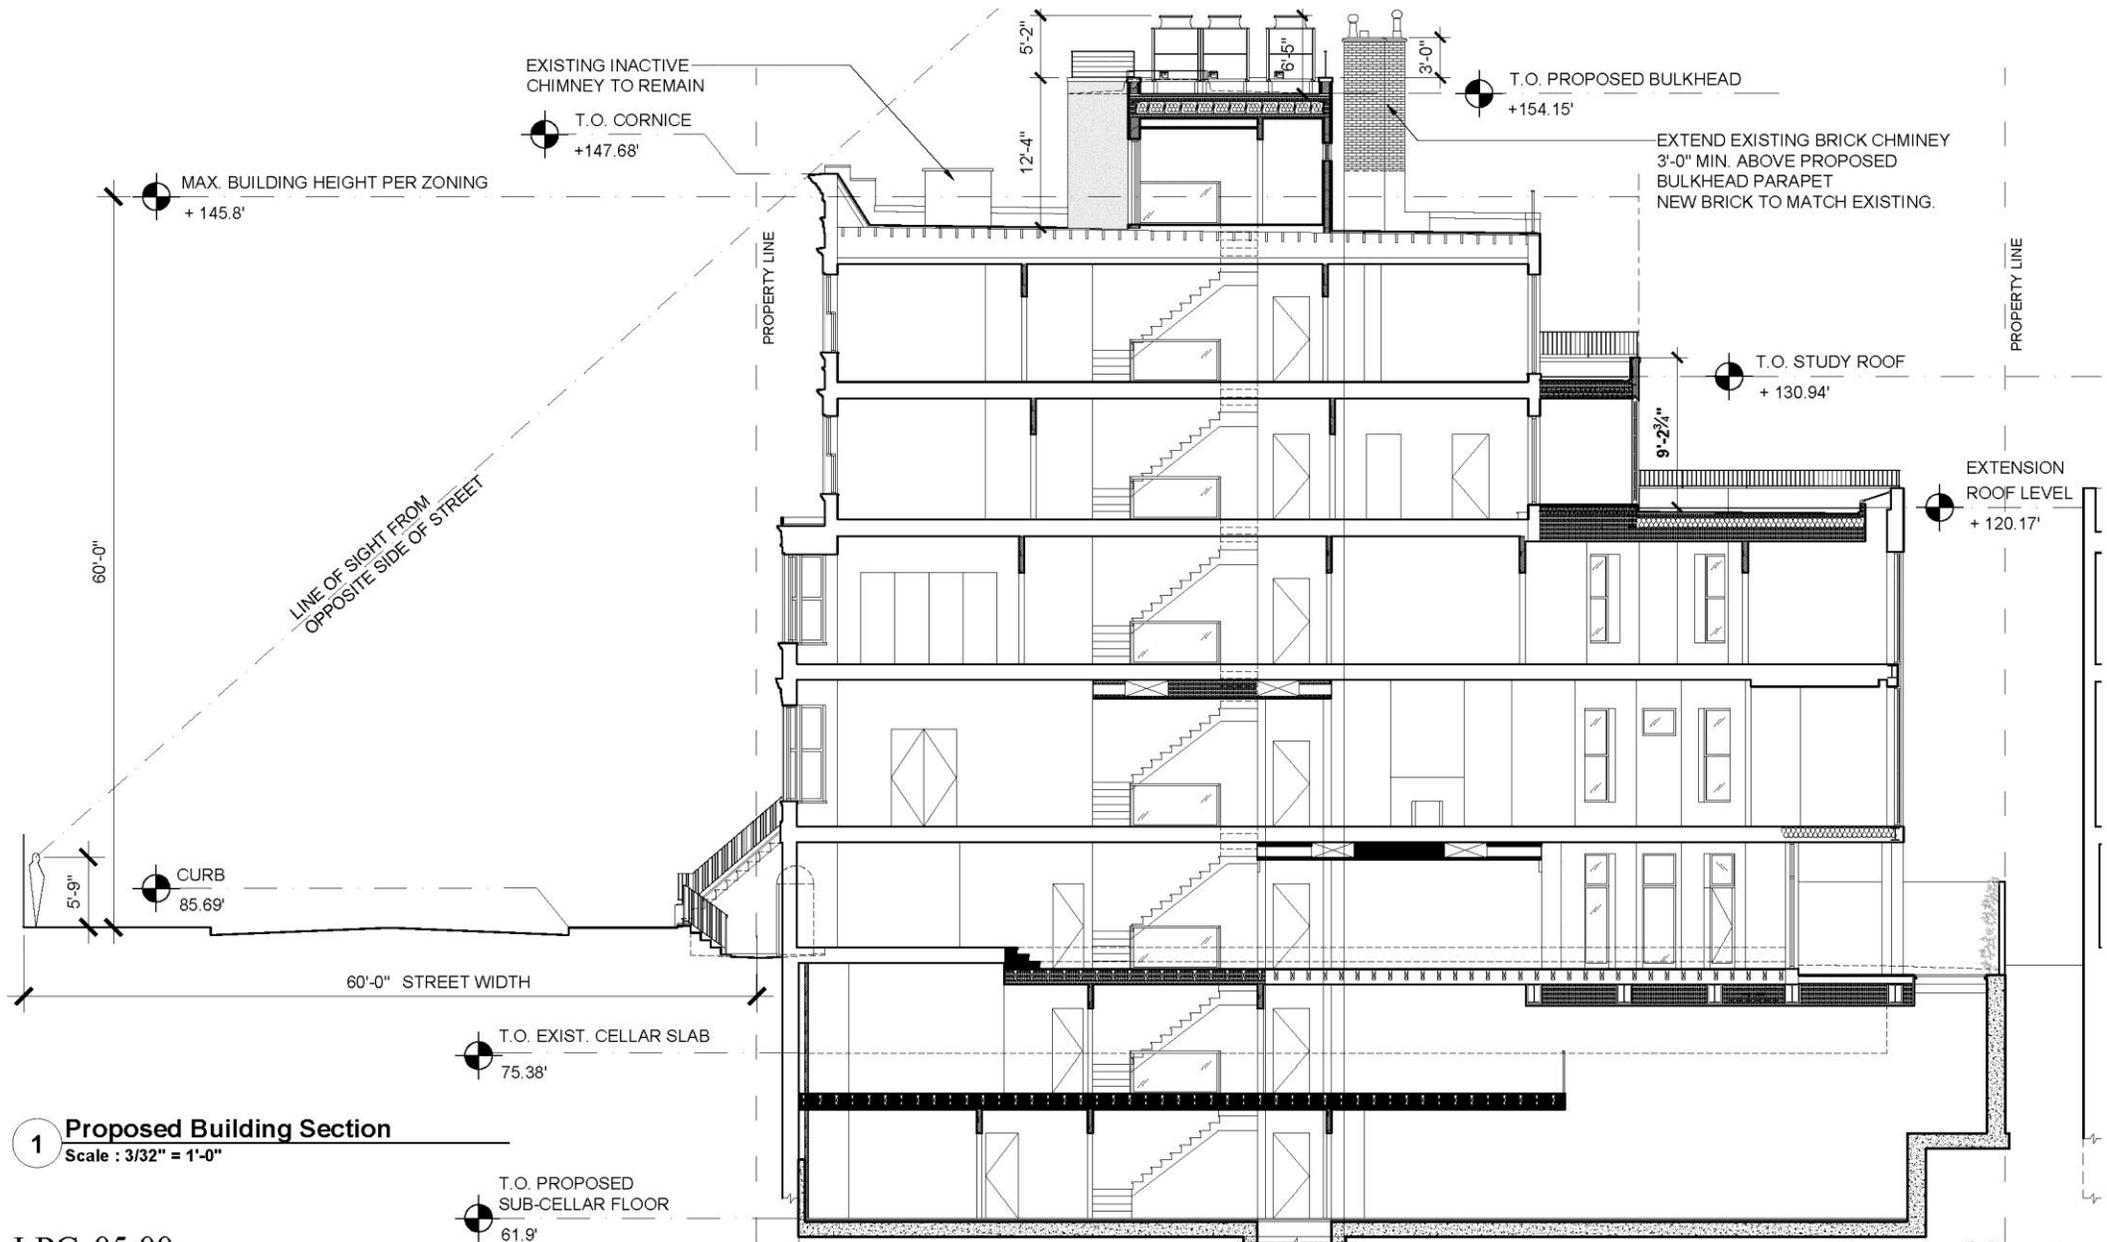
LPC-05.00

**1 Proposed Building Section**  
 Scale : 3/32" = 1'-0"

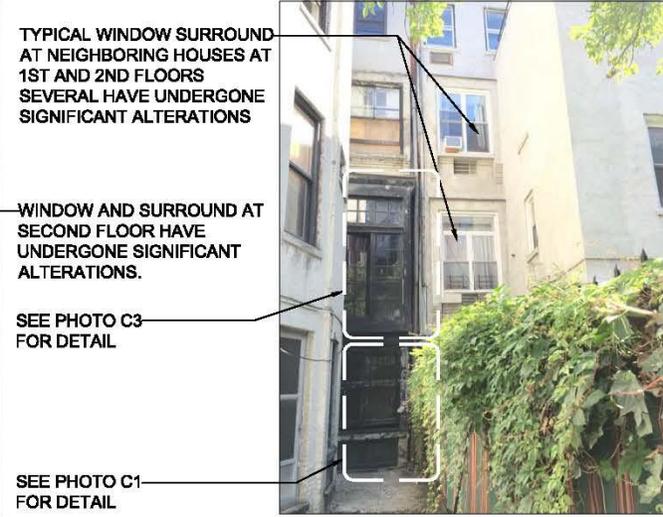
**C Partial Rear Facade Abutting Subject Property**

TYPICAL WINDOW SURROUND AT NEIGHBORING HOUSES AT 1ST AND 2ND FLOORS SEVERAL HAVE UNDERGONE SIGNIFICANT ALTERATIONS

WINDOW AND SURROUND AT SECOND FLOOR HAVE UNDERGONE SIGNIFICANT ALTERATIONS.

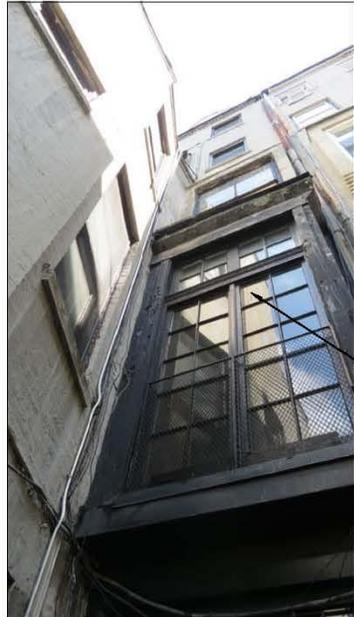
**C1 Existing Juliet Door at Parlor Floor**

FORMER BRICK WINDOW SURROUND LOCATION SIMILAR TO EXISTING AT 2ND FLOOR

EXISTING NON-HISTORIC DOOR AND TRANSOM CONSTRUCTION

PORTION OF REAR EXTENSION WALL, PAINTED FORMERLY EXPOSED TO THE EXTERIOR

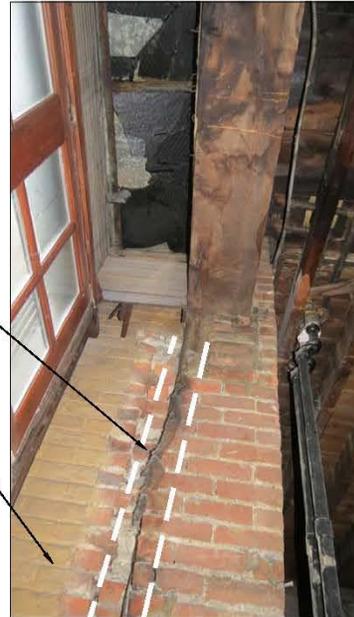
**C2 Existing Condition at inside of Juliet Door**

EXISTING METAL CLADDING TO HEAD OF WINDOW; INCONSISTENT WITH ADJACENT CONDITIONS.

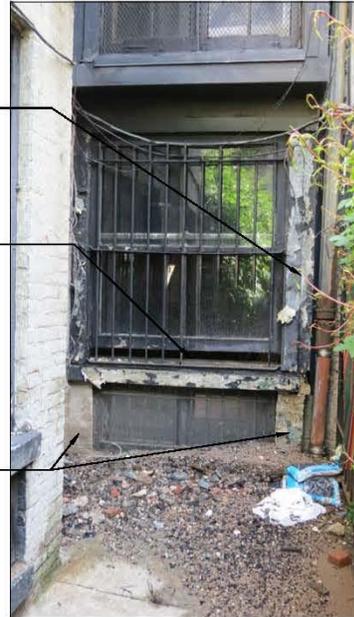
EXISTING WINDOW SURROUND AT SIDES OF BASEMENT WINDOW DROWNED IN PAINT AND PARGING; INCONSISTENT WITH BRICK SURROUND AT CELLAR WINDOW BELOW

BRICK SURROUND SIMILAR TO EXISTING AT 2ND FLOOR

**C3 Existing Basement Window at Rear Yard**

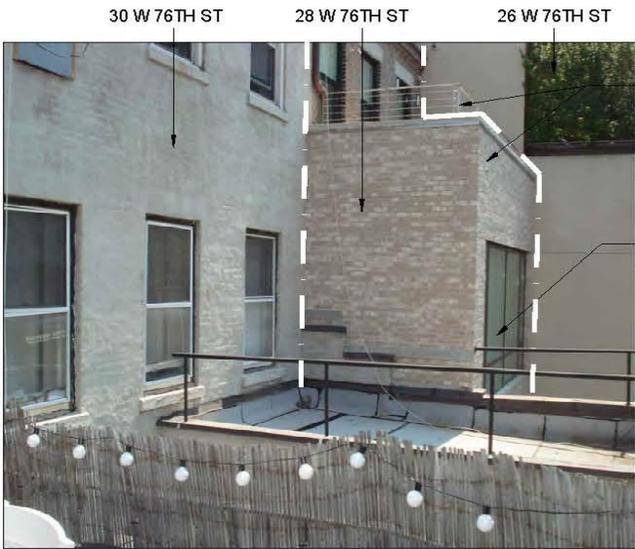
**K** Existing Rear Extensions at 30-28 W 76th St

RAILING AND PARAPET  
SIMILAR TO PROPOSED

FENESTRATION AT REAR  
EXTENSION SIMILAR TO  
PROPOSED

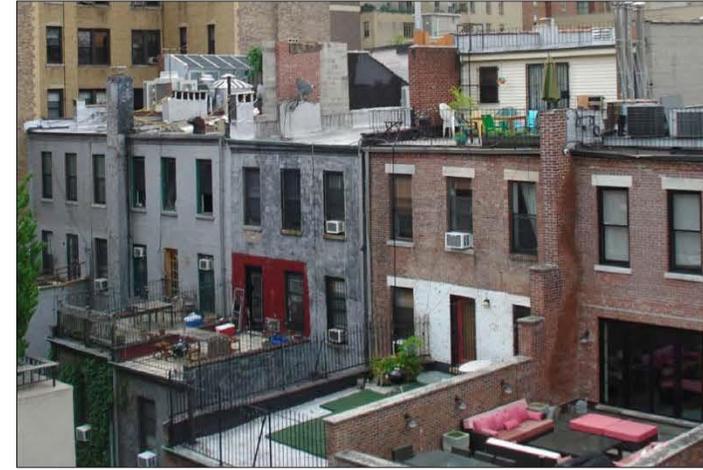
**N** East View of Block Interior from Existing Extension Roof

CONDENSER UNITS AND  
DUCTWORK NOT VISIBLE  
FROM STREET

TOP OF BULKHEAD  
ROOF AT 26 W 76TH ST

STAIR BULKHEAD IN  
SIMILAR POSITION TO  
PROPOSED BULKHEAD

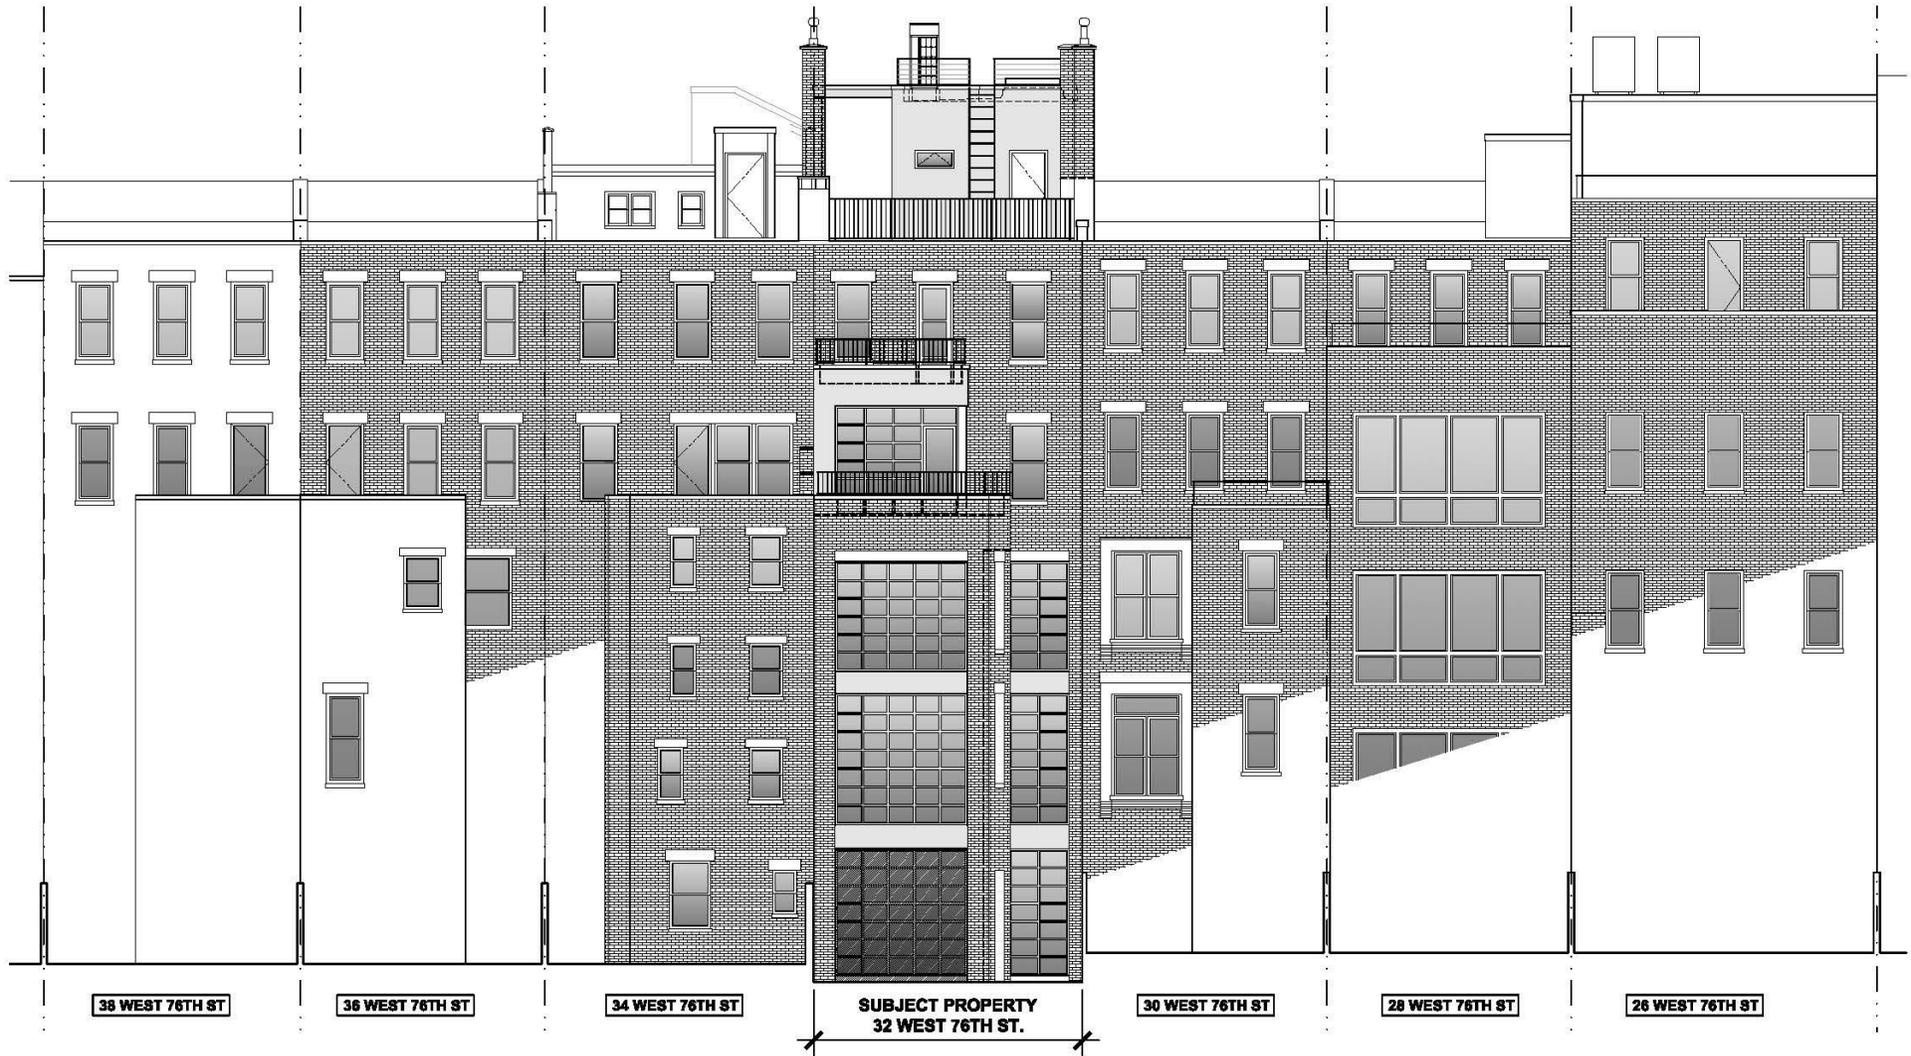
LPC-13.00

SUBJECT PROPERTY  
32 WEST 76TH ST.

**1** Interior Block Proposed Elevation  
Scale : 3/32" = 1'-0"

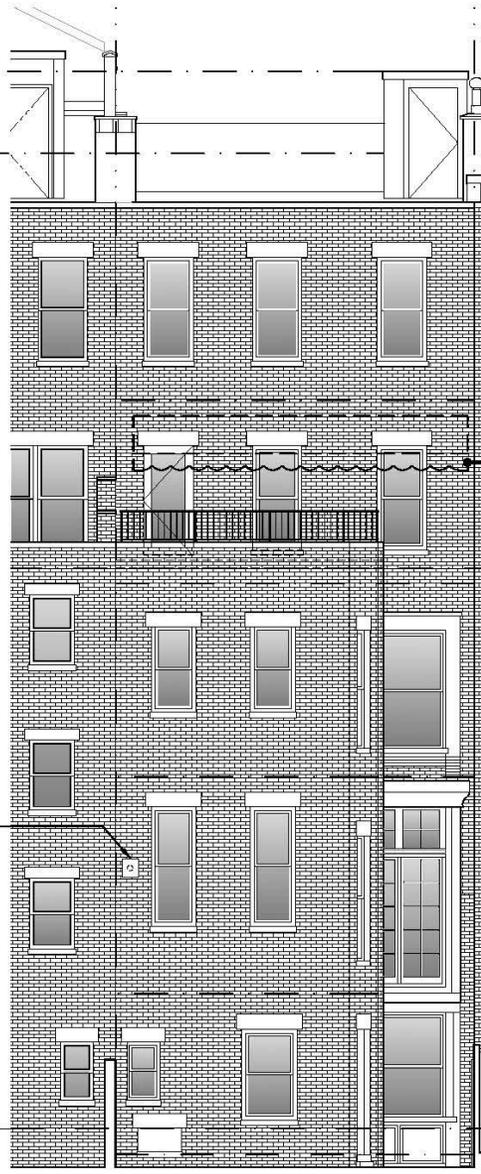
EXISTING VENT TO BE REMOVED

T.O. PROPOSED STAIR BULKHEAD  
+ 154.15'

PROPOSED GUARDRAIL  
CLEAR ANODIZED ALUMINUM  
RAILING AND CABLES

PROPOSED LADDER FOR FIRE  
DEPT. ACCESS

NEW 42" AFF METAL  
GUARDRAIL; PAINT  
BLACK TO MATCH  
WINDOWS (TYP.)

EXISTING AWNING  
TO BE REMOVED

PROPOSED CAST STONE  
LINTEL; MATCH EXISTING

PROPOSED METAL SPANDRELS  
BETWEEN FENESTRATIONS;  
COLOR TO MATCH WINDOW  
FRAMES

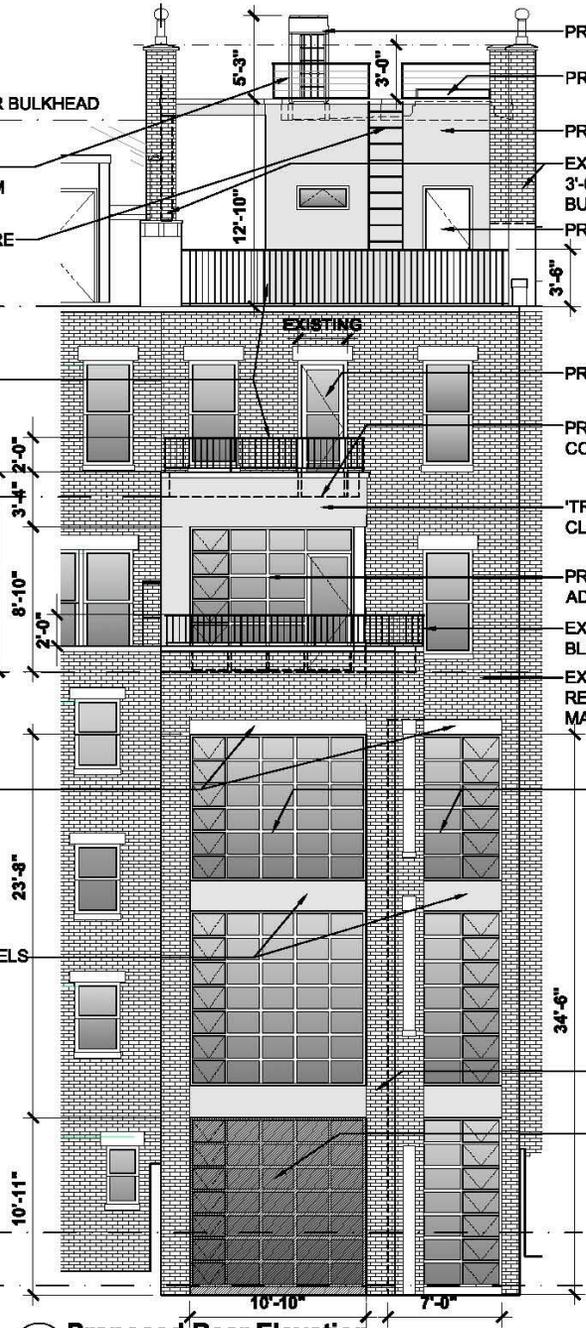
LPC-14.00

**2 Proposed Rear Elevation**  
Scale : 1/8" = 1'-0"

PROPOSED CONDENSERS

PROPOSED SKYLIGHT BEYOND

PROPOSED BULKHEAD BEYOND

EXTEND EXISTING CHMINEYS  
3'-0" MIN. BEYOND PROPOSED  
BULKHEAD PARAPET

PROPOSED BALCONY ABOVE  
CONSERVATORY

'TRESPA' RAINSCREEN  
CLADDING SYSTEM

PROPOSED "CONSERVATORY"  
ADDITION

PROPOSED METAL CURTAIN  
WALL GLAZING SYSTEM  
BLACK FRAME

PROPOSED COVERED  
TERRACE AT BASEMENT LEVEL

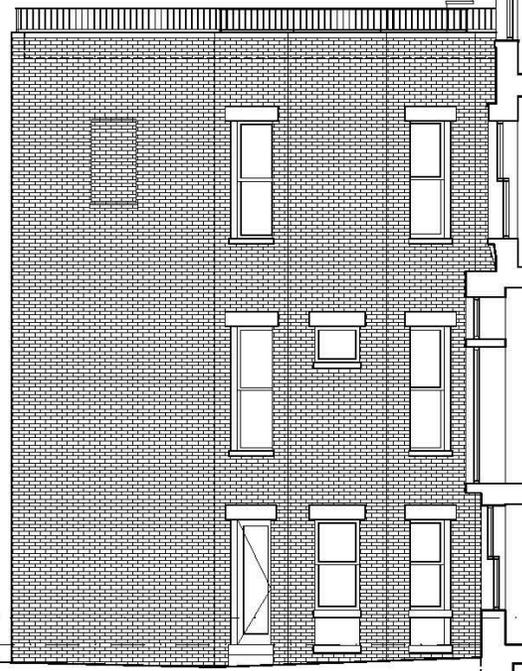
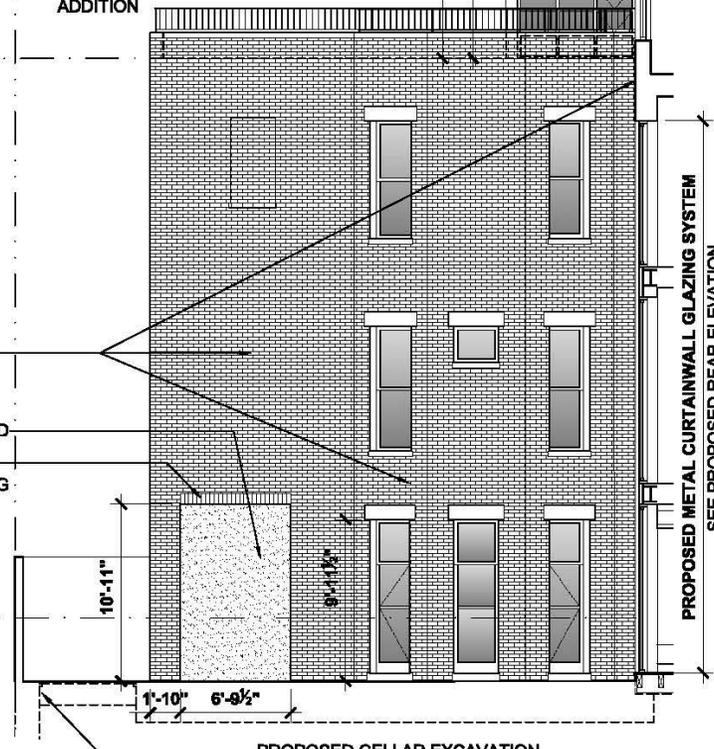
LPC-15.00  
*Existing & Proposed Rear Extension Elevations*

EXISTING BRICK TO BE REPAINTED; COLOR TO MATCH EXISTING  
STUCCO FINISH BEYOND  
PROPOSED HEADER COURSE OVER OPENING

PROPOSED GUARD RAIL TO MATCH EXISTING; PAINT BLACK TO MATCH WINDOWS  
PROPOSED BALCONY ABOVE CONSERVATORY  
TRESPA' RAINSCREEN CLADDING SYSTEM  
PROPOSED METAL CURTAINWALL GLAZING SYSTEM; BLACK FRAME  
PROPOSED "CONSERVATORY" ADDITION

PROPOSED CELLAR EXCAVATION  
SEE SECTIONS

PROPOSED METAL CURTAINWALL GLAZING SYSTEM  
SEE PROPOSED REAR ELEVATION

1 Existing East Elevation at Extension  
Scale : 1/8" = 1'-0"

2 Proposed East Elevation at Extension  
Scale : 1/8" = 1'-0"

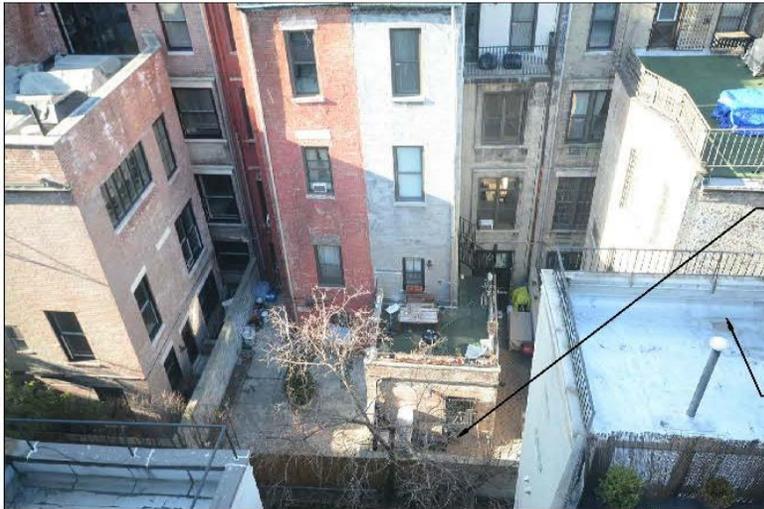
**C** View of Neighboring Rear Yards from Upper Roof

NEIGHBORING PROPERTY WITH REAR EXTENSION FEATURES 100% IMPERVIOUS SURFACE COVERAGE

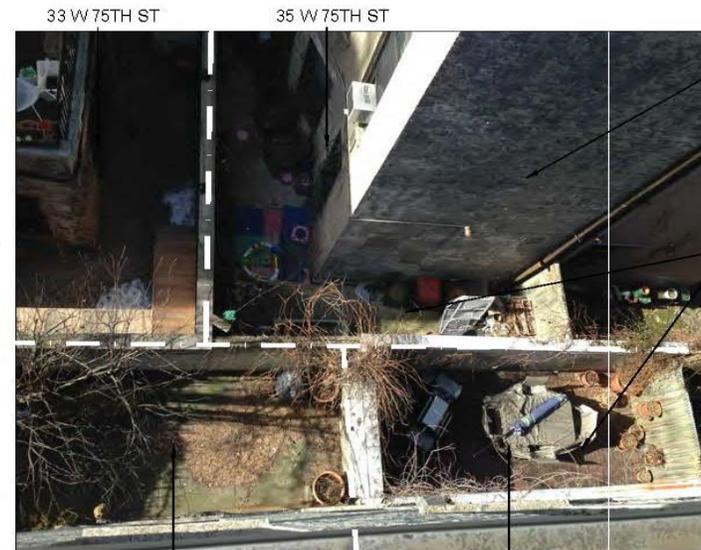
**D** View of Neighboring Rear Yards South of Project Site

PROPERTY WITH REAR EXTENSION SIMILAR TO THIS PROPERTY

ALL REAR YARDS SHOWN HAVE 100% IMPERVIOUS SURFACE COVERAGE

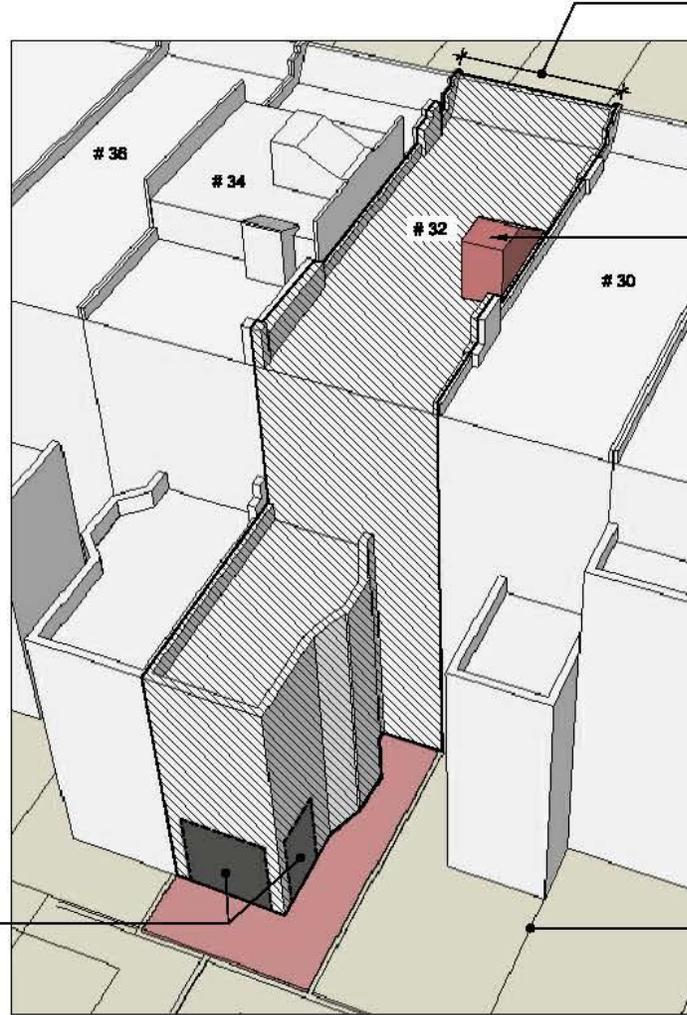
EXISTING WALLS IN THESE AREAS TO BE REMOVED FOR COVERED TERRACE AT BASEMENT LEVEL

SUBJECT PROPERTY  
#32 W. 76TH STREET  
(CROSS-HATCHED)

EXISTING STAIR  
BULKHEAD TO BE  
DEMOLISHED

1 Aerial View of Existing Conditions at 32 W. 76th Street Rear Extension  
Not to Scale

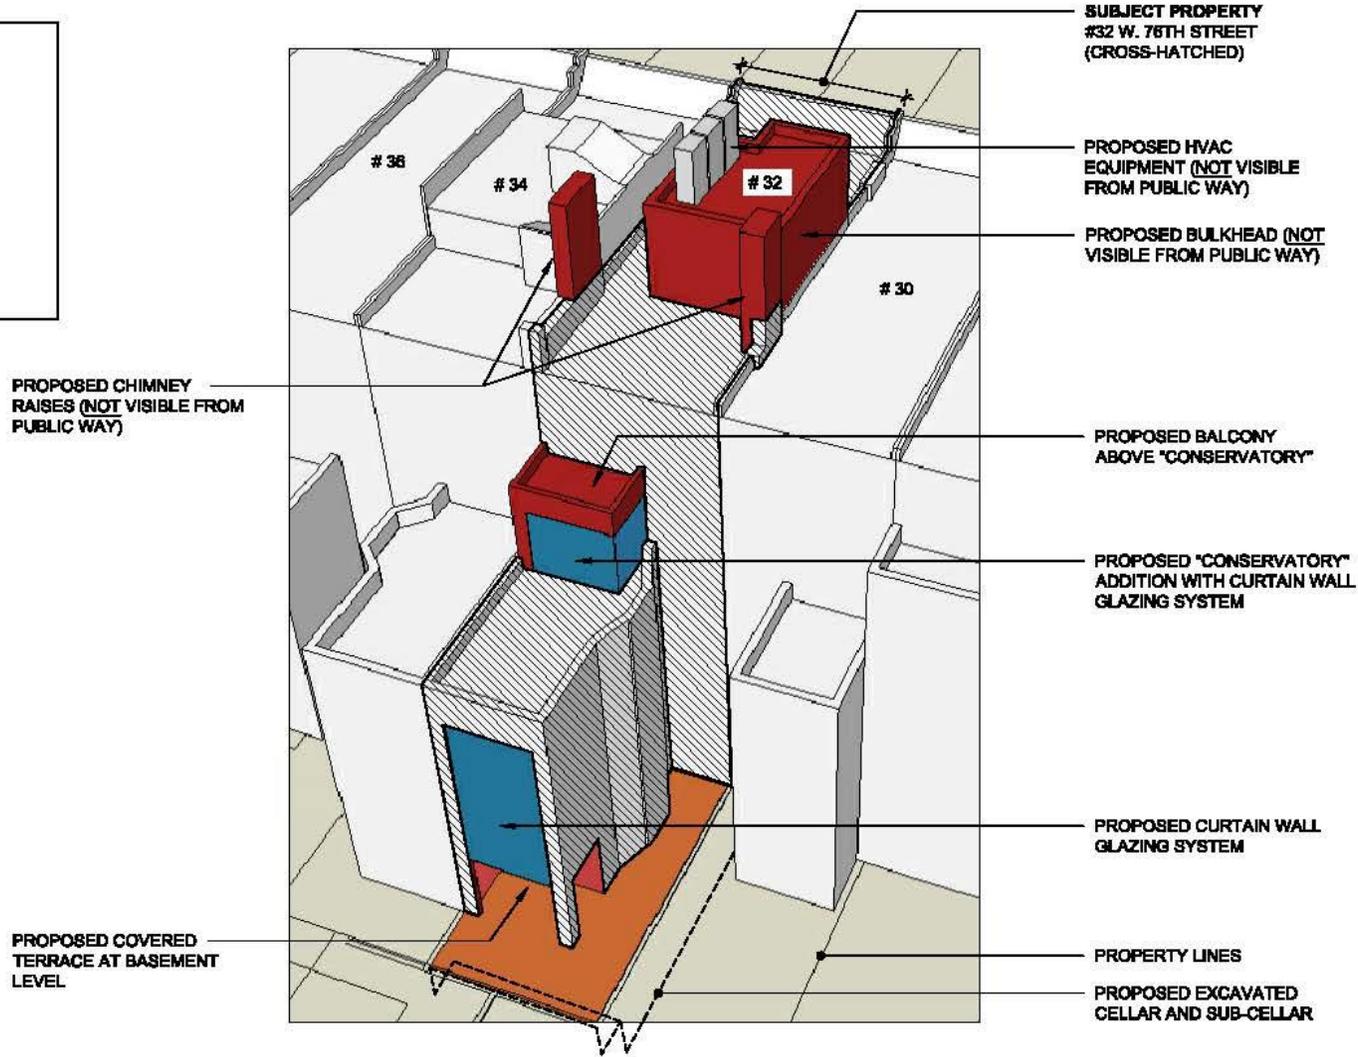
LPC-18.00

1 Aerial View of Proposed Conditions at 32 W. 76th Street Rear Extension  
Not to Scale

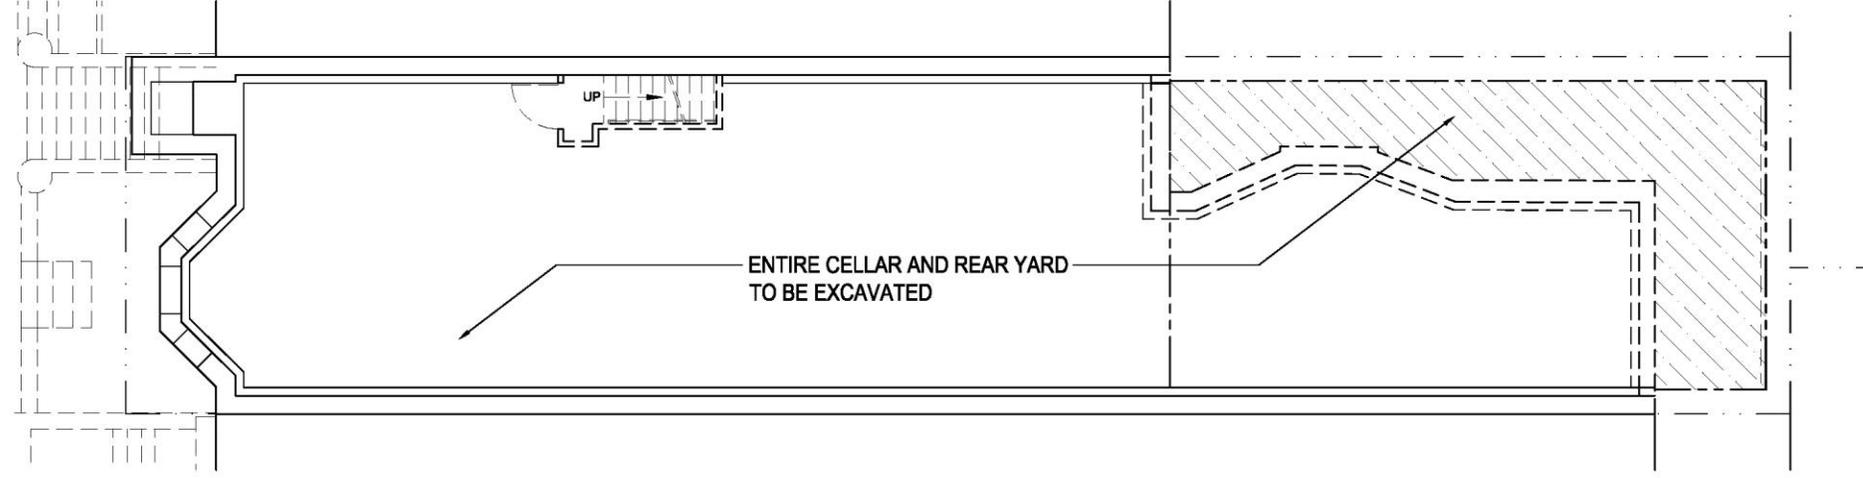
**1 Cellar - Demolition Plan**  
 Scale : 1/8" = 1'-0"

**NOTE:**  
 PARTIAL CELLAR EXCAVATION WITHIN EXISTING  
 BUILDING FOOTPRINT (2'-6" BELOW EXISTING SLAB)  
 UNDER PRIOR LPC PERMIT (DOCKET # 16-6255 ) &  
 DOB APPLICATION.

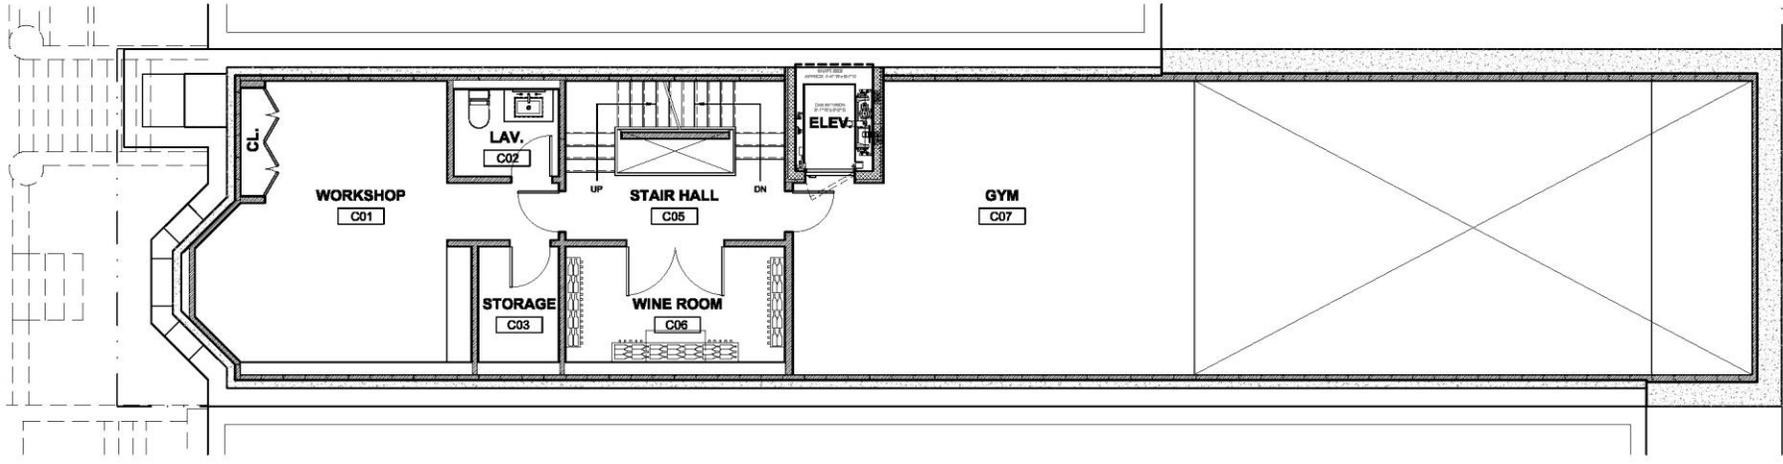
2 Cellar - Proposed Plan  
Scale : 1/8" = 1'-0"

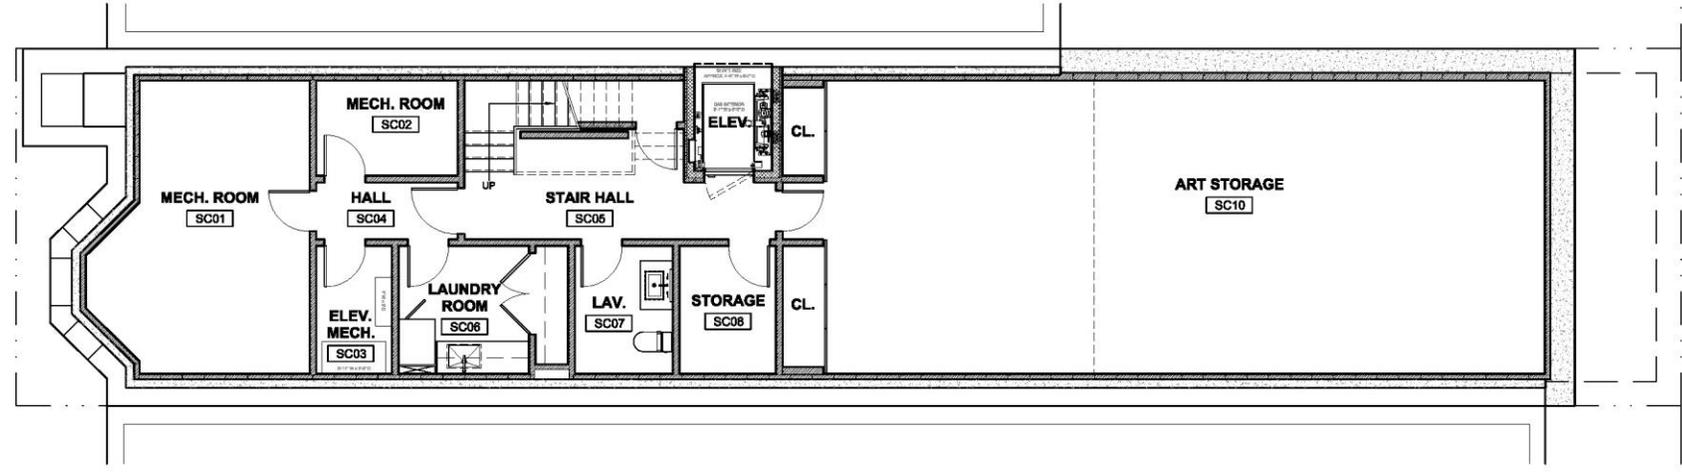
1 Sub-Cellar - Proposed Plan  
Scale : 1/8" = 1'-0"

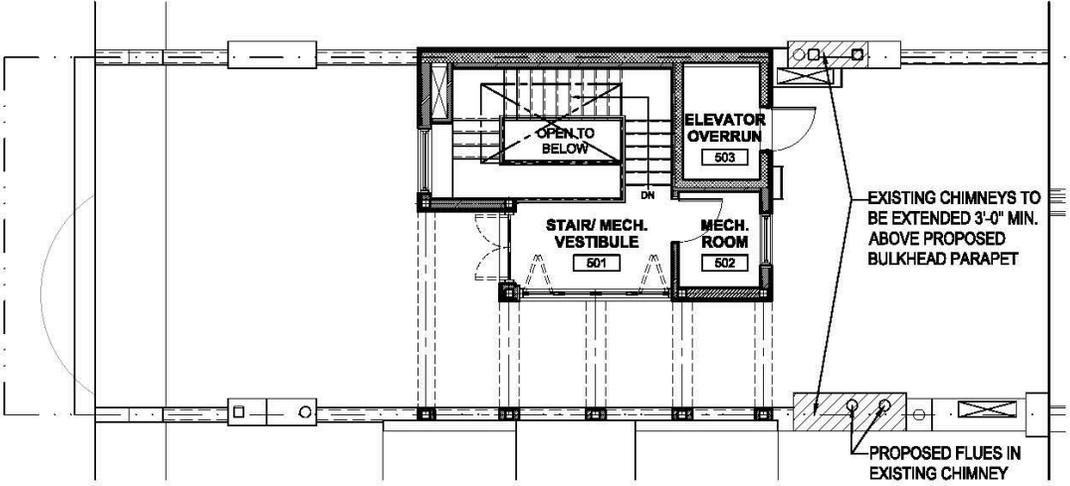
2 Proposed Bulkhead Level & Roof Plan  
Scale : 1/8" = 1'-0"

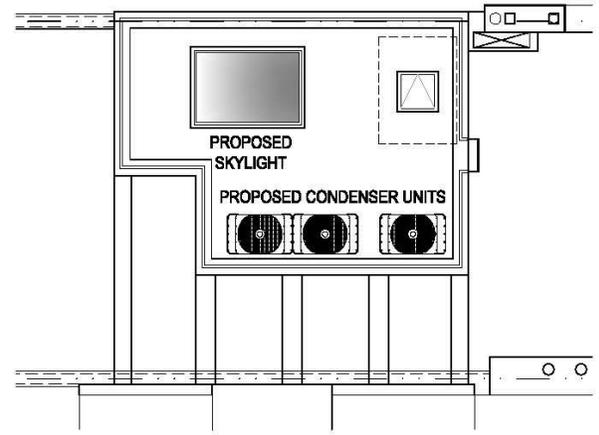
3 Proposed Bulkhead Roof Plan  
Scale : 1/8" = 1'-0"
