**202 NORTH 10TH STREET**

# **Remedial Investigation Report**

**NYC VCP Site Number: 15CVCP101K**

**MARCH 2015**

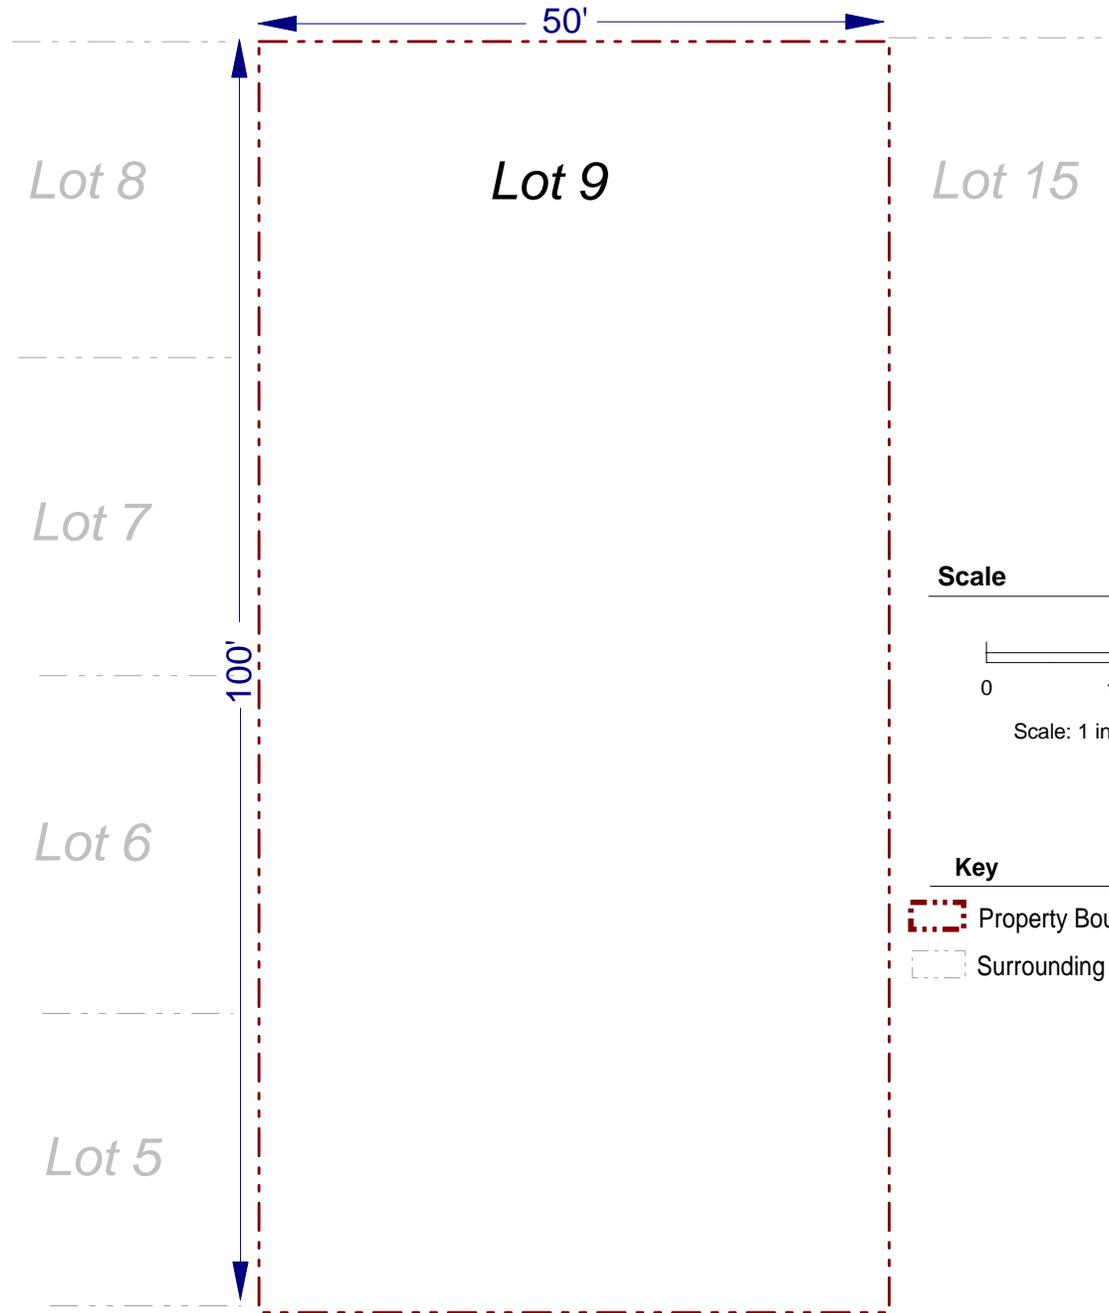
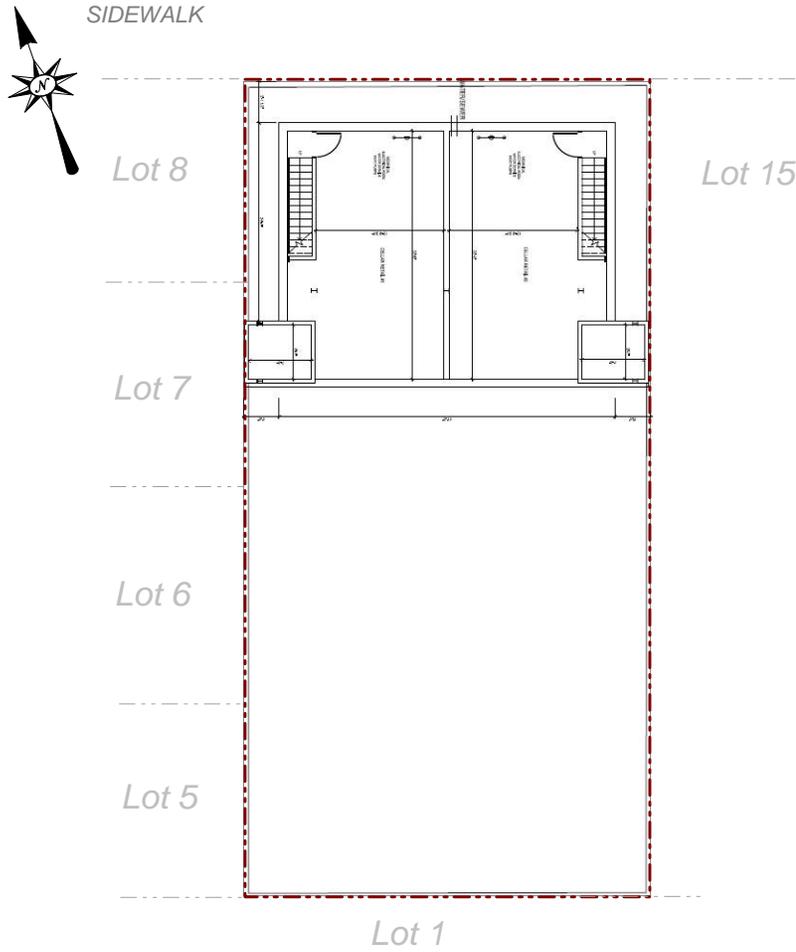
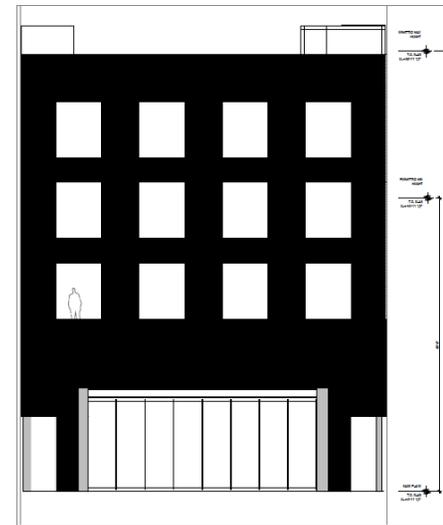
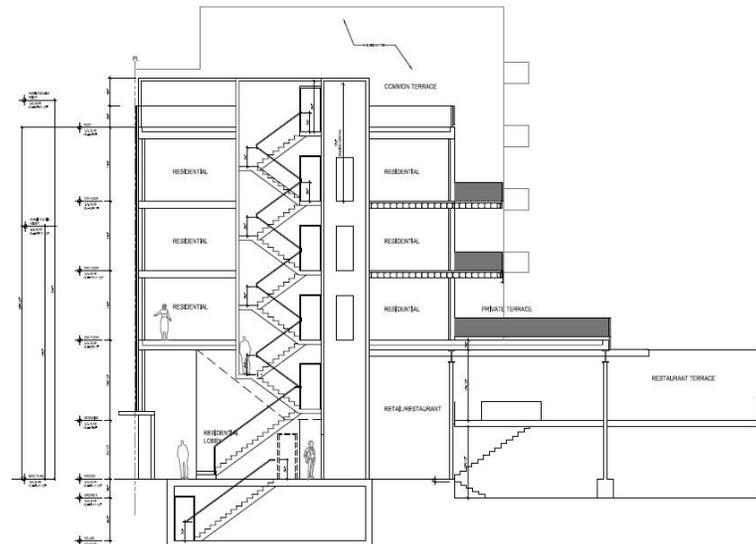
**FIGURE 3 REDEVELOPMENT PLANS**

Layout of the redevelopment plans for the cellar and first floor is presented in Figure 3. The current zoning designation is M1-2/R6A. The proposed use is consistent with existing zoning for the property.

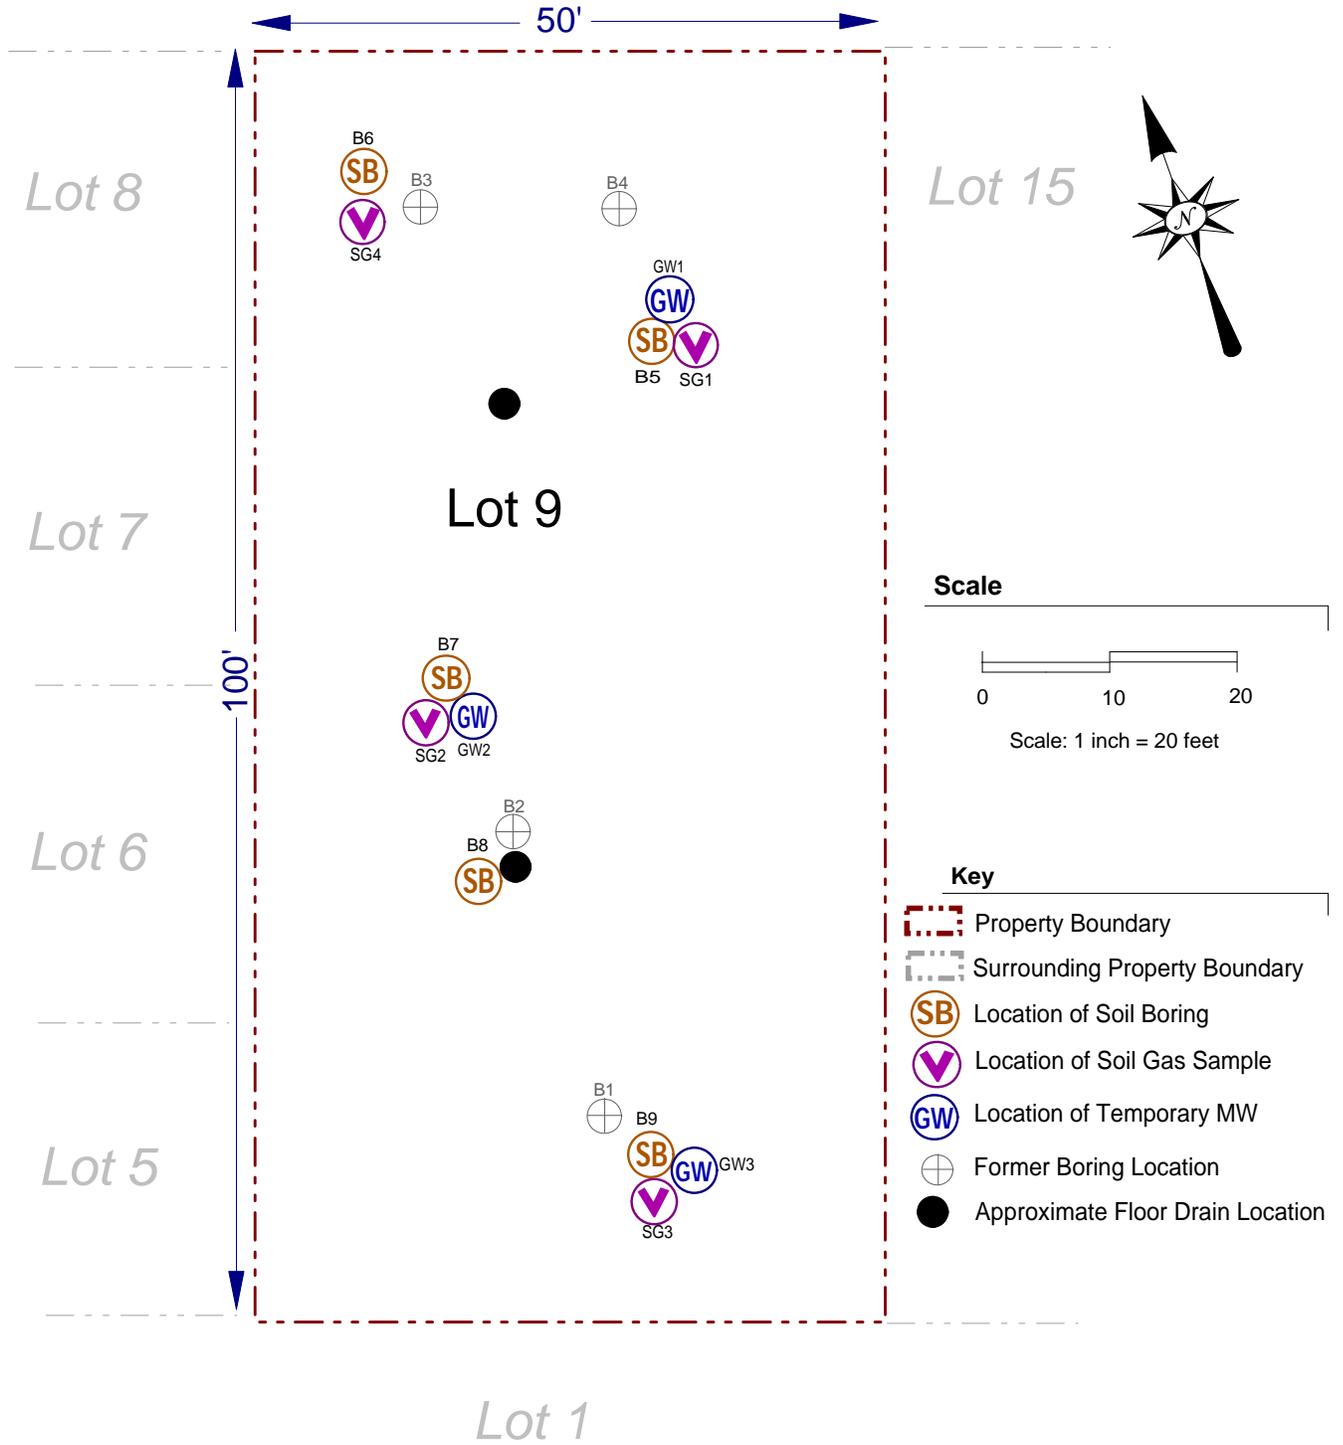
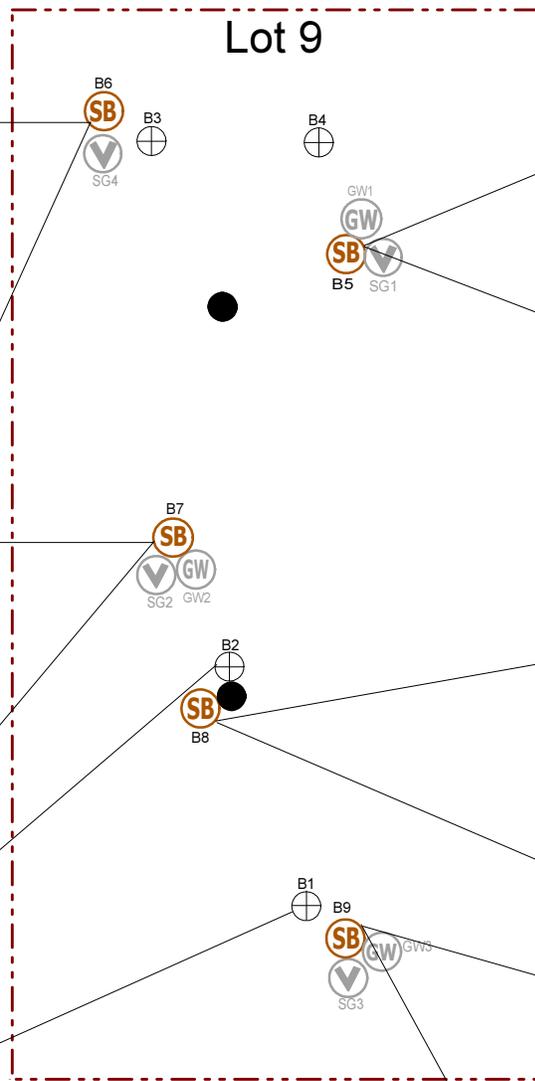
The soil vapor probes were installed using Geoprobe™ equipment and tooling. The approximate location of each of the soil vapor probes is shown on Figure 5. The vapor probes that were installed were the Geoprobe™ Model AT86 series, which are constructed of a 6-inch length of double woven stainless steel wire. The soil vapor probes were installed to a depth of approximately 5 to 6 feet below grade. Each probe was attached to ¼ inch polyethylene tubing which extended approximately 18 inches beyond that needed to reach the surface. The tubing was capped with a ¼ inch plastic end to prevent the infiltration of foreign particles into the tube. Coarse sand was placed around the probe to a height of approximately 1 foot above the bottom of the probe. The remainder of the borehole was sealed with a bentonite slurry to the surface.

Benz(a)anthracene	11,000
Benzo(a)pyrene	9,000
Benzo(b)fluoranthene	13,000
Benzo(k)fluoranthene	3,800
Chrysene	13,000
Dibenz(a,h)anthracene	1,700
Indeno(1,2,3-cd)pyrene	5,300
Arsenic	28.9
Chromium	55.4
Copper	294
Lead	441
Mercury	3.41

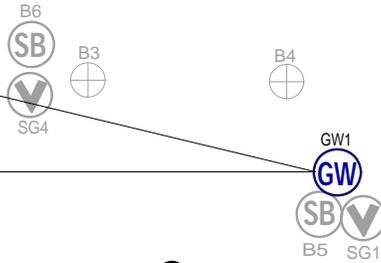
Figure No.  
**7**

SVOCs (µg/L)	
Benz(a)anthracene	0.06
Chrysene	0.05
Dissolved Metals (mg/L)	
Manganese	0.584
Sodium	58.2

Site Name: **REDEVELOPMENT PROJECT**  
 Site Address: **202 N 10TH STREET, BROOKLYN, NY**  
 Drawing Title: **GROUND WATER EXCEEDENCES**

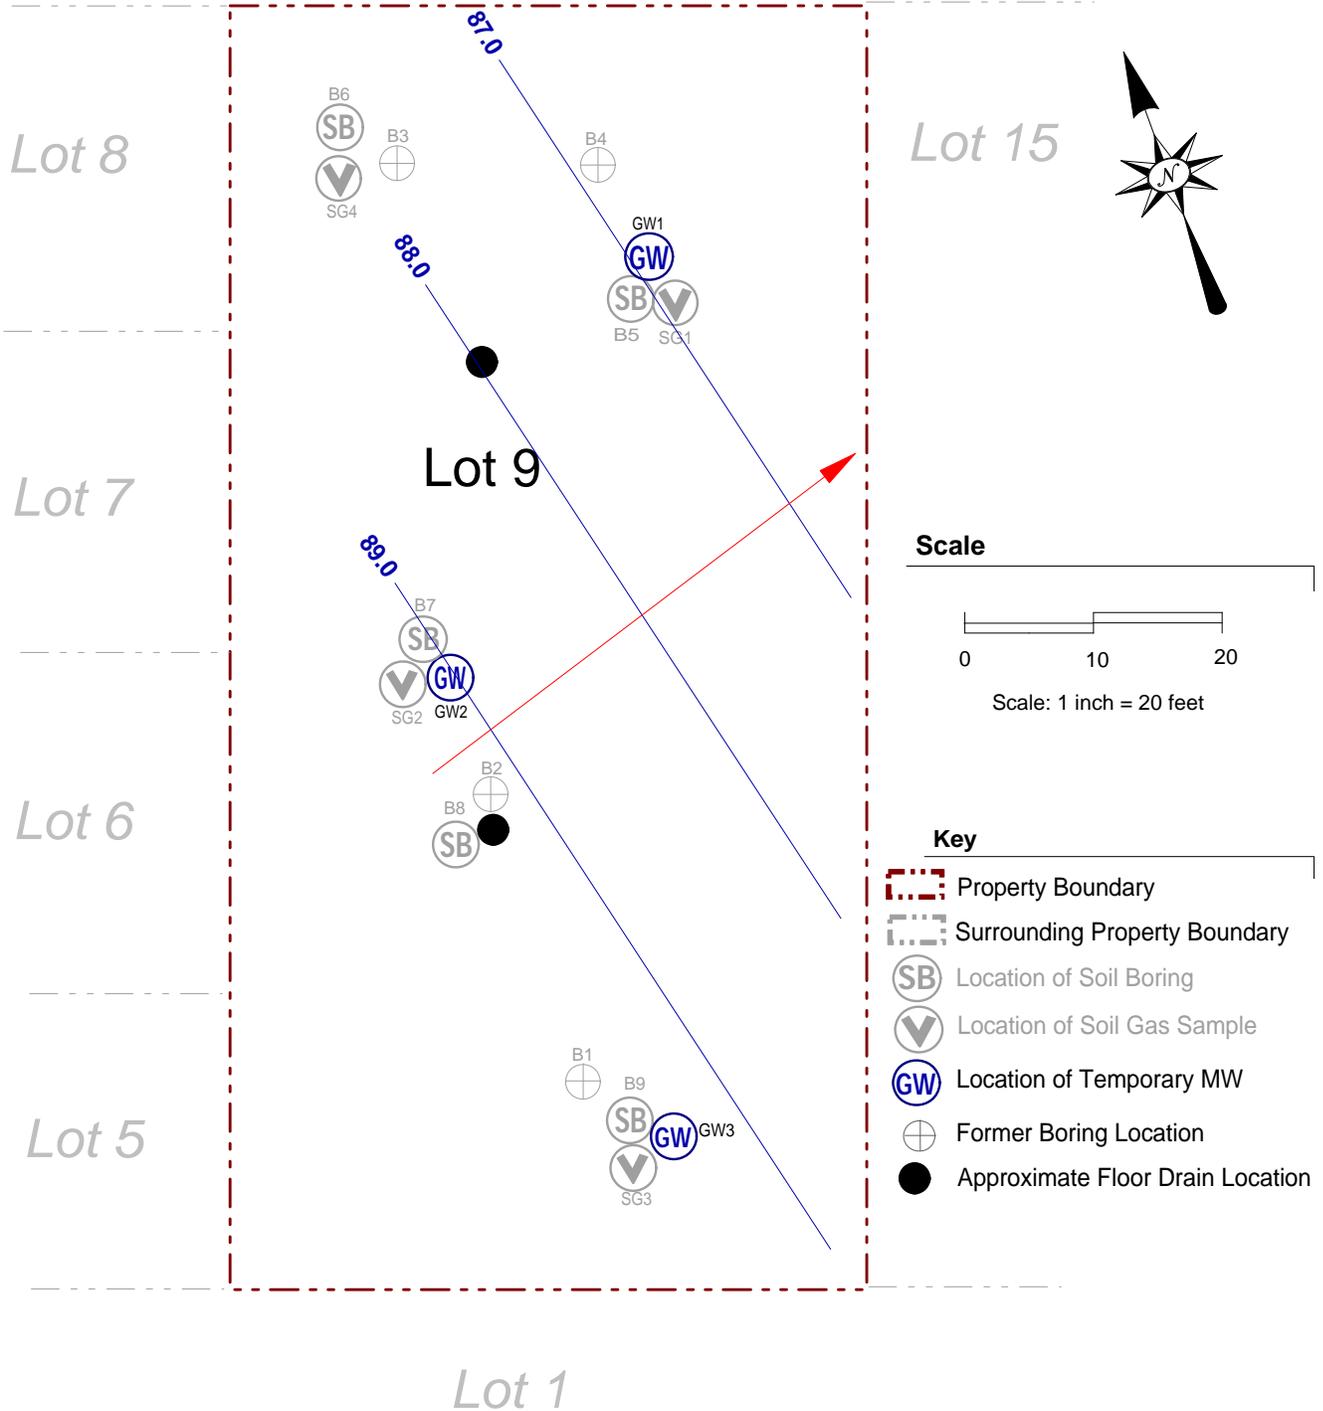
Figure No. **9**

Site Name: **REDEVELOPMENT PROJECT**  
 Site Address: **202 N 10TH STREET, BROOKLYN, NY**  
 Drawing Title: **GROUND WATER CONTOUR MAP**

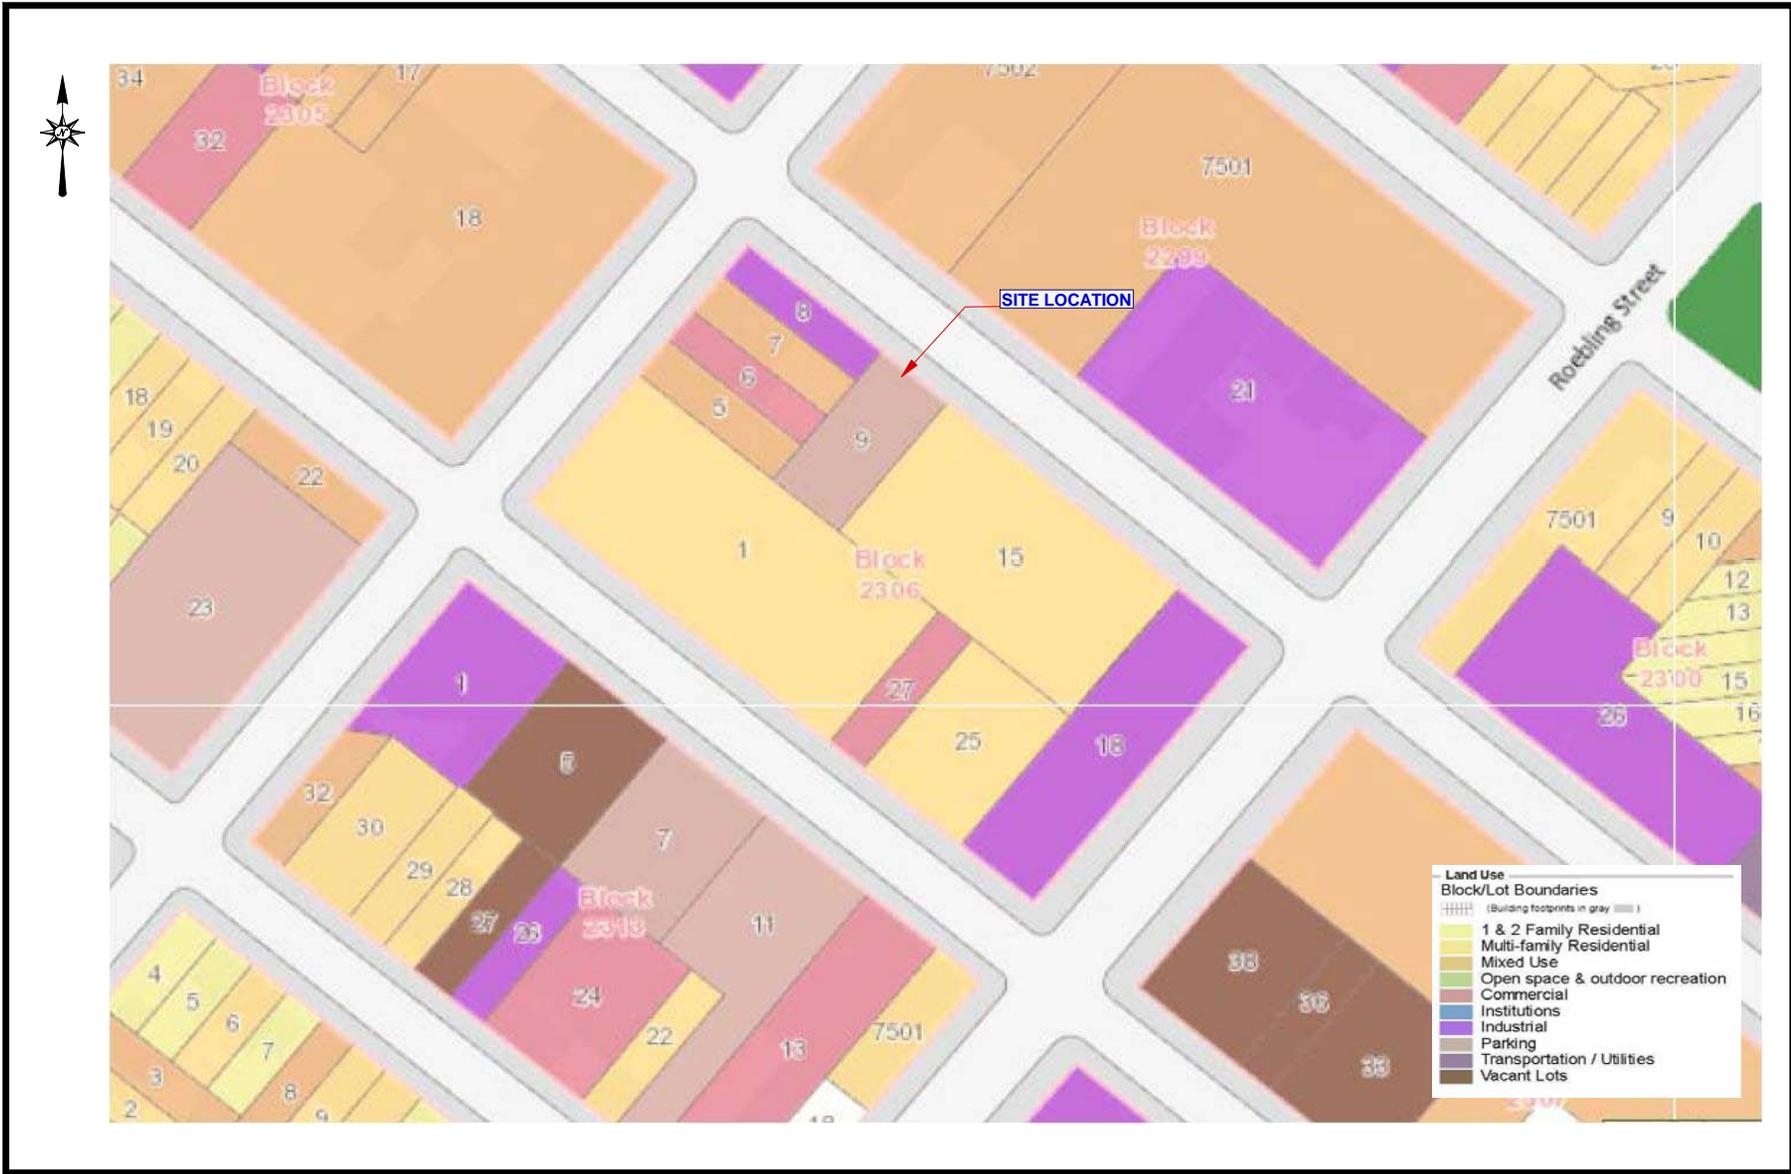
**Figure No.**  
**2**

The Site is located at 202 N 10th Street in the Williamsburg section of Brooklyn, New York, and is currently identified as Block 2306, Lot 9 on the New York City Tax Map. Figure 1 shows the Site location. Lot 9 is a rectangular shaped lot consisting of 50 feet of street frontage on N 10th Street and extending to a depth of approximately 100 feet for a total of approximately 5,000 ft<sup>2</sup>. The Site is located on the south side of North 10<sup>th</sup> Street between Driggs Avenue and Roebling Street and is bordered by two mixed use commercial and residential buildings, a commercial building, and an industrial building to the northwest (487 to 481 Driggs Avenue), a residential multi-family elevator building to the southeast (208 N 10th Street); a mixed residential and commercial use building to the northeast, across N 10th Street (214 N 11 Street); and a residential multi-family elevator building (205 N 9th Street) to the southwest. A map of the site boundary is shown on Figure 2.
