**23 WEST 116TH STREET
(BLOCK 1600, LOT 20)
MANHATTAN, NEW YORK**

Remedial Action Work Plan

**NYC BCP Number: 12CBCP033M & 12CBCP034M
NYC OER E-Designation Project Number: 12RH-A116M**

DECEMBER 2011

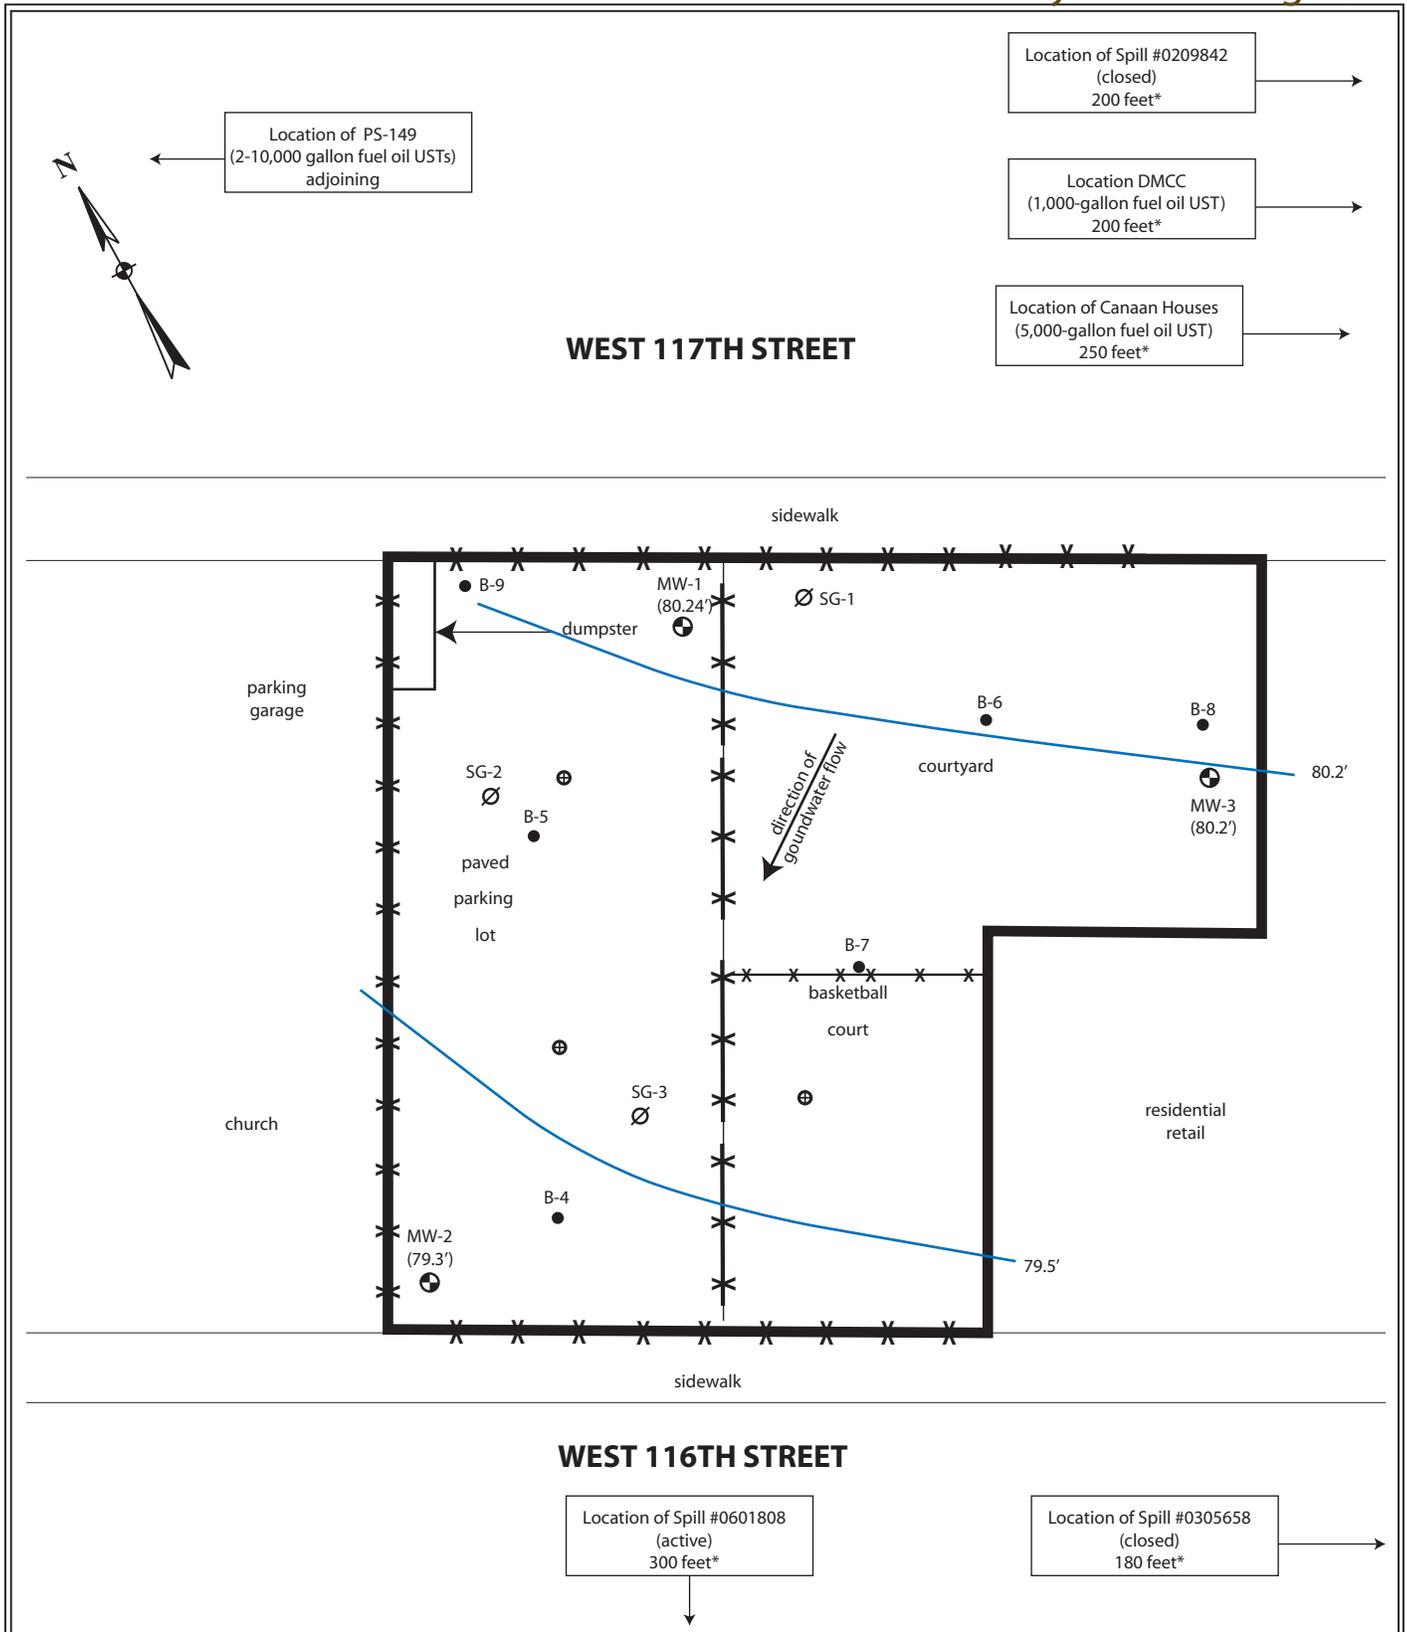
Figure 1: Fieldwork Map

All feature locations are approximate. This map is intended as a schematic to be used in conjunction with the associated report, and it should not be relied upon as a survey for planning or other activities.

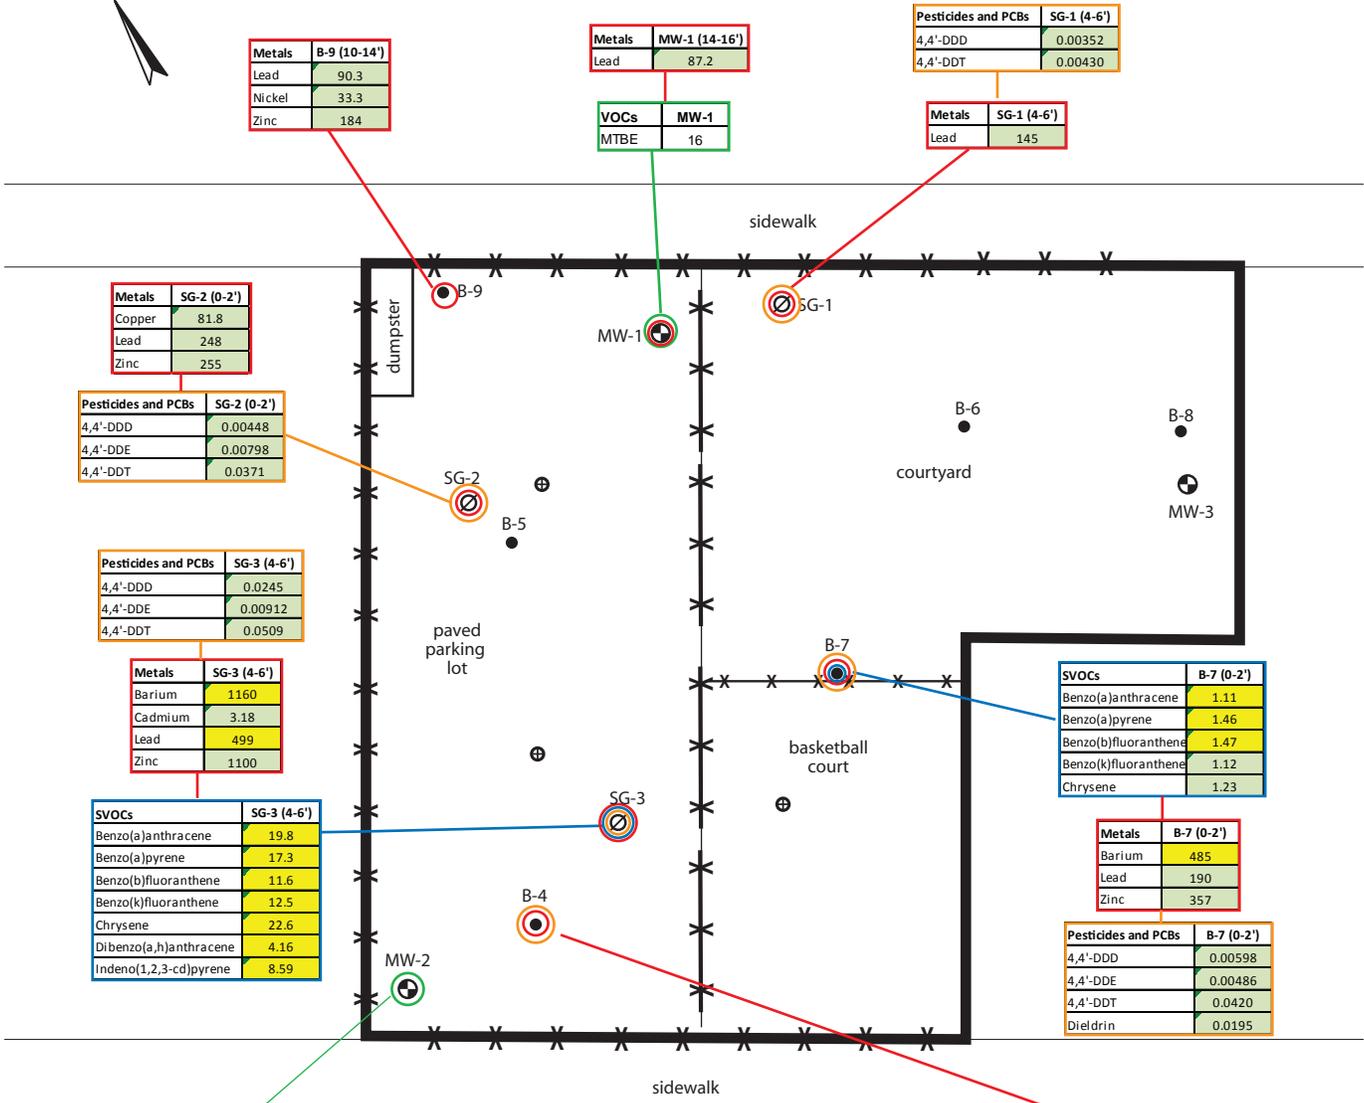
Contaminant	Location	Concentration	Exceedance Type
Metals	B-9 (10-14')	Lead: 90.3, Nickel: 33.3, Zinc: 184	Exceedance of metals in soil
Metals	MW-1 (14-16')	Lead: 87.2	Exceedance of metals in soil
Pesticides and PCBs	SG-1 (4-6')	4,4'-DDD: 0.00352, 4,4'-DDT: 0.00430	Exceedance of pesticides and PCBs in soil
Metals	SG-1 (4-6')	Lead: 145	Exceedance of metals in soil
Metals	SG-2 (0-2')	Copper: 81.8, Lead: 248, Zinc: 255	Exceedance of metals in soil
Pesticides and PCBs	SG-2 (0-2')	4,4'-DDD: 0.00448, 4,4'-DDE: 0.00798, 4,4'-DDT: 0.0371	Exceedance of pesticides and PCBs in soil
Pesticides and PCBs	SG-3 (4-6')	4,4'-DDD: 0.0245, 4,4'-DDE: 0.00912, 4,4'-DDT: 0.0509	Exceedance of pesticides and PCBs in soil
Metals	SG-3 (4-6')	Barium: 1160, Cadmium: 3.18, Lead: 499, Zinc: 1100	Exceedance of metals in soil
SVOCs	SG-3 (4-6')	Benzo(a)anthracene: 19.8, Benzo(a)pyrene: 17.3, Benzo(b)fluoranthene: 11.6, Benzo(k)fluoranthene: 12.5, Chrysene: 22.6, Di benzo(a,h)anthracene: 4.16, Indeno(1,2,3-cd)pyrene: 8.59	Exceedance of SVOCs in soil

SVOCs	B-7 (0-2')	Benzo(a)anthracene: 1.11, Benzo(a)pyrene: 1.46, Benzo(b)fluoranthene: 1.47, Benzo(k)fluoranthene: 1.12, Chrysene: 1.23	Exceedance of SVOCs in soil
Metals	B-7 (0-2')	Barium: 485, Lead: 190, Zinc: 357	Exceedance of metals in soil
Pesticides and PCBs	B-7 (0-2')	4,4'-DDD: 0.00598, 4,4'-DDE: 0.00486, 4,4'-DDT: 0.0420, Dieldrin: 0.0195	Exceedance of pesticides and PCBs in soil
Metals	B-4 (0-2')	Lead: 139, Zinc: 172	Exceedance of metals in soil
Pesticides and PCBs	B-4 (0-2')	4,4'-DDD: 0.00721, 4,4'-DDE: 0.00360, 4,4'-DDT: 0.00835	Exceedance of pesticides and PCBs in soil
VOCs	MW-2	cis-1,2-Dichloroethylene: 37, Tetrachloroethylene: 9.3	Exceedance of VOCs in groundwater

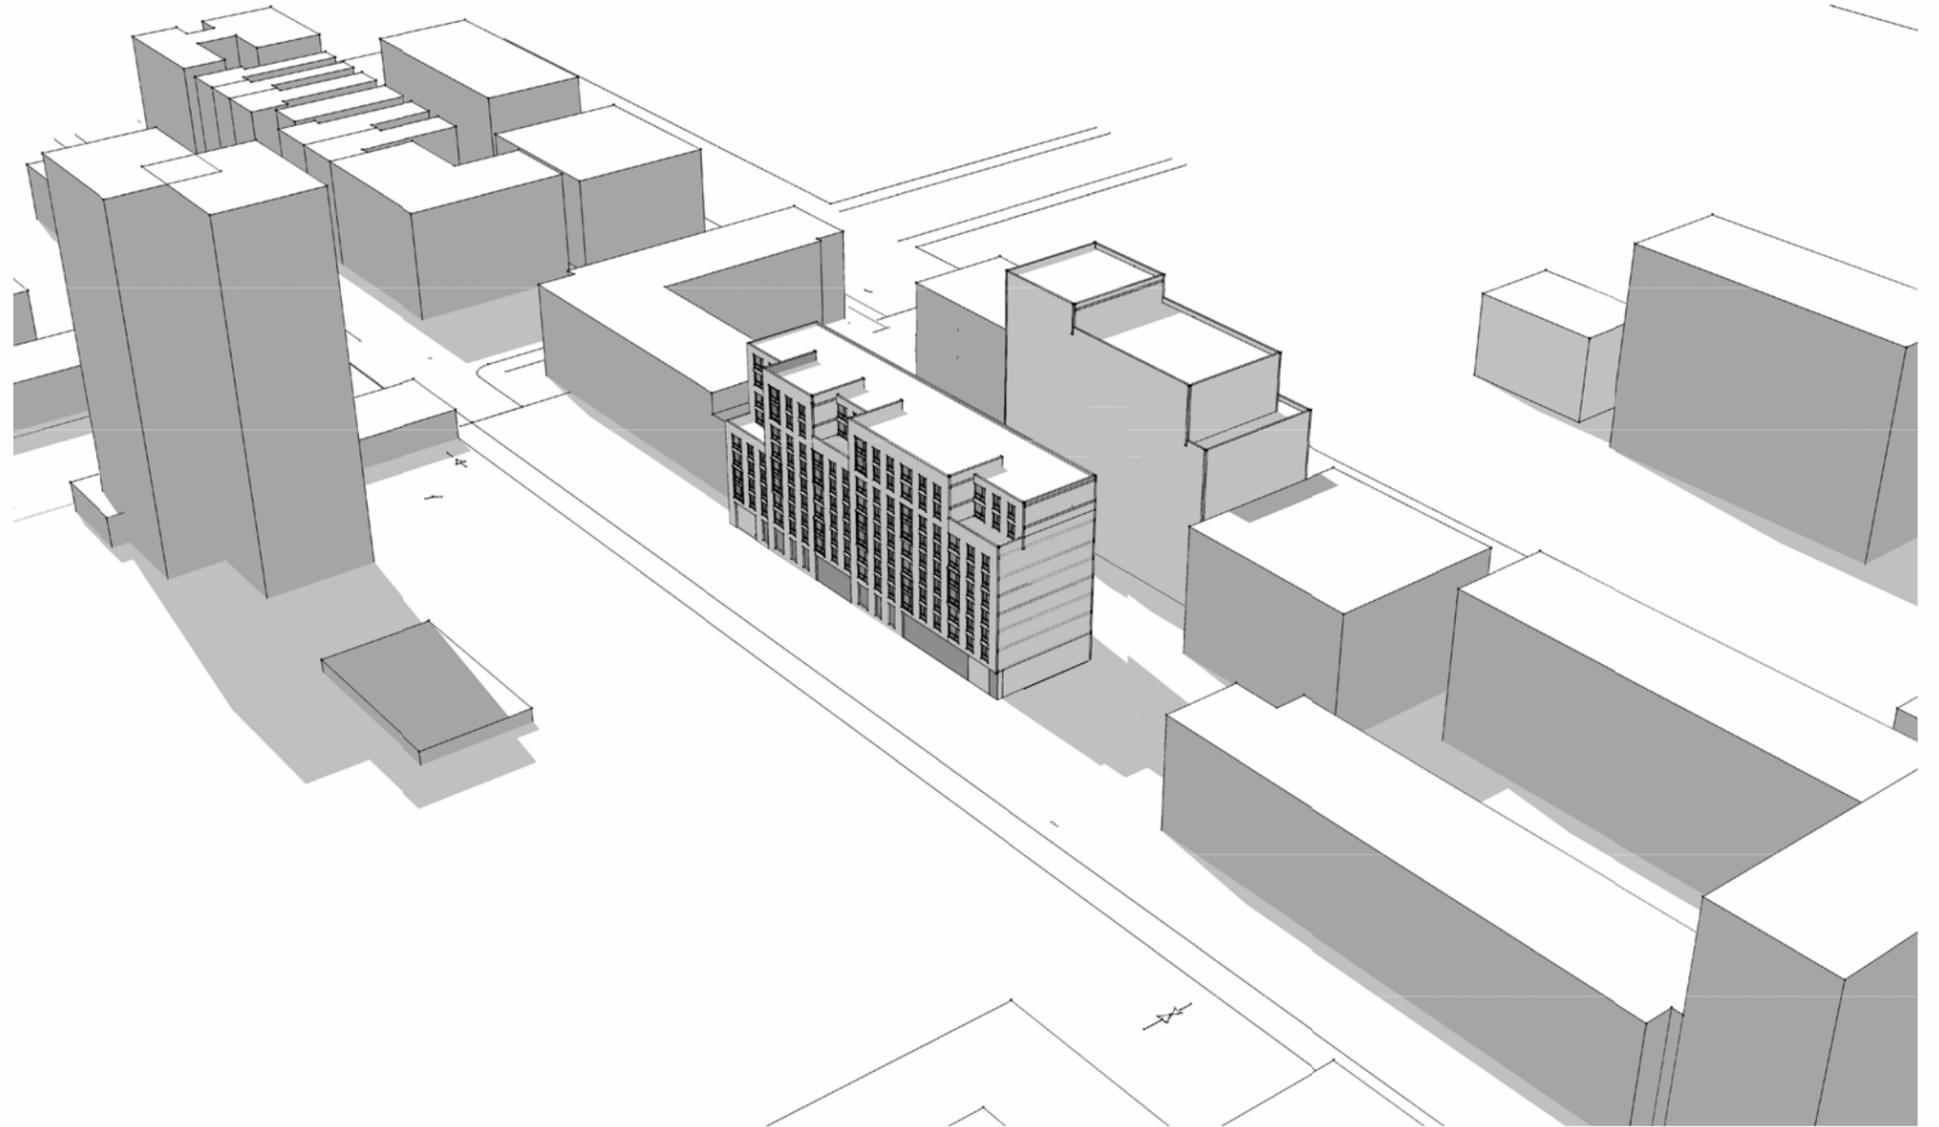
PROPOSED DEVELOPMENT AXONOMETRIC VIEW (WEST 117TH STREET)

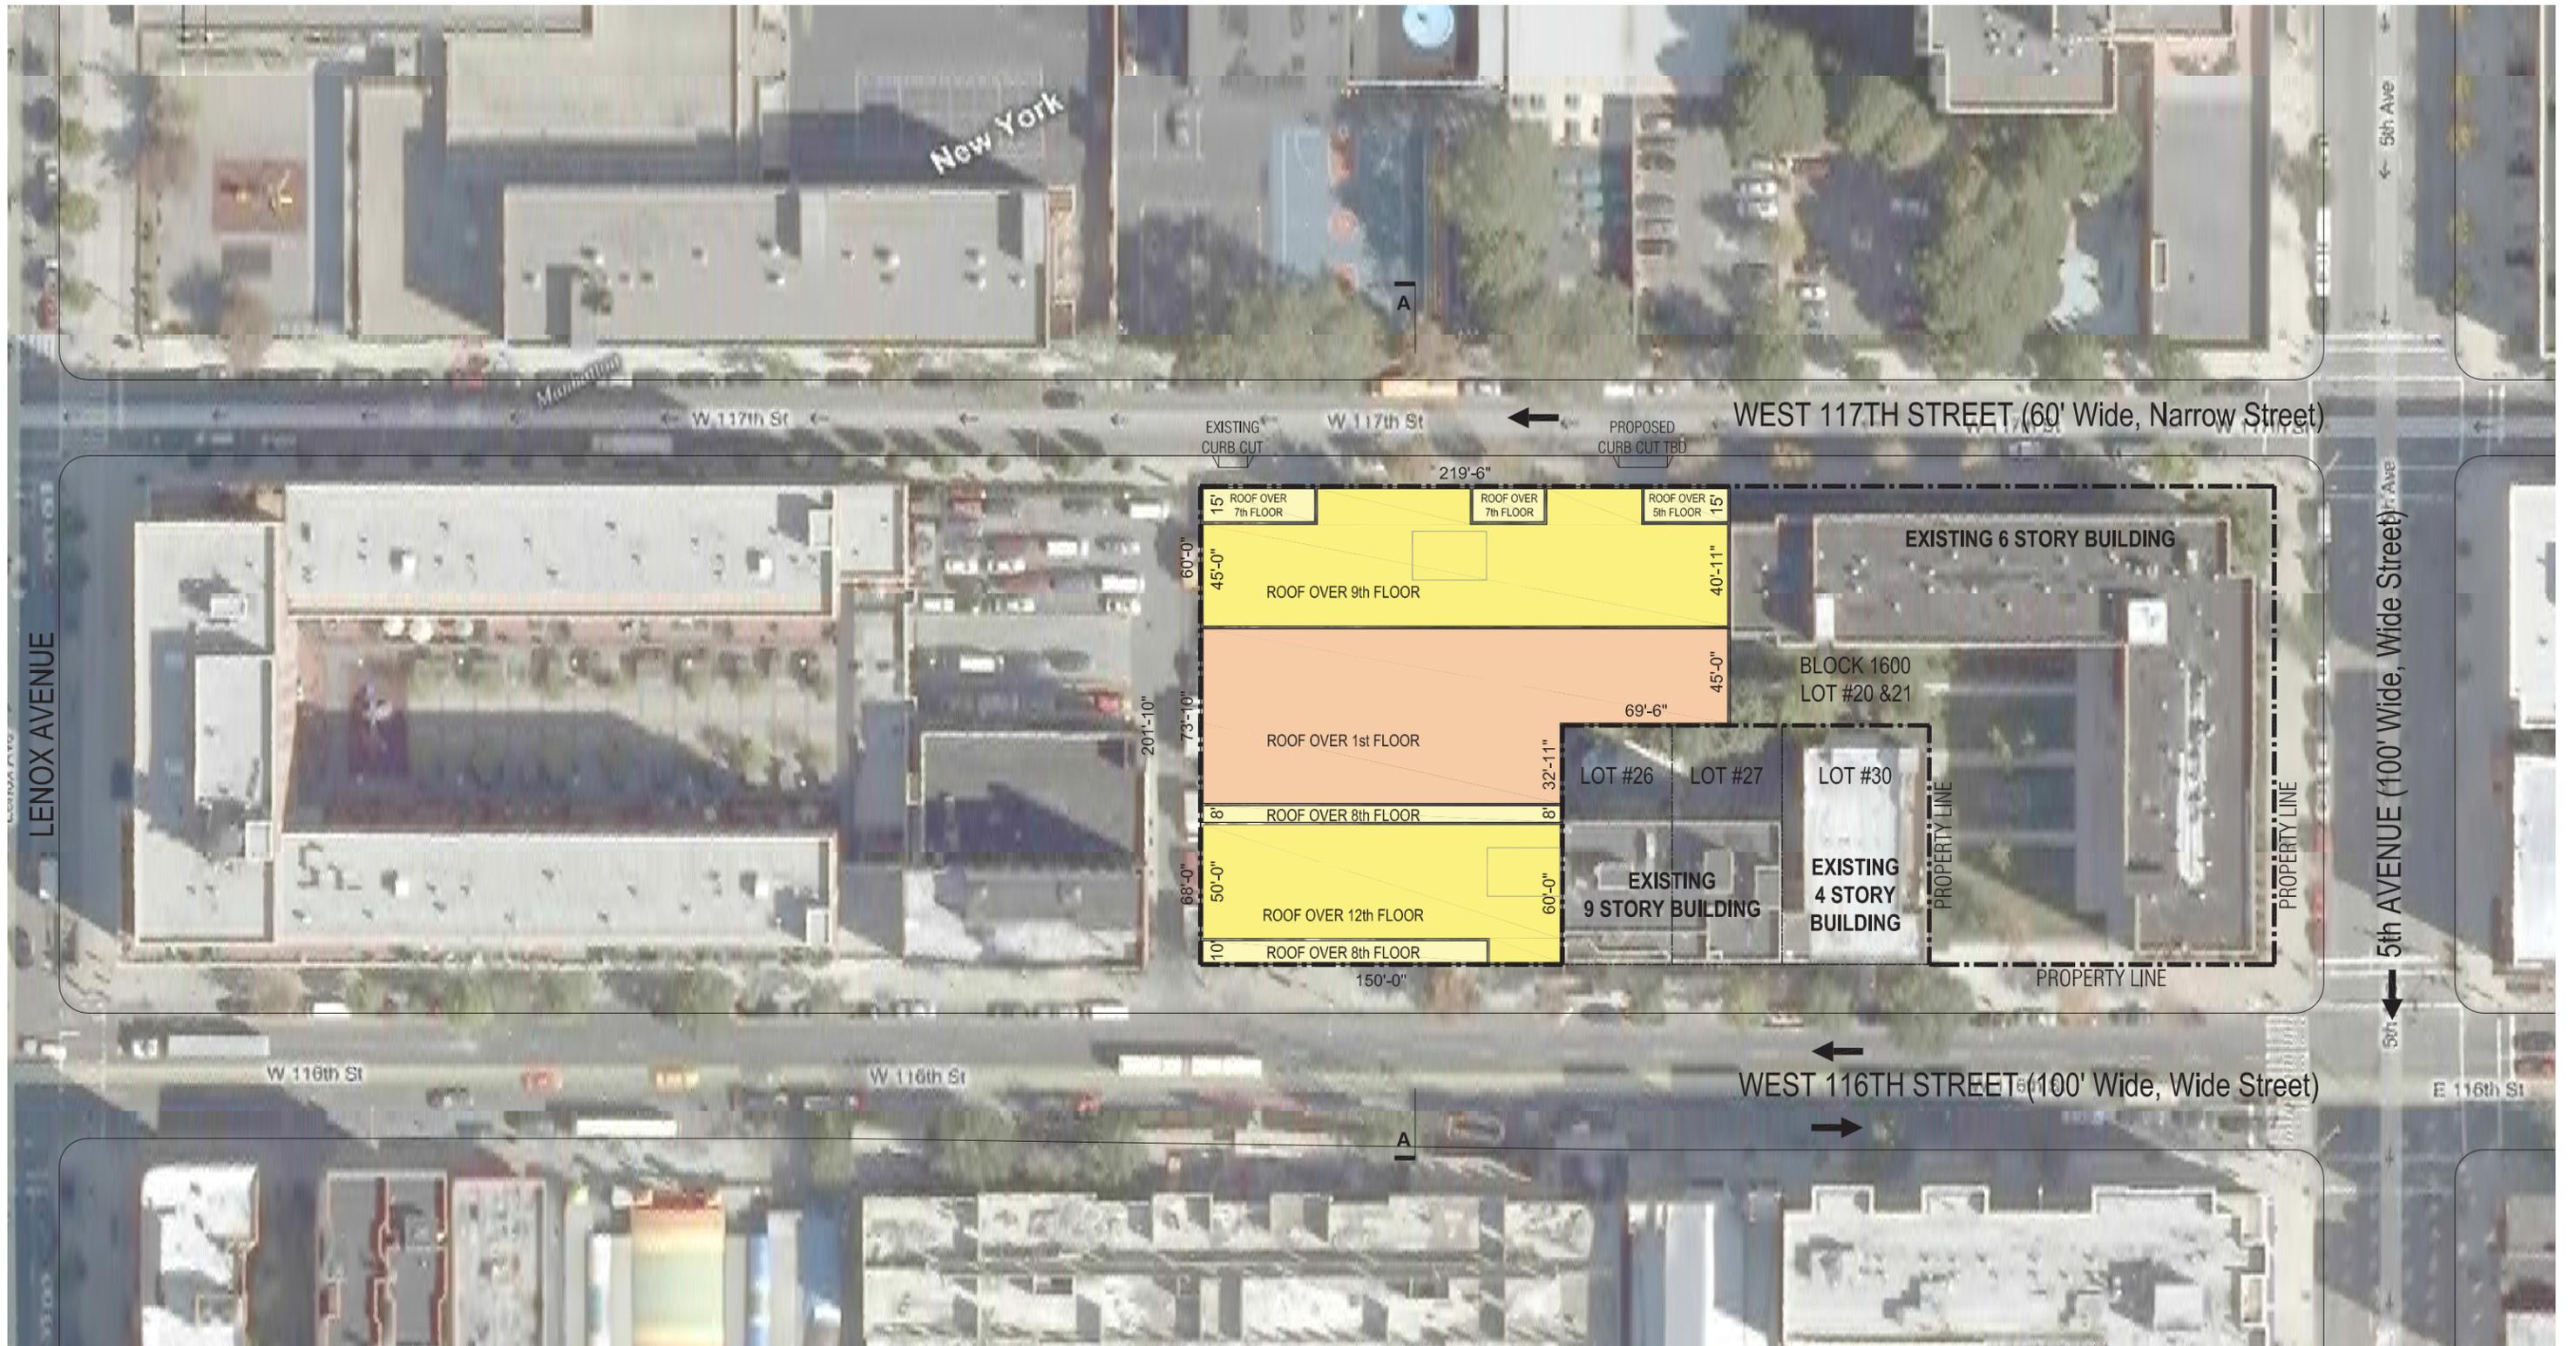
PROPOSED DEVELOPMENT SITE PLAN

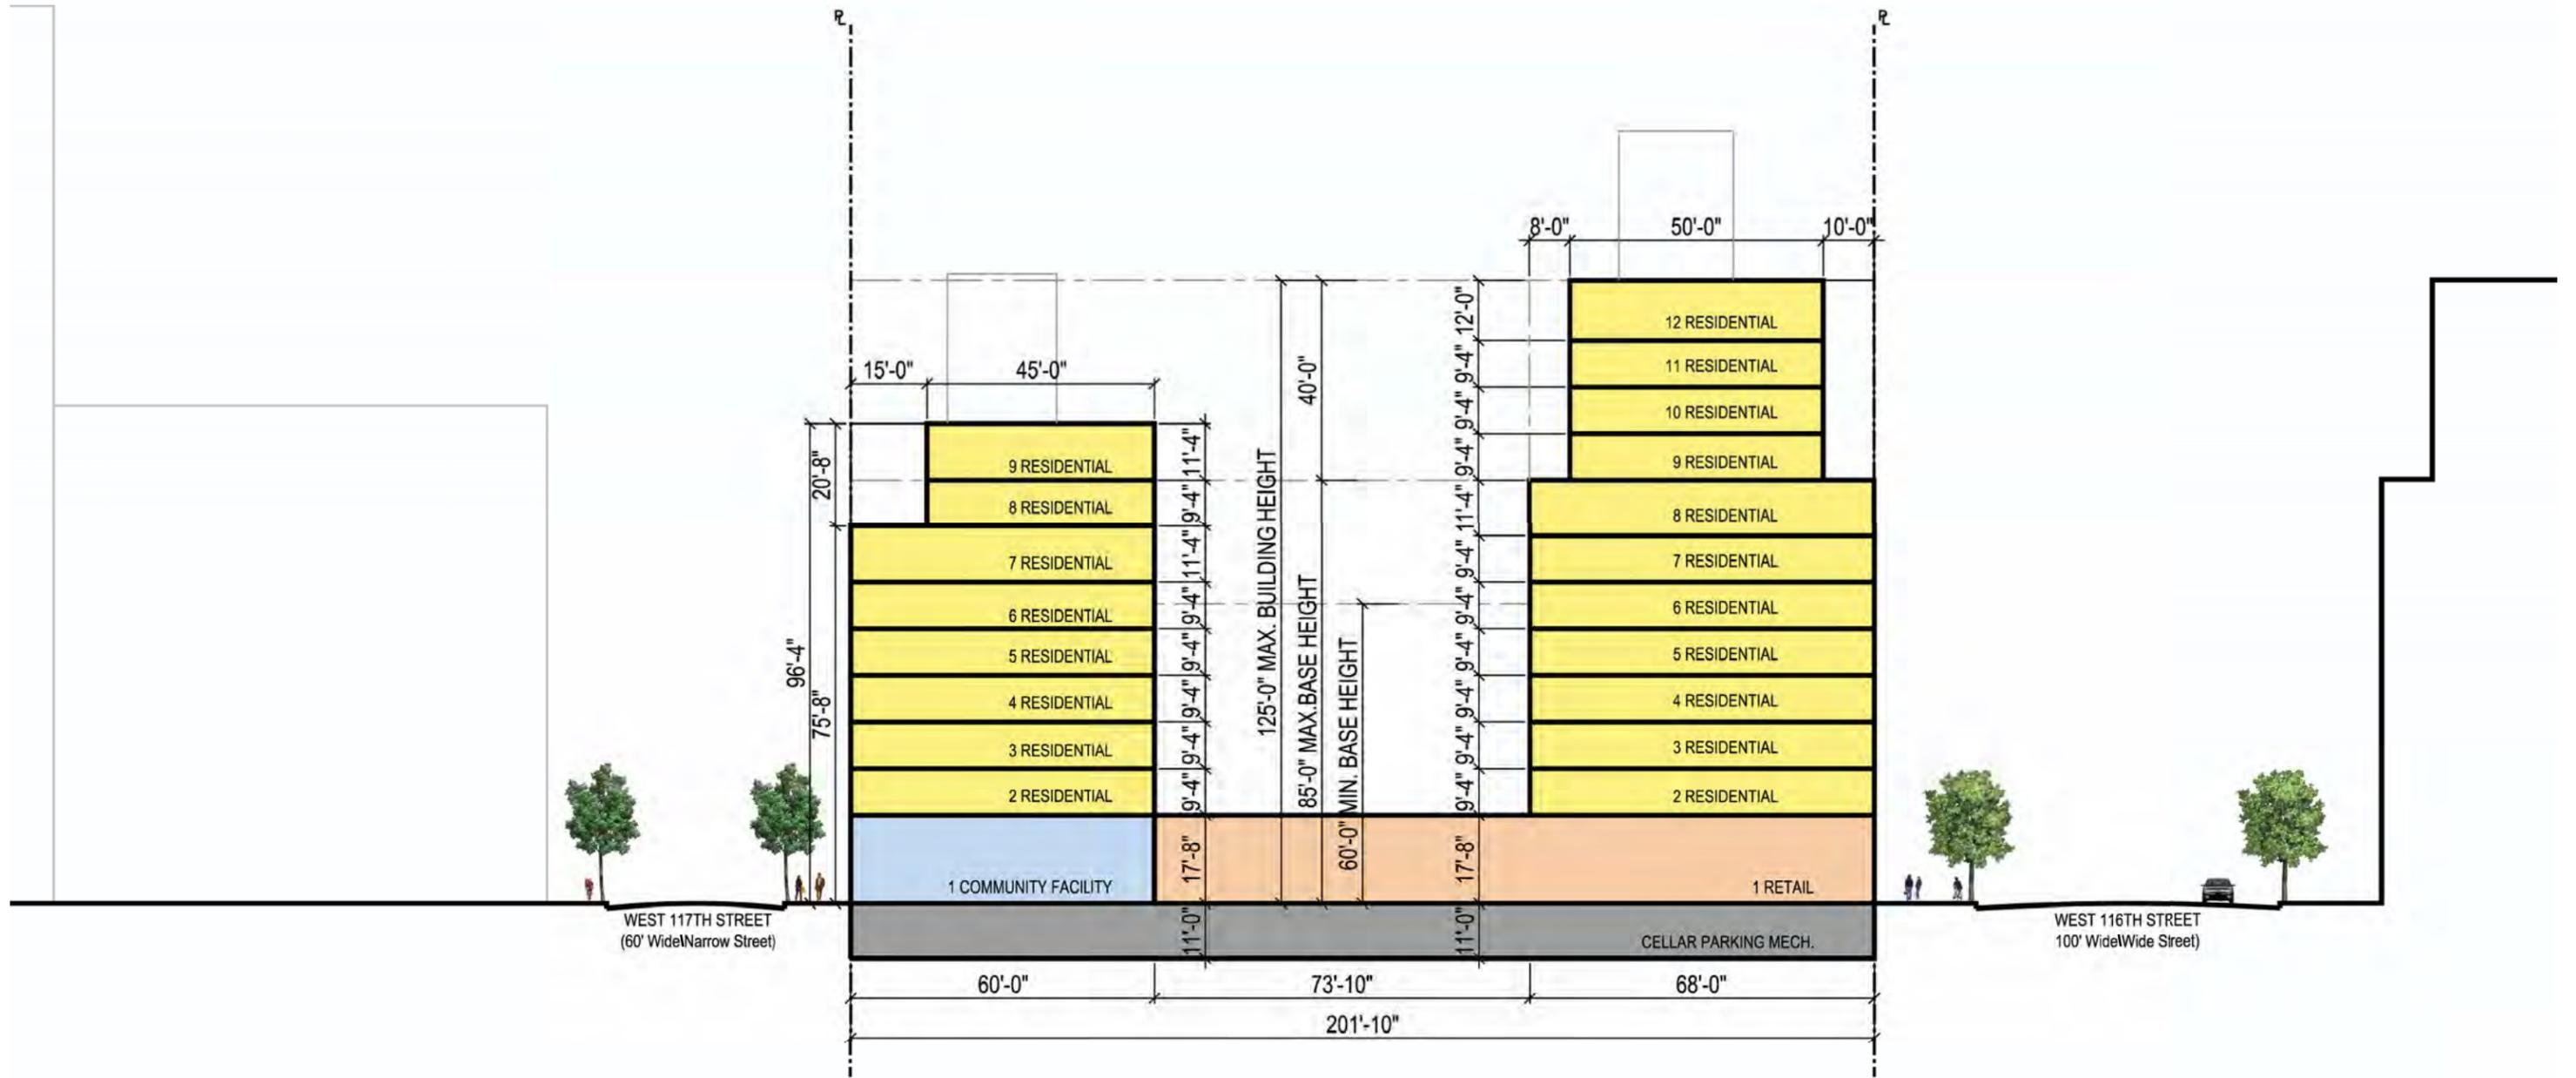
PROPOSED DEVELOPMENT SECTION A-A

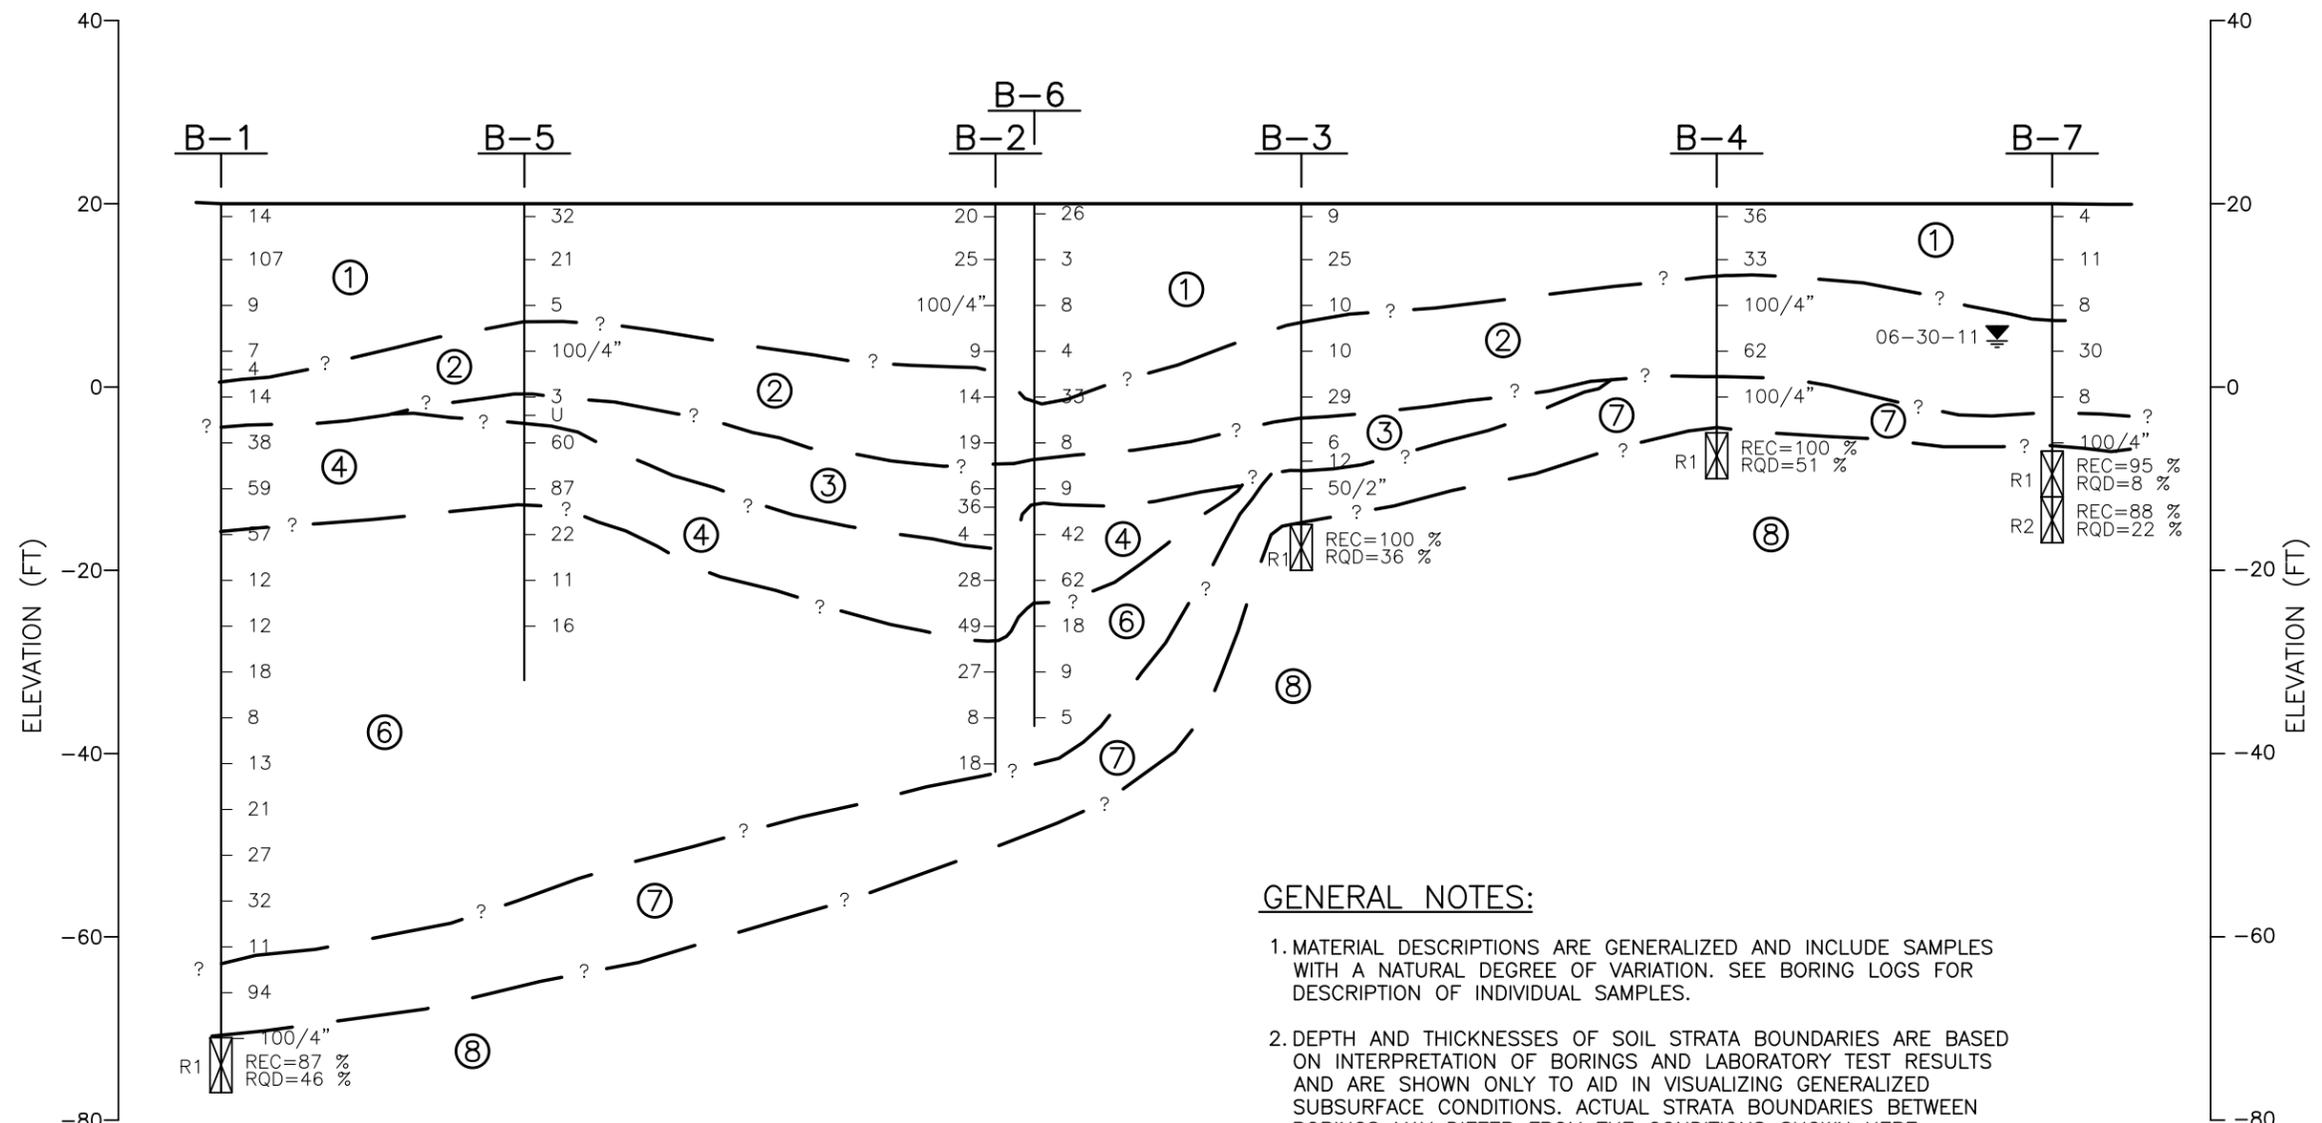
DR. BY	ET	SCALE	AS SHOWN	DWG. NO. 00377002-AA	PROJ. NO. 11100377
CK'D. BY	AF	DATE	AUGUST 8, 2011	FIG. NO.	3

- B-1**
GEOTECHNICAL BORING DRILLED BY CRAIG TEST BORING INC., UNDER URS SUPERVISION.
- CORE RUN NUMBER
- ROCK CORE RECOVERY, EXPRESSED AS A RATIO OF TOTAL LENGTH OF RECOVERED CORE TO THE LENGTH CORED, IN PERCENT
- ROCK QUALITY DESIGNATION DEFINED AS THE TOTAL LENGTH OF ALL THE PIECES OF CORE 4-INCH OR LARGER DIVIDED BY TOTAL LENGTH OF CORE RUN, IN PERCENT
- N-VALUE, DEFINED AS NUMBER OF BLOWS OF A 140-LB HAMMER FREE FALLING FOR 30 INCHES REQUIRED TO ADVANCE A STANDARD SPLIT SPOON SAMPLER 12 INCHES AFTER INITIAL 6 INCH PENETRATION
- APPROXIMATE STRATA BOUNDARY
- WATER LEVEL IN THE OBSERVATION WELL AND DATE OF OBSERVATION

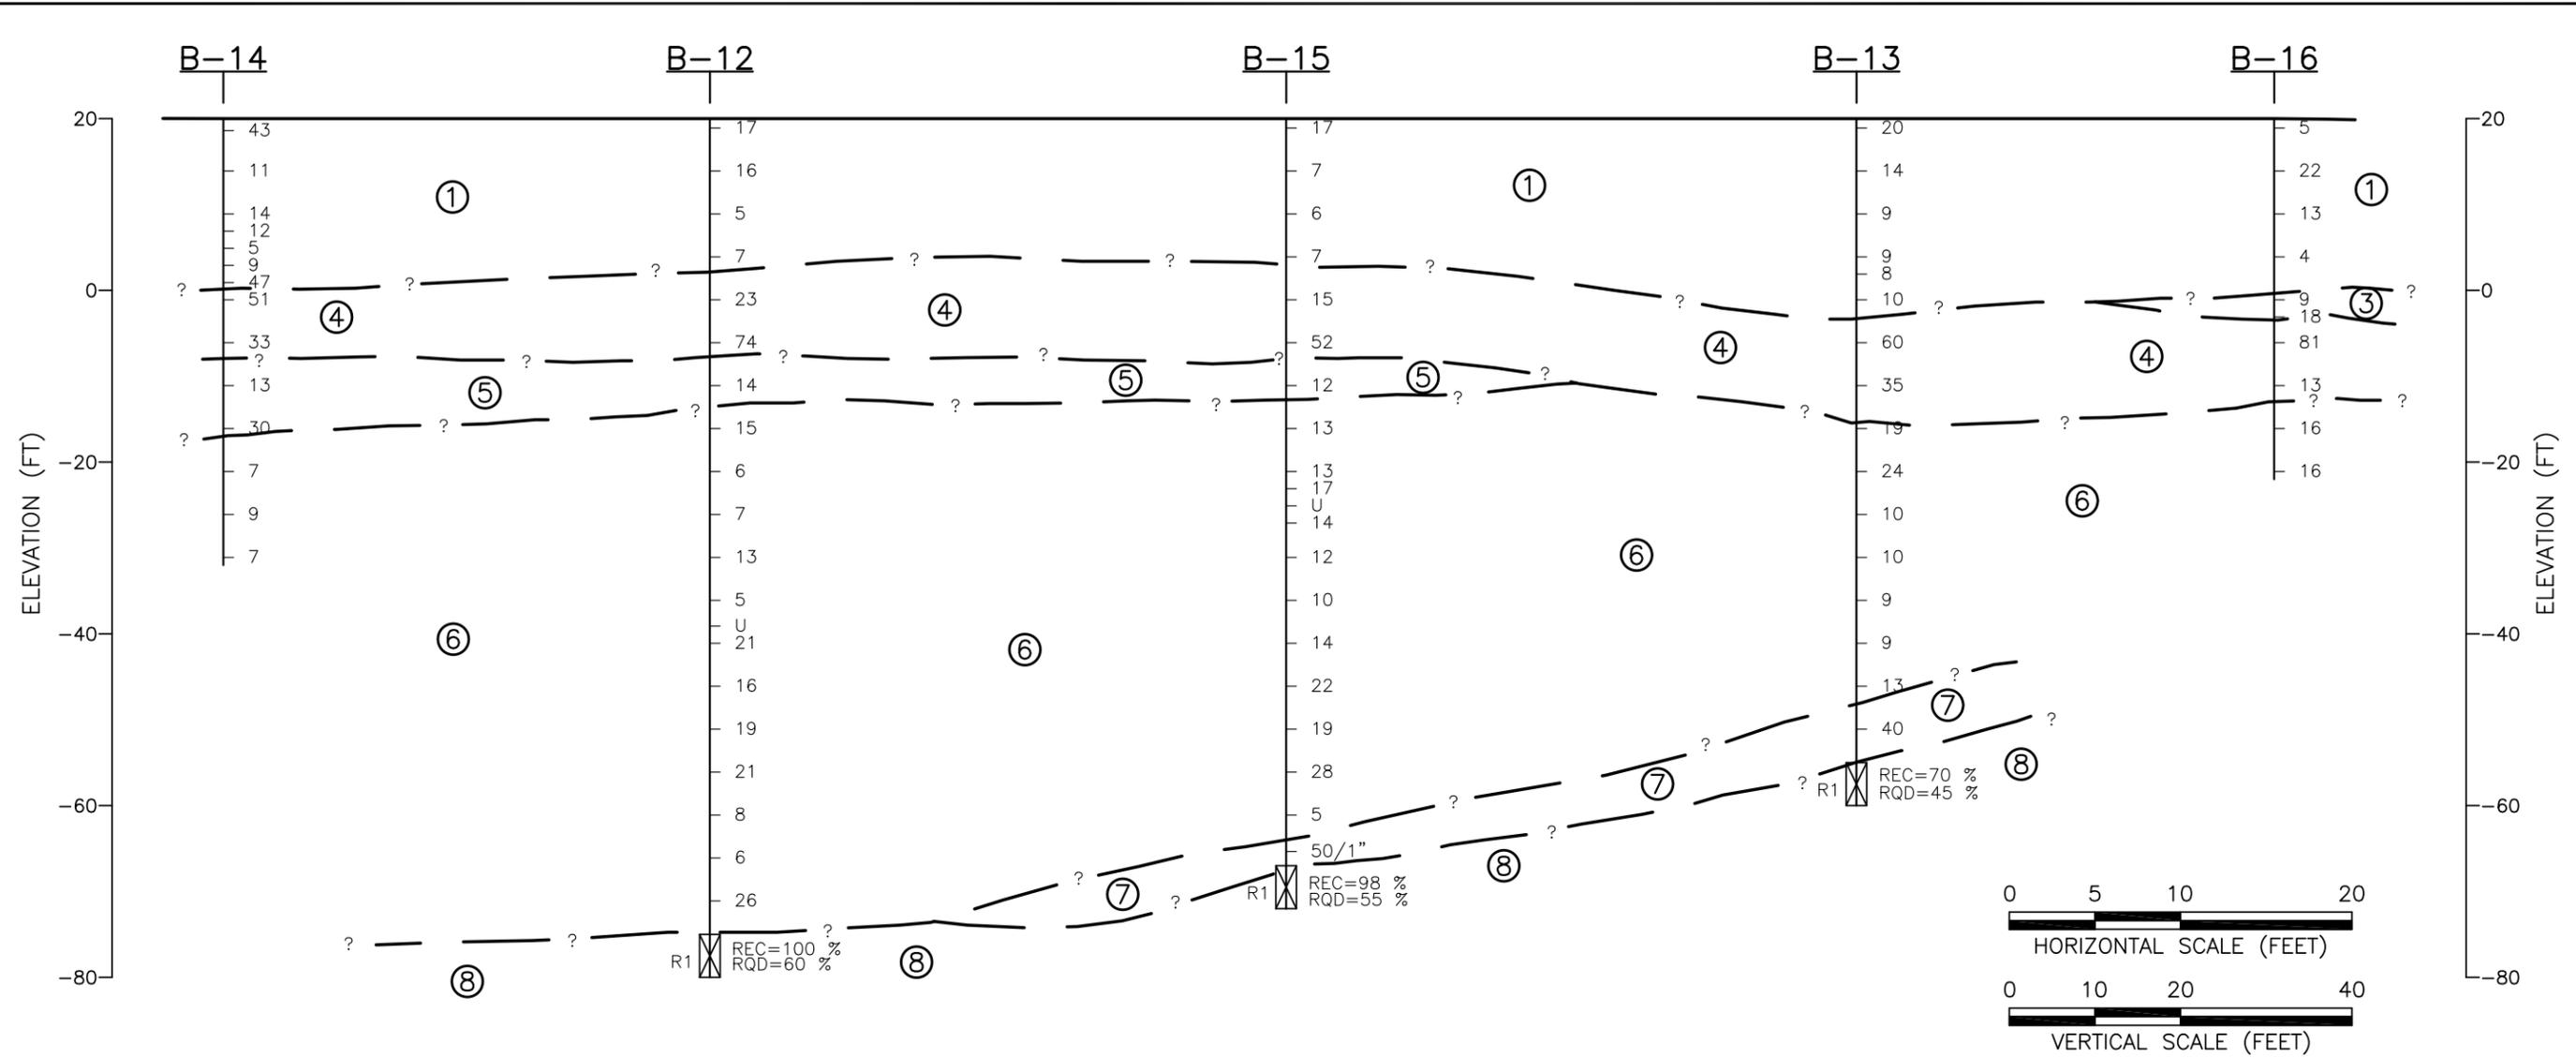
GENERALIZED SUBSURFACE PROFILE B-B'			
WEST 116TH & WEST 117TH STREET NEW YORK, NEW YORK			
URS WAYNE, NEW JERSEY			
DR. BY	ET	SCALE	AS SHOWN
CK'D. BY	AF	DATE	AUGUST 8, 2011
DWG. NO. 00377003-BB		PROJ. NO. 11100377	
FIG. NO. 4

- B-1**
GEOTECHNICAL BORING DRILLED BY CRAIG TEST BORING INC., UNDER URS SUPERVISION.
- CORE RUN NUMBER
- | | | | |

1. MATERIAL DESCRIPTIONS ARE GENERALIZED AND INCLUDE SAMPLES WITH A NATURAL DEGREE OF VARIATION. SEE BORING LOGS FOR DESCRIPTION OF INDIVIDUAL SAMPLES.
2. DEPTH AND THICKNESSES OF SOIL STRATA BOUNDARIES ARE BASED ON INTERPRETATION OF BORINGS AND LABORATORY TEST RESULTS AND ARE SHOWN ONLY TO AID IN VISUALIZING GENERALIZED SUBSURFACE CONDITIONS. ACTUAL STRATA BOUNDARIES BETWEEN BORINGS MAY DIFFER FROM THE CONDITIONS SHOWN HERE.
3. ELEVATIONS REFER TO MANHATTAN BOROUGH DATUM.

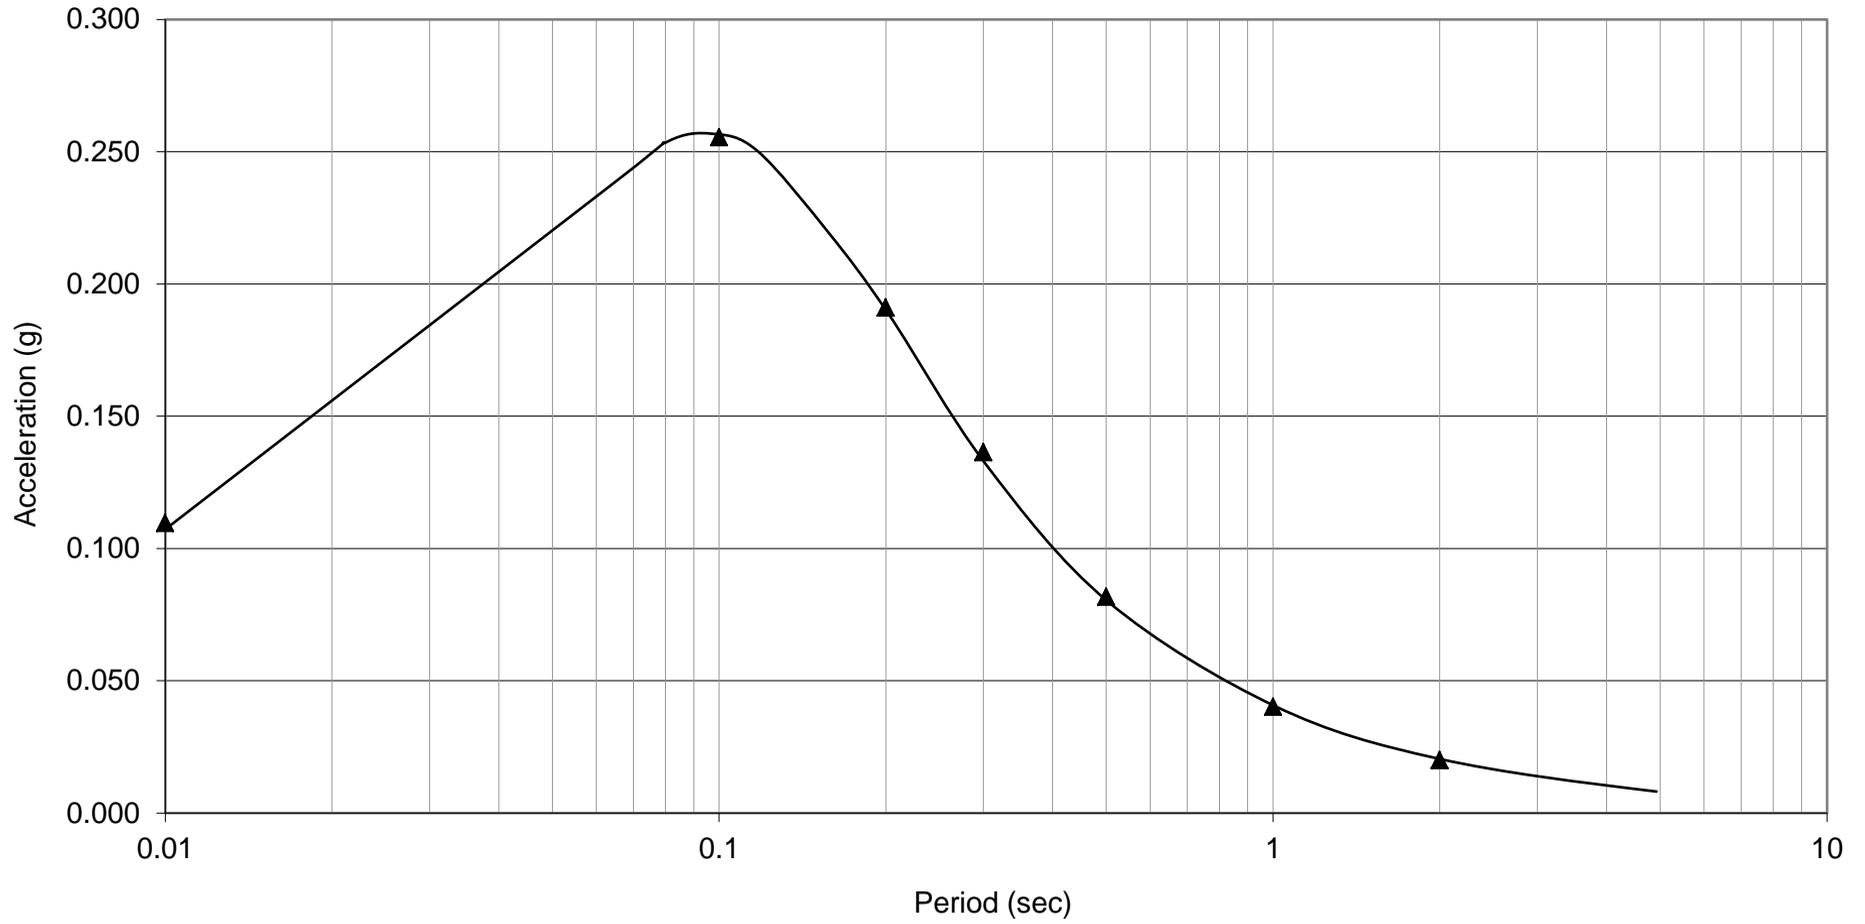
<small>WAYNE, NEW JERSEY</small>		
DR. BY: TGT	SCALE: As shown	PROJ: 11100377
	DATE: July 2011	FIG NO: 5

▲2/3(2008 USGS) Recommended Rock Response Spectrum

Rock Response Spectrum West 116th Residential New York, New York

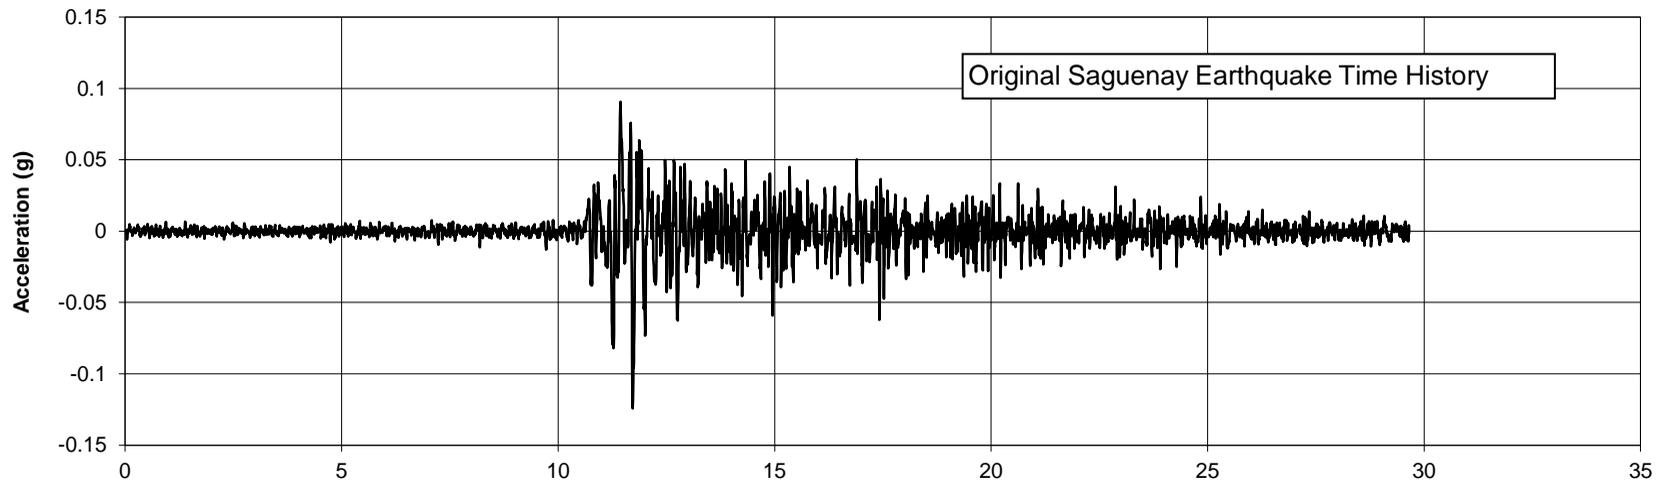
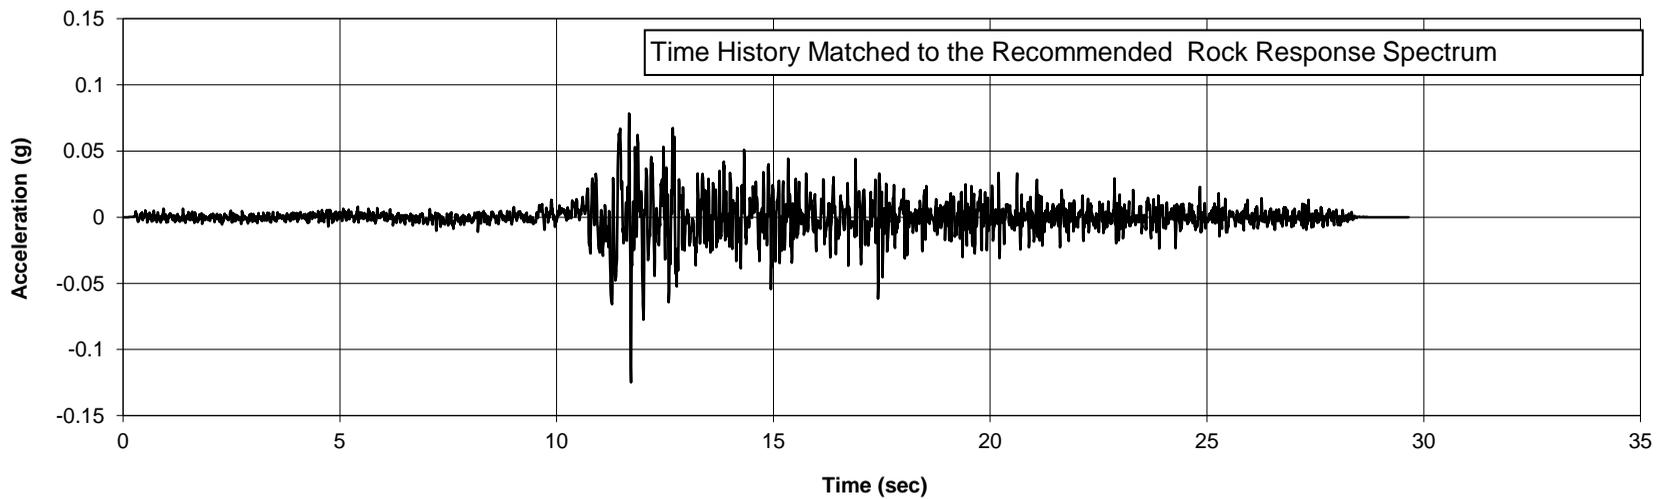
Rock Acceleration Time Histories 2/3(2500-Year Return Period) - 2008 USGS Data West 116 Residential, New York, NY		
URS WAYNE, NEW JERSEY		
DR. BY: TGT	SCALE: As Shown	PROJ: 11100377
	DATE: July 2011	FIG NO: 6
