**23 WEST 116TH STREET
(BLOCK 1600, LOT 20)
MANHATTAN, NEW YORK**

Remedial Action Work Plan

**NYC BCP Number: 12CBCP033M & 12CBCP034M
NYC OER E-Designation Project Number: 12RH-A116M**

DECEMBER 2011

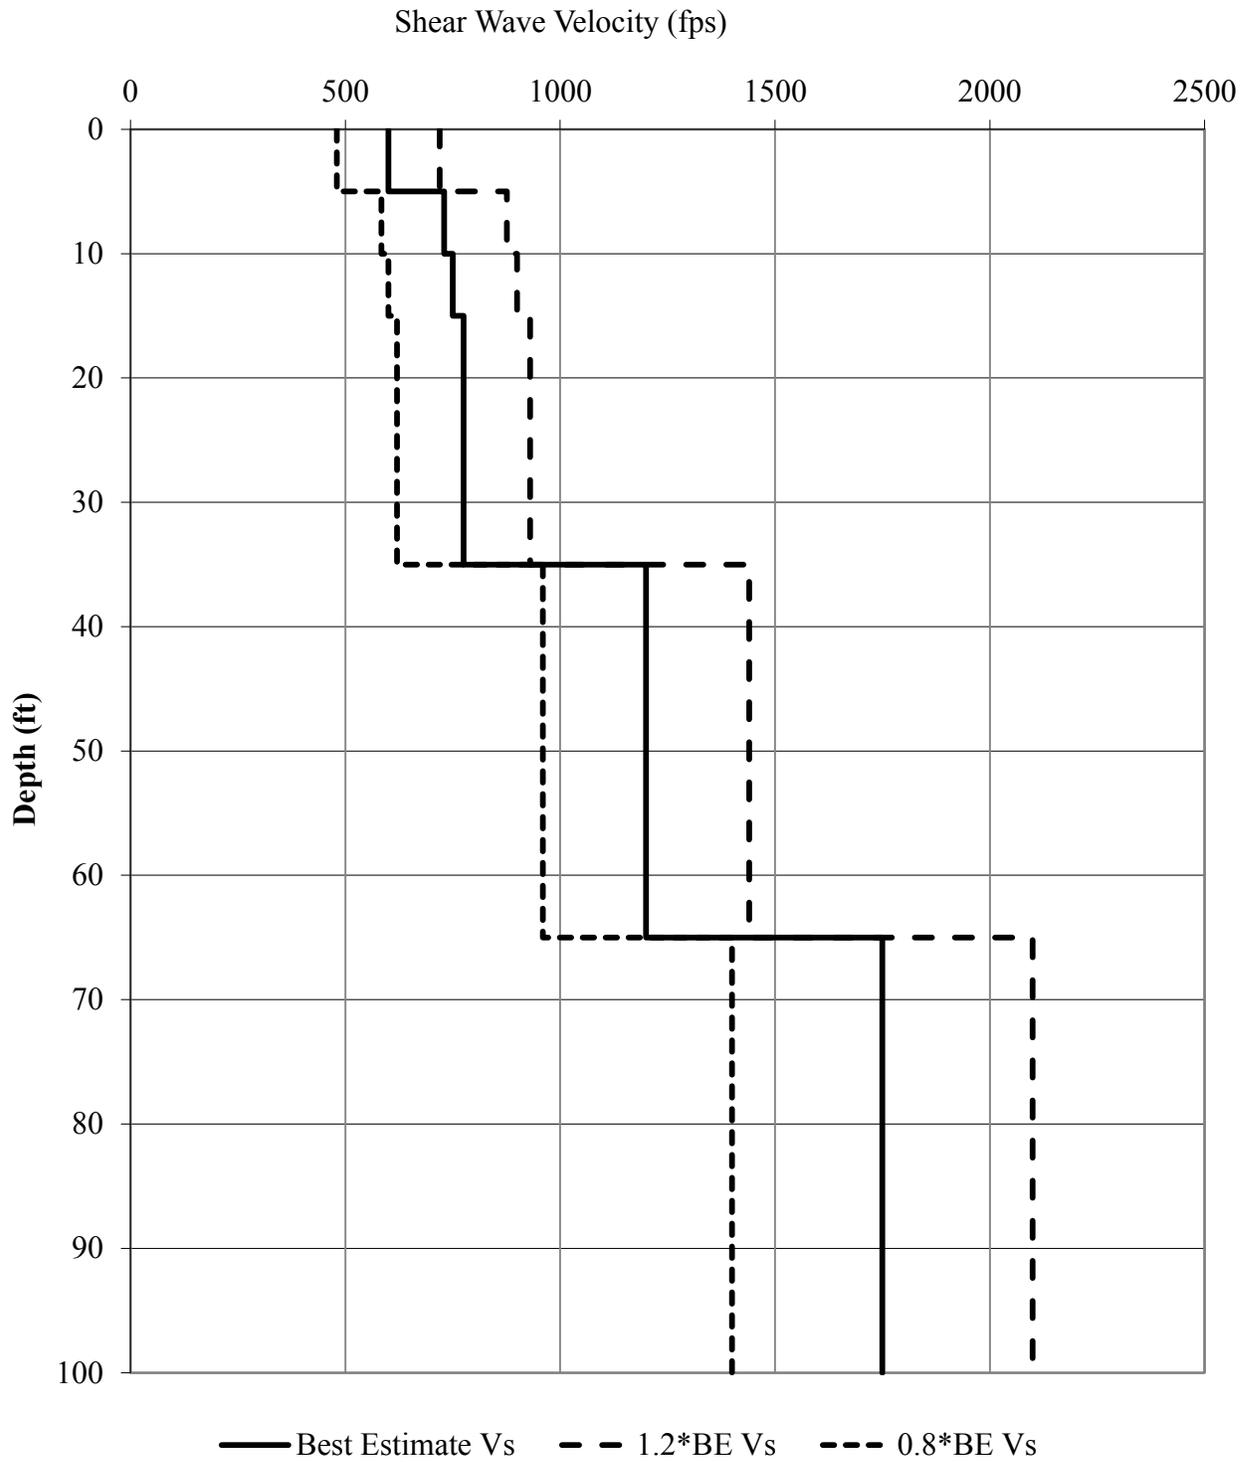
DR. BY: TGT	SCALE: As shown	PROJ NO: 11100377
CHK'D BY:	DATE: August 2011	FIG NO: 7

**Shear Wave Velocity Profile for Site Response Analysis
West 116th Residential
New York, NY**

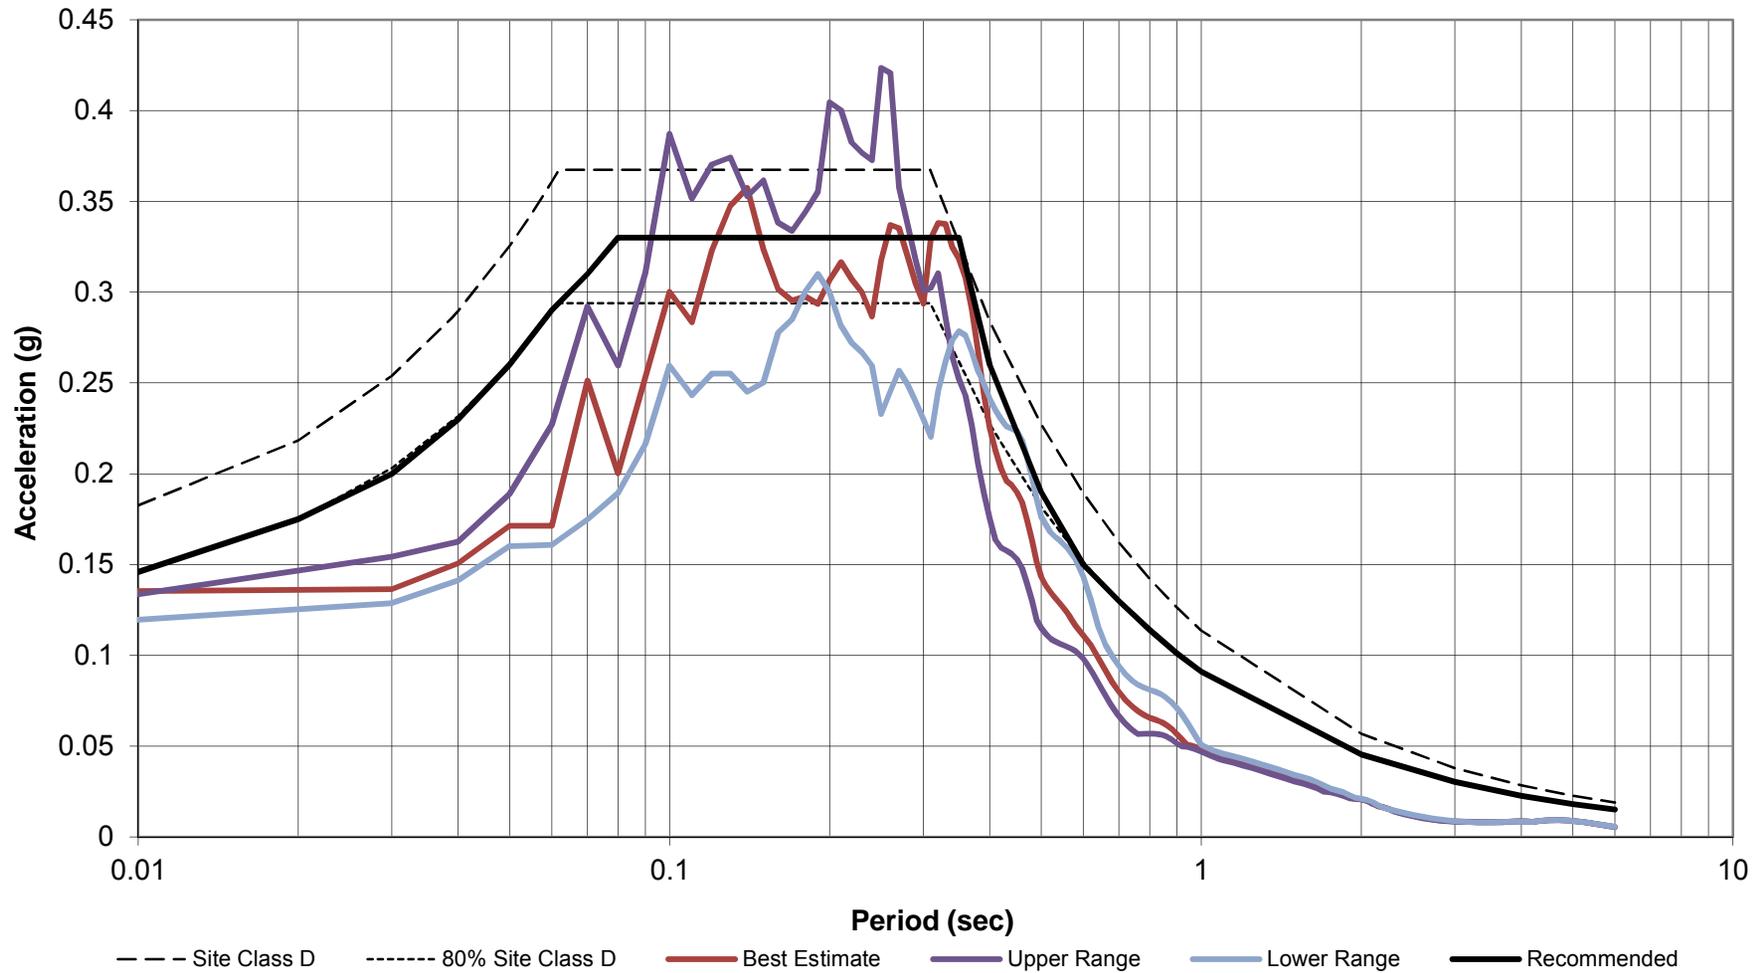
DR. BY: AR	SCALE: As shown	PROJ: 11100377
	DATE: July 2011	FIG NO: 8

5% Damping

**Site Response Analysis Results
West 116th Residential
New York, New York**

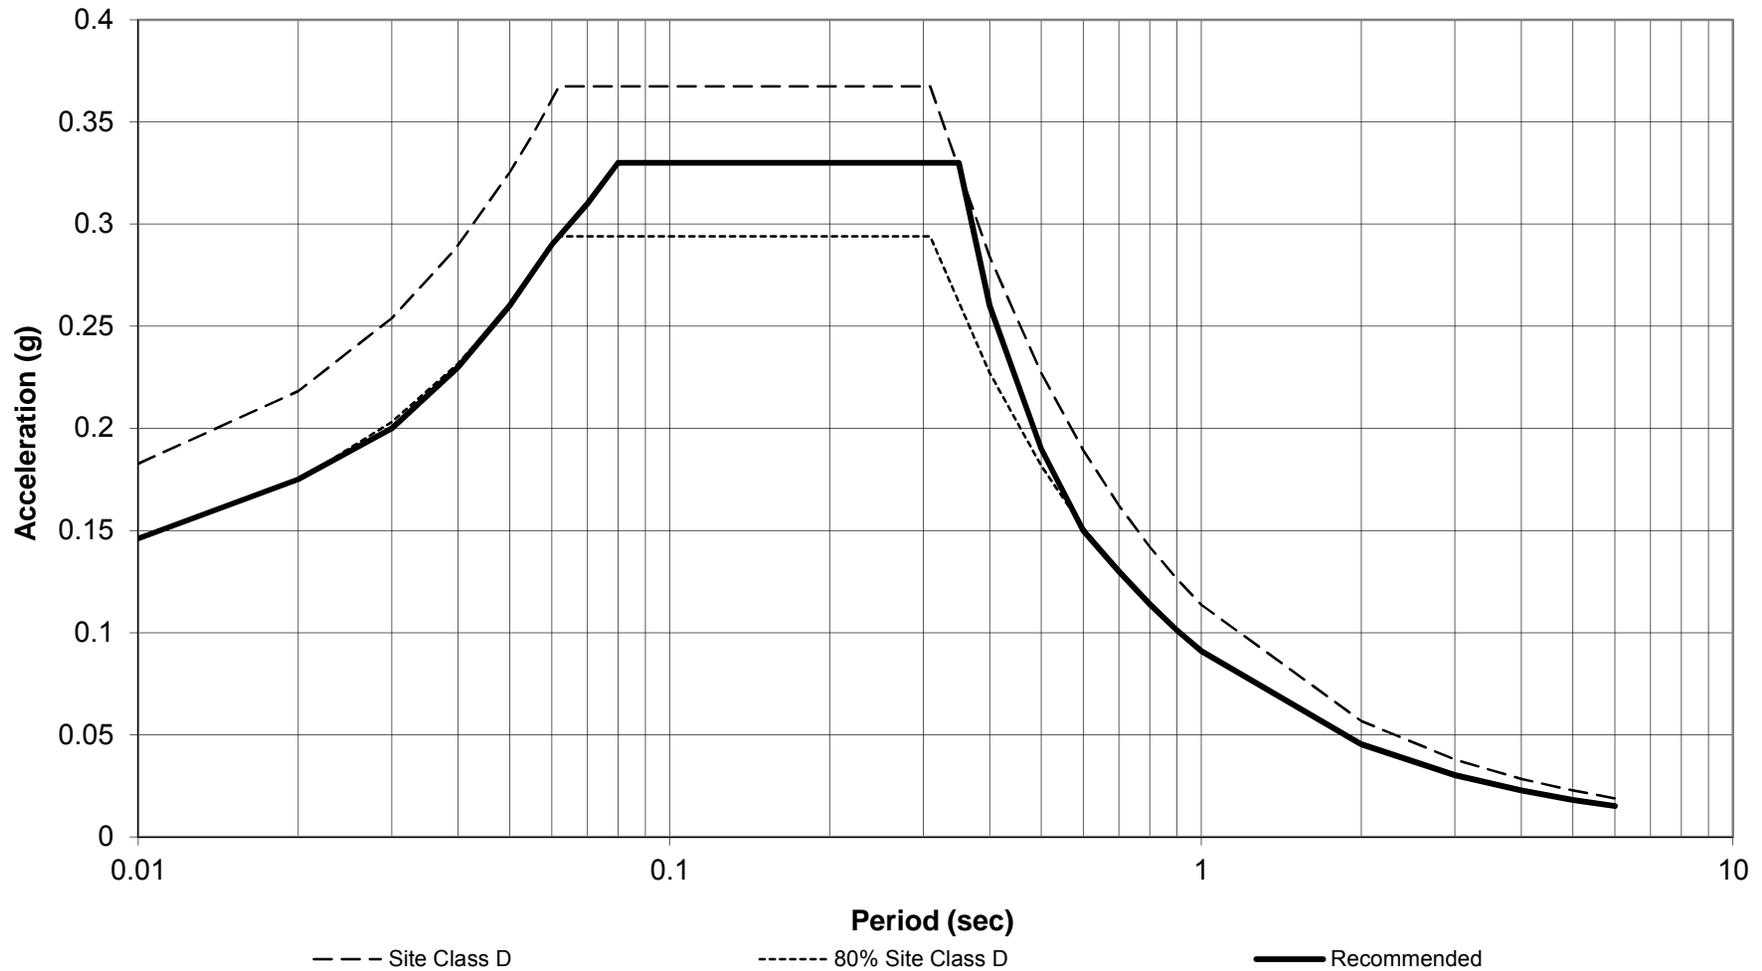
DR. BY: AR	SCALE: As shown	PROJ: 11100377
	DATE: July 2011	FIG NO: 9

5% Damping

**Recommended Response Spectrum
West 116th Residential
New York, New York**

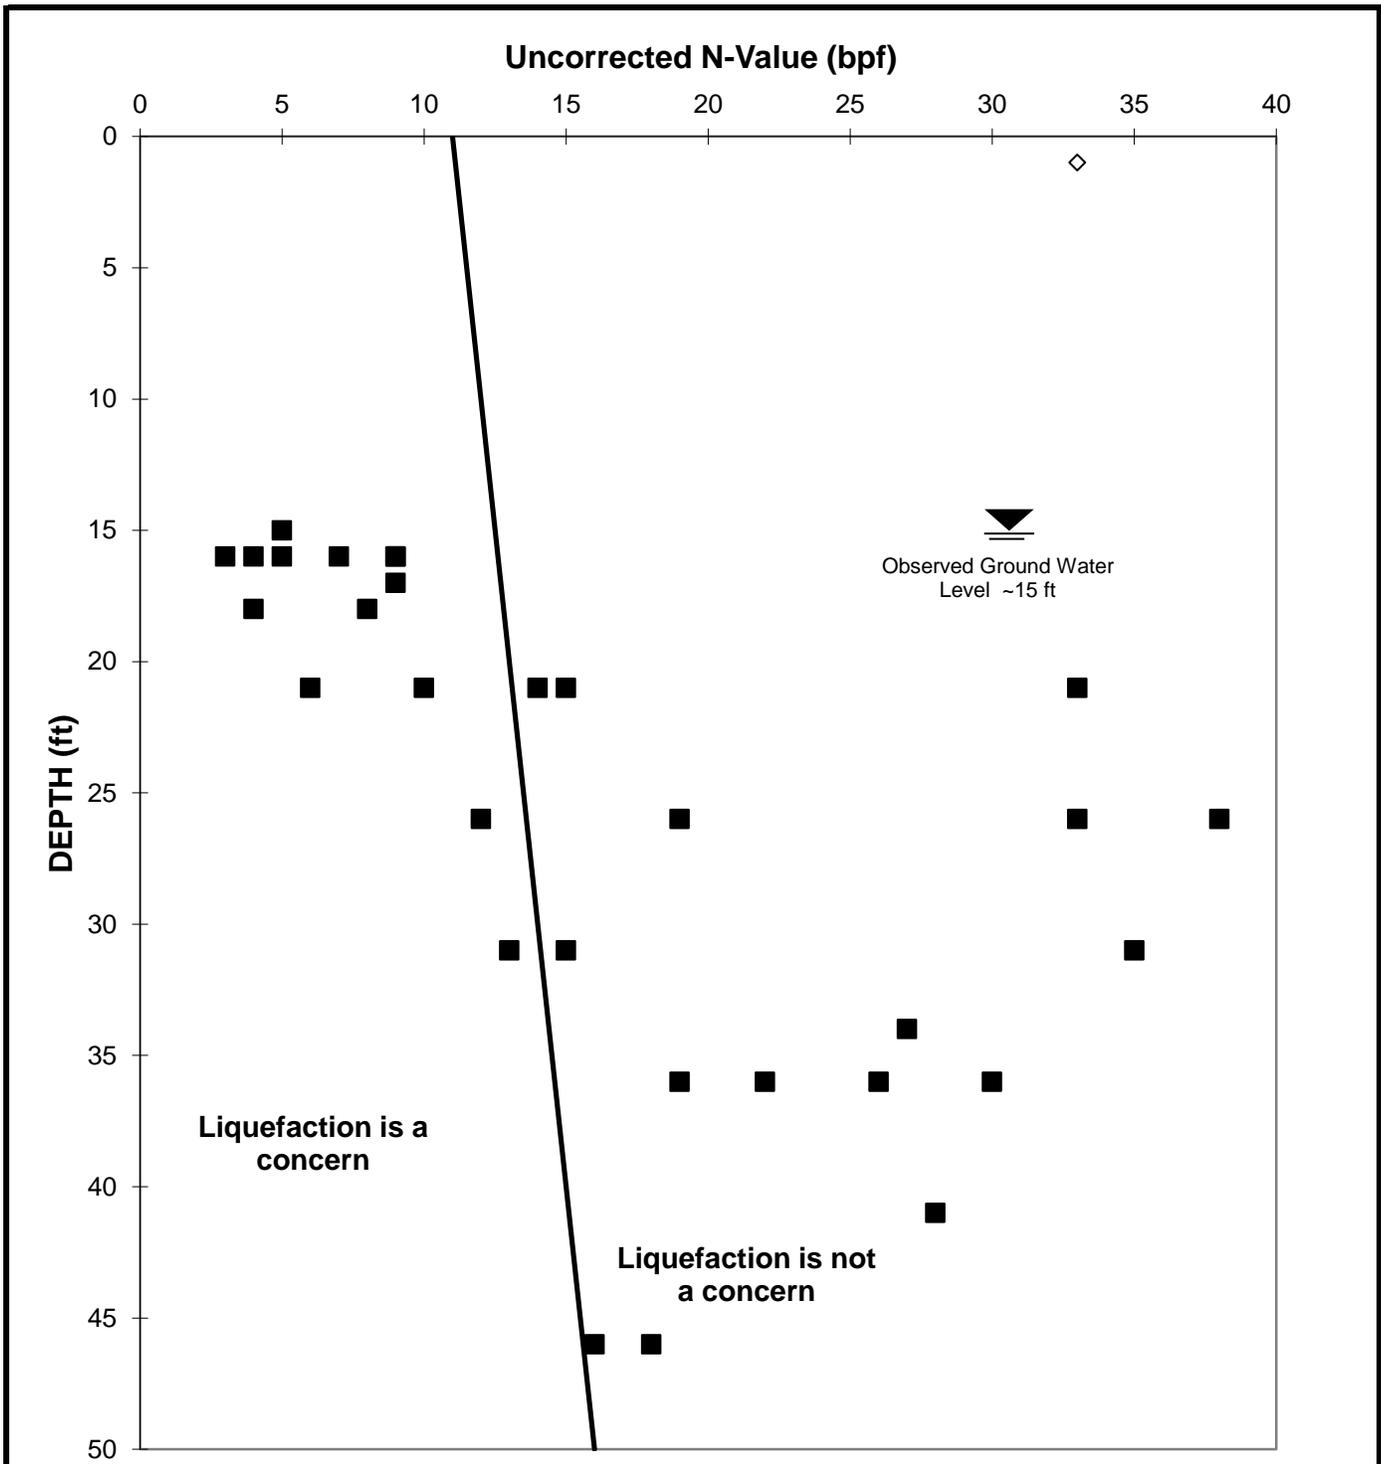
Figure is appropriate for a Standard Occupancy Structure only. Based on the seismic portion of the 2008 NYCBC.

Soil Liquefaction Potential		
West 116th Residential		
New York, NY		
URS WAYNE, NJ		
DR. BY:	SCALE: As Shown	PROJ NO: 11100377
CHK'D BY:	DATE: July 2011	FIG NO: 10

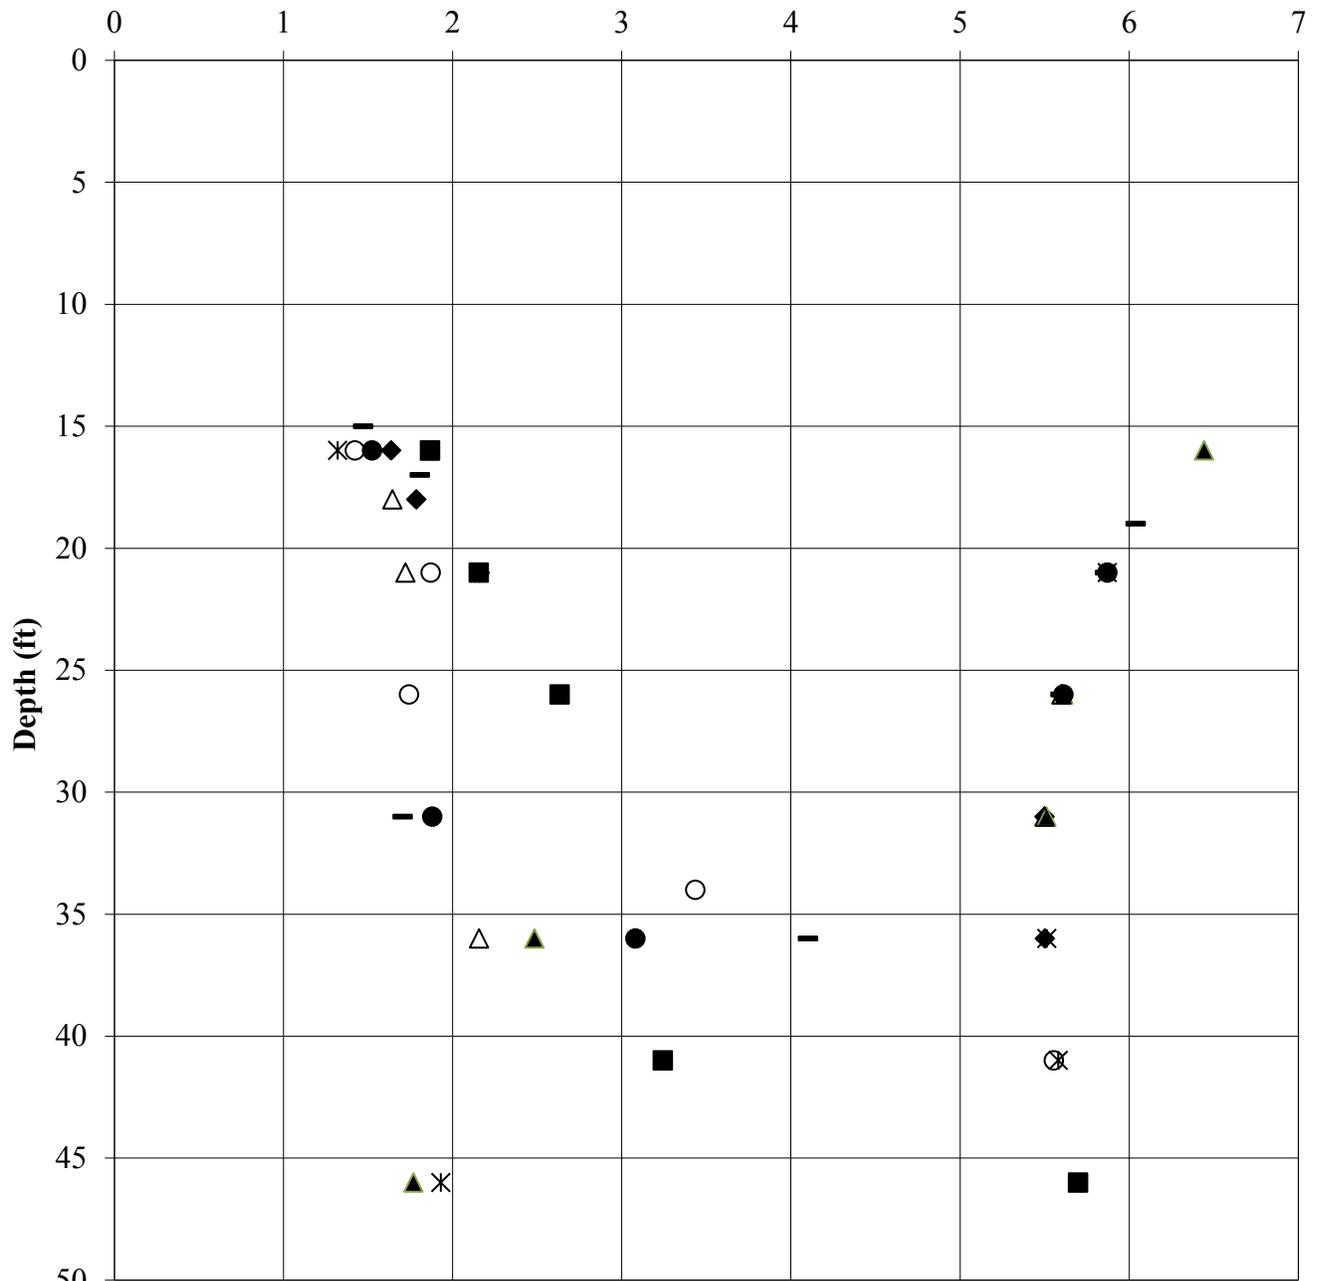
◆ Boring B-1 ■ Boring B-2 ▲ Boring B-5 ✕ Boring B-6 ● Boring B-8 ○ Boring B-10 △ Boring B-13 - Boring B-14

FOS Against Liquefaction		
West 116th Residential		
New York, NY		
URS		
WAYNE, NEW JERSEY		
	SCALE: As Shown	PROJ NO: 11100377
BY: TGT	DATE: August 2011	FIG NO: 11

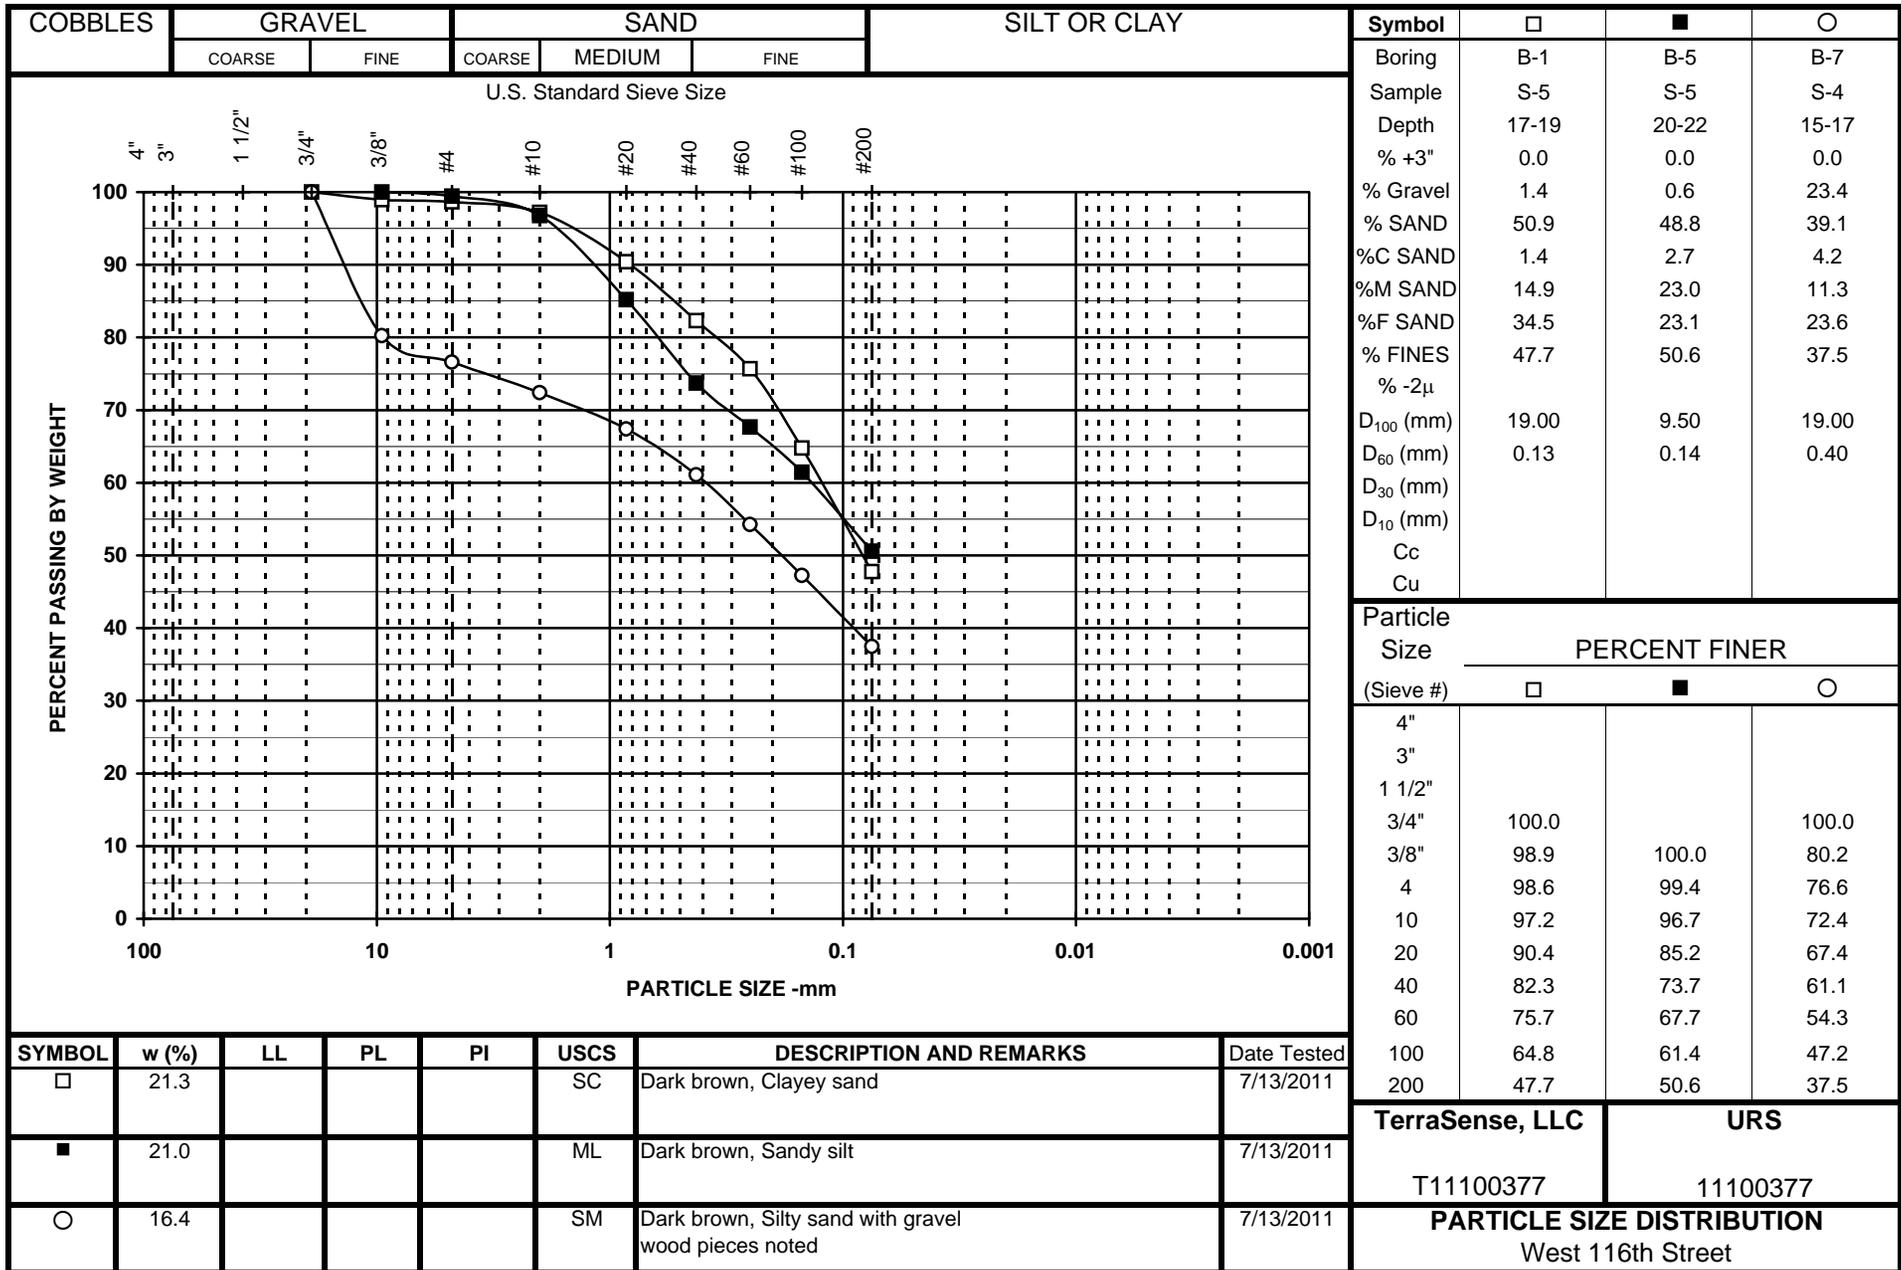
PARTICLE SIZE DISTRIBUTION
West 116th Street
