LAM GEN REDEVELOPMENT
112 WEST 25TH & 113 WEST 24TH STREET
BLOCK 800, LOTS 49 & 50
MANHATTAN, NEW YORK

Remedial Investigation Report

NYC VCP Project Number: 16CVCP019M

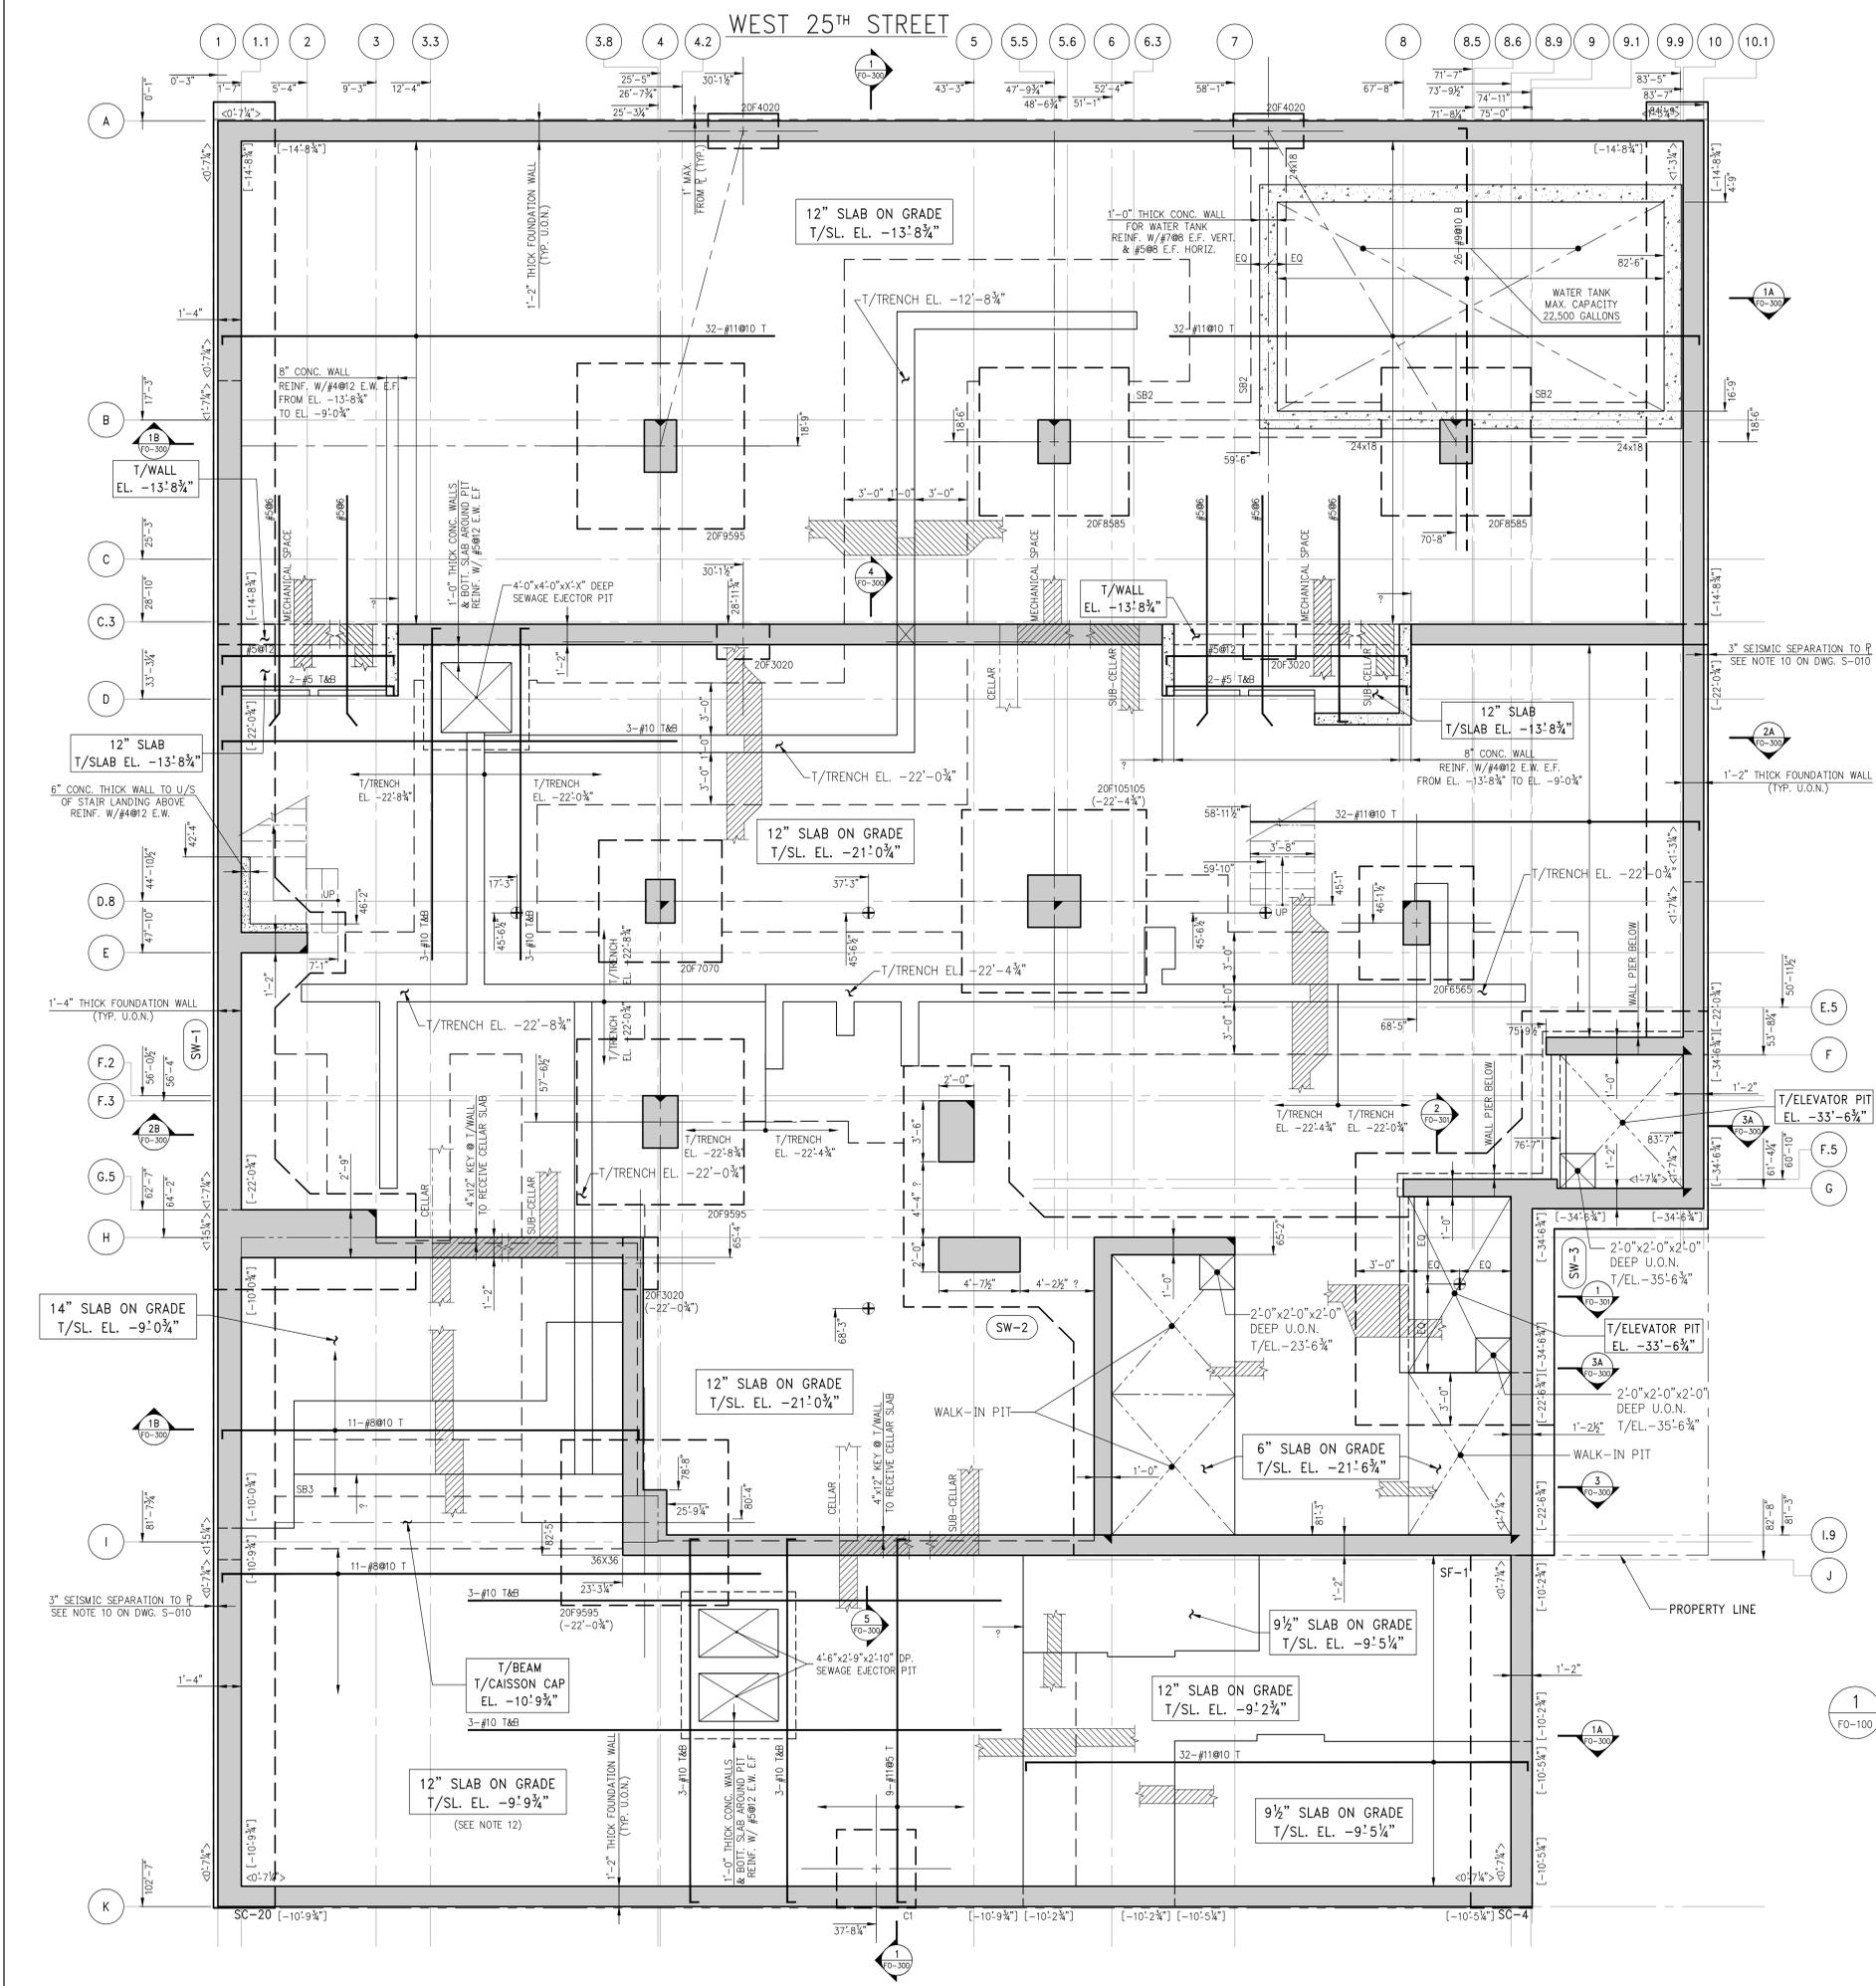
1 FOUNDATION PLAN (SUB-CELLAR & CELLAR)

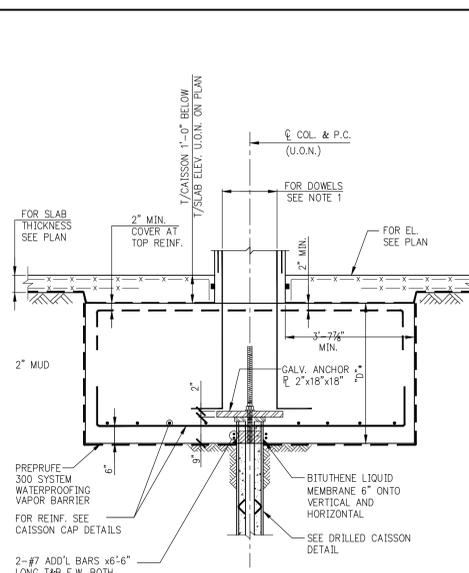
TYPICAL CROSS SECTION THRU CAISSON CAP DETAIL

- SCALE: 1/2" = 1'-0"
- NOTES:**
- WHERE SLAB IS POURED OVER FOUNDATION PRIOR TO COLUMN, VERTICAL REINFORCING AND DOWEL LAP TO START AT TOP OF SLAB.
 - L INDICATES LENGTH OF THE CAISSONS.
 - * INDICATES THAT DEPTH OF CAISSON CAP SHALL BE INCREASED BY 9" WHEN LENGTH OF THE CAISSONS (L) IS 7'-0" < L < 10'-0" (I.E. CAISSON EMBED. = 1'-3")
 - ** CAISSON CAP REINF. PLACED EITHER SIDE OF CAISSON WHEN PILE EMBED. = 1'-3"
 - IF LENGTH OF CAISSONS IS LESS THAN 7'-0", CAISSONS SHALL BE CUT AND CAISSON CAP SHALL BE EXTENDED DOWN TO REST ON SUITABLE SOIL.

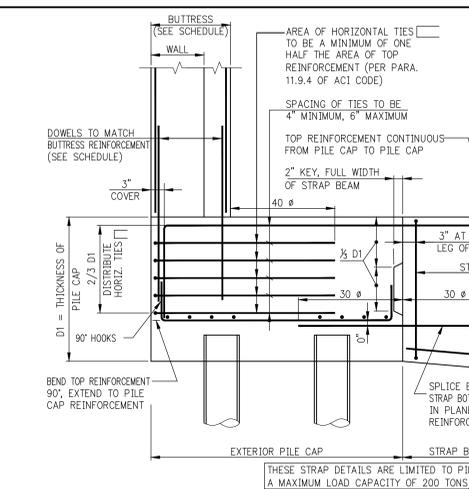
ELEVATION - EXTERIOR PILE CAP

- NOTES:**
- SEE FOUNDATION DRAWINGS FOR STRAP BEAM SIZE, REINFORCEMENT, AND STIRRUPS.

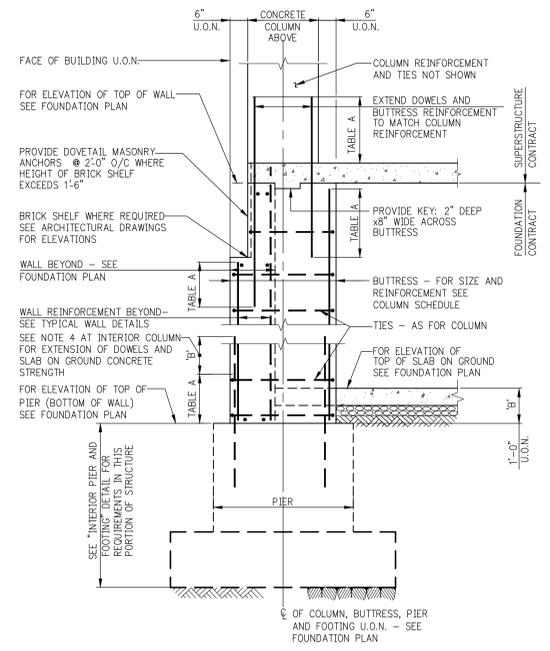
BUTTRISS AT CONCRETE COLUMN

- IF GRADE 75 COLUMN REINFORCEMENT IS USED, INCREASE DOWEL EMBEDMENT LENGTH TO 24 DIAMETERS.
- MINIMUM CONCRETE STRENGTH OF $f'_c=4,000$ PSI IS REQUIRED FOR PIER AND FOOTING. SEE PLANS AND NOTES FOR GREATER STRENGTH REQUIREMENTS.

THIS DETAIL DOES NOT APPLY WHERE COLUMN REINFORCEMENT IS IN TENSION.

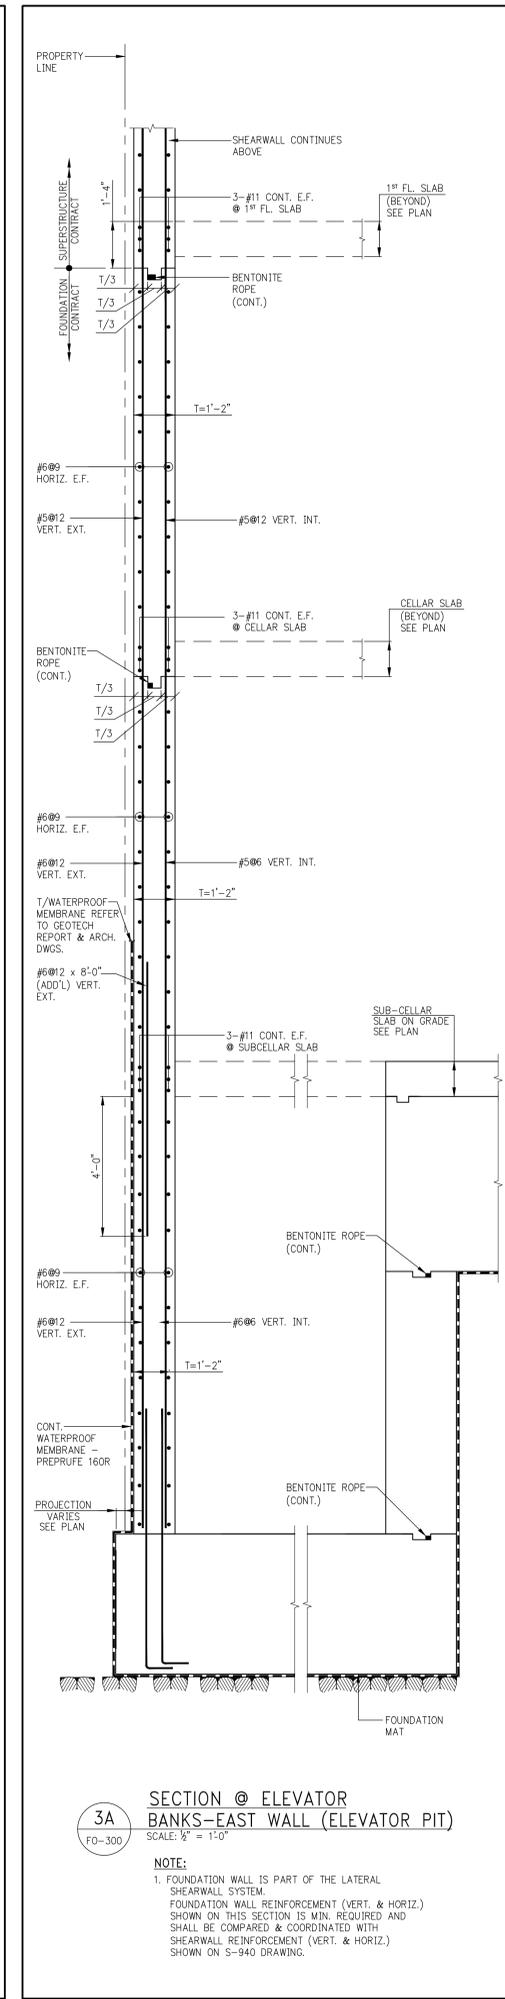
**SECTION @ ELEVATOR
BANKS-EAST WALL (ELEVATOR PIT)**
SCALE: 1/2" = 1'-0"

NOTE:
1. FOUNDATION WALL IS PART OF THE LATERAL SHEARWALL SYSTEM. FOUNDATION WALL REINFORCEMENT (VERT. & HORIZ.) SHOWN ON THIS SECTION IS MIN. REQUIRED AND SHALL BE COMPARED & COORDINATED WITH SHEARWALL REINFORCEMENT (VERT. & HORIZ.) SHOWN ON S-940 DRAWING.

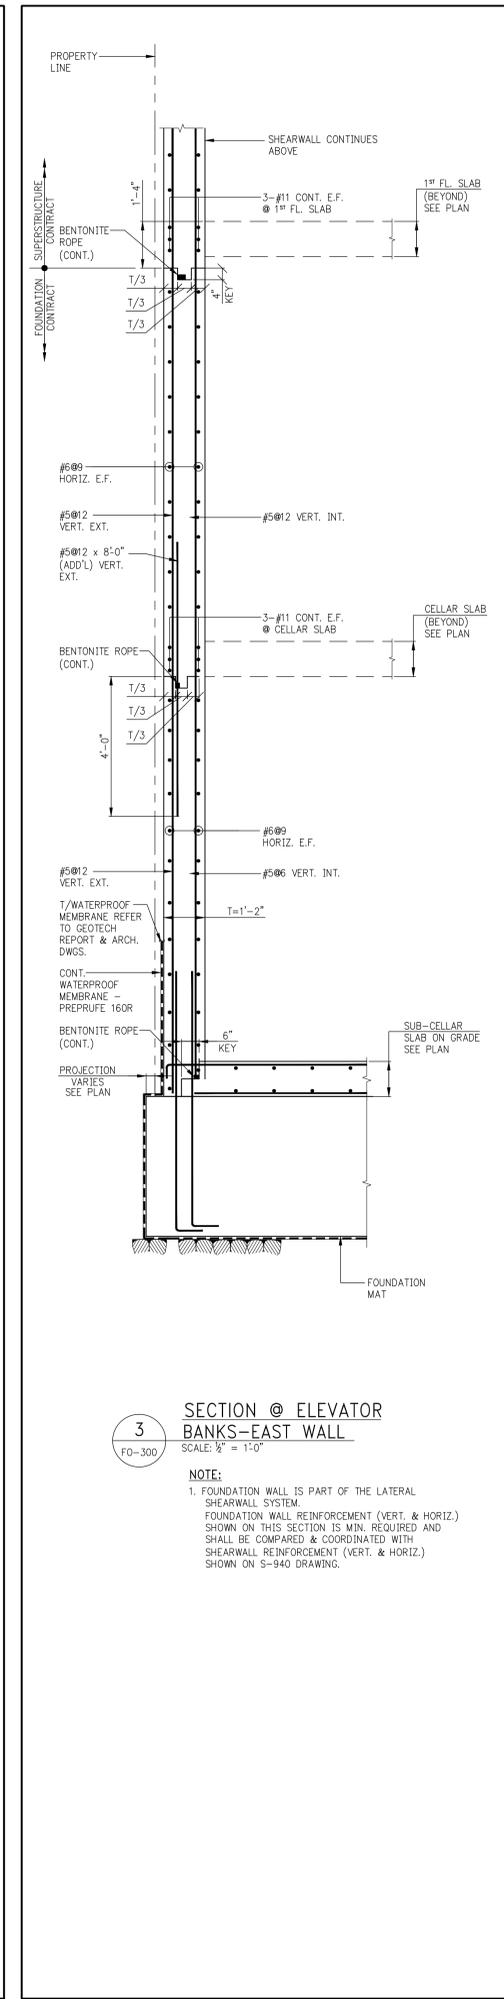
**SECTION @ ELEVATOR
BANKS-EAST WALL**
SCALE: 1/2" = 1'-0"

NOTE:
1. FOUNDATION WALL IS PART OF THE LATERAL SHEARWALL SYSTEM. FOUNDATION WALL REINFORCEMENT (VERT. & HORIZ.) SHOWN ON THIS SECTION IS MIN. REQUIRED AND SHALL BE COMPARED & COORDINATED WITH SHEARWALL REINFORCEMENT (VERT. & HORIZ.) SHOWN ON S-940 DRAWING.

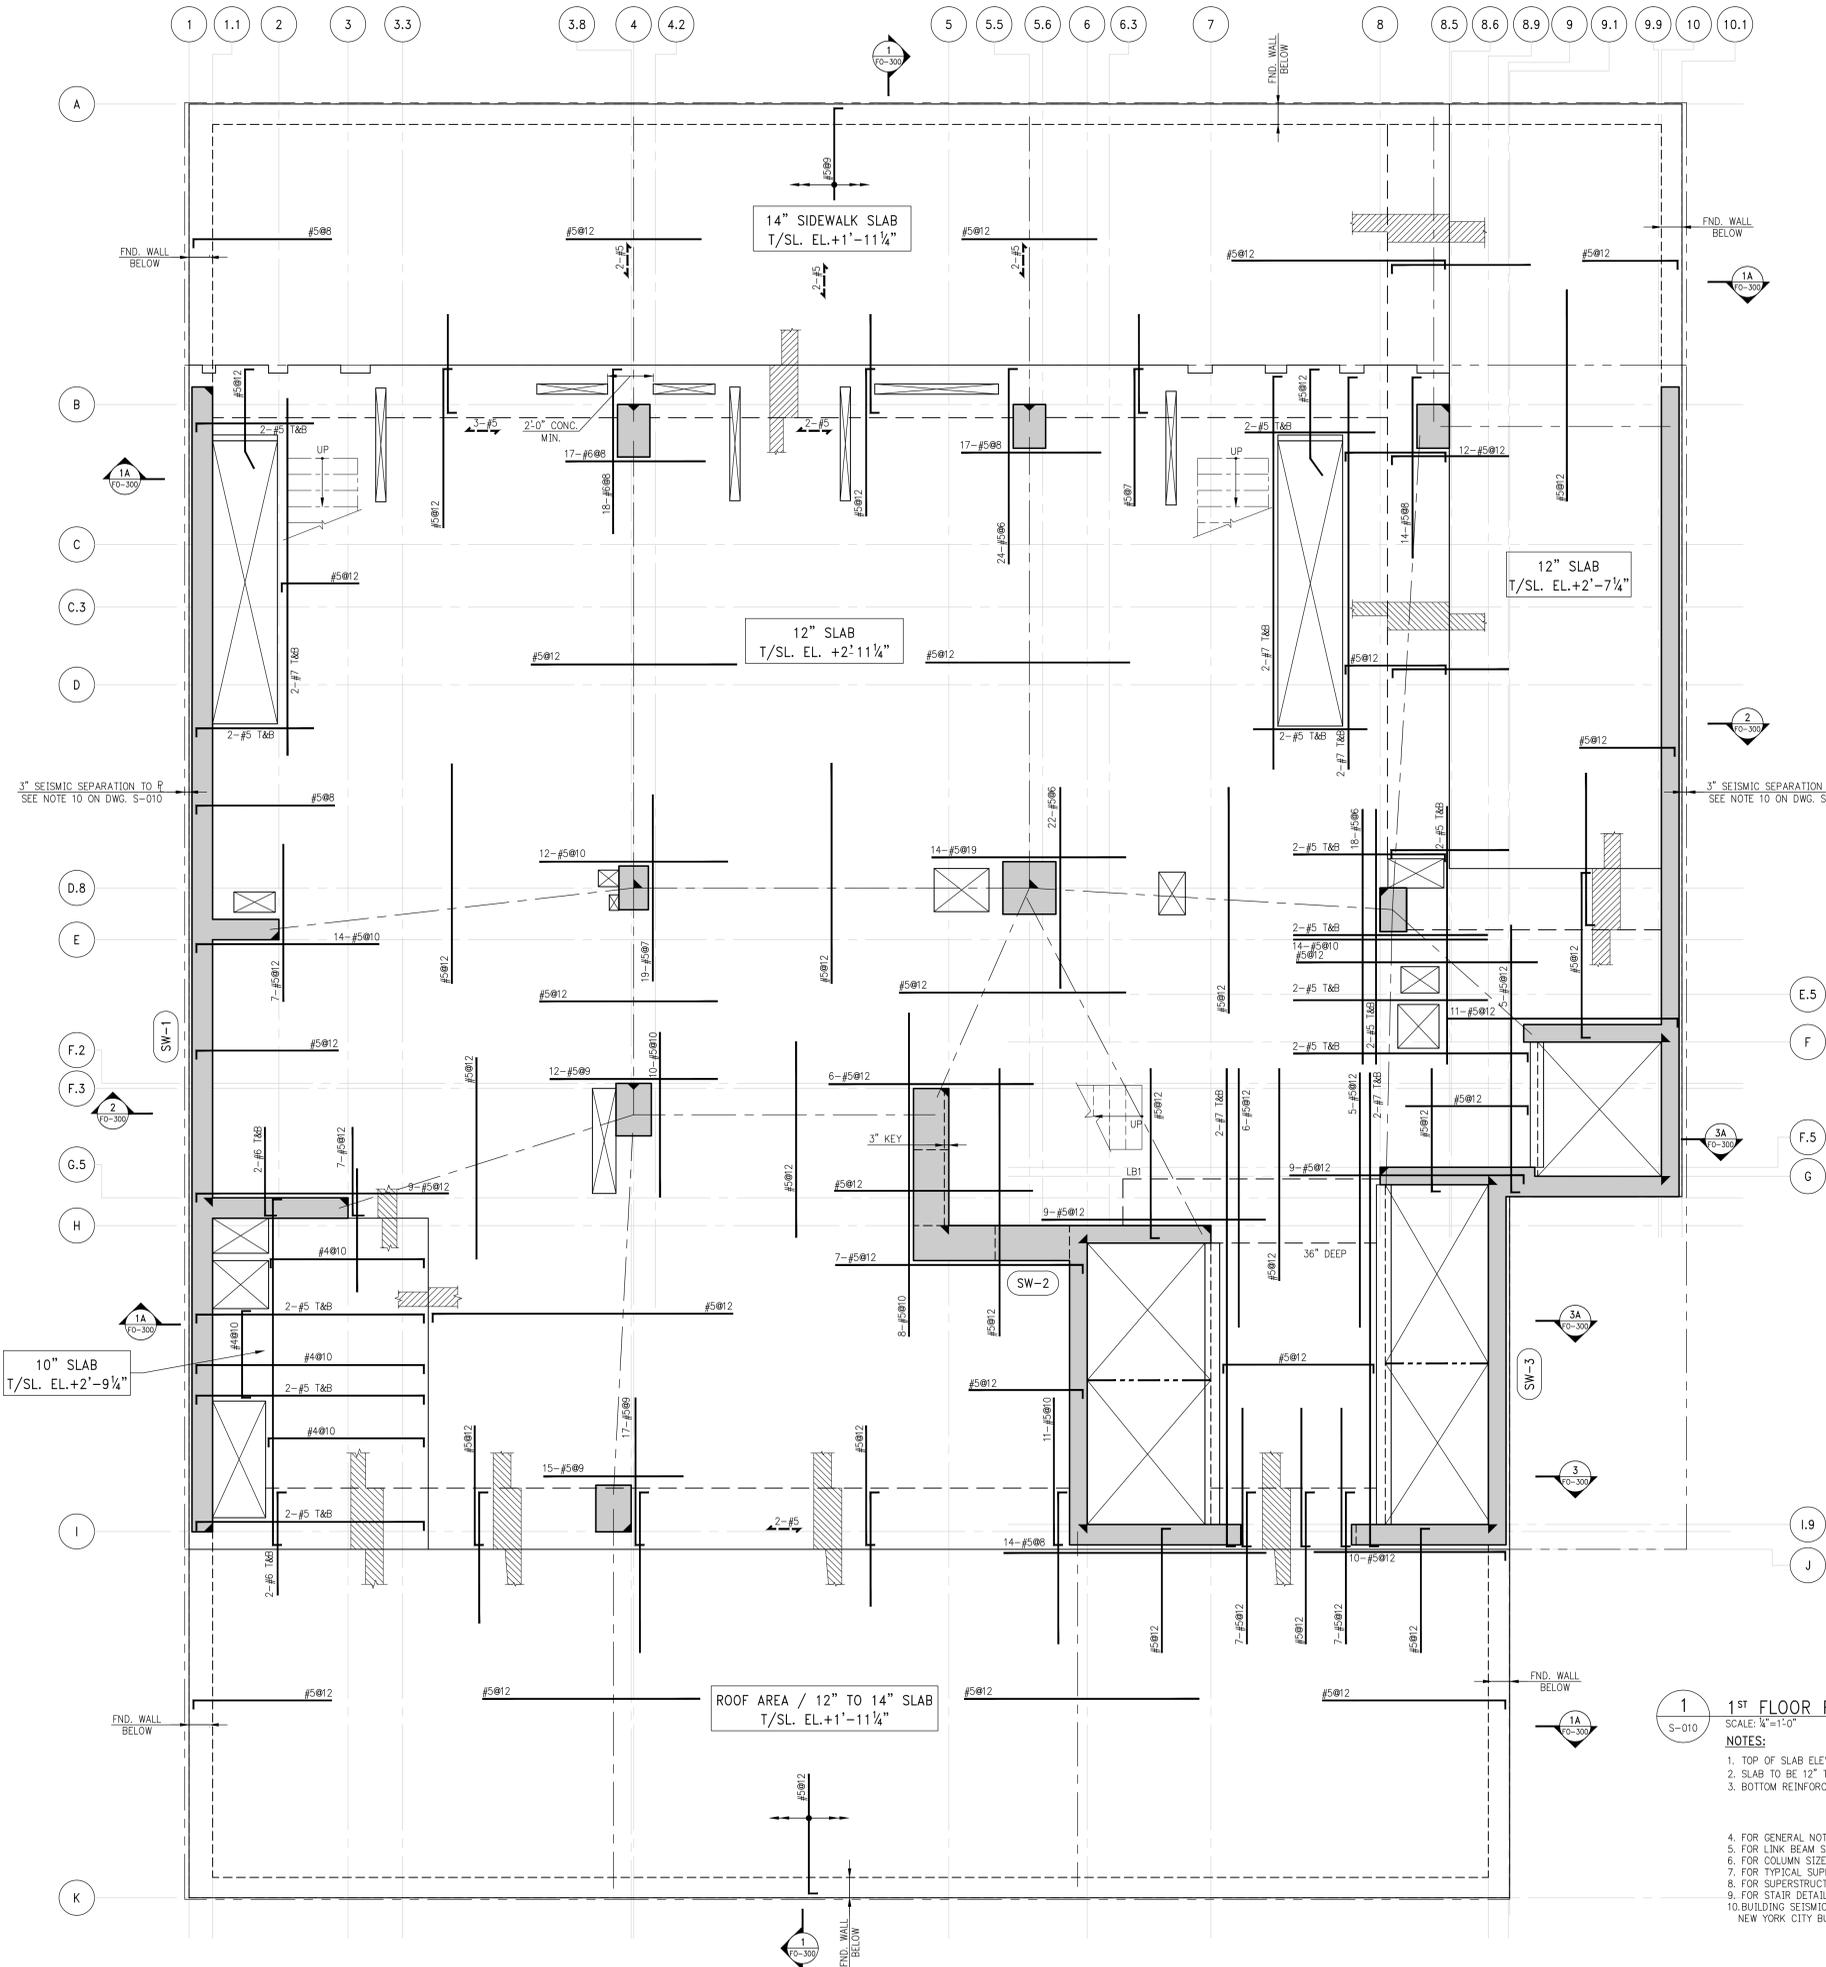
1 1ST FLOOR FRAMING PLAN
SCALE: 1/4" = 1'-0"

- NOTES:
- TOP OF SLAB ELEVATION TO BE +2'-11 1/4" U.O.N. ON PLAN
 - SLAB TO BE 12" THICK U.O.N. THUS ON PLAN
 - BOTTOM REINFORCEMENT TO BE #4@12 CONT. E.W. FOR 9" SLAB U.O.N. #4@10 CONT. E.W. FOR 10" SLAB U.O.N. #4@10 CONT. E.W. FOR 11" SLAB U.O.N. #5@12 CONT. E.W. FOR 12" SLAB U.O.N.
 - FOR GENERAL NOTES, ABBREVIATIONS AND LEGEND SEE DRAWING F0-001
 - FOR LINK BEAM SCHEDULE AND SHEARWALL DETAILS SEE S-940 SERIES DRAWINGS.
 - FOR COLUMN SIZES, REINFORCEMENT AND DETAILS SEE S-950 SERIES DRAWINGS.
 - FOR TYPICAL SUPERSTRUCTURE DETAILS SEE S-960 SERIES DRAWINGS.
 - FOR SUPERSTRUCTURE SECTIONS SEE S-970 SERIES DRAWINGS.
 - FOR STAIR DETAILS AND SECTIONS SEE S-980 SERIES DRAWINGS.
 - BUILDING SEISMIC SEPARATIONS HAVE BEEN PROVIDED IN ACCORDANCE TO 2008 NEW YORK CITY BUILDING CODE, CHAPTER BC 1617.3.2.

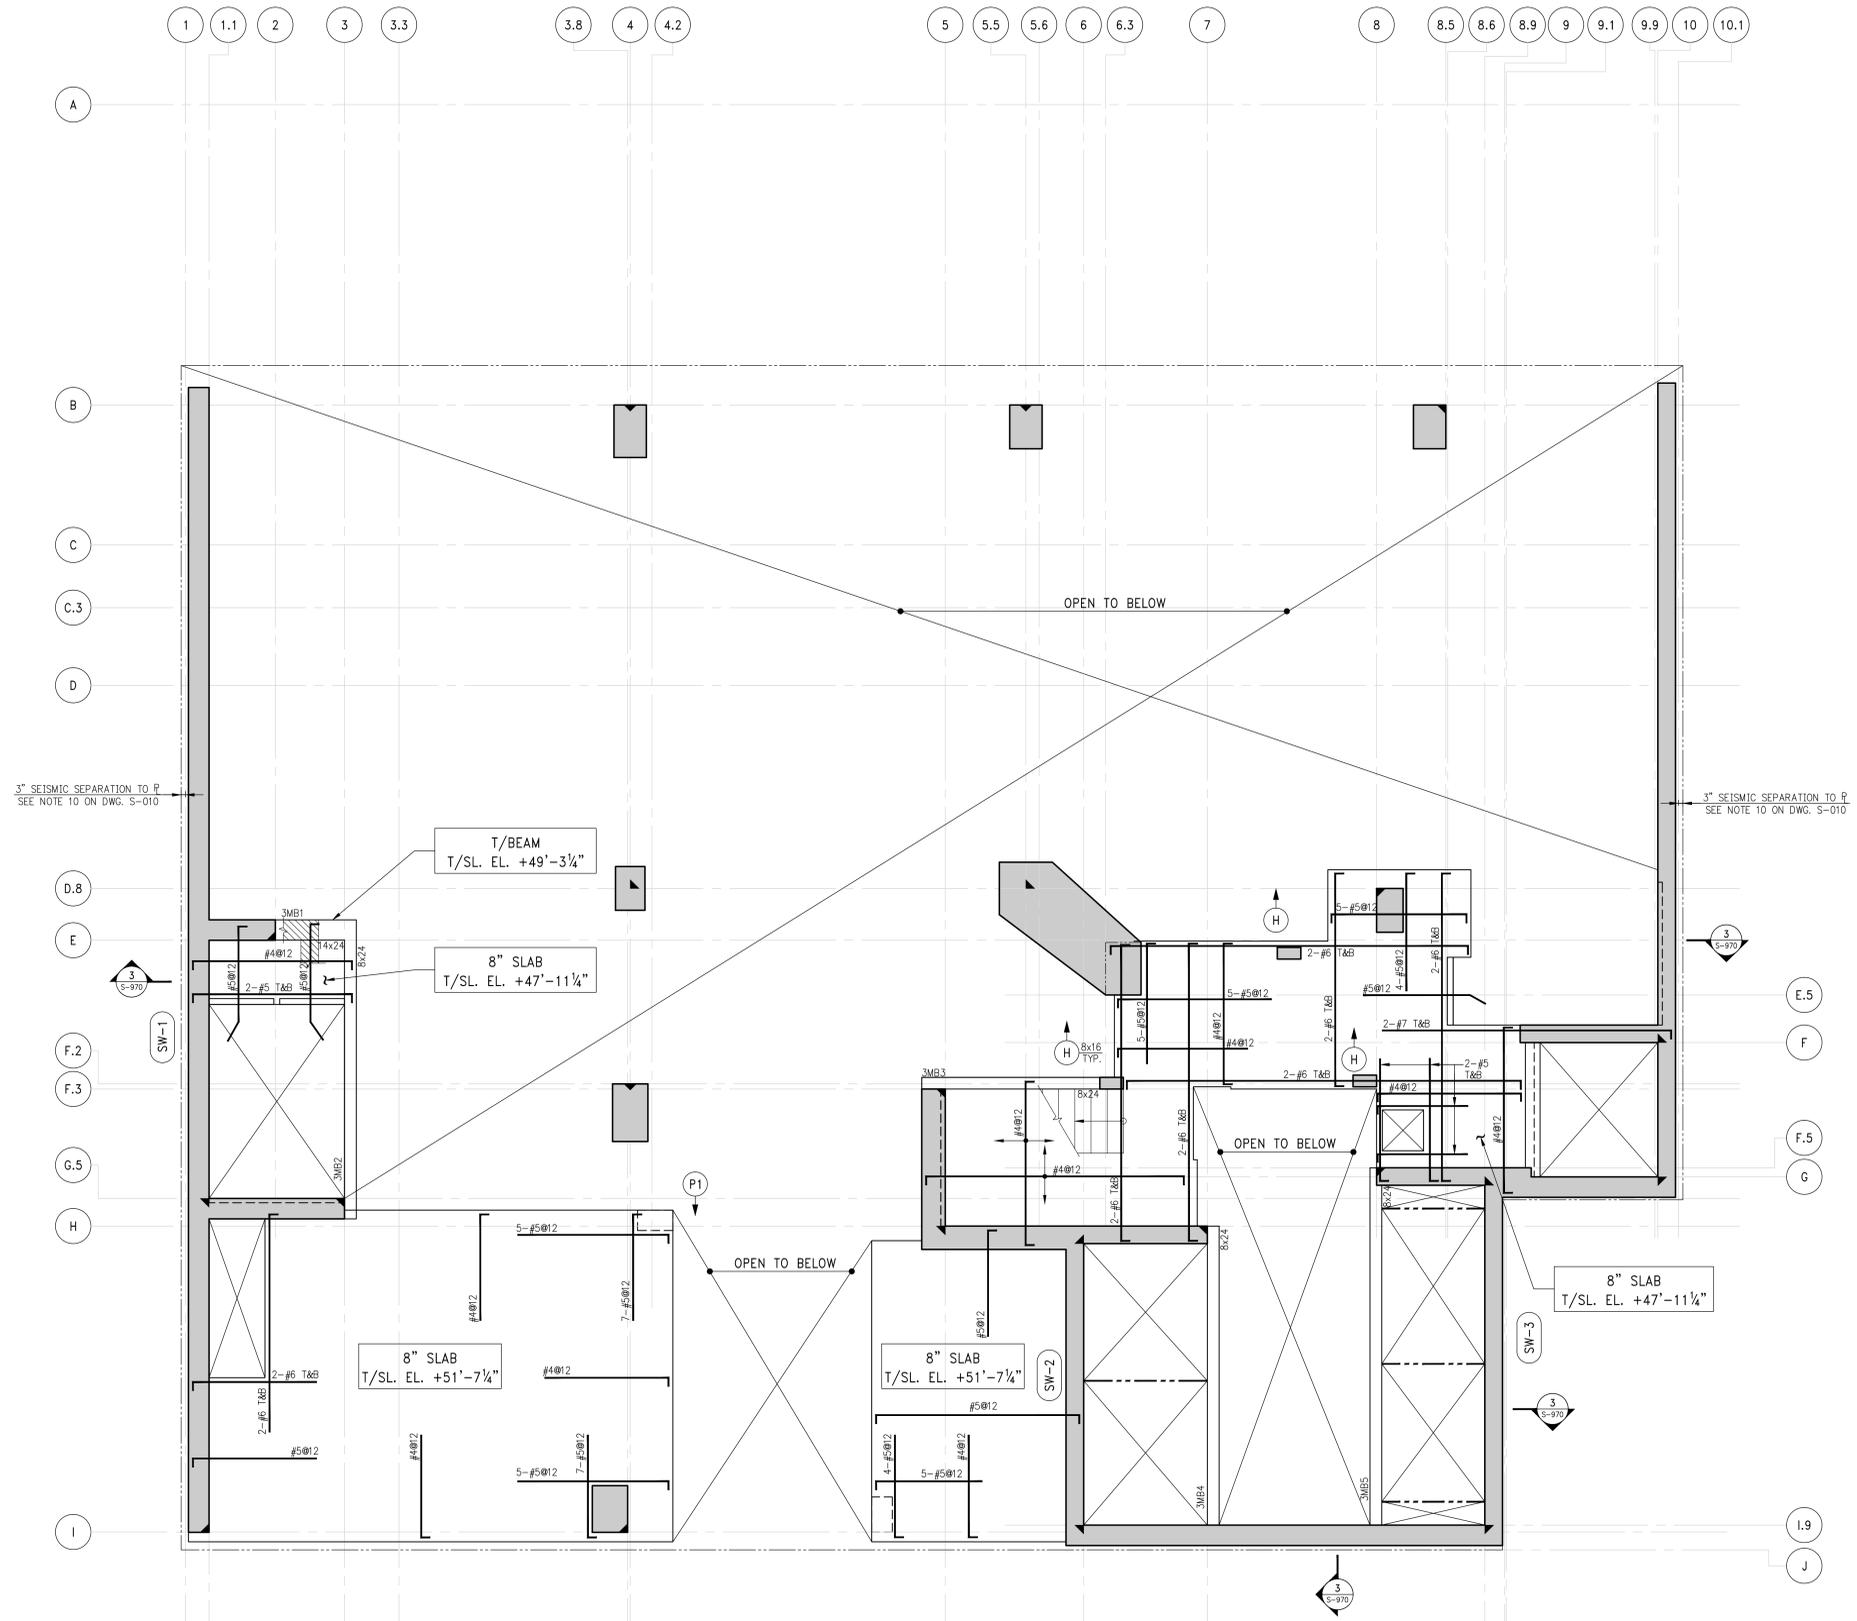
1
S-035 STAIR TRANSFER AT 3RD FLOOR FRAMING PLAN
SCALE: 1/4"=1'-0"

- NOTES:
1. TOP OF SLAB ELEVATION TO BE +47'-11 1/4" U.O.N. THUS [] ON PLAN.
 2. SLAB TO BE 8" THICK U.O.N. THUS [] ON PLAN.
 3. BOTTOM REINFORCEMENT TO BE #4@12 CONT. E.W. FOR 8" SLAB U.O.N.
 4. FOR BALANCE OF NOTES SEE DRAWING S-010.

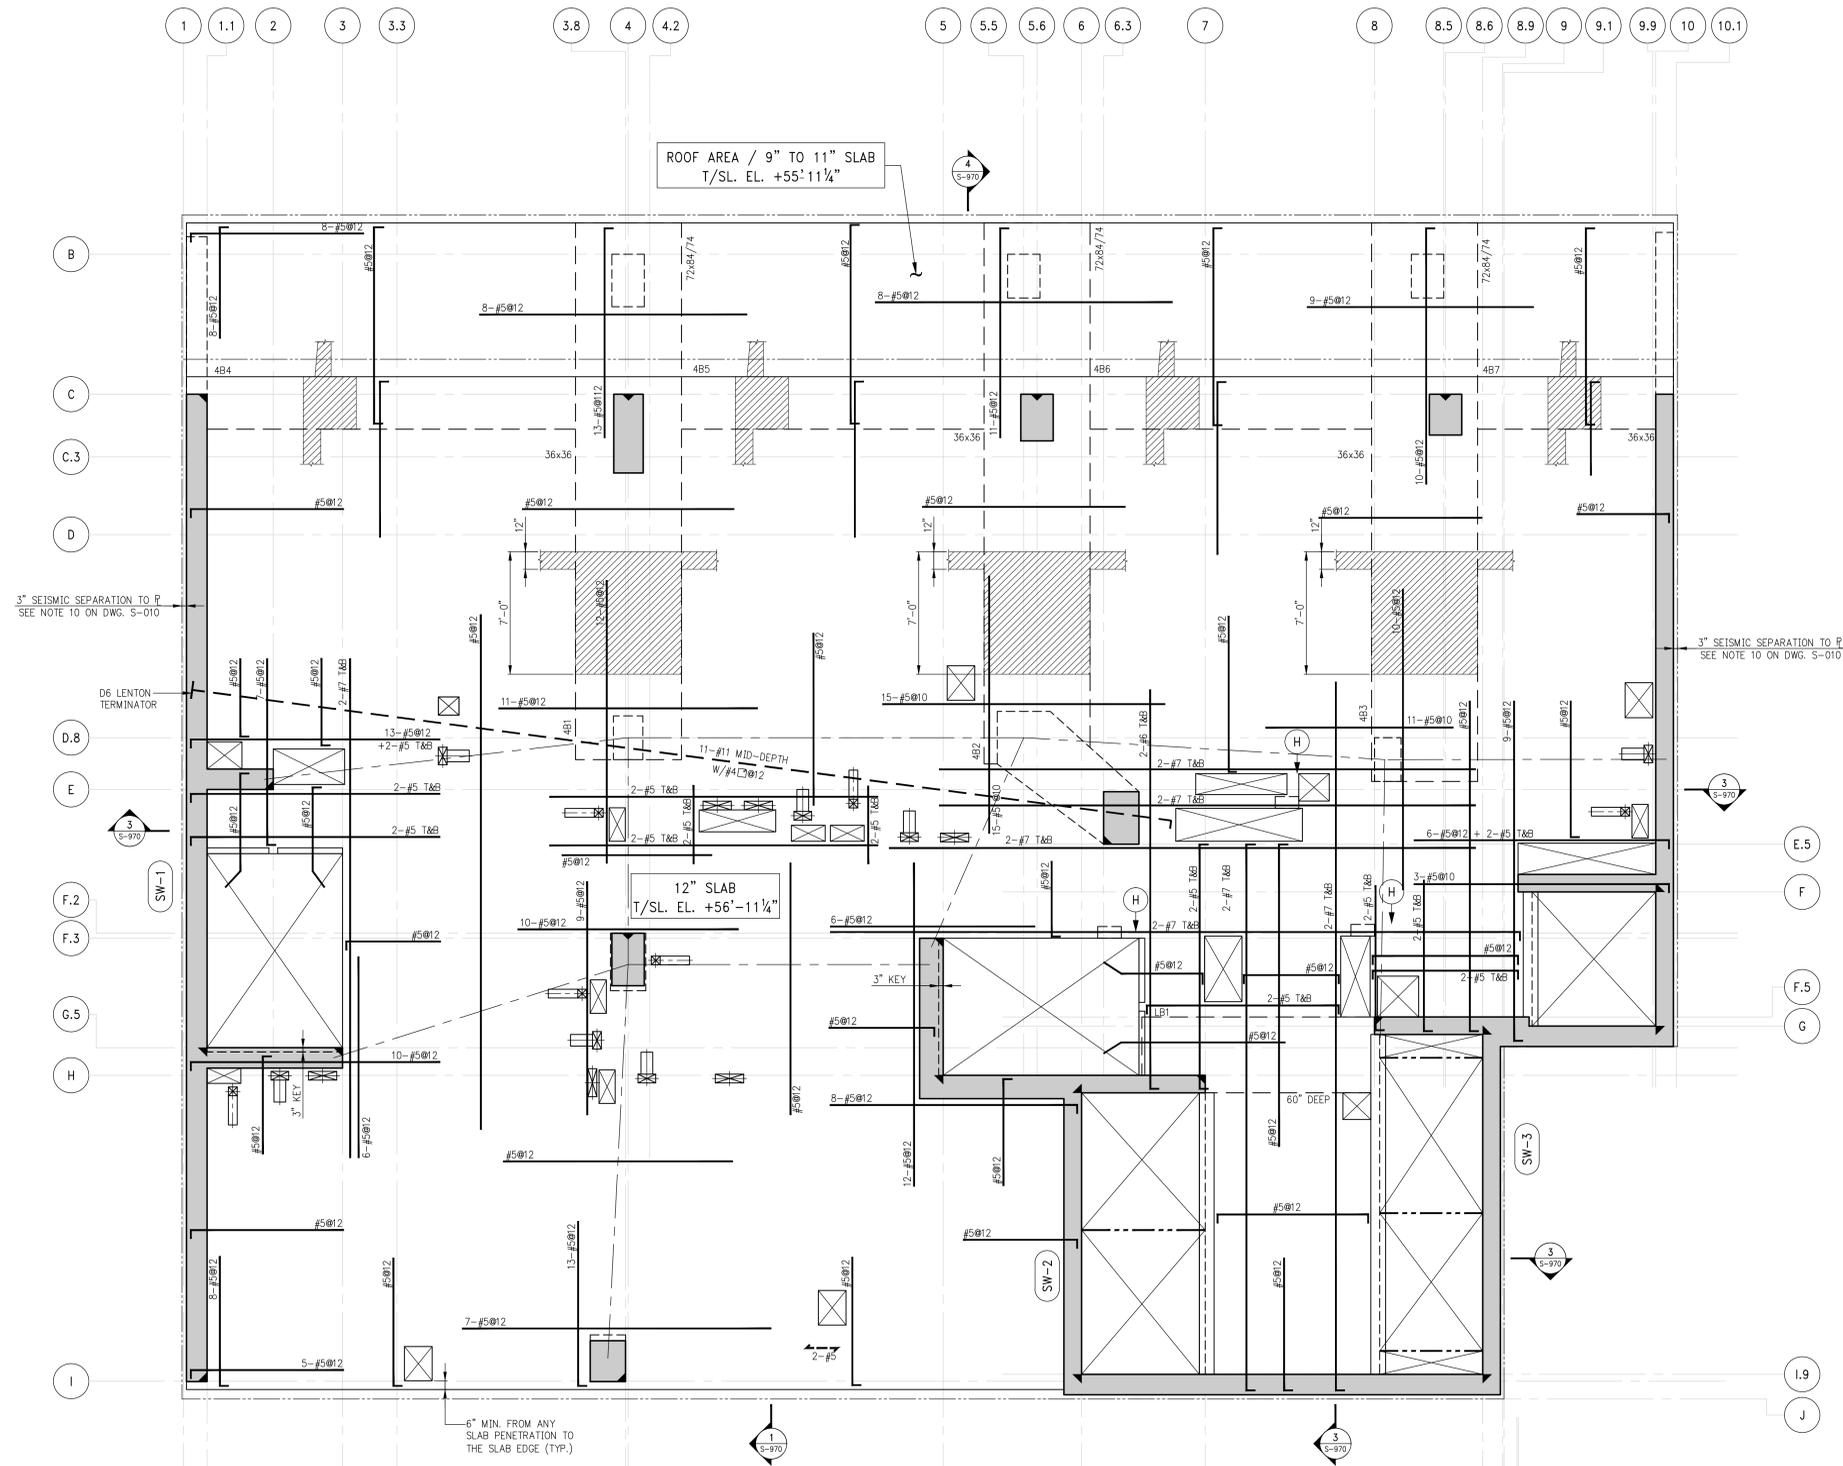
1
S-040 **4TH FLOOR FRAMING PLAN**

- SCALE: 1/4" = 1'-0"
- NOTES:
- TOP OF SLAB ELEVATION TO BE 56'-11 1/4" U.O.N. THUS [] ON PLAN
 - SLAB TO BE 12" THICK U.O.N. THUS [] ON PLAN
 - BOTTOM REINFORCEMENT TO BE: #4@12 CONT. E.W. FOR 9" SLAB U.O.N. #5@12 CONT. E.W. FOR 12" SLAB U.O.N.
 - FOR BALANCE OF NOTES SEE DRAWING S-010.

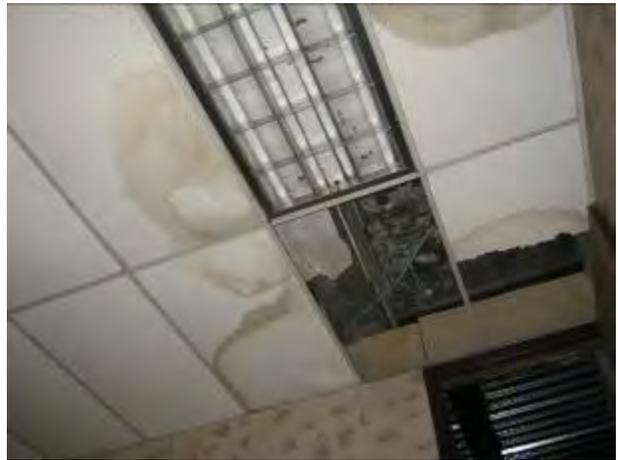
16. View of water damaged ceiling tiles in first floor office space.
