**172-180 NASSAU STREET
BROOKLYN, NEW YORK**

Remedial Action Report

NYC VCP Number: 13CVCP076K

APRIL 2014

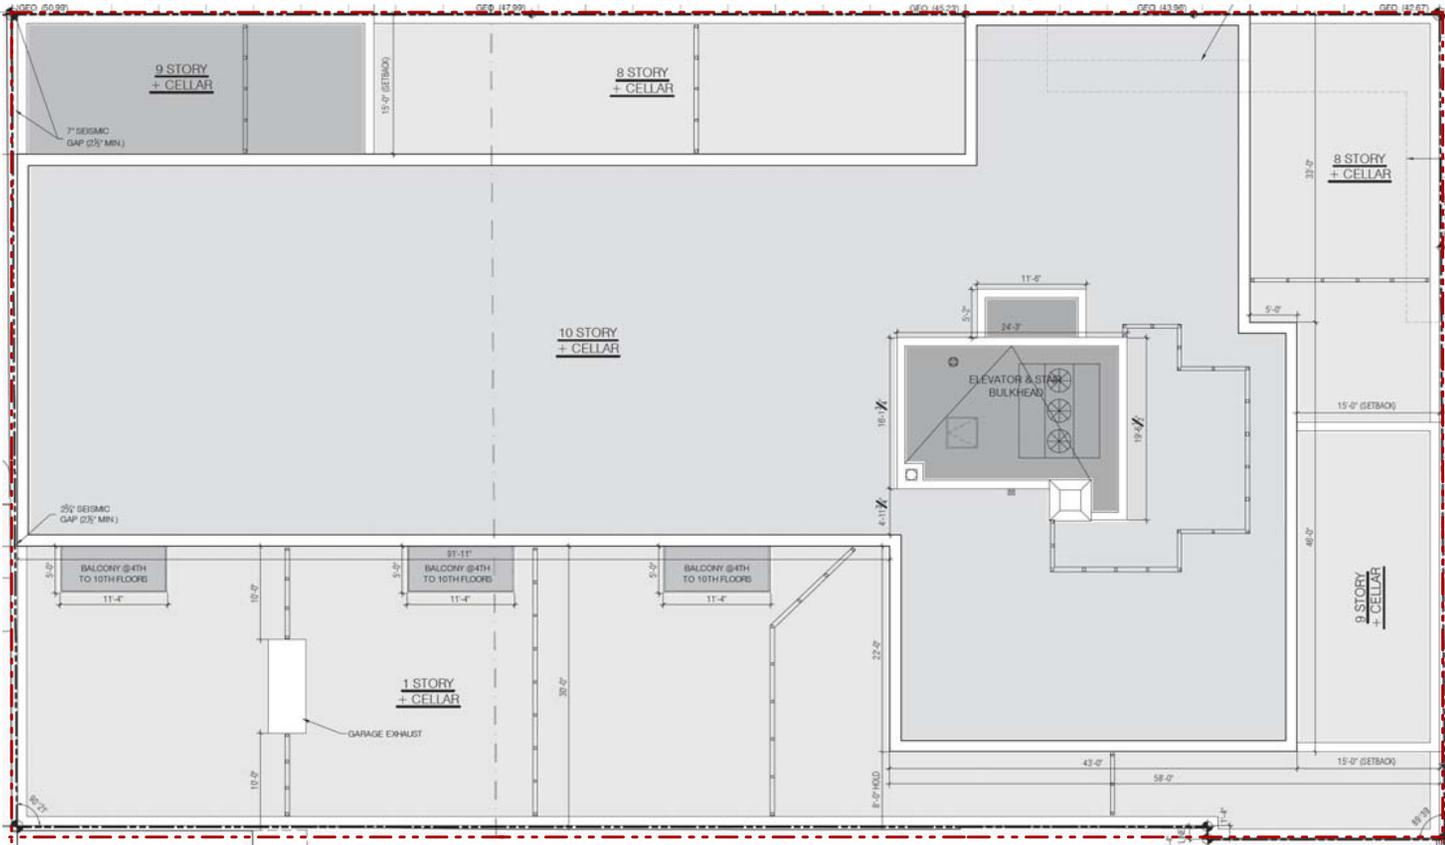
ENVIRONMENTAL BUSINESS CONSULTANTS	Phone 631.504.6000 Fax 631.924.2870	Figure No. 3	Site Name: REDEVELOPMENT PROJECT
			Site Address: 172-180 NASSAU STREET, BROOKLYN, NY

The proposed future use of the Site consisted of a new 12-story apartment building. Layout of the proposed Site development is presented in Figure 3. The current zoning designation is C6-2. The proposed use is consistent with existing zoning for the property.

The proposed redevelopment plans for the Site included the construction of a new 12-story apartment building with a full cellar level below grade. The apartment building has 124 dwelling units, accessory recreation areas at the cellar and first floor levels, and an outdoor accessory recreation area at the roof level. The proposed project gross area is approximately 125,000 ft², including the cellar level.

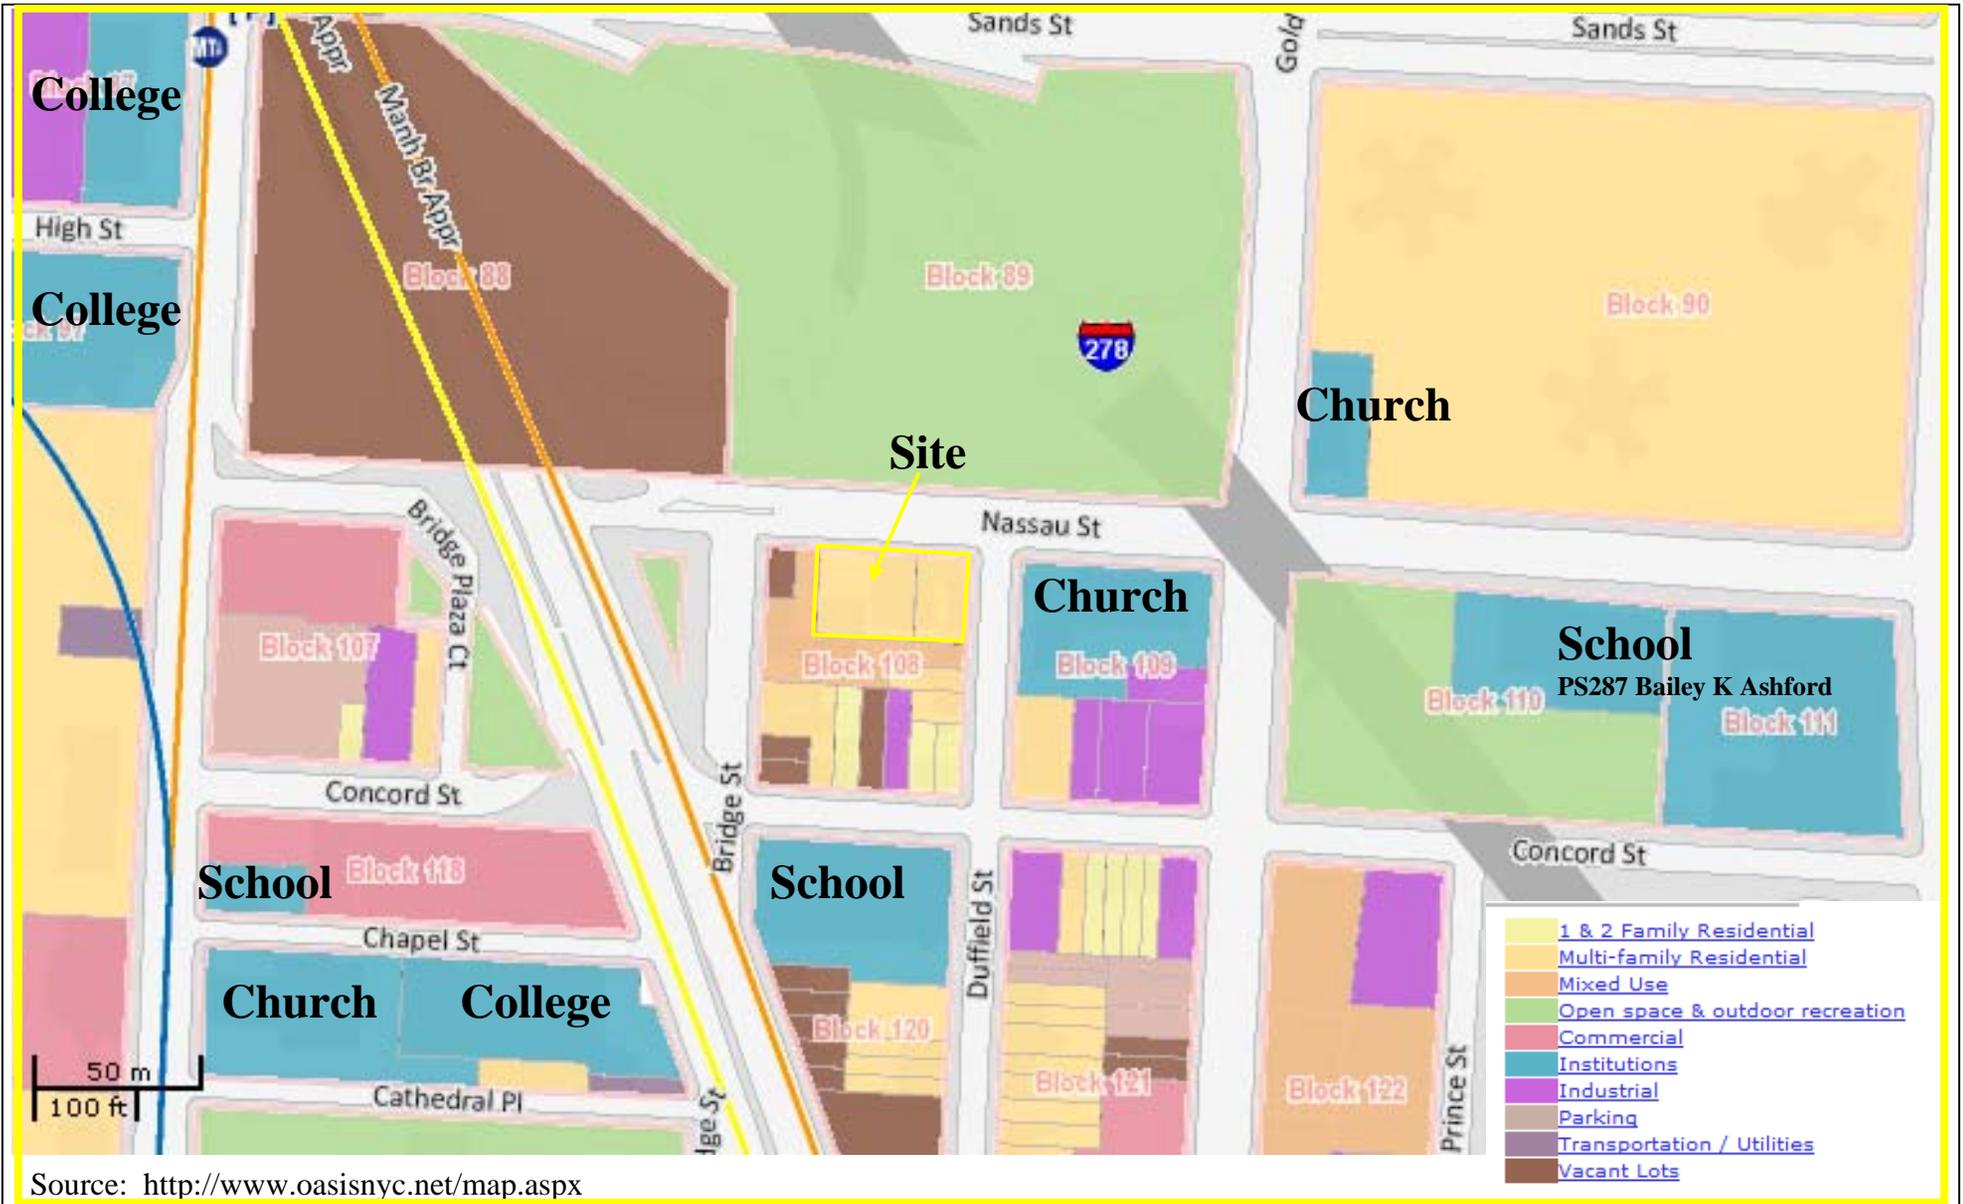
FIGURE 4
SURROUNDING LAND USE MAP

- 200 Nassau Street; 1-13 Duffield Street occupied by the D.R. White Catholic Community Center to the east.
- 170 Nassau Street, located between 168 Nassau Street and 172 Nassau Street, is currently being redeveloped as a covered entry-way to a new 18-story apartment complex located at 189 Bridge Street.
- 12 Duffield Street and 193 Bridge Street are located to the south, and both are used as parking for the 18-story apartment complex located at 189 Bridge Street.
- Trinity Park (Public Park and Playground) to the north.

Figure 4 shows the surrounding land usage.

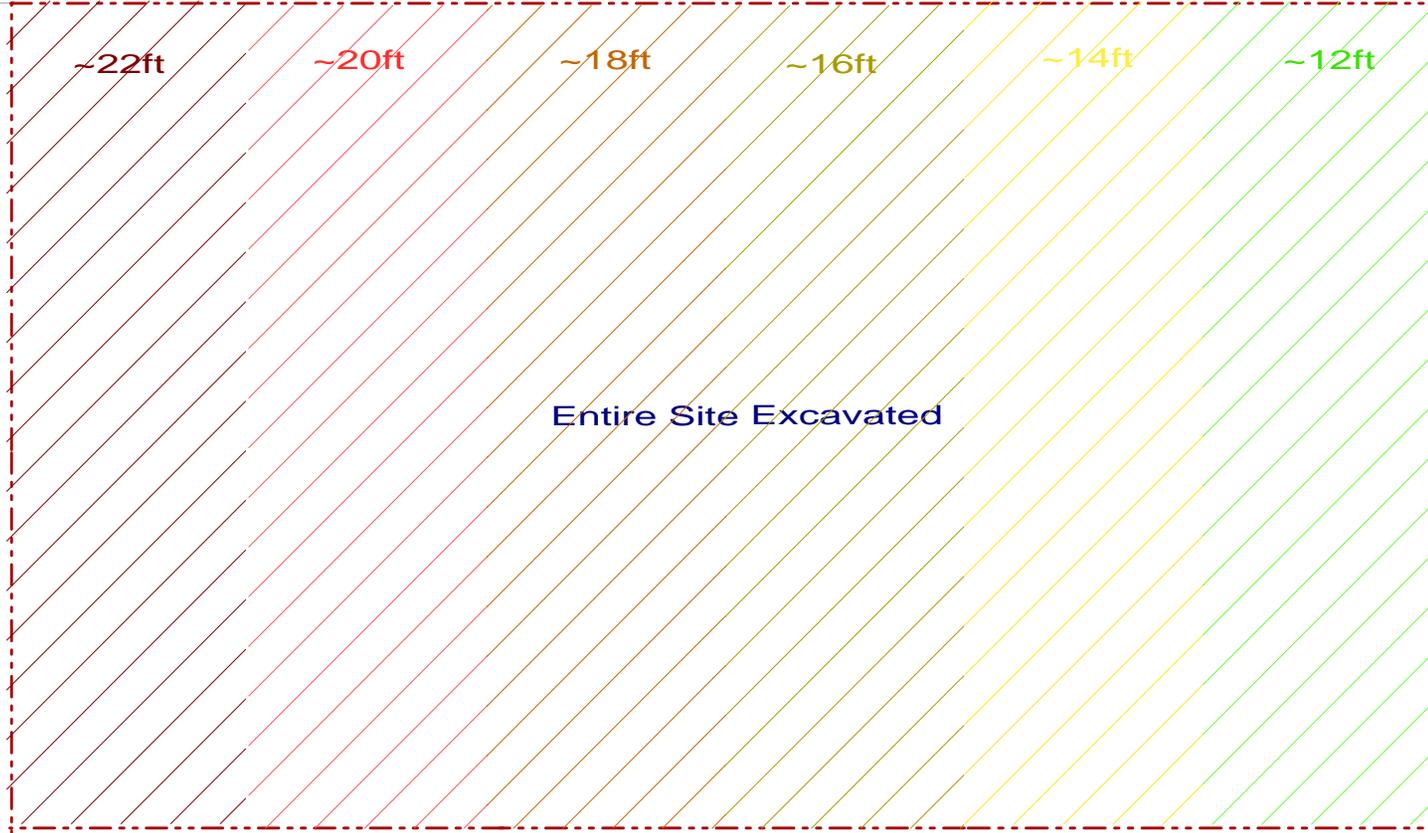
Historic Fill with large amounts brick and concrete was encountered across the Site from grade to a depth of approximately 9 feet. A native fine brown sand with some large stones was encountered below the historic fill layer.

A total of 9,675.74 tons of soil was removed and transported to Fenimore Landfill, and a total of approximately 4,781.43 tons of soil was removed and transported to Prospect Park, LLC. A map showing the location where excavations were performed is shown in Figure 5. No material was reused on-Site.

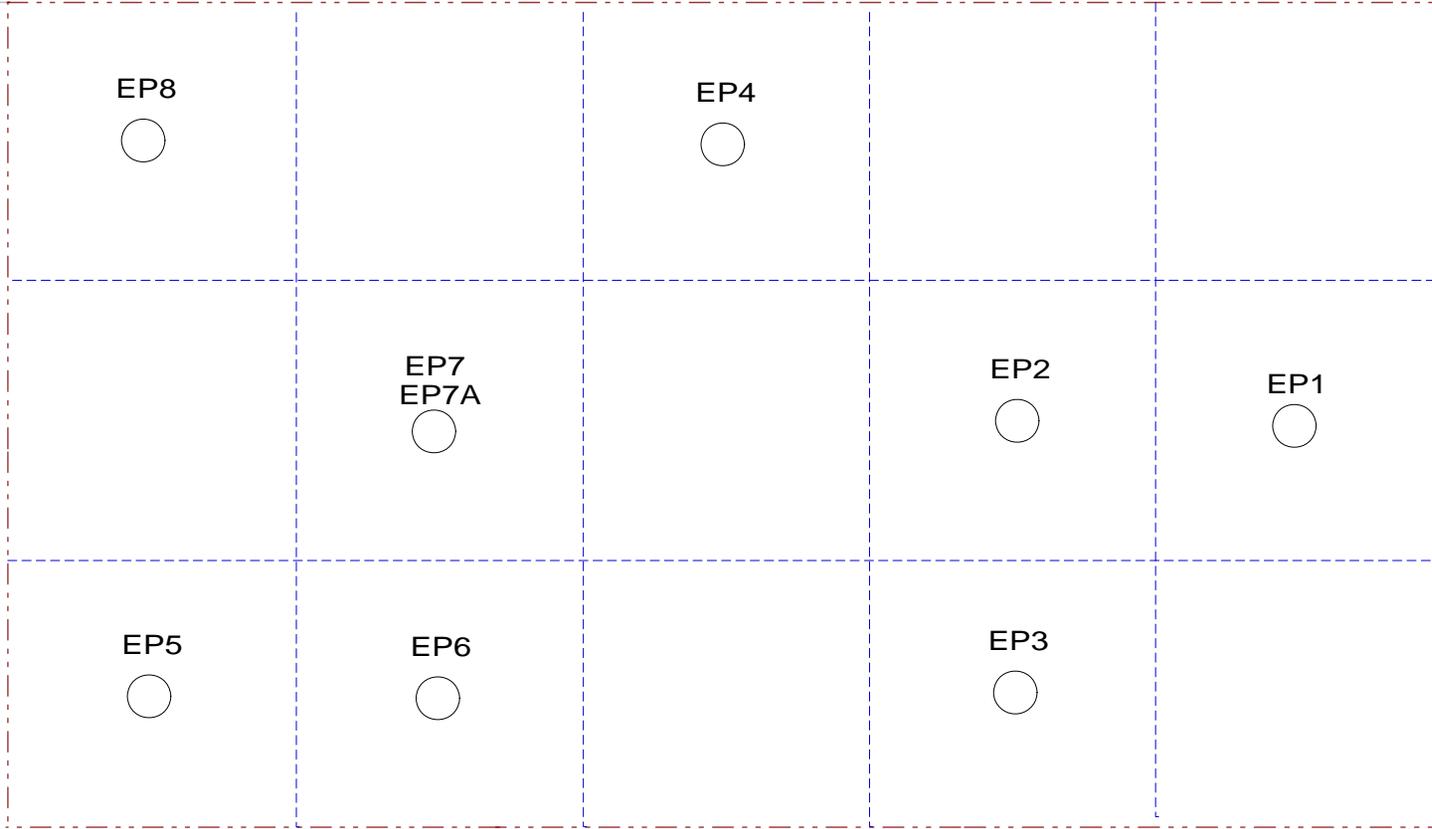
Following excavation for the new buildings, EBC collected eight endpoint soil samples and one duplicate endpoint soil sample. The location of each of the endpoint soil samples is shown on Figure 6. Dedicated disposable sampling equipment was utilized to collect each endpoint sample, eliminating the need for field equipment (rinsate) blanks.
