**FEASIBILITY STUDY REPORT  
FOR  
FORMER NUHART PLASTIC MANUFACTURING SITE  
280 FRANKLIN STREET  
BROOKLYN, NEW YORK

NYSDEC SITE # 224136**

**PREPARED FOR  
DUPONT STREET DEVELOPERS, LLC**

**JANUARY 2016**

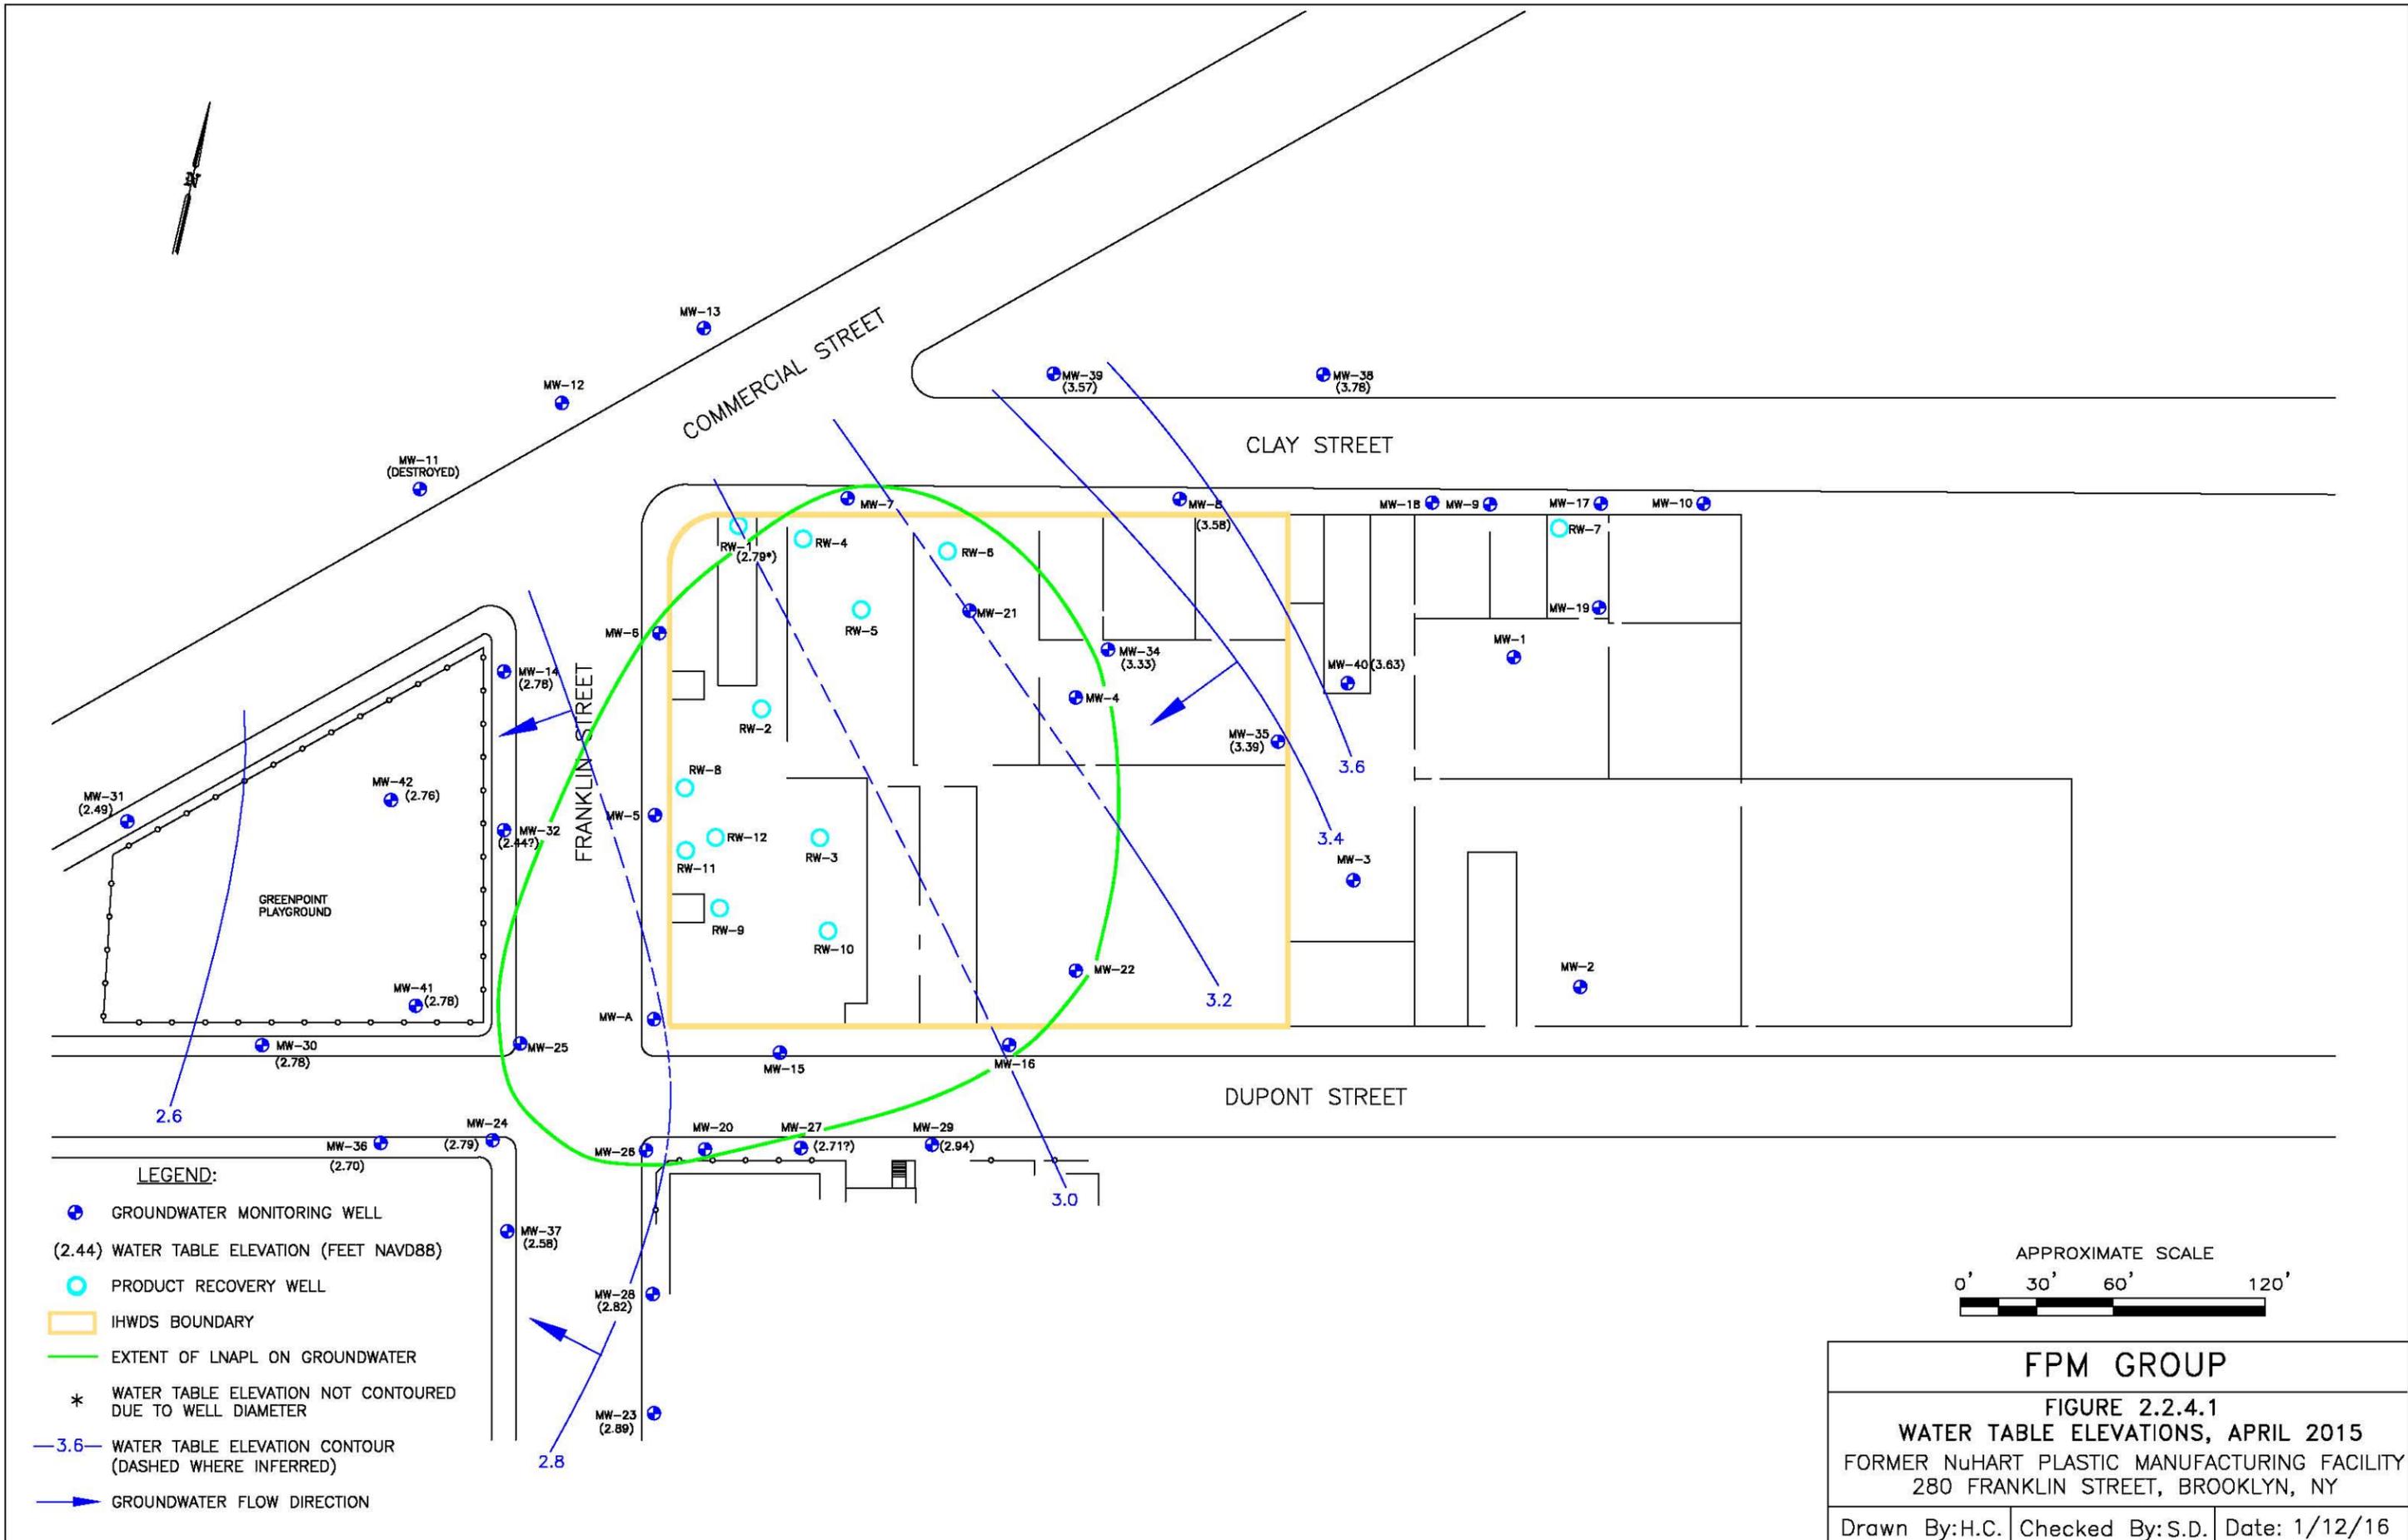
The elevation of the water table in April 2015 (seasonal high water level) is shown on Figure 2.2.4.1 and indicates that groundwater flow beneath the Site and vicinity is generally to the southwest. The gradient (slope) is relatively low (about 0.004) on the northeastern portion of the Site and becomes nearly flat (about 0.001) on the southwestern portion of the Site and further to the southwest. This indicates that groundwater flow beneath the Site is very slow and likely decreases further to the southwest. Some variability was noted in the water levels, particularly to the southwest of the Site. This variability may be due to the nature of the materials in which the well screens are installed, as further discussed in Section 2.2.5 below. For the purpose of understanding the overall direction of groundwater flow in the Site vicinity, minor variations in water levels were ignored during development of Figures 2.2.4.1 and 2.2.4.2.

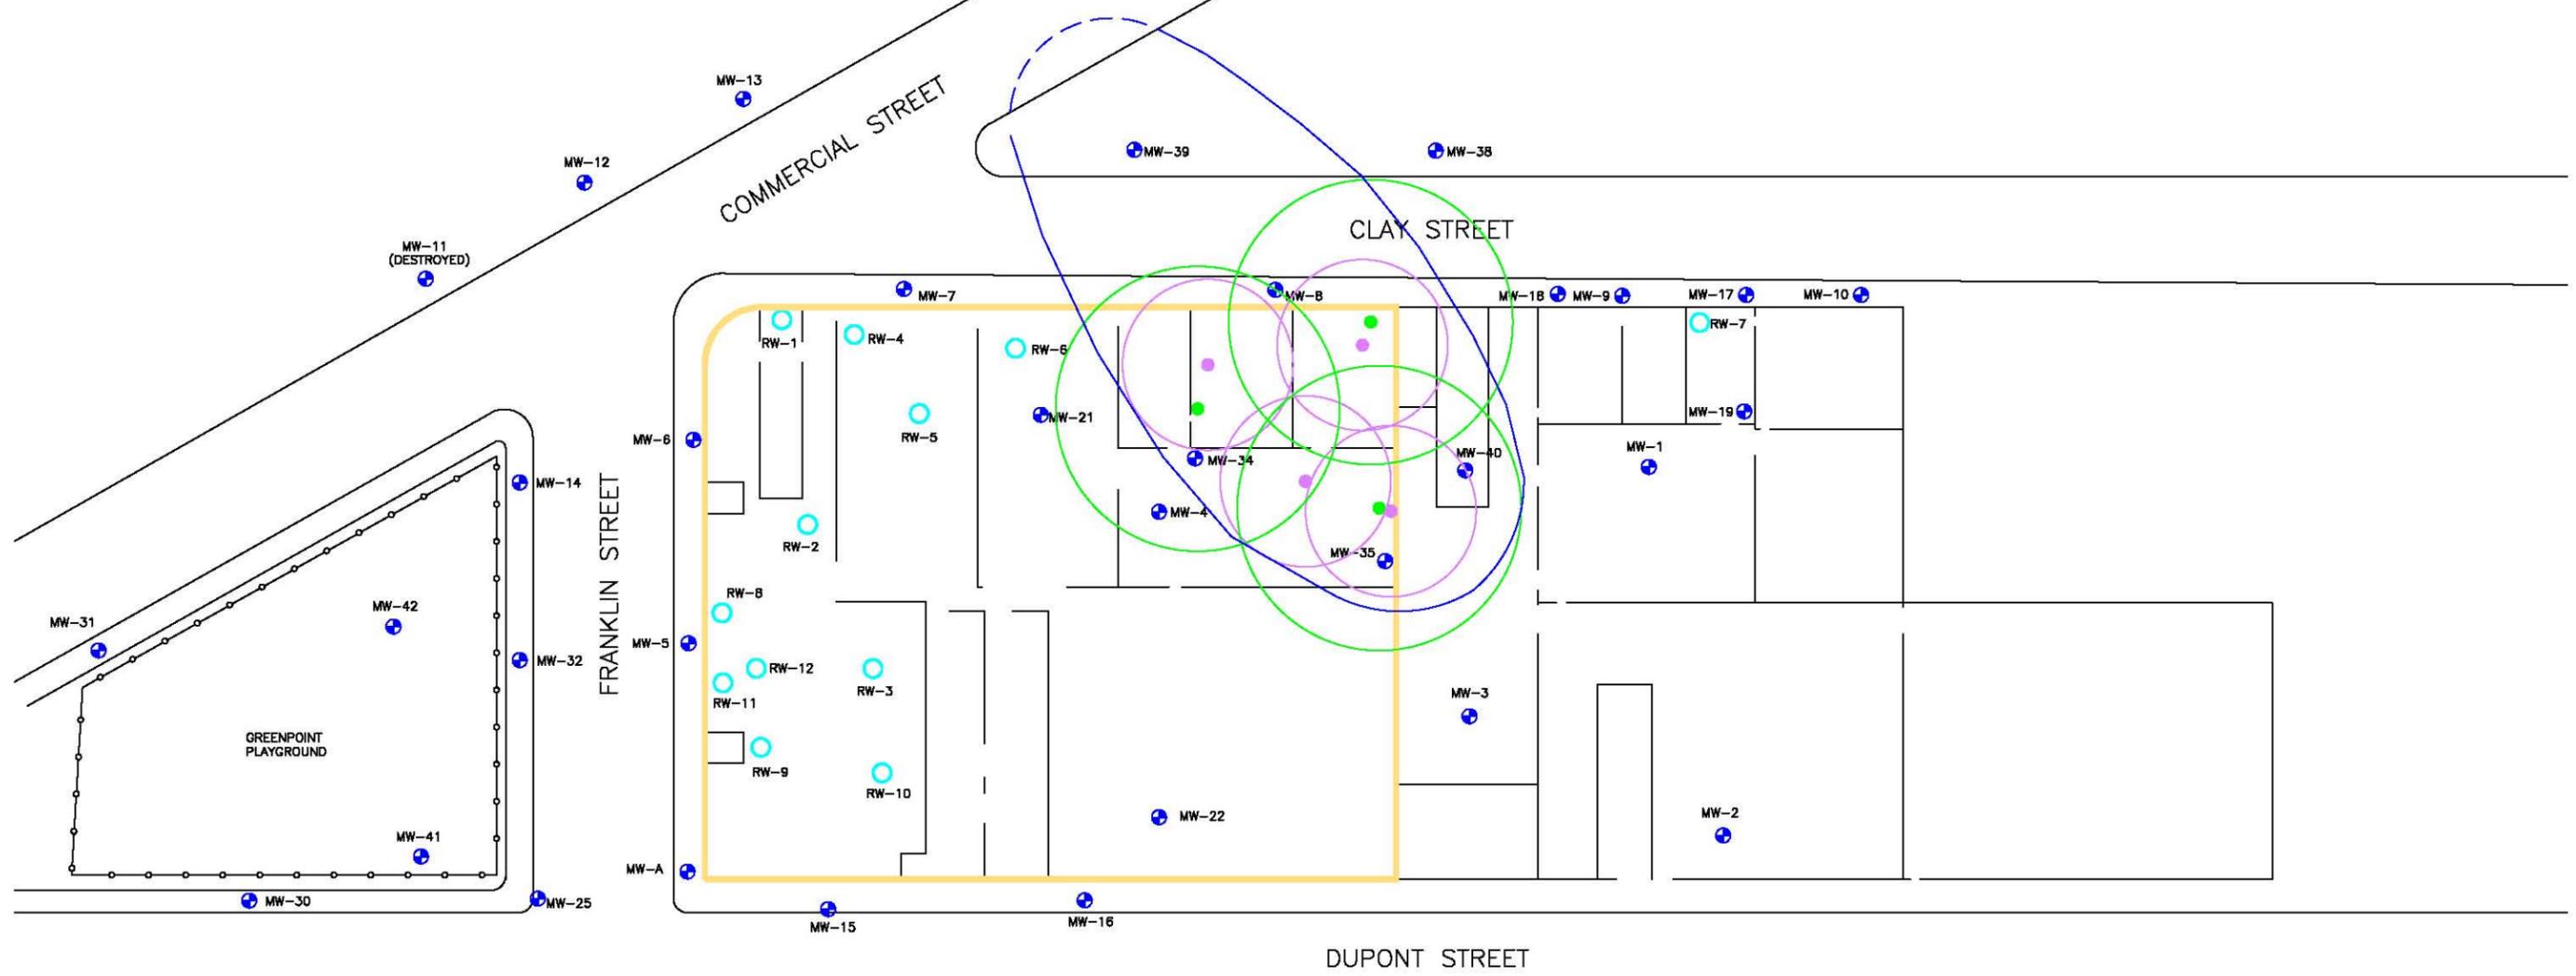
- GROUNDWATER MONITORING WELL
- PRODUCT RECOVERY WELL
- IHWDS BOUNDARY
- TCE  $\geq 100$   $\mu\text{g/l}$  IN GROUNDWATER
- PROPOSED AIR SPARGE WELL WITH RADIUS OF INFLUENCE
- PROPOSED SOIL VAPOR EXTRACTION WELL WITH RADIUS OF INFLUENCE

SVE wells would be required to capture vapors resulting from sparging. The SVE wells would also treat VOC-impacted soil that may be present in the unsaturated zone in the presumed source area and remove soil vapors associated with the VOC-impacted area. SVE system design would take stratigraphic variations into consideration to maximize effectiveness. The SVE system would likely include three wells; potential SVE well locations are shown on Figure 4.1.2.1 and are based on previous experience with SVE system layouts in the NYC metro area. It is anticipated that an SVE ROI of about 50 feet may be achieved with a flow rate of about 100 SCFM under a vacuum of between 10 and 150 inches of water. The blower would be appropriately sized for the anticipated total flow rate and vacuum of the SVE system. Sub-slab monitoring points would also be installed to just below the slab to allow for confirmation of the SVE ROI and to allow for sub-slab vapor sampling, as needed.

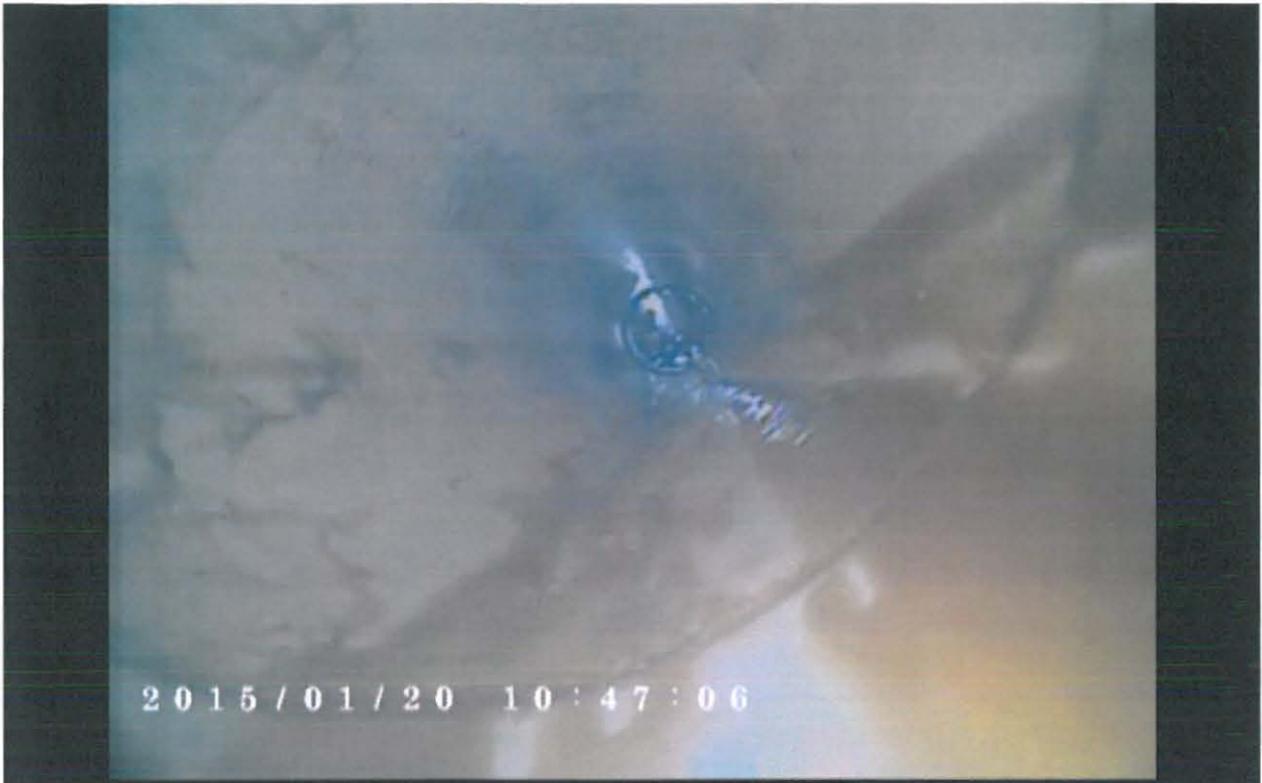
### **RW-8**

Product entering well after well is pumped down. The joint between the solid casing and screen is visible. It should be noted that much of the product visible on the lower and right portions of the photo is running off of the pump which has just been pulled from the well, and is not representative of what is entering the screen.

Several of the wells containing product were video-taped under pumping and recovery conditions to assess whether the PVC wells screens and/or casings may be affected by contact with the LNAPL. None of the video testing results showed any apparent distortions of the well casings or screens, widening or obstruction of the screen slots, restriction of groundwater or product flow into the wells, encrustations or growths adhering to the casings or screens, or other conditions that may affect the integrity of the wells or well screens, or the flow of fluids into the wells. This information supports the continued use of Schedule 40 PVC well materials at this Site for monitoring or other purposes that do not typically require use of alternate well materials, and also indicates that the data obtained from these wells is anticipated to be valid.

The observed presence of sand at RW-8 and RW-10 suggests that additional measures may be necessary to preclude sand intrusion into future wells if such wells are used for LNAPL recovery purposes. These measures may include reducing the screen slot and/or gravel pack size, more intensive well development, or some combination of these measures.

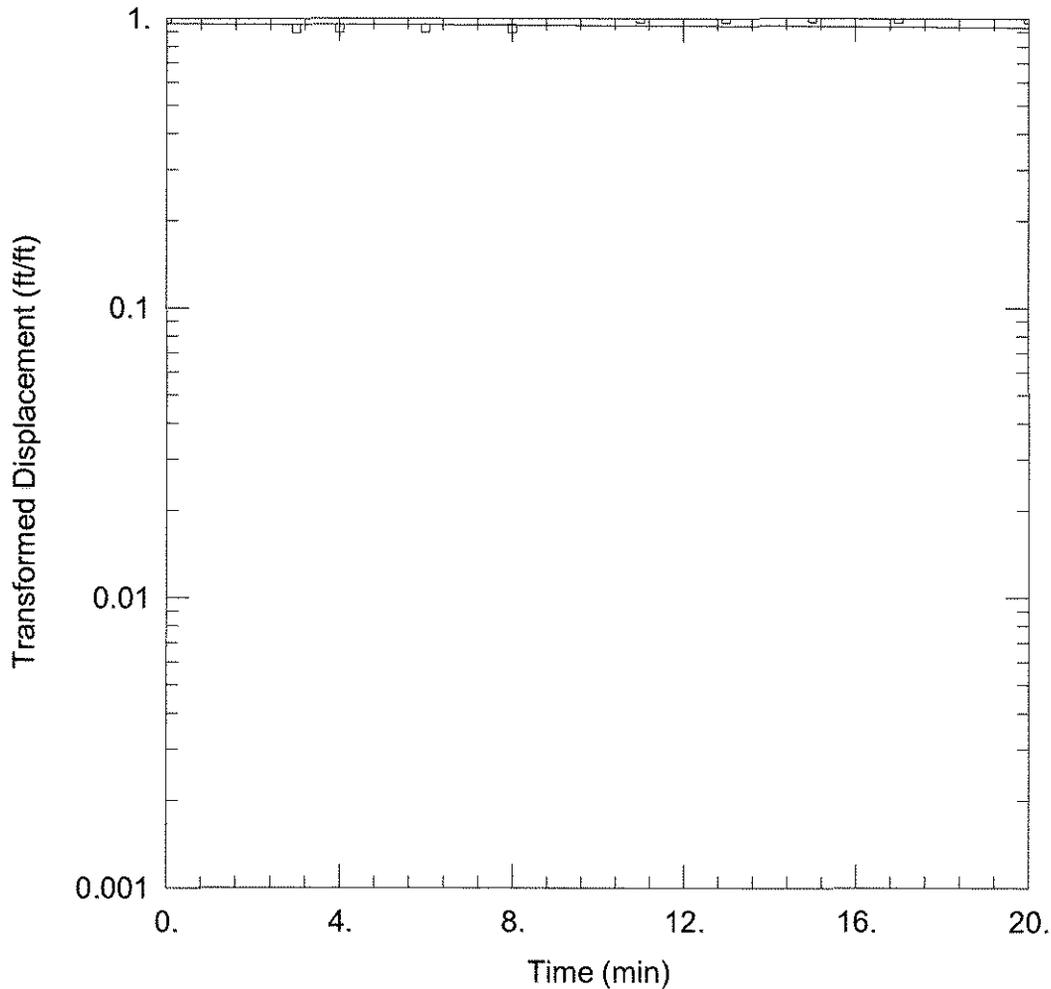
Aquifer Model: Unconfined Solution Method: Dagan  
 K = 1.099E-6 ft/min y0 = 0.1247 ft

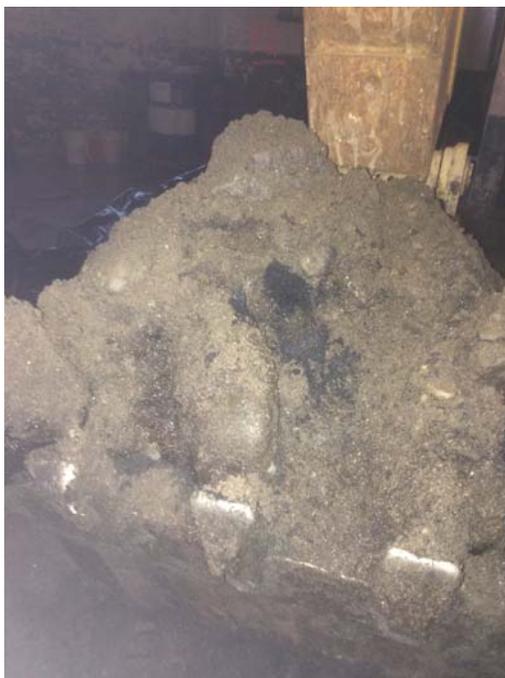
Photo #2 – Bucket of till soil with cobbles visible. Darker areas are stained with product.

- Native material that appears to be glacial till (an apparently unsorted mixture of fine to coarse-grained materials ranging from silt up to cobbles) is present from about 10.5 feet to at least 14 feet in the test pit area. This material is extremely loose and was noted to run into the test pit as each bucket of soil was removed. The behavior of this material suggests that shoring will be required for any excavations that penetrate this material.

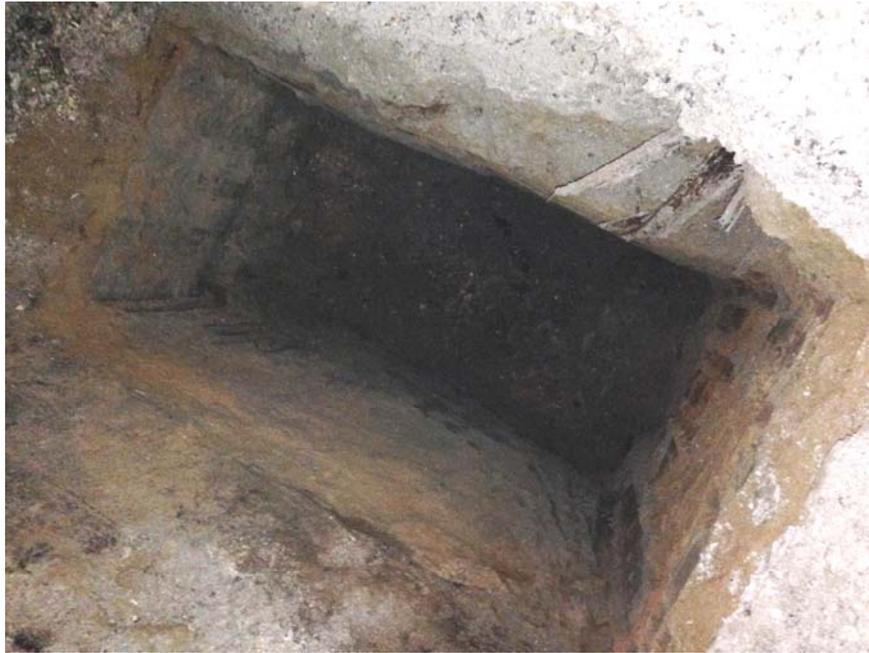
Photo #3 – Complete test pit. Visible stratigraphy includes historic fill (gray, at top), native sand/silt (tan), clay (gray), and till (bottom of pit). Product can be discerned as small shiny areas at the bottom of the pit.

The following observations were noted from the test pit, which was performed in proximity to RW-12 near the southwest corner of the Site:

- Although staining and odors typical of product were noted at two intervals in the test pit (top of clay at about 5.75 feet and about 12.5 feet, just above the top of the product), no organic vapors were detected by the photoionization detector (PID). The odors were observed to be moderate in proximity to the removed stained materials, but were not perceived to extend beyond the immediate area of the test pit or the pile of excavated impacted soil placed adjacent to the test pit pile. Odor was not noticeable at a short distance from the stained materials. These observations suggest that odors from product-impacted materials that may be exposed during remedial activities may not present a significant concern.

- Historic fill containing significant amounts of anthropogenic debris, ash, and cinders is present to a depth of about five feet in the test pit area. Although this material did not exhibit any significant odors or staining, the visual appearance of the historic fill suggests that it is likely to contain constituents commensurate with its origin and the fill, if excavated, will likely require offsite disposal as regulated material.

- 
- Native soil, including silty fine sand and clay, is present beneath the historic fill to a depth of about 10.5 feet in the test pit area. No visible indications of potential impacts were noted in this soil, with the exception of some minor staining and odor at the top of the clay; these impacts did not appear to extend significantly into the clay. This suggests that the soil beneath the Site slab and above the product smear zone is not likely to be impacted by the product except in areas where releases occurred and the product migrated downward from tanks, piping, trenches or other structures that formerly contained product.
