507 WEST 24TH STREET GALLERY MANHATTAN, NEW YORK

Remedial Investigation Report

NYC BCP Site Number: 12CVCP047M

Roux Associates, Inc.
209 Shafter Street, Islandia, New York 11749
nepler@rouxinc.com
(631) 232-2600

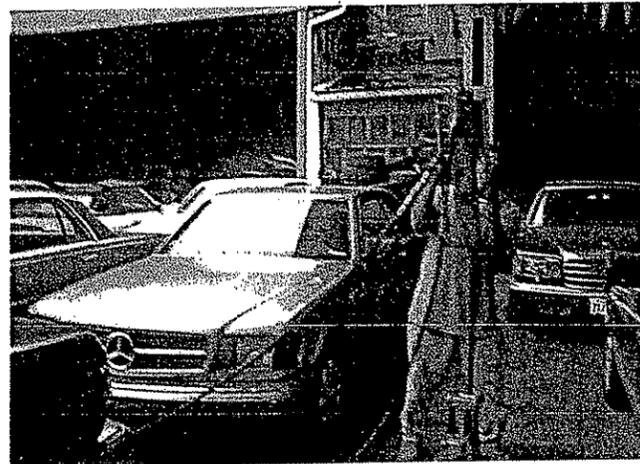
Installation of Soil Probe

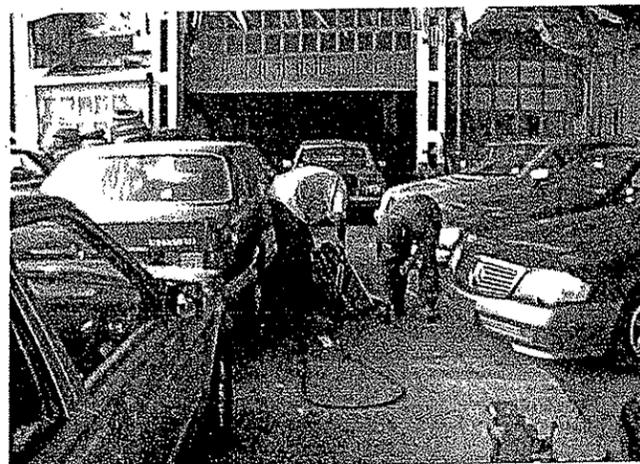
Removing Macro Core

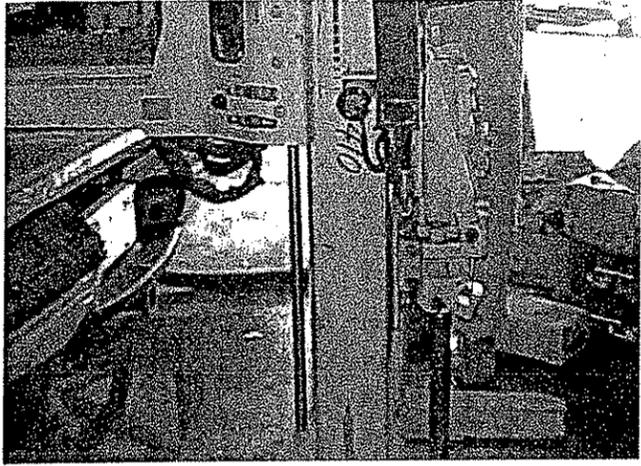
Installation of Groundwater Probe
