186-02 JAMAICA AVENUE

Remedial Investigation Report

E-Designation: E-175

SOIL MECHANICS ENVIRONMENTAL SERVICES

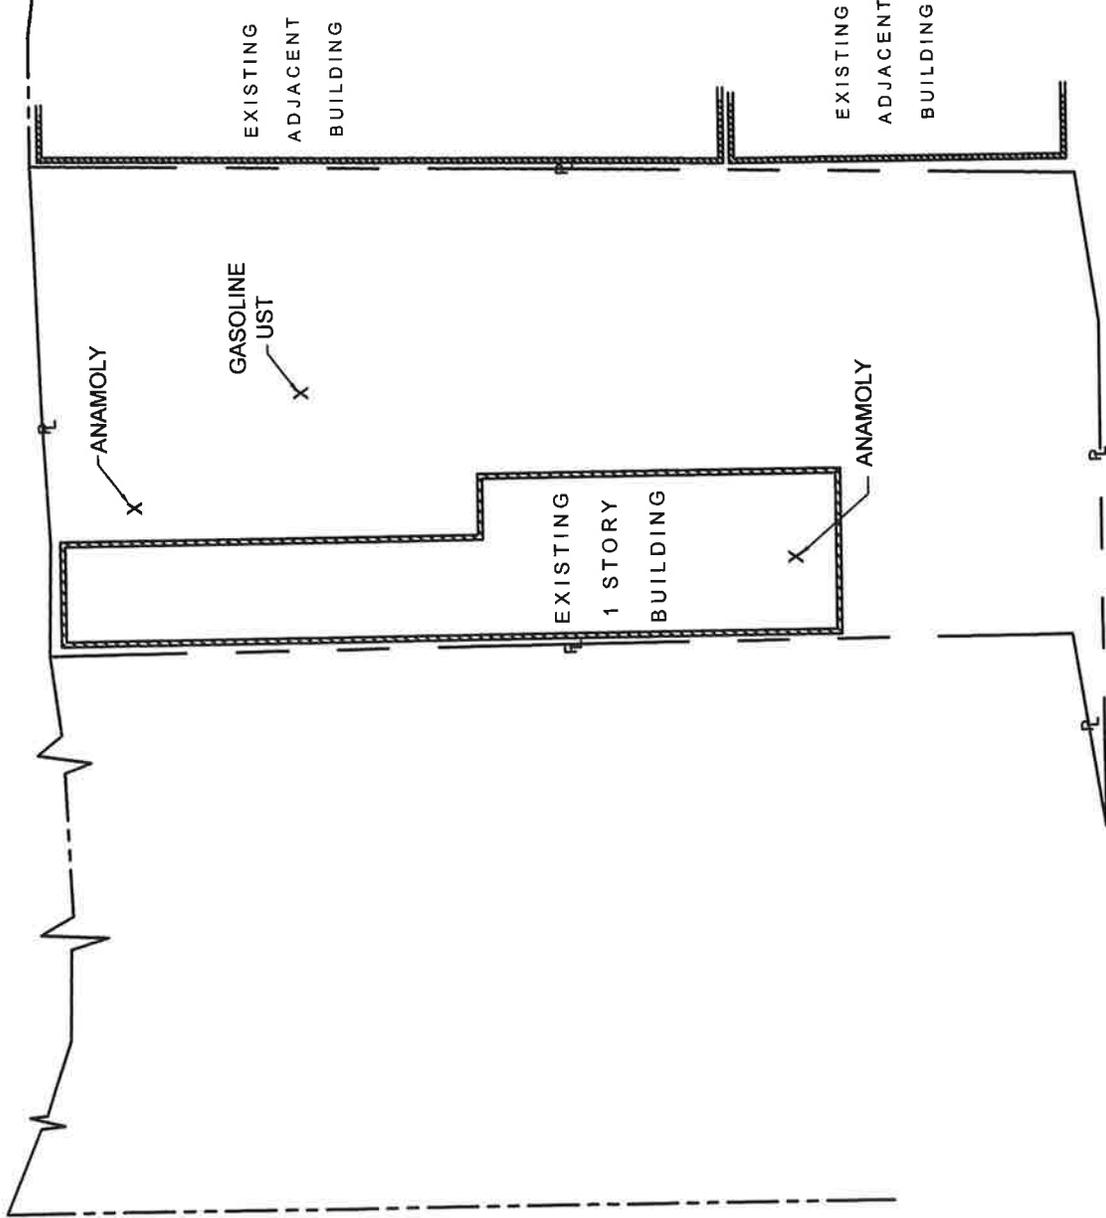
FIGURE 5
GPR SURVEY RESULTS MAP
QUEENS, NEW YORK

Using a hydraulic combination hoe, an exploratory test pit was completed outside the northeastern portion of the existing building for the purposes of investigating the GPR anomaly. The test pit was approximately 2.0 – 3.0 feet wide by approximately 8.5 feet deep upon its completion. Results of the test pit revealed no visual evidence of a UST. The anomalous condition was found to consist of a section of I-beam, remnants of a concrete column, and portions of a basement (associated with former building). Due to access constraints, an exploratory test pit was not completed at the anomaly identified within the southern portion of the existing building. In lieu of an exploratory test pit, soil probes GP-10 and GP-11 were completed in proximity to the GPR anomaly identified within the southern portion of the building to evaluate subsurface soil quality.

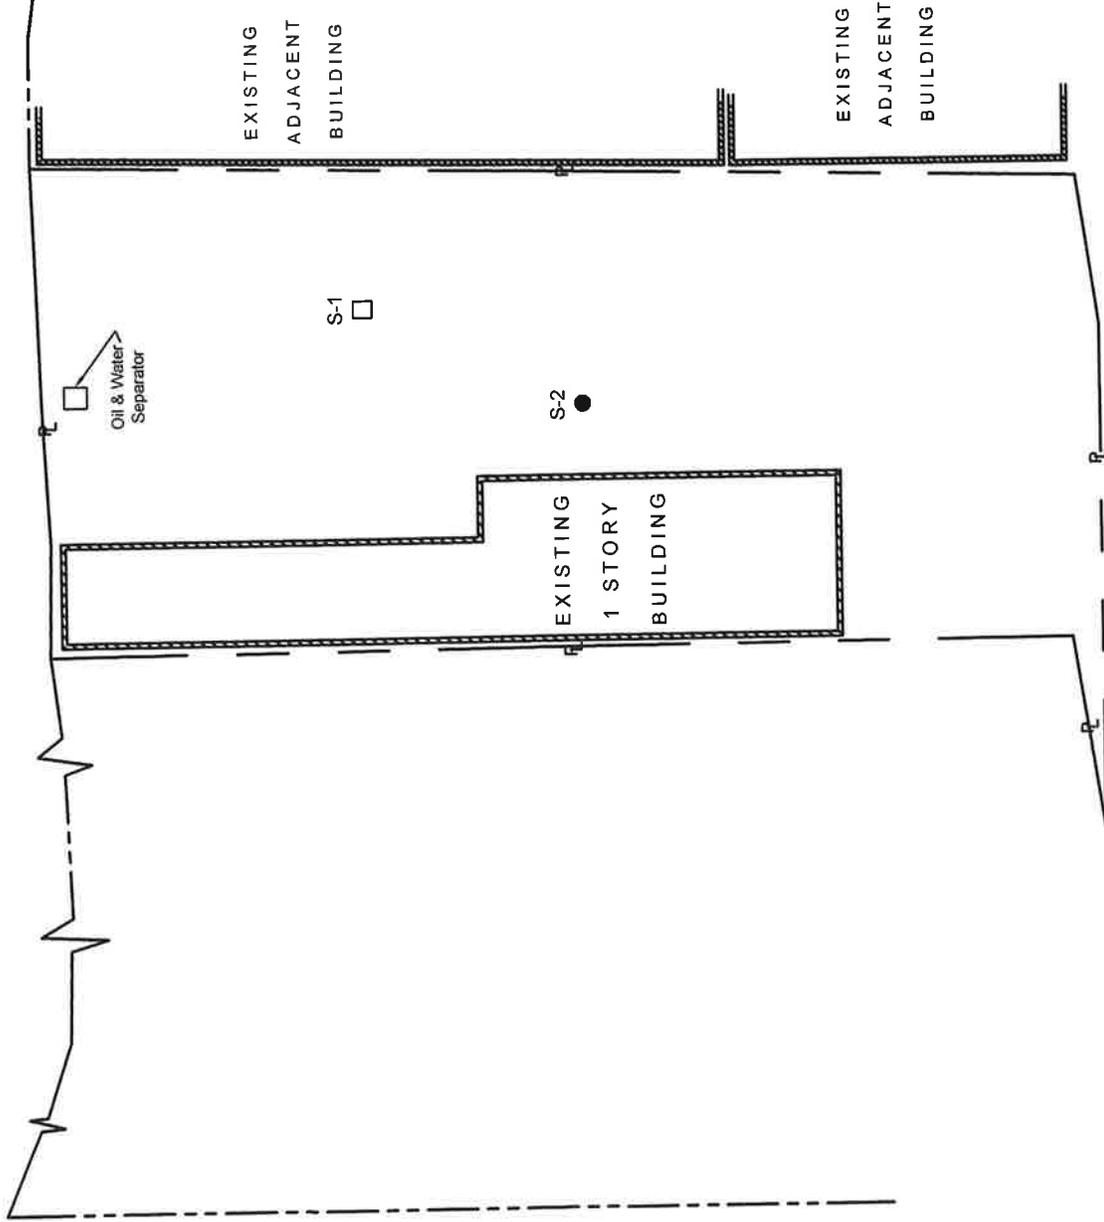
FIGURE 6
LOCATION OF SUBSURFACE DRAINAGE STRUCTURE MAP
QUEENS, NEW YORK

formations. It should be noted that intake/outfall pipes were identified within both structures which suggests that additional overflow pools are present.

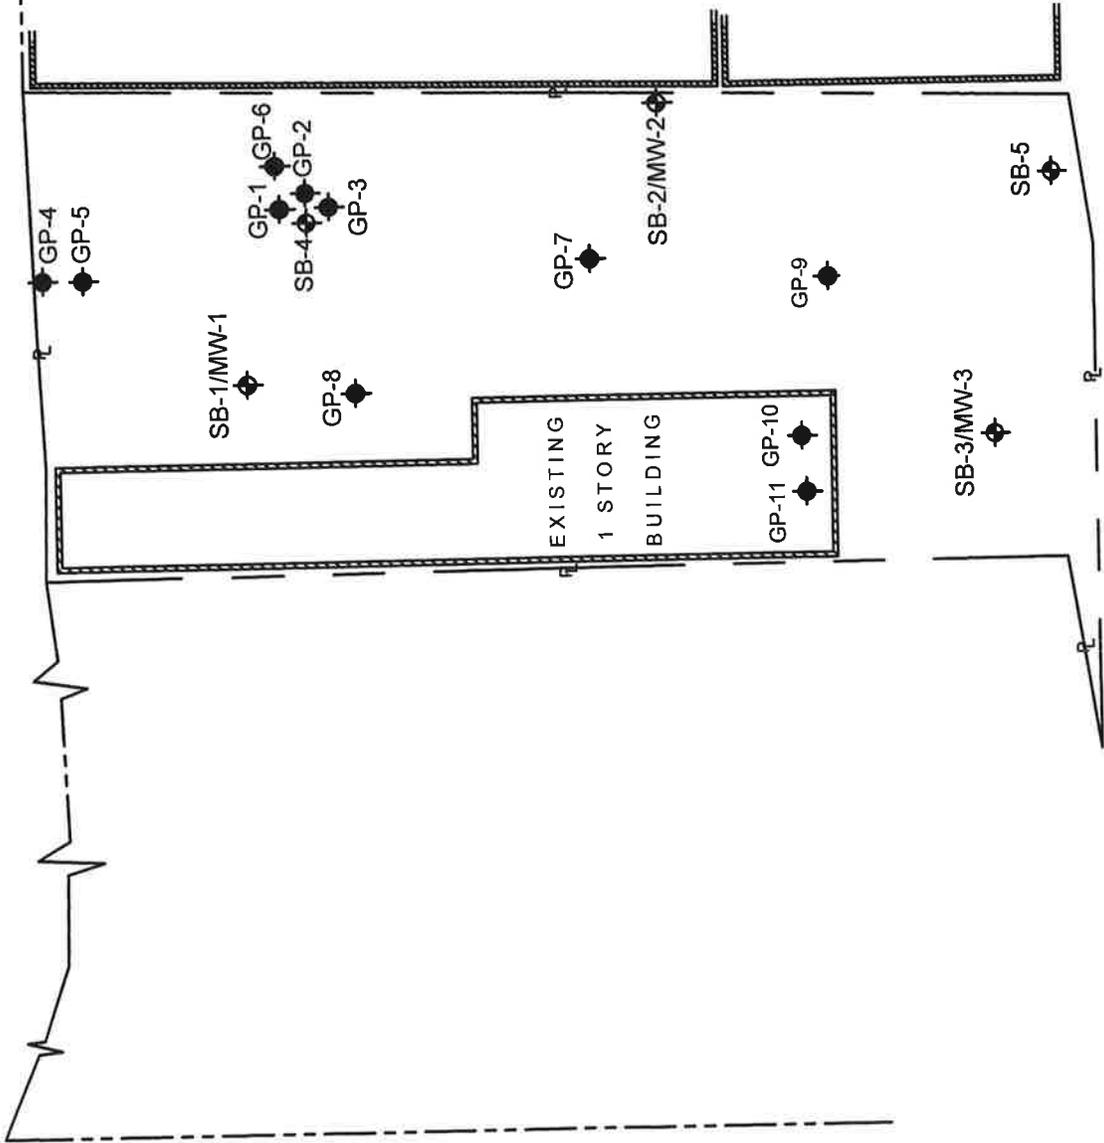
SAMPLE LOCATION PLAN
 FIGURE 8
 QUEENS, NEW YORK

Five (5) soil vapor implants (SV-2 through SV-6) were installed at exterior locations using direct push technology sampling equipment. The soil vapor implants were constructed of a 6 inch length of double woven stainless steel wire. The implants were installed to a depth of 5.0 feet below grade. Each implant was attached to a ¼ inch polyethylene tubing which was capped with a ¼ inch plastic end to prevent the infiltration of foreign particles into the tube. Coarse sand was placed around the vapor implants to a height of approximately 1.0 foot above the bottom of the implant. The remainder of the boring was sealed with a bentonite slurry to the surfaces. Further, an outdoor (ambient) air sample was collected during the sampling event. The soil vapor samples were 2-hour duration samples and the outdoor (ambient) air sample was an 8-hour duration sample.

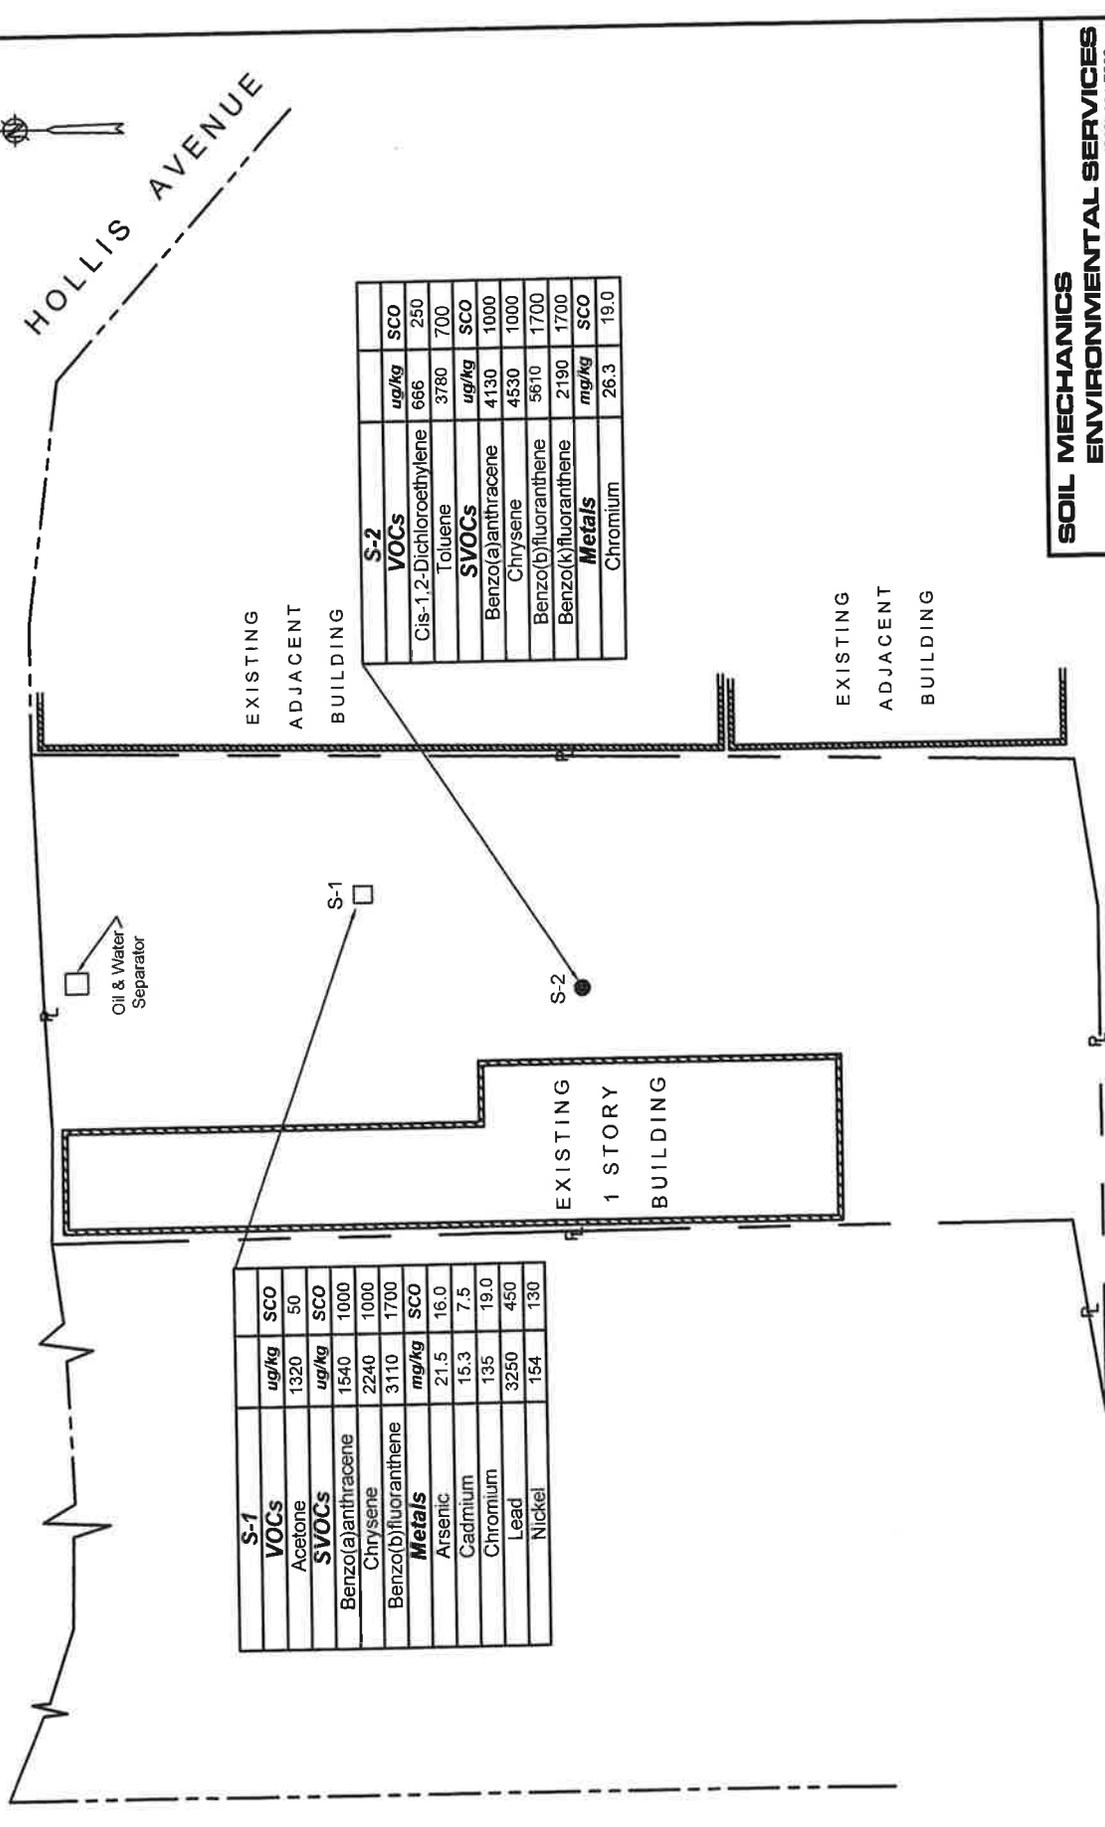
S-1		
VOCs	ug/kg	SCO
Acetone	1320	50
SVOCs	ug/kg	SCO
Benzo(a)anthracene	1540	1000
Chrysene	2240	1000
Benzo(b)fluoranthene	3110	1700
Metals	mg/kg	SCO
Arsenic	21.5	16.0
Cadmium	15.3	7.5
Chromium	135	19.0
Lead	3250	450
Nickel	154	130

S-2		
VOCs	ug/kg	SCO
Cis-1,2-Dichloroethylene	666	250
Toluene	3780	700
SVOCs	ug/kg	SCO
Benzo(a)anthracene	4130	1000
Chrysene	4530	1000
Benzo(b)fluoranthene	5610	1700
Benzo(k)fluoranthene	2190	1700
Metals	mg/kg	SCO
Chromium	26.3	19.0

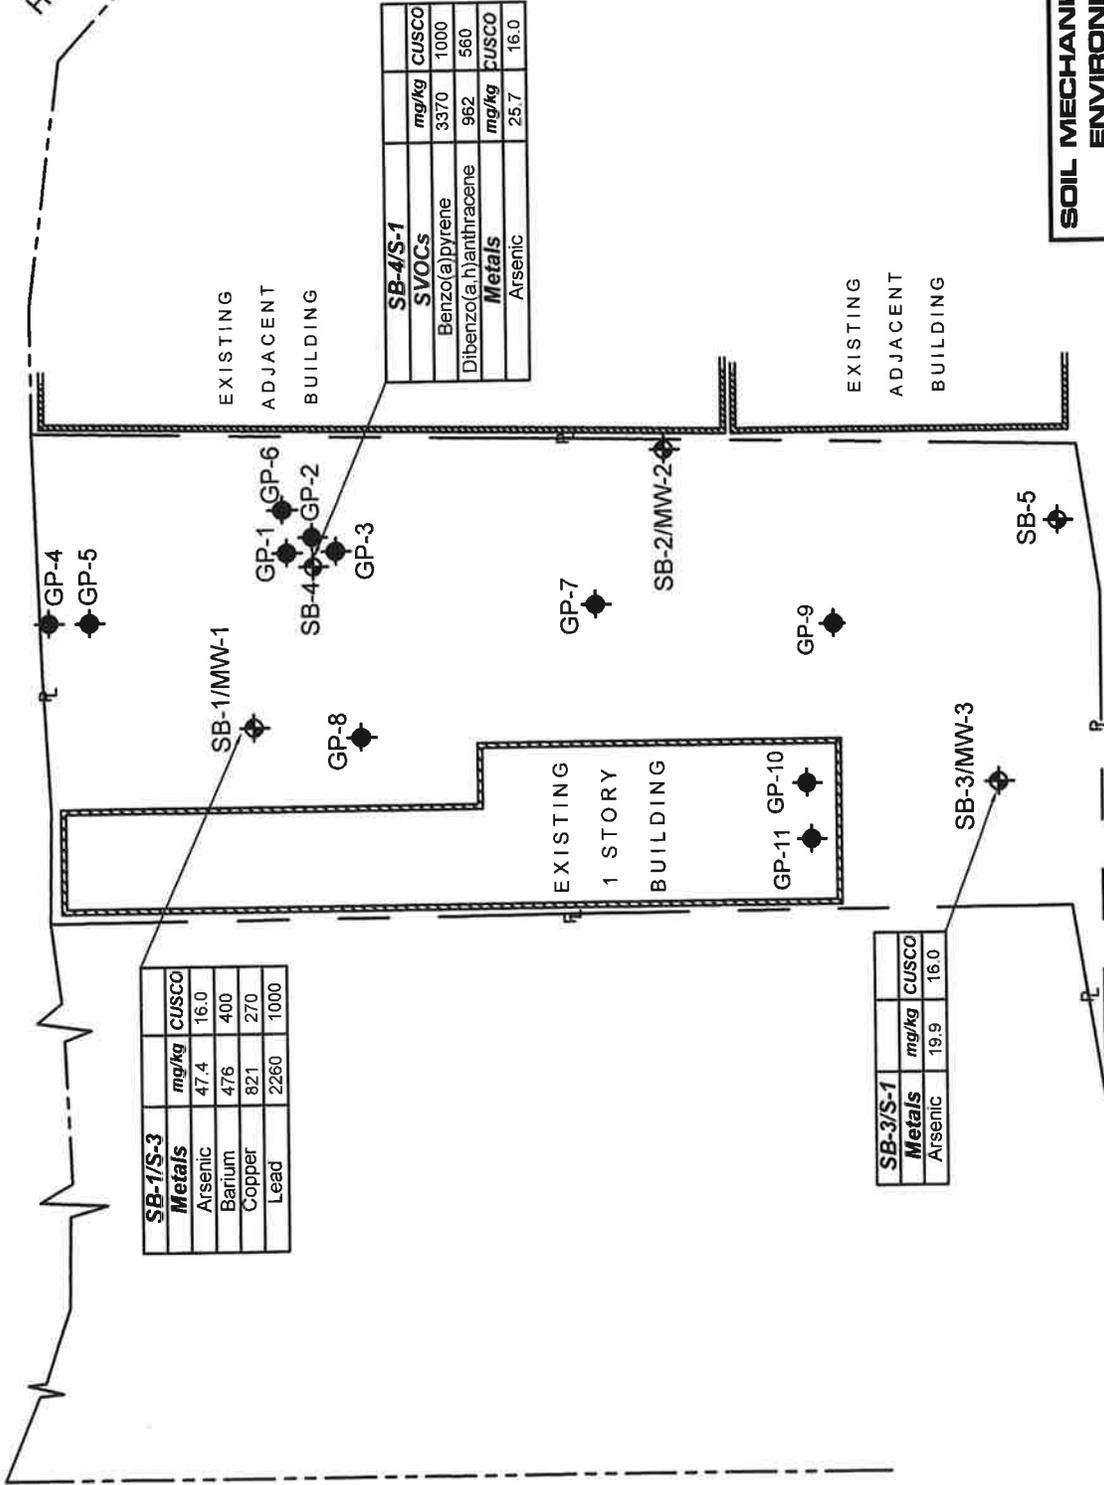
SB-1/S-3		
Metals	mg/kg	CUSCO
Arsenic	47.4	16.0
Barium	476	400
Copper	821	270
Lead	2260	1000

SB-3/S-1		
Metals	mg/kg	CUSCO
Arsenic	19.9	16.0

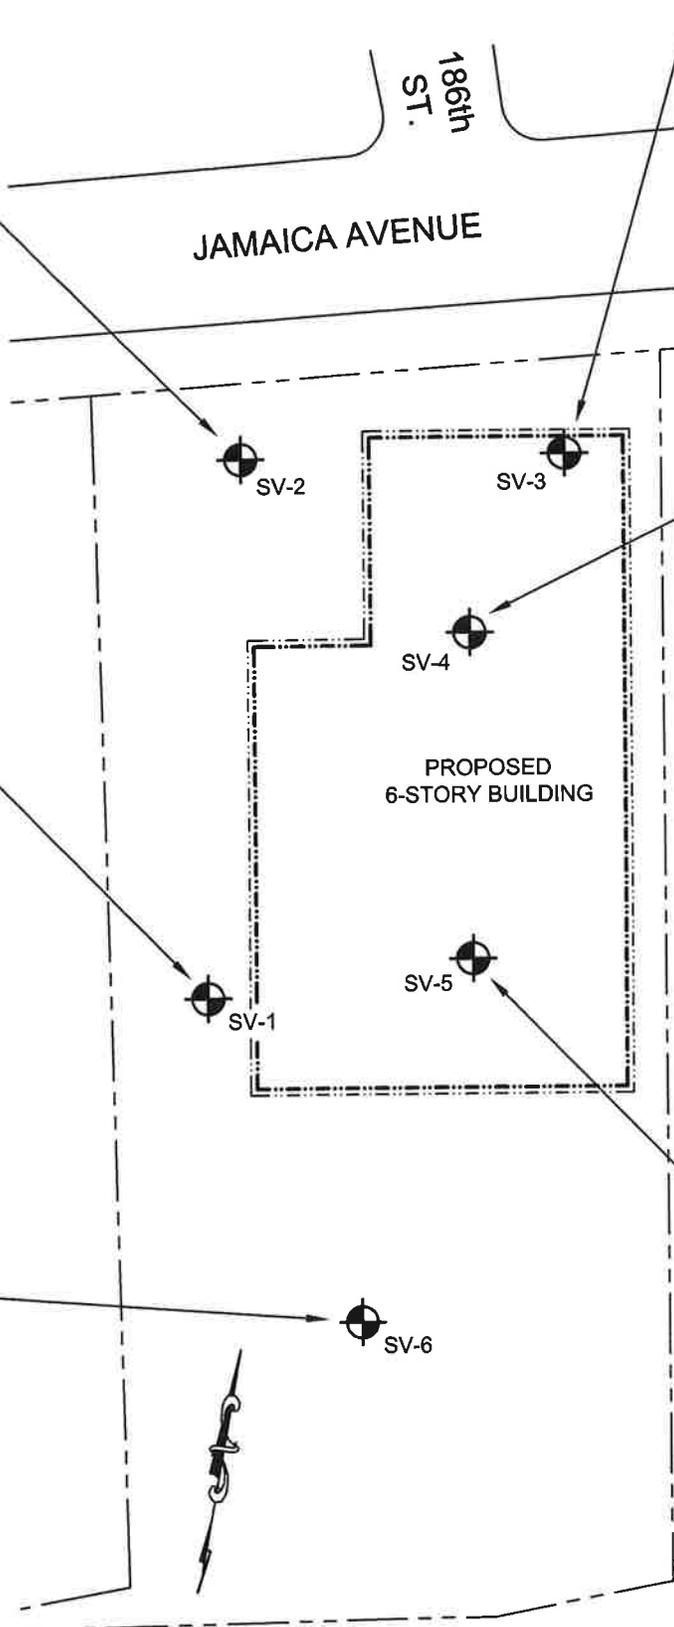
SV-6	
VOCs	ug/m3
1,1,1-Trichloroethane	1.1
1,2,4-Trimethylbenzene	1.1
1,4-Dichlorobenzene	0.92
2,2,4-trimethylpentane	1.0
Acetone	42
Benzene	1.7
Carbone Disulfide	42
Chloroform	0.60
Cyclohexane	0.77
Ethylbenzene	0.93
Freon 11	3.3
Freon 12	2.6
Heptane	1.9
Hexane	4.4
m&p xylene	2.8
Methyl isobutyl ketone	1.4
Methylene Chloride	2.3
o-xylene	0.88
Tetrachloroethylene	2.7
Toluene	4.4

SV-3	
VOCs	ug/m3
1,2,4-Trimethylbenzene	1.0
2,2,4-trimethylpentane	1.2
Acetone	17
Benzene	1.5
Carbone Disulfide	0.41
Chloromethane	0.78
Ethylbenzene	0.79
Freon 11	1.4
Freon 12	2.7
Heptane	0.87
Hexane	1.3
Isopropyl alcohol	3.7
m&p xylene	2.4
Methylene Chloride	1.2
o-xylene	0.75
Tetrachloroethylene	2.1
Toluene	5.1
Trichloroethene	1.1

SV-4	
VOCs	ug/m3
1,2,4-Trimethylbenzene	2.0
1,3,5-Trimethylbenzene	0.65
1,4-Dichlorobenzene	1.0
2,2,4-trimethylpentane	13
4-ethyltoluene	0.60
Acetone	44
Benzene	2.7
Carbone Disulfide	1.6
Chloroform	0.65
Cyclohexane	3.6
Ethyl acetate	8.1
Ethylbenzene	2.3
Freon 11	1.8
Freon 12	2.5
Heptane	5.6
Hexane	9.7
Isopropyl alcohol	7.5
m&p xylene	6.5
Methyl ethyl ketone	5.1
Methyl isobutyl ketone	1.4
Methylene Chloride	3.5
o-xylene	1.9
Tetrachloroethylene	1.9
Toluene	19
Trichloroethene	0.55

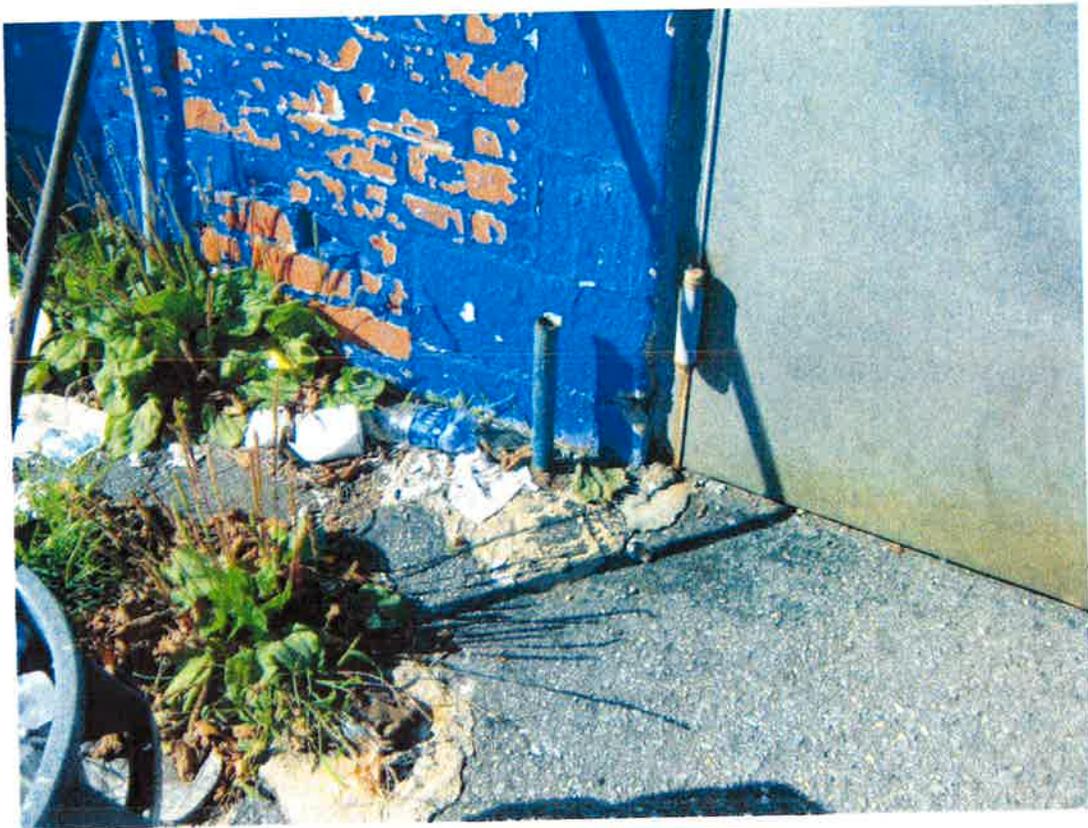
VIEW OF VENT PIPE

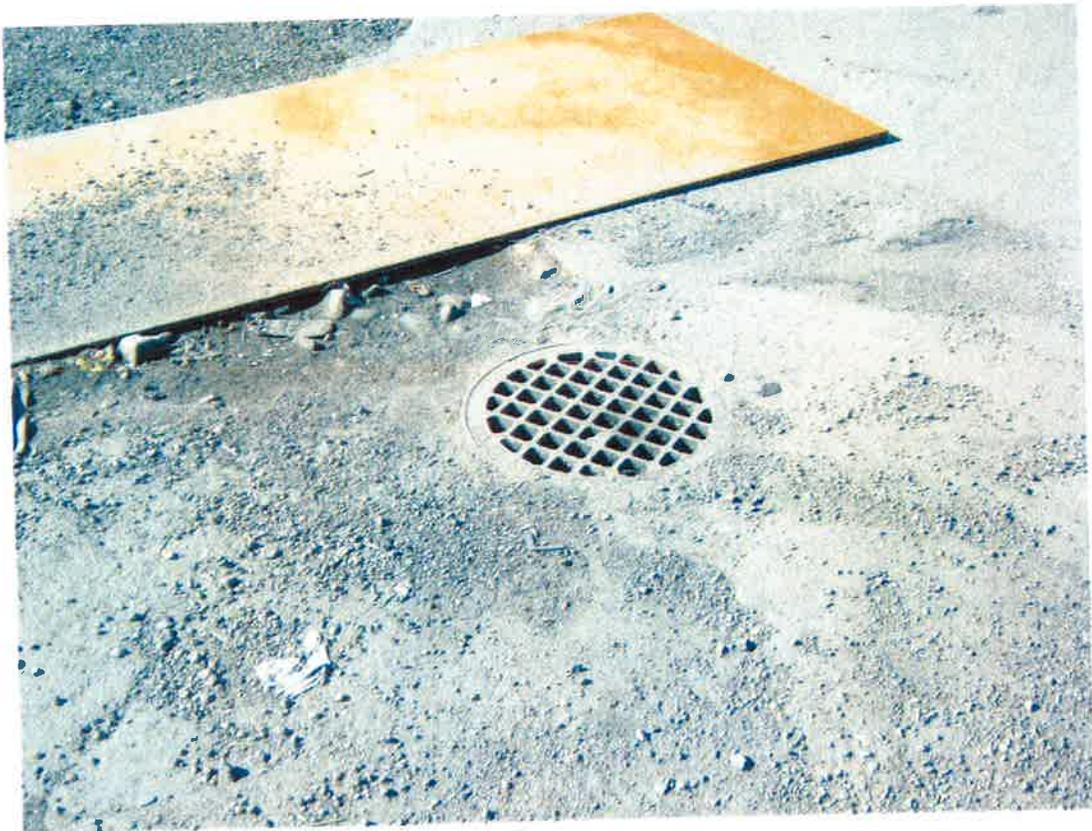
VIEW OF SUBSURFACE DRAINAGE STRUCTURE

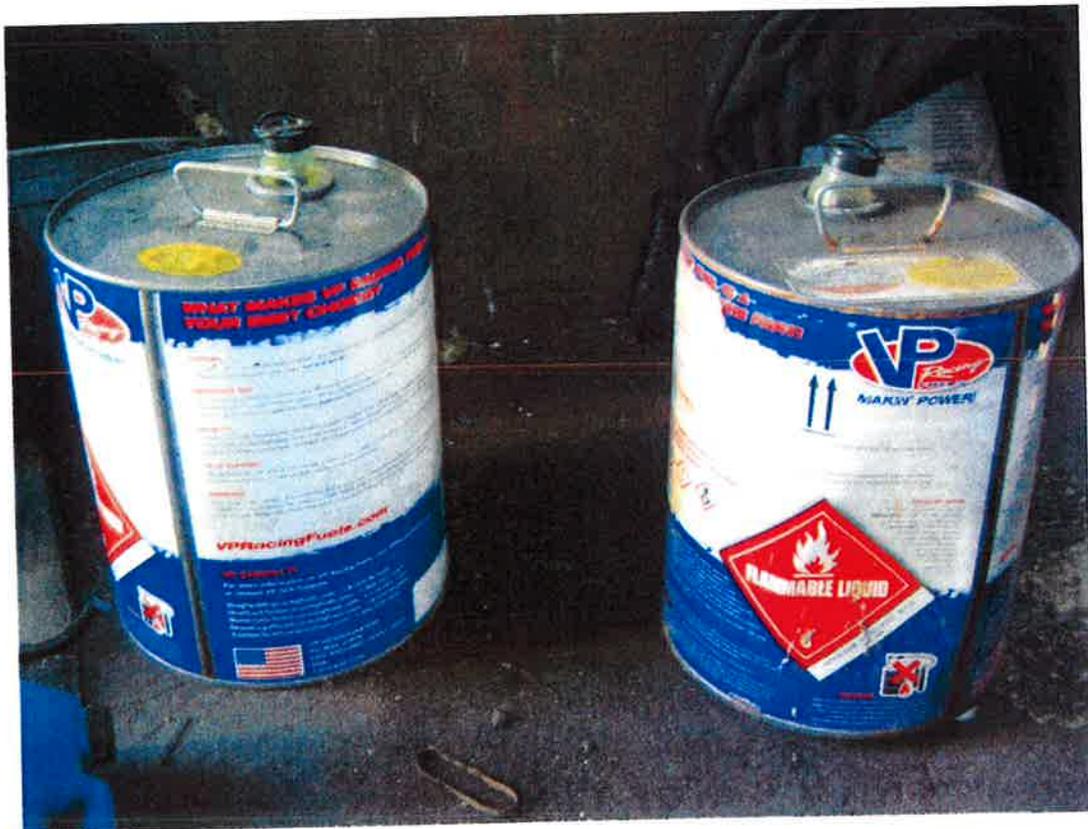
VIEW OF 5-GALLON CONTAINERS OF RACING FUEL

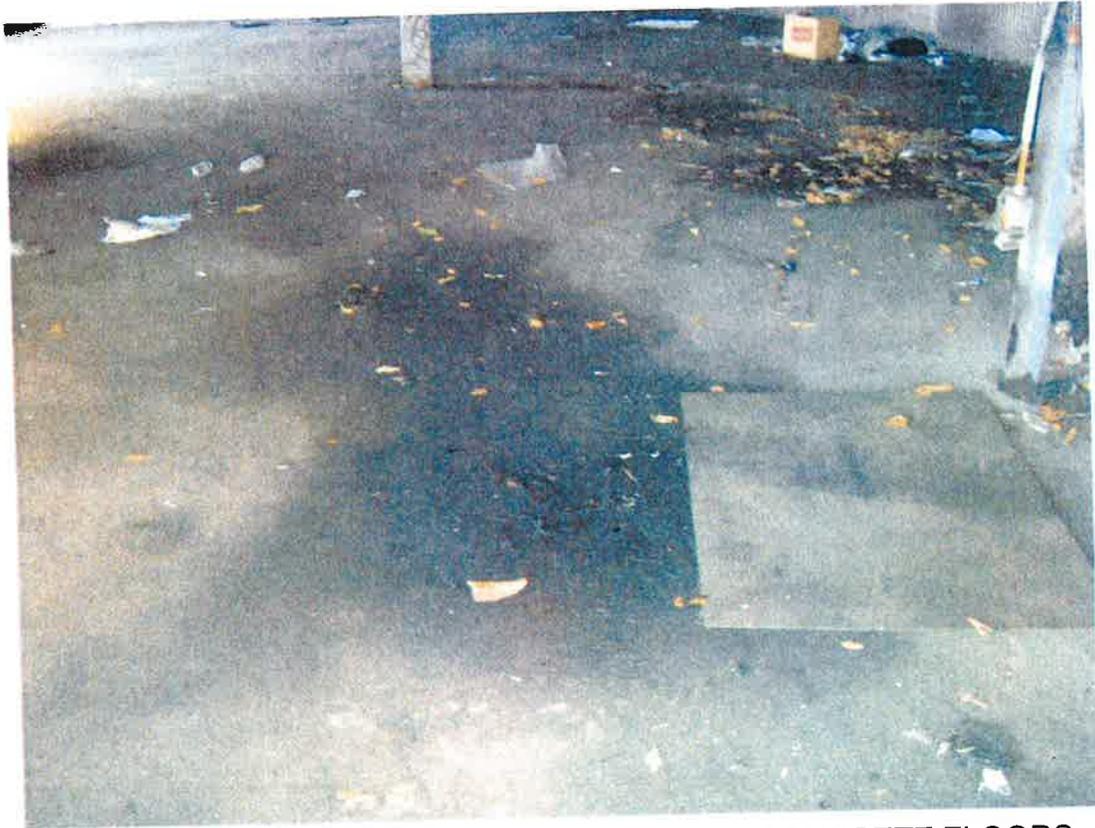
VIEW OF TYPICAL OIL-LIKE STAINING ON CONCRETE FLOORS

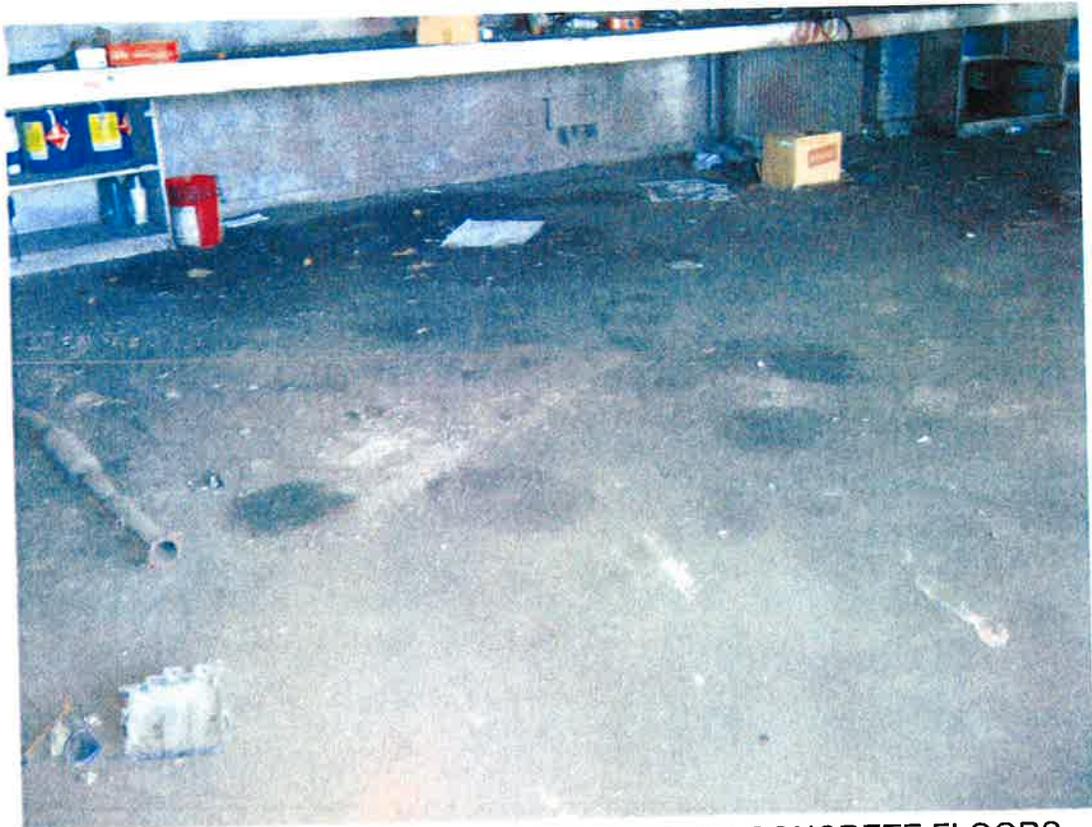
VIEW OF TYPICAL OIL-LIKE STAINING ON CONCRETE FLOORS
