23-10 QUEENSBORO SITE

QUEENS, NEW YORK

Remedial Investigation Report

NYC BCP Site Number: 12CBCP036Q
E-Designation Site Number: #12RHAZ016Q

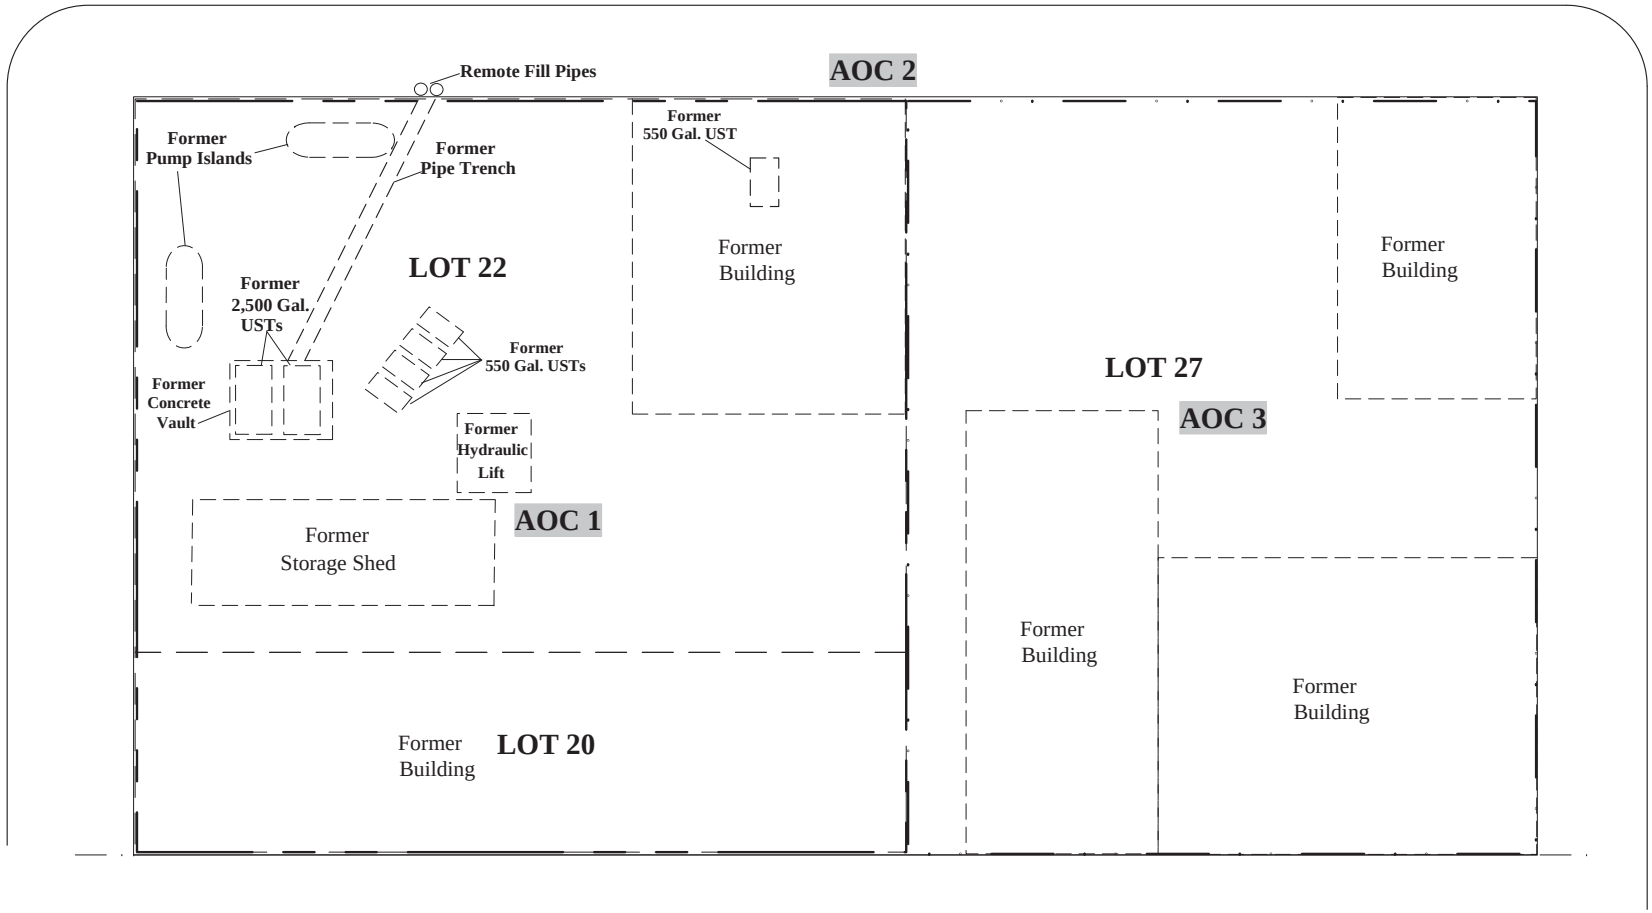
Figure 4
Map of Areas of Concern

AOC 1: Gas station and associated tanks and appurtenances on the western and central portion of the property
AOC 2: Historical fill throughout the site
AOC 3: Soil vapor impacts beneath the central and eastern portions of the Site

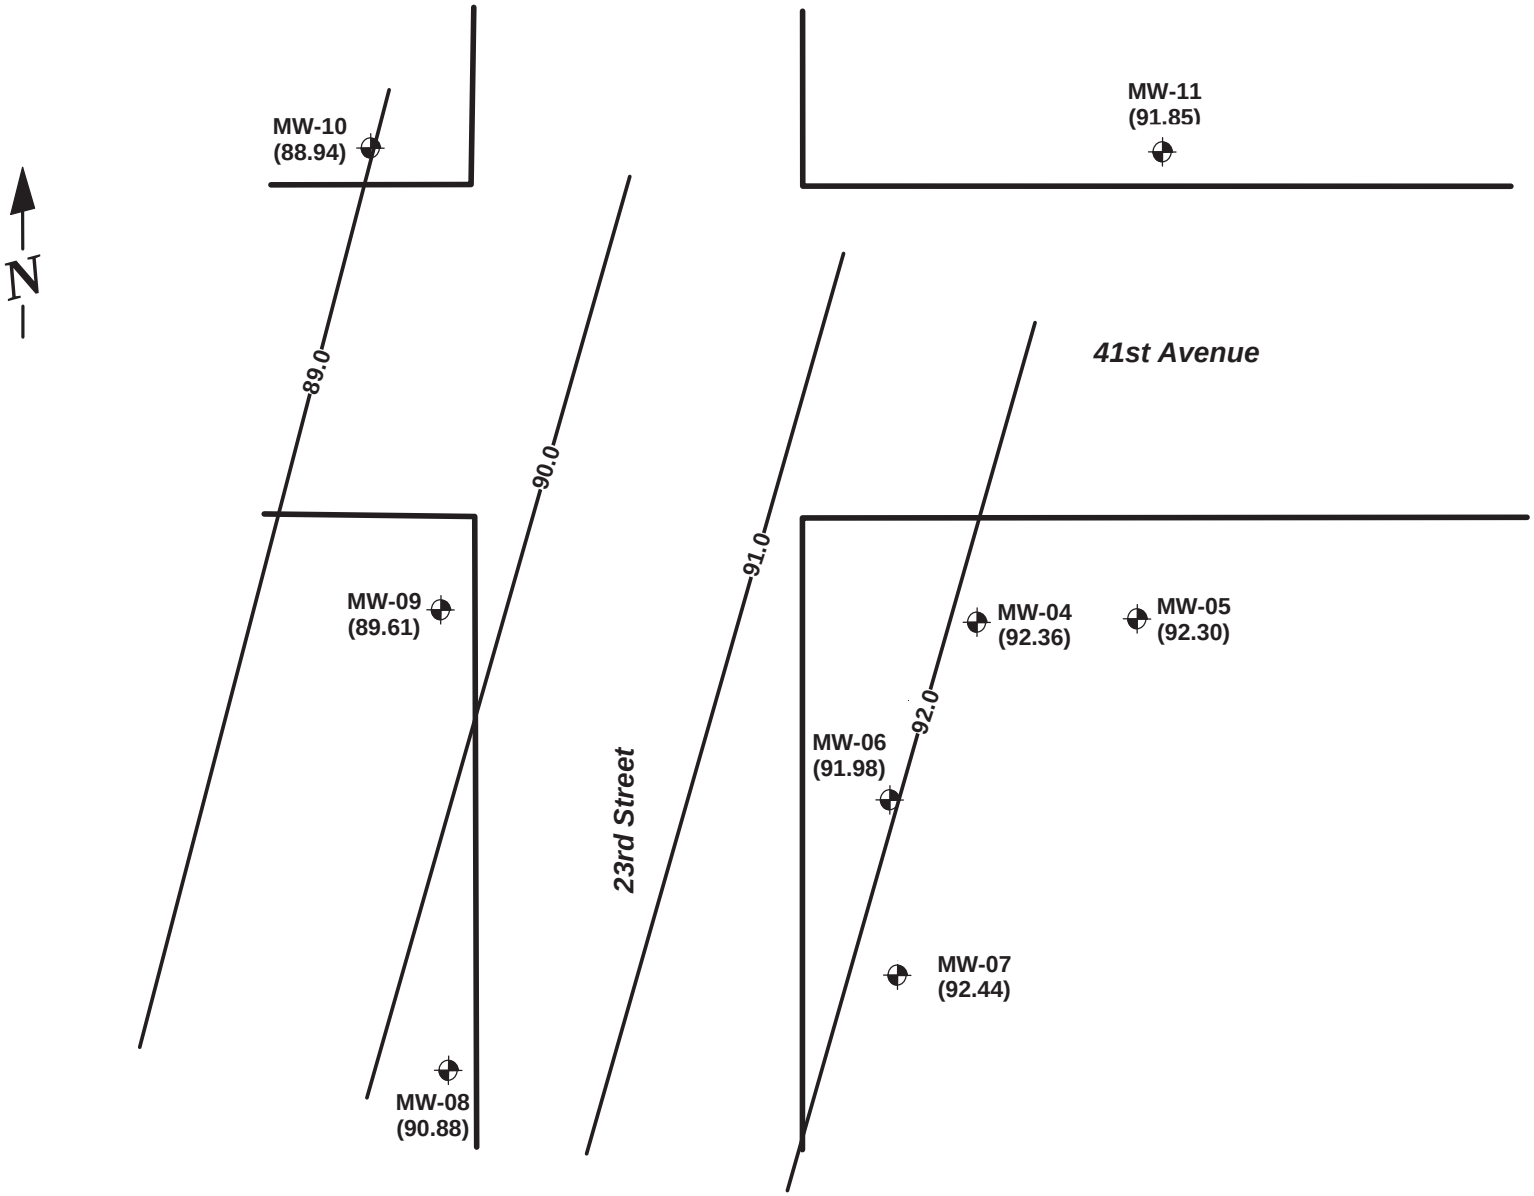
Figure 6
Groundwater Flow Map

A map of groundwater elevations with inferred groundwater contours from the March 17, 2011 monitoring event is provided in Figure 6. Groundwater flow is generally from the east to the west towards the East River. MTA subway dewatering facilities and adjacent building sumps may influence localized flow conditions.

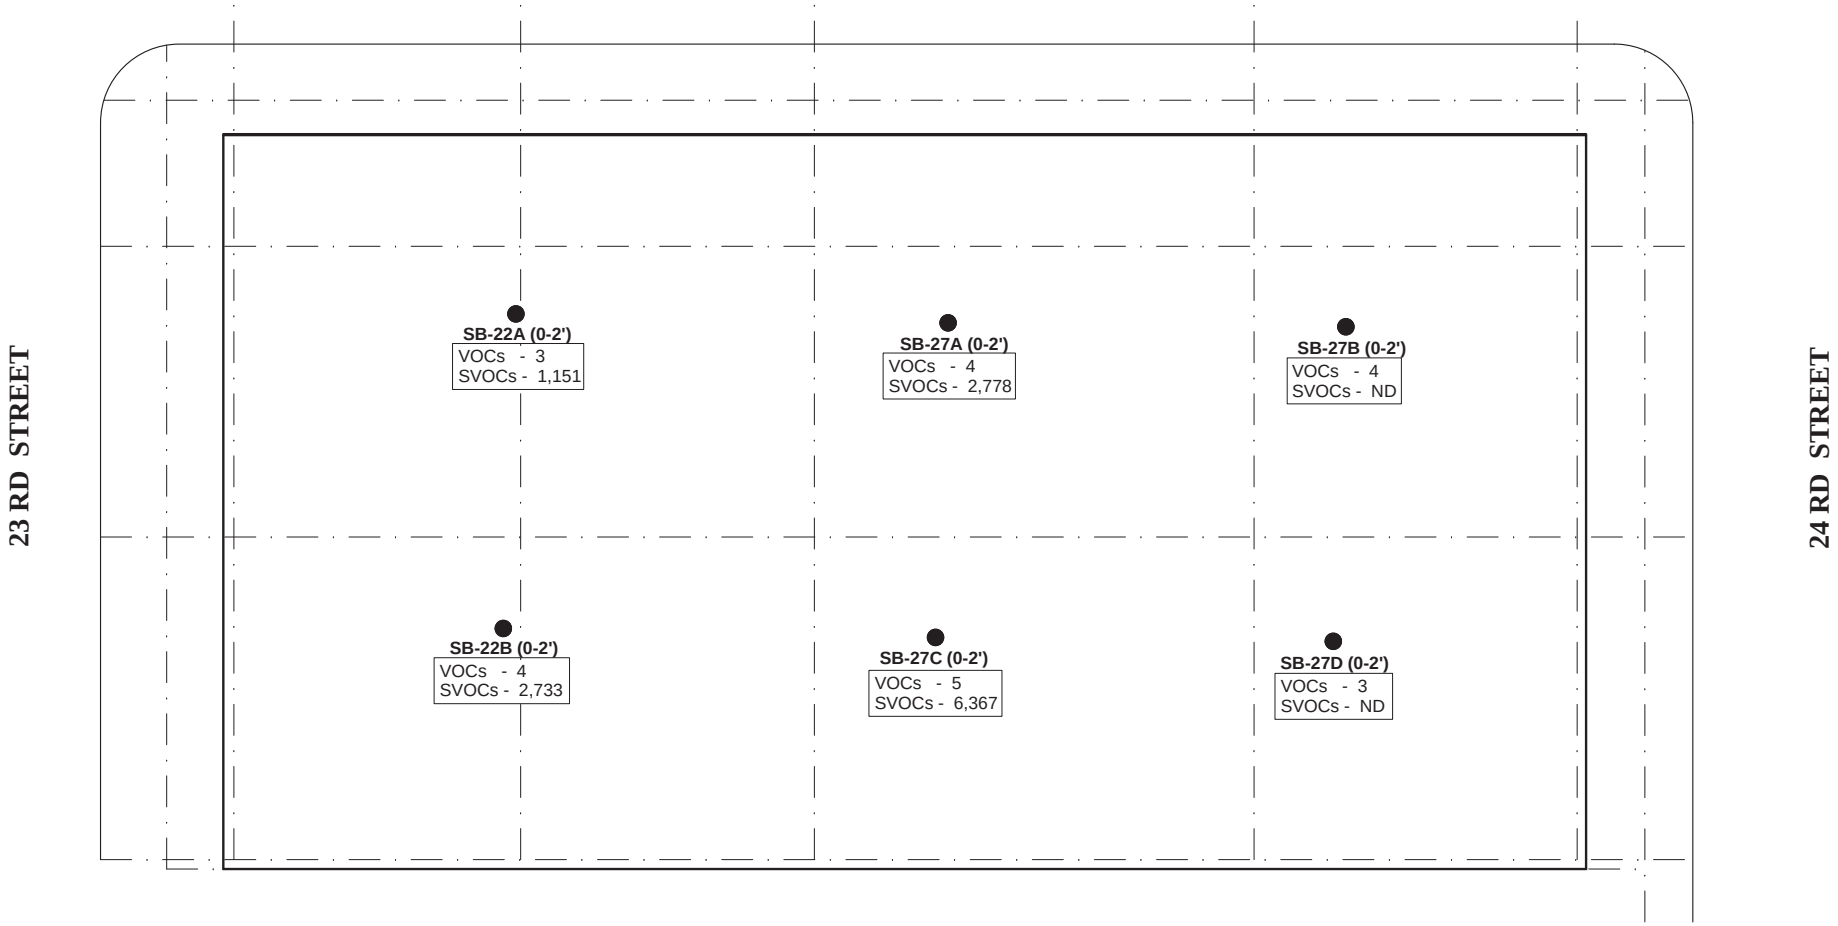
Figure 7A
Shallow Soil Quality

Tables 3A to 3D summarize soil quality in soil/fill material beneath the Site. Figures 7A and 7B depict the extent of total VOCs and total SVOCs in shallow and deep soil horizons, respectively. Data collected from several rounds of investigation were compared to the NYSDEC Part 375 Unrestricted Use (Track 1) Soil Cleanup Objectives (SCOs), Restricted Use (Track 2) Restricted-Residential SCOs, and Restricted Use (Track 2) Commercial SCOs. The data presented in this RI is sufficient to delineate the vertical and horizontal distribution of contaminants in soil/fill at the Site.

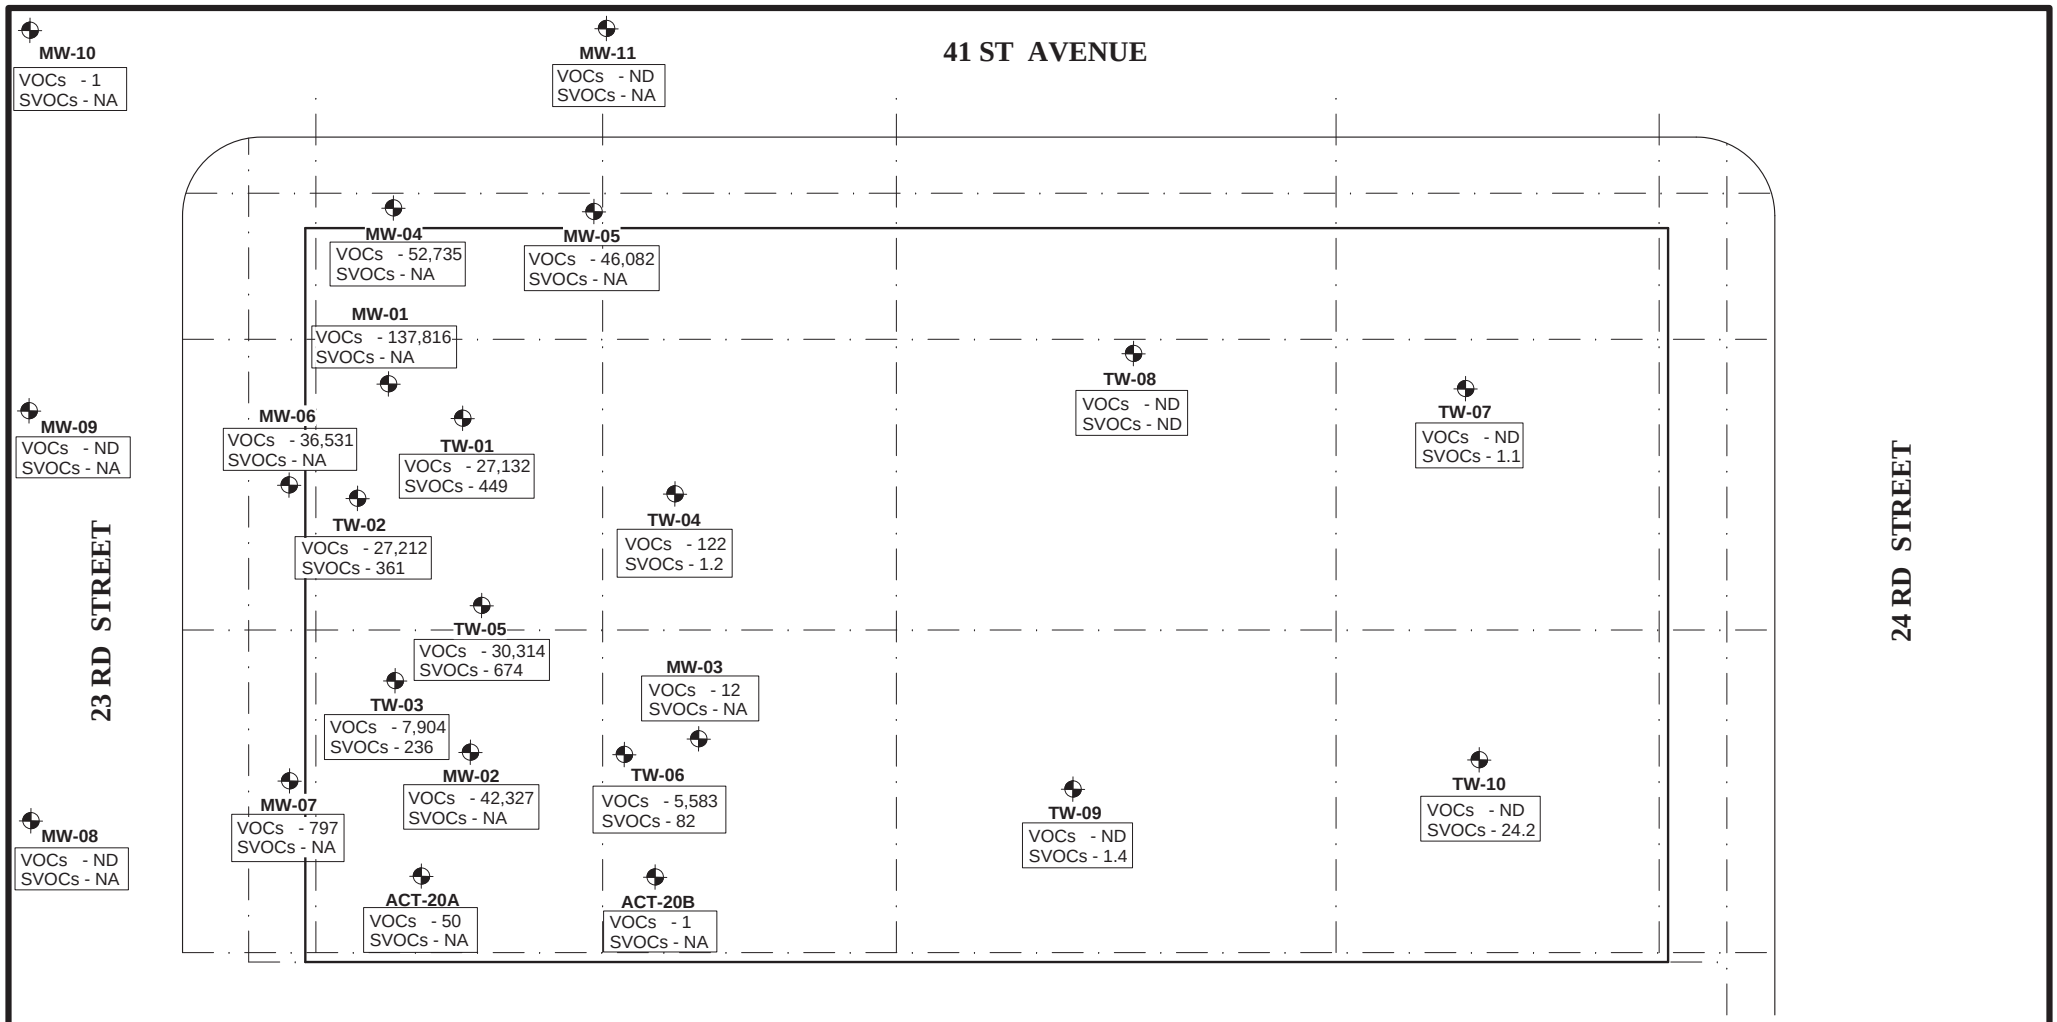
Figure 8
Map of Groundwater Chemistry Results

Starting in August 2006, several rounds of groundwater sampling were performed at the request of the NYSDEC for VOCs. The first round of groundwater sampling in August 2006 indicated that several gasoline-related compounds exceeded the Part 703.5 GWQS, including 1,2,4-trimethylbenzene, 1,3,5-trimethylbenzene, 4-isopropyltoluene, BTEX, isopropylbenzene, methyl tert-butyl ether, naphthalene, n-propylbenzene, sec-butylbenzene, and tert-butyl benzene. The concentrations of VOCs found in the monitoring wells on-site (MW-01 through MW-03) exceeded the GWQS standards.

A second round of sampling in the on-site permanent monitoring wells occurred in November 2006 that indicated several gasoline-related compounds exceeded the Part 703.5 GWQS standards, including 1,2,4-trimethylbenzene, 1,3,5-trimethylbenzene, 4-isopropyltoluene, BTEX, isopropylbenzene, methyl tert-butyl ether, naphthalene, n-propylbenzene, sec-butylbenzene, and tert-butyl benzene. The concentrations of VOCs found in the monitoring wells on-site (MW-01 through MW-03) exceeded the GWQS standards.

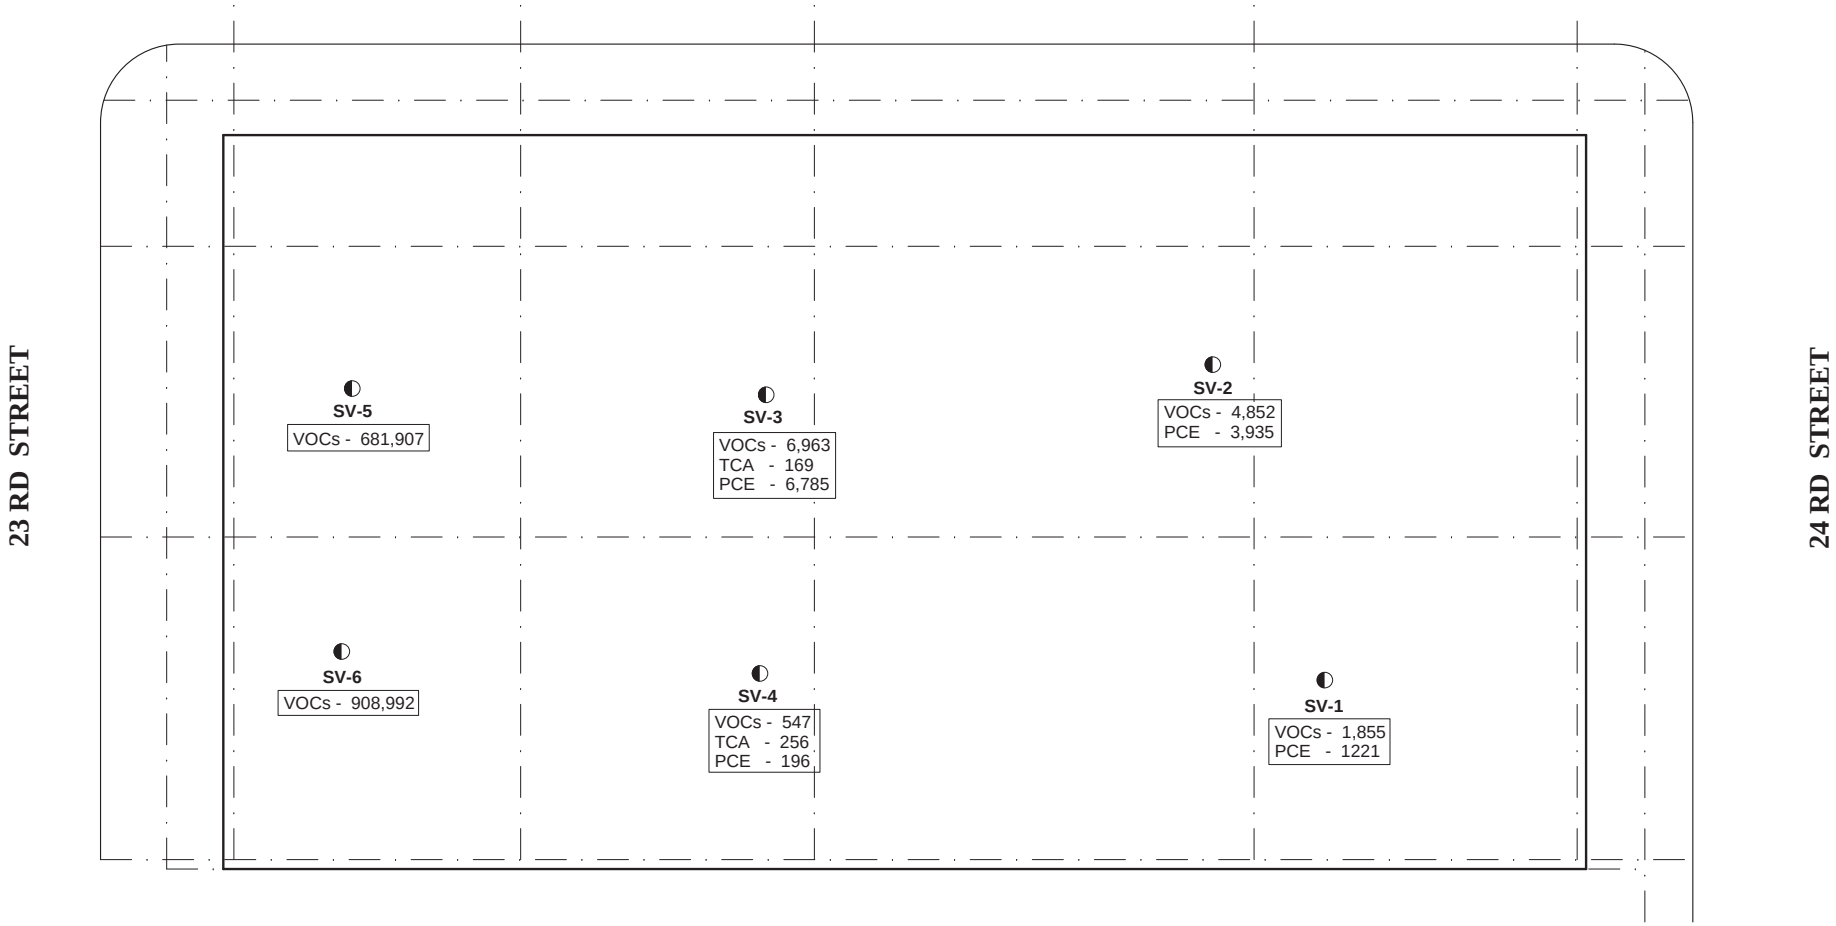
Figure 9
Map of Soil Vapor Chemistry Results

SV-4
VOCs - 547
TCA - 256
PCE - 196

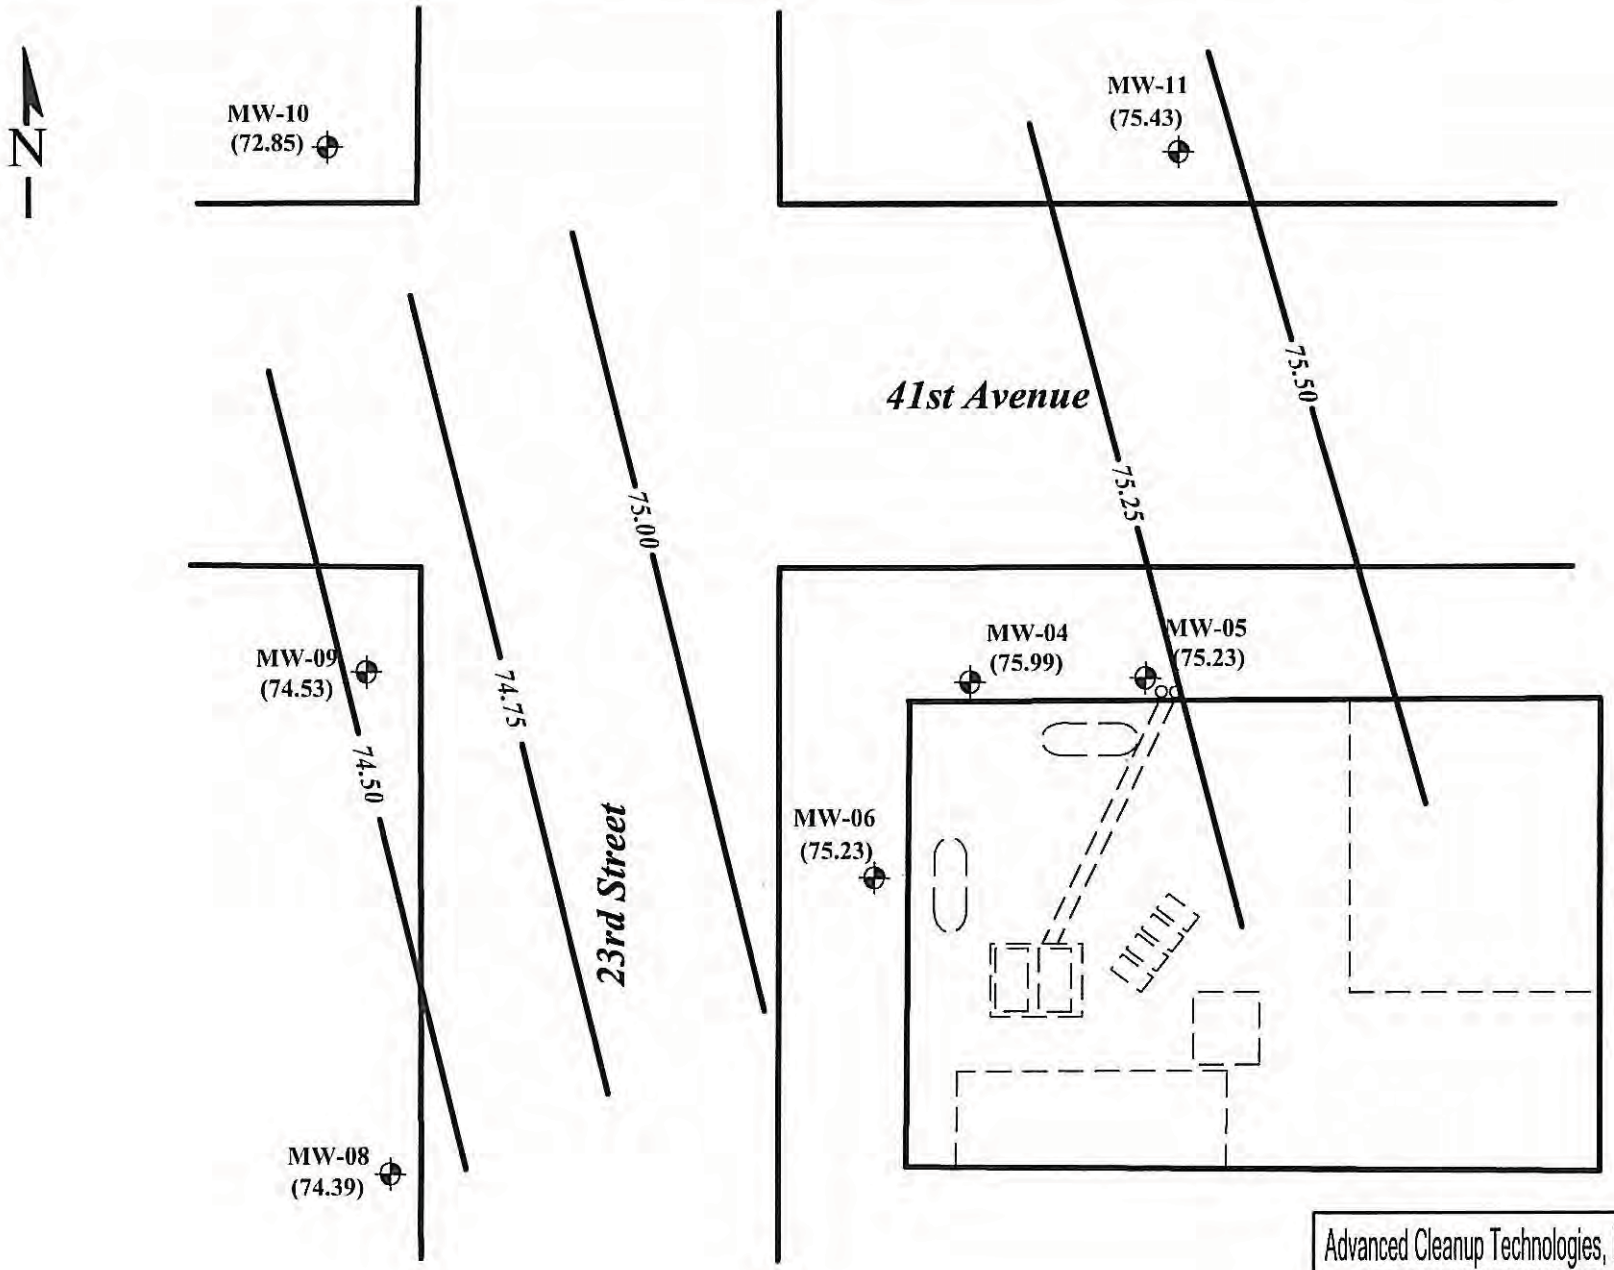
Figure 4 represents ground water flow on January 7th and Figure 5 represents ground water flow on January 18th. Both diagrams depict ground water flow in a west to southwesterly direction beneath the Site. Areas of localized recharge and discharge consistent with observations made in 2006 were again noted during both recent monitoring events. These conditions may be attributed to artifical recharge from adjacent water or sewer pipes and ground water depression from nearby buildings or subway tunnels running beneath 41st Avenue and 23rd Street. Neither of these conditions should affect the migration of impacted ground water away from the Site.

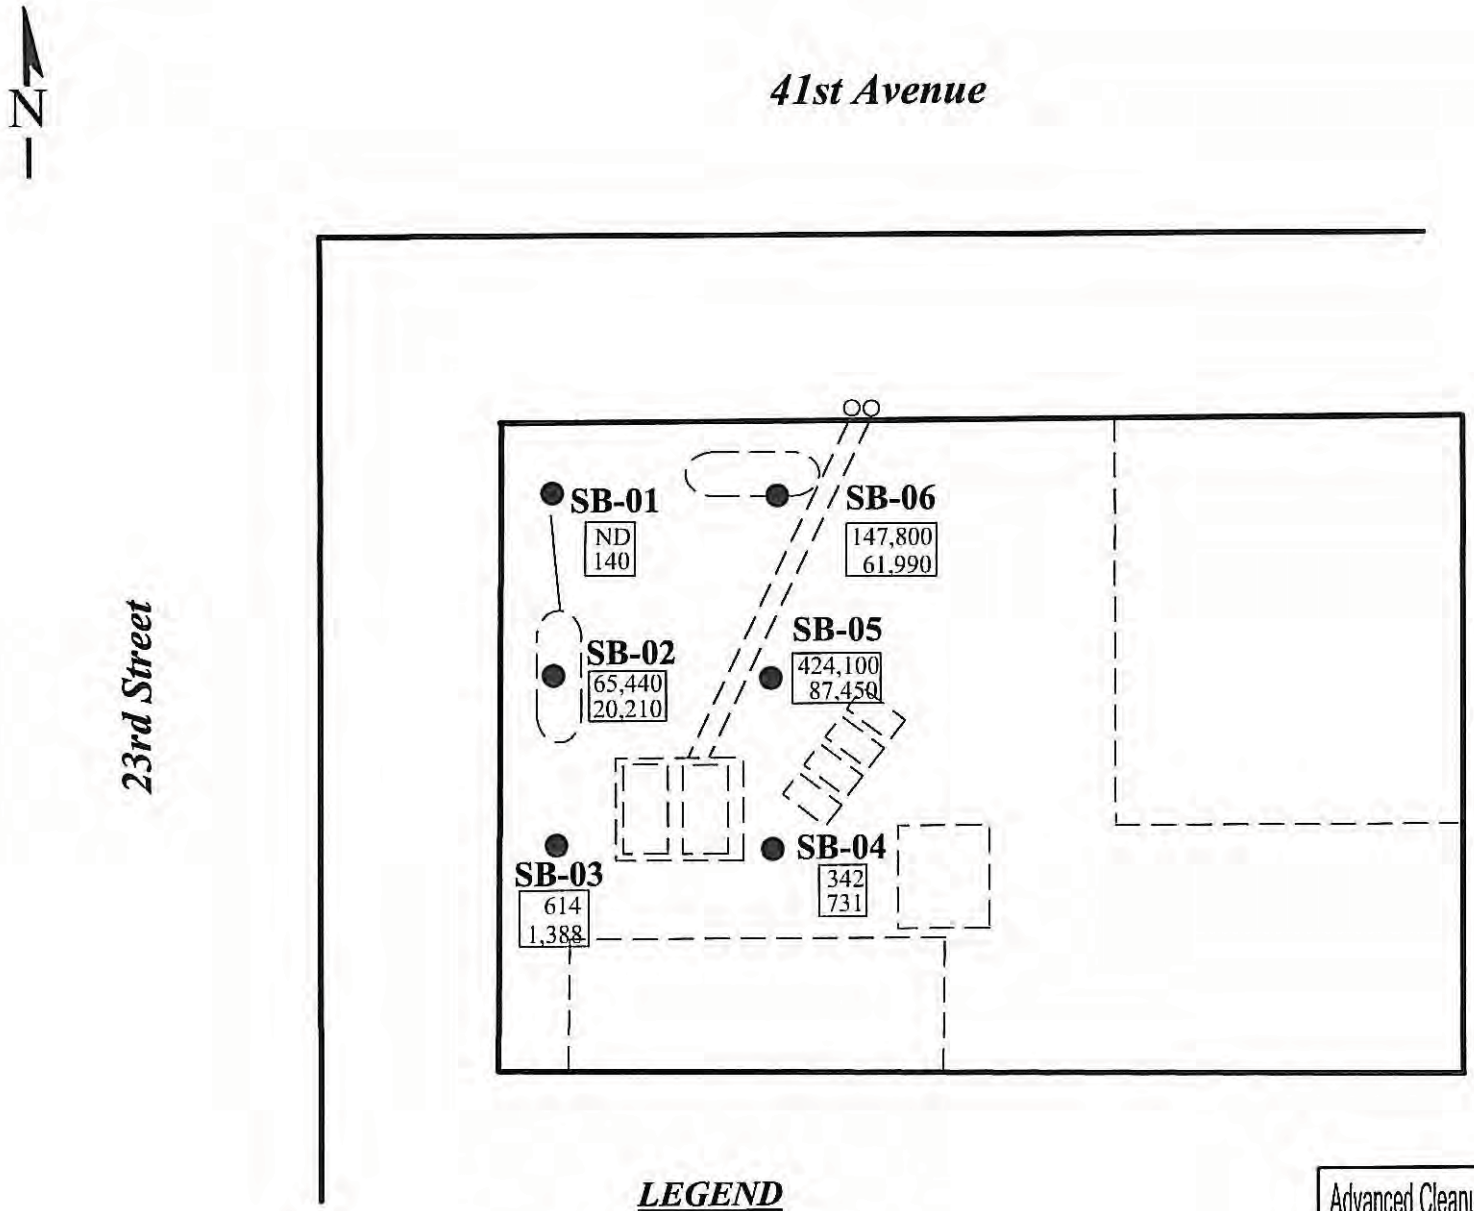
Figure 6

The extent of subsurface soil impacted by gasoline constituents is depicted in Figure 6. Significant gasoline contamination was identified in soil borings SB-02, SB-05 and SB-06 which encompass the area of the Site where the two former pump islands and remote piping were located. The northwest corner of the Site where SB-01 was installed had virtually no gasoline contamination.

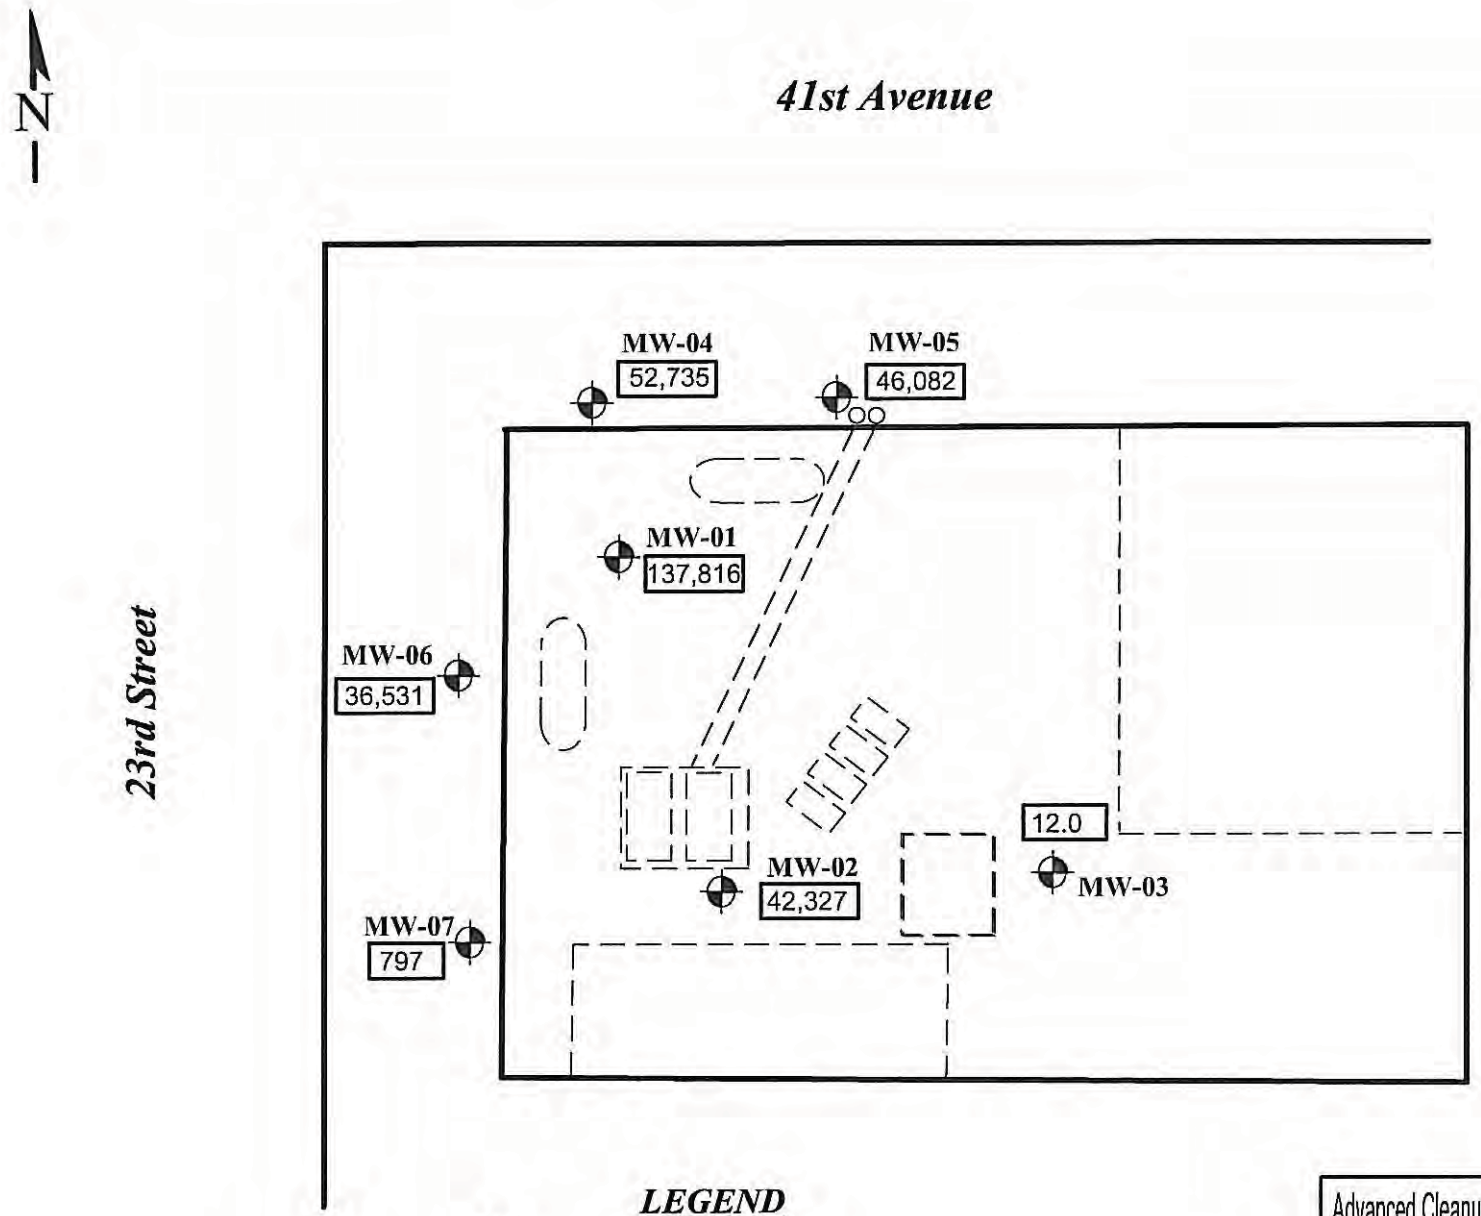
Figure 7

The results of the November 2006 sampling event were presented to the NYSDEC in a November 21, 2006 letter report and are summarized in Figure 7. Copies of the laboratory reports from that sampling event are also contained in Appendix C. As indicated in Figure 7, high concentrations of gasoline constituents were identified in ground water beneath the western portion of the Site. However, no separate-phase product was identified in any of the monitoring wells.
