1 EXISTING CROSBY STREET - LOOKING EAST

SEVERE CRACKING AND MOVEMENT; HAZARDOUS CONDITION AT BRICK MASONRY AND LINTEL

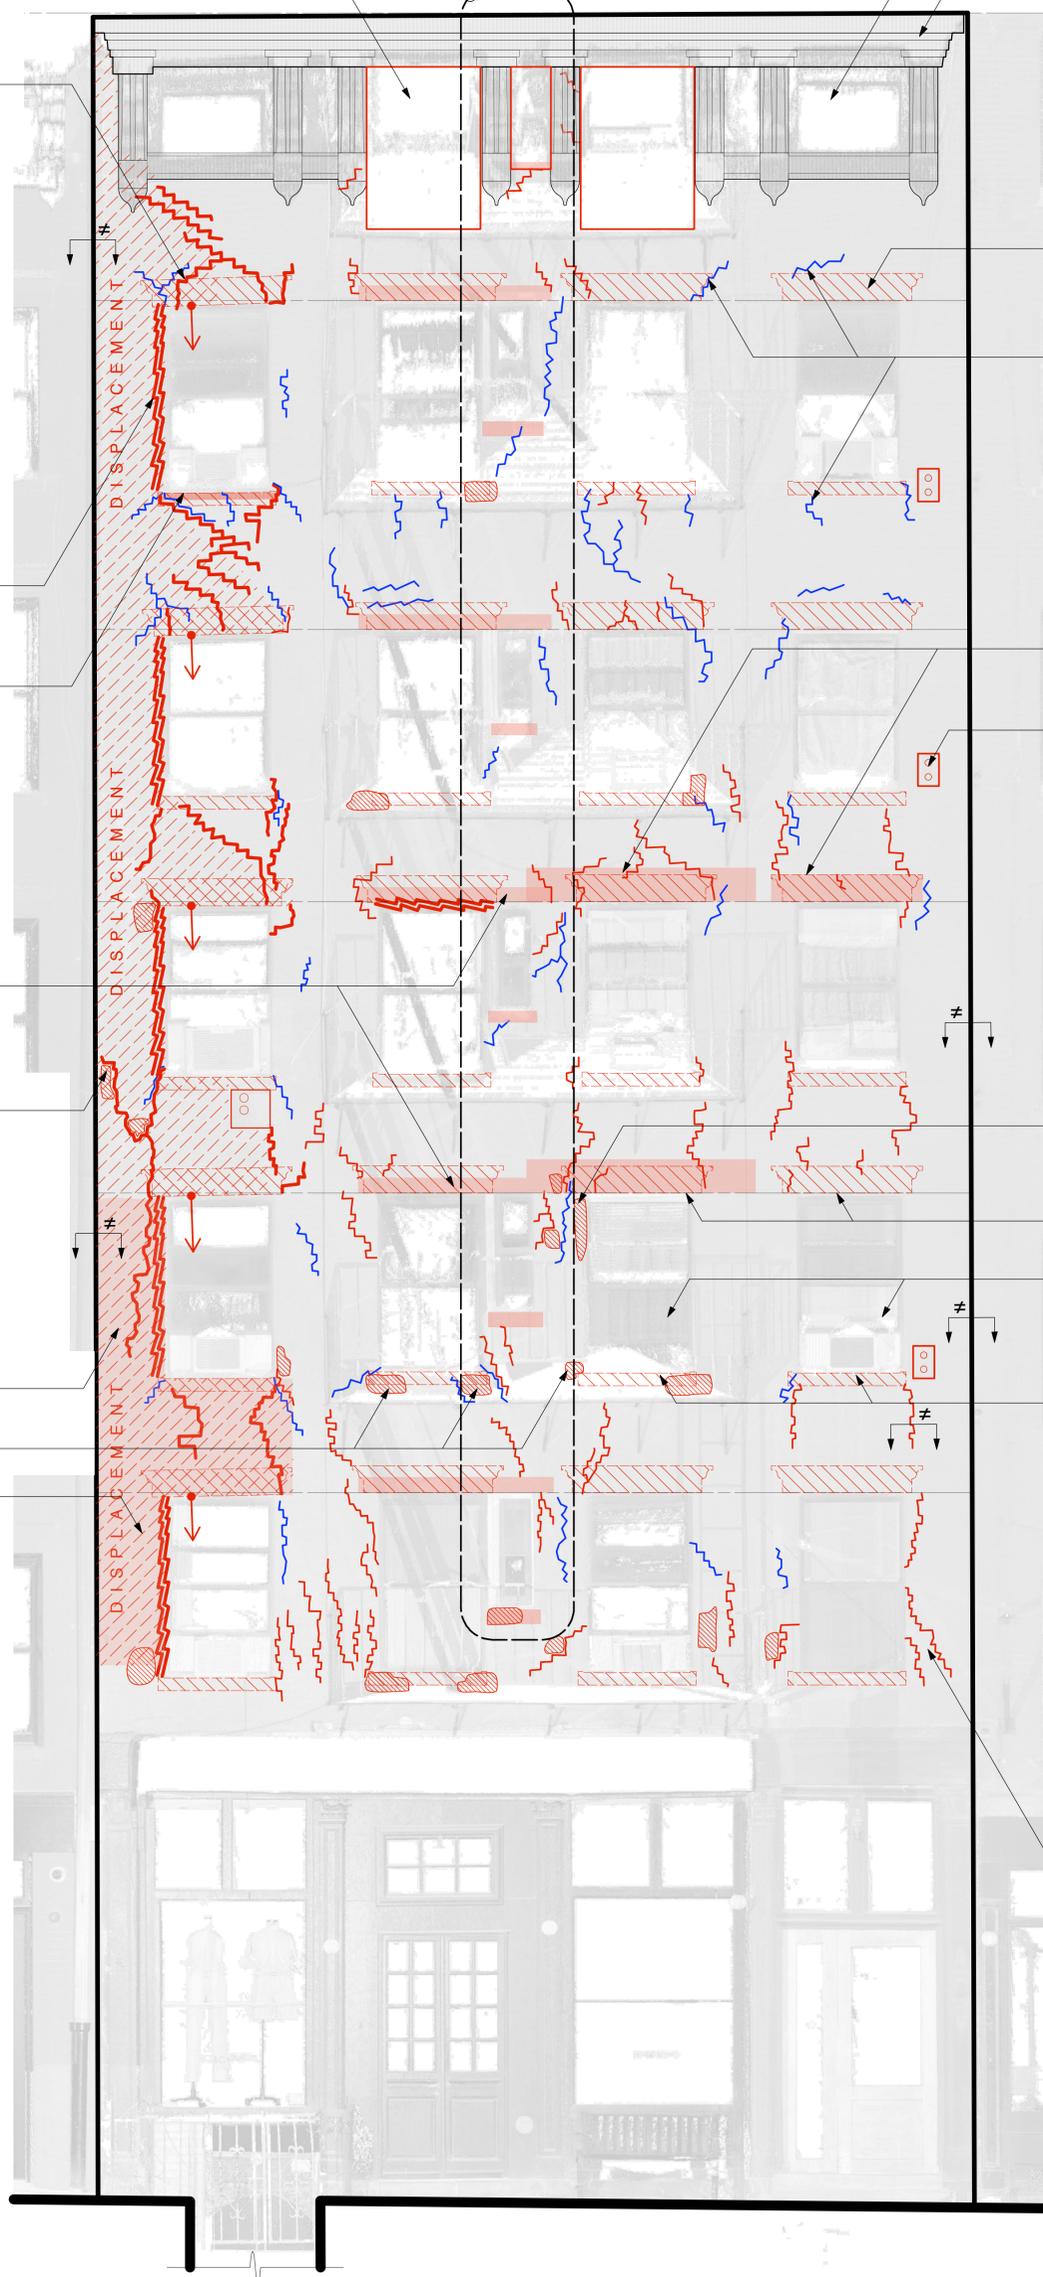
DELAMINATION: FACE BRICK HAS SEPARATED FROM INNER WYTHES THROUGHOUT FACADE

NON-HISTORIC STONE SILL BACK PITCHED TO INTERIOR (NOTE ACCUMULATION OF SPOILS FROM ACTIVE CRACKING)

NON-ORIGINAL LINTEL (TYP): STONE LINTEL REMOVED AND STEEL BEAM ADDED WHEN WINDOW CONFIGURATION ALTERED (SEE NOTE AT TOP).

DISPLACEMENT: WALL IS OUT OF PLANE (TYP)

SPALLING AT STONE SILLS (TYP)

NON-HISTORIC MATERIAL: RECONSTRUCTED BRICK DOES NOT MATCH ORIGINAL

ORIGINAL STONE LINTELS CHOPPED BACK THROUGHOUT, ROUGHLY PATCHED WITH MORTAR AND COATED.

BRICK MASONRY CRACKING ON THE INTERIOR (TYP).

NON-ORIGINAL CONCRETE LINTELS. DO NOT MATCH ORIGINAL CONDITION.

ORIGINAL BRICK MASONRY REMOVED AND METAL VENTS INSTALLED (TYP).

ACTIVE SPALLING & CRACKING; HAZARDOUS CONDITION AT BRICK MASONRY

ORIGINAL STONE SILLS CHOPPED BACK THROUGHOUT, ROUGHLY PATCHED WITH MORTAR AND COATED

MULTIPLE LAYERS OF COATING OVER ENTIRE FACADE. NOTE: COATING REMOVAL REVEALED BRICK IS CRUSHED THROUGHOUT

HISTORIC CORNICE TO BE SALVAGED AND REINSTALLED
