**PHASE I ENVIRONMENTAL SITE ASSESSMENT
FOR
SHAFT 33B – WATER MAIN ROUTE**

**OCTOBER 2004
Revised DECEMBER 2005**

Prepared By: Malcolm Pirnie, Inc.

ENVIRONMENTAL SITE ASSESSMENT REPORT
Shaft 33B – Water Main Route
New York, New York

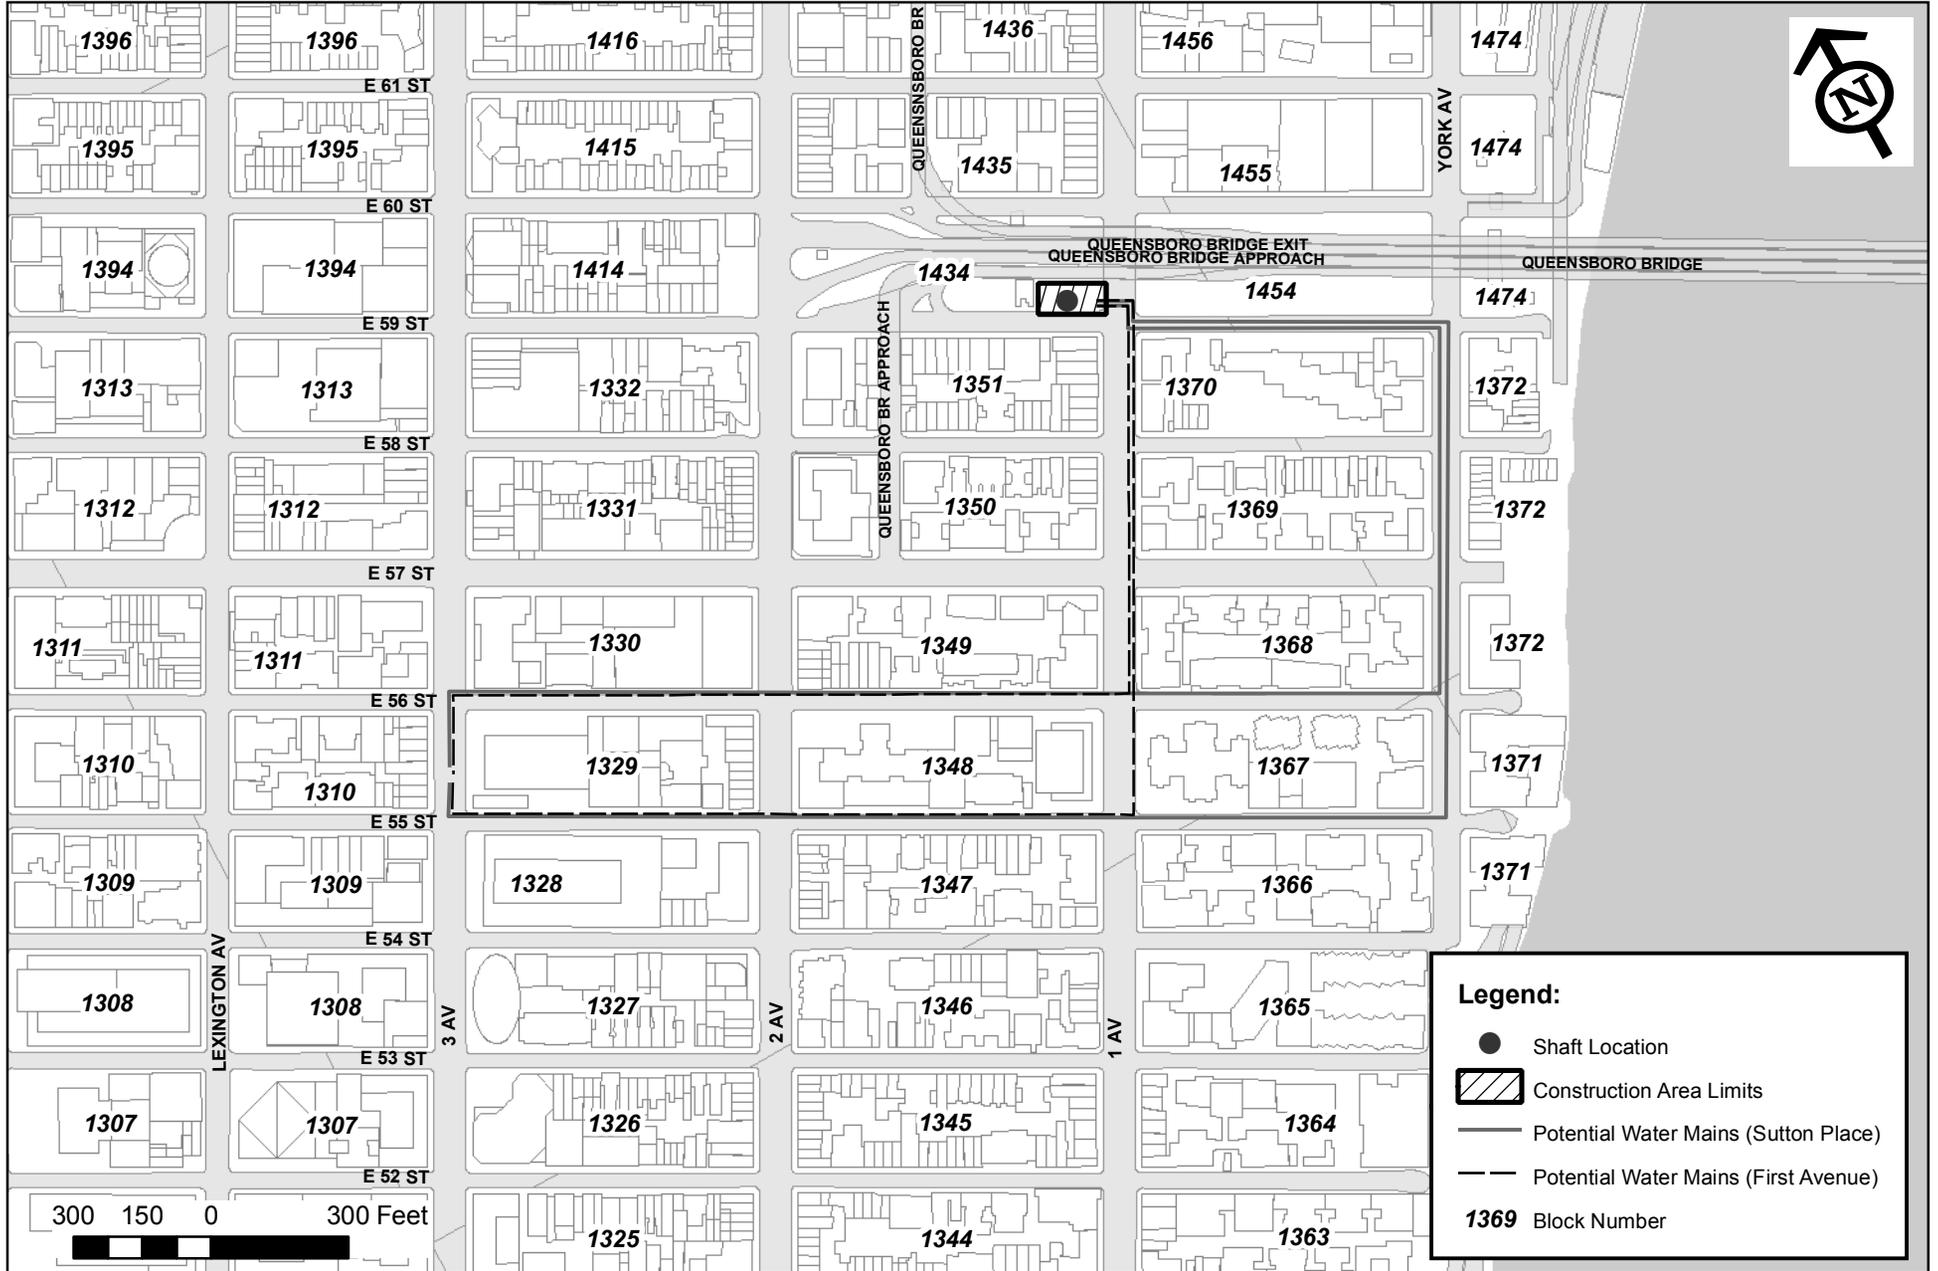
FIGURE 1

The Route, as shown in Figure 1, consists of a corridor of land encompassing adjacent properties at a distance of ¼ mile from the water main route in New York, New York. The area around the Site is zoned for a variety of uses, including residential development, commercial uses, infrastructure, and open space. Occupied commercial space consists predominantly of small, independently-owned businesses at ground level with residential space above. The Site is bordered by E. 61st Street to the north, E. 53rd Street to the south, Sutton Place to the east, and Lexington Avenue to the west.

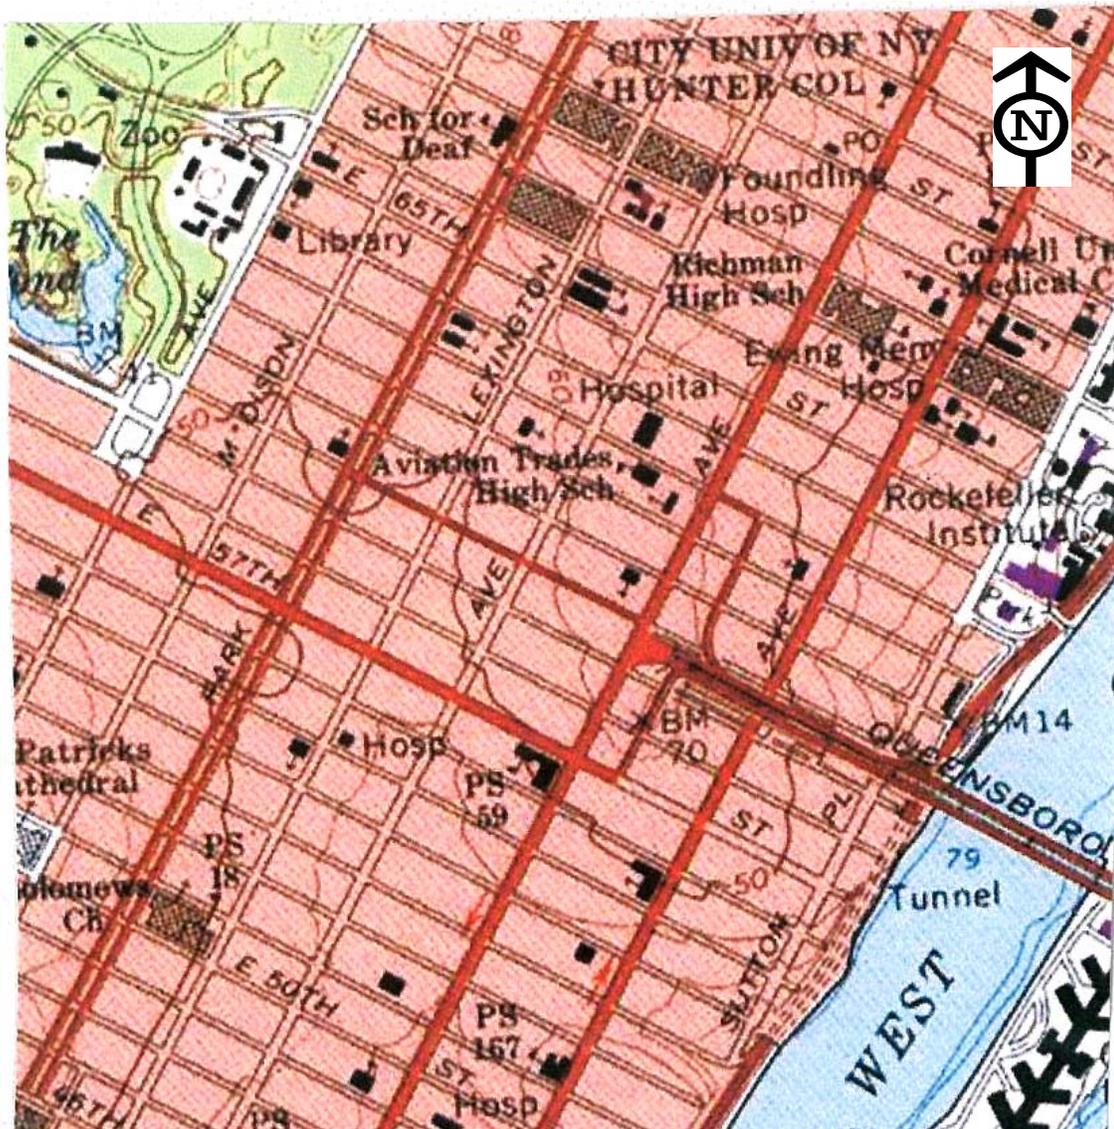
NEW YORK CITY DEPARTMENT OF ENVIRONMENTAL PROTECTION
CITY WATER TUNNEL NO. 3, STAGE 2
SHAFT 33B - WATER MAIN ROUTE
SITE TOPOGRAPHIC MAP

This Environmental Site Assessment (ESA) Report [**Report**] has been prepared for the sole use of Malcolm Pirnie, Inc.'s Client, the New York City Department of Environmental Protection (NYCDEP). The purpose of this Report is to provide information to the Client on the environmental conditions of the subject route bordered by E. 61st Street to the north, E. 53rd Street to the south, Sutton Place to the east, and Lexington Avenue to the west in New York, New York, as shown in the topographic map provided in Appendix A.¹

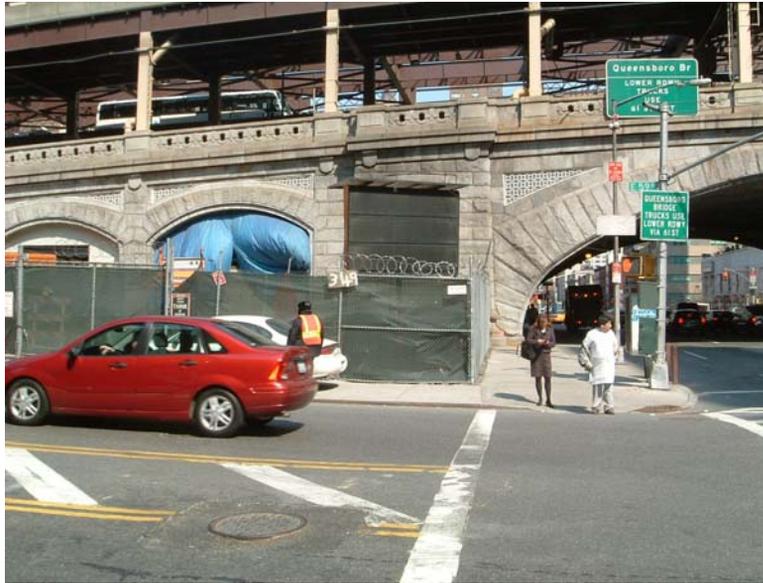
PHOTO 1: PREFERRED SHAFT 33B SITE

Recent geotechnical borings at the preferred Shaft 33B Site located at the north end of the water main route are likely representative of conditions along the length of the water main route. The recent borings at preferred Shaft 33B Site showed bedrock to be approximately 22 feet below
